# FINDING OF NO SIGNIFICANT IMPACT AND DECISION DOCUMENT

## North Entrance Road Reconstruction Project (Mammoth Hot Springs, WY to Gardiner, MT) Environmental Assessment PEPC 148162

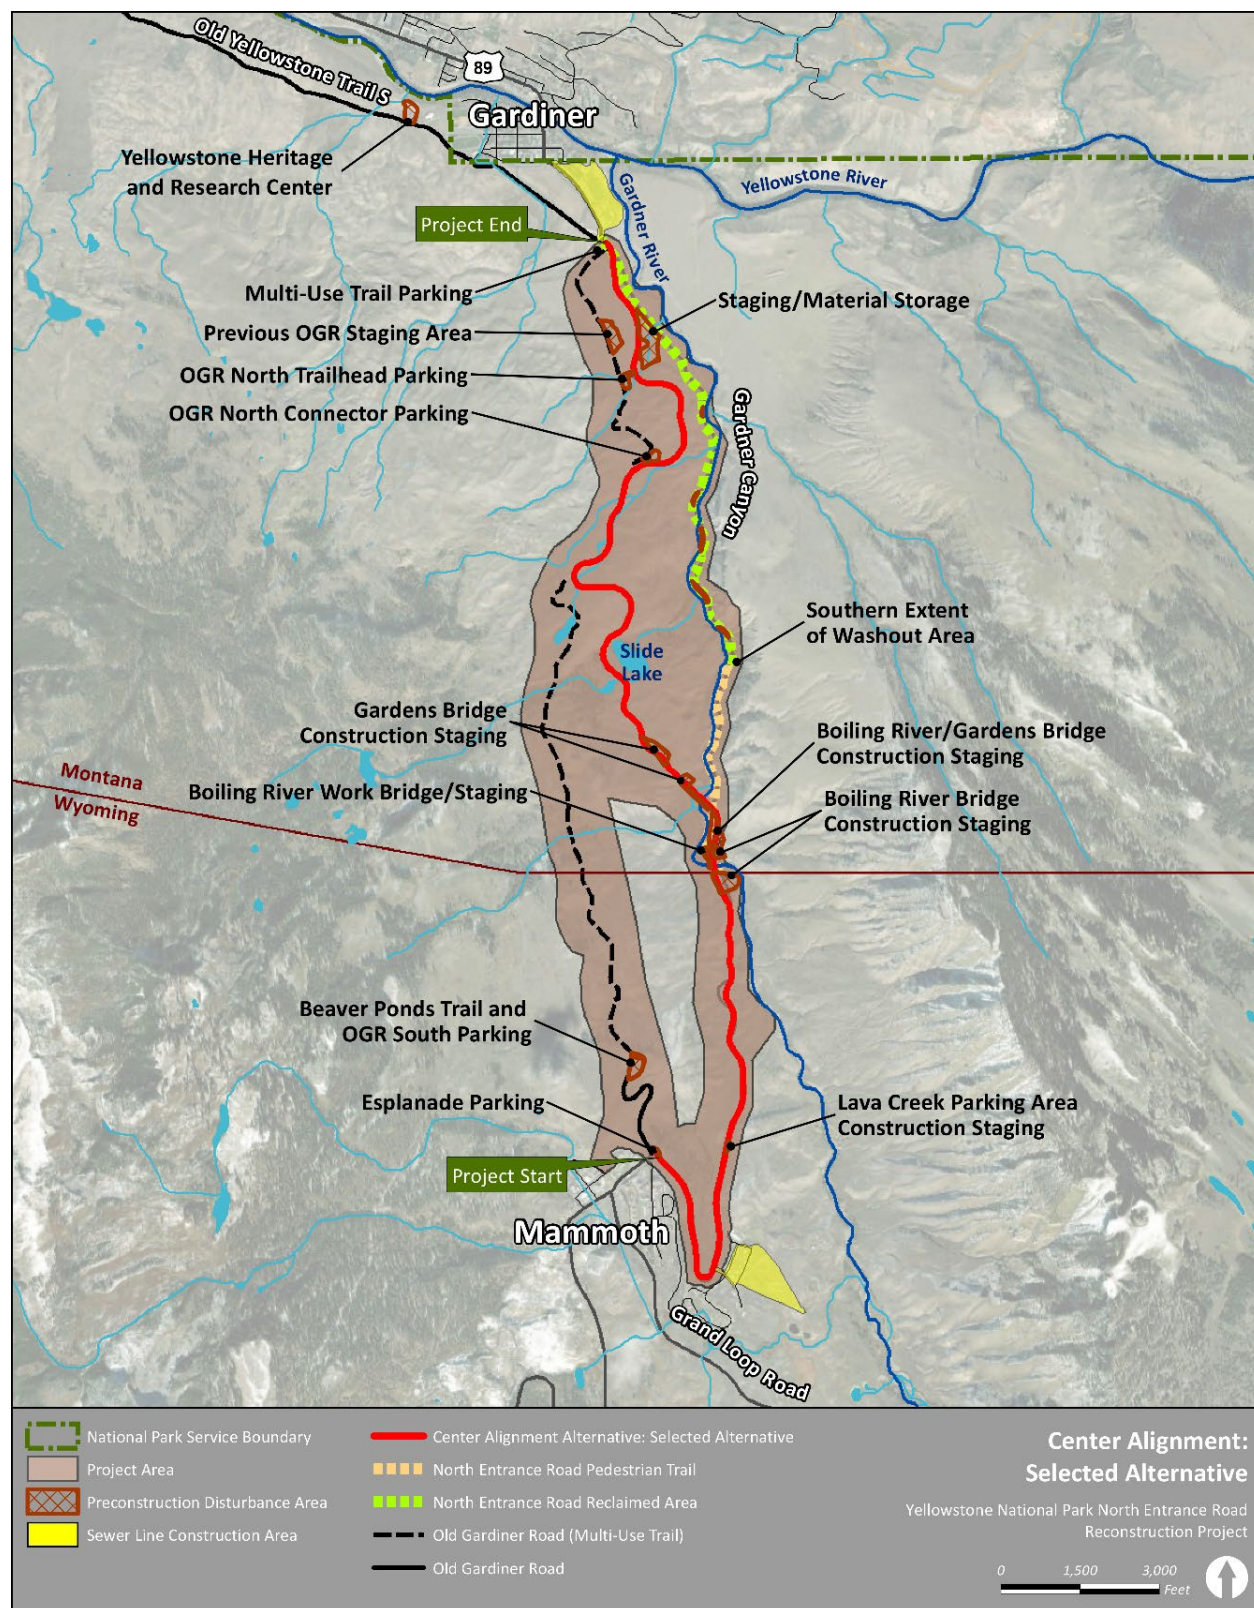
Figure 2. Center Alignment: Selected Action

As part of the selected action, portions of the old North Entrance Road located in the Gardner Canyon will be removed, along with remaining flood-damaged infrastructure, including the old sewer line. The segment from the new Gardens Bridge to the large washout will be removed and replaced with a 6-foot-wide Architectural Barriers Act (ABA)-compliant trail into the canyon. Along this segment, interpretive wayside exhibits highlighting the 2022 flood may be installed. The selected action also includes construction of a new sewer line (reestablishing the connection between Mammoth Hot Springs and Gardiner that was destroyed during the 2022 flood) along the OGR. Portions of the sewer line will be located within the active roadway corridor (primarily near Mammoth) but primarily located within the OGR alignment to avoid traffic disruptions if maintenance is required. Generally, the portions of sewer located in active transportation corridors will be located within the shoulder to avoid traffic disruptions and asphalt demolition/repair. More details on the selected action are described in EA Appendix C.

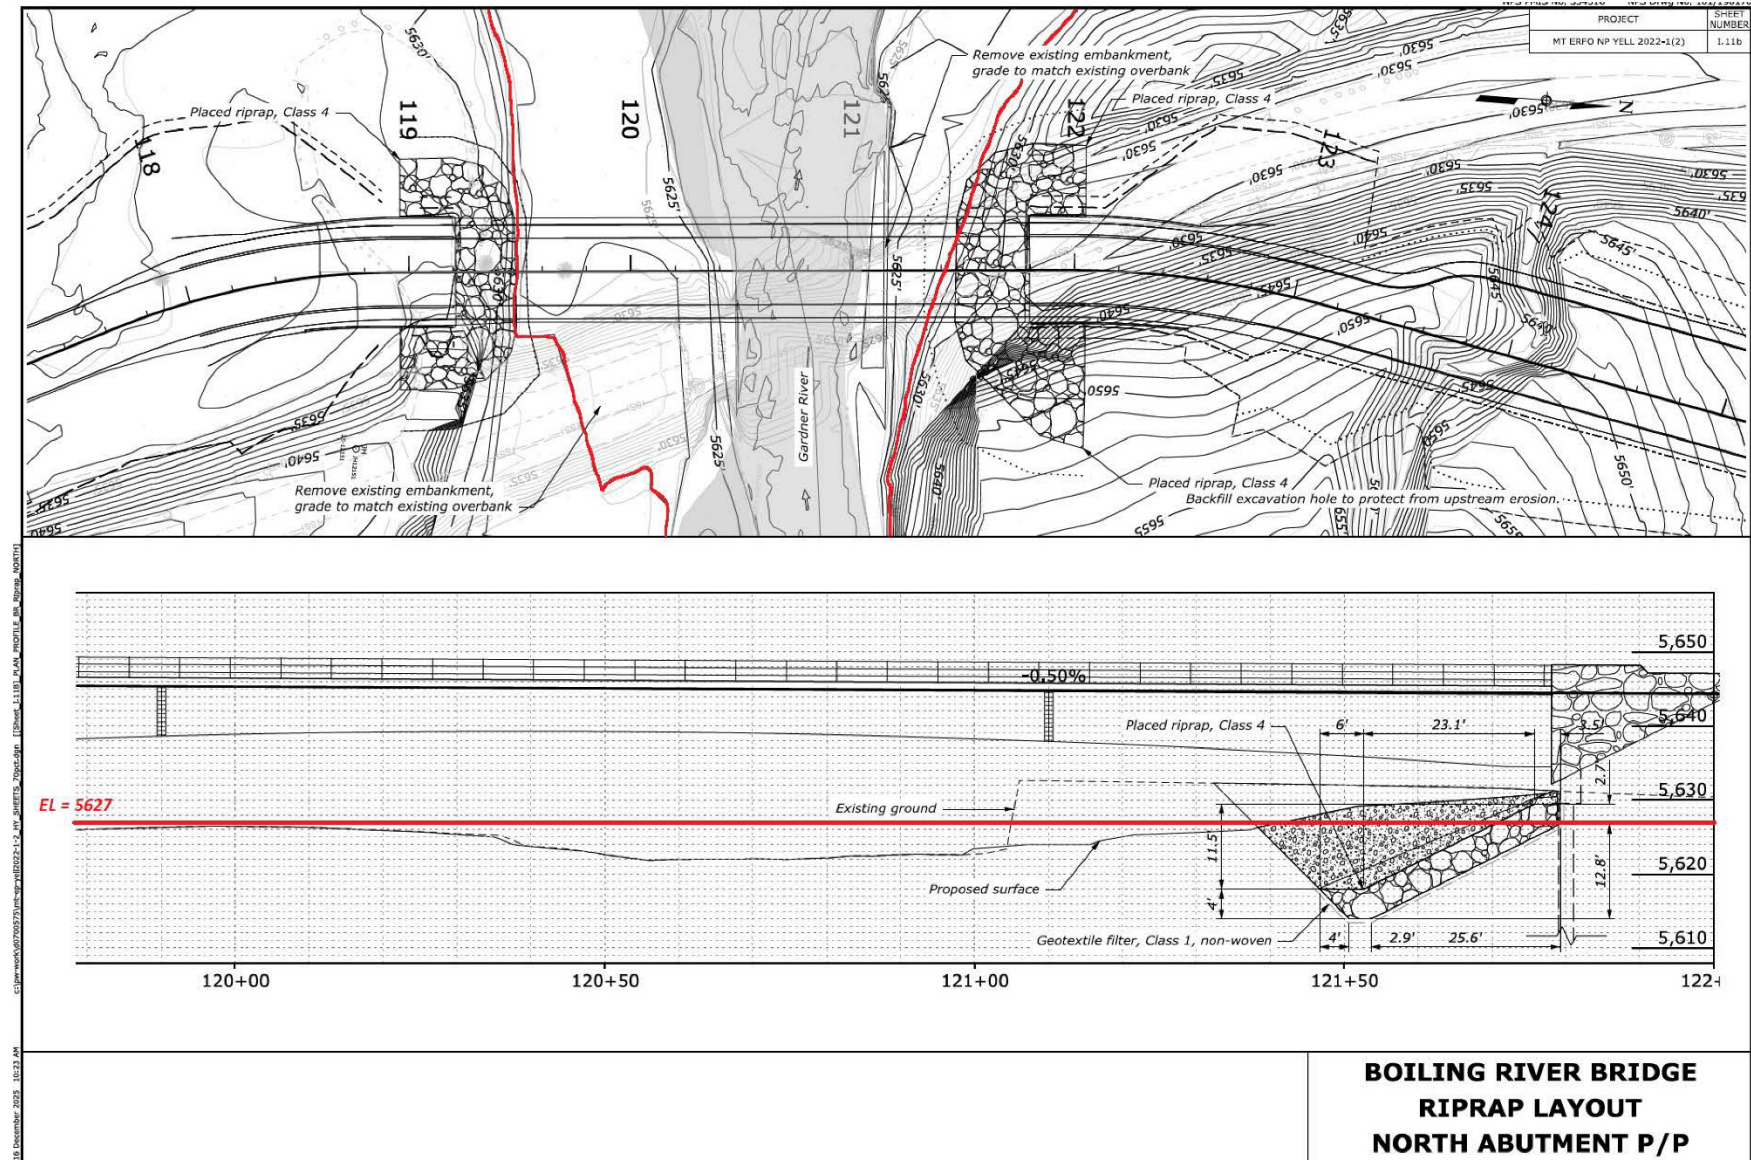
The new bridge would be designed to pass the 100-year and 500-year floods with a lower chord elevation of 5,634.84 feet to provide 5 feet of freeboard above the 100-year water surface for woody debris and ice passage (modeled elevation of 100-year flood = 5626.7 and 500-year flood = 5627.00; see model results, Section 3). The abutments and wingwalls of the new bridge would be outside the NPS Regulatory Floodplain, as modeled (FHWA 2025). The bridge abutments would be protected by buried Class 4 riprap, as shown in Figure 7 and Figure 8.

FIGURE 8. BOILING RIVER BRIDGE PLAN AND ELEVATION NORTH ABUTMENT (500-YEAR FLOODPLAIN ELEVATION: 5,627.0 FEET, SHOWN IN RED)

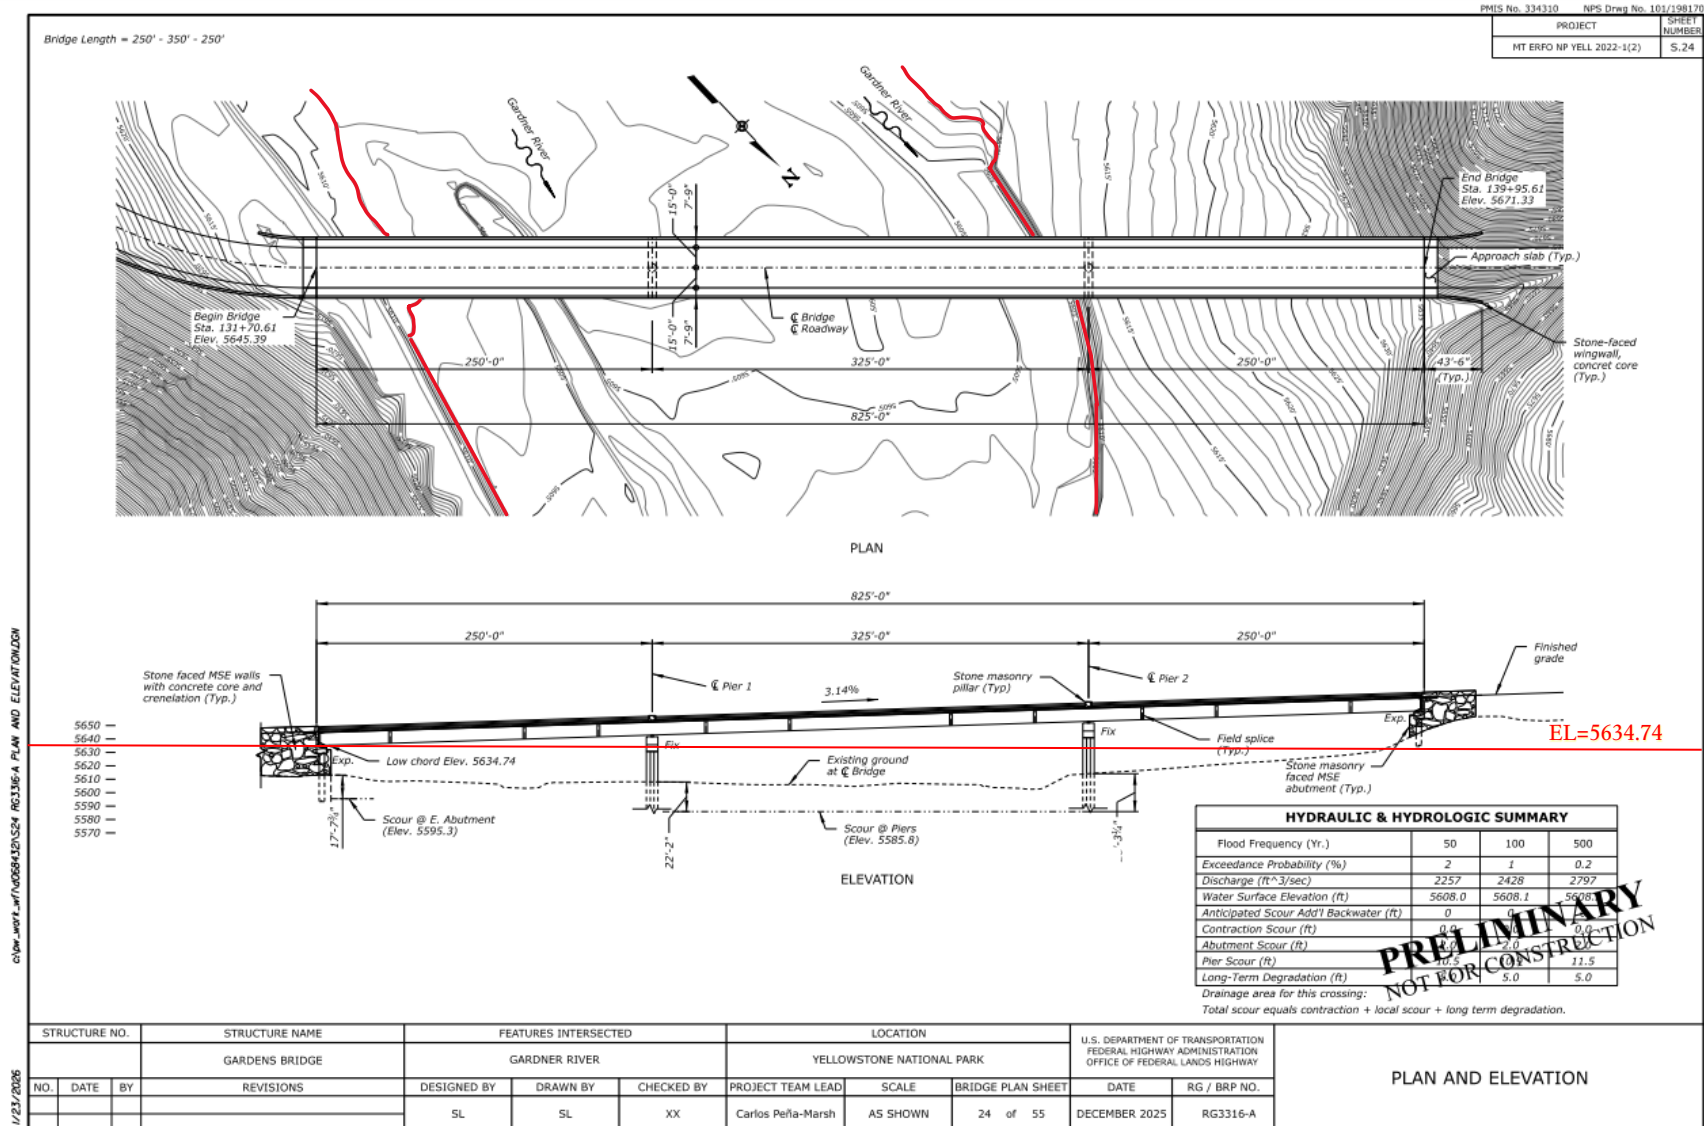
The Gardens Bridge would be designed to pass the 100-year (elevation=5608.1) and 500-year (elevation=5,608.2 feet) floods. The abutments of the new bridge would be outside the 100-year and 500-year floodplains, as modeled (FHWA 2025). The bridge would have a low chord elevation of 5,634.74 feet and would have a minimum of 5 feet of vertical clearance above the 100-year floodplain elevation to allow for the passage of woody debris and ice.

FIGURE 9. THE GARDENS BRIDGE PLAN AND ELEVATION (500-YEAR FLOODPLAIN ELEVATION: 5608.2 FEET, SHOWN IN RED).

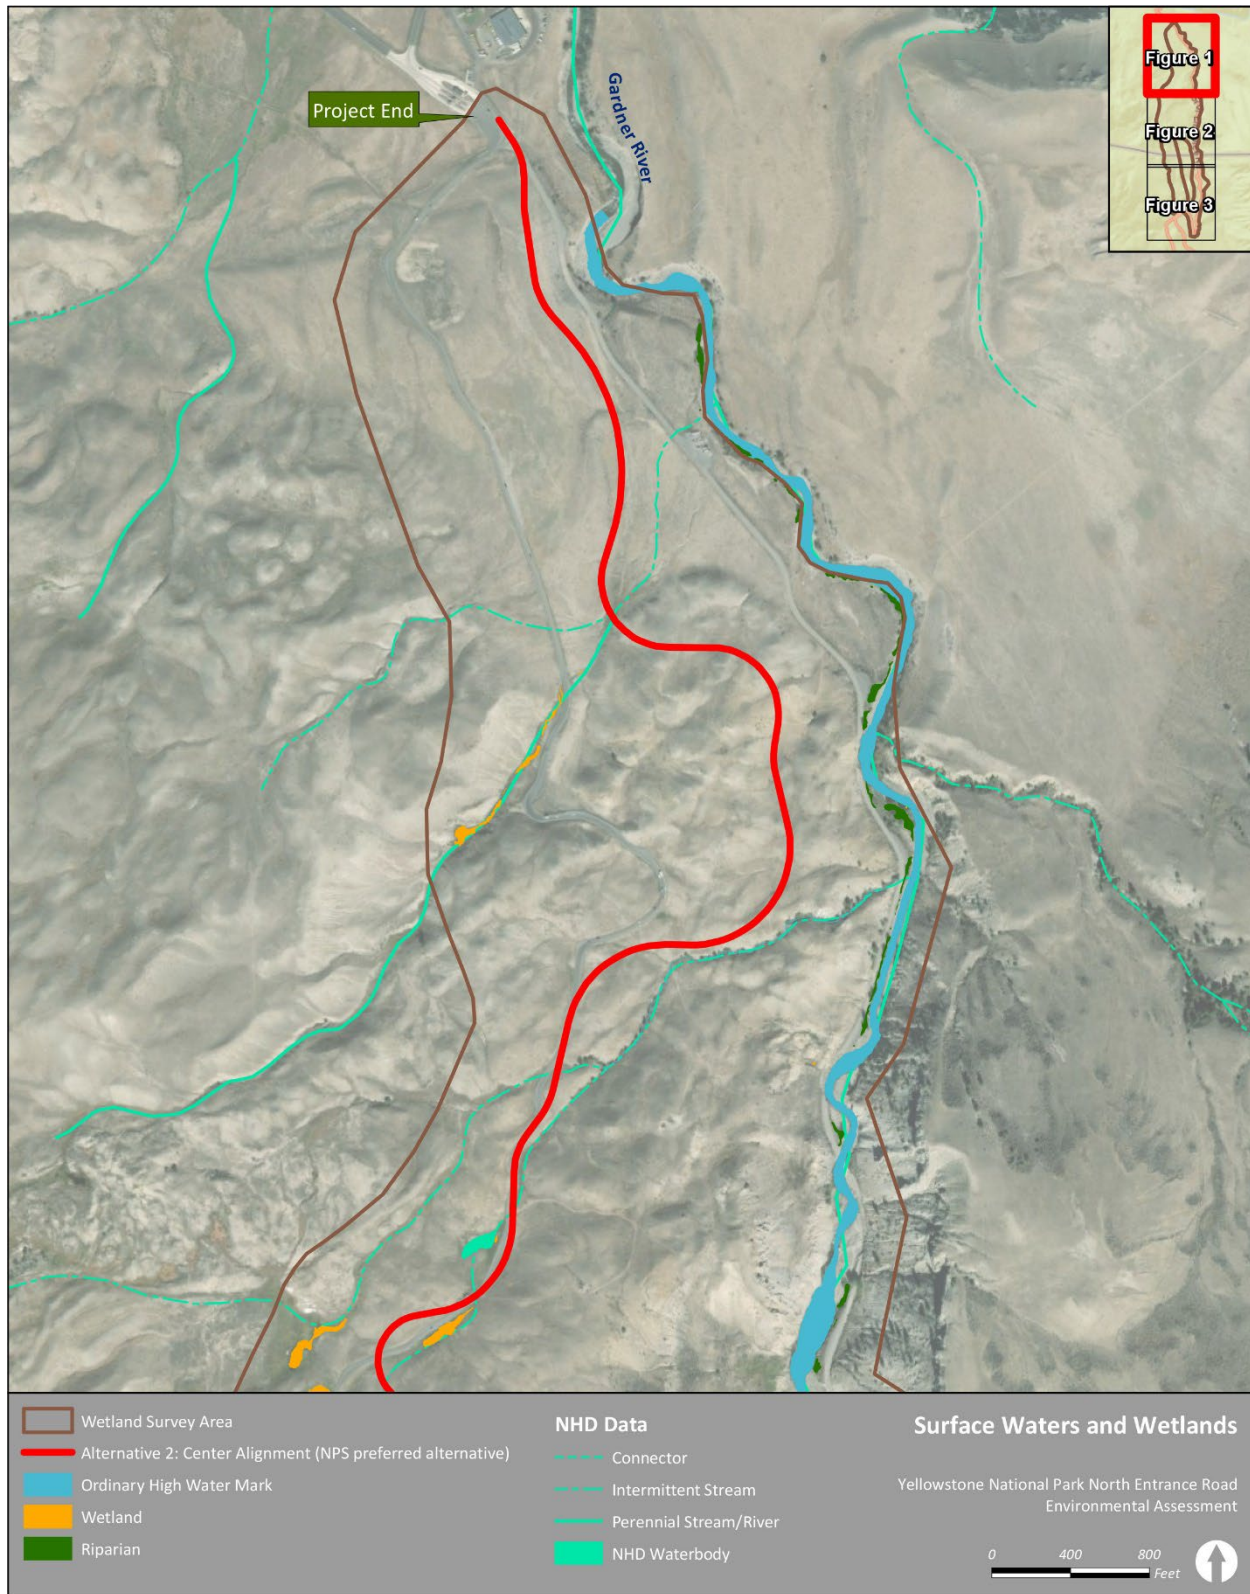
FIGURE 13. SURFACE WATERS AND WETLANDS

The project area was surveyed for wetlands and other waters as described below. Data were collected from various locations in the project area to document the characteristics of uplands and wetlands and the transition areas between them. Figure 13 through Figure 15 show a summary of the wetlands in the project area. Under NPS DO #77-1, wetlands include both vegetated wetlands and other waters such as lakes, ponds, and streams, which are considered unvegetated wetlands (NPS 2024). Wetlands in the project area that have hydrophytic vegetation, hydric soil, and wetland hydrology are described as vegetated wetlands in this statement of findings. The Gardner River, Slide Lake, and other ponds and streams in the project area are described as unvegetated wetlands. Vegetated wetlands and riverine wetlands in the project area are described below and are shown in detail in Attachment A. The acreage and type of each wetland are provided in Table 1 and Table 2. Approximately 32.71 acres of lakes, ponds, rivers, and streams (unvegetated wetlands) and 18.0 acres of vegetated wetlands occur in the project area (Table 1 and Table 2; Attachment A, Figure 2a through Figure 2n).

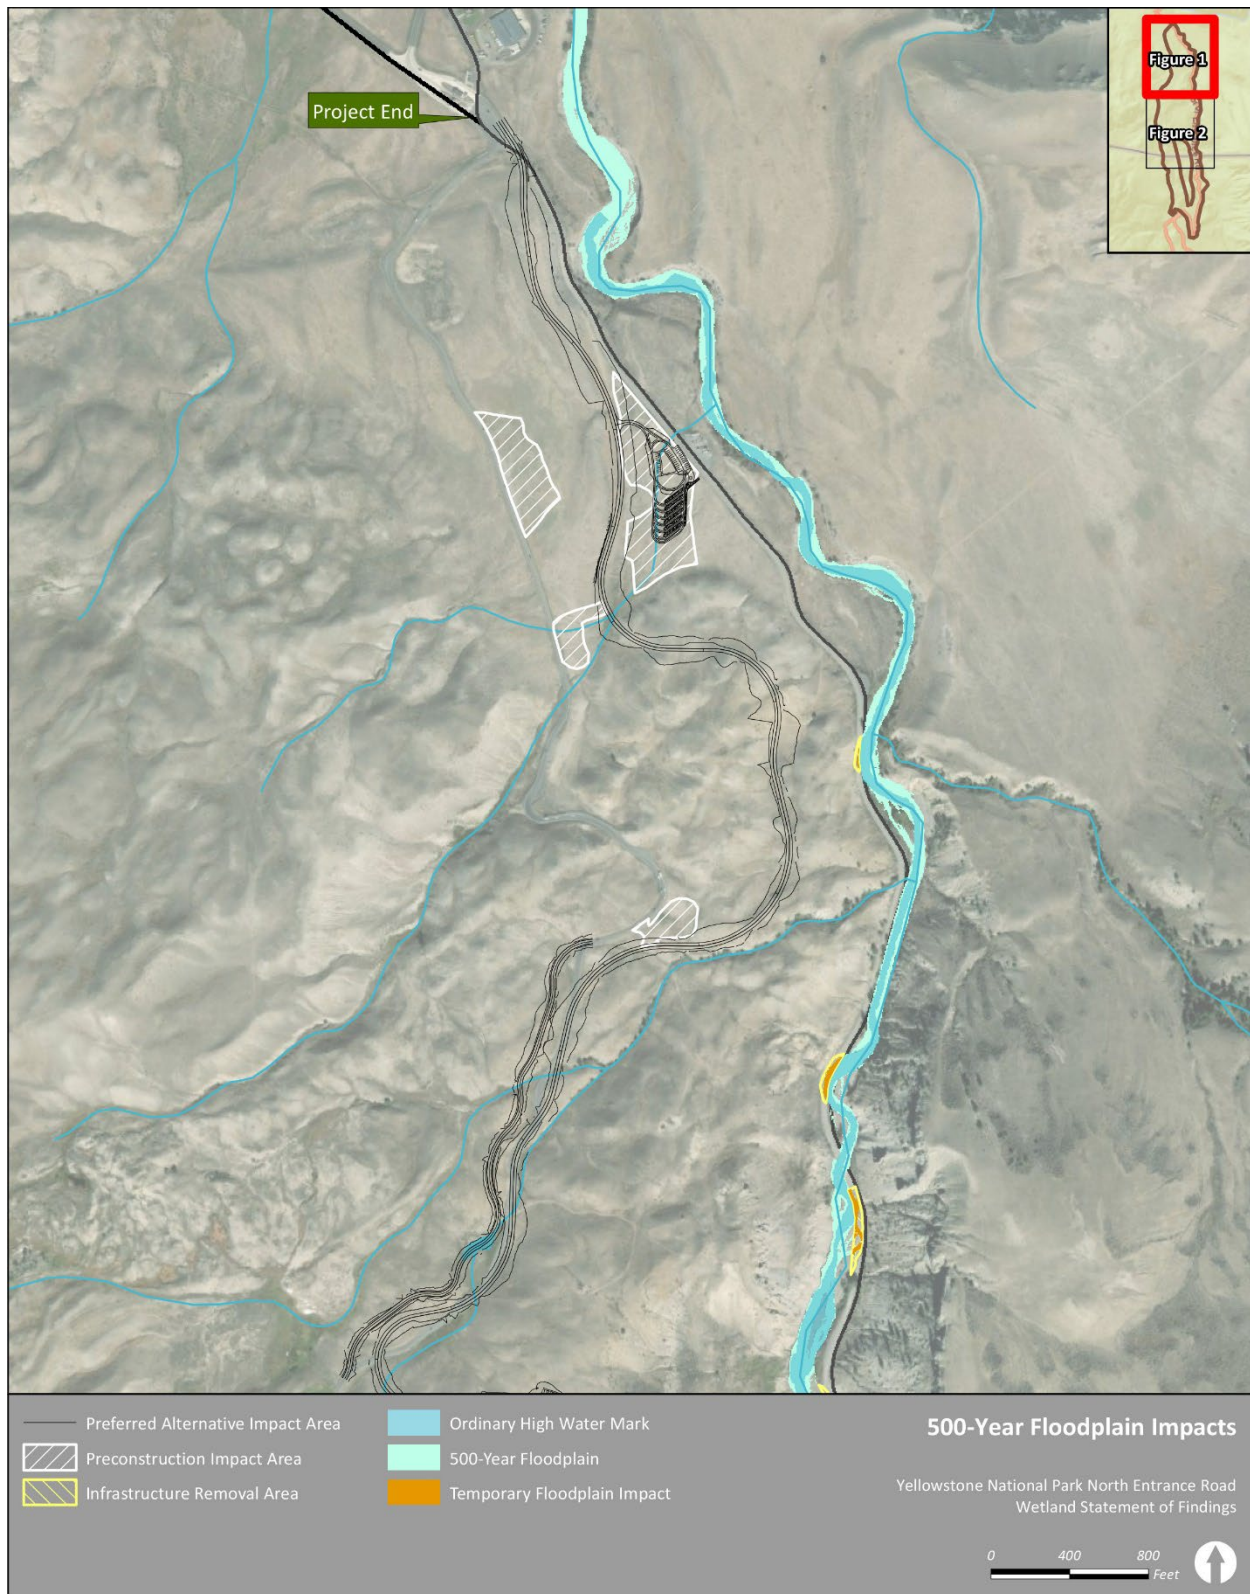
FIGURE 16. PROPOSED TEMPORARY FLOODPLAIN IMPACTS

Construction of both bridges would require temporary work bridges. These temporary bridges would be constructed with two rows of temporary piles installed in the channel for the length of the temporary crossing. The temporary work bridges would be removed once the proposed new Boiling River and Gardens Bridges are constructed. The temporary work bridge for the Boiling River would be in place for two years, and the temporary work bridge for the Gardens Bridge would be in place for three years. Because the work bridges would be in place for multiple years, they would be designed, at a minimum, to pass the 10-year flood event, with additional freeboard of 5 feet to the low chord. Temporary work bridges and other temporary impacts are shown on Figure 16 and Figure 17.

Temporary structures are also being considered for access in the Gardner River Canyon where segments of the old North Entrance Road canyon alignment would be removed along with all other old flood-damaged infrastructure, such as the old sewer line. Temporary access for construction/restoration may include backfilling along existing washouts (northern washouts) and temporary structures (southern washout). The eroded streambanks along the Gardner River would be regraded and recontoured after removal of flood-damaged infrastructure to recreate a more natural condition. No material would be added to the floodplain during removal of the damaged infrastructure.

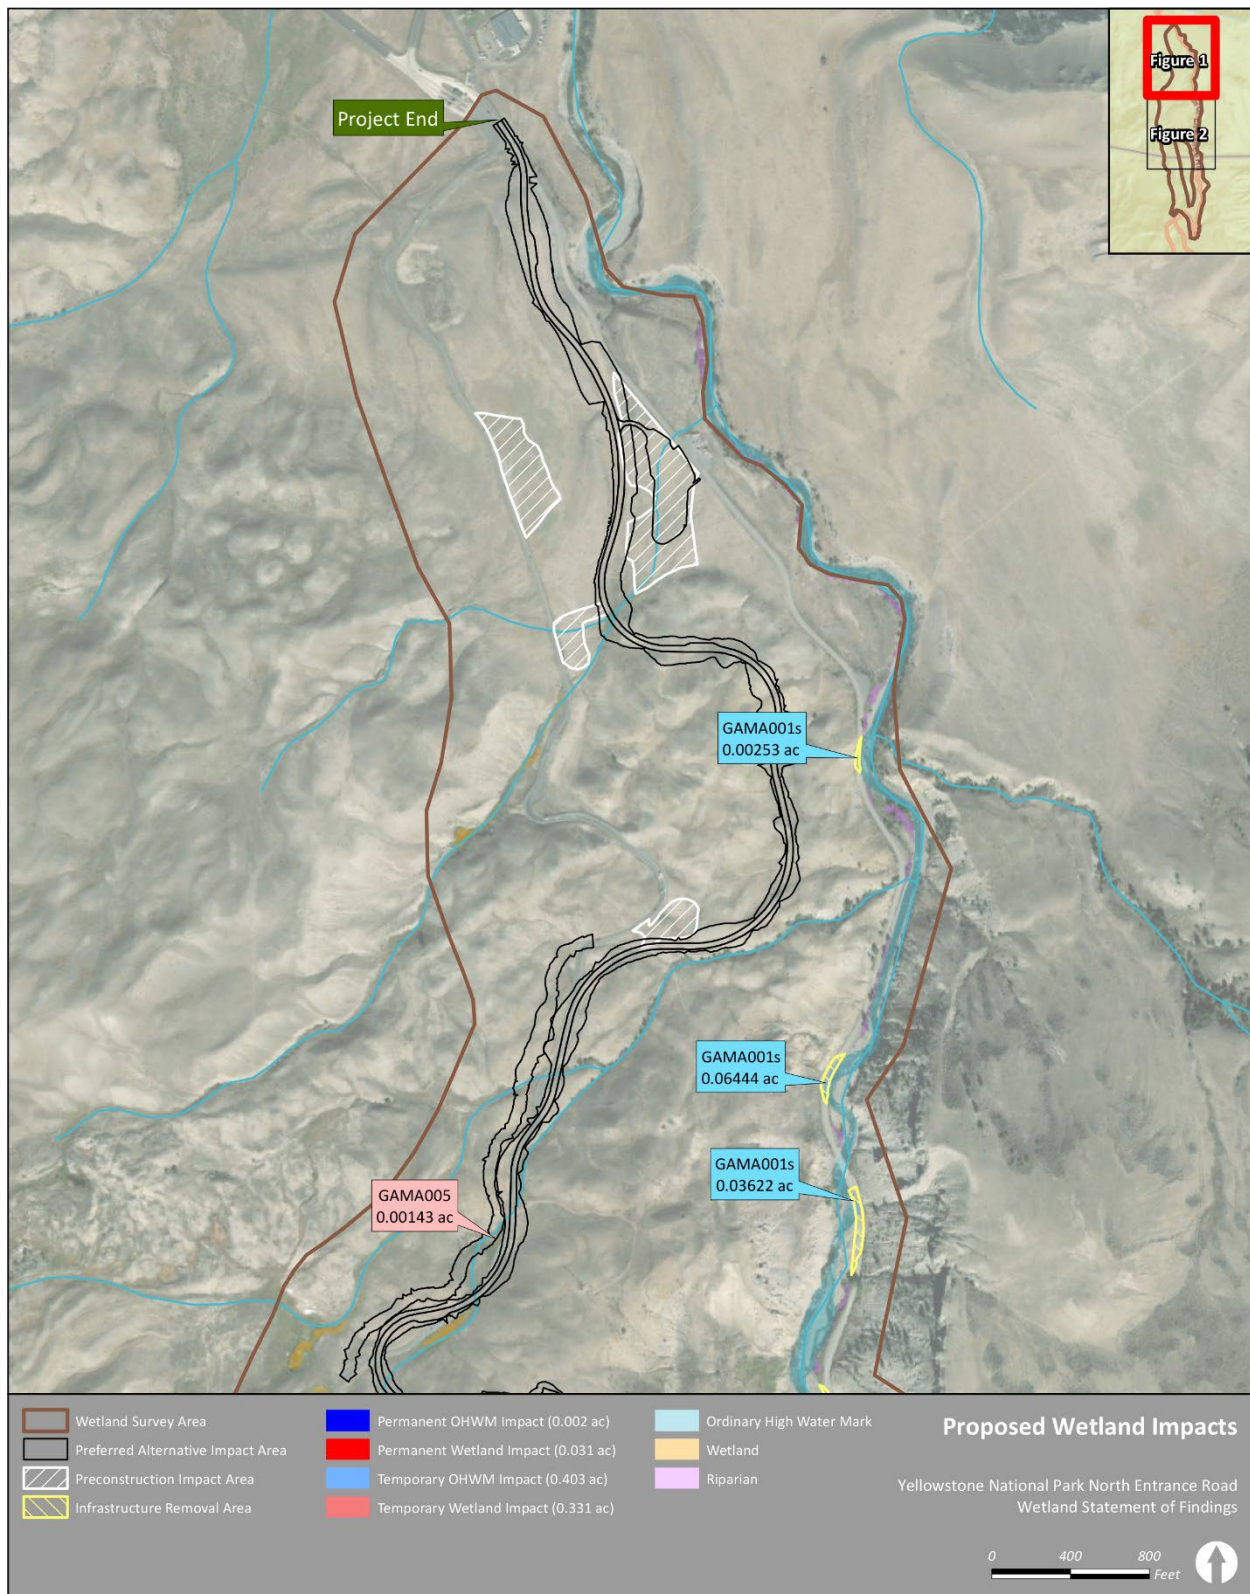
FIGURE 18. PROPOSED WETLAND IMPACTS

Proposed impacts on rivers and streams (unvegetated wetlands) are shown in Table 8. Proposed impacts on vegetated wetlands are shown in Table 9. Proposed impacts are also shown in Figure 18 and Figure 19.

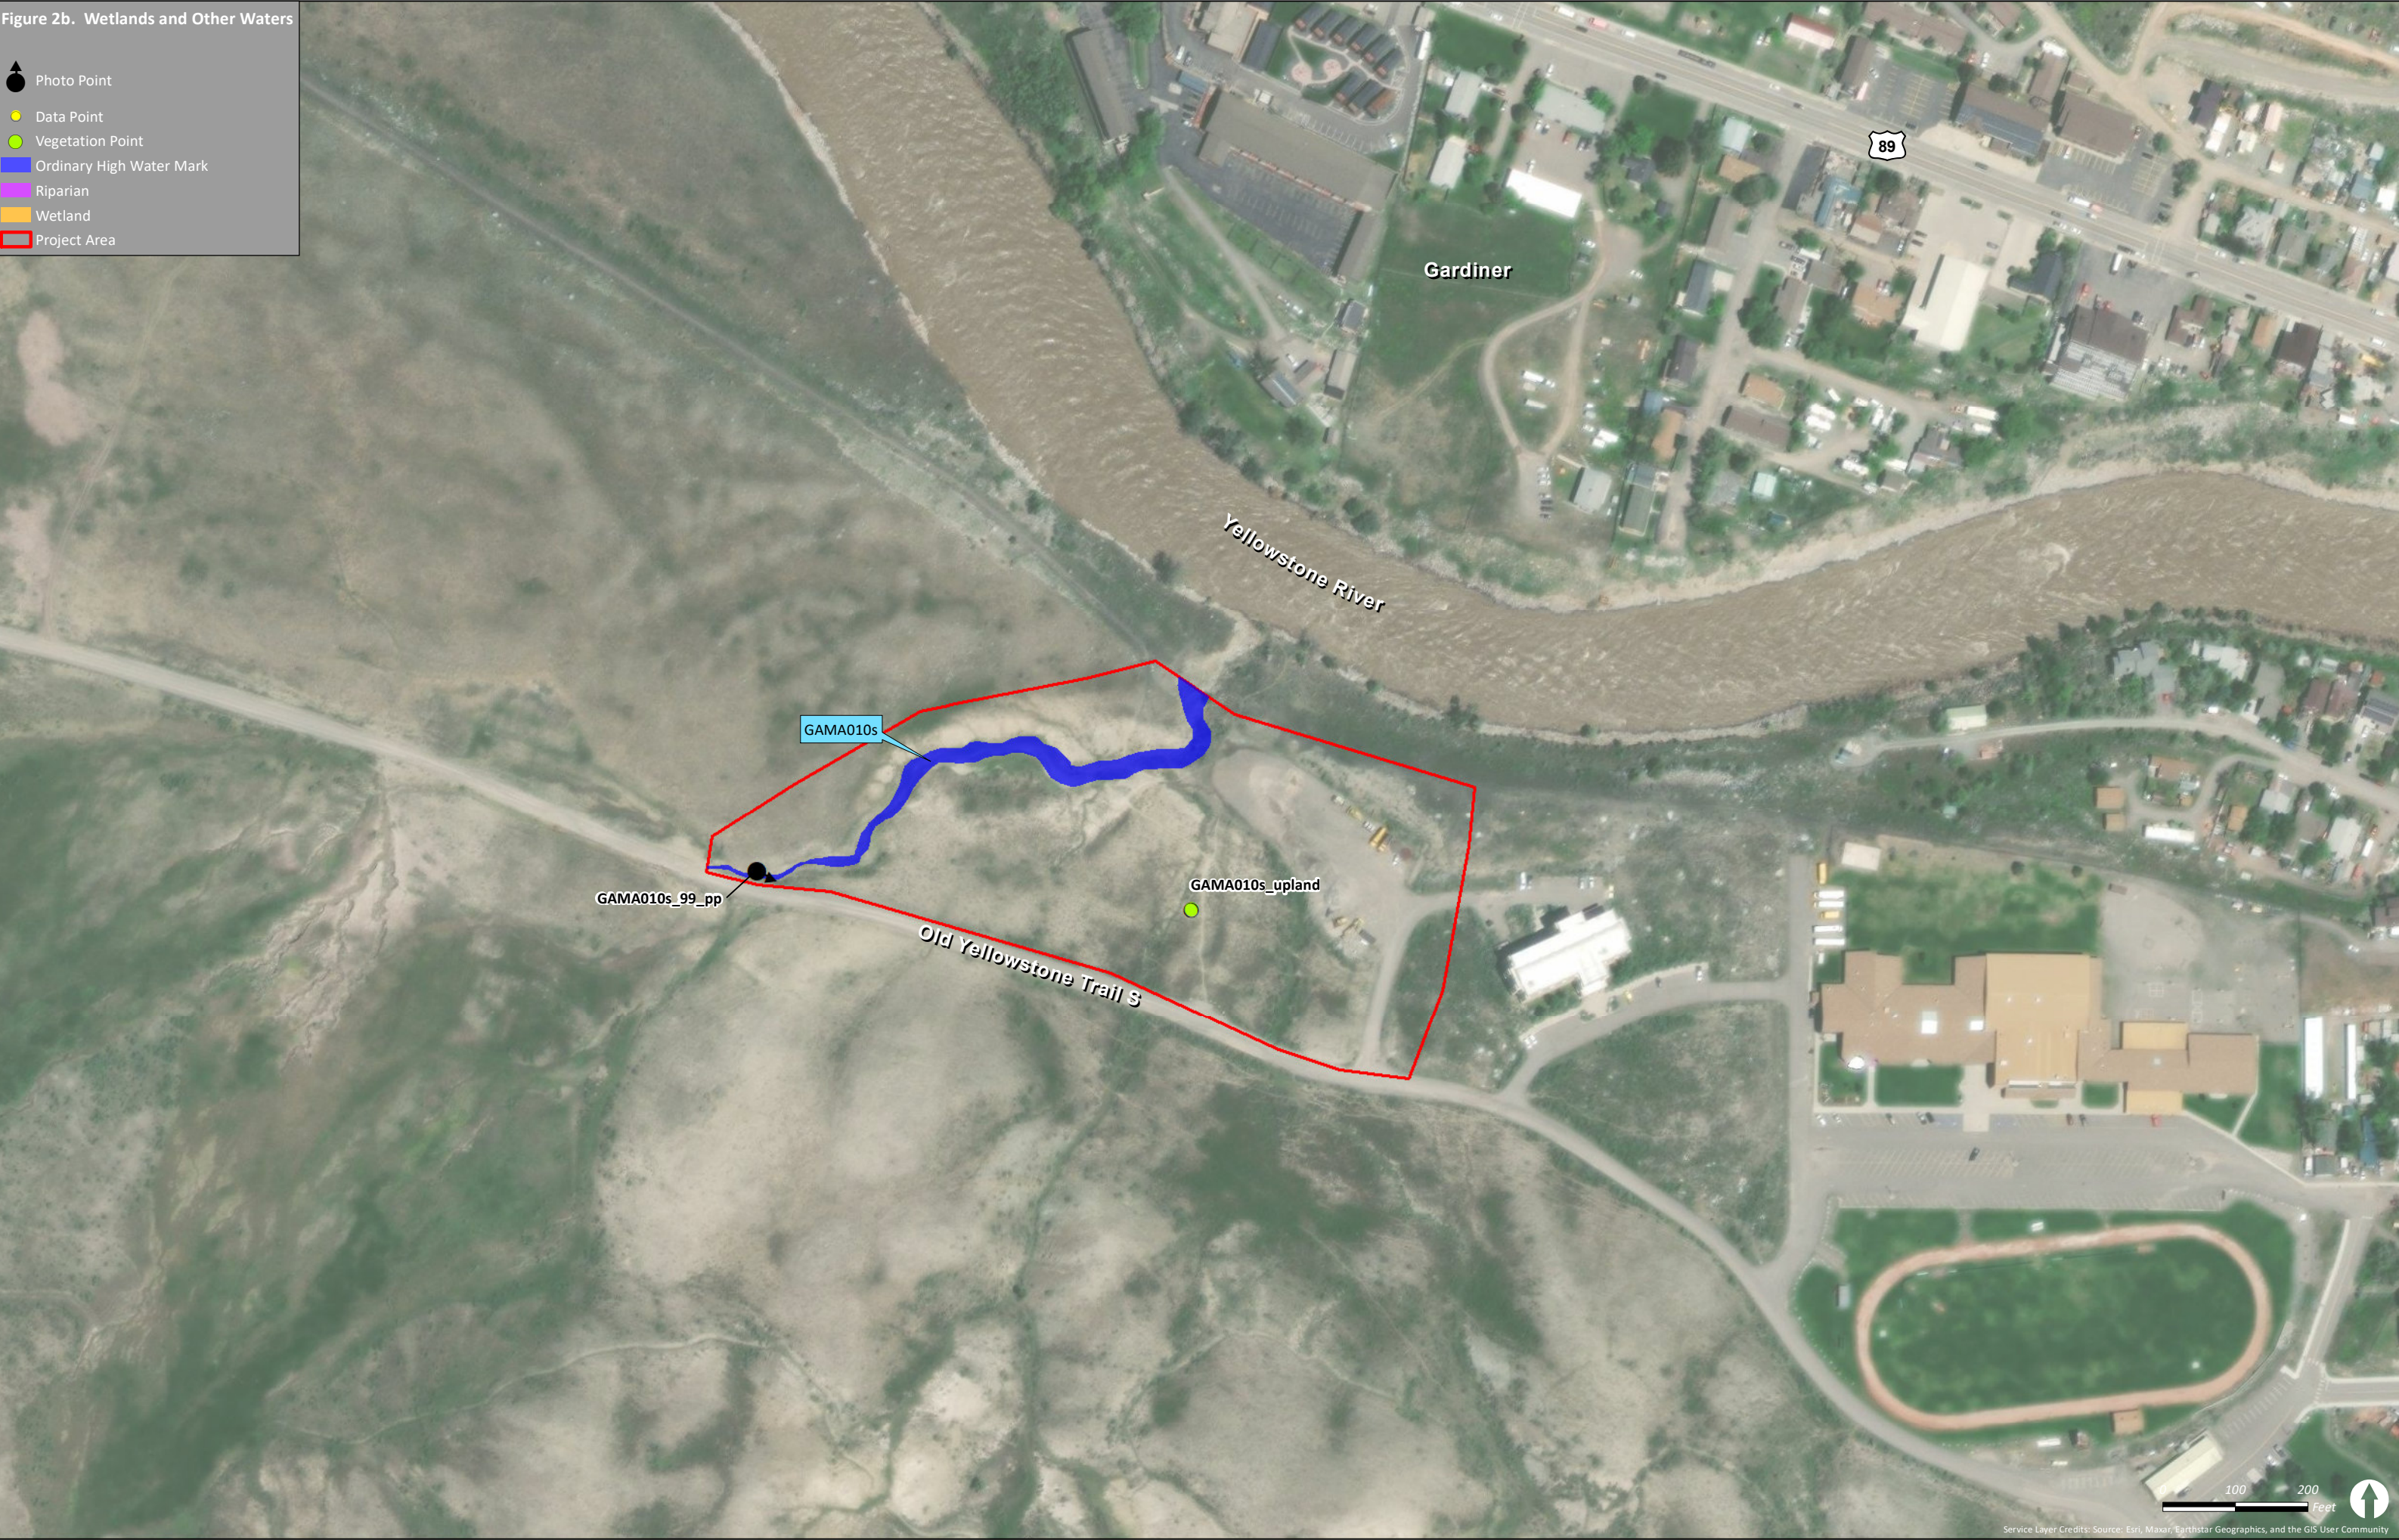
Figure 2c. Wetlands and Other Waters

The Gardner River flows roughly southward to northward along the east side of the project area (Attachment A, Figure 2c through Figure 2n). The river crosses the damaged North Entrance Road multiple times and, during the catastrophic flooding, washed out portions of the North Entrance Road. The Gardner River is approximately 25 to 60 feet wide in the project area with a water depth of several inches to several feet observed during the 2023 site visit. The substrate of the Gardner River is sand, gravel, cobble, and boulders with limited areas of exposed bedrock. Wetlands of variable sizes occur along both banks and are primarily palustrine emergent (PEM)

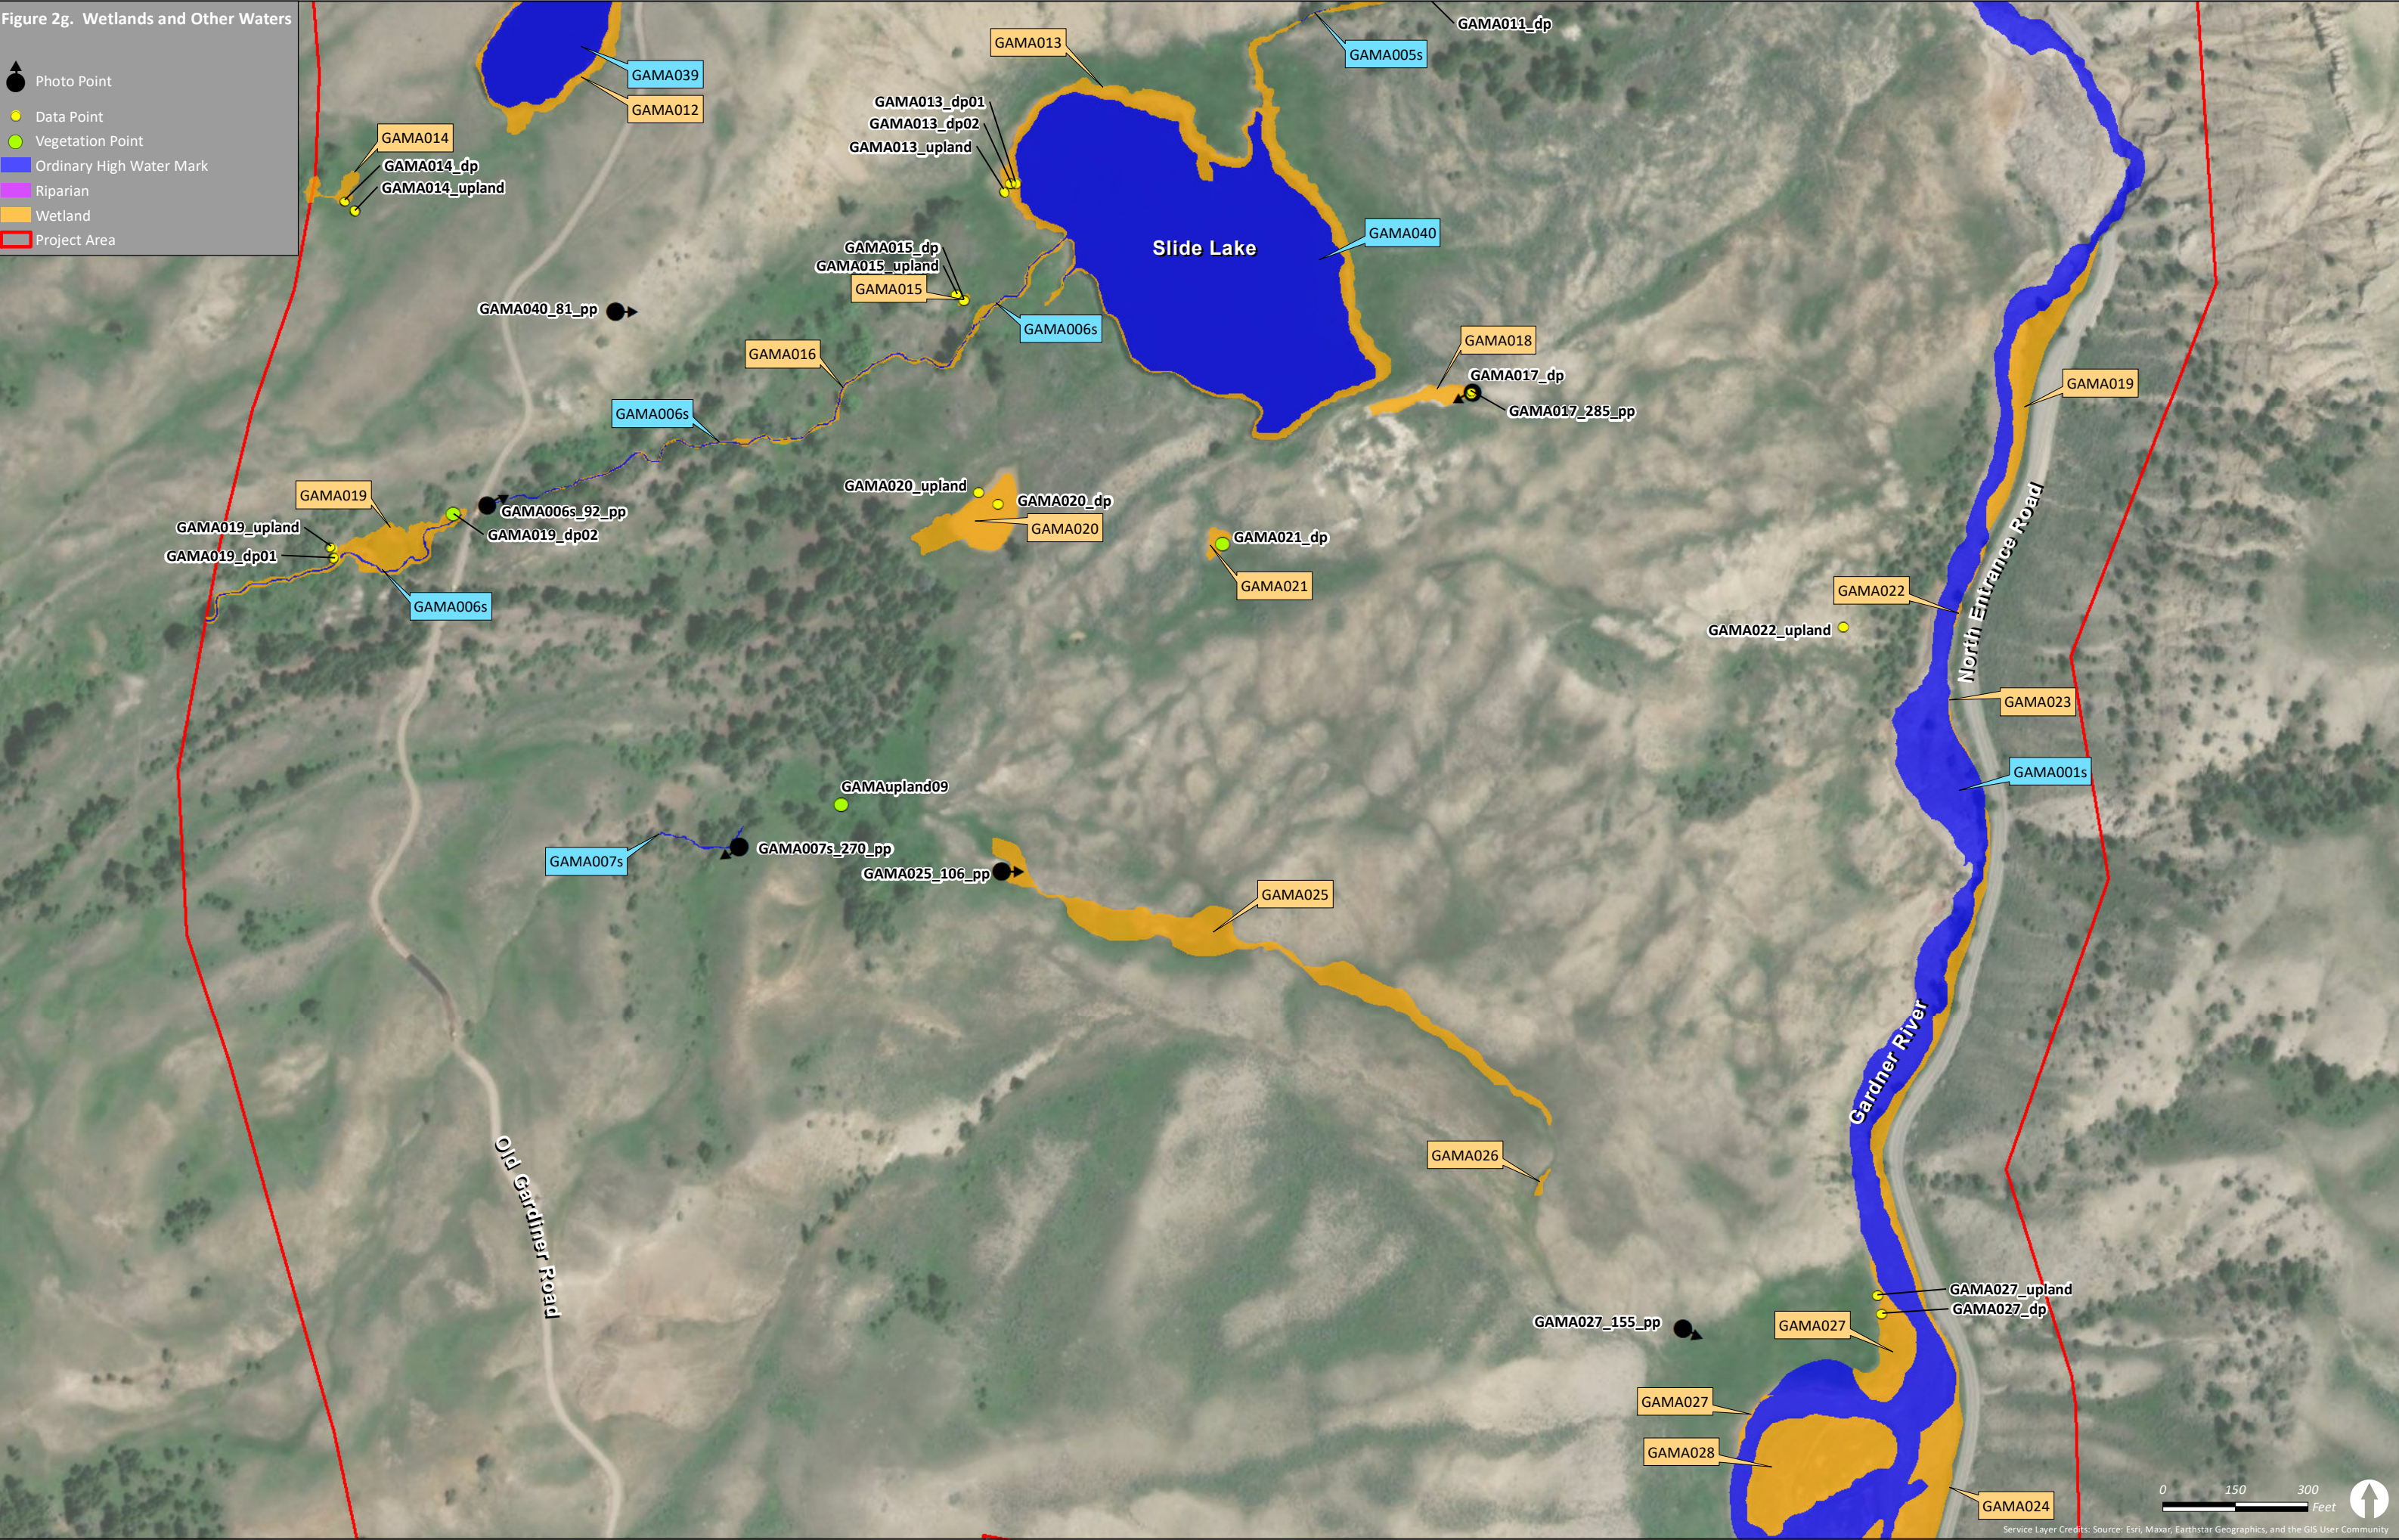
Figure 2h. Wetlands and Other Waters

PEM wetlands are along the Gardner River with limited areas of PSS wetlands (Attachment A, Figure 2h). Due to the dynamic nature of the active stream channel, some wetlands have developed more recently because of flooding, and more wetlands were likely present pre-flooding than are currently in the project area. The primary water source for this wetland community is surface water and subsurface seepage. The dominant species in these wetlands are crack willow (*Salix fragilis* – facultative [FAC]), bluejoint (*Calamagrostis canadensis* – facultative wetland [FACW]), water sedge (*Carex aquatilis* – obligate [OBL]), Baltic rush (*Juncus balticus* – FACW), American licorice (FAC), and redtop (*Agrostis gigantea* – FAC). Hydrology indicators included drift deposits, sediment deposits, oxidized rhizospheres on living roots, geomorphic position, and a positive FAC-neutral test. Hydric soil was indicated by loamy mucky mineral and redox dark surface.

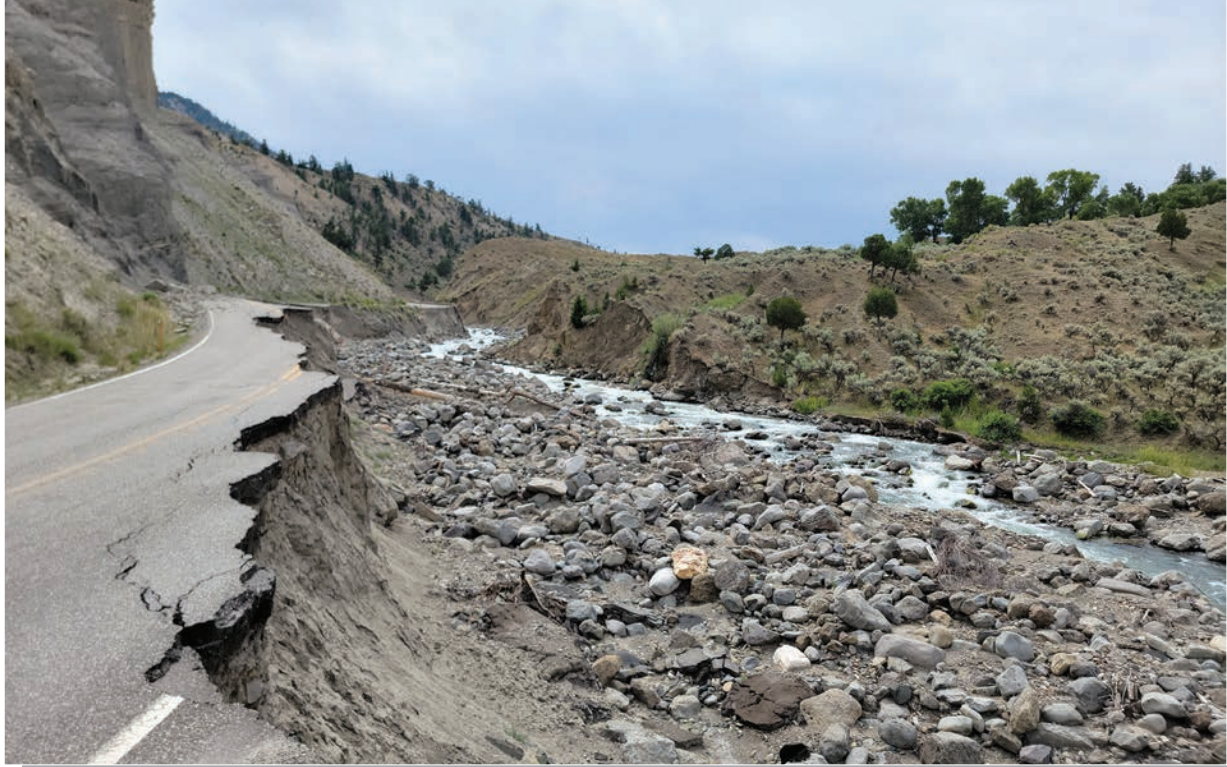
**GAMA001s\_135\_pp** – Road damage along Gardner River (GAMA001s). View is to the southeast.
