# FINDING OF NO SIGNIFICANT IMPACT AND DECISION DOCUMENT

## North Entrance Road Reconstruction Project (Mammoth Hot Springs, WY to Gardiner, MT) Environmental Assessment PEPC 148162

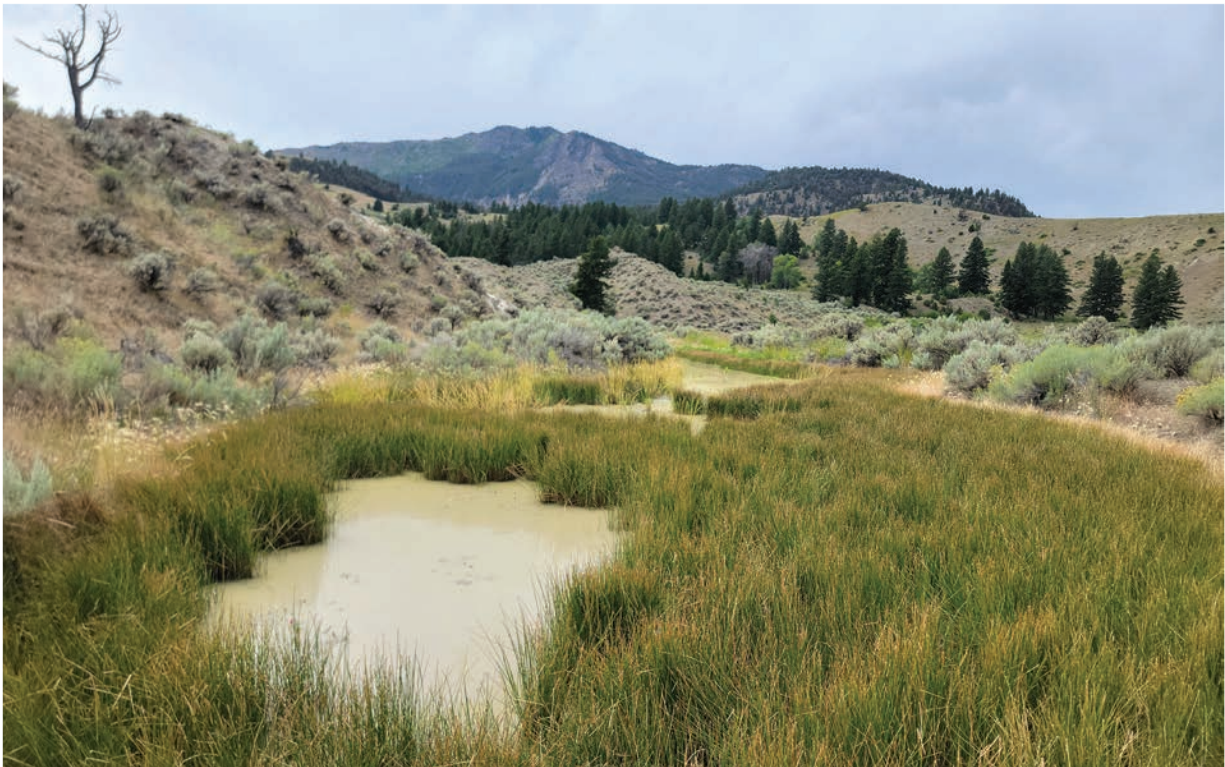
**GAMA017\_285\_pp** – GAMA017 just south of Slide Lake (GAMA040). View is to the southwest.

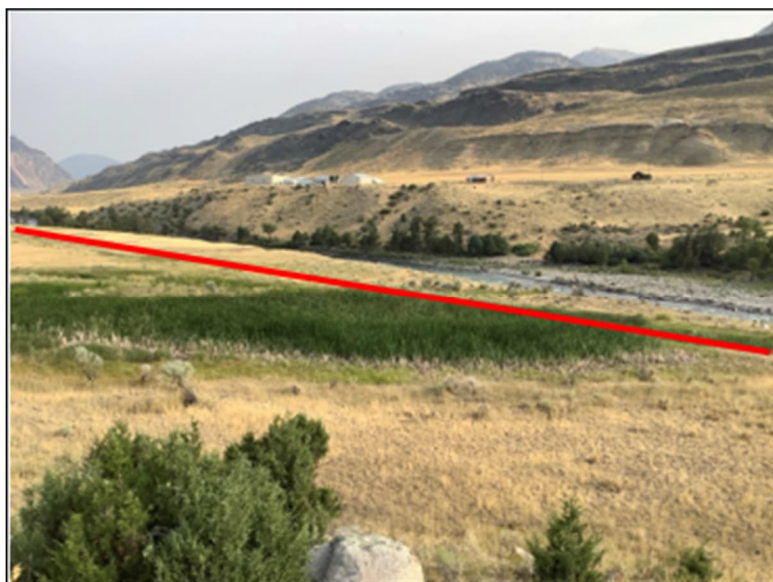
**Photo 2.** View to the northwest of the Landslide Creek cattail marsh and the abandoned railroad bed (red line).

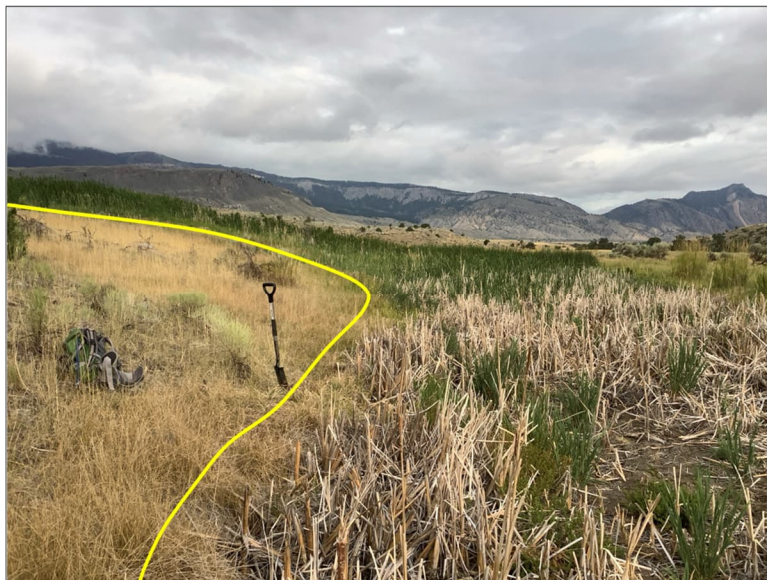
**Photo 3.** View to the west of the Landslide Creek cattail marsh. Shrub plantings could create up to 0.25 acre of habitat (yellow line) and enhance the cattail marsh.

However, smaller clumps of shrub plantings could be protected using t-posts and wire fencing spaced at sufficient distance from each other to deter grazing by large ungulates while allowing movement of smaller animals. Brush piles could also be constructed using native materials; plantings would be protected by the brush pile during the establishment phase (Attachment 1, Sheet N.19). Plantings would occur along the upslope margins to accommodate shifting wetland margins downslope and would include prickly rose, skunkbush sumac, serviceberry (*Amelanchier alnifolia*, FACU), and silverberry (*Elaeagnus commutata*, FAC) (Photo 3). Planting with these berry-producing shrubs would increase woody vegetation cover in the area while providing a food source for birds and small mammals. To minimize disturbance, plant materials and fencing would be installed using hand tools. Typical details for shrub plantings are in Attachment 1, Sheets N.16 and N.17). Spacing plantings within a 5-foot-wide buffer would create up to 0.25 acre of riparian buffer and potentially enhance up to 1.44 acres of the marsh. Noxious weeds, including Canada thistle, would also be treated. Additional data collection to better understand site conditions would include digging more soil test pits along the margins to identify preferred soil text and moisture locations for the plantings.

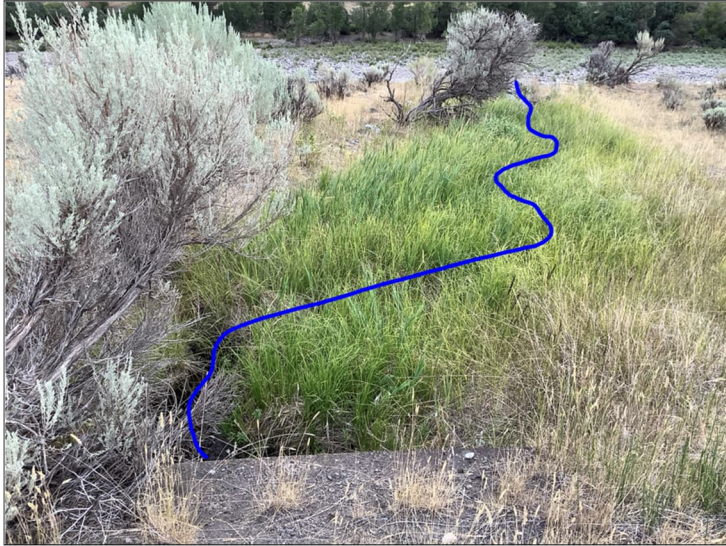
**Photo 4.** View to the north of Landslide Creek (blue line) flowing from the existing culvert towards the Yellowstone River. Proposed restoration activities would include replacing the culvert with a pedestrian bridge and enhancing the existing fringe wetlands with shrub plantings.

Restoration activities at this marsh could also include replacing the existing culvert with a pedestrian bridge (Photo 4). This would increase hydrologic connectivity across the abandoned railroad bed while maintaining usage of the existing bike trail. This reach of Landslide Creek could be enhanced through the placement of post-assisted diffusion structures and riparian shrub plantings. The diffusion structures would slow flow and raise the existing groundwater levels. Shrub plantings would increase physical structure and improve sediment retention before reaching the Yellowstone River. This reach of Landslide Creek was not included in the 2024 delineation. If restoration activities proceed in this area, an aquatic resource delineation of Landslide Creek and the fringe wetlands would be required before potential credit acres could be quantified.

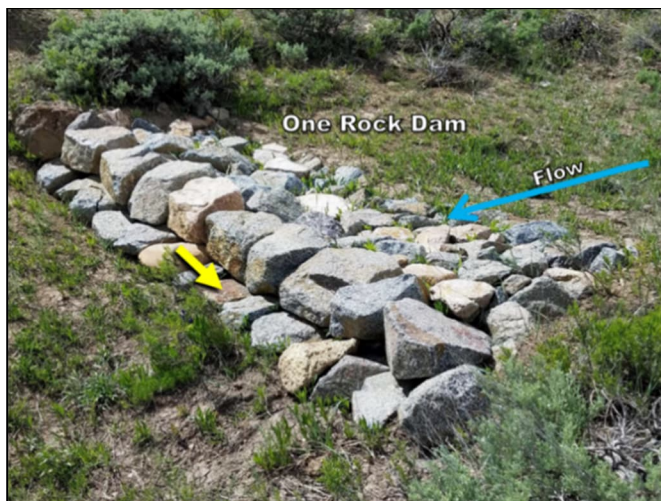
**Photo 6.** Example of Zeedyk structure (Maestas et al. 2018).

To further facilitate the establishment of a riparian buffer on the downstream end, a one-rock dam similar to a Zeedyk structure (Photo 6) would be constructed of native materials and installed at the proposed culvert outlet to slow water permeation into the soil.

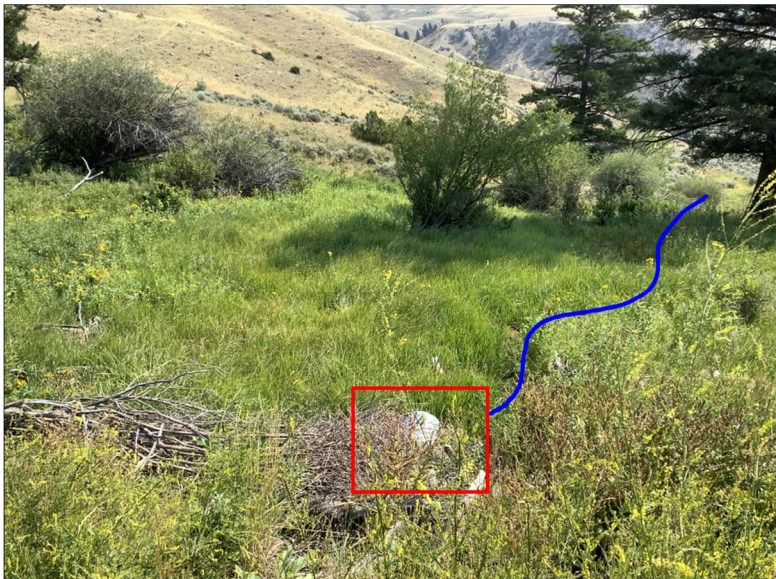
**Photo 7.** View to the northeast (downslope) of the Old Gardiner Road restoration site. The photo shows the existing culvert outlet (red square), stream (blue line), and wetland (foreground).

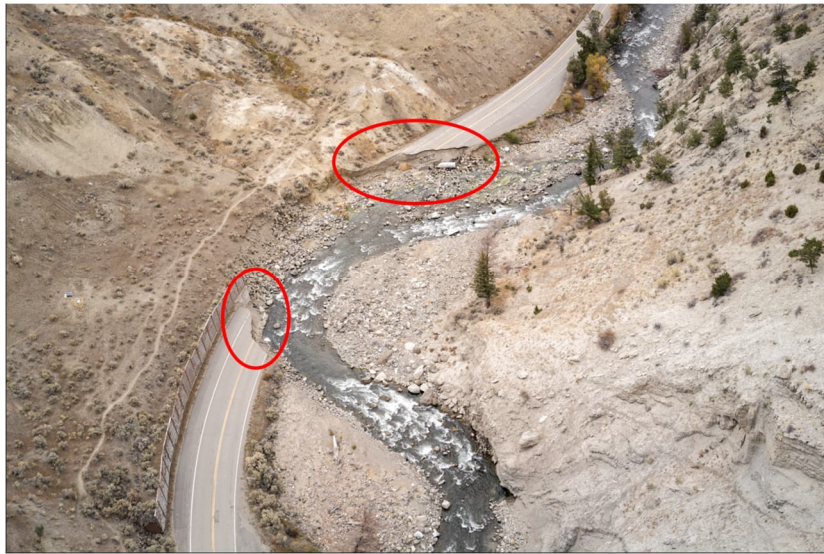
The North Entrance Road connected Mammoth to Gardiner until the June 2022 flood, when several sections of the road were washed out (Photo 8). Other sections of the road and associated infrastructure remain in place but continue to deteriorate. Vegetation along the Gardner River consists of scattered shrubs and trees, including Rocky Mountain juniper, prickly rose, assorted willows (*Salix* spp.), and balsam poplar (*Populus balsamifera*, FAC). Cobbles and gravels dominate the soil profile.

**Photo 8. Overhead view of Gardner River Canyon post-2022 flood (source: NPS). Bank stabilization and riparian buffers (red circles) in select locations would enhance the Gardner River and fringe wetlands.**

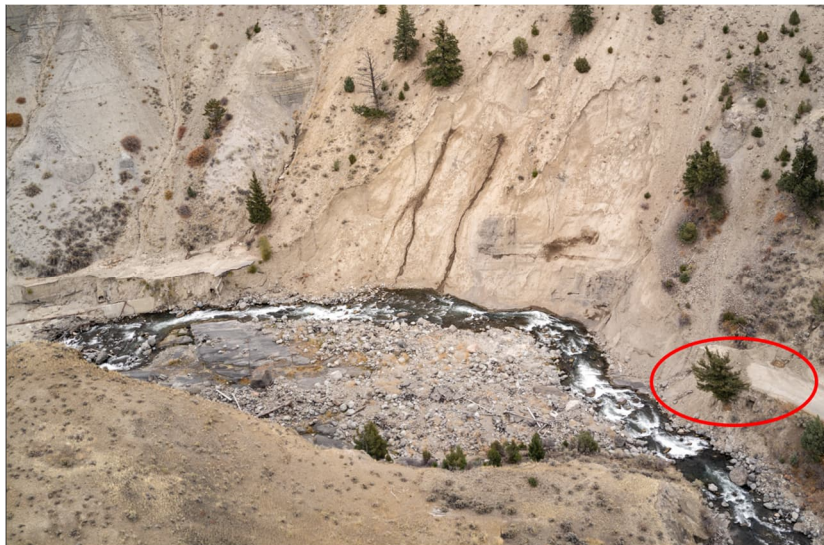
**Photo 9. Overhead view of Gardner River Canyon (source: NPS). Bank stabilization (red circle) would maintain the integrity of remaining road elements converted to pedestrian trails.**

Reclamation activities within Gardner River Canyon present opportunities to enhance up to 23.26 acres (17,733 linear feet) of the Gardner River and 6.02 acres of existing fringe wetlands delineated in 2023 (ERO 2023). Desktop review of 30 percent conceptual design plans for road reclamation identified several locations for restoration activities (Figures 4 and 5; Attachment 4). Based on this assessment, approximately 1.01 acres of floodplain could be restored simply by removing the existing road embankment so natural processes reshape the bed and bank. At select areas, bank stabilization would likely be required to prevent additional scour and sedimentation within the river (Photos 8 and 9). Three conceptual cross sections have been developed (Attachment 4, Sheet G.12); identification of appropriate places to apply these cross sections would be made following two-dimensional hydraulic modeling and additional site visits.

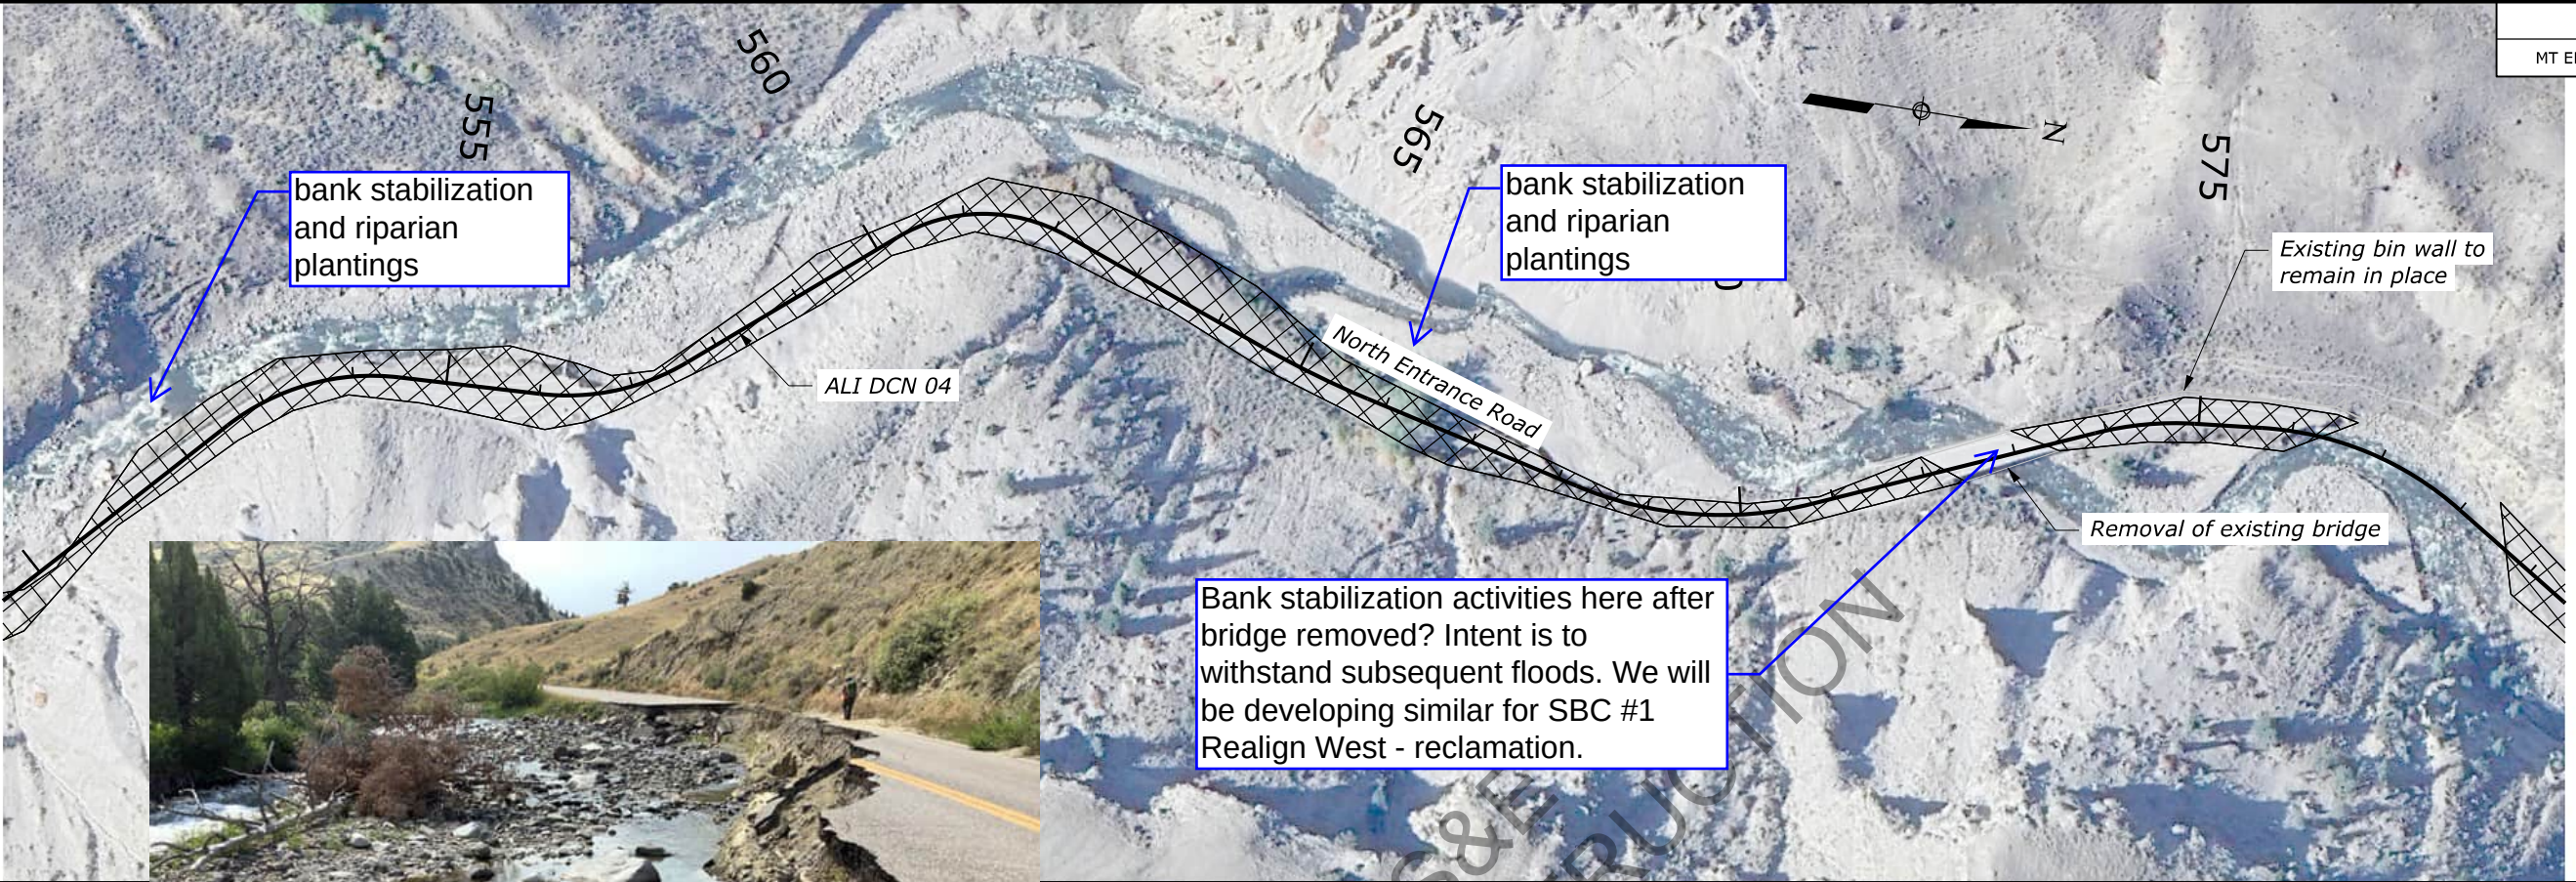
Bank stabilization activities here after bridge removed? Intent is to withstand subsequent floods. We will be developing similar for SBC #1 Realign West - reclamation.

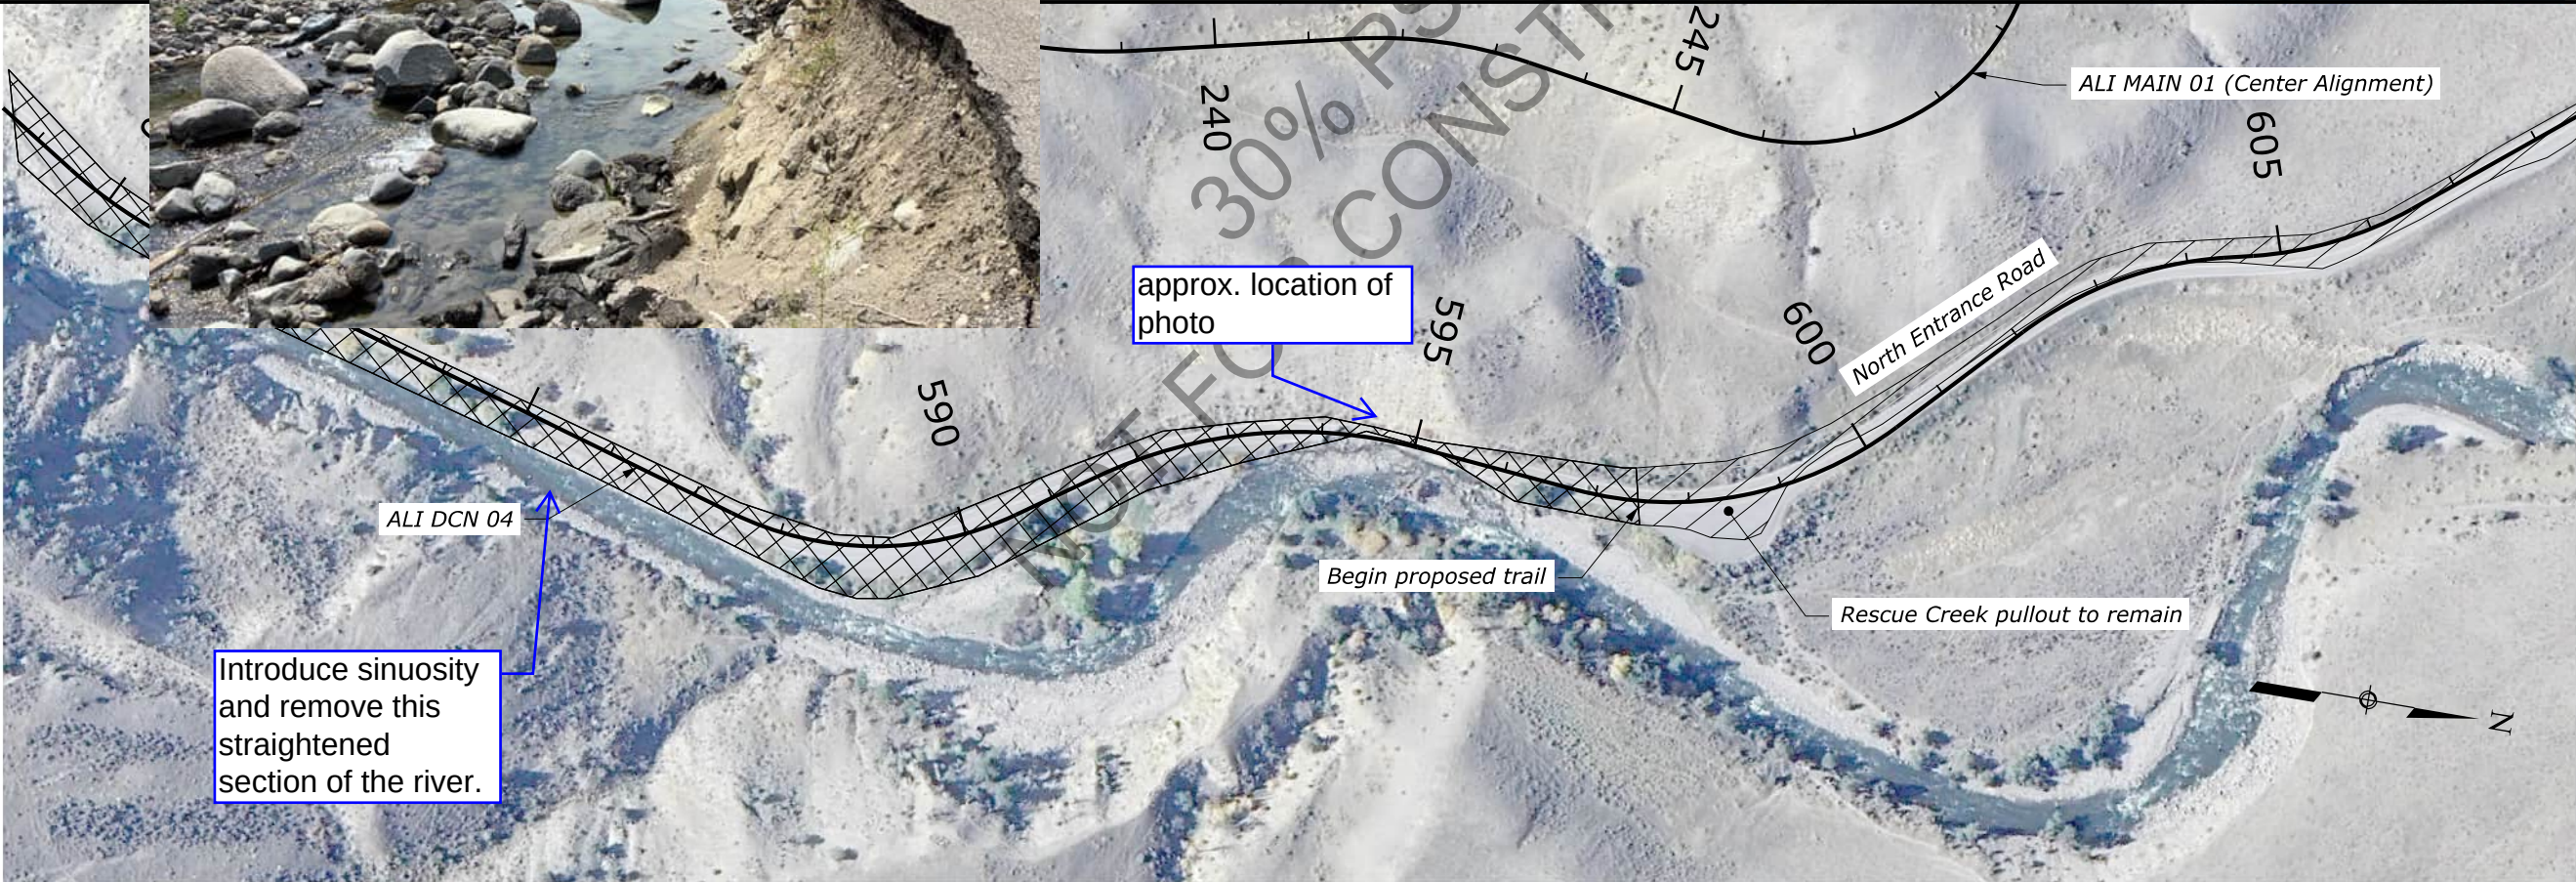
Introduce sinuosity and remove this straightened section of the river.

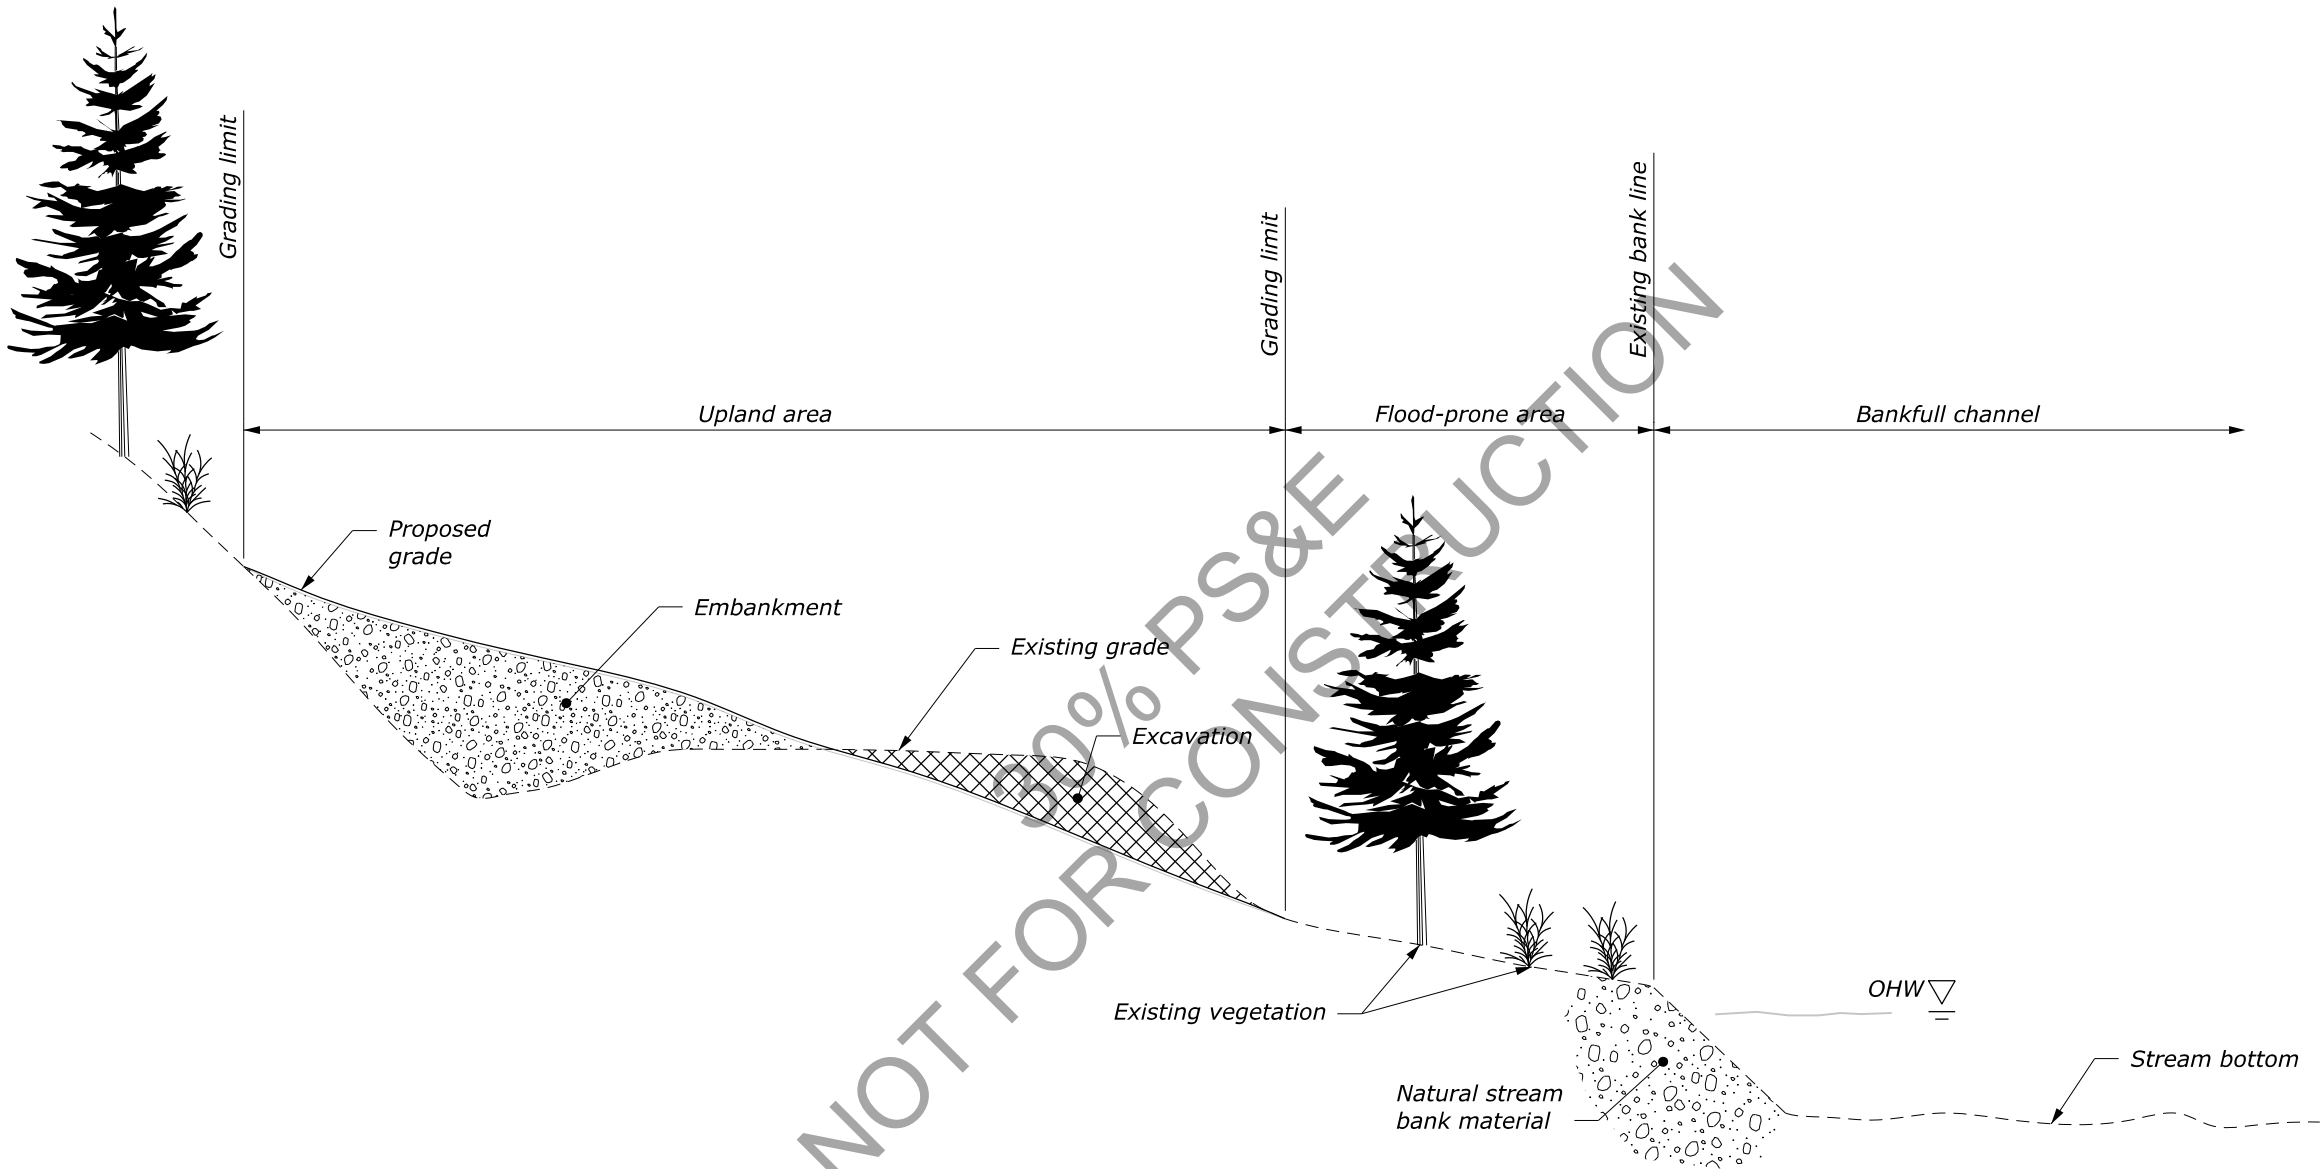
NOTE:  
1. Preserve vegetation and bank materials beyond regrade area).  
2. Place mulch, landscape woody debris, and vegetation over regrade area above ordinary high water.

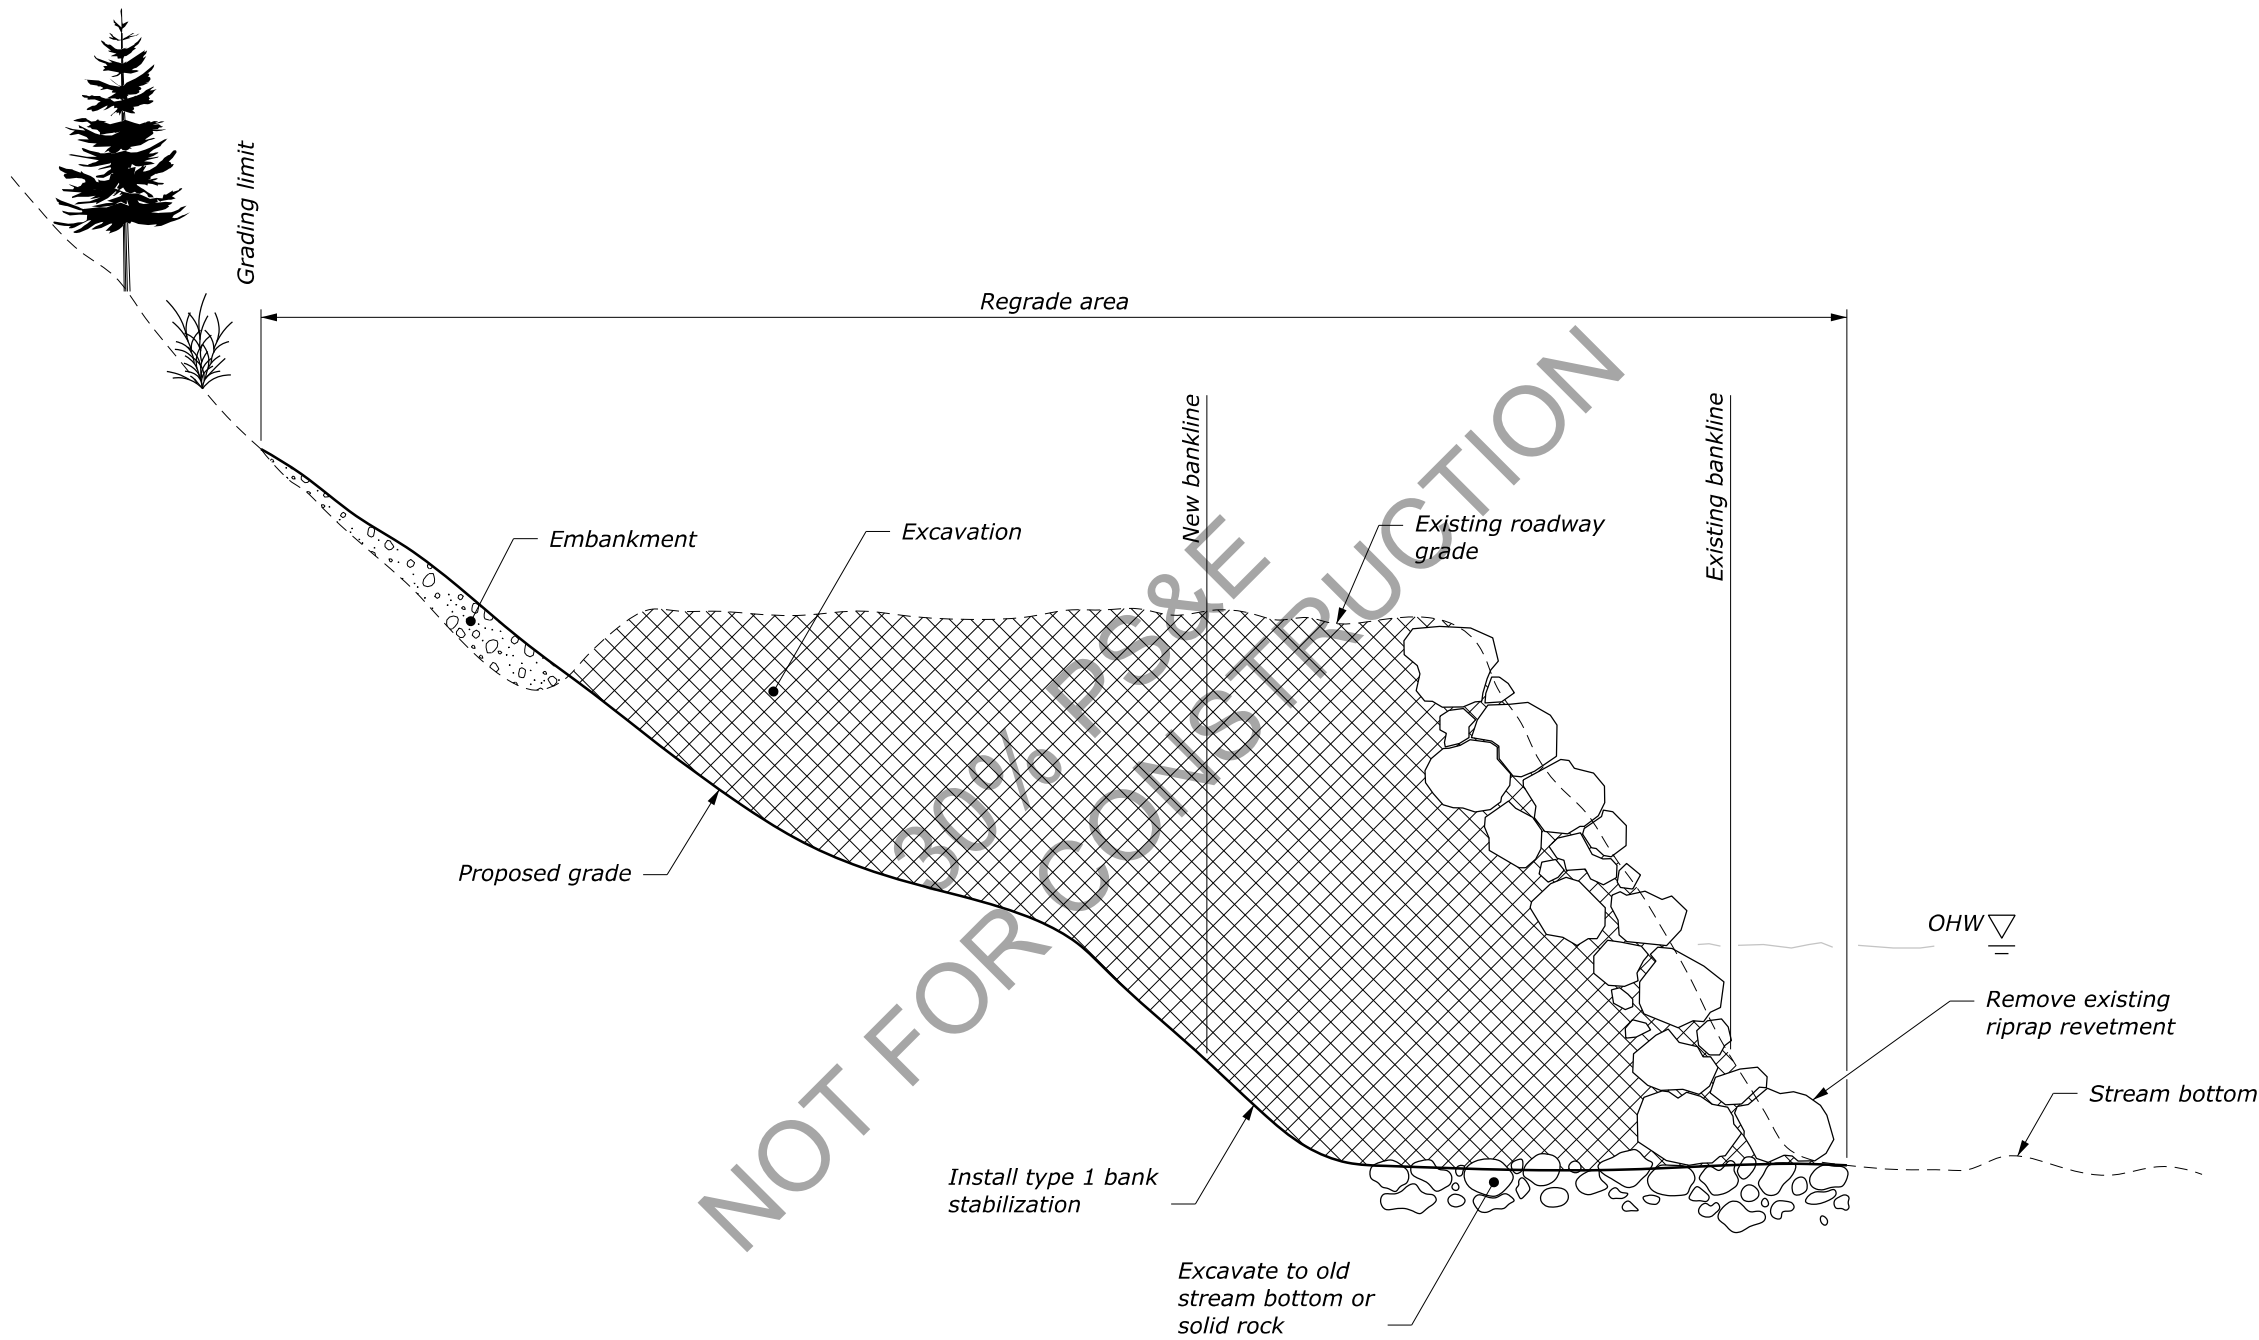
**STREAM BANK REALIGNMENT**

**NOTE:**  
1. Place mulch, landscape woody debris, and vegetation over regrade area above ordinary high water.  
2. Excavate and remove roadbed material to pre-road ground surface elevation. Verify depth in field.

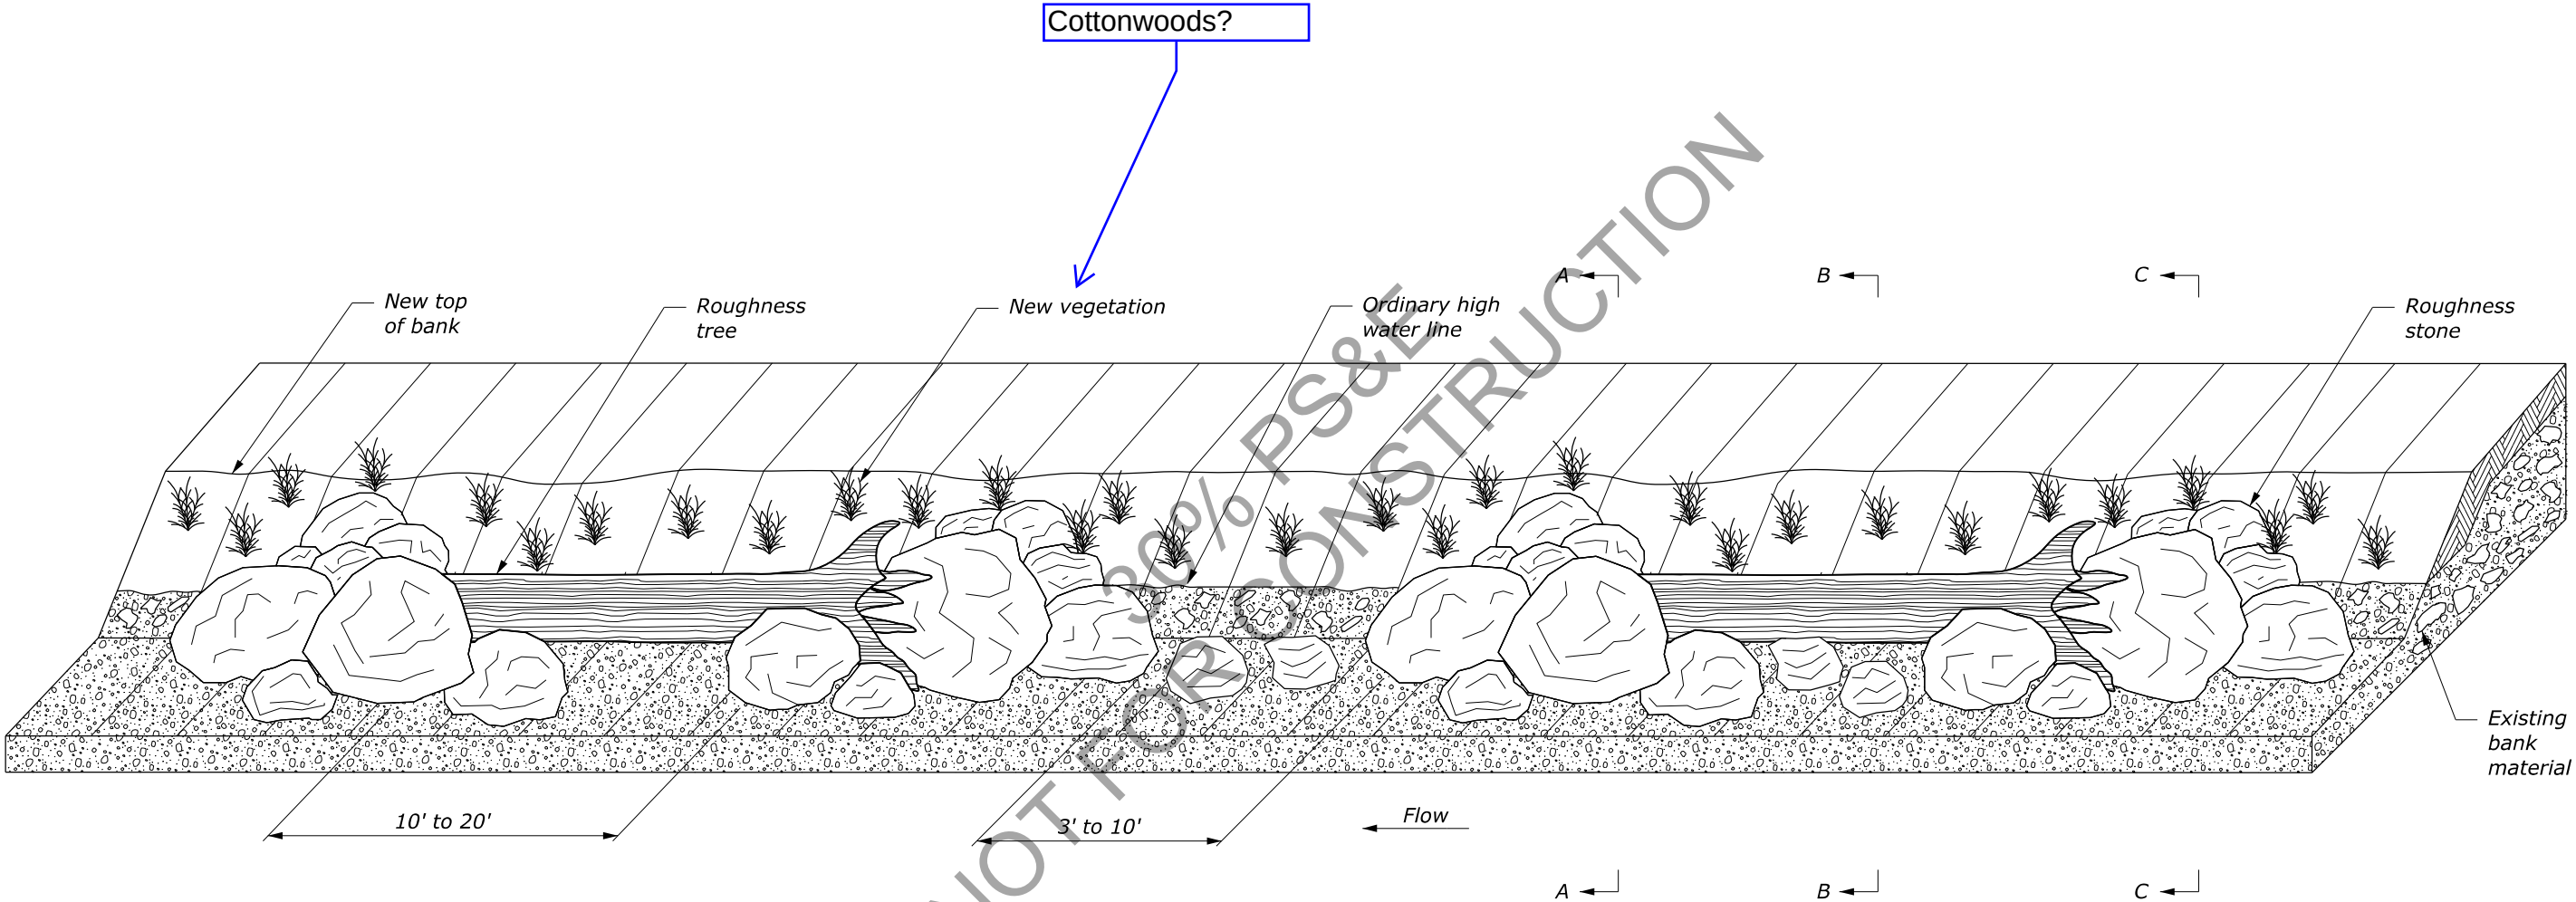
NOTE:  
1. Field verify existing bank material gradation. Adjust spacing per CO.

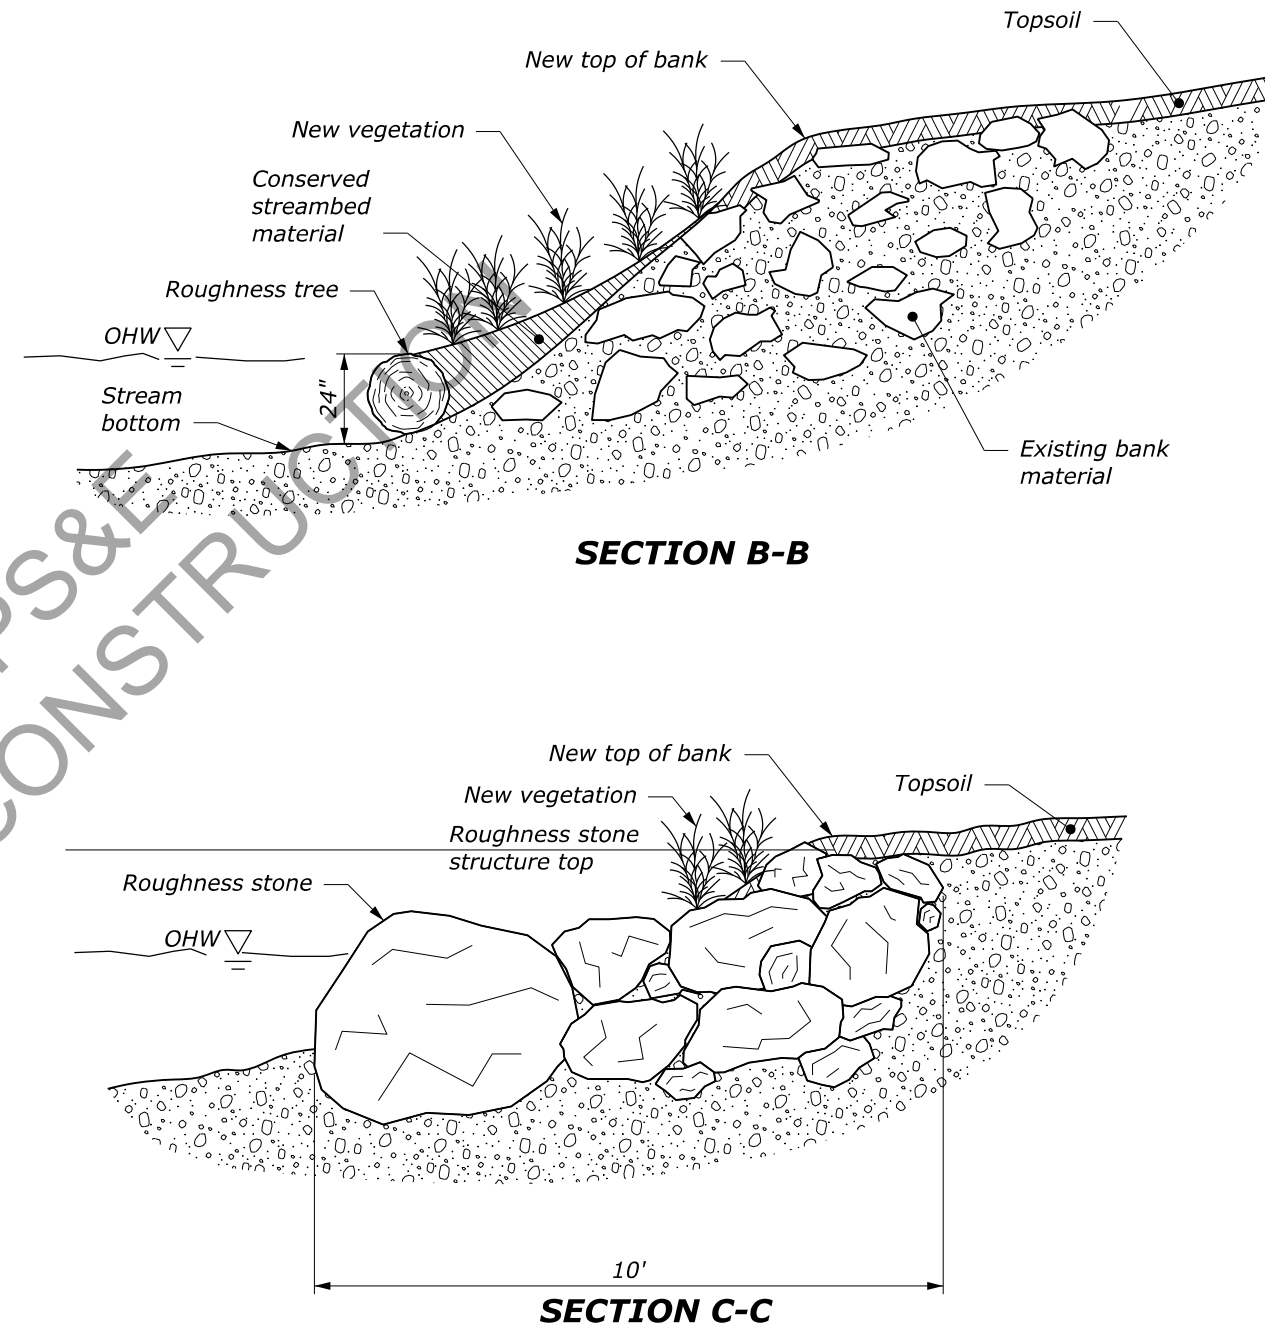
- NOTE:
1. Field verify existing bank material gradation.
  2. Place top of roughness stone at least 3 ft above adjacent floodplain elevations.
