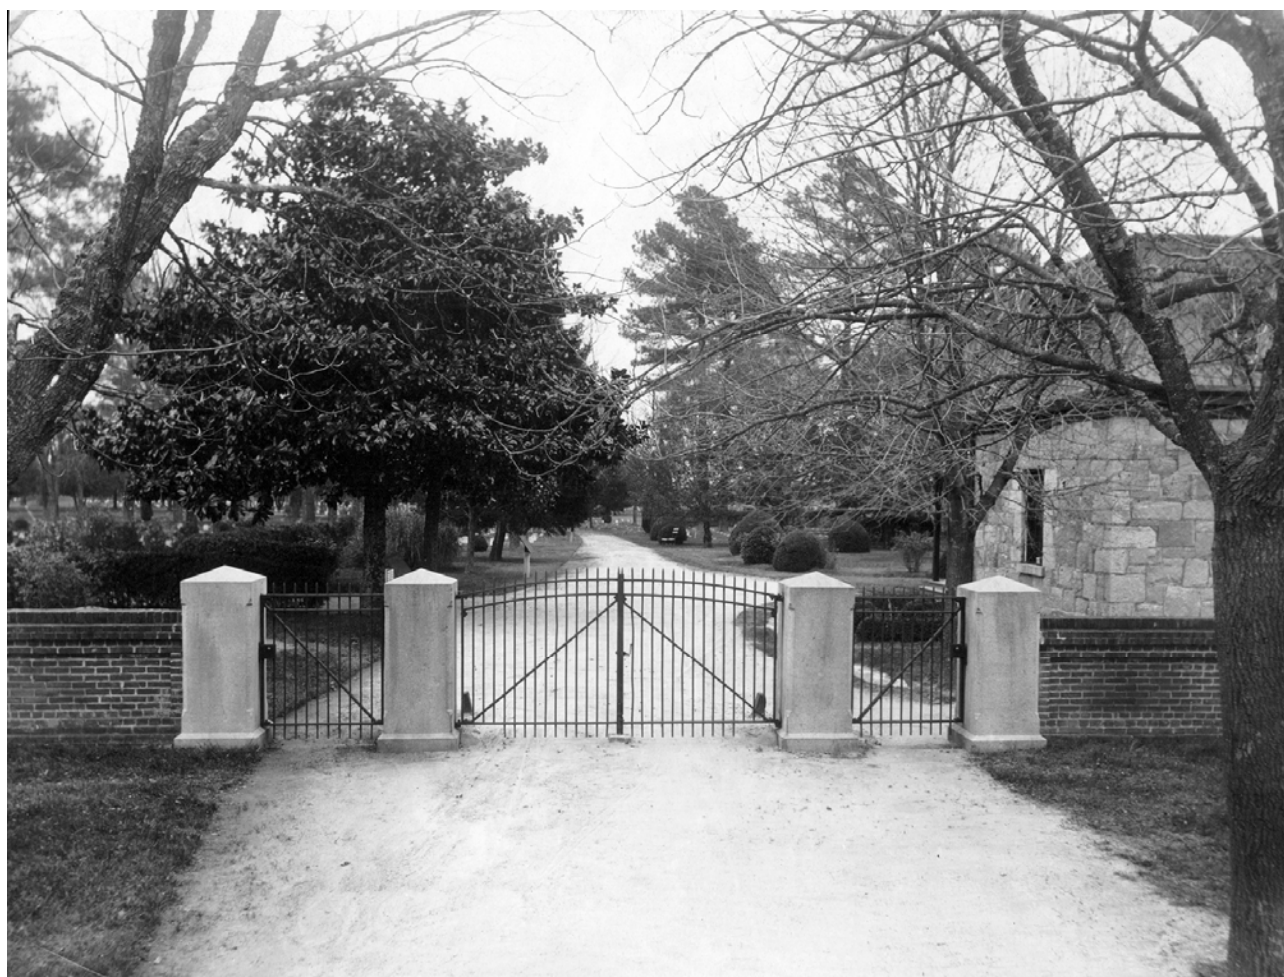
**Figure 1.57: Photograph of Poplar Grove National Cemetery looking east from the main gate, 1904. Note graveled main drive, dark trim on lodge, clipped boxwoods around circular turn-around (to right), tall loblolly pines in background, hedge and magnolias in front of service area (at left), and tablet and settee along drive in the distance. Records of the Quartermaster General, RG 92, Still Pictures Division, National Archives II, College Park, Maryland.**

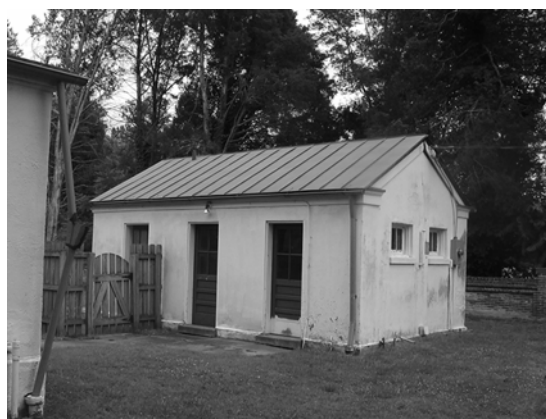
**Figure 1.61 (left): The utility (public restroom) building completed in 1929, view looking southeast from a current photograph. The fence and white paint on the stucco are later additions. SUNY ESF, 2006.**

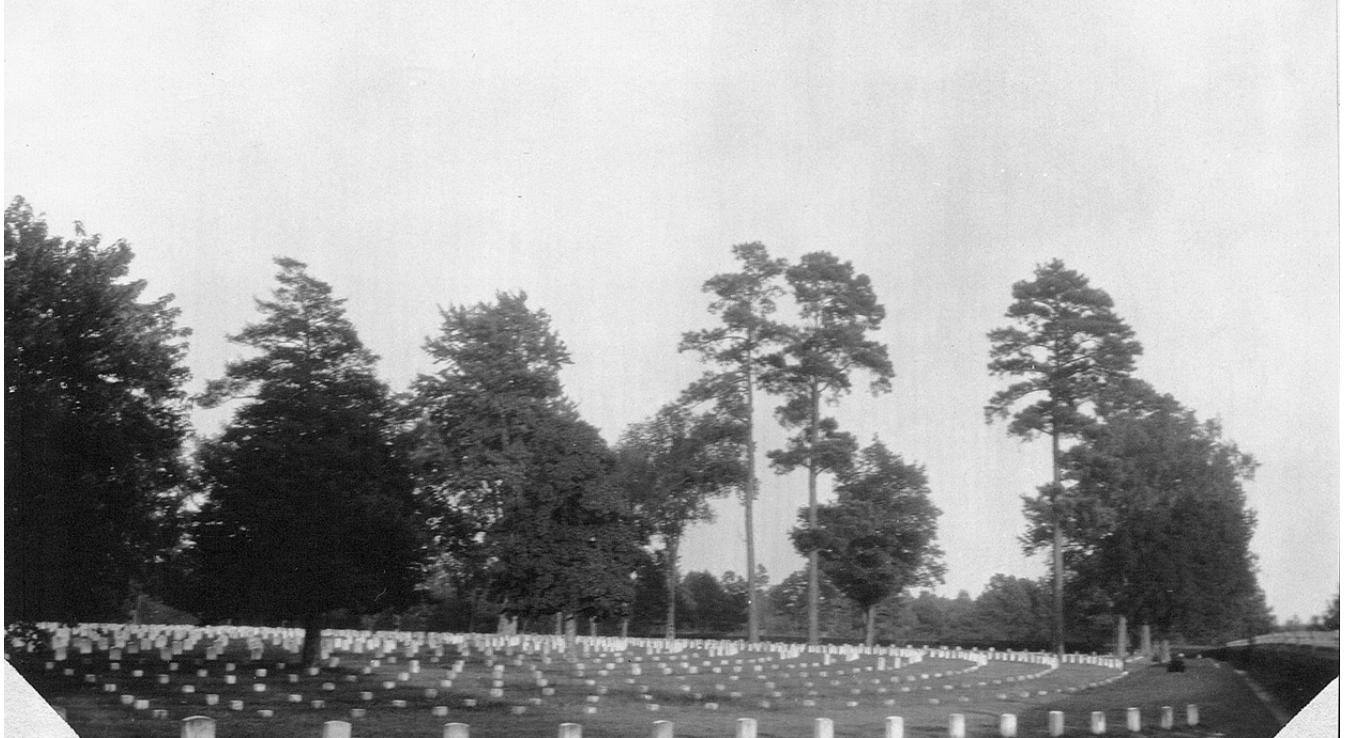
**Figure 1.65: Photograph of Poplar Grove taken from the near the rostrum looking east along the south wall, from a tree inspection report, February 1932. The caption in the report reads: "Characteristic pines and hollies at Poplar Grove, Petersburg, Va." The dark appearance of the brick walls is partly due to coverage in ivy. RG 92, Entry 1891, Office of the Quartermaster General, Correspondence, Geographic File, 1922-1935, box 1773, National Archives II, College Park, Maryland.**
