SUBJECT: Soil Testing Reports

## Dirt Hauling Log

**FIELD REPORT NO. 72**

**PROJECT** East Wing Modernization Environmental Support  
**LOCATION** 1600 Pennsylvania Ave  
Washington, DC 20500

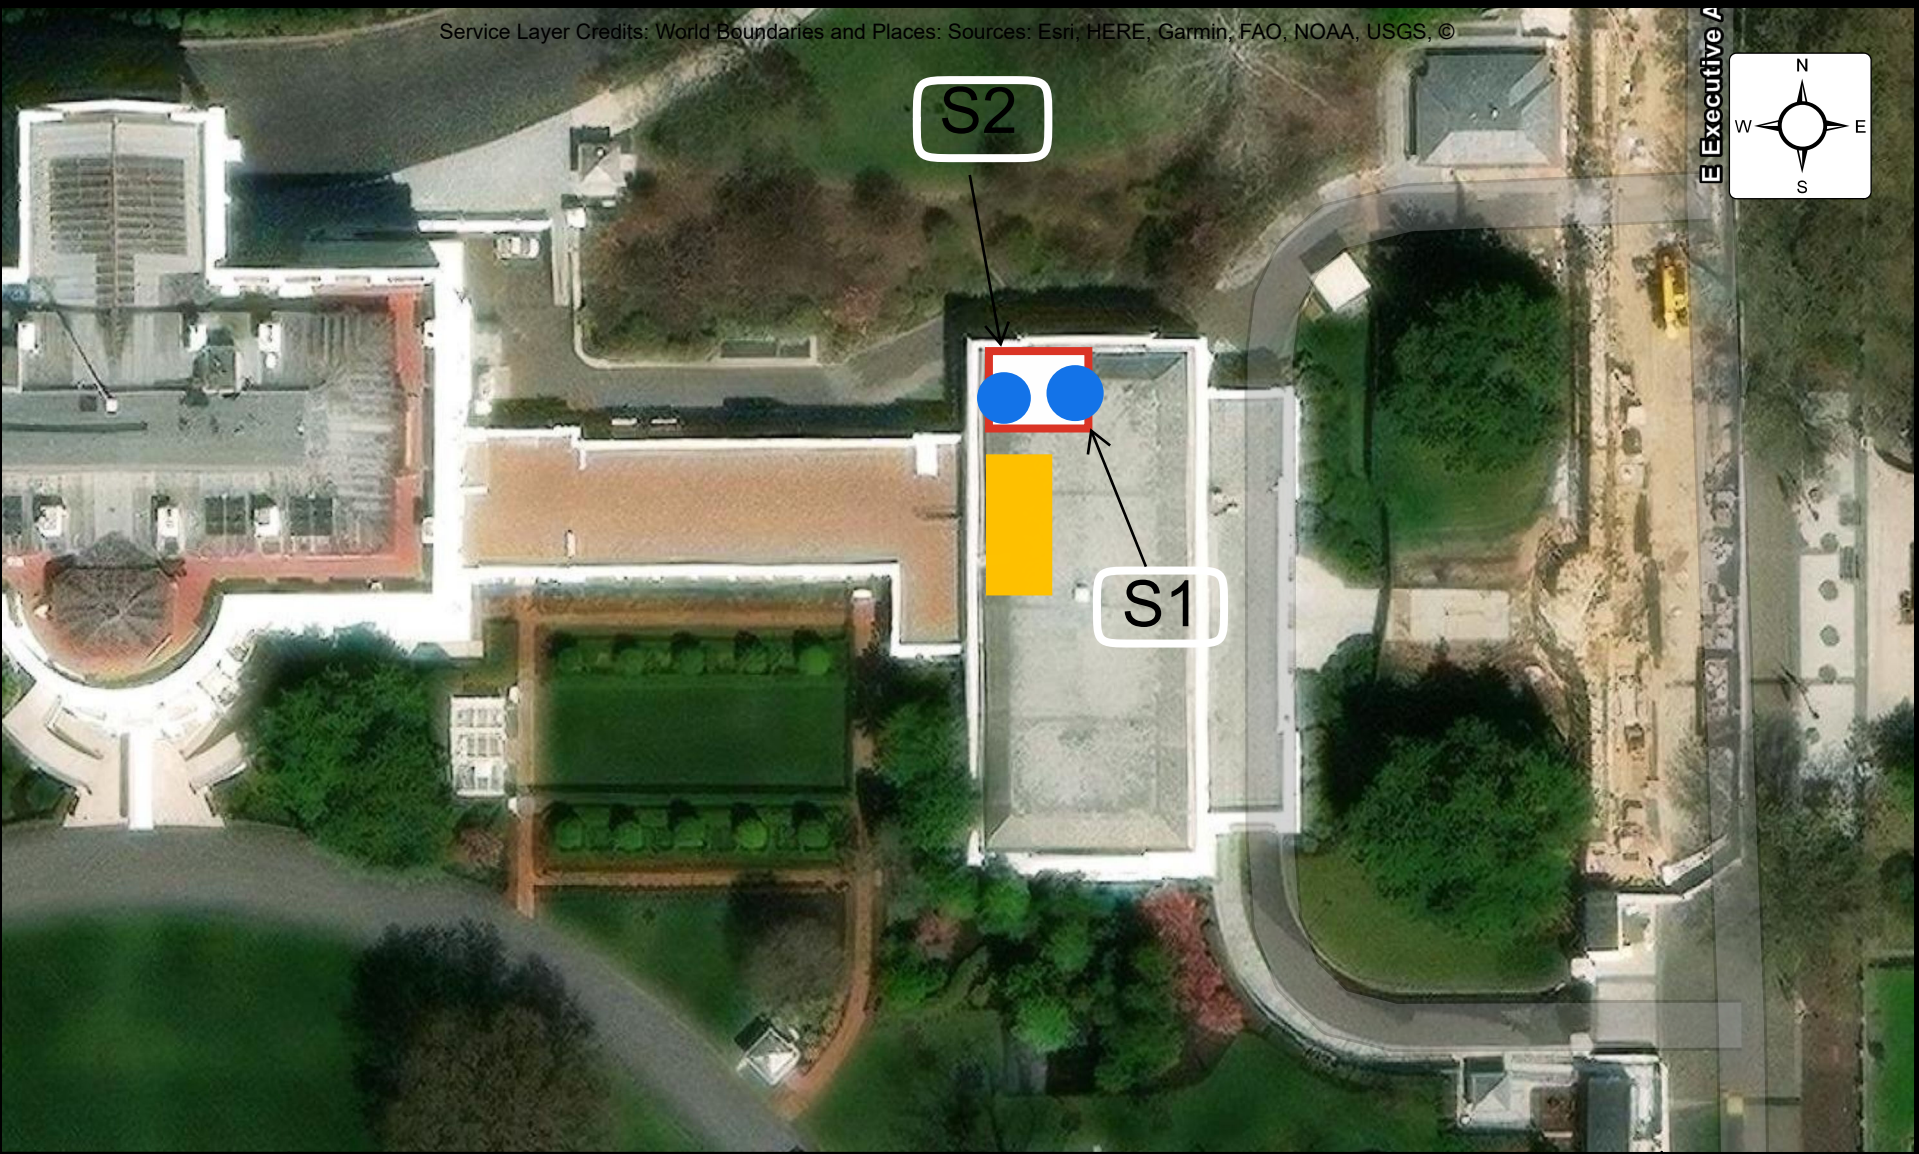
# SITE LOCATION DIAGRAM

On this date, Strittmatter was observed excavating on the northwest portion of the former East Wing at depths ranging from approximately 15 to 20 feet below ground surface (bgs).

Material field screened on this date was generally comprised of dark orangish brown silt and sand with rock fragments. Field screening did not indicate evidence of petroleum impact in the samples screened, and staining and suspect odors were not observed/detected in the excavated material.

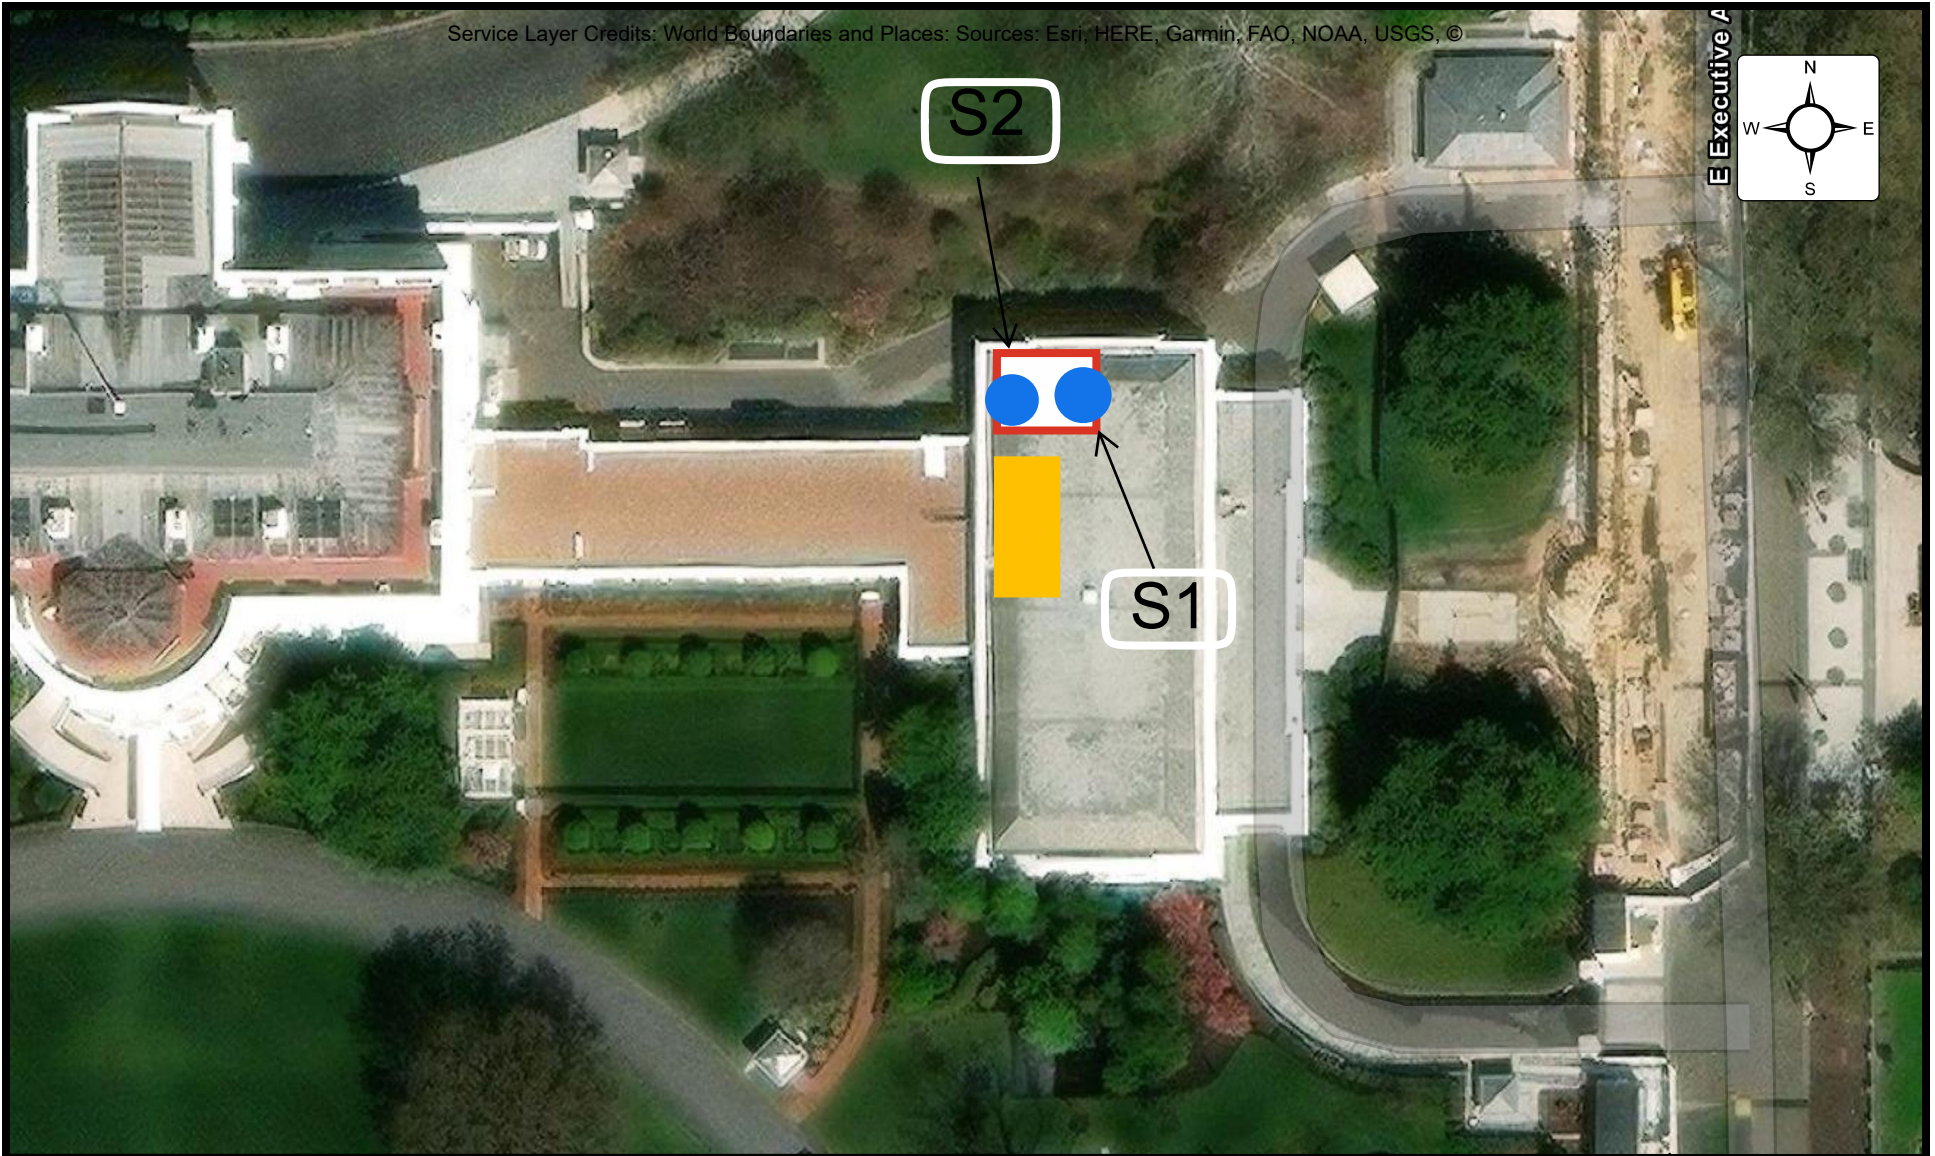
# SITE LOCATION DIAGRAM

On this date, Strittmatter was observed excavating in the northwest portion of the former East Wing at depths ranging from approximately 15 to 20 feet below ground surface (bgs).

Material field screened on this date was generally comprised of dark orangish brown silt and sand with rock fragments. Field screening did not indicate evidence of petroleum impact in the samples screened, and staining and suspect odors were not observed/detected in the excavated material.
