# Pinehurst Branch Stream and Wetland Restoration

## Environmental Assessment Public Scoping Meeting

Rock Creek Park  
Virtual Meeting  
October 1, 2026

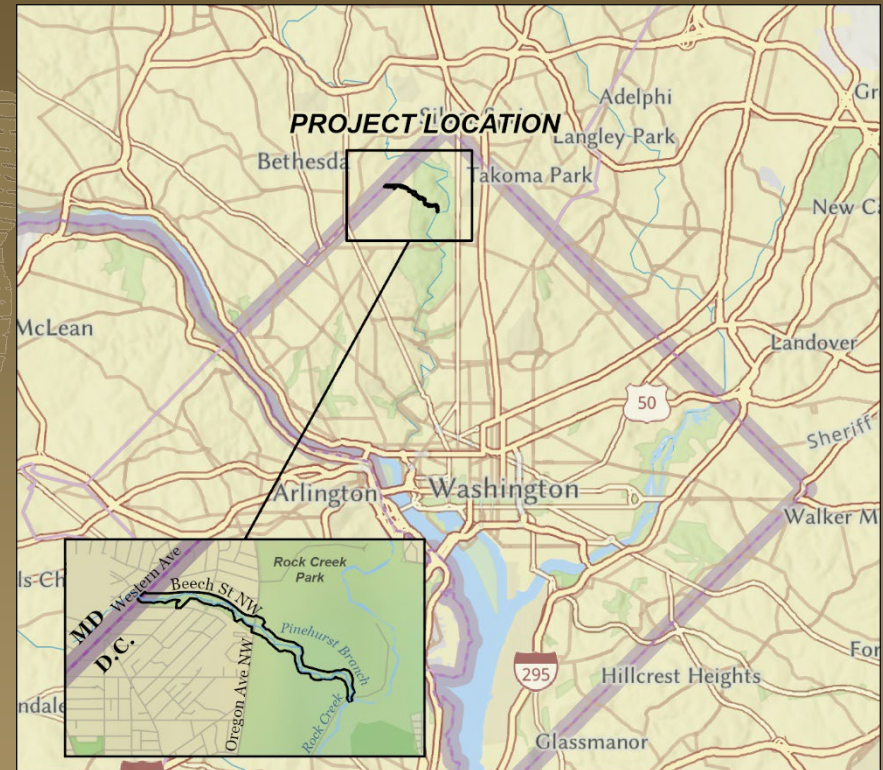
Map shows project location in Washington DC with a zoomed-in inset identifying the project area where stream and wetland activities will occur.

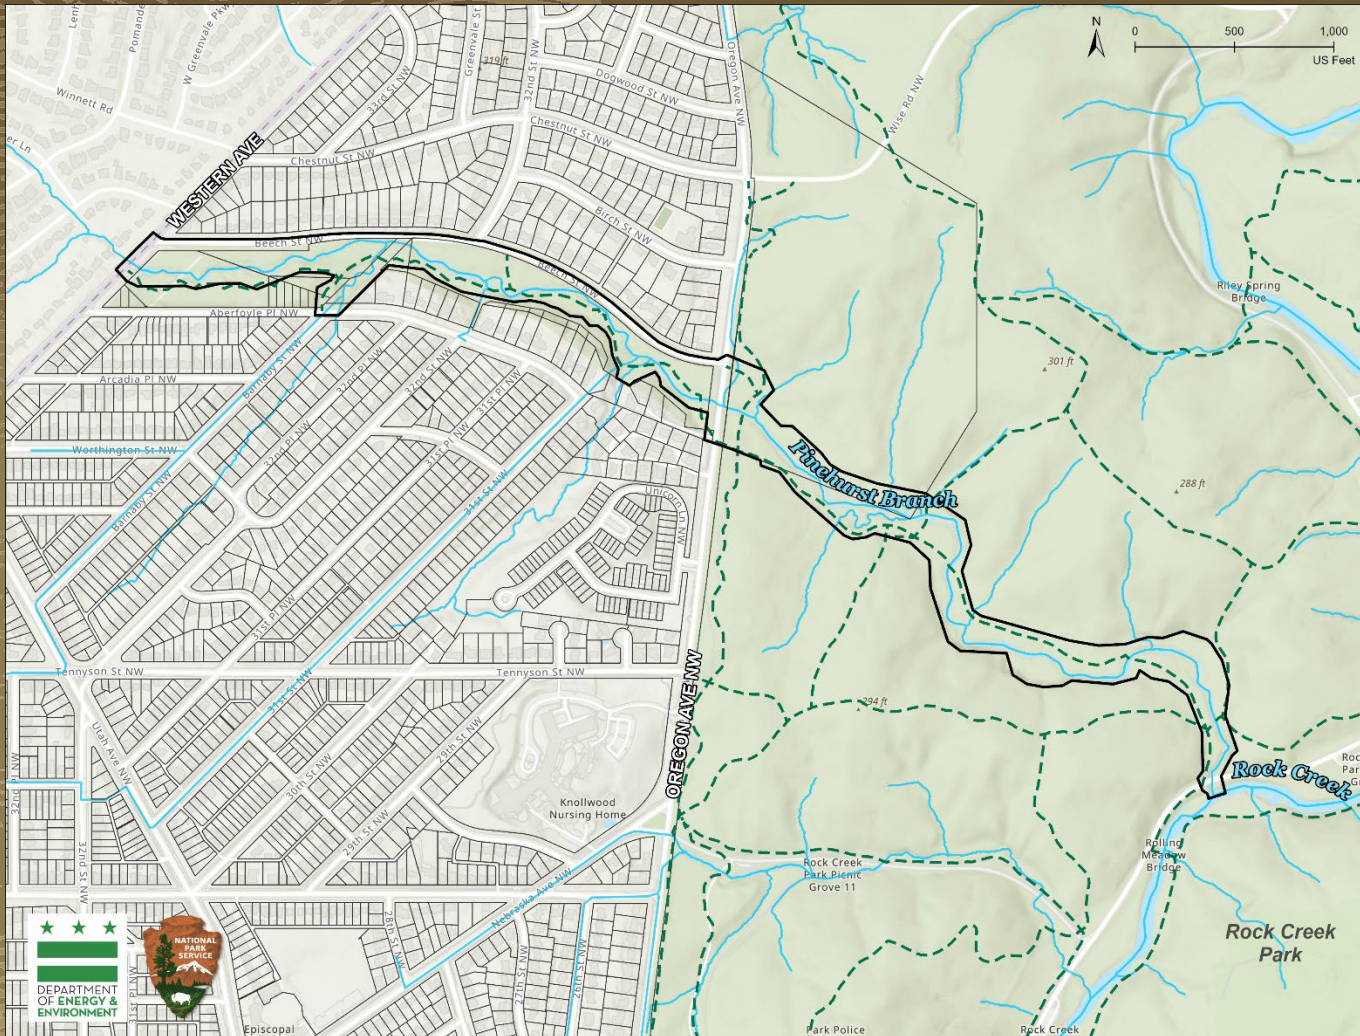
# Project Area Map

Map shows Pinehurst Branch, the surrounding neighborhood, and Rock Creek Park, and outlines the project area where stream and wetland activities are proposed.

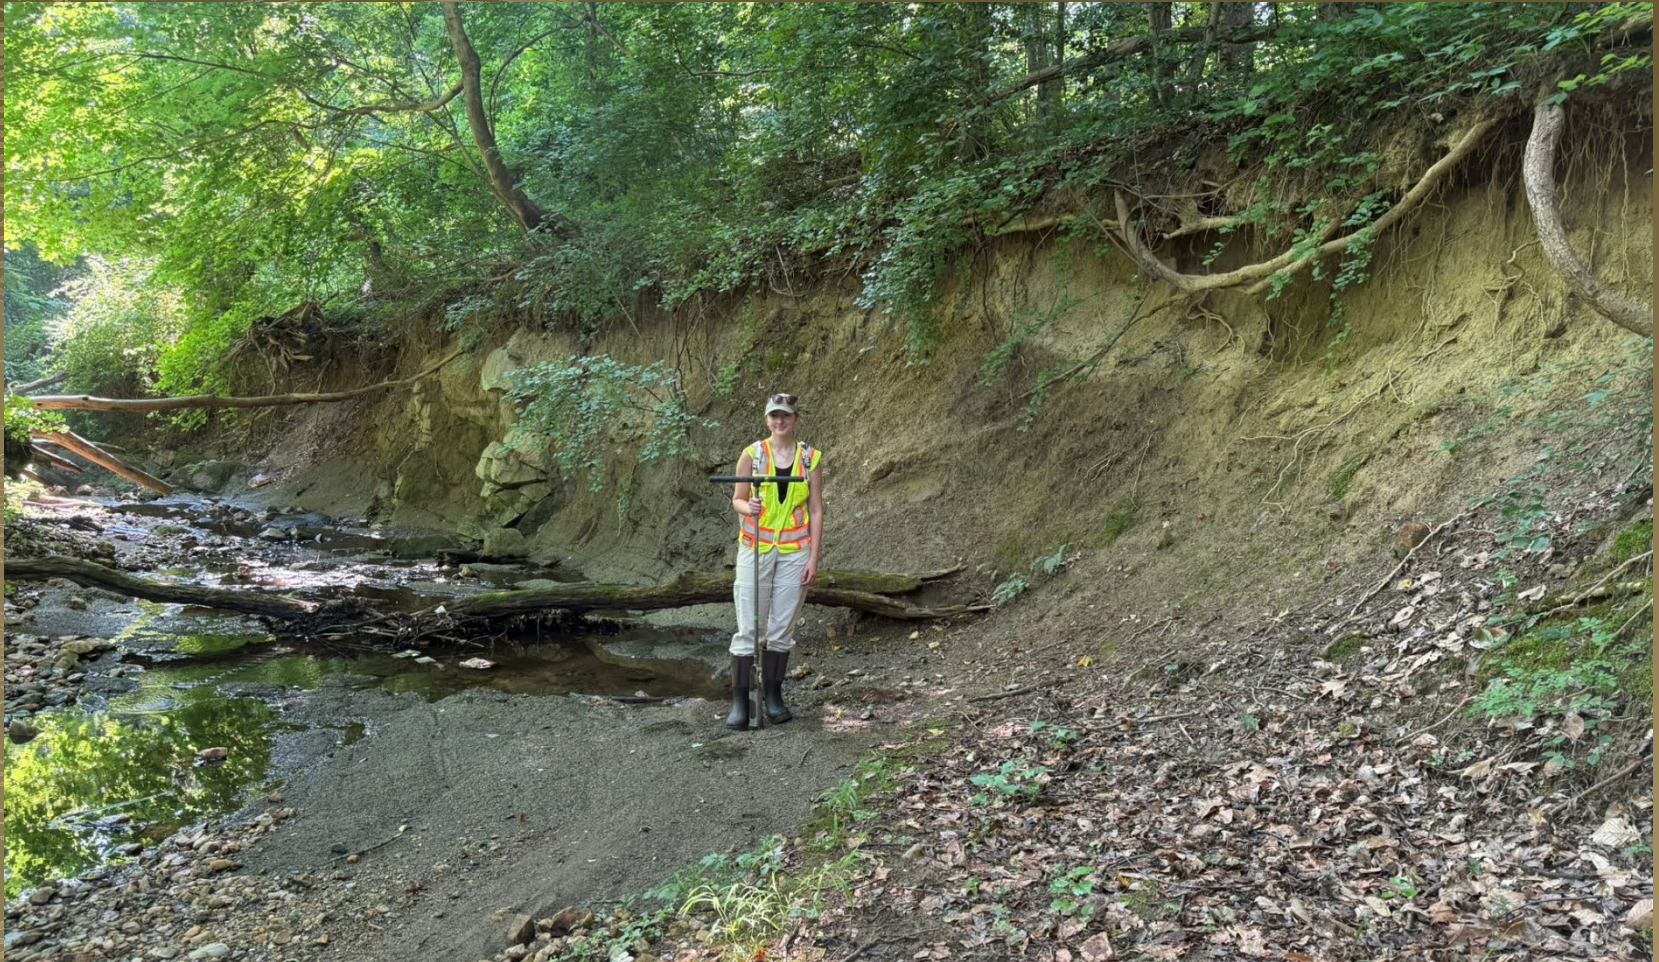
# Active Bank Erosion and Tree Impacts

Person stands in front of an actively eroding streambank along Pinehurst Branch. The streambank is vertical with exposed soil and overhanging tree roots. Downed trees span the stream in the background.

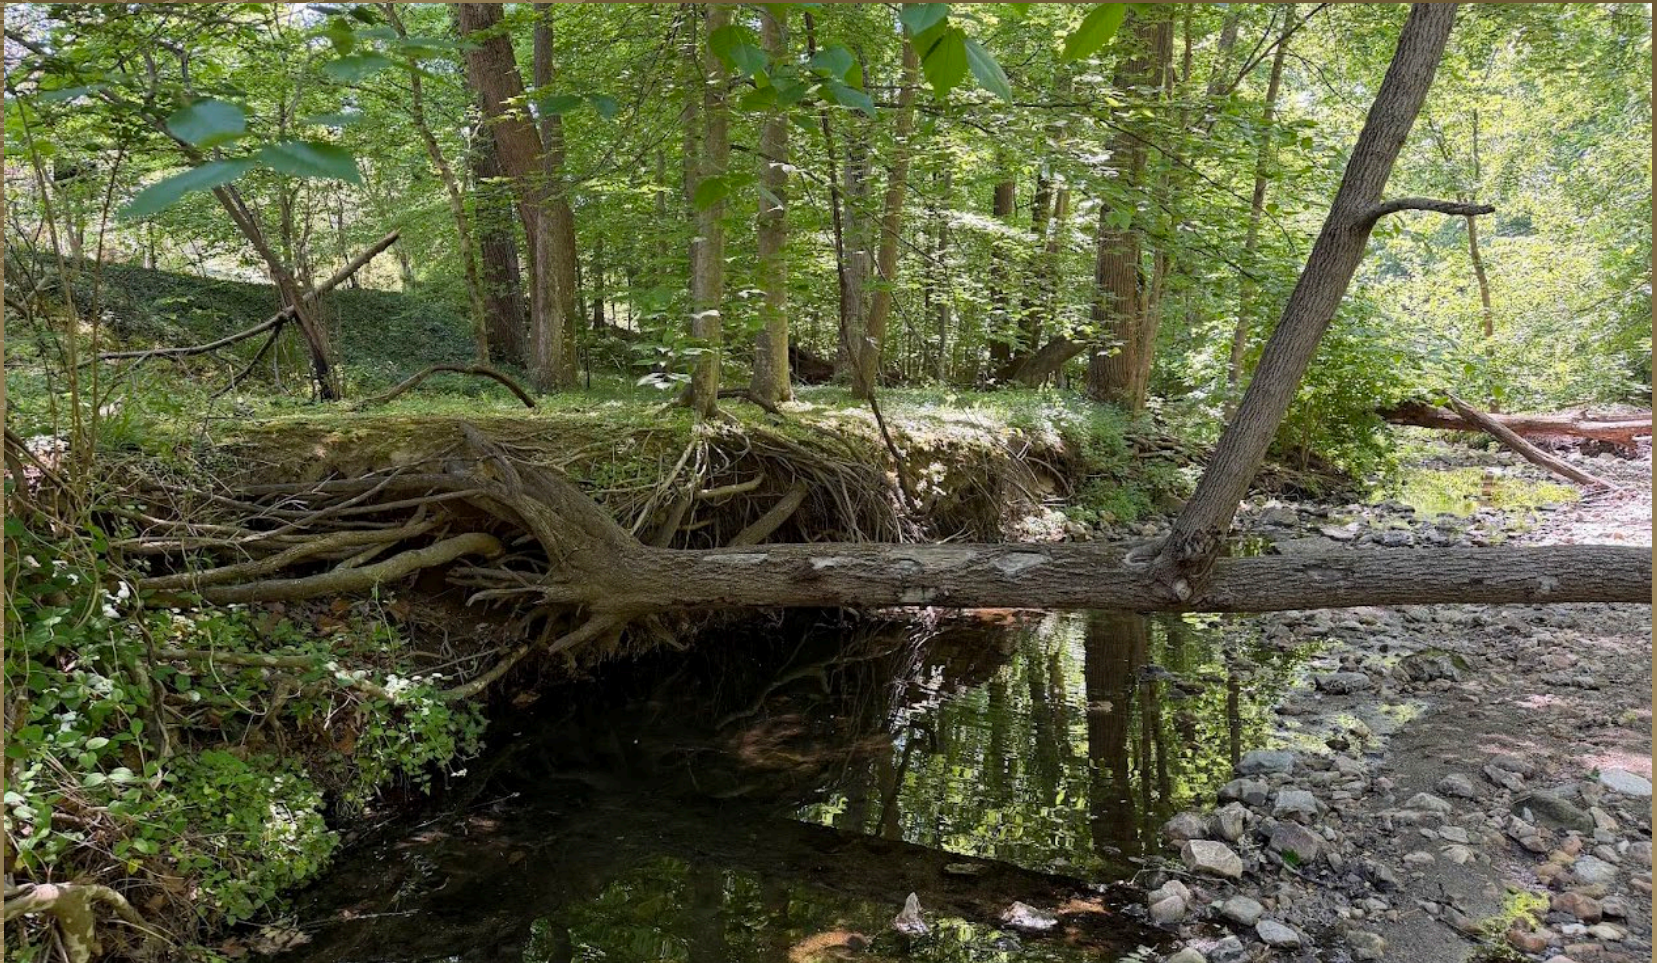
# Active Streambank Erosion Causing Tree Loss

Active streambank erosion along Pinehurst Branch. The streambank has eroded under a tree causing it to fall across the channel.

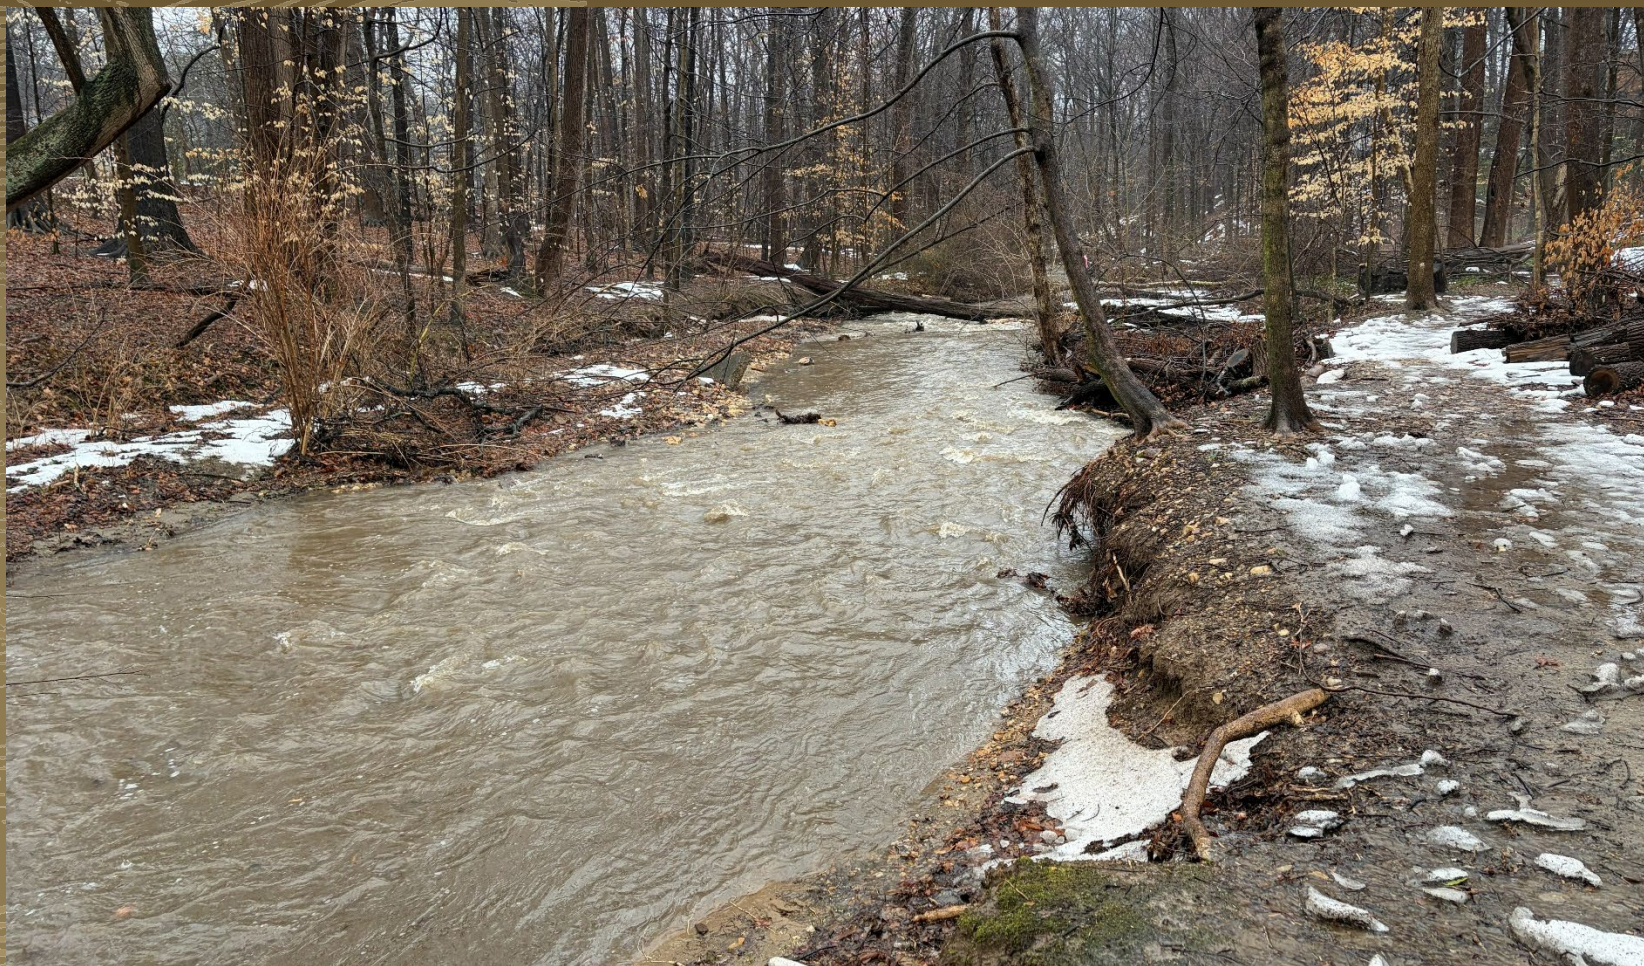
# Floodplain Disconnection

Image of Pinehurst Branch during a storm. The stream flow is not able to access the floodplain to provide flood attenuation due to channel incision.

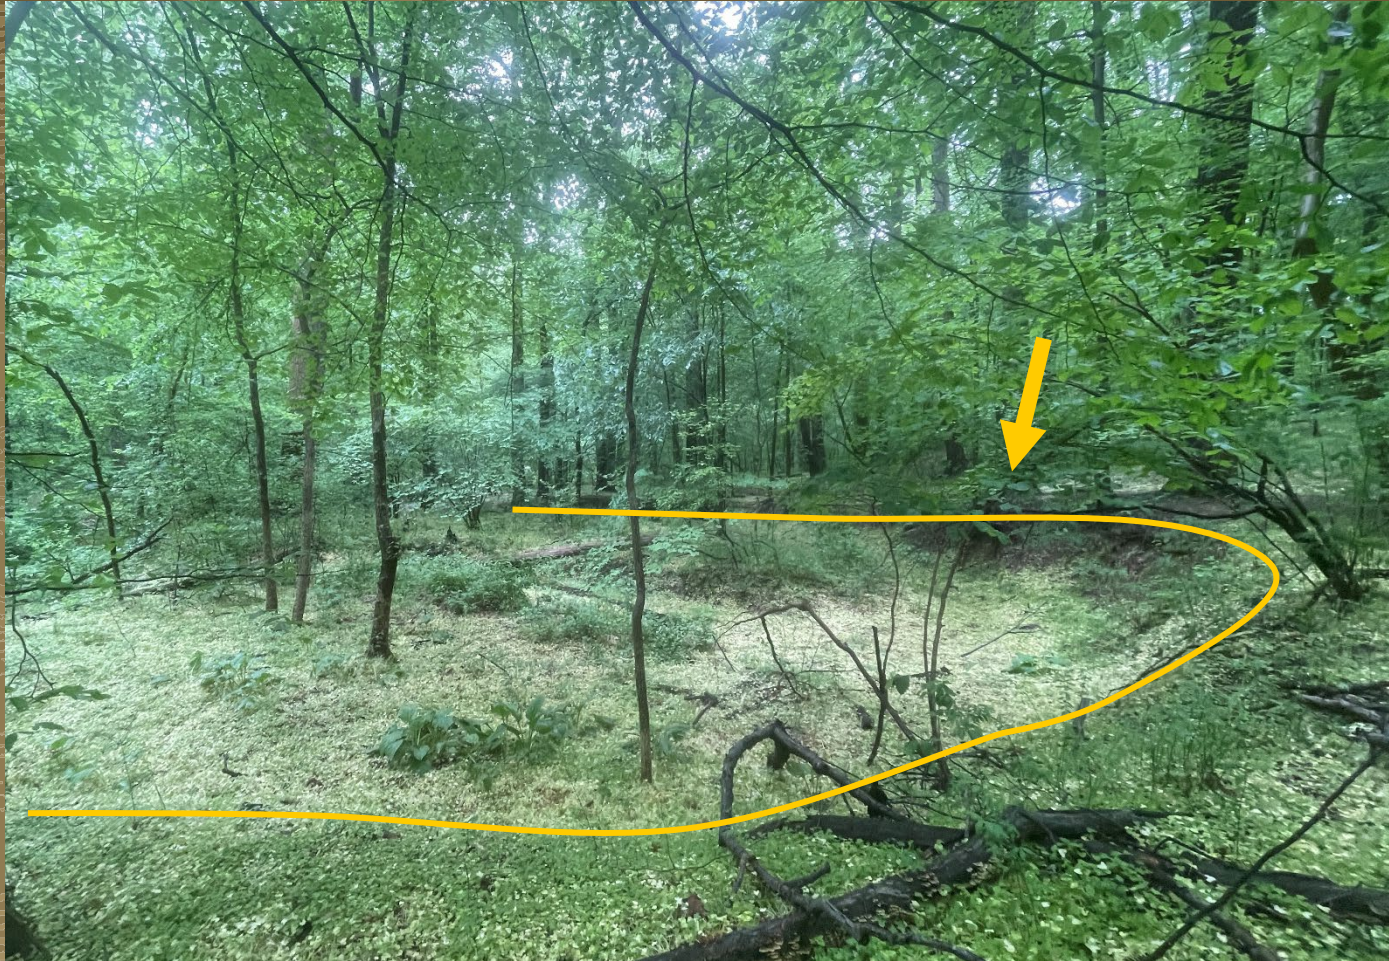
# Relict and Degraded Wetlands from Floodplain Disconnection

The image shows a relict and degraded wetland that is located within the floodplain of Pinehurst Branch. There is a line and arrow in the image denoting the relict and degraded wetland boundary from the upland area.

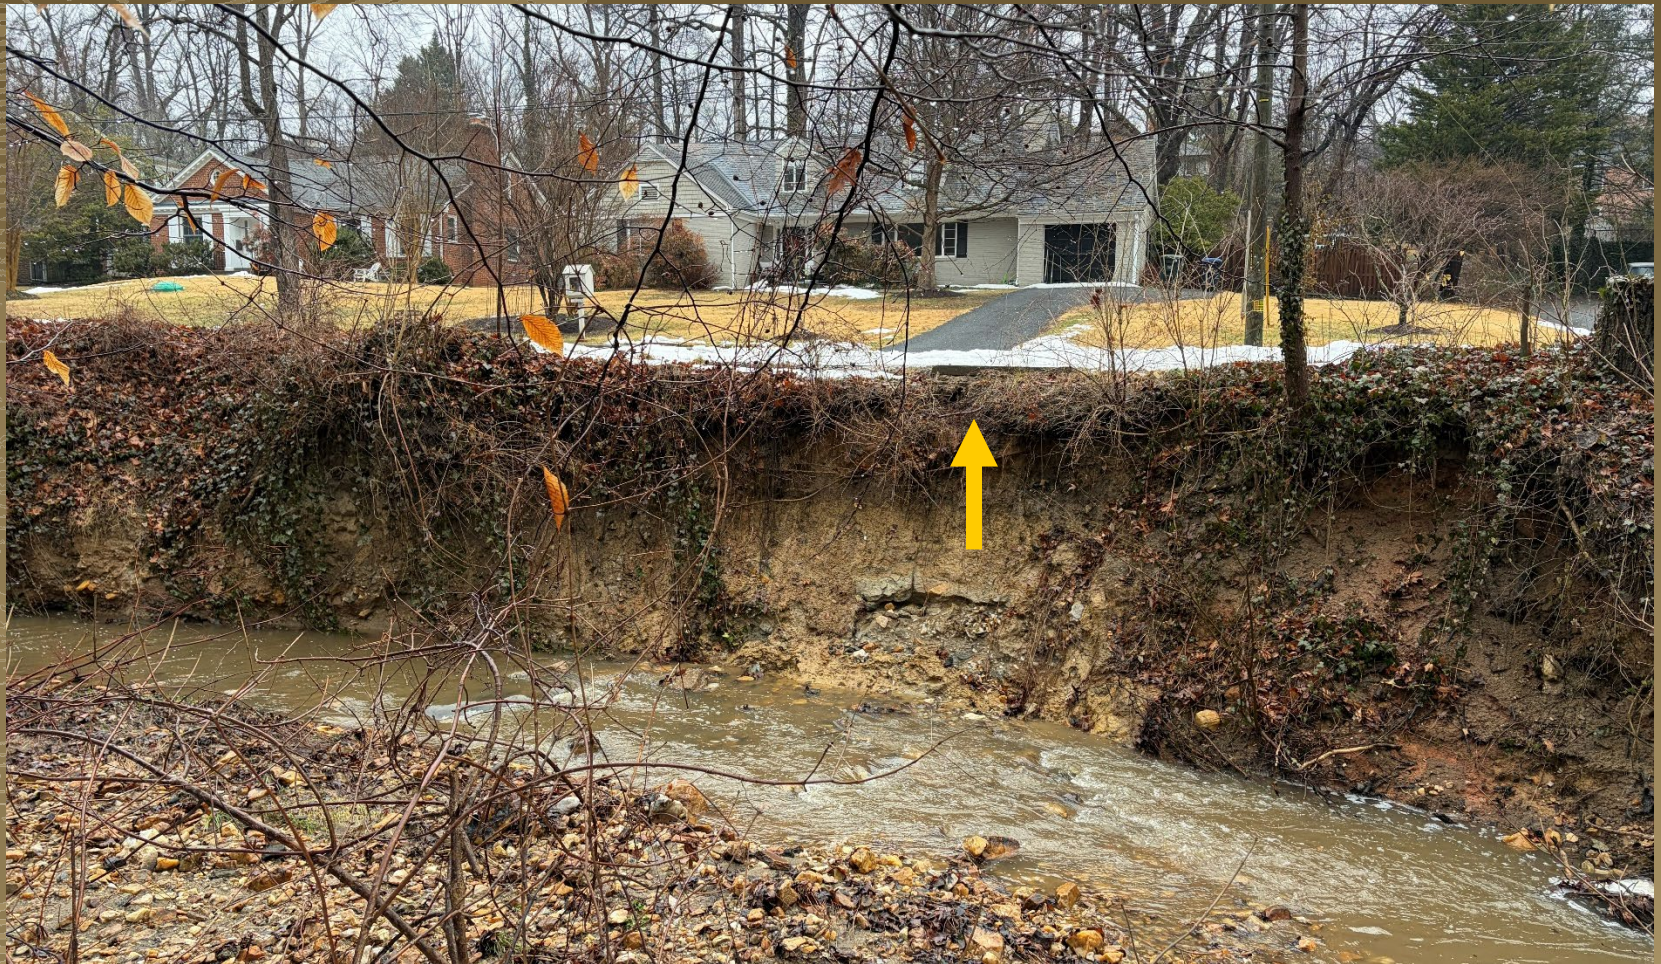
# Active Bank Erosion and Threatened Roadway Infrastructure

Active streambank erosion along Pinehurst Branch. An arrow is pointing at a stormwater inlet structure along Beech Street that is threatened by the active streambank erosion.

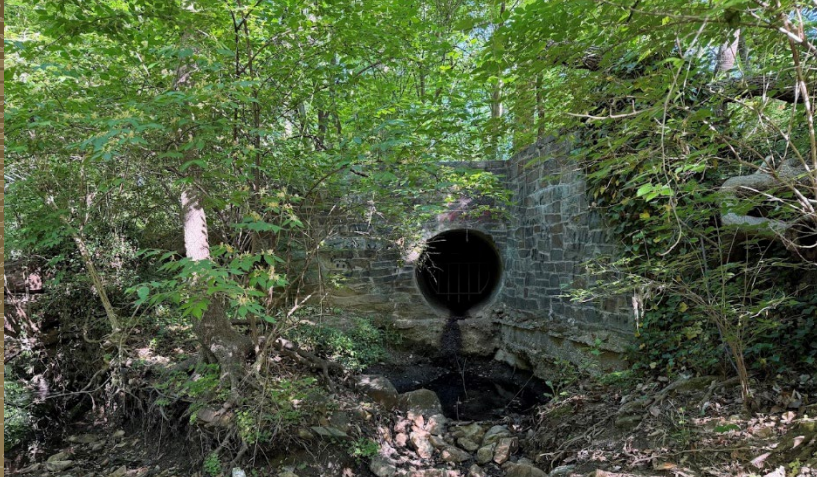
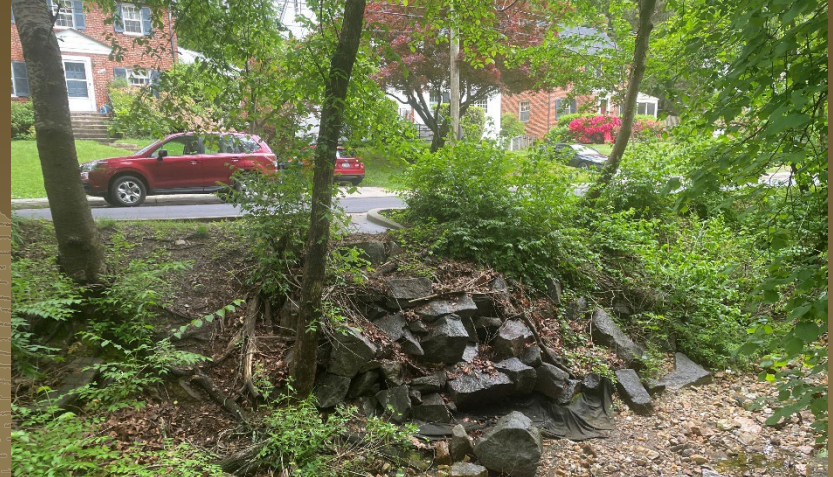
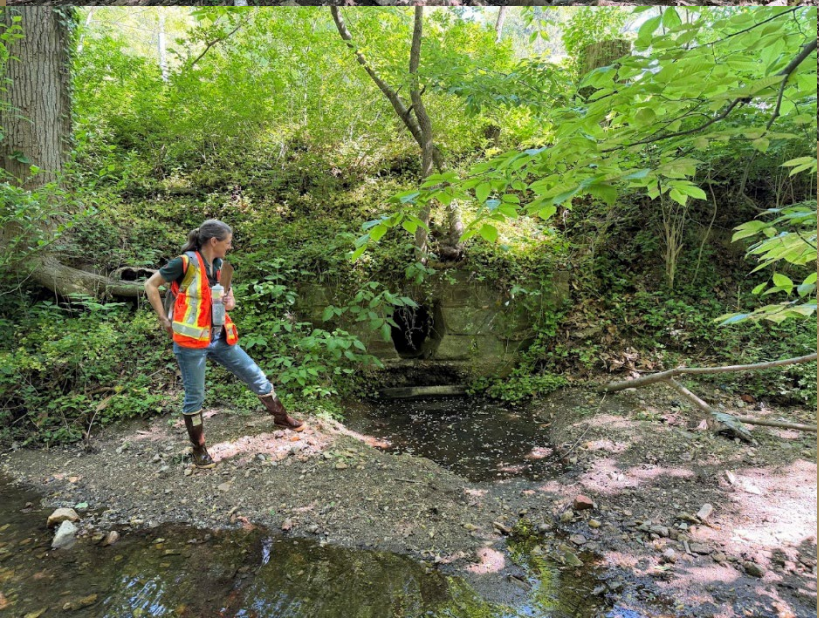
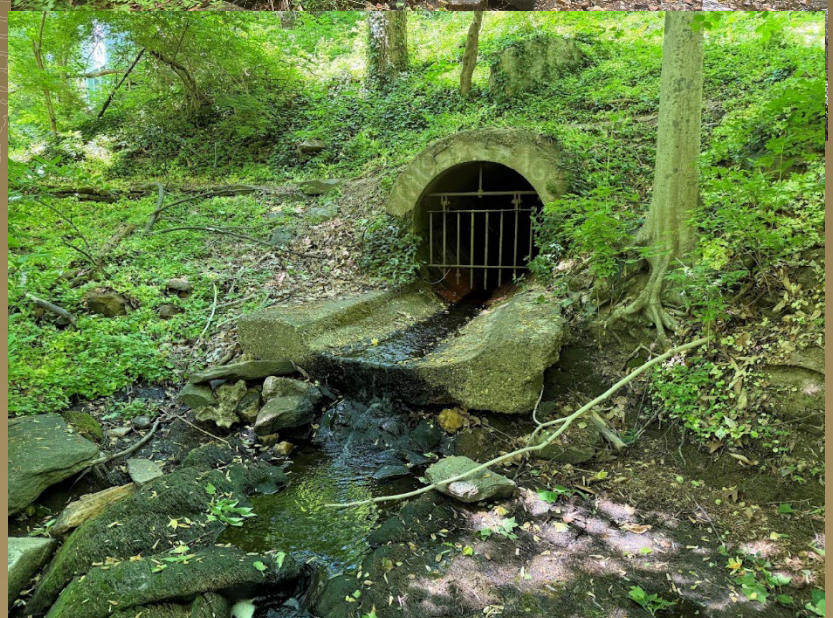
# Erosion Affecting Storm Drain Outfalls

Four images showing how active streambank erosion has damaged existing storm drain outfall headwalls and aprons causing infrastructure instability.

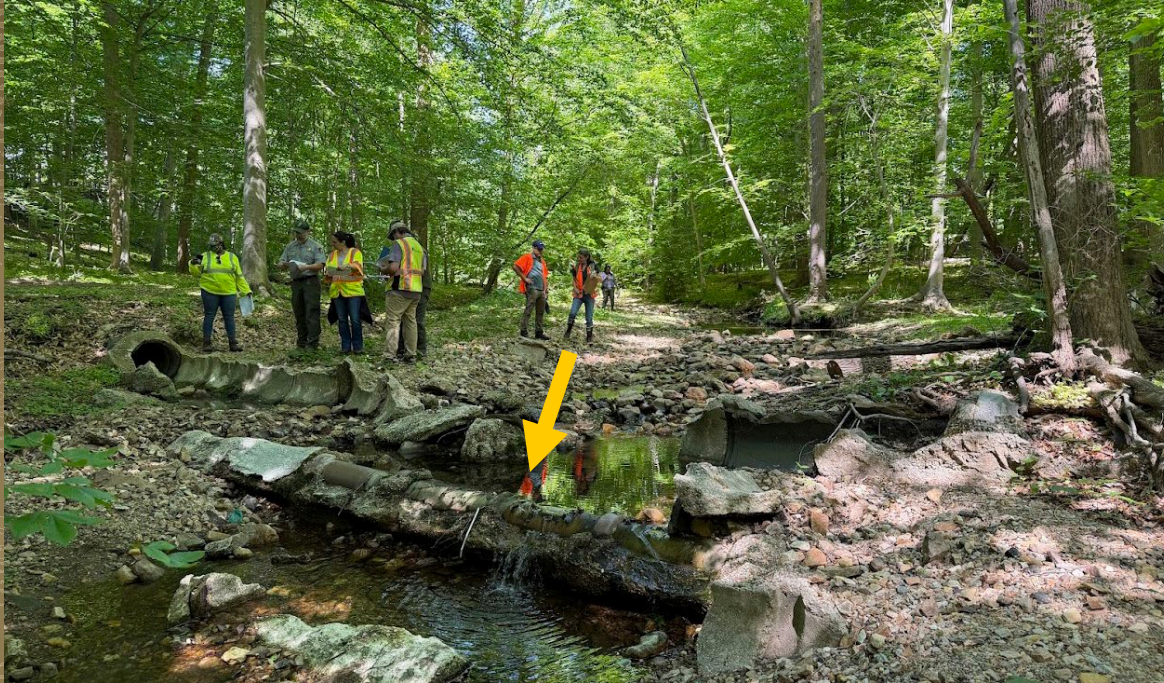
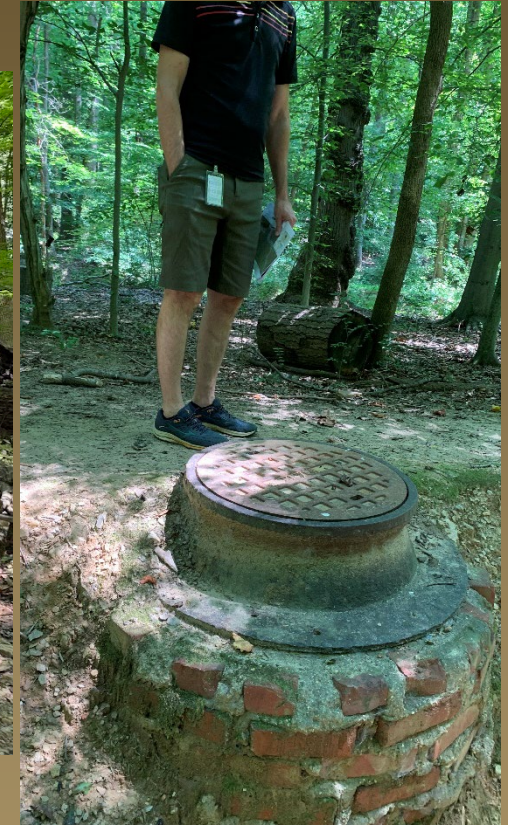
# Exposed Sanitary Sewers and Abandoned Manholes

There are two images. The image on the left shows an exposed sewer infrastructure crossing Pinehurst Branch caused from active stream channel erosion. The image on the right shows an abandoned sewer manhole within Rock Creek Park, which is intended to be removed with this project.

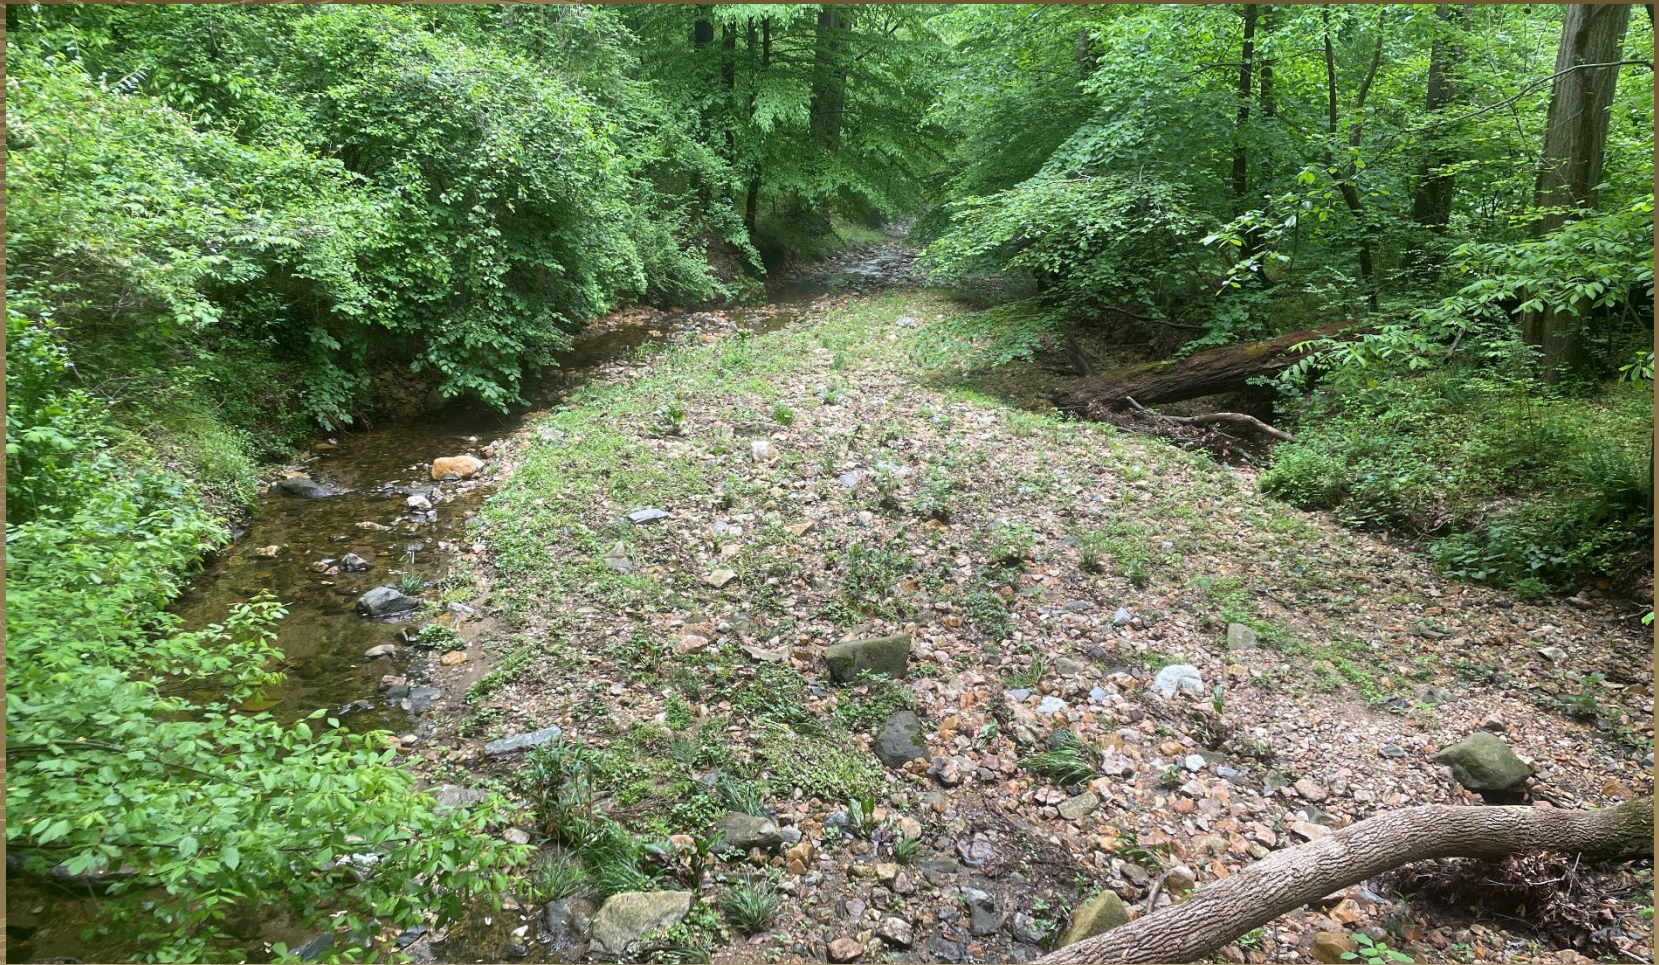
# Excessive Sediment Accumulation

Image shows excessive sediment built up in the form of a point bar within the Pinehurst Branch channel. Sedimentation is causing stream bank erosion, degrading aquatic habitat conditions (less pools), and increasing flood risk.

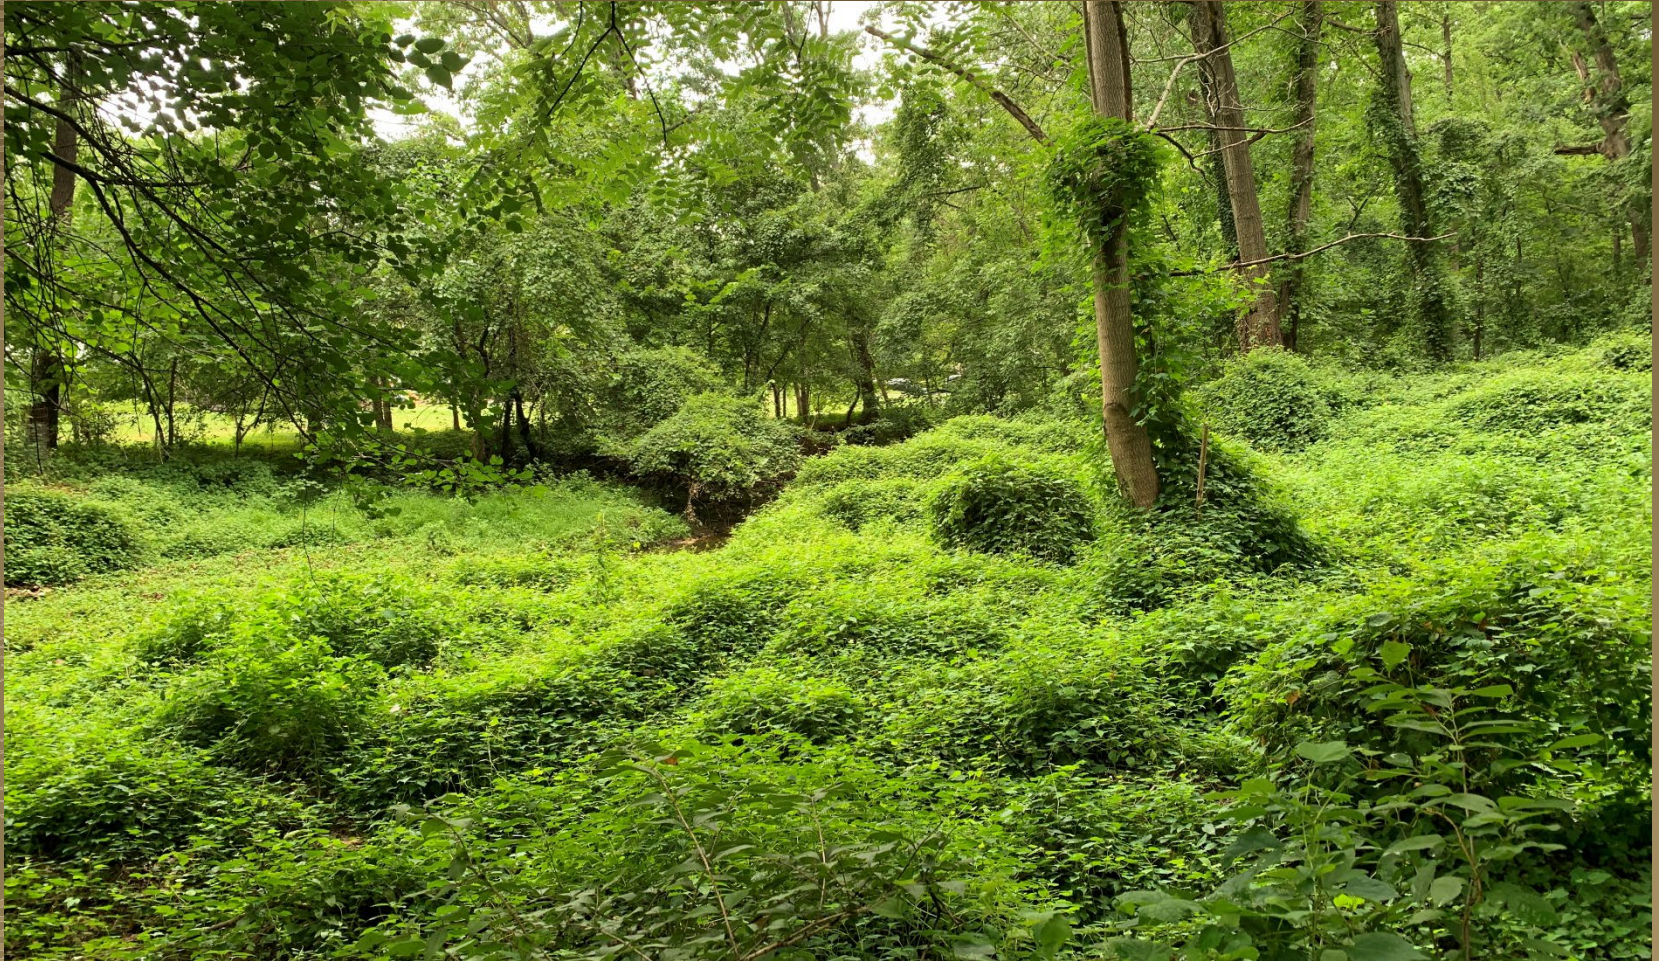
# Non-native Invasive Dominated Floodplain

Image shows green, non-native invasive species covering the floodplain along a section of Pinehurst Branch.

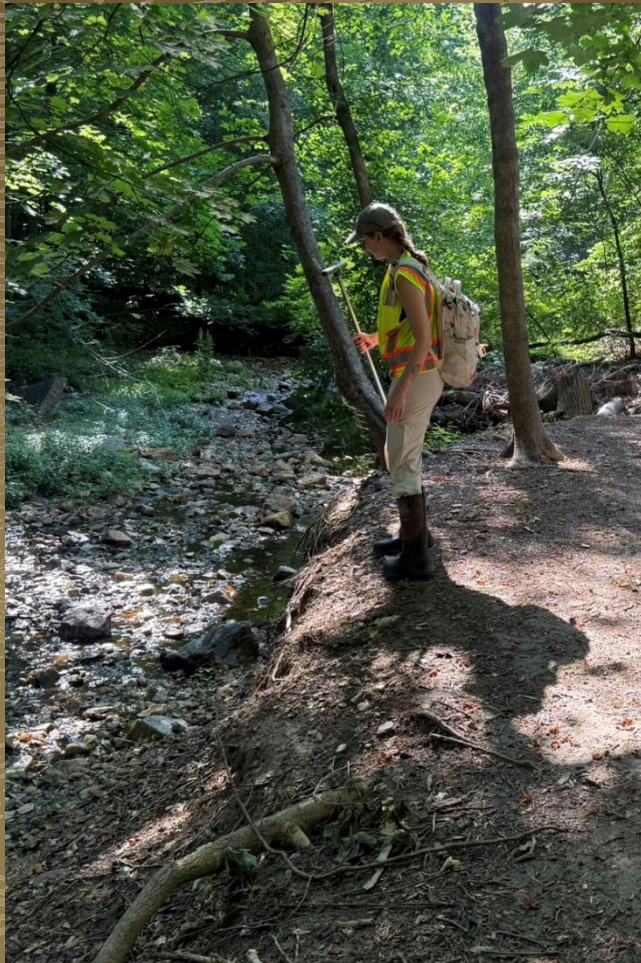
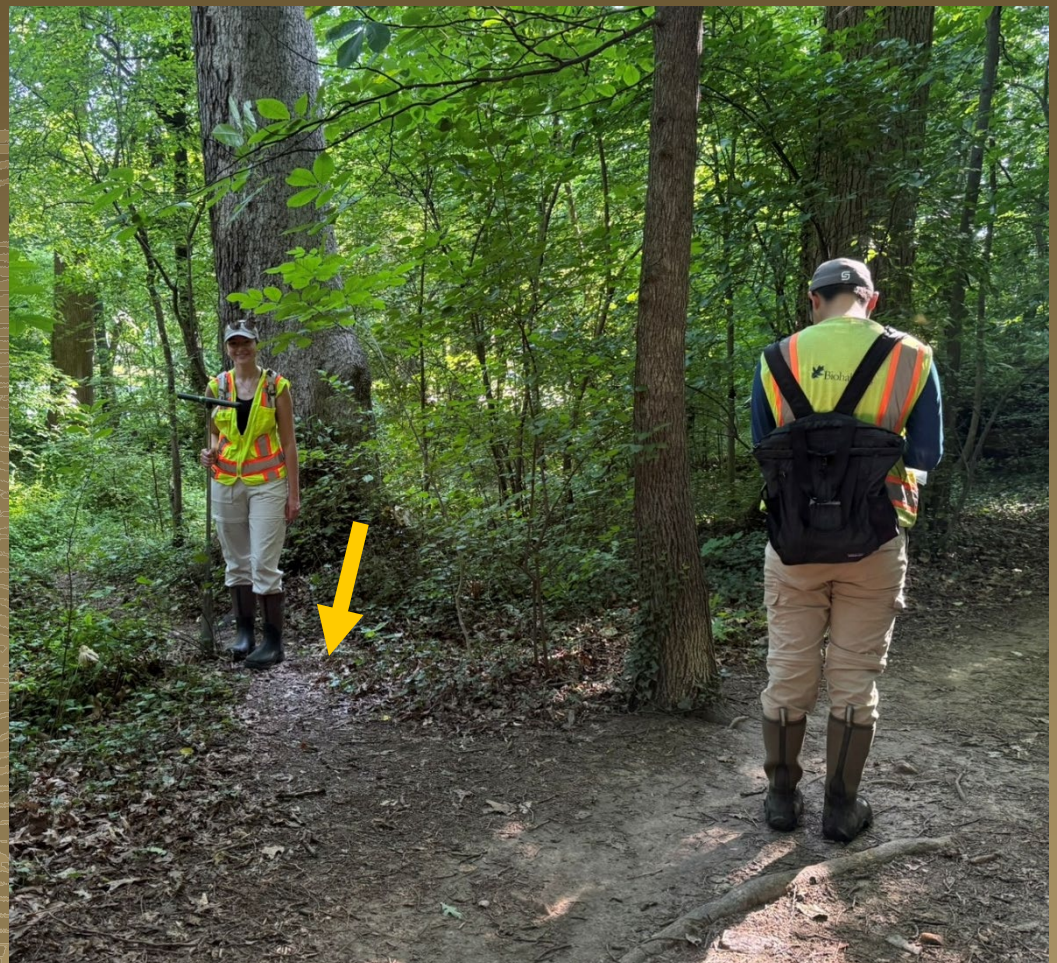
# Stream and Social Impacts to NPS Trails

Two images are shown. The image on the left depicts streambank erosion cutting into NPS trails that are adjacent to the stream. The image on the right shows an arrow pointing to an example of an unofficial social trail that is damaging native vegetation.

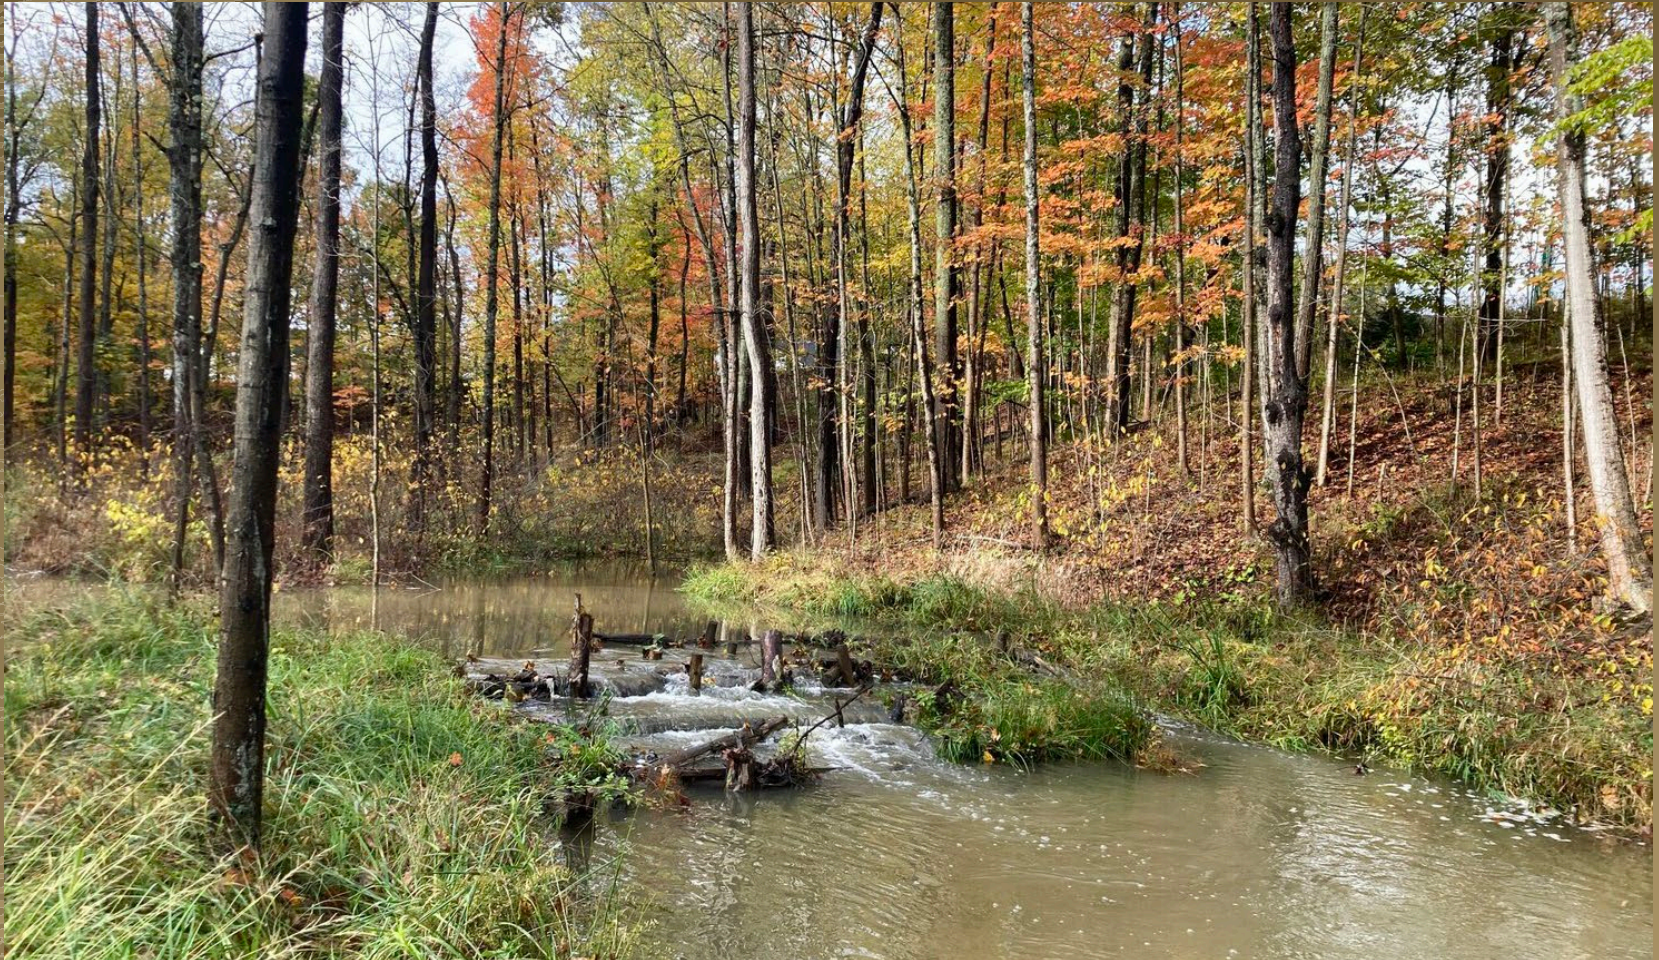
## Baseflow Channel & Partial Floodplain Reconnection

Image shows a forested area with a stream flowing over a wood structure.

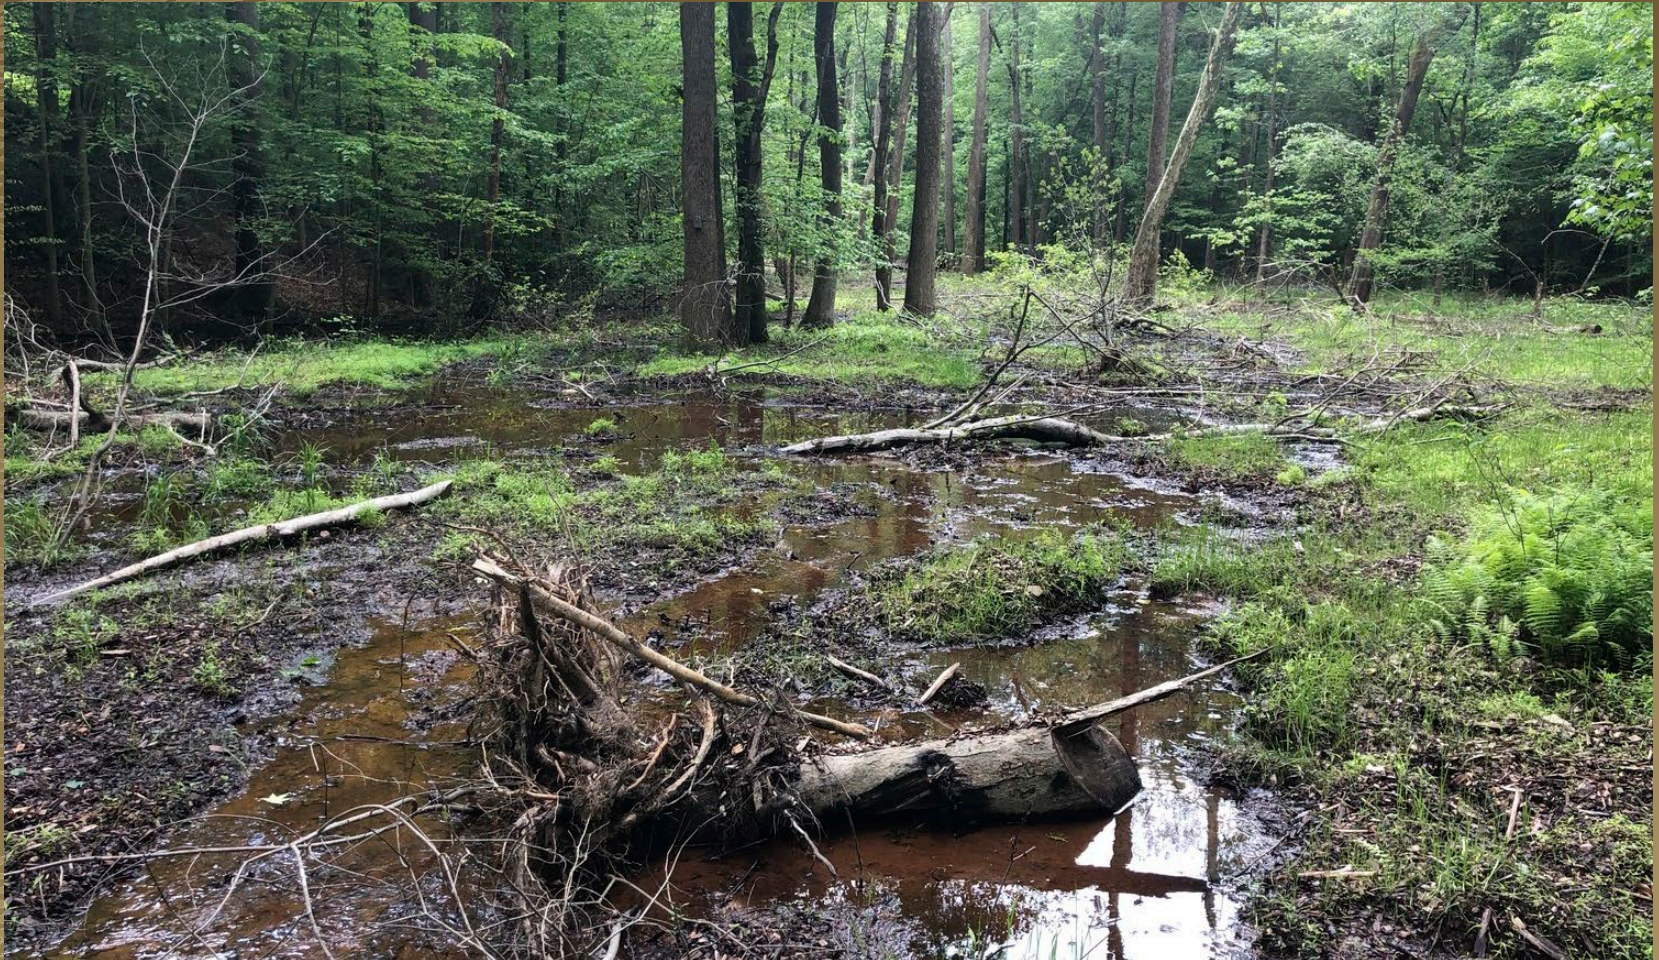
## Full Floodplain Reconnection

Image shows a forested area with a stream and wetland complex with wood debris.

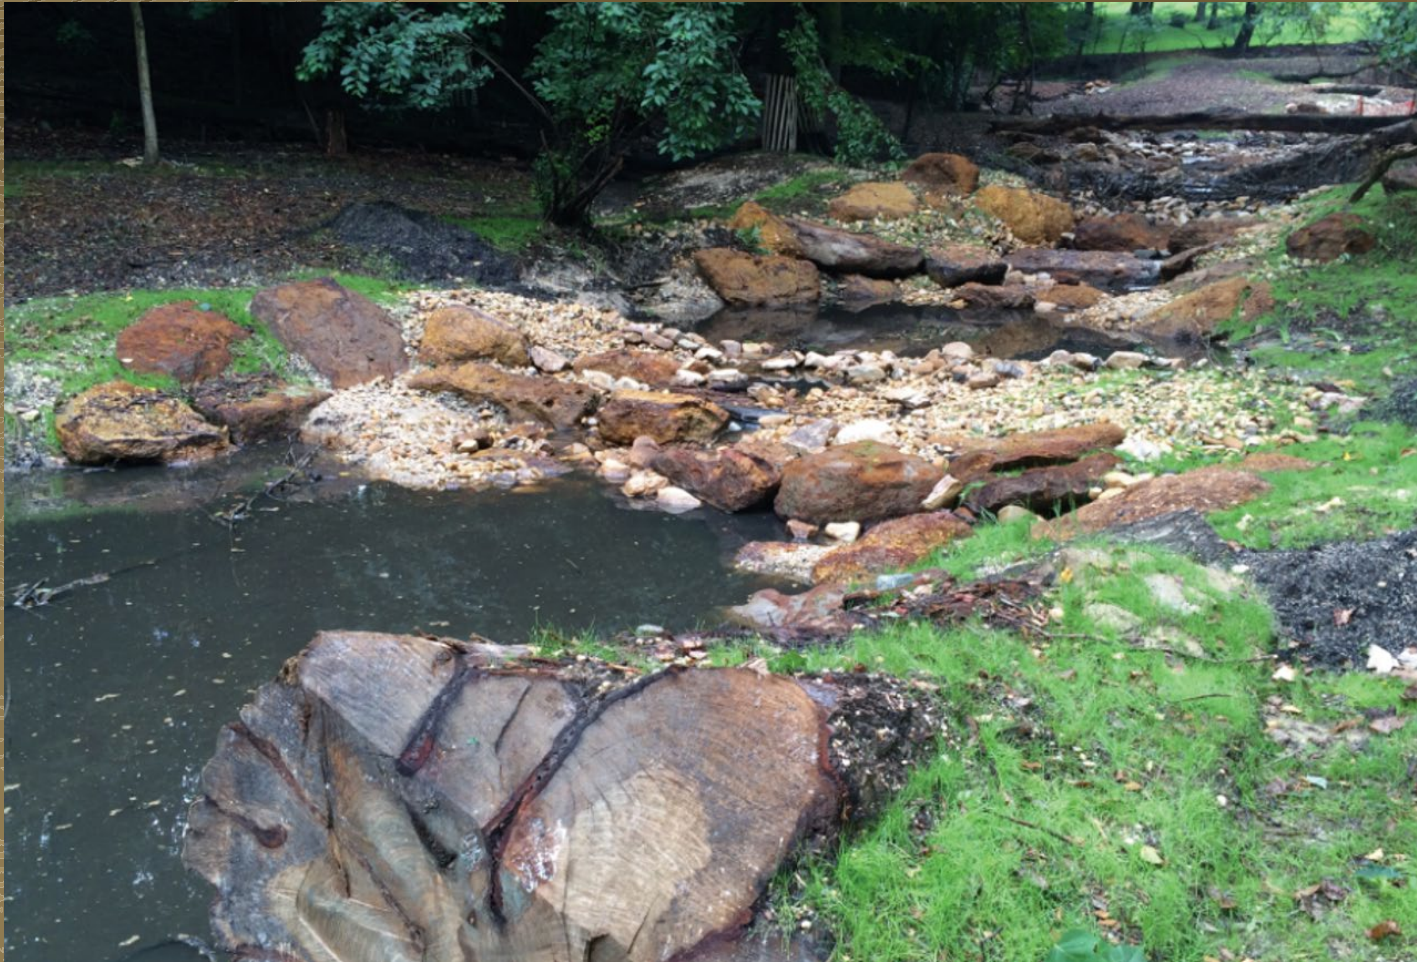
## Outfall Channel Stabilization

Image shows a forested area with a series of rock structures and pools along an outfall channel.
