# Pinehurst Branch Stream and Wetland Restoration

## Environmental Assessment Public Scoping Meeting

Rock Creek Park  
Virtual Meeting  
October 1, 2026

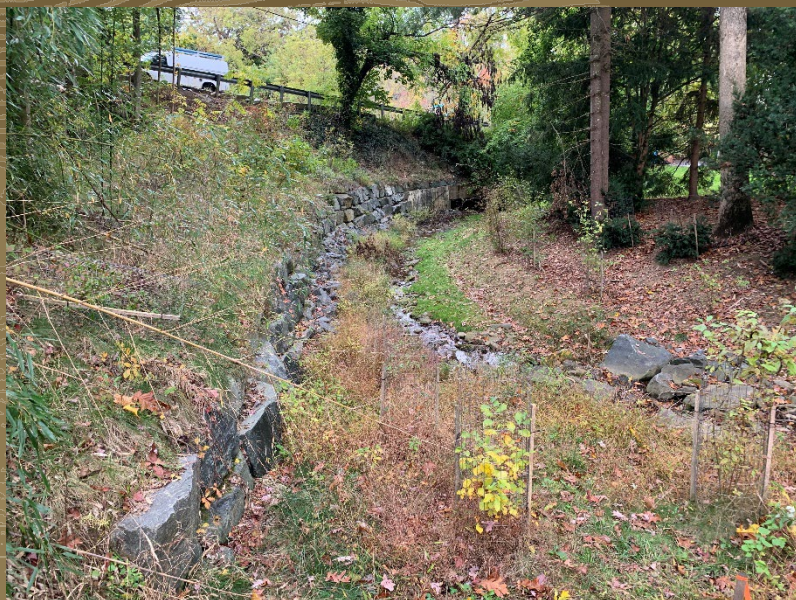
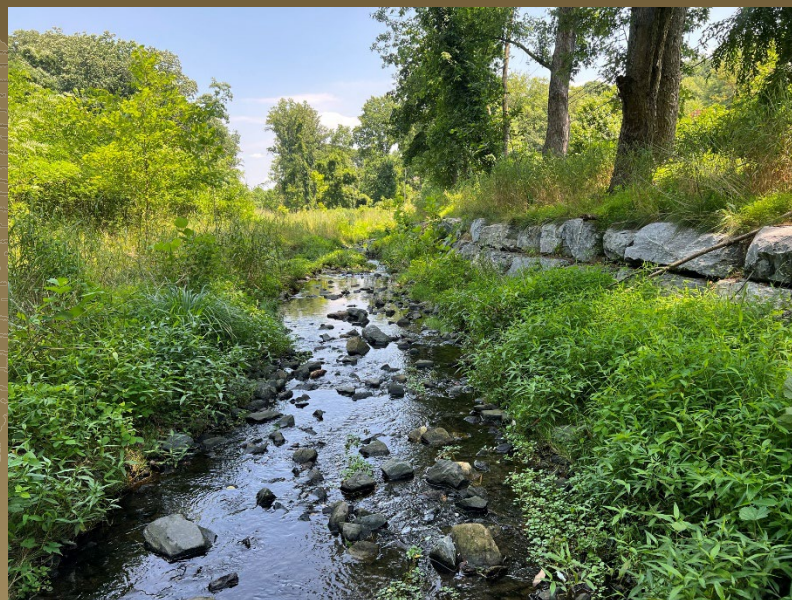
## Channel and Floodplain Stabilization Measures – Bank Stabilization and Protection

Two images are shown. The left image shows stacked rock along the left side of a bank to protect the road infrastructure. The right image shows stacked rock along the right bank to stabilize an eroding streambank and protect trees.

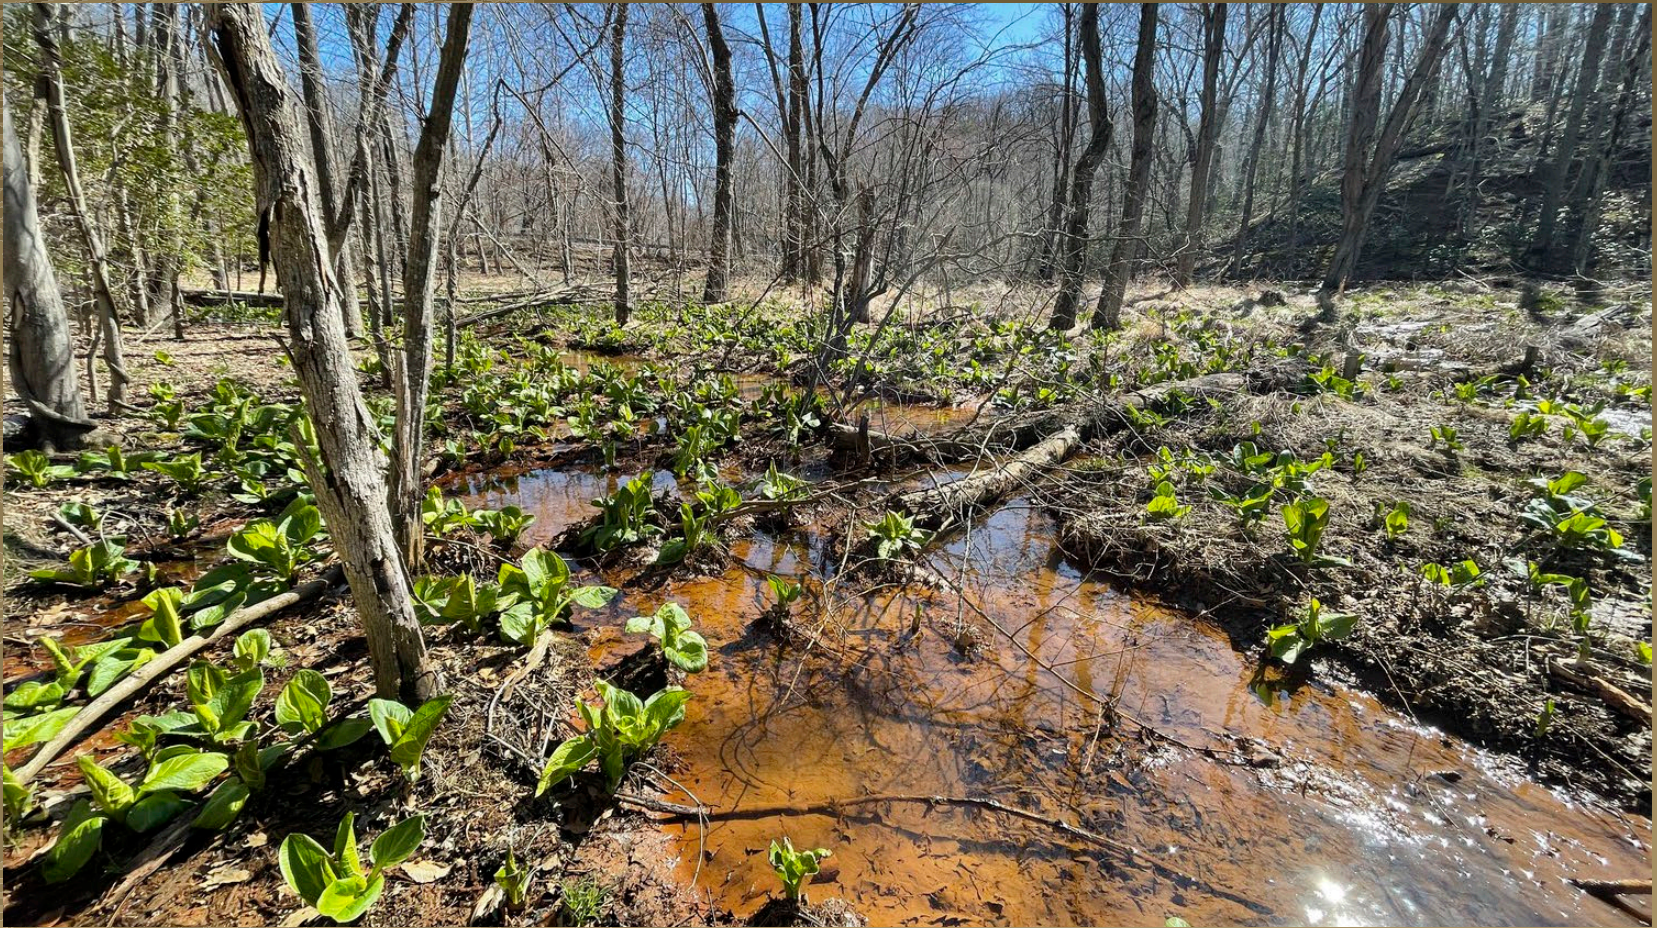
## Floodplain Enhancement – Wetland Restoration

Image depicts a restored floodplain with native riparian and wetland species.

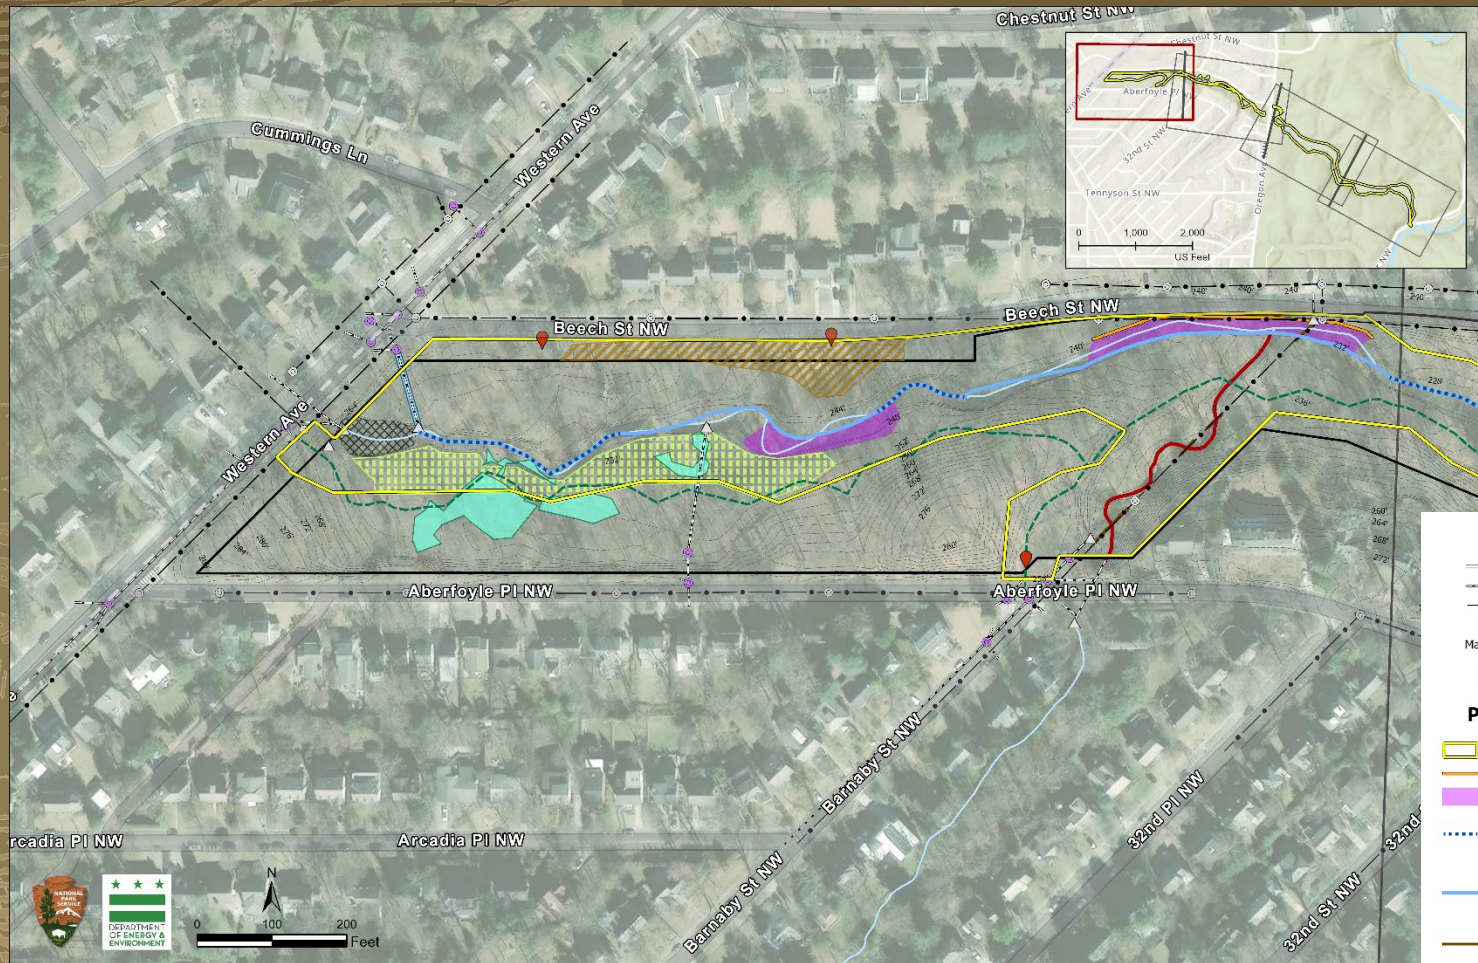
## Concept Map 1

Map of Pinehurst Branch from Western Ave, NW, to approximately 1,600 feet downstream. Map depicts the limit of work and proposed locations of stream and wetland activities.

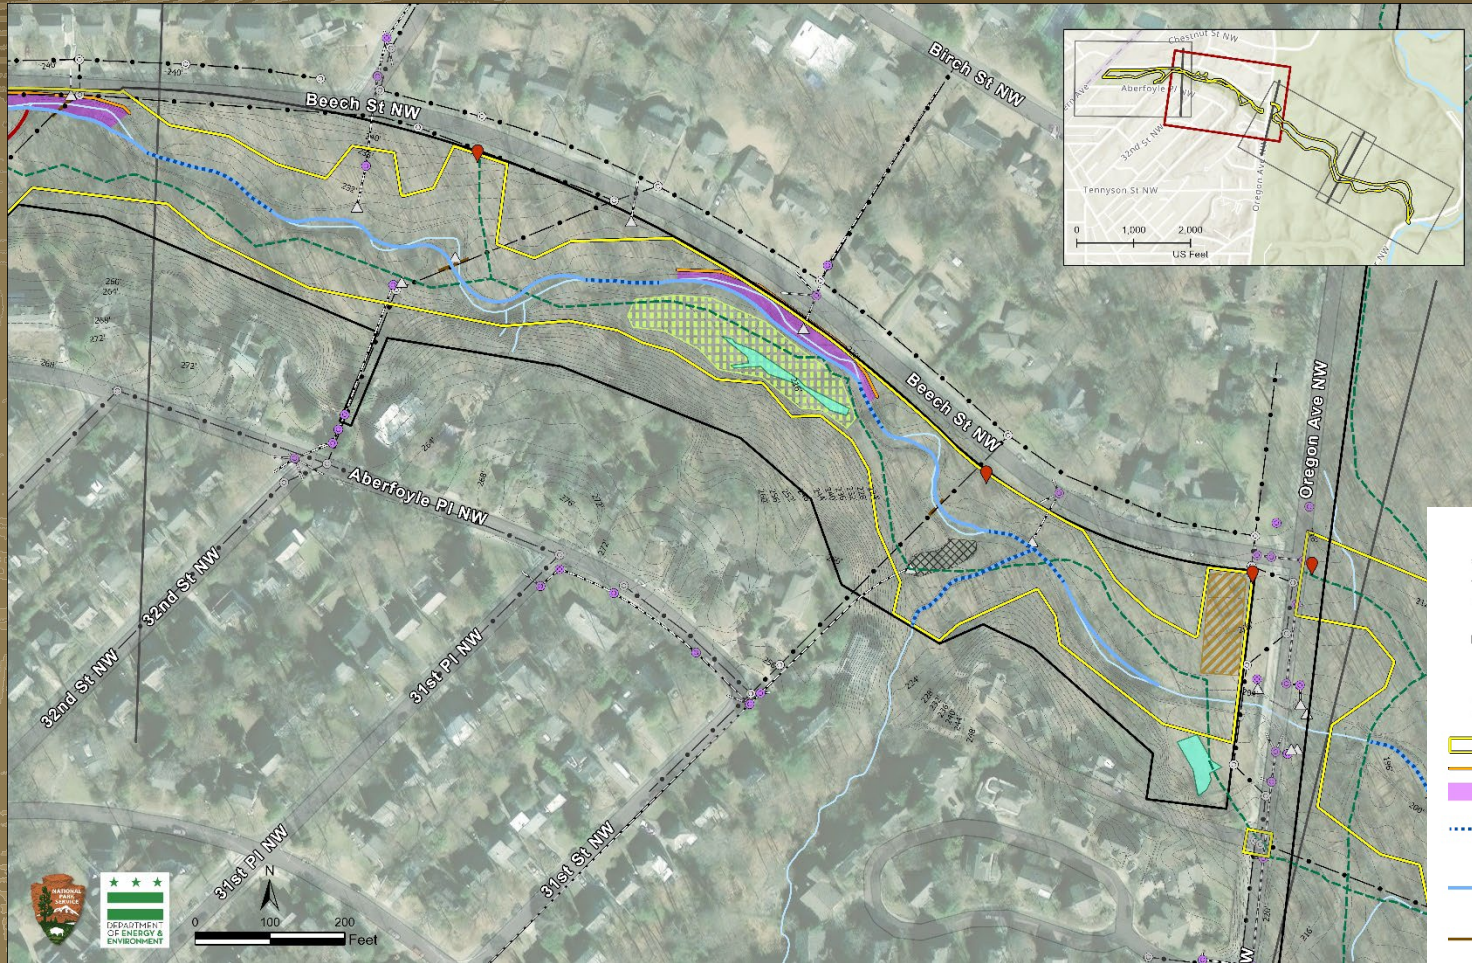
## Concept Map 2

Map of Pinehurst Branch from the intersection of Beech St, NW, and 32<sup>nd</sup> St, NW, downstream to Oregon Ave, NW. Map depicts the limit of work and proposed locations of stream and wetland activities.

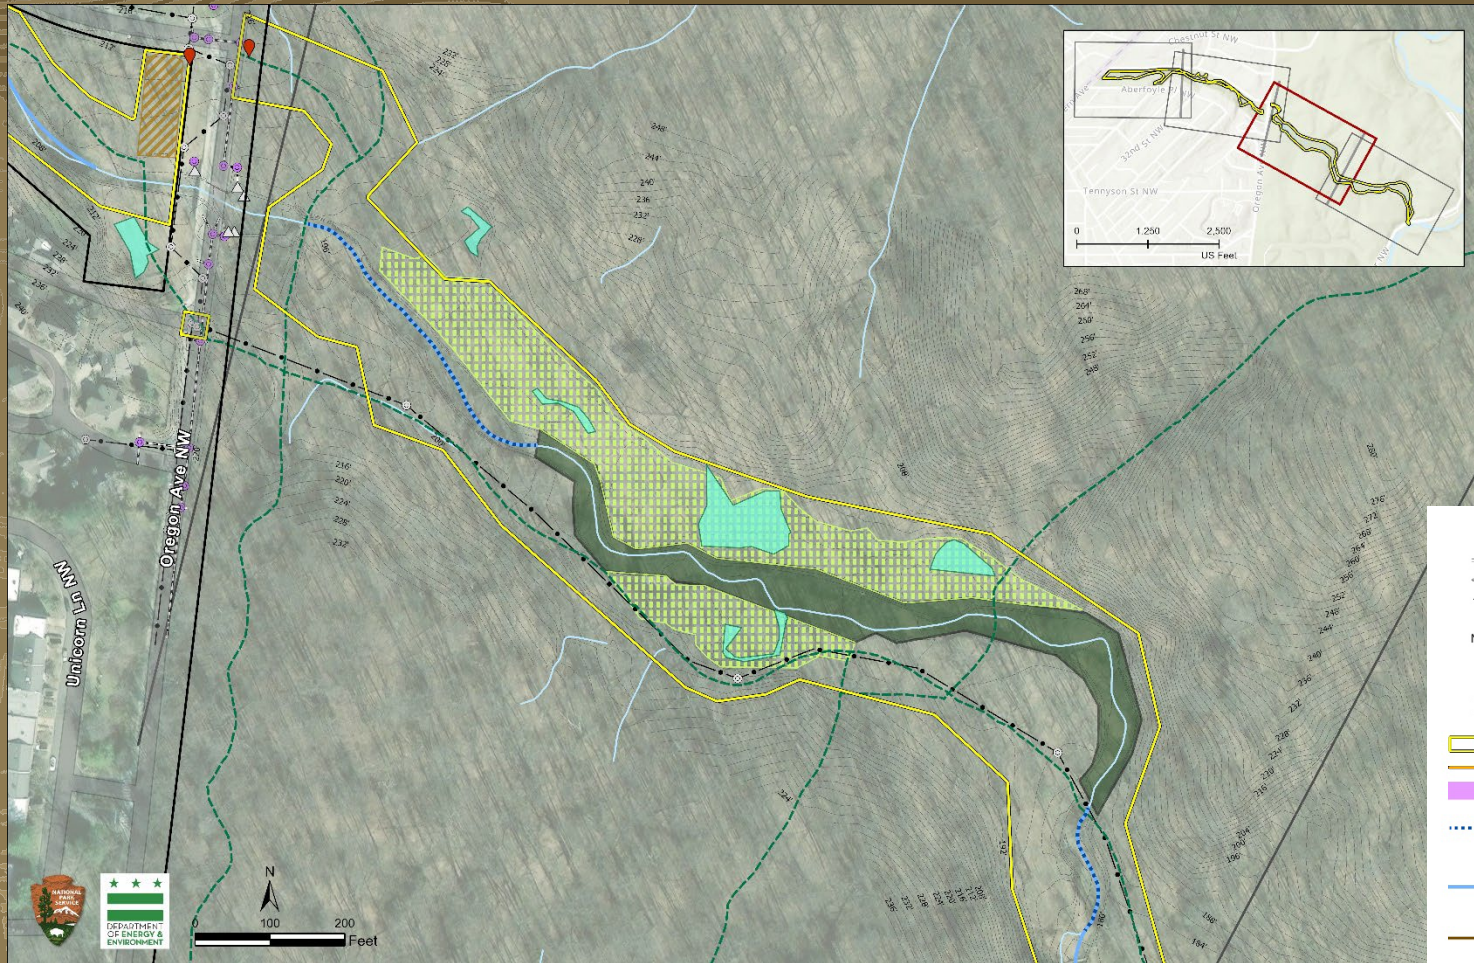
## Concept Map 3

Map of Pinehurst Branch from Oregon Ave, NW, downstream approximately 1,900 feet. Map depicts the limit of work and proposed locations of stream and wetland activities.

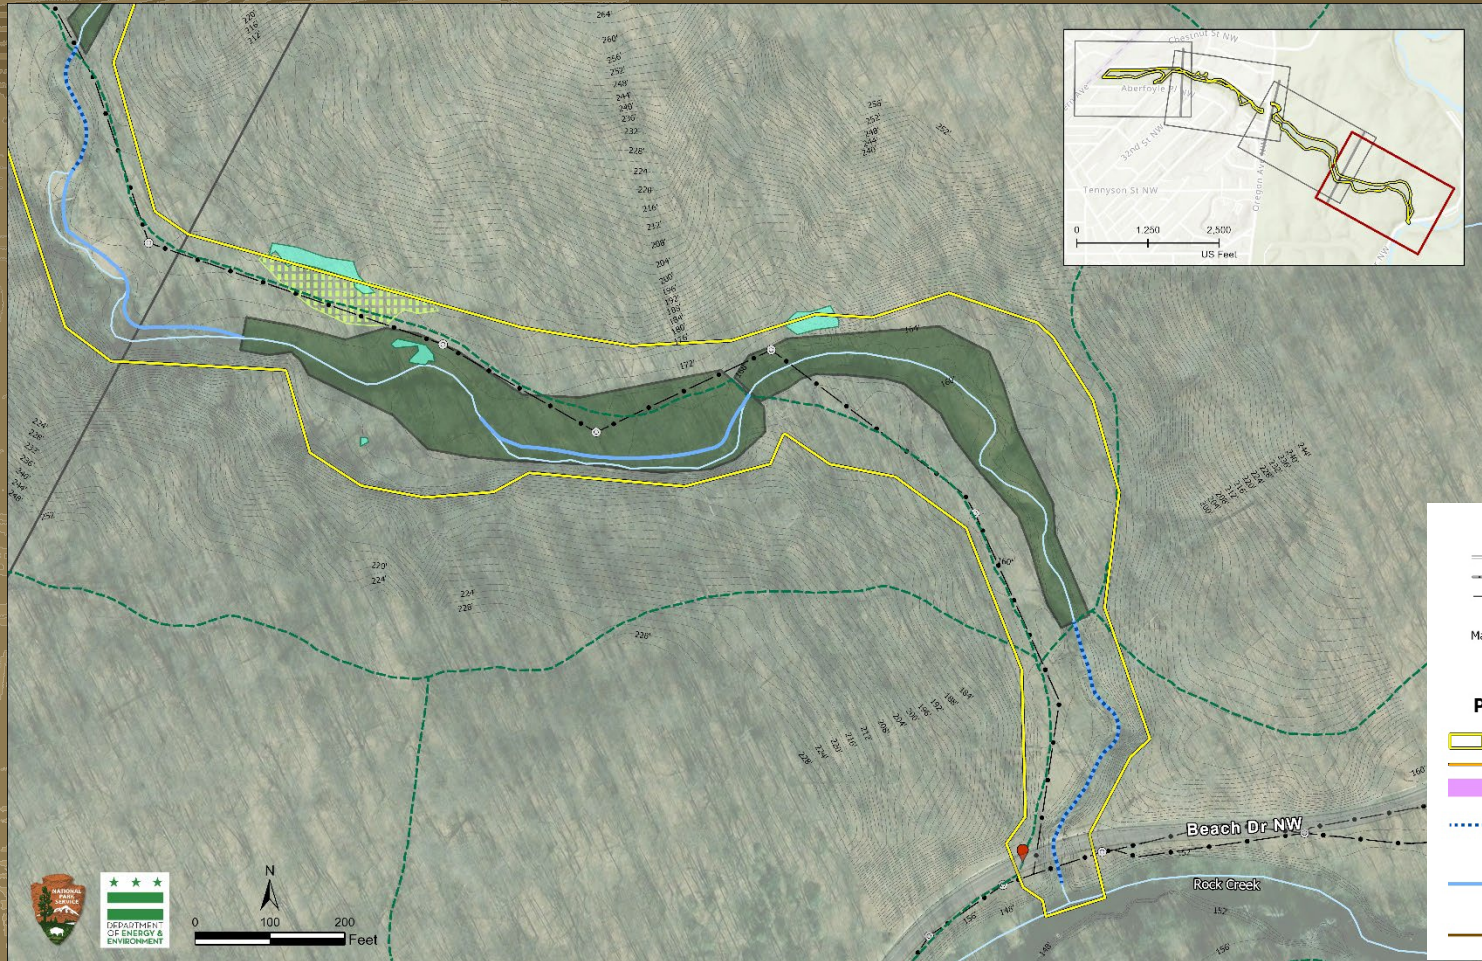
## Concept Map 4

Map of Pinehurst Branch's downstream limits from Beach Dr, NW, upstream approximately 1,900 feet. Map depicts the limit of work and proposed locations of stream and wetland activities.

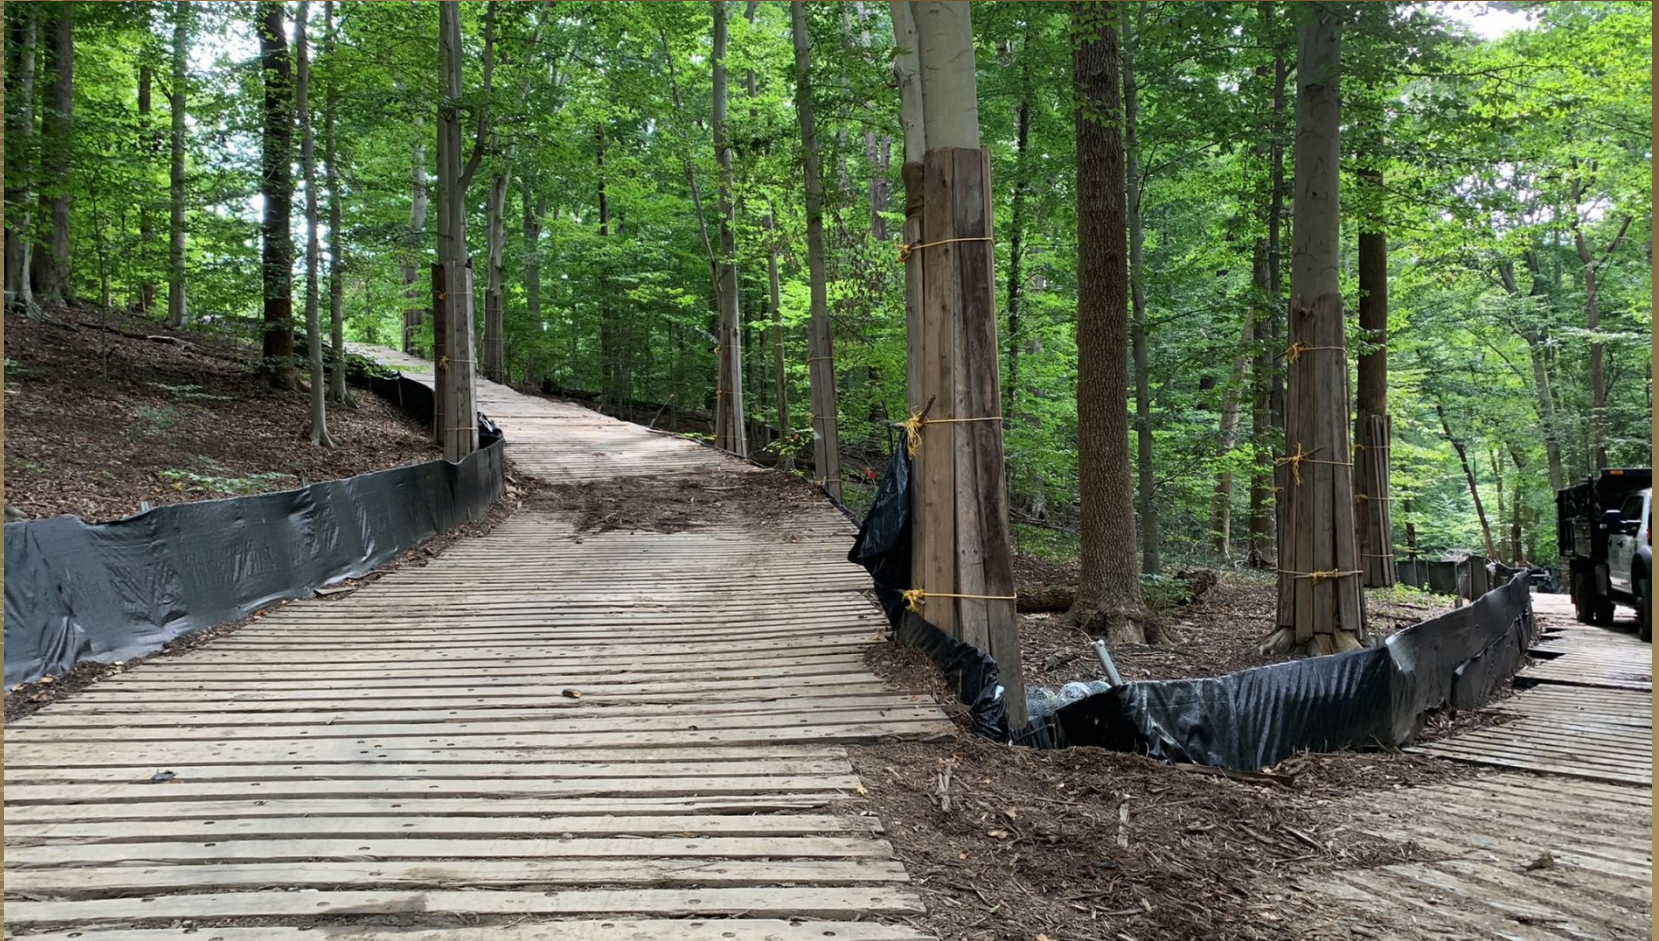
# Proposed Construction Access Through Riparian Area

Image shows mulch and hardwood mat construction access road navigating through a forest to avoid and minimize tree impacts. Tree protection and erosion and sediment control implemented are shown along the access road.

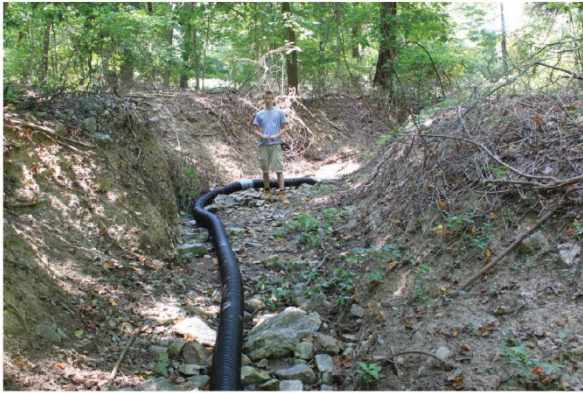
PRE-RESTORATION CONDITION

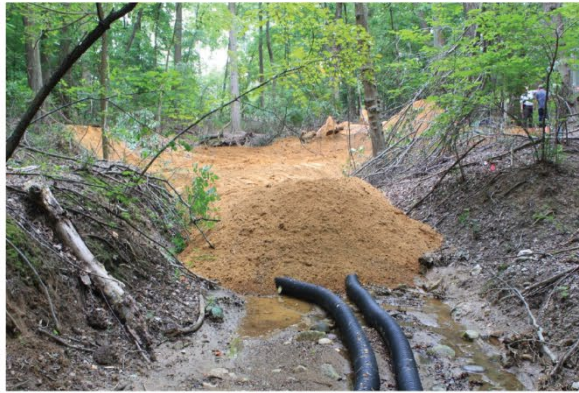
INSTALLATION CONDITION (DEWATERING PIPES)

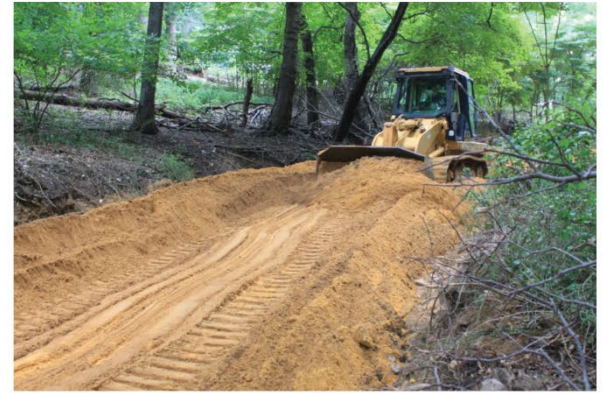
INSTALLATION CONDITION (FILLING CHANNEL WITH SAND AND GRADING ACCESS ROAD)

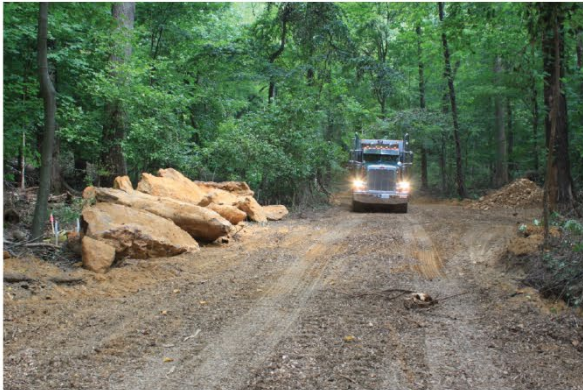
INSTALLATION CONDITION (DELIVERY OF MATERIALS)

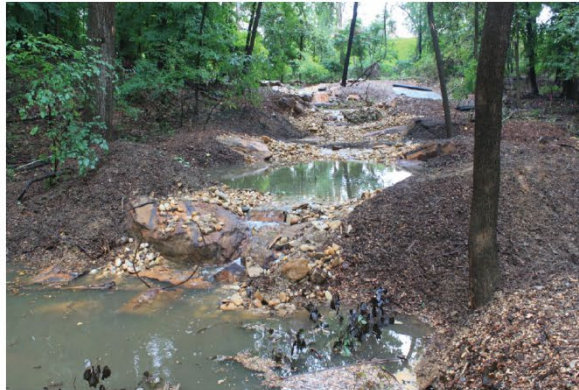
POST-RESTORATION CONDITION (BEFORE PLANTING)

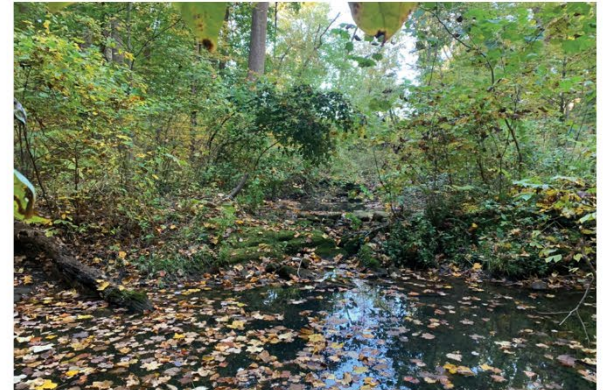
POST-RESTORATION CONDITION (10 YEARS LATER)

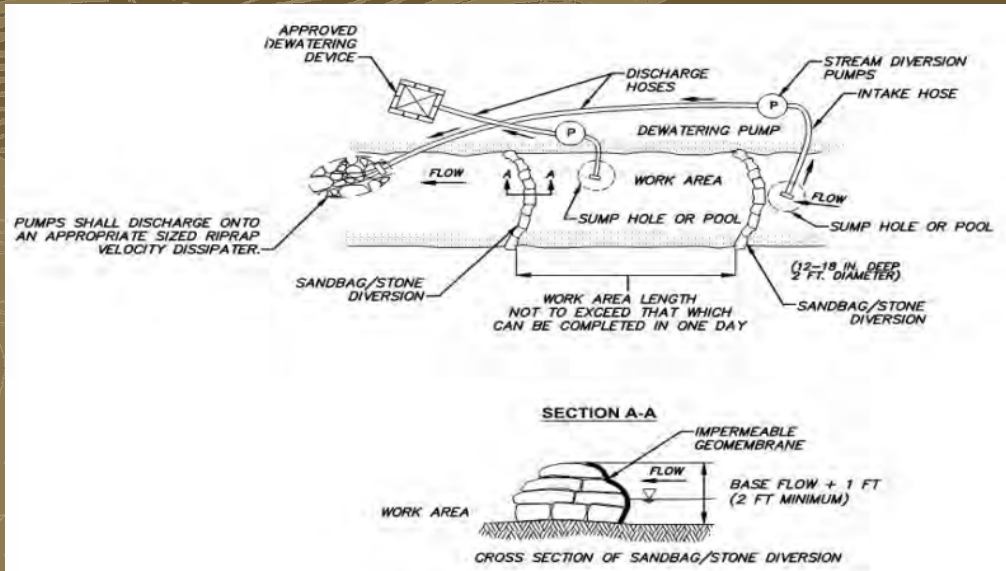
Left:  
Schematic of  
Pump Around  
Setup

Right:  
Dewatering  
Device (filter  
bag)

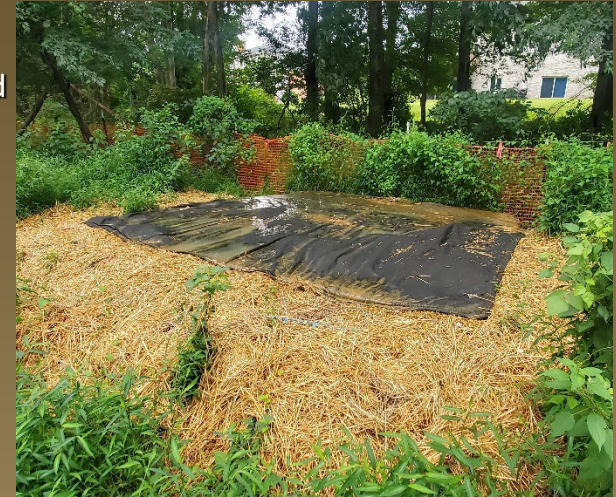
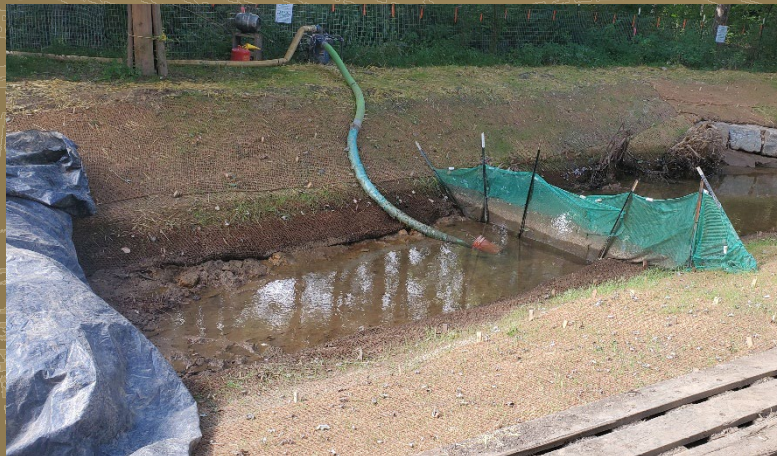
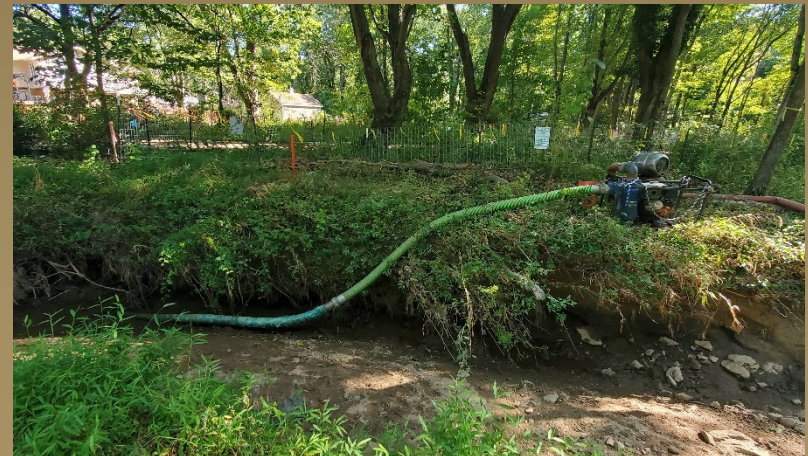
Left: Sandbag  
Diversion and  
fish exclusion  
netting

Right: Stream  
Diversion  
Pump and  
Discharge Hose

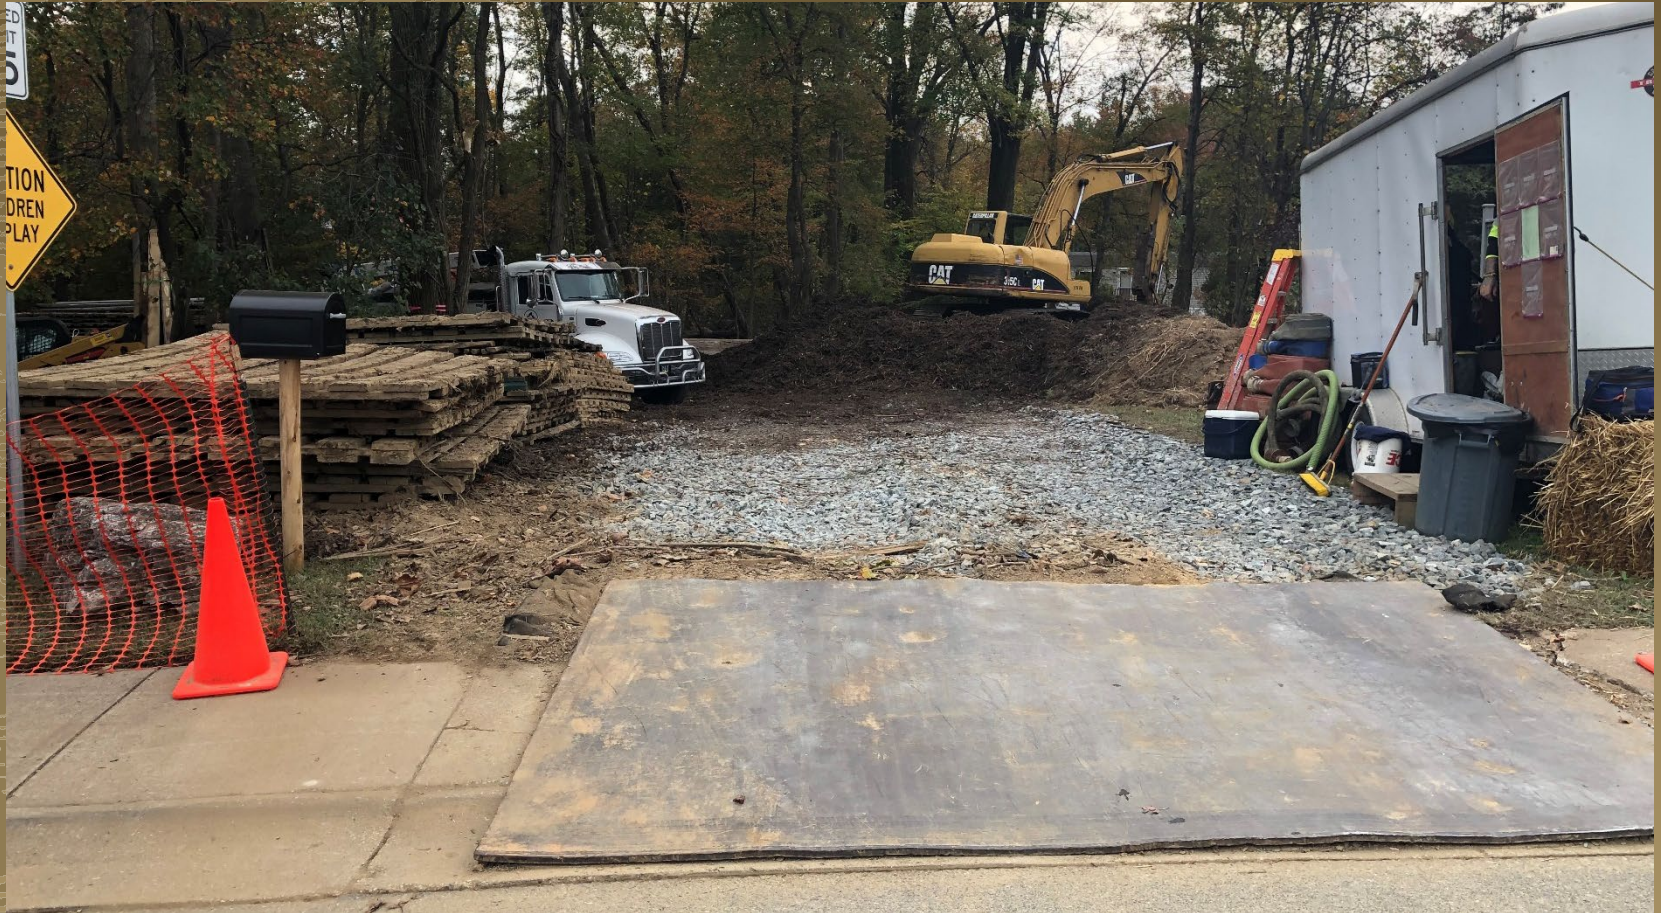
## Construction Entrance and Staging/Stockpiling Areas

Image shows steel plate over a public sidewalk connecting to a gravel construction entrance. The gravel construction entrance connects to a staging/stockpile area where a construction trailer, equipment, and construction materials are stored.
