Appendix H: Ecological Restoration Planning for the Tuolumne Wild and Scenic River Comprehensive Management Plan

Ecological Restoration Planning for the Tuolumne Wild and Scenic Comprehensive Management Plan

Division of Resources Management and Science Yosemite National Park

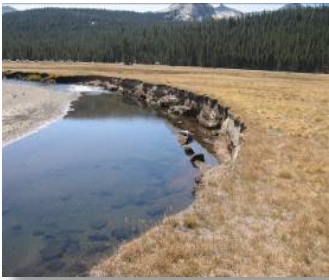
Fig. 1-1. Riverbank erosion

NPS staff and researchers observed apparent absence of willow and extensive riverbank erosion along the Tuolumne River as it flows through Tuolumne Meadows. This triggered a recent study (Cooper et al 2006) which found that the banks of the Tuolumne River are eroding on outside meanders without concomitant riparian vegetation recruitment on the complementary point bar, likely resulting in channel widening. Channel widening produces a shallower channel with a lower river stage for any given flow volume and a concurrent drop of the groundwater level associated with the river (Cooper et al. 2006). A wider, shallower channel also influences the magnitude and frequency of overbank flow. The low vegetation cover on riverbanks, perhaps exacerbated by human trampling, contributes to the rapid bank erosion.

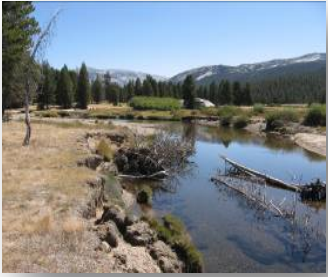
Fig. 1-3. Trampled vegetation on riverbanks

Human trampling can exacerbate vegetation loss and subsequent riverbank erosion (Milestone 1978, Madej et al. 1994), (Figure 1-3). Certain reaches of the Tuolumne River experience high levels of visitor use and are devoid of vegetation, facilitating more erosion. Protection of riverbanks in sensitive areas can help promote vegetation establishment and improve riverbank stability. If further studies indicate that current and past human actions impact riverbank conditions in the Tuolumne Meadows area, ecological restoration may be warranted.

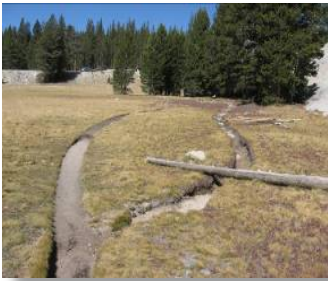
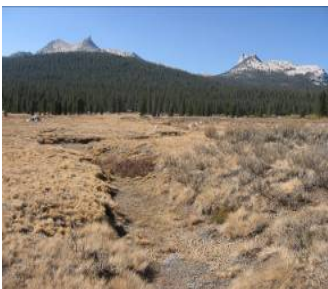
Fig. 1-5. Trails and channels can interrupt or channelize sheet water flows

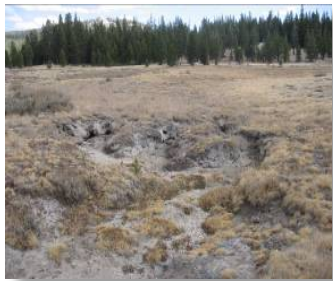
Fig. 1-6. Headcut near Delaney Creek

To mitigate downcutting, headcutting, and other disruptions to hydrologic flow, it is important to understand and address the source of the problem. Because headcutting is a result of channeling (often in trail ruts or incised streambeds), simply filling in the deep gouges does not address the cause of the headcut and it will likely continue. Mitigation of the source or cause of the high velocity and concentrated flow is necessary to limit the development and enlargement of headcuts. To restore the hydrologic conditions to limit further headcutting, the following actions are proposed:

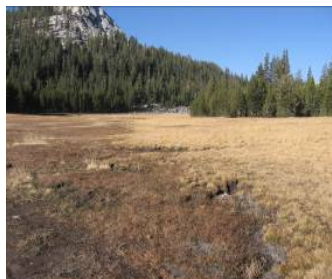
Fig. 1-8. Diffuse headcut

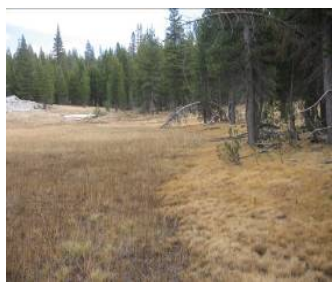
Fig. 1-9. Healthy transition between vegetation types

Incipient headcuts are more diffuse and characterized by an abrupt transition between different vegetation types (Figure 1-8, 1-9). These types of headcuts occur below Pothole Dome where surface water flows off the dome at high velocity and is channeled onto informal trails. The abrupt slope transition from the relatively flat and vegetated surface of the meadow to the unvegetated trail surface erodes the trail margin, progressively incising the meadow surface upslope from the trail. With water flow concentrated by the trail, sediment is channeled to discrete deposition points rather than deposited over larger areas of the meadow.

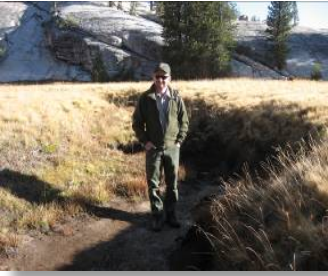
Fig. 1-10. Incised channel near Pothole Dome

Ditches and incised channels alter the hydrologic regime by channeling and concentrating water flow, intercepting surface and groundwater, cutting off flow to downstream areas and altering the timing, velocity, depth and direction of groundwater flow. The resulting concentrated flow and velocity leads to further downcutting. Mitigation of the source in upstream areas and any conditions that have led to channel incision is also necessary. To restore the landform from past ditching and channel incision, the following actions are proposed:

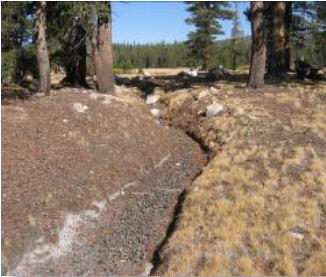
Fig. 1-11. Ditch draining kettle pond

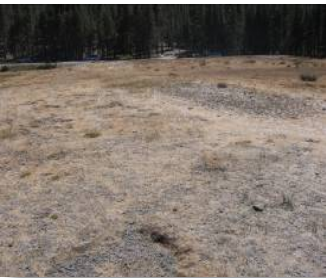
Fig. 1-12. Bare area adjacent to shuttle bus stop

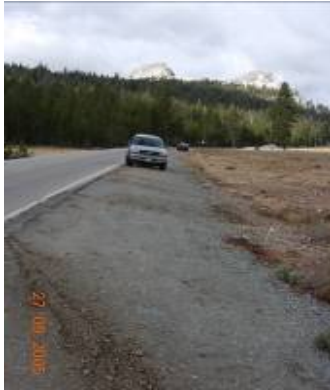
Fig. 1-14. Parking lot creep

Limited parking for visitors to the Tuolumne Meadows area puts enormous pressure on the existing parking areas. These areas exhibit parking lot “creep” (Figure 1-14) and continue to expand as more and more visitors try to find parking. Areas around the parking areas exhibit damaged vegetation, bare ground and many informal trails. This also impacts cultural resources and archeological sites. The most impacted areas include the Cathedral Meadow Trailhead (Figure 1-15), the Soda Springs trailhead and the Lambert Dome/Glen Aulin Trailhead. Issues and design for the trailheads along the entire Tioga Road will be addressed in a separate environmental assessment. Depending on the preferred alternative for parking determined in the Tuolumne Meadows Plan, the following actions are proposed to maximize natural and cultural resource protection:

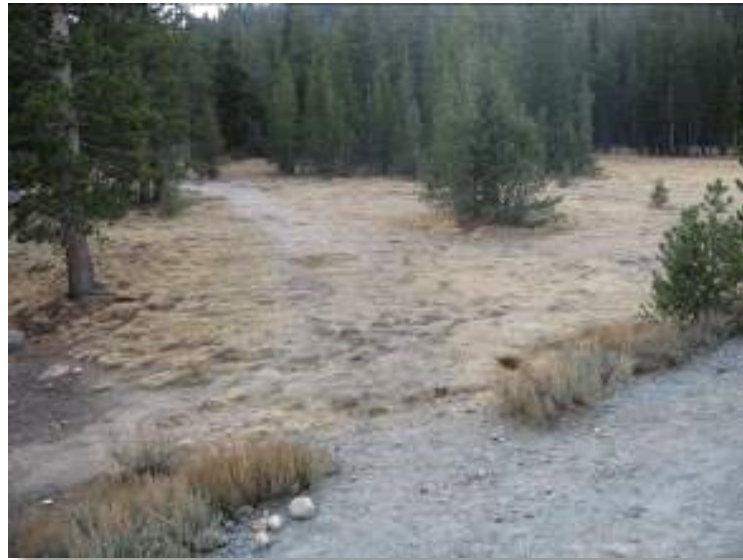
Fig. 1-15. Impacted vegetation adjacent to Cathedral Lakes Trailhead

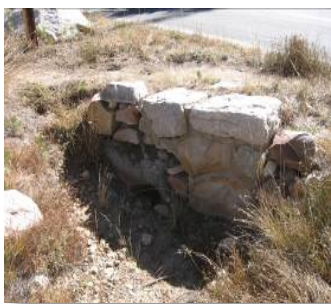
Fig. 1-16. Partially blocked culvert

Highway 120 (Tioga Road), runs east to west along the southern edge of Tuolumne Meadows and surface water flowing from the southern slopes is channeled through 35 culverts. In 2006, culverts clogged with vegetation and sediment were observed in 12 locations and signs of ponding water south of the road were observed in 23 locations (Cooper et al. 2006), (Figure 1-16). In most places, water is diverted to run parallel to the road at a distance less than 10 meters before a culvert allows water conveyance under the road and into the meadow (Cooper et al. 2006). Ponding is much more frequent near the east end of the meadow, where culverts are spaced further apart. The campground, gas station, store, and other infrastructure, coupled with lower gradient surface slopes, further interrupt water flow. The Tuolumne River is spanned by a bridge on the east end of the meadows that impacts the free-flow of the river.

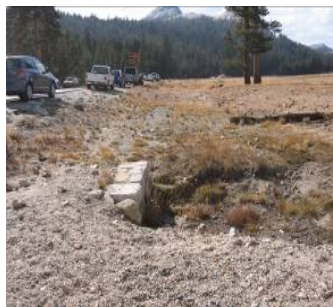
Fig. 1-17. Culvert set too low in meadow

In addition, many of the culverts along Tioga Road are lower or higher than the surface level of the meadow (Figure 1-17). This increases downcutting, headcutting, and ponding, producing lower water availability and concomitant changes in species composition.

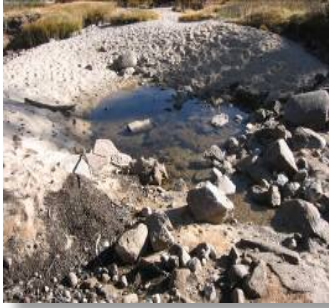
Fig. 1-18. Ponding at culvert below Budd Creek

A single culvert conveys the majority of Budd Creek under the Tioga Road and does not effectively accommodate high spring flows. As a result, upstream incision on the south side of the road has deepened the channel and reduced overbank flow. A secondary culvert and associated channel accommodates Budd Creek during very high flows but channel incision and decreased overbank flow from the main stem limits this function (Figures 1-18, 1-19).

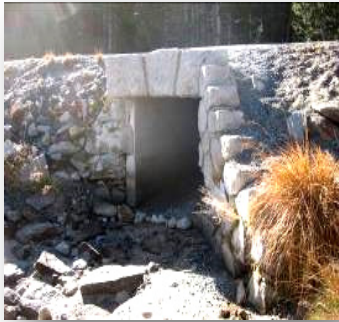
Fig. 1-19. Budd Creek culvert

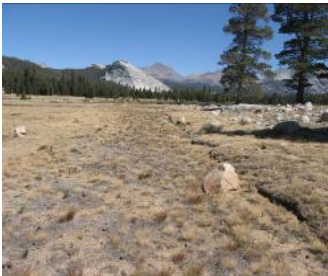
Fig. 1-21. Old roadbed north of the Visitor Center

There are remnants of these old roadbeds along the northern and southern edges of Tuolumne Meadows (Figure 1-21, 1-22). Many sections of the roads are difficult to detect, while other sections are obvious and characterized by sparse vegetation, multiple ruts, and conifer encroachment. While these roadbeds have historic value, they also impact meadow integrity in a number of ways including channeling water, altering vegetation composition, retaining compacted soils, and disrupting hydrologic connectivity (ponding upslope and drying downslope areas).

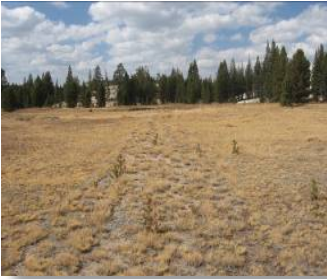
Fig. 1-22. Old roadbed near Delaney Creek

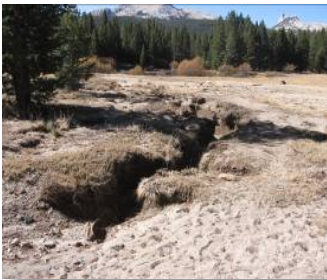
Fig. 1-23. Headcut and downcutting

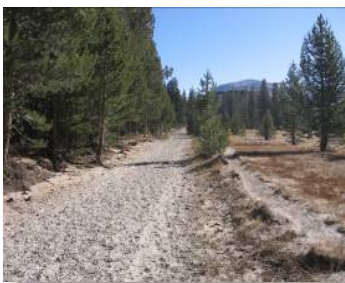
Fig. 1-24. Wide deep rut with trail on side

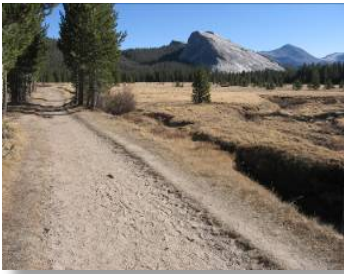
Fig. 1-25. Ditches adjacent to old roadbed

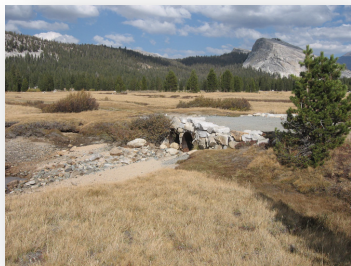
Fig. 1-26. Scour downstream of culvert on Unicorn Creek

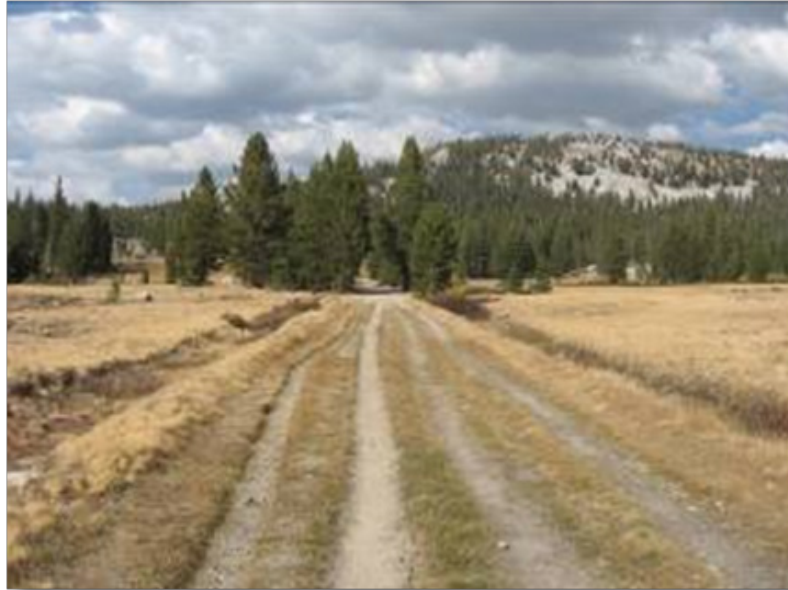
Figure 1-27. Multiple trail ruts on old roadbed

The section of the Old Tioga Road that begins east of the Visitor Center from the current Tioga Road to Parson’s Lodge now serves as the main foot and stock trail to the lodge and the Soda Springs area. Constructed in 1915, the roadbed was elevated above the meadow level with soil dug from the sides of the road (Figure 1-25). Today, the road averages 12 feet wide, and the roadside ditches channel water laterally alongside the roadbed into one of four culverts (one of which conveys Unicorn Creek). These roadside channels, along with the damming effect of the roadbed, alter surface flow ultimately changing plant communities. Where the road crosses Unicorn Creek and another small drainage, inadequate culverts have caused significant scour and headcutting downstream of the roadbed (Figure 1-26). A bridge across the Tuolumne River brings visitors to the lodge and these bridge abutments constructed on the riverbanks alter natural river processes and sediment deposition and scour. In addition, conifer encroachment on the roadbed (Figure 1-27) detracts from scenic views of the meadow.

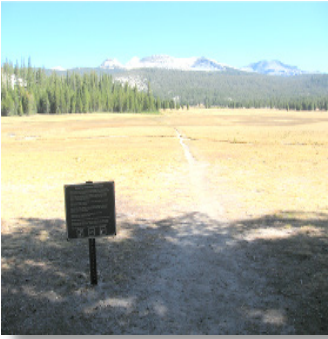
Fig. 1-29. Wilderness sign at informal trail

Informal hiking trails are common throughout Tuolumne Meadows. Some of these trails exhibit heavier use just in the past decade, as they become more defined from constant traffic. Informal trail conditions vary depending on the level of use. Deep multiple ruts characterize some informal trails while others only exhibit trampled vegetation. A restoration project at Pothole Dome in the 1990's addressed multiple informal trails and proved effective in protecting the central part of the meadow. In addition, fencing was installed to guide visitors to walk along the edge of the meadow. In recent years, an informal trail originating from parking just east of Pothole Dome and extending to the Tuolumne River has become much more prominent, particularly after an "Entering Yosemite Wilderness" sign was placed at the edge of the road (Figure 1-29). The sign is an indication to visitors that it is a formal trail and subsequently, use has increased. High concentrations of informal trails exist adjacent to the Tuolumne Store and Grill, at the Soda Springs trailhead, around the Soda Springs area, along the Cathedral Peak parking area and along the banks of the Tuolumne River. Many of these informal trails also affect cultural resources and merit removal. To minimize the extent and impact of informal trails, the following actions are proposed:

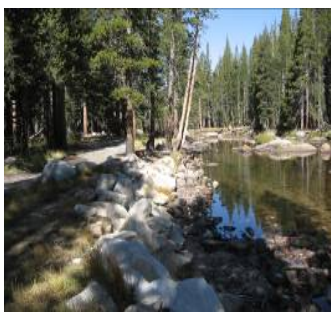
Fig. 1-30. Riprap along river in Tuolumne Campground

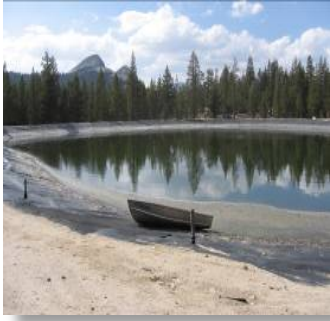
Fig. 1-32. Sewage Treatment Pond

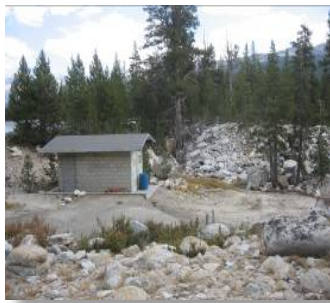
Fig. 1-33. Pump station associated with treatment pond

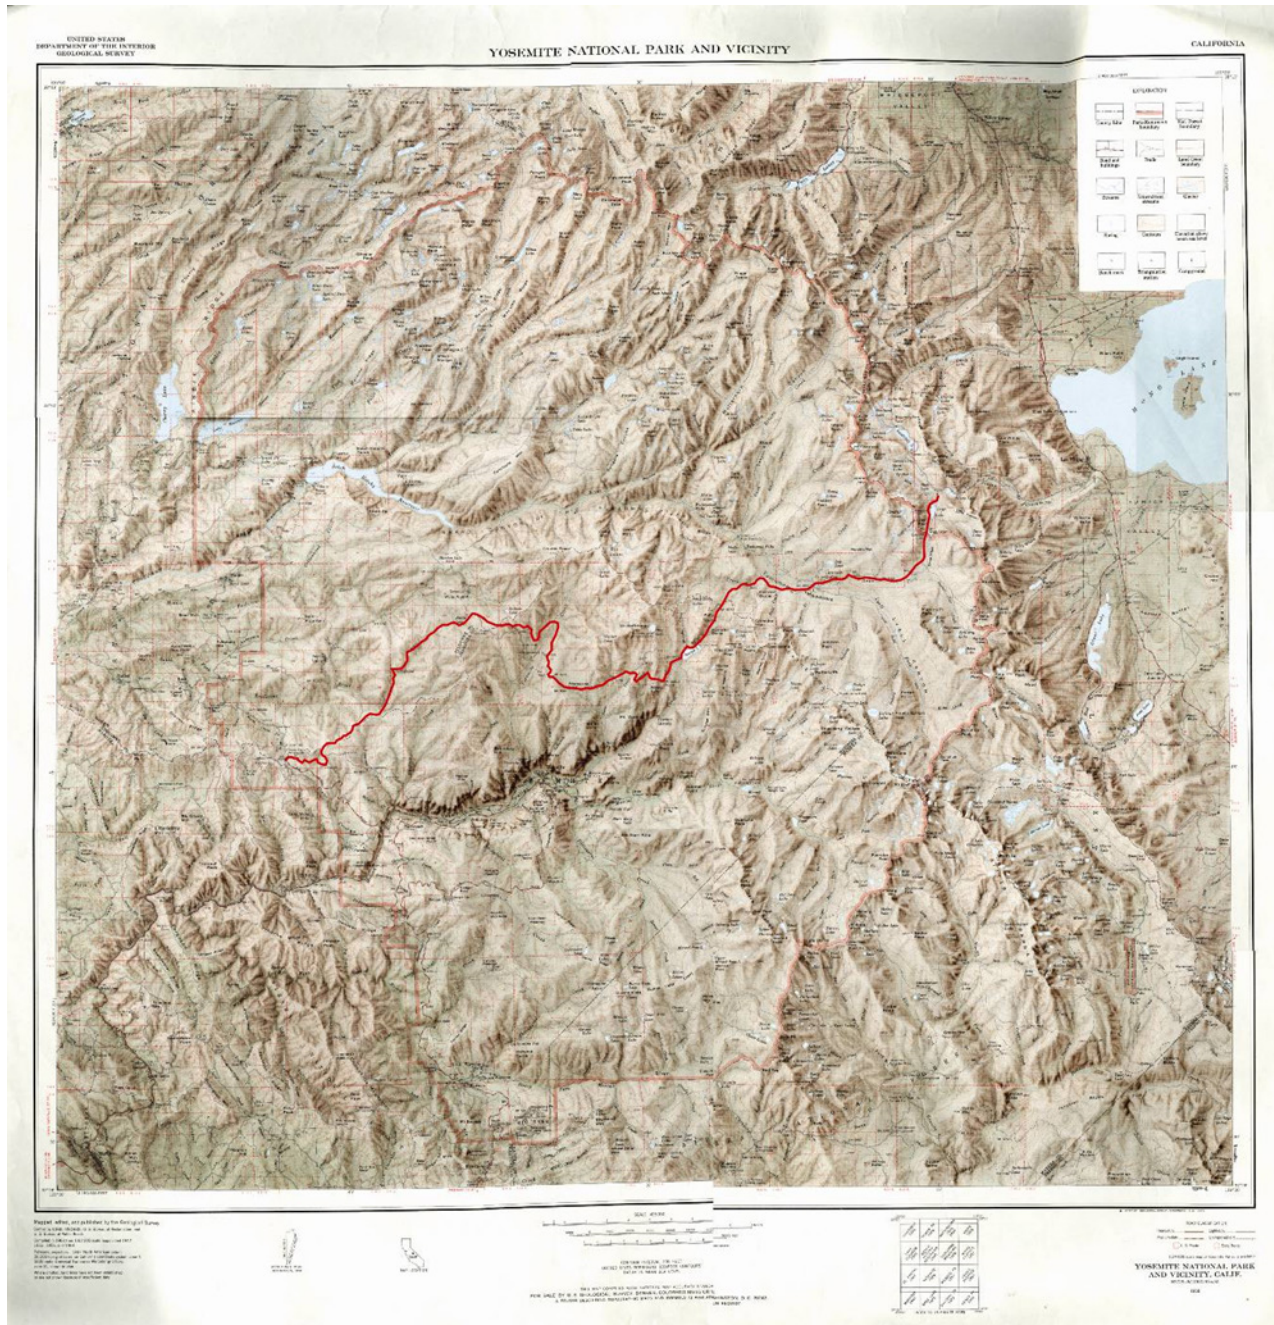
Figure 2-3. Map showing the 1910 alignment of the Tioga Road (black) overlaid with the 1958 alignment of the Tioga Road (red). Notice that the alignment is profoundly different, particularly along the western stretches of the road

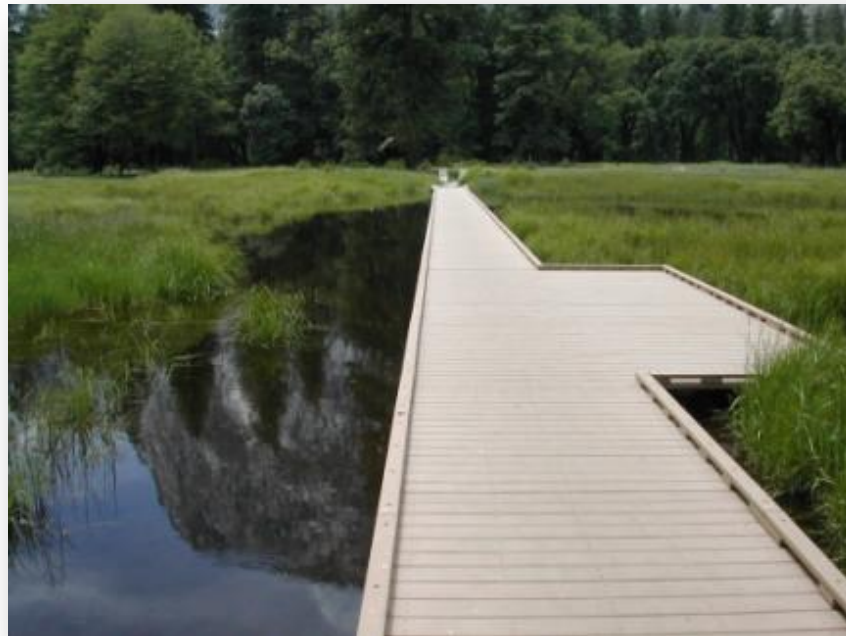
Figure 3-1: Cook's Meadow boardwalk in Yosemite Valley. Constructed of recycled plastic, a material commonly used in Yellowstone National Park, where a roughened surface is used to provide traction on frosty mornings. However, Yosemite managers have found that this product does not last and requires frequent maintenance.

In areas of heavy snowpack such as the Tuolumne Meadows area, the strength of the boardwalk must be sufficient to support snow weight. Boardwalks can require high maintenance costs and labor, particularly in high elevation areas that receive heavy snowpack or that flood regularly. Over time, boardwalks can begin to sag where the wood is weakening and connections loosen. Freeze/thaw is also an issue for some composite products and some products can be very slippery when frosty. Other parks like Glacier and Yellowstone have successfully constructed, and continue to maintain, boardwalks in such climates. Following is a brief description of several products that may be used, with uses in these two parks discussed as appropriate.

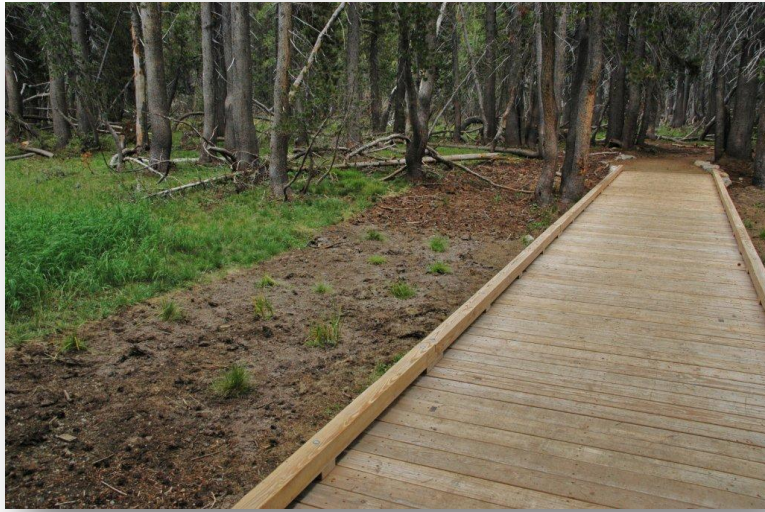
Figure 3-2: Newly installed TimberSIL® boardwalk at Tenaya Lake 2012

TimberSIL® wood is infused with a microscopic layer of amorphous glass that provides an effective permanent barrier to rot, decay and other common wood problems. The wood is non-toxic, odorless and nonvolatile, is not corrosive to fasteners, does not cause excessive wear on tools, and has a natural clear color. The company that produces this material claims that TimberSIL® Glass Wood is stronger and longer lasting than natural or composite wood / lumber, does not burn and is guaranteed not to rot or decay for 40 years. This product looks like natural wood and is being used at Tenaya Lake (Figure 3-2). Yosemite staff working with this product found that it is somewhat difficult to work with as the boards are warped and require a sealing epoxy on the ends. In addition, further investigation is required to ensure that this product could accommodate stock.

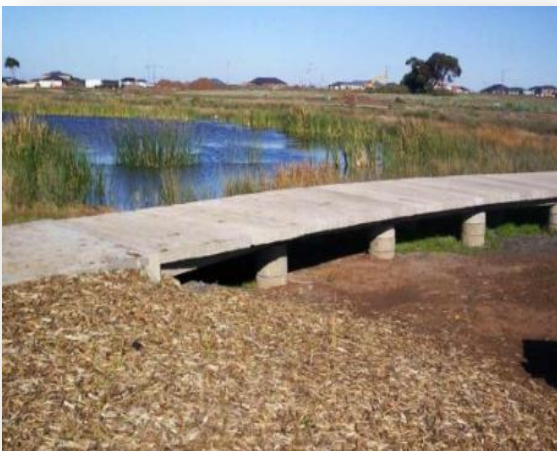
Figure 3-3: Boardwalk Estate, Melbourne Australia: Permatrak® boardwalk with pier supports allows water flow underneath the structure

Permatrak® is a precast concrete boardwalk system for elevated trails (Figure 3-3). This trail material is primarily supported by piers and footings, is less susceptible to freeze/thaw damage than treated wood, and will not float away during high water events. Components are precast and can be assembled and installed on site with a relatively low level of impact. There are standard and custom colors available and it can be finished to resemble a wood texture (Figure 3-4). A slip resistant surface is also available, like a standard concrete walkway.

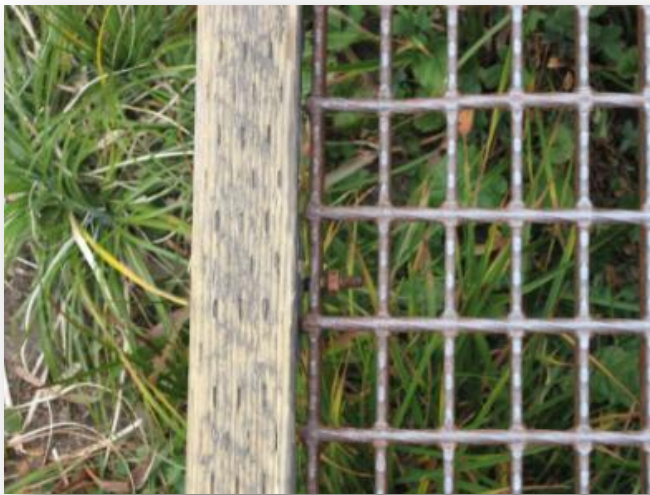
Figure 3- 5: plants growing beneath grate

This boardwalk material is used extensively in Glacier National Park (Figures 3-5 - 3-8) and other areas with heavy snowpack. It is typically supported by a series of crossbeams but piers may also be an option. Benefits include allowing light to penetrate through the tread and allow some plants to grow underneath the trail. It is also less susceptible to flooding impacts and heavy snow load. In frosty conditions, the surface can become slippery but surface traction can be added. Maintenance requirements are generally less than wooden boardwalks. There are several different types of steel grating with varying gap size and strength. Gap sizes must be less than ¼" to be American Disability Act (ADA) compliant and must be of sufficient strength and gap size to withstand stock traffic.

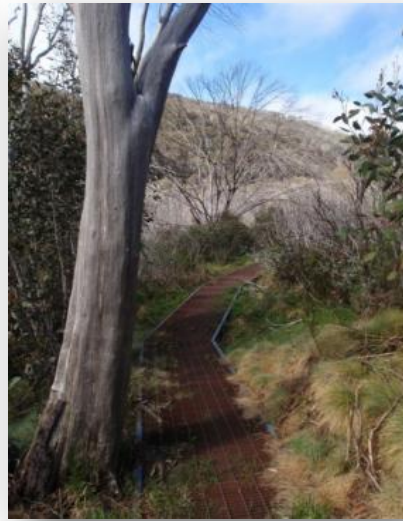
Figure – 3-6: Metal grate boardwalk in Australia

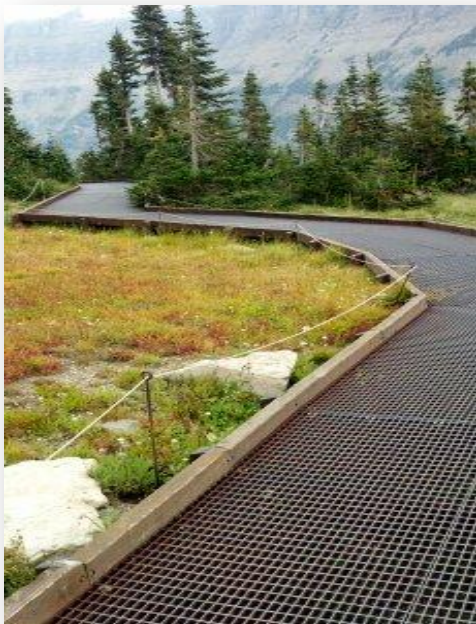
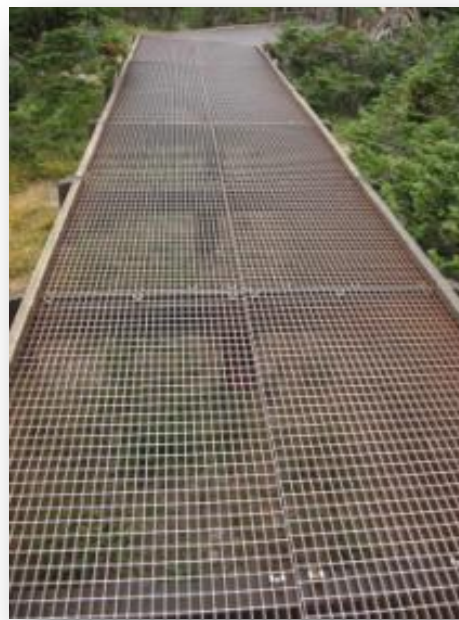
Figure 3-7 and 3-8: Metal grate boardwalk in Glacier National Park

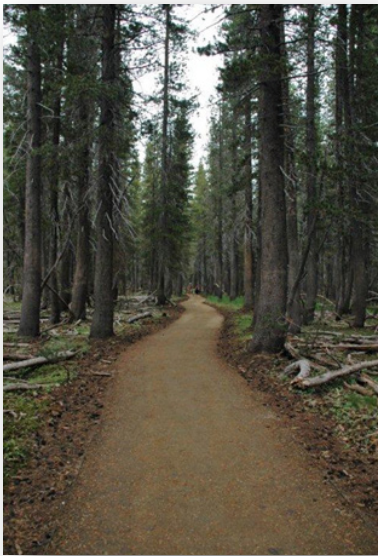
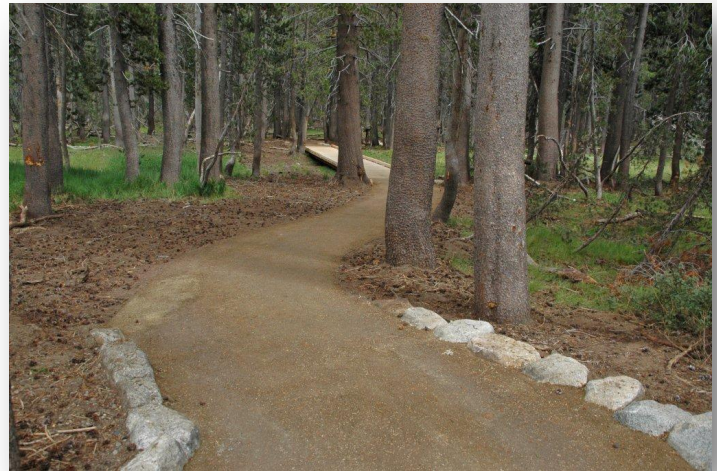
Figures 3- 9 and 3-10: Stabilizer® trail at Tenaya Lake 2012

This product stabilizes soils with the crushed seeds of a native plant that is activated by water. The powder is blended into the soil and works its way into the pore spaces. The swelling action triggered by the addition of water, pulls the particles and binds them together and depending on the aggregate used, can provide a very hard to relatively flexible surface. When the stabilizer is saturated, excess water drains and the soil remains stable without becoming muddy because the stabilizer keeps the soil particles bonded. It is uncertain how this product performs in seasonally wet areas but it could be used in sections of trail that are rarely or only intermittently saturated. Stabilizer® was most recently used in Yosemite on the Tenaya Lake east beach access trail (Figures 3-9 and 3-10).

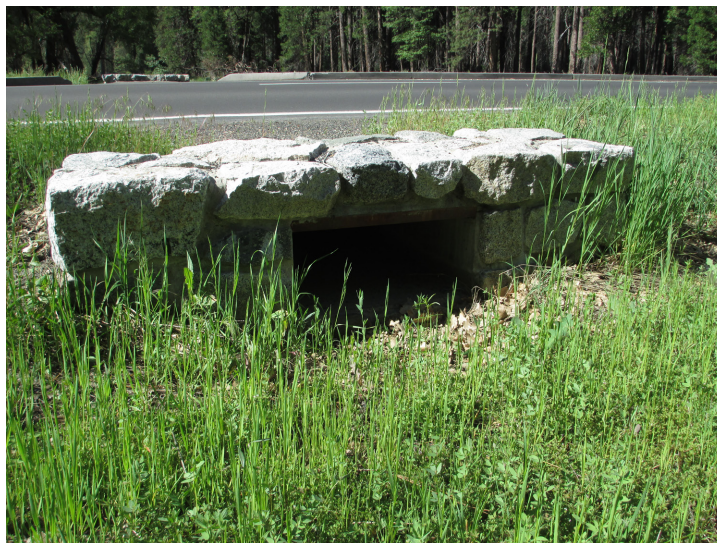
Figure 3-11 Road box culvert in Yosemite Valley (trail would be lower profile)

Rockwork to support and frame the box culvert and delineate the trail surface decreases visibility and provides a more rustic appearance (Figure 3-11). Surfacing on a box culvert may be native soil overlying an aggregate that improves stability yet maintains the appearance of a trail.

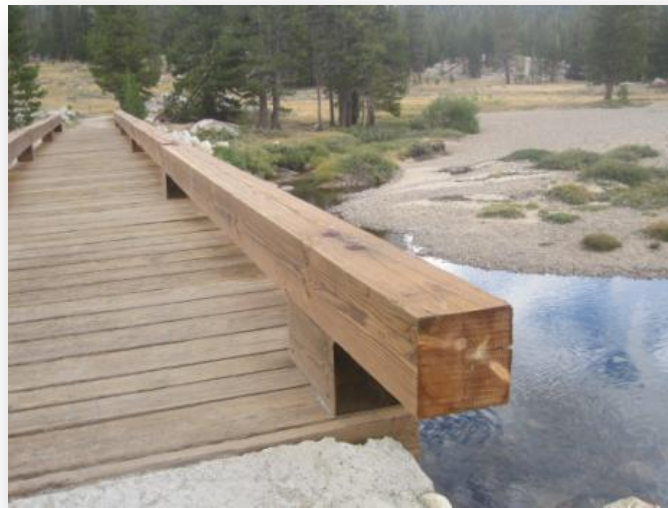
Figure 3-12: Bridge over the Tuolumne River

The width of the spans will be 10 feet to match the trail and bridge width and would not be substantially higher than meadow grade (18 inches). If railing were required, style would be similar to the 8x8 foot beams on the bridge over the Tuolumne River.
