CHAPTER 3 AFFECTED ENVIRONMENT

South Fork Fishing and Hunting Club Clubhouse

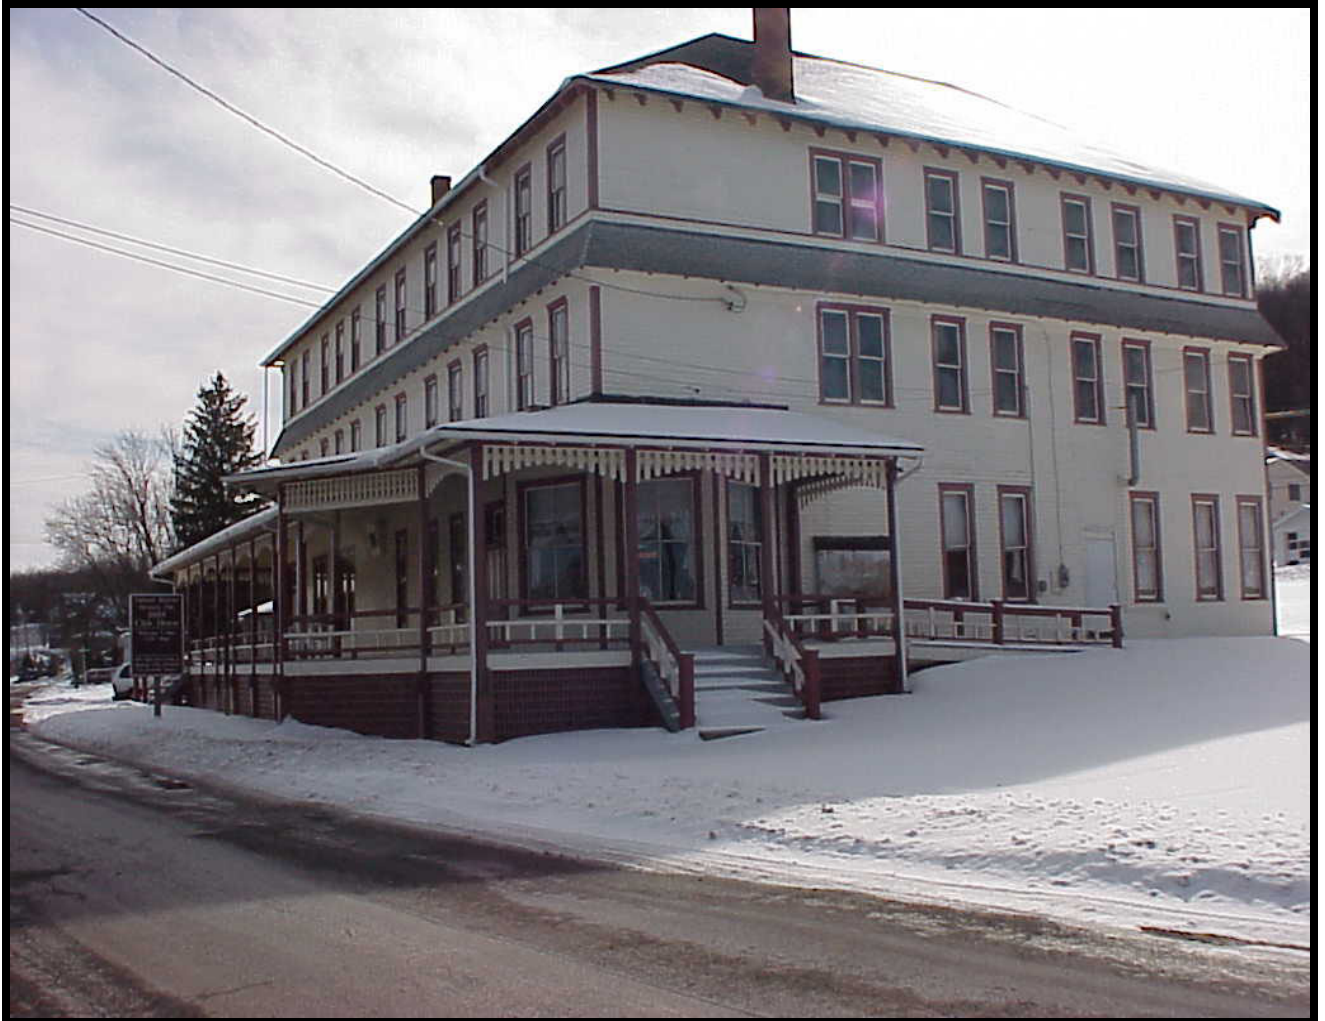
Figure 3-5: South Fork Fishing and Hunting Club Clubhouse

Although the exact dates of construction for the different Clubhouse structures and additions are uncertain, the *Historic Structures Report* (HSR) states that the Clubhouse was established in 1879.³ The chronology of occupancy for the Club appears to have occurred between 1881 and 1889. The existing South Fork Fishing and Hunting Club Clubhouse is a three-story wood frame structure that is L-shaped with a gray asphalt shingle, hipped roof and a wide covered front porch (**Figure 3-5**).

The 12,525-square-foot⁴ building sits on a gently sloping lot, encompassing about 1.65 acres⁵. A bay window projects into the porch at the northeast corner of the first floor near the existing entrance to the building. The pent roof wraps the perimeter of the building between the second and third floors, with the exception of the southern elevation. Two modest one-story frame additions were attached to the southwest corner of the building.⁶ One of the additions was removed by NPS personnel in 2003.⁷

The existing South Fork Fishing and Hunting Club Clubhouse is a large three-story, L-shaped structure, with a hipped roof and a wide covered front porch. The Clubhouse is the most notable structure in the neighborhood mainly because of its size and close proximity to the road. A distinctive front porch was reconstructed in 1992 by the Club's historical society. The Clubhouse is situated on a large, gently sloping lot with a gravel parking lot located on the side.

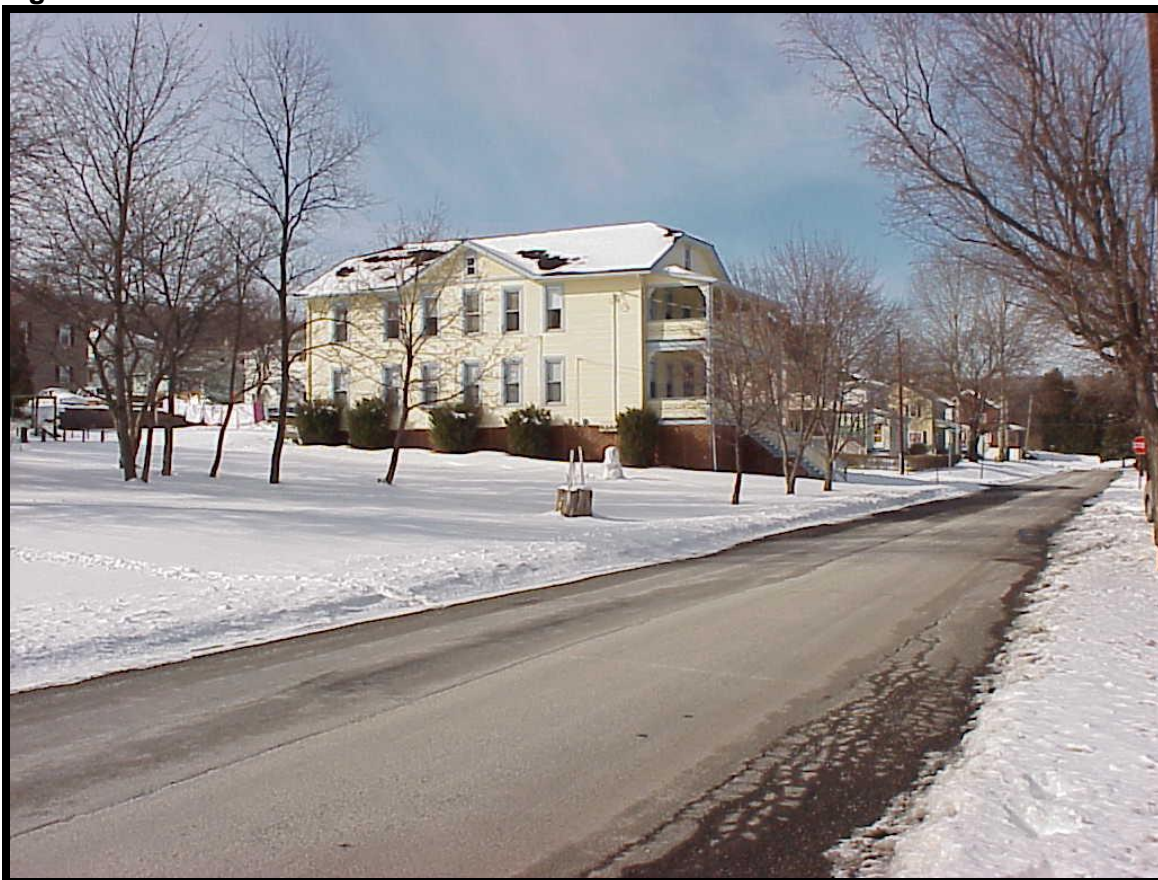
Figure 3-6: Clubhouse Annex

The Clubhouse Annex is a two-story structure with a basement that is approximately 4,498 square feet¹³ in size. Previously, this structure was used for guest rooms between 1921 and 1950. The exterior of the building was resided with vinyl during the mid-1990s, and the interior has been renovated for rental units. This building is currently divided into four apartments, of which three were leased as of December 2006 (**Figure 3-6**).

The grade at the rear (western end) of the structure has been altered so that it is now level with the top course of the concrete block. Block retaining walls provide the transition between the natural grade of the site and this raised level at the back of the building. The structure's four corners have 30-inch brick piers, suggesting that they may have been used to raise the structure.¹⁴

The scalloped edge of wood shingles is visible beneath the bottom course of hexagonal existing asphalt shingles at the south gable. Double hung windows with simple 5-inch flat wood trim are regularly spaced on all four levels of the building. A number of historic sashes were retained and stored in the basement; however, these are wood and double hung. The rear or west window would have been the connection point for the second level of the outhouse. The smaller rear porch sits on a concrete pad at grade and has plywood soffits. The front porch rests on a full story high concrete block foundation with vinyl siding cladding above and a garage door entry. The porch is full width of the building and divided into five bays.

The Clubhouse Annex is adjacent to the Clubhouse and is a utilitarian building that was re-sided with vinyl in the mid-1990s. The roof is gabled with a jerkinhead section at both the east and west ends. The building is situated on a large lot and is compatible with the adjacent structures.

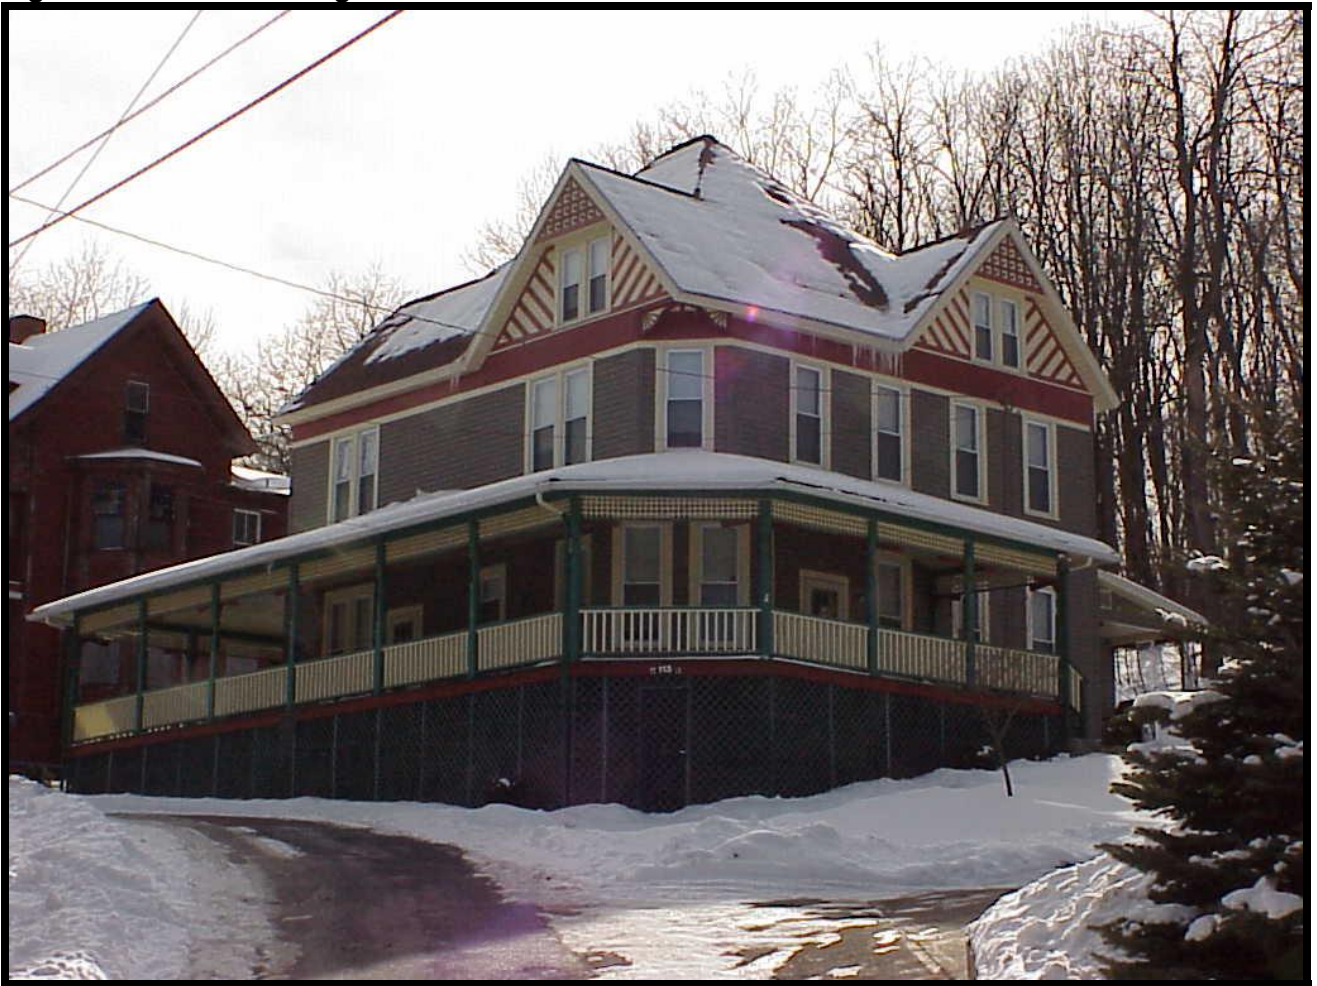
Figure 3-7: Brown Cottage

Brown Cottage, sometimes referred to as Knox Cottage, is a 3,542-square-foot, 2-1/2-story Stick Style frame structure with a hipped and gabled roof (**Figure 3-7**). This cottage is believed to have been built in 1888 by the James W. Brown Family and later became the property of the Maryland Coal Company in 1907. Brown Cottage features a wraparound front porch and a one-story rear wing with porches. The northeast corner of the cottage is angled and features a bay window on the first floor. The cottage was configured into two side by side duplex units in 1921 by the Maryland Coal Company and has separate entrances from the front porch. As shown in **Figure 3-7**, this structure is situated with very little set-back from the road.

The eaves of the roof have been fully enclosed and two decorative wood brackets span the eave of the roof at the northeast corner of the second story.¹⁵

As previously described under Historic Structures, Brown Cottage is a modest, Stick Style, 2-1/2 story frame structure with a hipped and gabled roof, wraparound front porch and a bay window. Brown Cottage is situated on a site that rises steeply to the west with little setback from the road. Brown Cottage is located adjacent to Moorhead Cottage at the end of Cottage Street.

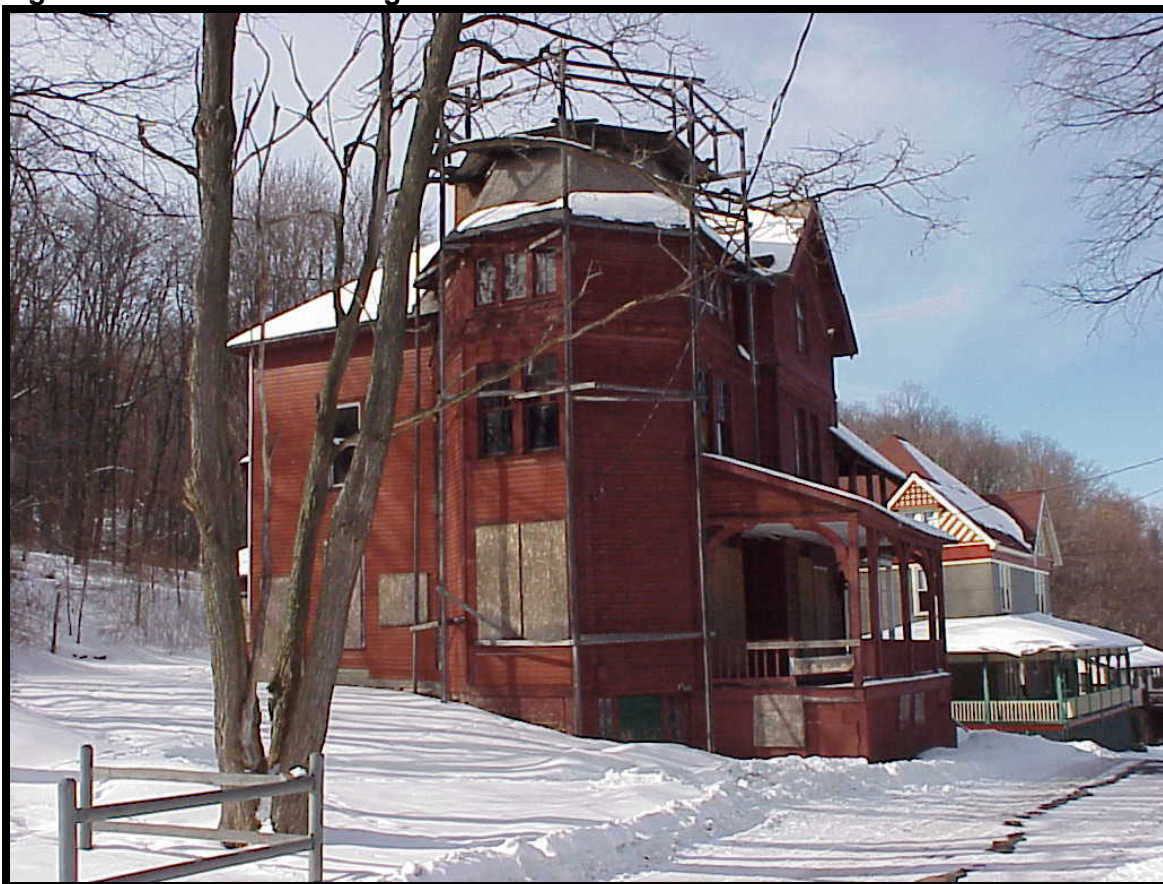
Figure 3-8: Moorhead Cottage

Moorhead Cottage is a 2,447-square-foot, 3-story frame Queen Anne/Shingle Style house that was believed to have been one of seven earlier cottages completed by 1883 (**Figure 3-8**). The structure was constructed with hipped and gabled roof, dormers, a distinctive octagonal tower, and first and second floor porches. The existing main porch is only a fragment of the original porch that wrapped the east and south elevations of the building. Portions of the original front porch and the polygonal roof of the tower were removed. The small porch attached to the south side of the rear ell of the cottage has been enclosed with siding and fixed multi-pane windows.¹⁶

The building is situated on a steeply sloping site, the front of which has been extended and regraded to incorporate a modern access road that extends to Brown Cottage. The building was configured into a side by side duplex by the Maryland Coal Company.

The existing visible foundation is a product of renovations made throughout the mid-twentieth century. The foundation is a series of masonry piers with masonry block or glass block infill. The masonry materials include concrete block and two types of yellow construction block.

The Moorhead Cottage is a three-story, Queen Anne/Shingle Style frame house of the early 1880s with hipped and gabled roof, dormers, a distinctive octagonal tower and front porches. Similar to Brown Cottage, Moorhead Cottage has interesting architectural features, such as lattice work on multiple porches, hipped and gabled roofs, an octagonal tower on the Moorhead Cottage, and bay and octagonal windows. Similar to Brown Cottage, Moorhead Cottage have minimal setback from the roadway.

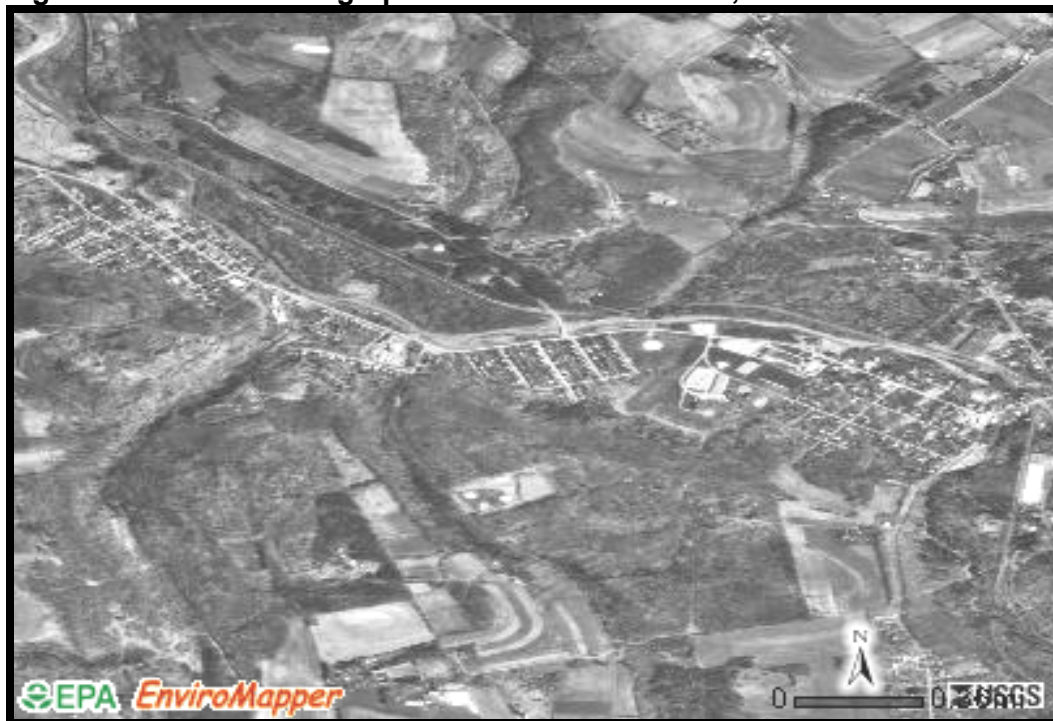
Figure 3-9: Aerial Photograph of St. Michael-Sidman, PA

Figure 3-9 shows an aerial photograph of the St. Michael-Sidman area. St. Michael lies to the left and Sidman stretches to the right. As shown, land use surrounding the village of St. Michael is mostly agricultural and reclaimed mining sites. Within the South Fork Fishing and Hunting Club Historic District, land use is principally residential interspersed with some business and small institutions such as a church and the Rose of Sharon, a private personal care home, which is located on the corner of Main Street and Lincoln Street, before Cottage Street.
