# CHAPTER THREE: AFFECTED ENVIRONMENT

# THE AFFECTED ENVIRONMENT

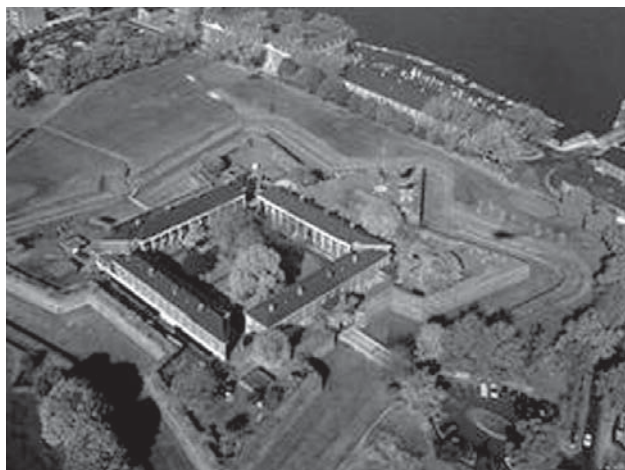
Fort Jay circa 1985. HABS.

The current fort configuration represents many years of evolving military engineering that began around 1776. Rudimentary earthen fortifications were erected in attempts to protect New York Harbor from British invasion at the onset of the American Revolution. These impermanent works were supplemented in 1794 and again in 1805 by American Lieutenant Colonel Jonathan Williams. Williams's improvements reconfigured Fort Jay and reinforced the walls with masonry. Fort Jay is a square fort with four projecting corners (or bastions), a projecting ravelin—the fifth point of the star—and is surrounded by a dry moat, which is itself surrounded by a *glacis*—an open lawn gently sloping to the shore, which served to deflect artillery over the fort and allowed for an unobstructed field of fire from the fort. The masonry walls are 20 feet high and 8 feet thick at the base. They are constructed of red sandstone with a top course of bluestone. Clipped lawn in the dry moat directly abuts the masonry walls. Two terraces created by masonry retaining walls

Fort Jay is centrally located within the historic district and at the highest point on the island. This siting allowed the most comprehensive view and widest reach of the fort's 104 guns. The fort's main entrance is located on its east side, directly aligned with the historic main pier at Buttermilk Channel, now the site of the NPS dock (102). The doorway is a narrow passageway, once controlled by a heavy wooden gate. Above the gate is a small gatehouse topped by an elaborate sandstone sculpture combining an eagle with other military symbols. A concrete and asphalt bridge (219)—which replaced a drawbridge—leads from the fort over the dry moat and connects with a circular entry drive which replaced a barbican—a defensive earthwork—in the 1930s.

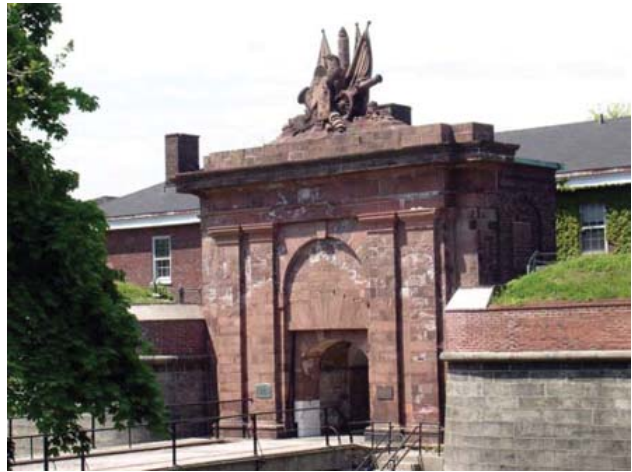
Above: Fort Jay gatehouse. NPS.  
Below: Trophée d'Armes. Peter Aaron/Esto.

The monumental sandstone gate is surmounted by a 15-foot carved sandstone *trophée d'armes*, commissioned by the New York State Artillery. A brick two-room gatehouse is situated to the rear and abuts the back of the gate; within the gate are a set of wooden doors and remnants of a former drawbridge. The *trophée d'armes* consists of an eagle holding a shield depicting the Hudson River with the sun rising over the mountains in the background. The eagle is flanked on either side by flags, a mortar and cannon, and various artillery implements. A banded bundle of rods—similar to a Roman fasces but lacking the enclosed axe—with a “liberty cap” perched on top is positioned behind the eagle. The carving is in poor condition, with many elements missing or patched. Initial research indicates it may be one of the earliest American monumental carvings of stone and fort decoration. The gatehouse is an integral part of Fort Jay and must be preserved.

The *trophée d'armes* is in poor condition, with many elements missing or patched. Research is needed to identify the exact date of the sculpture's construction, the artist, and reasons for its commissioning. Initial stabilization is underway, part of a multi-phase restoration project. The Gatehouse is also in poor condition.

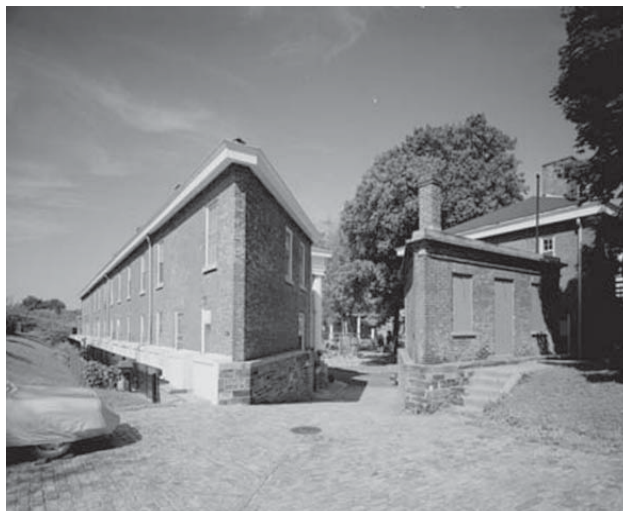
Barracks and triangular building. HABS, 1985.

Located at the ends of three barracks are small two-story triangular structures constructed circa 1830 of brick, granite, and sandstone. Originally numbering eight, several have been incorporated into the barracks. They served a

The triangular buildings are in poor condition.

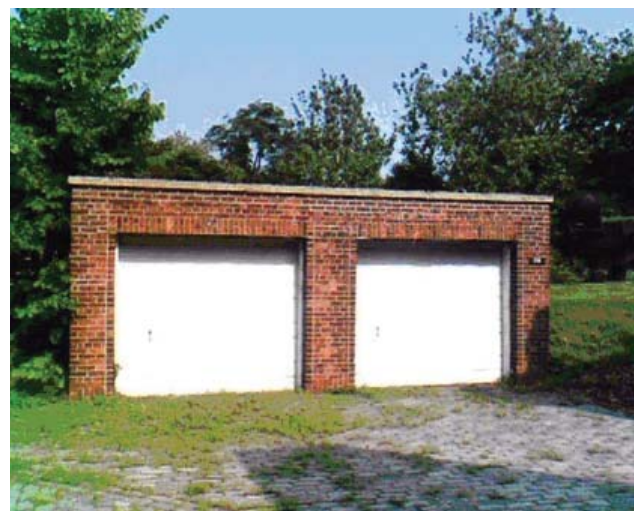
Fort Jay garages. NPS.

The garages are in good condition.

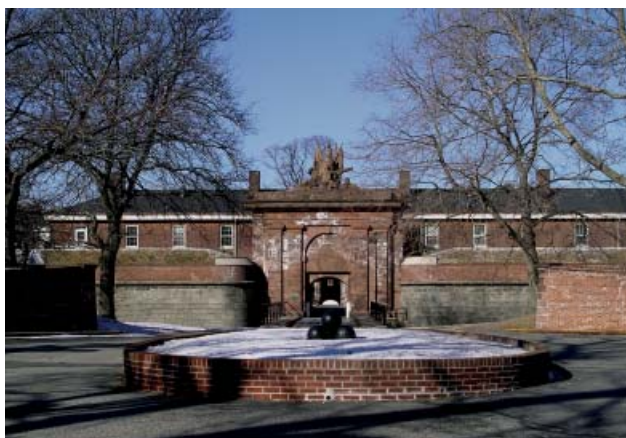
Brick planter where barbican used to be, in front of the entrance to Fort Jay. NPS.

The planter is in poor condition. Rehabilitation of the entrance to Fort Jay will take into account the shape, size, and materials of the pre-1930s feature.

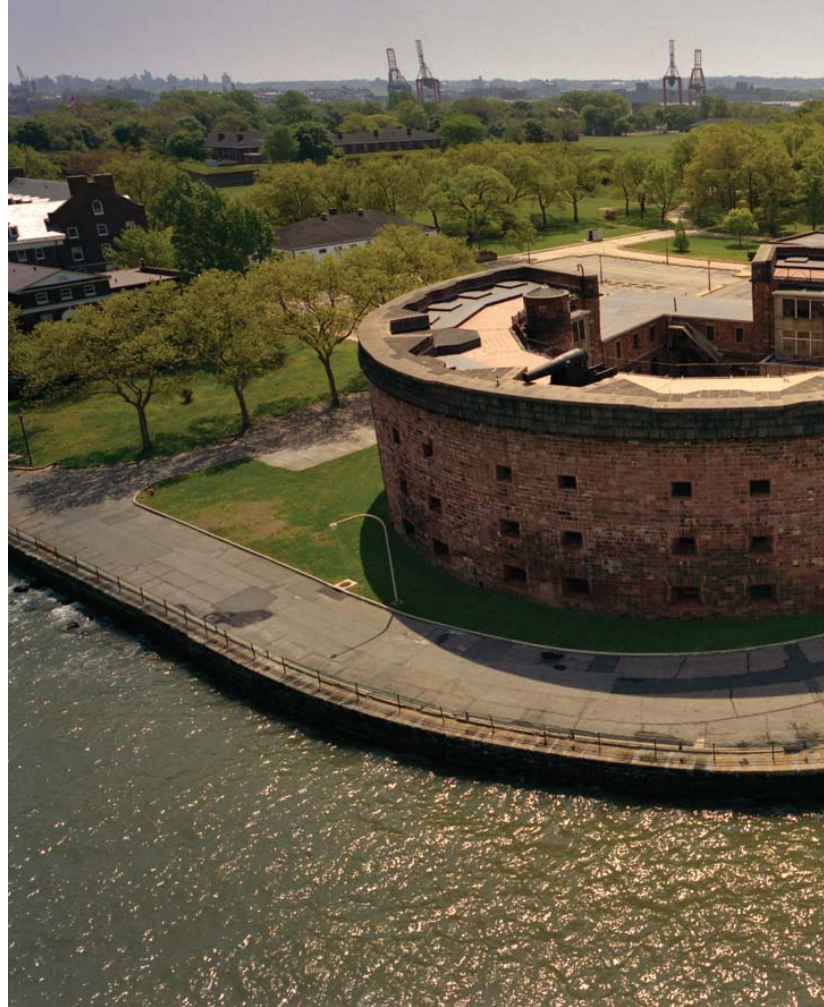
Aerial of Castle Williams. Lisa Kereszi.

Plumbing and central heating had been installed by 1916, which were renovated along with the electrical system in the 1930s. The floors and roof were also reinforced with steel in the 1930s, and steel grating and solitary confinement cells were installed in selected casemates of the second and third tiers.

Extensive renovations were carried out in 1947–48, resulting in the industrial appearance of the courtyard today. Concrete balconies enclosed with steel sashes replaced existing wooden galleries, and a three-story brick addition enclosed a steel stair. Concrete floors and brick partitions were installed in the casemates of the second tier, and steel security sashes and doors replaced those made of wood.

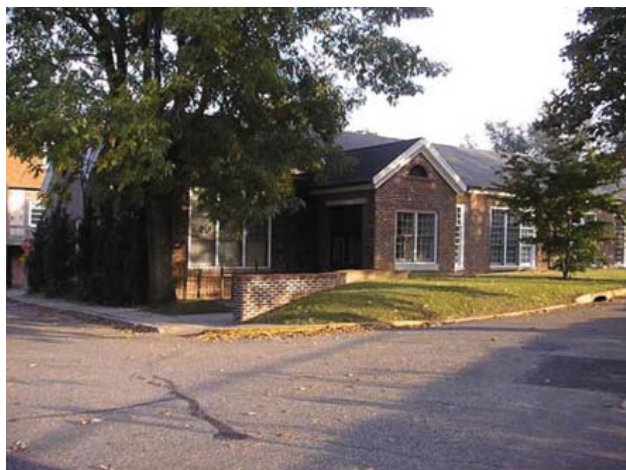
Building 107, NPS headquarters. NPS.

Built as a storehouse for the New York Arsenal, this long, single-story, brick-masonry structure was built in several sections. It has parallel double gable roofs with wood eaves and fascia. Originally constructed between 1856 and 1857, sections of it burned and were rebuilt in 1904. The eastern section was added between 1908 and 1918. Roughly half of the interior was rehabilitated by the Coast Guard as offices, circa 1996. The remainder was gutted and left unfinished. The total usable space within Building 107 is approximately 11,000 square feet. It is currently used as NPS headquarters for the National Monument.

The building is a Category 2 contributing resource that must be preserved. The building is in good condition.

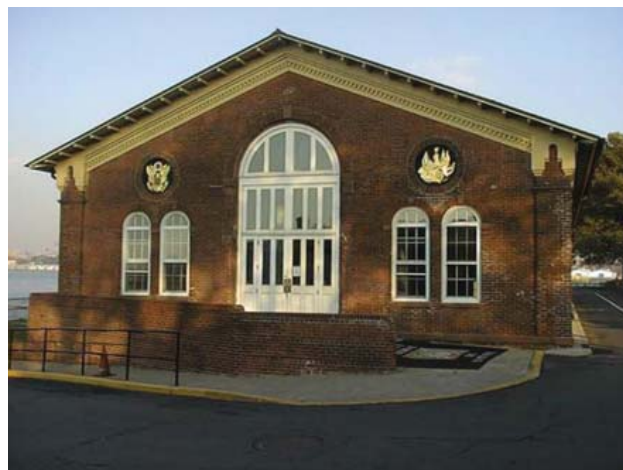
Building 140. NPS.

Building 140 is a Category 2 contributing resource that must be preserved. GIPEC is responsible for the preservation and maintenance of the building. NPS is responsible for the maintenance of its easement area. The building is in good condition.

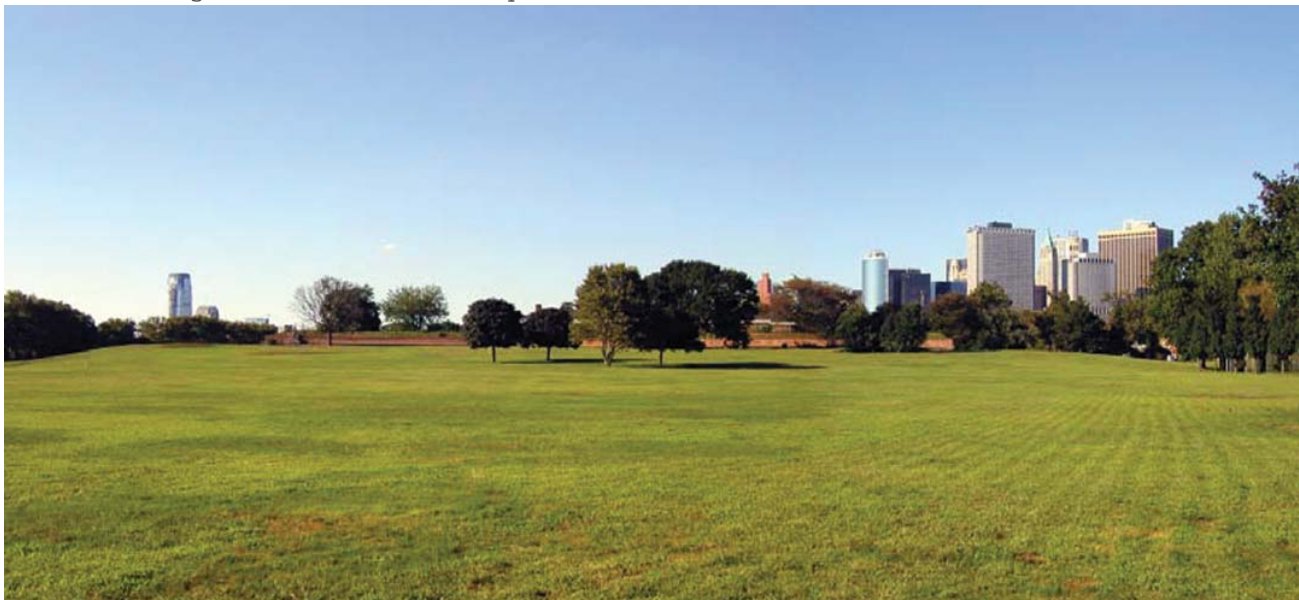
*Glacis looking north toward Fort Jay and Lower Manhattan. NPS.*

The *glacis* is important to understanding the evolution of development on the island. The open lawn area is its primary character-defining feature, important for resource interpretation and education and must be preserved. The open historic lawn is protected from waterfront wind and has incredible views of New York and Jersey City. The resource will be monitored for signs of degradation and the level and intensity of public use will be coordinated with GIPEC. The *glacis* is in fair condition.

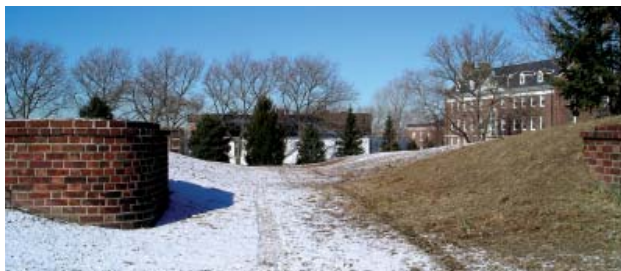
Covered defile, looking towards Castle Williams. NPS.

Traces of this feature are visible today closer to Fort Jay. The defile had been filled in, although a depression in the ground marks its original location. Building 251, trees, a parking lot and a road are now on the original alignment, closest to Castle Williams. Surviving features of the defile, now covered with earth, include brick retaining walls and cobblestone paving. These were

identified by archeological excavations undertaken in 1997–98 by PAL. The 2003 NPS *Archeological Overview and Assessment Report* determined that there are few if any cultural materials associated with the defile and made no further recommendations. In 2006, a portion of the defile was uncovered by landscape contractors. In 2007, the park will conduct an archaeological assessment and site investigation to determine the extent of damage, condition of remaining features, and to recommend future treatment. Any rehabilitation activities associated with the defile or the *glacis* in that immediate area will necessitate archeological monitoring or other oversight as per NPS guidelines. The defile site is considered disturbed and in fair condition.
