# The Water Wheel and Casey's Canoe Livery Restoration Project

## Environmental Assessment June 2007

Produced by Sleeping Bear Dunes National Lakeshore  
Natural Resource Division

**SLEEPING BEAR DUNES NATIONAL LAKESHORE  
THE WATER WHEEL AND CASEY'S CANOE LIVERY SITE RESTORATION,  
Benzie County-Lake Township  
ENVIRONMENTAL ASSESSMENT**

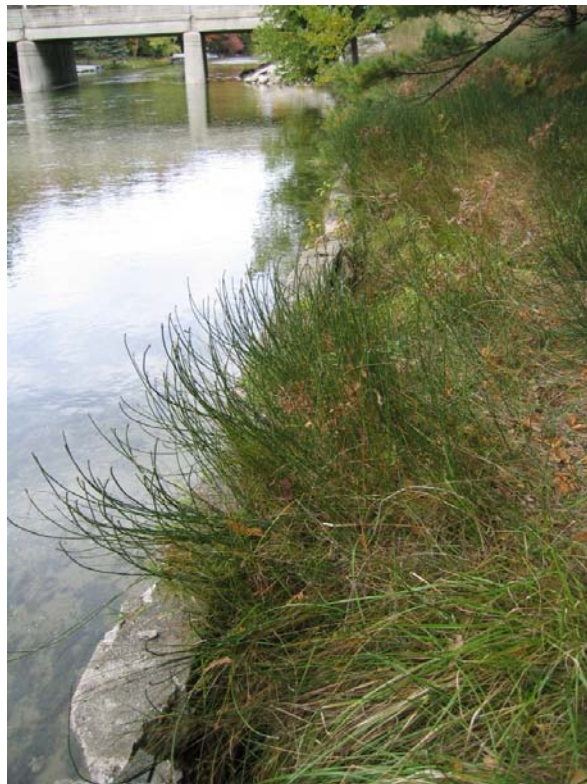
Water Wheel-Concrete Retaining Wall

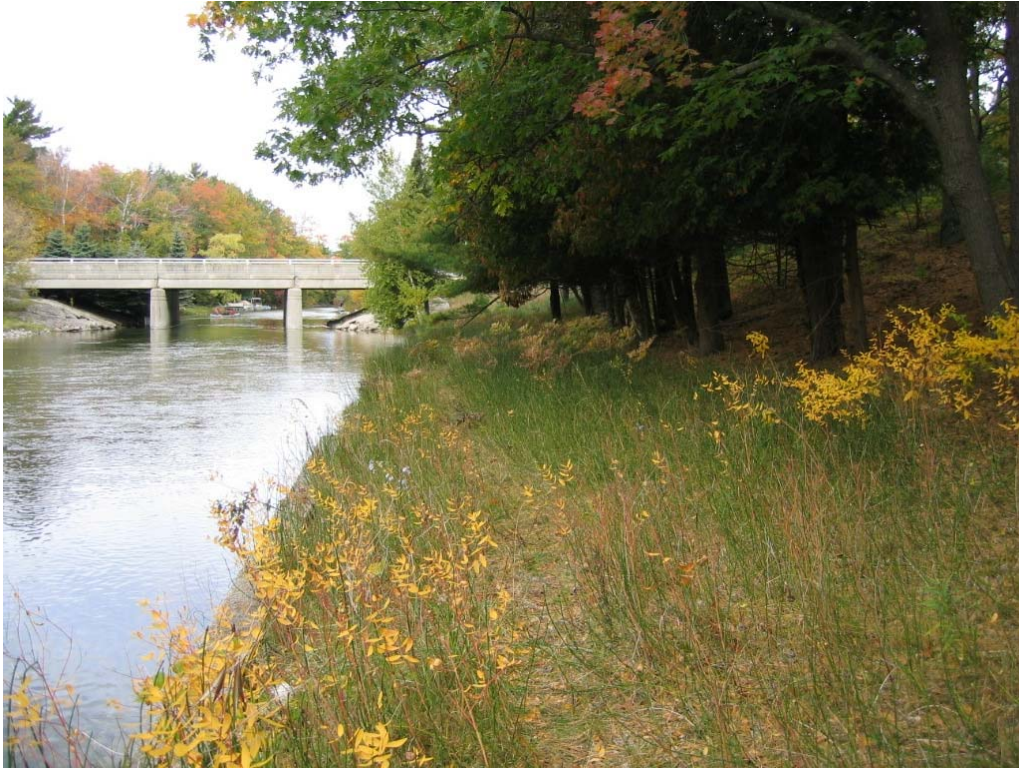
Water Wheel-Concrete Retaining Wall

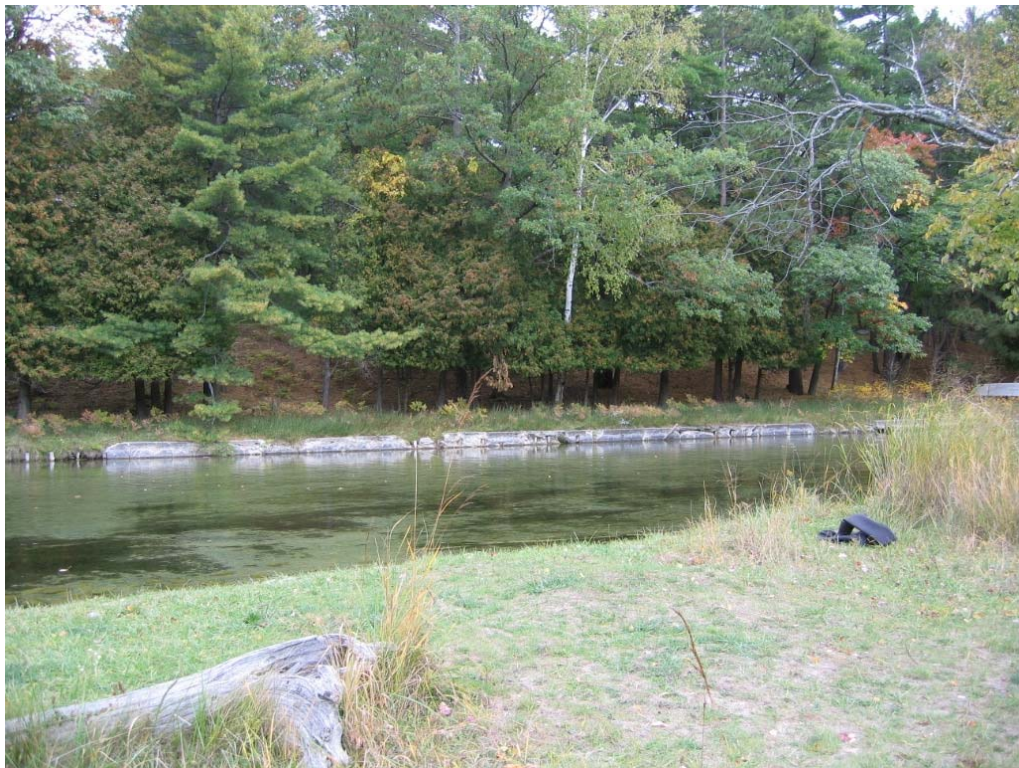
Water Wheel-Concrete Retaining Wall

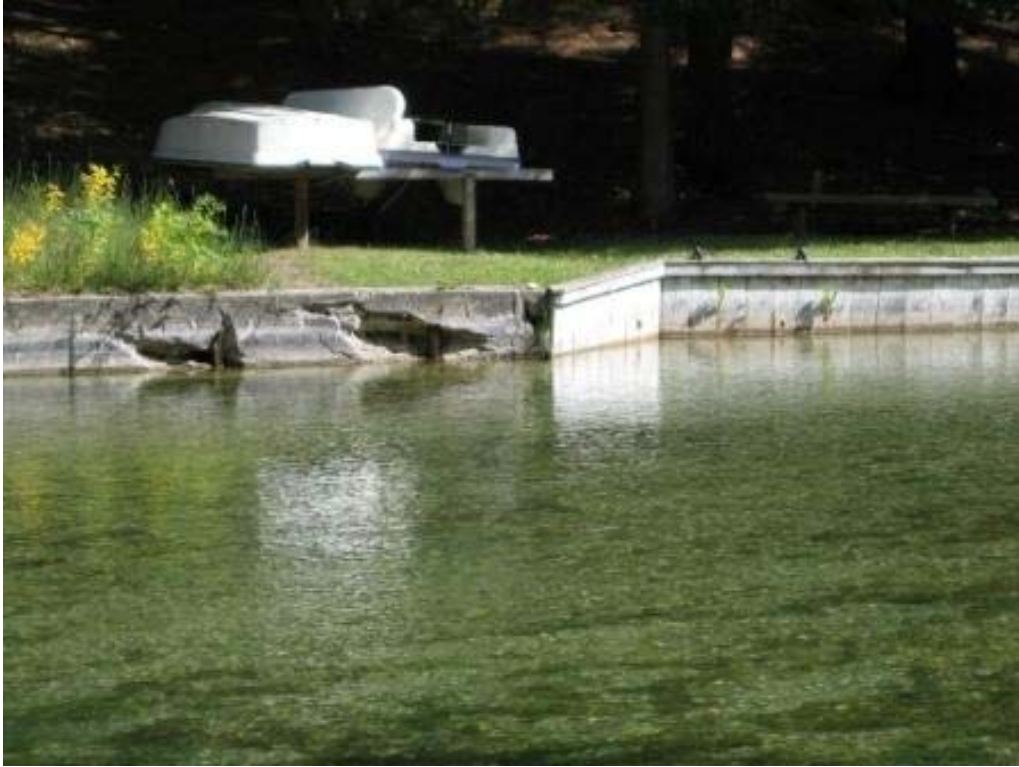
Water Wheel-Concrete & Inholder (46-115) Retaining Walls Intersection

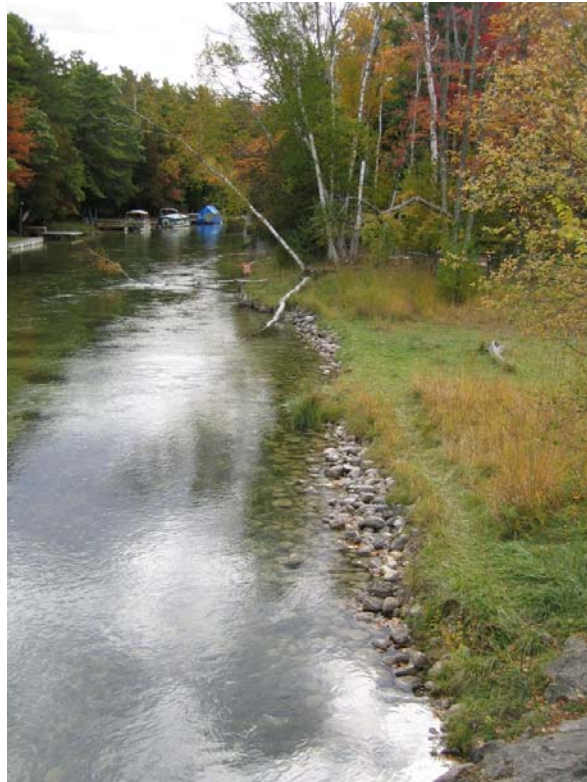
Casey's-Steel Sheet Piling (Buried) & Cobble

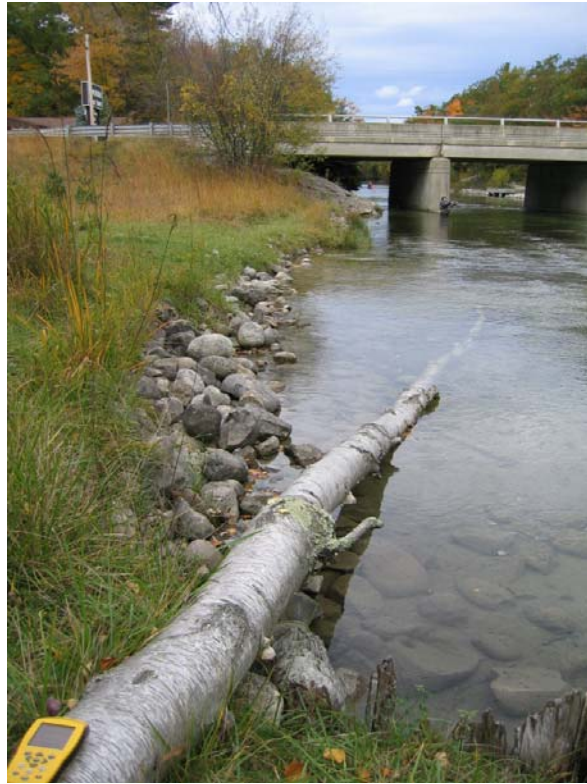
Casey's-Steel Sheet Piling (Buried) & Cobble

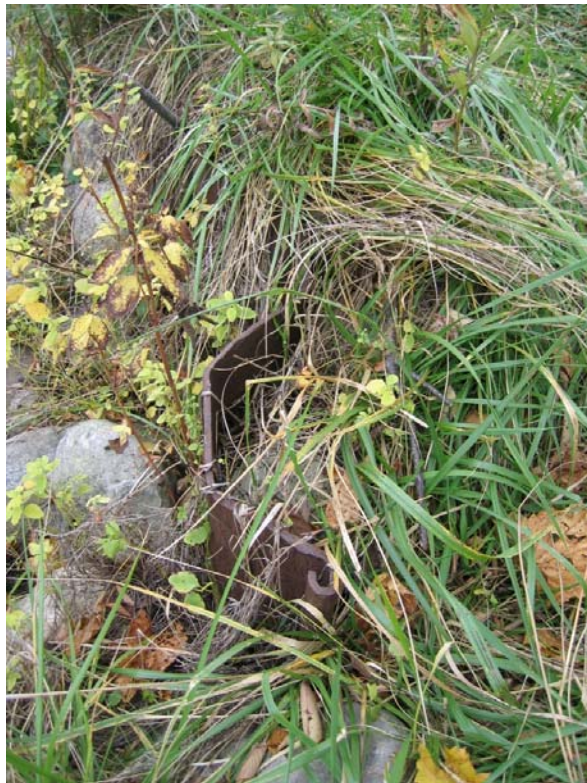
Casey's-Steel Sheet Piling

The steel sheet piling would be completely removed using an excavator and a vibratory driver extractor. A contractor would be hired for this removal process. It is possible that the cost of hiring a contractor would be recovered through the salvaged steel sheets; however, this is unknown until the condition of the sheets is assessed.

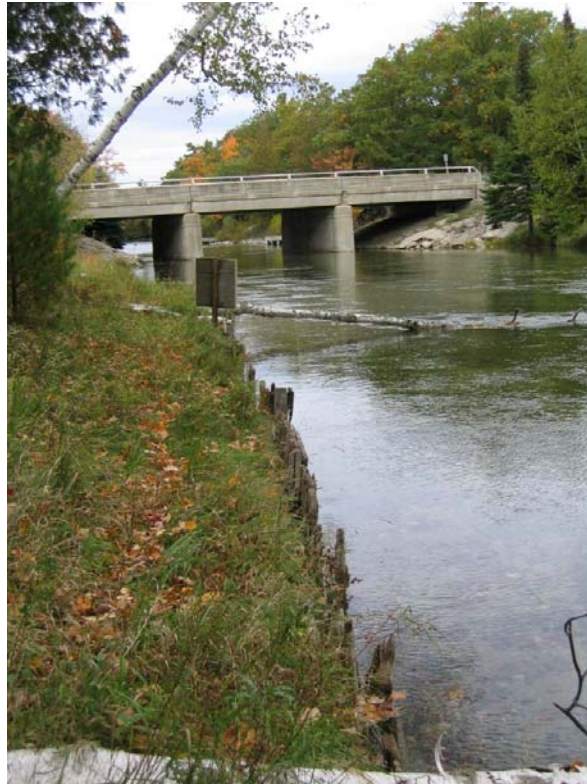
Casey's-Wood Retaining Wall

The wood wall, located in the Platte River, would be removed. Removal of this structure would require minimal effort since it has greatly deteriorated.
