APPENDIX E

Environmental Assessment for the Bank Stabilization of the Cockspur Island Lighthouse

Archaeological Trip Report

Subject: Trip Report Describing Activities Performed While
Conducting Research at the National Archives and
Records Administration (NARA), College Park, MD, and
Washington D.C. for Fort Pulaski National Monument
(FOPU), September 7-13, 2008, Followed by Pedestrian
and Magnetometer Survey conducted at Lighthouse,
September 24-26, 2008, SEAC Acc. 2203.

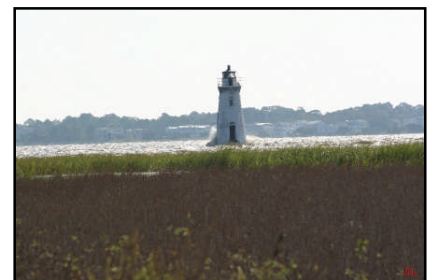
Cockspur Island Lighthouse during high tide.

The Cockspur Island Lighthouse is one of five historic lighthouses remaining in Georgia. The lighthouse is only accessible to park visitors during low tide. The lighthouse is supported by a wooden grillage base that exists under the foundation of the structure. This base consists of support beams that were sunk seventy feet into the salt marsh clay.

There are two principle issues affecting the Cockspur Island Lighthouse: island erosion and infestation of the wooden foundation of the lighthouse by marine borers. The island is under water for approximately fifty to sixty percent of the day. During high tide, the island is completely submerged, as well as the first several steps to the lighthouse's doorway. Natural processes, including winds and tides, as well as waves caused by passing ships have eroded the island away, so now it only consists of a narrow strip of land visible during low tide. Up until 1980, the island offered a significant amount of protection for the lighthouse.

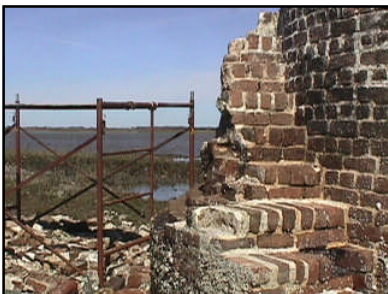
Damaged lighthouse steps.

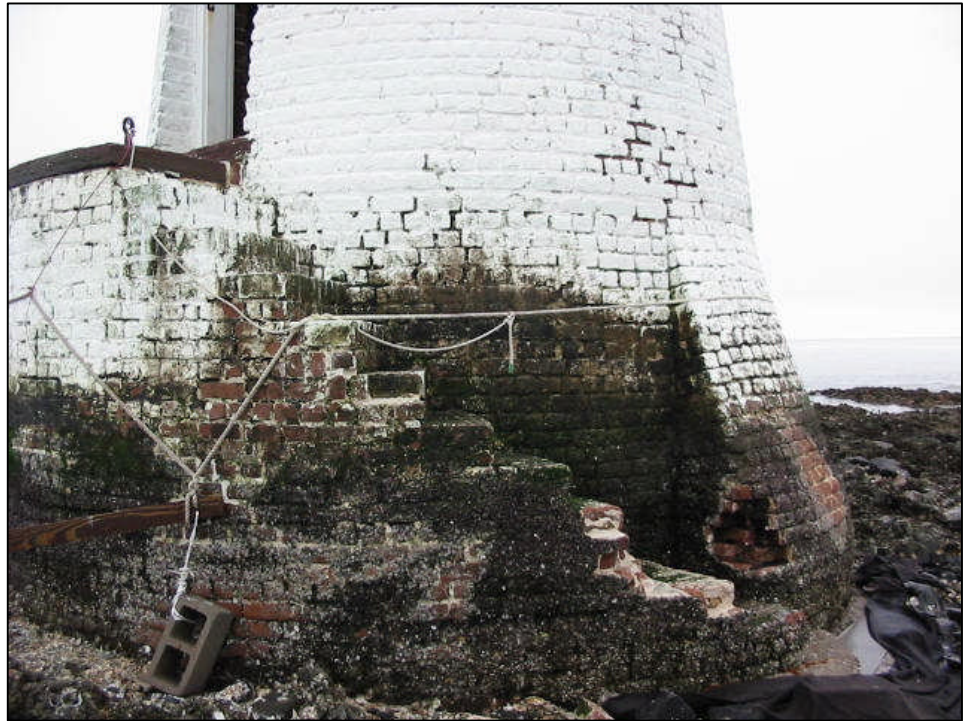
Portions of the lighthouse's wooden foundation are now exposed and have visual shipworm damage. The National Park Service has completed emergency repairs to the portions of exposed wood by covering the wood foundation, thus removing the oxygen that encourages shipworm infestation. The shipworm infestation can compromise and eventually destroy the wooden foundation. If the foundation fails, the historic lighthouse would fall into the water and be lost.

The NPS has been making emergency repairs to the lighthouse's exposed wooden foundation that is being damaged by shipworms.

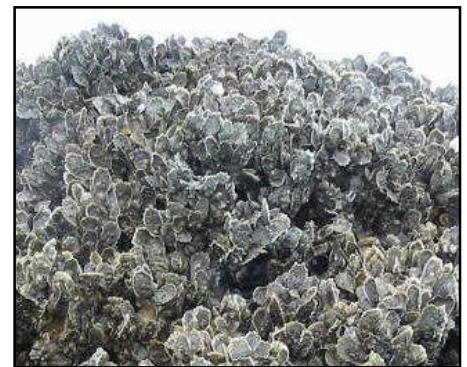
Live reefs on the island create an unsafe walking surface for visitors.

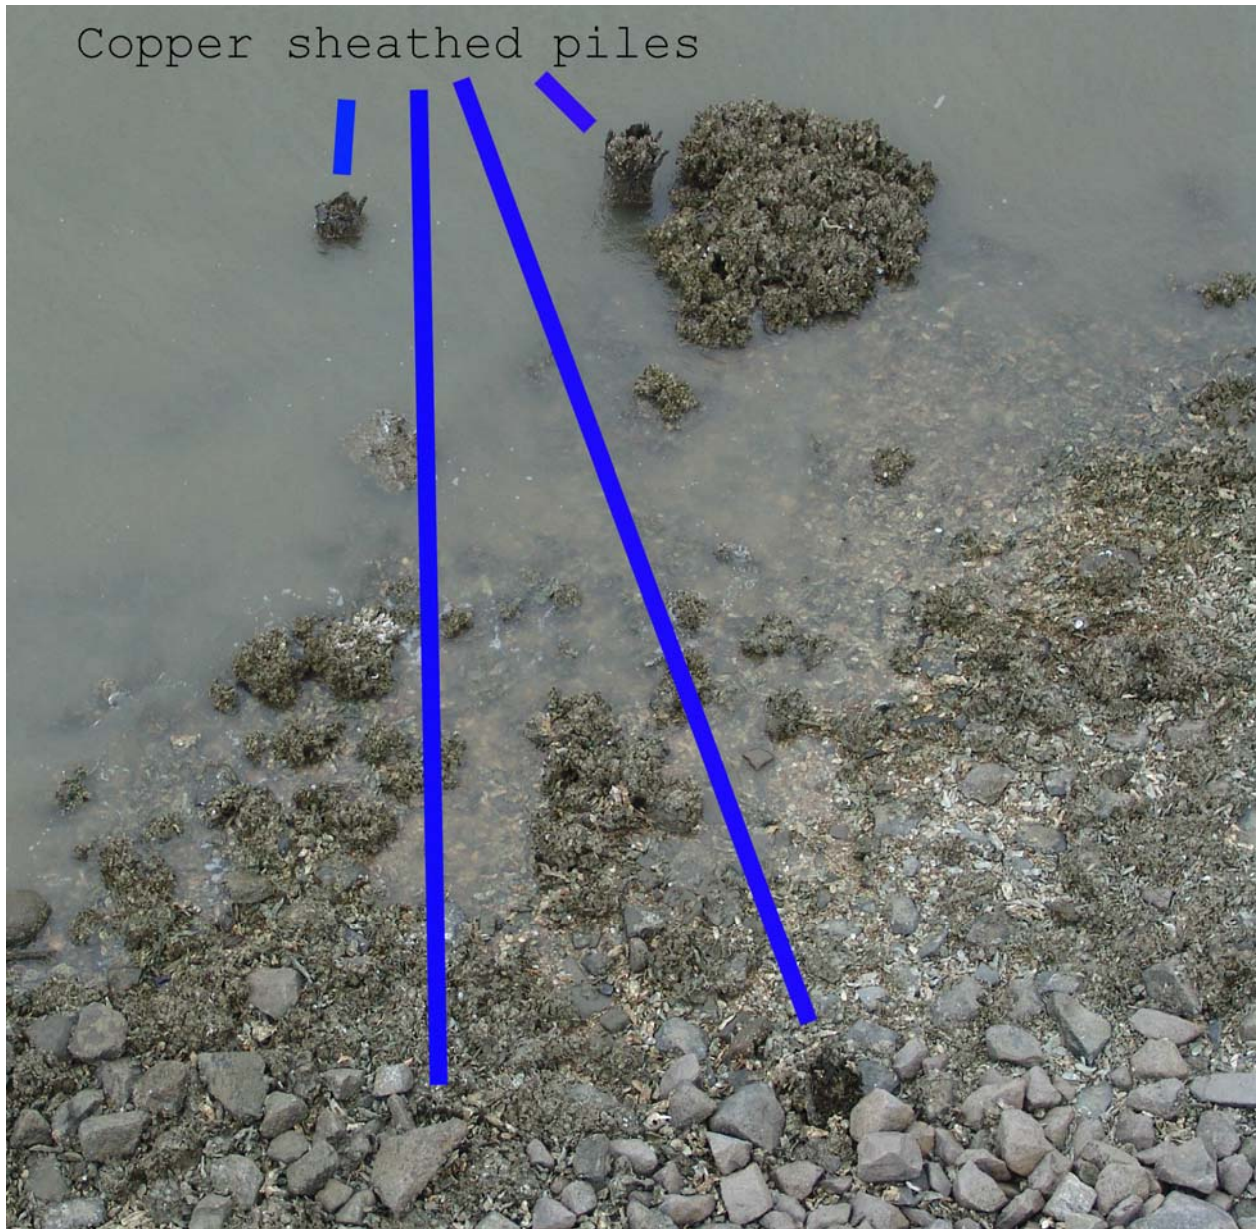
The basal remains of four copper sheathed piles were located, photographed, and mapped in with a Trimble Pro XRS Global Positioning System (GPS) unit (Figure 1). The projected southern direction in which the piles extended would have placed them in deepening water toward the south channel of the Savannah River which likely indicates that these piles supported a boat dock, wharf, or possibly a boat house. The clipping files for Cockspar Island indicate that in 1868 "A substantial boat landing has been erected; piles cased with yellow metal; ..." (Clipping Files 1868). The clipping files produced further information regarding the boat landing for the lighthouse. In 1885 the clipping files report "The landing at the tower was strengthened, a boat landing was built on metaled (sic) piles, 200 linear feet of plank walk were laid, and various minor repairs were made" (Clipping Files 1885).

Figure 1. Copper sheathed piles extending into south channel.

Savannah River are most likely the remains of the 1868 boat landing which was repaired and expanded on many occasions. The many bricks scattered over the surface of the small island appear to be of the Savannah Gray type, most certainly used in the construction of the 1848 lighthouse. Their presence greatly reduced the efficacy of the proton magnetometer. A more detailed discussion of the magnetometer survey is provided in the next section.

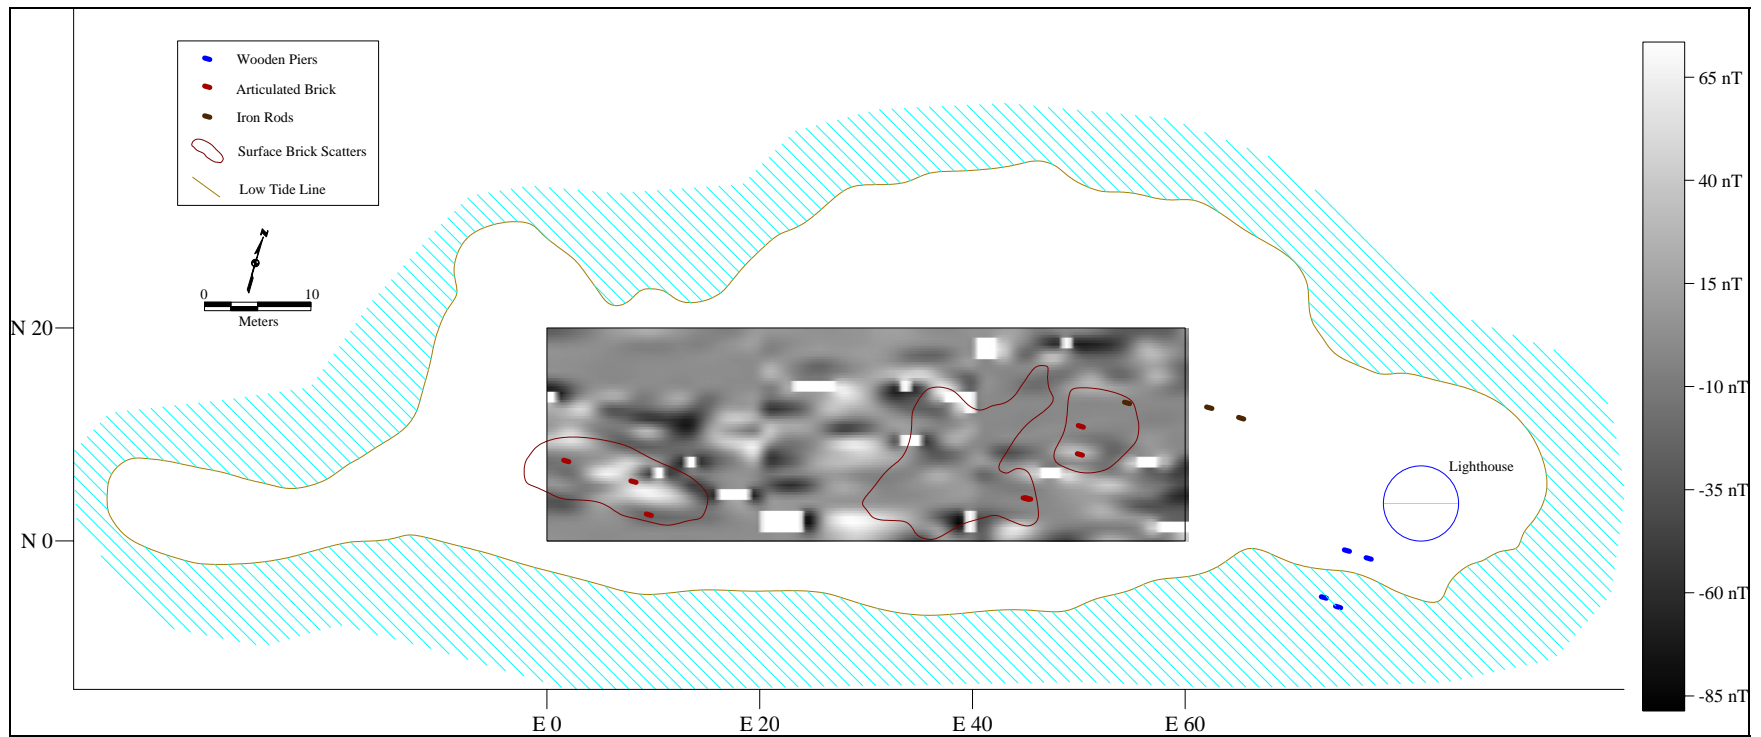
Gradiometer surveys are conducted by carrying the unit over the ground surface in a series of linear transects making up a larger grid. Three adjacent (east/west) grids measuring 20-by-20-meters were established to the west of the lighthouse. The grids were laid out in a manner that allowed as much of the land surface exposed during low tide to be surveyed as possible. Despite these efforts, the northwest corner of the westernmost grid became submerged prior to completion of the survey, and some of the data from this portion of the grid may be skewed because of the need to raise the FM-256 approximately two feet higher above the ground surface to keep it out of the water. The unit was carried along north/south transects spaced at one-meter intervals within each grid. Magnetic readings were collected every 12.5 centimeters along each transect at a 1 nT resolution. Upon completion of the survey, data from the three grids were combined into a single composite measuring 20-by-60-meters (oriented east/west) and then post-processed using the software package Geoplot (produced by Geoscan Research for use with the FM-256). Extraordinarily high and low readings (usually caused by the presence of large iron objects) were clipped from the dataset to accentuate the lower magnetic variations usually caused by archeological features. Interpolated data was added to the dataset between transects and individual magnetic readings along the transects in order to smooth contours and a low pass filter was run to accentuate anomalies ranging between one and two meters in size. The entire composite dataset was then exported into the contour mapping software package Surfer for the production of the graphic displays seen in Figures 2 and 3 below.

Unfortunately, there was little information to be gleaned from the processed magnetic data set. There were no apparent anomaly patterns that would suggest any buried structures or features,

Figure 2. The project area and gradiometer results from the Cockspur Lighthouse island survey.

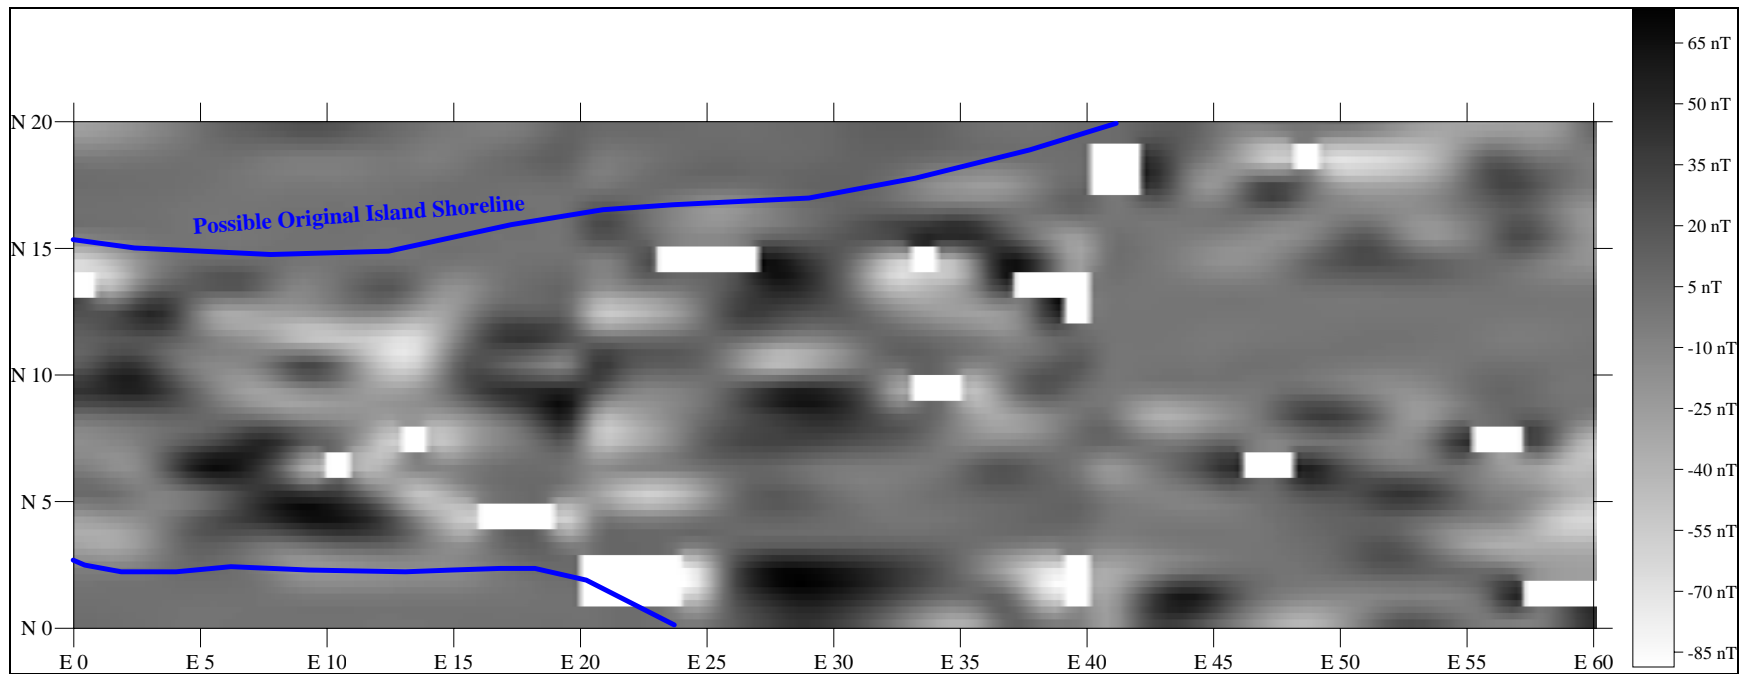
Figure 3. Gradiometer results. White blocks represent clipped (removed) data spikes.

and it is possible that most of the variation in the data set stems from the demolished brick covering the surface of the island. There was only one noticeable trend within the data, that most of the collection of magnetic dipoles recorded is confined to an east/west oriented band through the center of the western grid that expands north and south through the central grid and encompasses the entire eastern grid. This general trend and positioning of anomalies may be indicative of the original dimensions of the island as it was constructed to support the lighthouse (Figure 3).

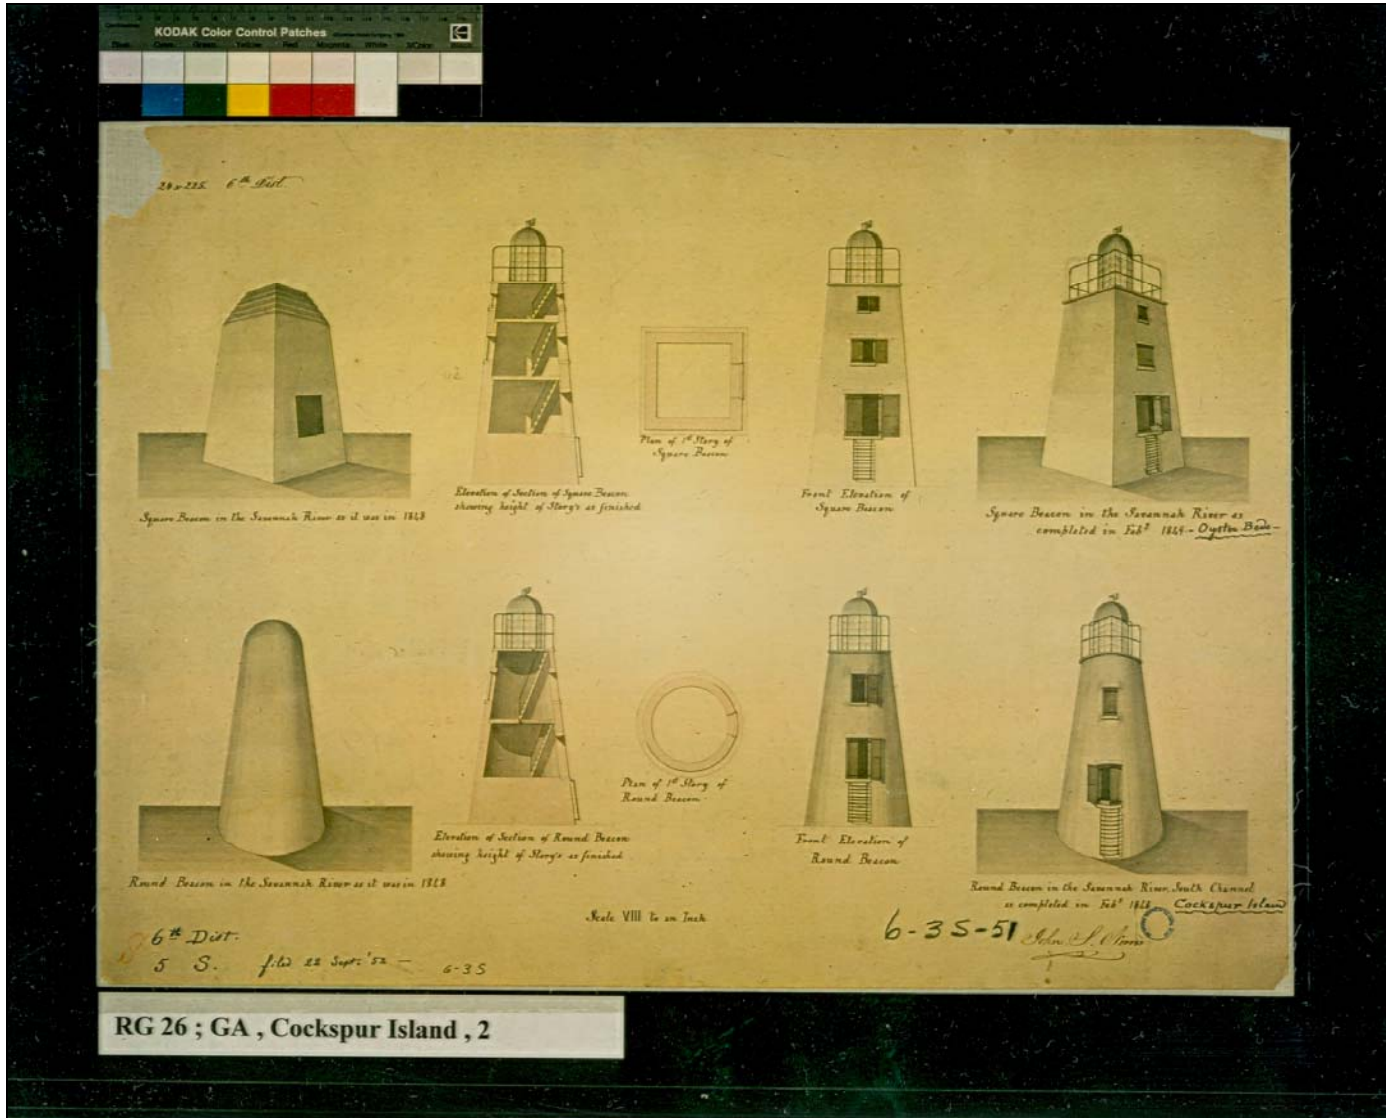
RG 26 ; GA , Cockspur Island , 2

Figure 4. Drawing of 1848 Lighthouse on Cockspur Island. (Lower right)

Two drawings of the Cockspur Island lighthouse from 1848 and 1855 were located, photocopied, and photographed (see Appendix 1). The 1855 map, in particular, revealed information regarding the foundation of the lighthouse that confirms the mapping work completed during the June project (Kidd 2008).

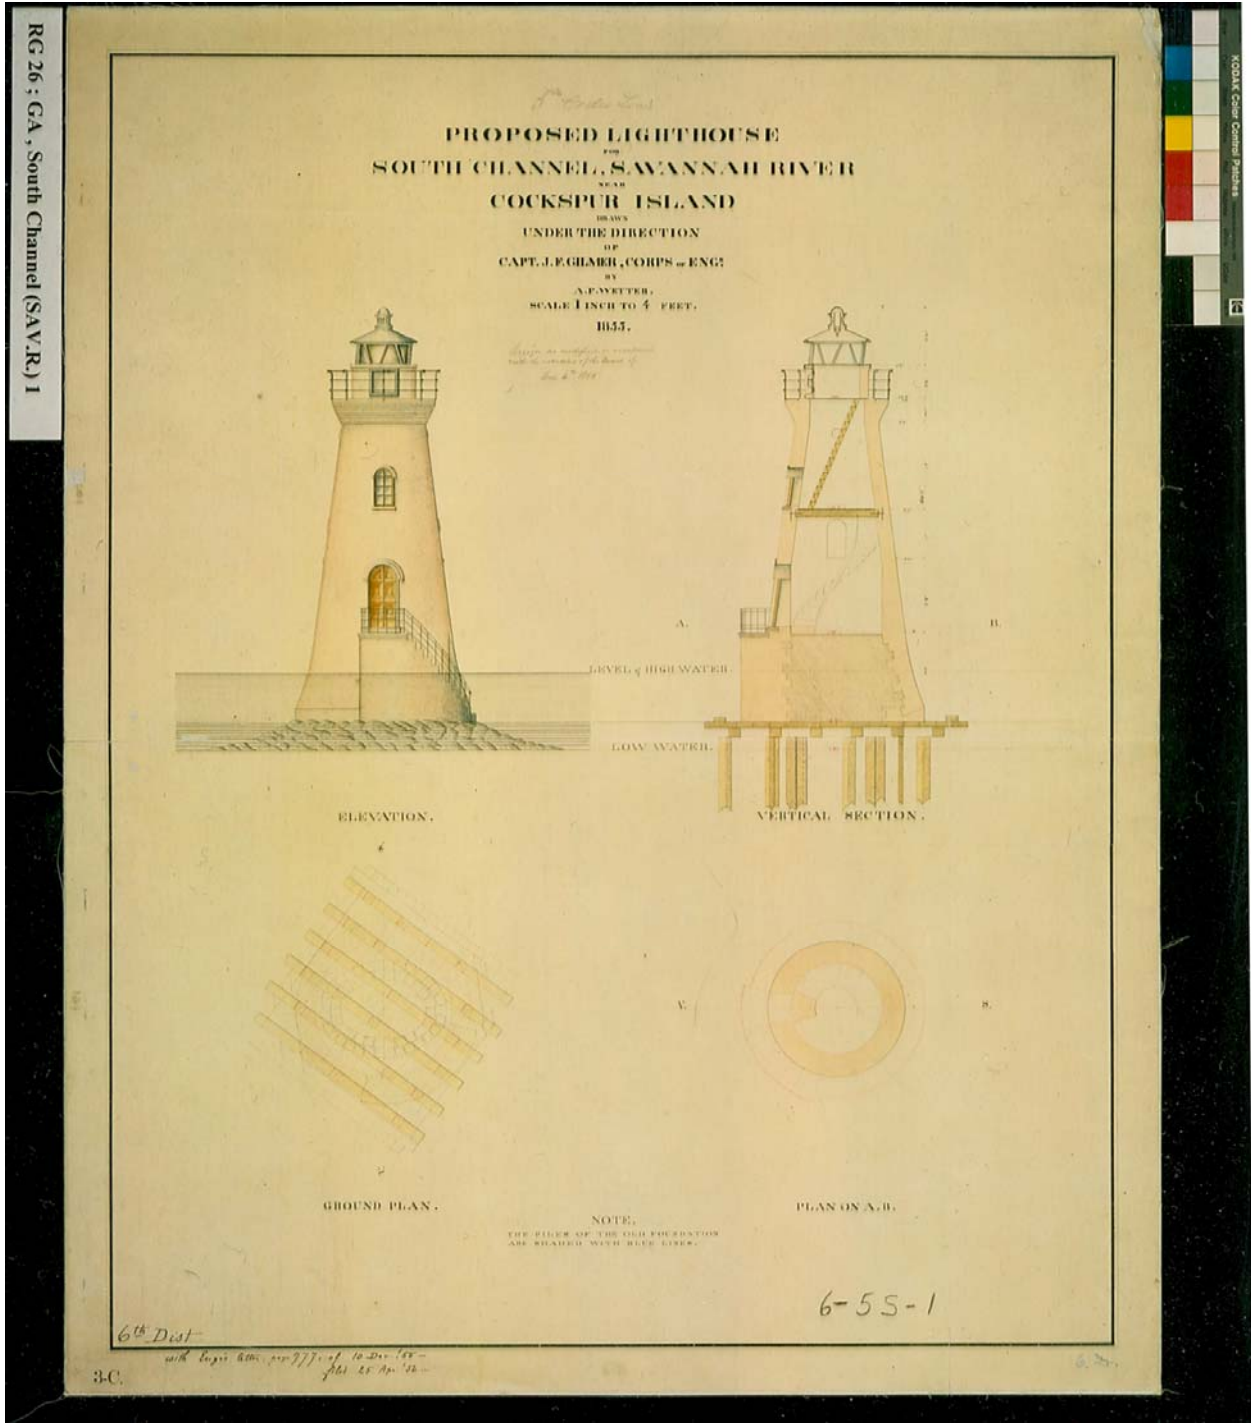
Figure 5. Drawing of 1855 Lighthouse on Cockspar Island.
