**A Ground Penetrating Radar Survey to Find and Delineate the Pinery
Feeder Dam in the Cuyahoga River, Near Ohio State Route 82**

Final Report

By Dustin Bates¹ and John Peck^{1*}

October 28, 2010

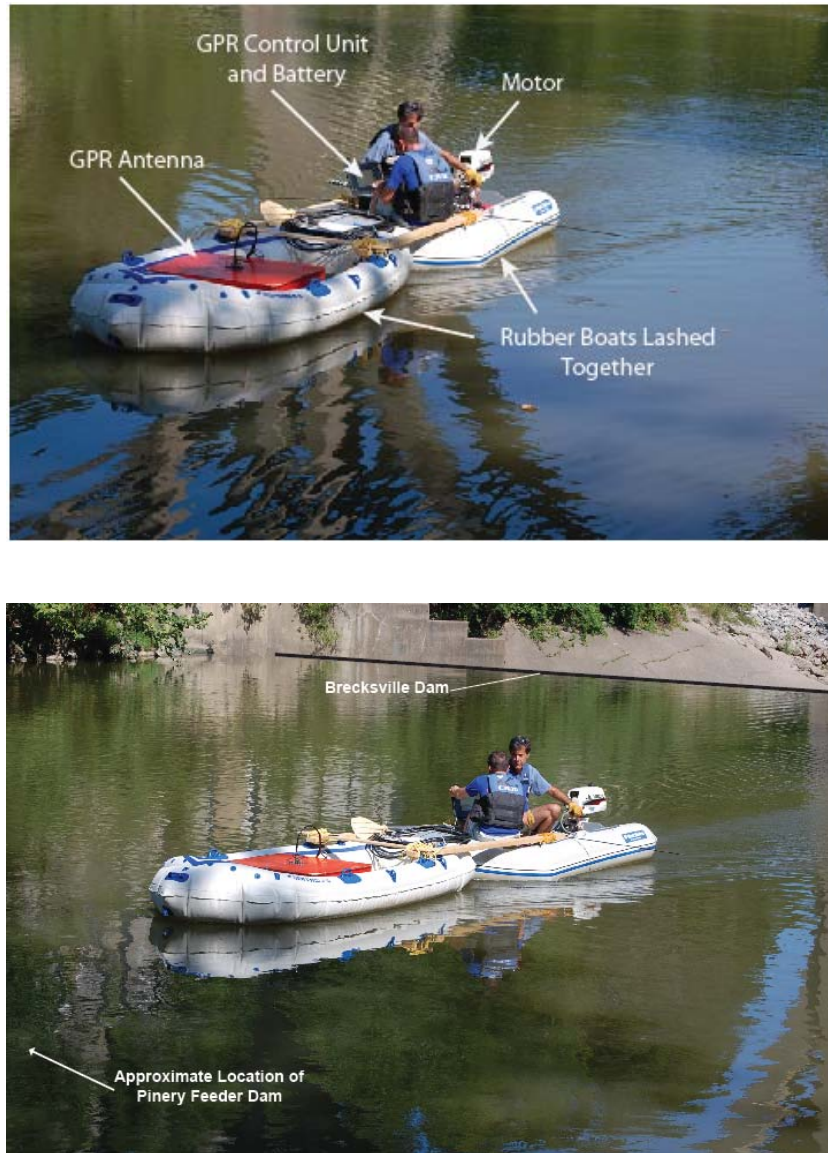
Figure 3. (Top) Photograph of the GPR survey. Two rubber boats were lashed together to allow for separation of the antenna from potential interference by the motor, battery, GPR control unit, and cables. The 120 MHz antenna was placed by itself in the front boat. (Bottom) Photograph showing the measurements of a GPR survey trackline, location of the Brecksville Dam and approximate location of the Pinery Feeder Dam. Photos by Greg Tkachyk.

together. The radar control unit, battery and operators were in the back boat, and the antenna was in the front boat (Figure 3). Rubber boats were used because the conductivity of a metal boat would have interfered with the radar signal. Figure 3 shows the setup of the two boats and radar equipment. This setup was lightweight and allowed for quick maneuvering throughout the survey area. The low flow condition of the Cuyahoga River on August 19, 2010, allowed for a safe survey close to the Brecksville Dam. Figure 4 shows a 30-day interval of mean daily discharge from the Old Portage stream gauging station. The survey occurred when the mean daily discharge was approximately 200 cfs. On August 19, 2010 the water elevation was measured at 5.7 ft. on the gauging staff located at the Pinery Feeder canal gate. Because saline water limits the effectiveness of the GPR method a water sample was collected the day of the survey. On August 19, 2010 the conductivity of the water was measured to be 862 microsiemens.

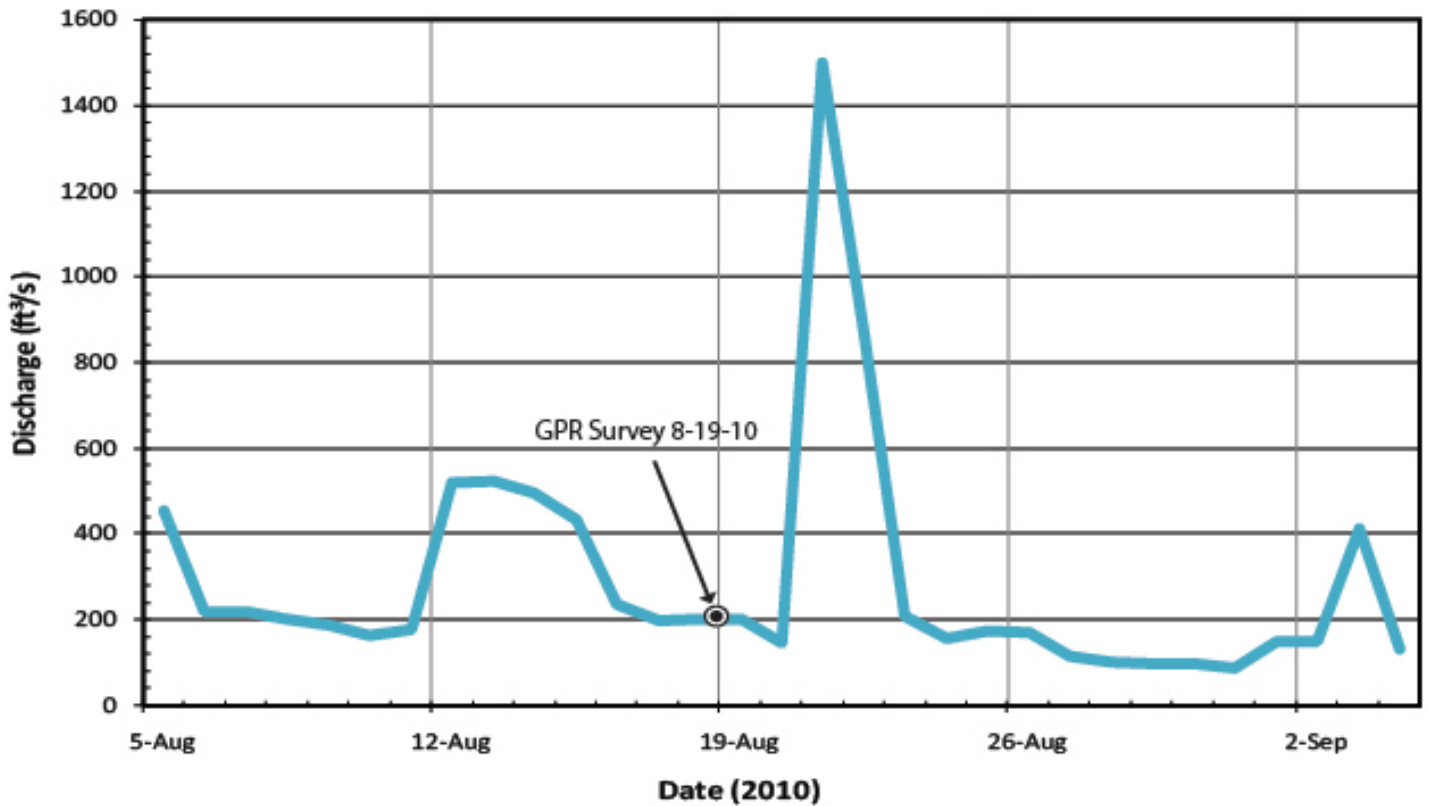
Figure 4. Mean daily discharge of the Cuyahoga River at the USGS gauging station at Old Portage Path in Summit County Ohio. The graph shows the hydrograph over a 30-day period. Note that the GPR survey took place during low flow conditions and 2 days before a rain event. Data from the USGS, 2010. Ohio Water Science Center, <http://oh.water.usgs.gov/data.htm>

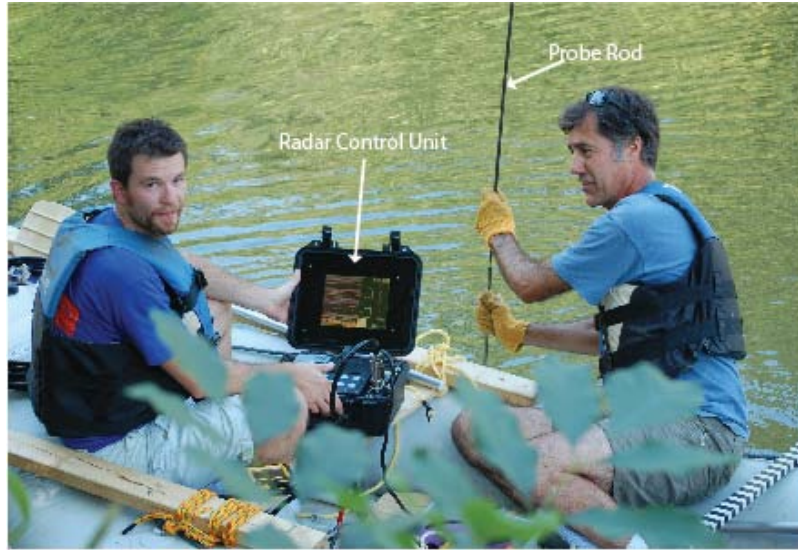
Figure 5. Photograph showing the method of determining a site specific dielectric constant by physically measuring the water depth while simultaneously collecting GPR data. Photo by Greg Tkachyk.

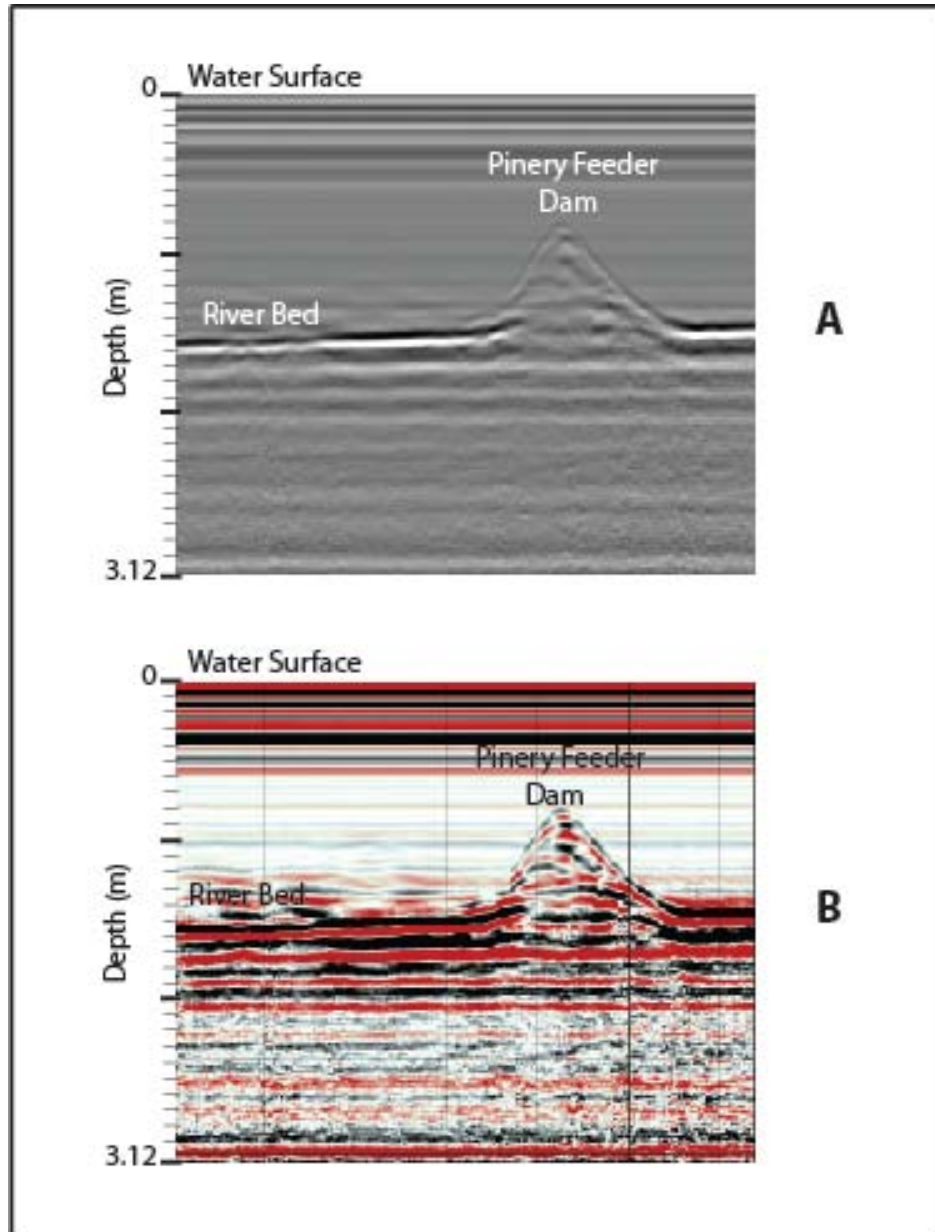
Figure 7. Comparison of the GPR profile data. (A) RADAN, proprietary GSSI, data converted to bitmap format shown in grayscale. This format closely resembles the display screen on the GPR control unit in the field. (B) Bitmap file converted to seg-y format and plotted on a color scale. On B the black color represents positive amplitudes and the red represents negative amplitudes.

radar data were collected in RADAN format, a proprietary format used by GSSI systems. The RADAN files were converted to Bitmap files using the open source program, *rad2bmp*. The *rad2bmp* program does not allow for color-scale changes, rather it uses grayscale. The grayscale bitmap data closely resembles the output display data for the GPR unit in the field. For better visualization of the data, the bitmap files were converted to seg-y files using the open source program *kogeo*. The *kogeo* program offers a variety of options to define color scales. An example of the radar data is shown in Figure 7, where the original grayscale bitmap and color seg-y conversion profiles are shown for comparison. Because of the greater clarity of the colored profiles, all survey lines were processed into seg-y format.

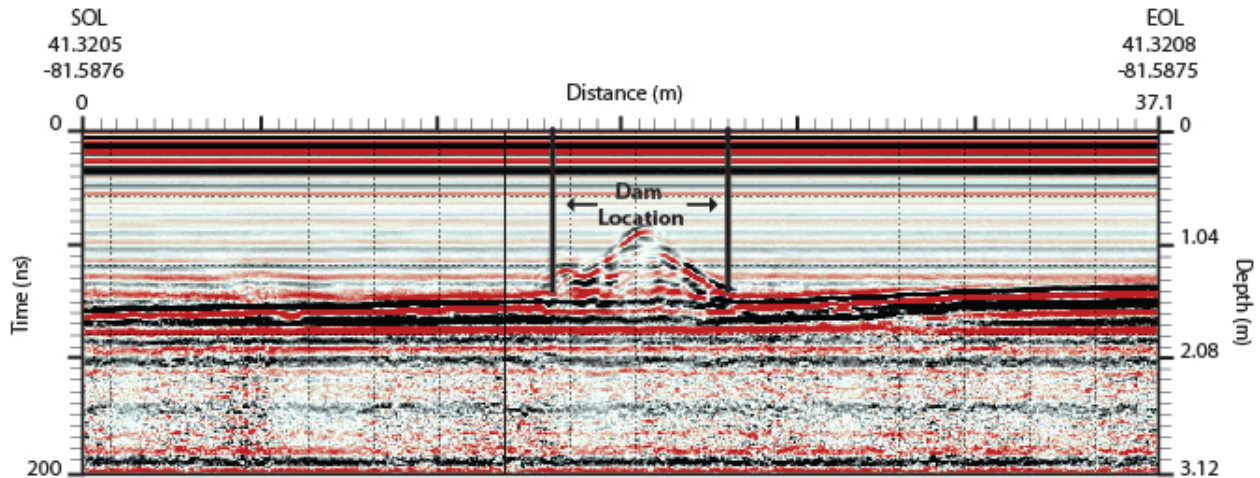
Figure 14. Line 91, vertical exaggeration is 3.81. Start of line (SOL) and end of line (EOL) GPS coordinates were plotted into ArcMap 9.3. Assuming constant boat speed, the distance between was divided into equally spaced units. Black vertical lines define the upstream and downstream sides of the dam. The distance from the SOL and the vertical lines were measured with the ruler tool in ArcMap thus allowing the Pinery Feeder Dam location to be plotted in map view.

the SOL. This process was performed on 19 separate profiles and an example profile can be seen in Figure 14.

Line 91 shows the typical dam structure also seen on many of the other GPR profiles. Stair-step features are seen on either side of the dam structure. These stair-step features likely represent actual parts of the crib structure. The high-amplitude reflection of the river bottom leading up to and extending away from the dam, is the result of bedrock. Using the metal probe rod, the bedrock nature of the channel floor was confirmed. The channel floor reflection loses intensity under the dam due to attenuation of the GPR signal through the dam structure.
