## Chapter III: Existing Conditions / Affected Environment

The project area for this Cultural Landscape Report is defined by the boundary of the Quincy Unit of Keweenaw National Historical Park as described in Chapter I. The Torch Lake area is not included within the boundary of the Quincy Unit. Chapter II: Landscape History, addresses the Torch Lake area to help readers understand the comprehensive landscape development related to the corporate history of the Quincy Mining Company. Because the Torch Lake area is not within the project area, it is not covered by the Existing Conditions, Landscape Analysis, or Recommended Treatment sections of this Cultural Landscape Report.

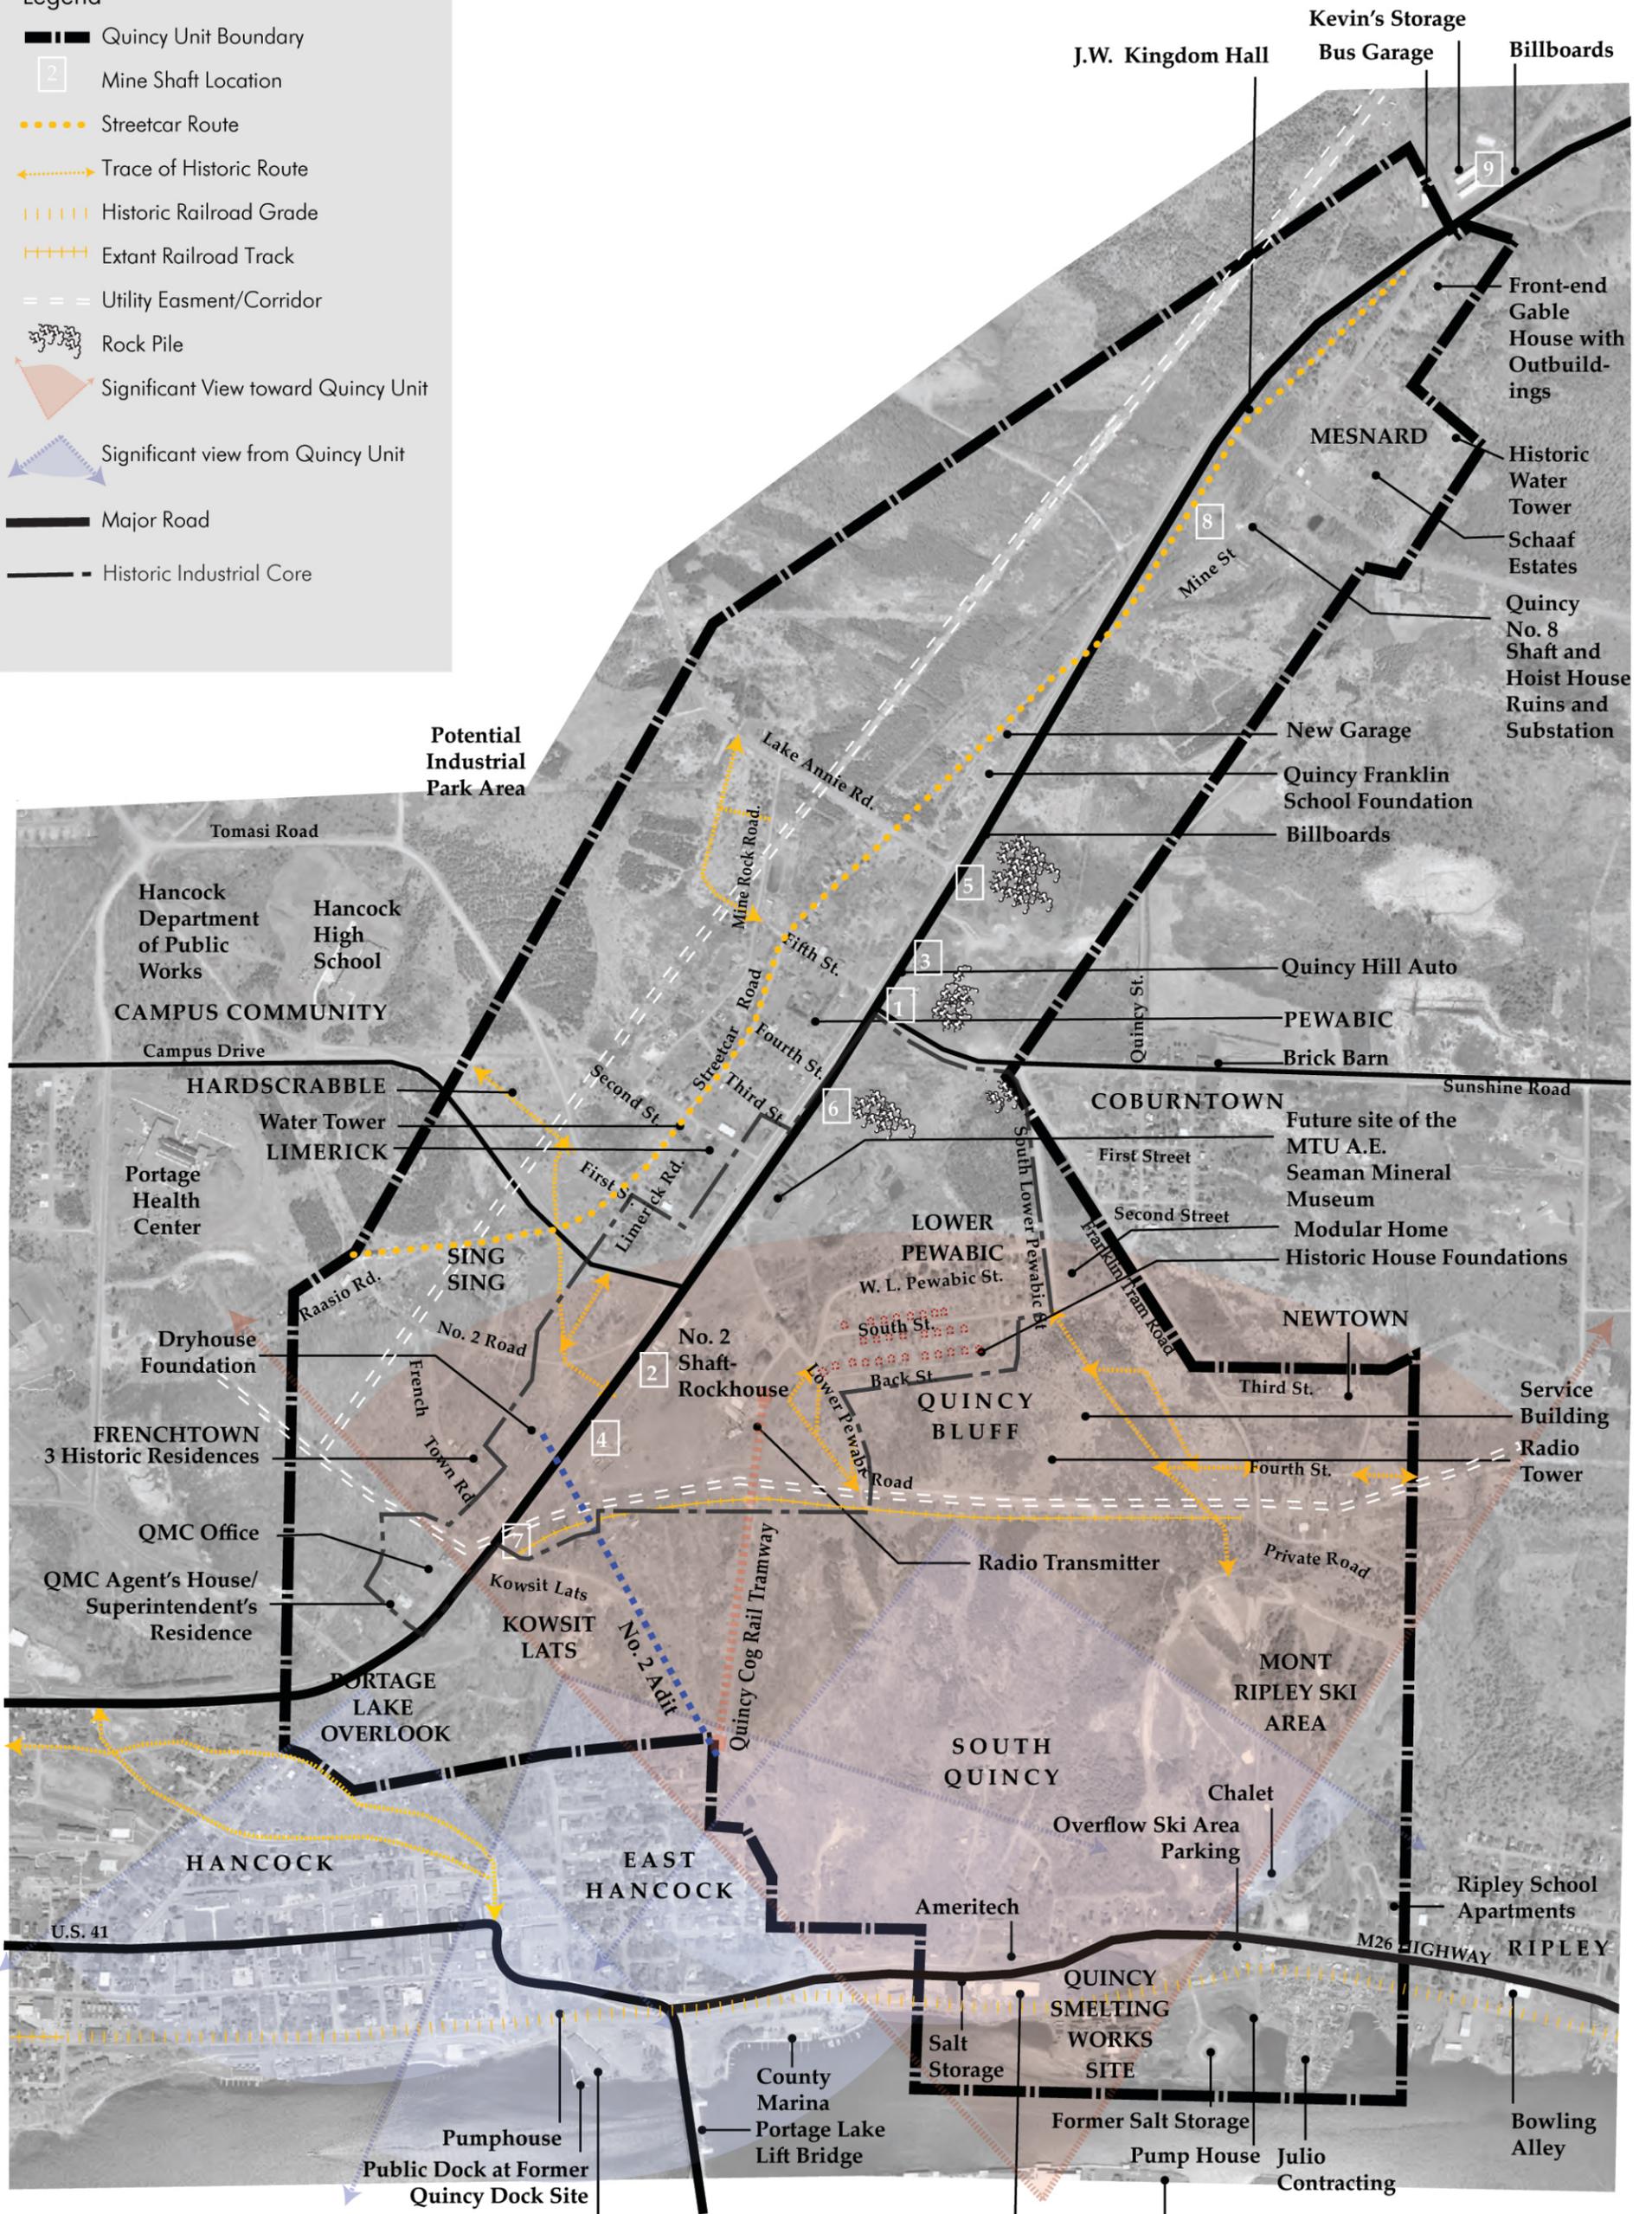
Figure 3- 1: Quincy Unit Existing Conditions

This chapter describes existing conditions within the Quincy Unit at two levels of detail. Unit-wide existing conditions are those that relate to the overall Quincy Unit (Figure 3-1 illustrates the boundaries and existing conditions of the Quincy Unit). Unit-wide conditions addressed include land use, vegetation, circulation, archaeological resources, wetlands, special status species, socioeconomics, visitor experience, and park operations at a broad scale, providing a context for understanding the overall unit.

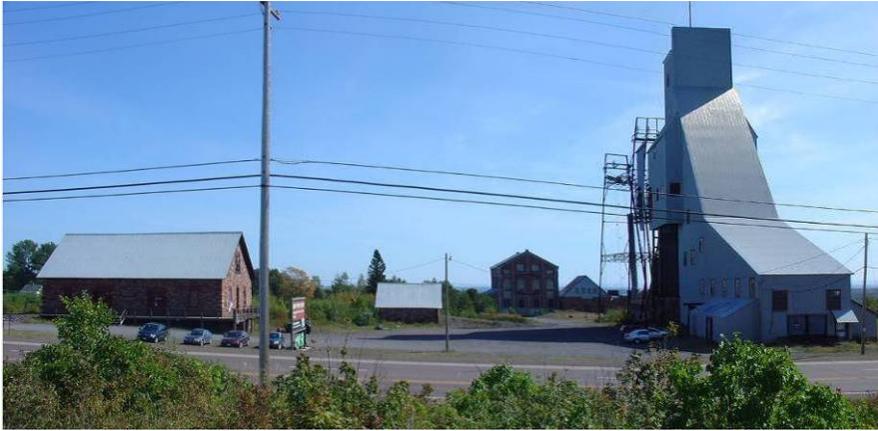
Figure 3- 12: Quincy Mine gift shop, oil house, No. 2 hoist house and No.2 shaft-rockhouse, from across U.S. 41, 2006 (source: QEA)

- **The Gift Shop:** Once a supply office, the building now functions as the Quincy Mine Hoist Association gift shop and houses a seasonal visitor information desk staffed by the National Park Service (see Figures 3-12 and 3-13).

- **The Parking Lot:** This area between the supply house and the No. 2 shaft-rockhouse is utilized for undefined gravel parking (see Figures 3-12 and 3-13).

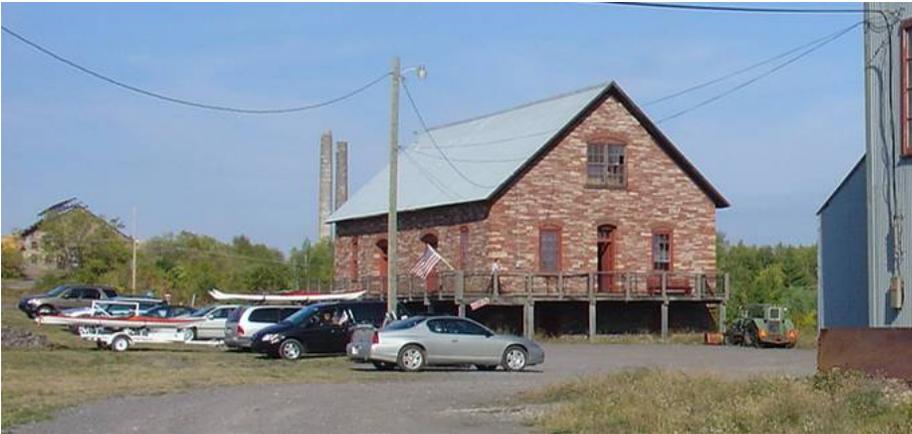
Figure 3- 13: South elevation of gift shop and parking area, 2006 (source: QEA)

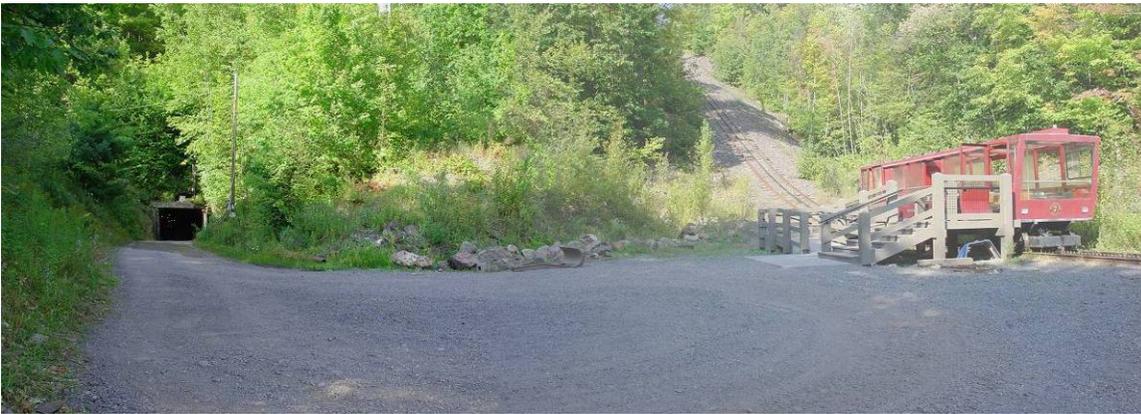
Figure 3-16: View looking north toward tram at the adit, 2006 (source: QEA)

- **The Cog Rail Tramway:** The tramway provides a link between the No. 2 hoist house and the mine adit for visitors experiencing the mine tour (see Figure 3-16).

- **The Adit:** The adit is an entrance to the underground mine tour and links the surface to the seventh level of the mine (see Figure 3-16).
- **The area between the No.2 shaft-rockhouse and No.2 hoist houses:** This is a display area of mine-related artifacts. A complete inventory of the artifacts was prepared by Scott See of Michigan Technological University. The eastern portion of the area is used for parking (see Figure 3-17).

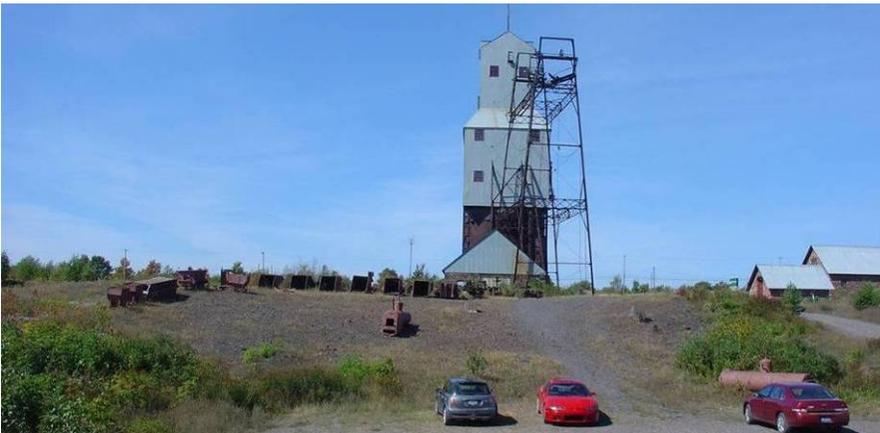
Figure 3-17: The area between the No. 2 hoist house and the shaft-rockhouse is used for parking and as a display area for mining artifacts, 2006 (source: QEA)

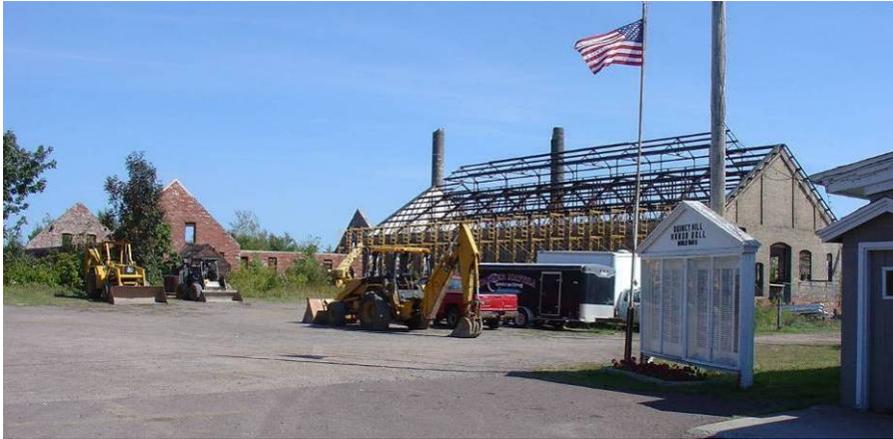
**Figure 3-18: The Quincy machine shop is being rehabilitated to be the home of the A.E. Seaman Mineral Museum, 2006 (source: QEA)**

- **The Quincy Machine and Blacksmith shops:** This property is owned by Michigan Technological University. The machine shop is being rehabilitated to house the A.E. Seaman Mineral Museum. Plans for the blacksmith shop include utilizing it in the future when the museum facility expands (see Figures 3-18 and 3-19).
- **The lawn northeast of the No. 2 hoist houses:** This is a display area for mine-related artifacts (see Figure 3-20). A complete inventory of the artifacts was prepared by Scott See of Michigan Technological University.
- **The railroad track northeast of the No. 2 hoist houses:** The railroad track provides a display of rolling stock on a historic railroad grade (see Figure 3-21).

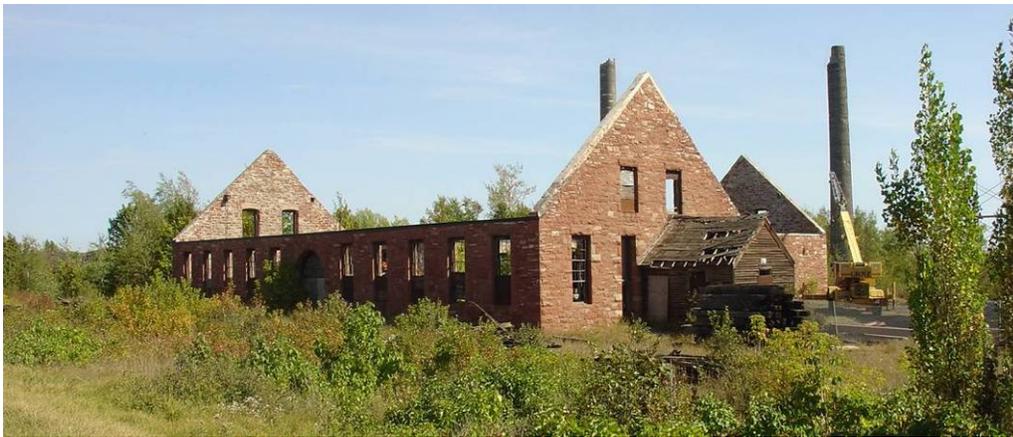
**Figure 3-19: The Quincy blacksmith shop is planned to accommodate expansion of the A.E. Seaman Mineral Museum, 2006 (source: QEA)**

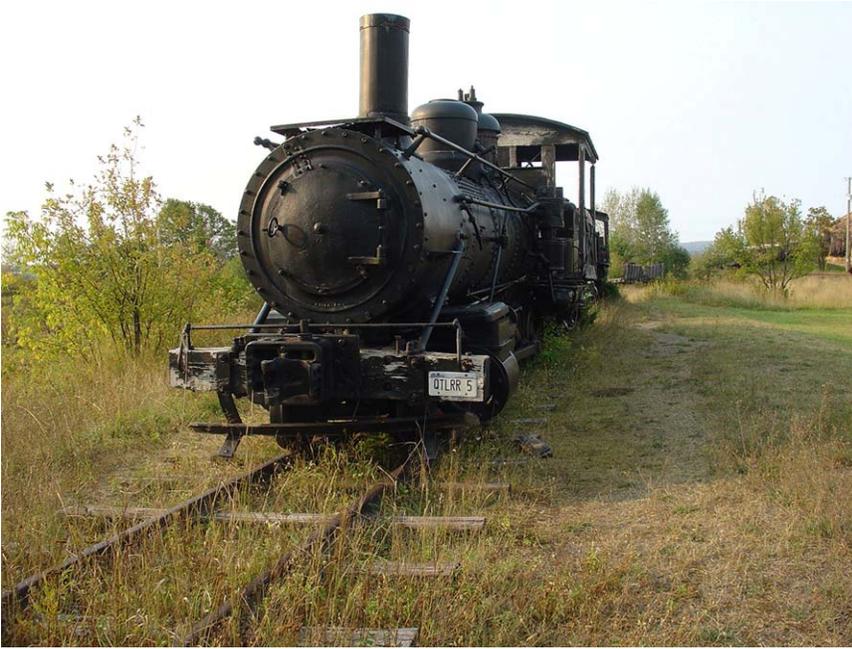
Figure 3- 21: Railroad track and rolling stock northeast of No. 2 hoist houses, 2006 (source: QEA)

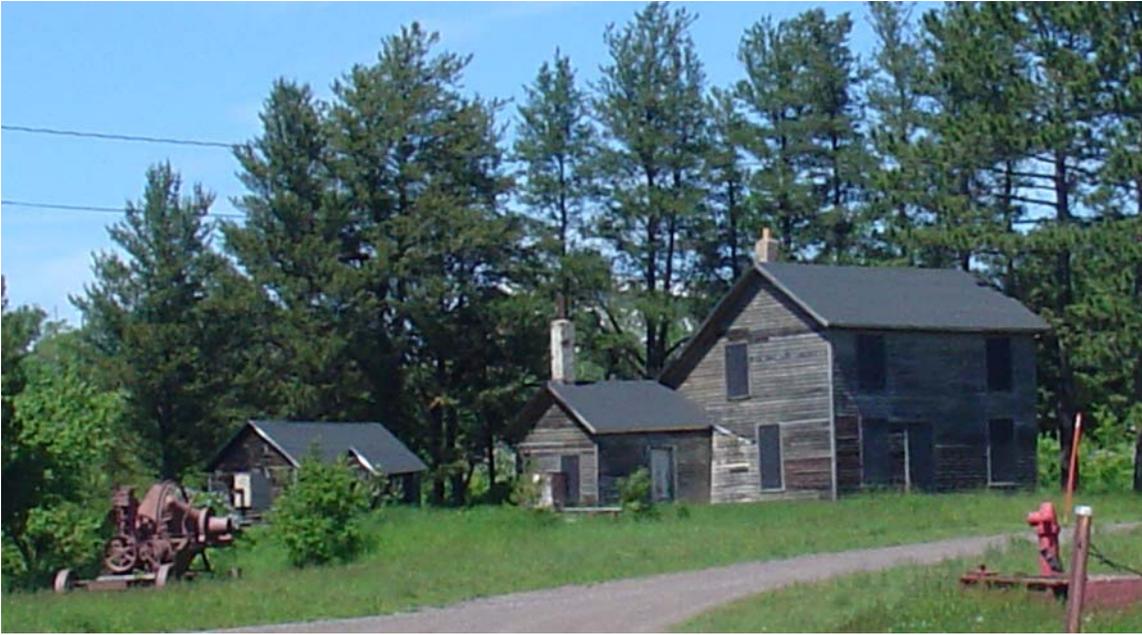
- **Martin House Site:** The property includes a house, privy and barn (see Figure 3-22). The Quincy Mine Hoist Association would like to use it for interpretation of a miner's domestic life. It has been stabilized by NPS workers but requires further structural repairs.

Figure 3- 22: View of Martin House Property facing northwest, 2008 (source: QEA)

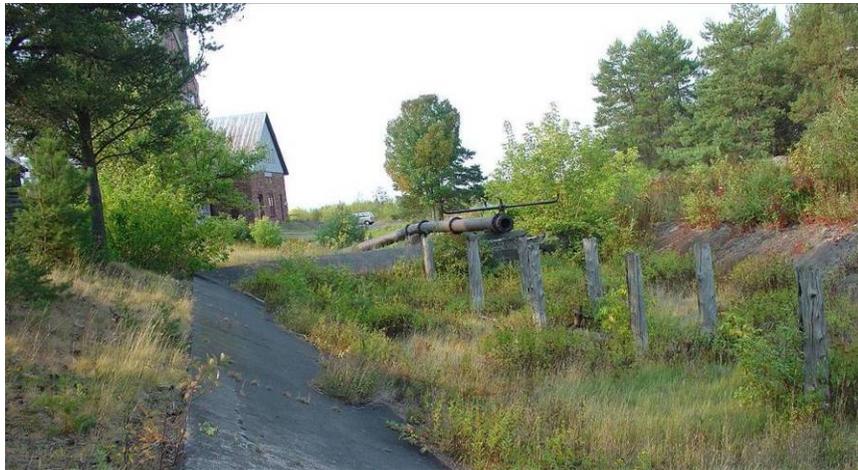
Figure 3- 23: View looking south of northernmost cooling pond, 2006 (source: QEA)

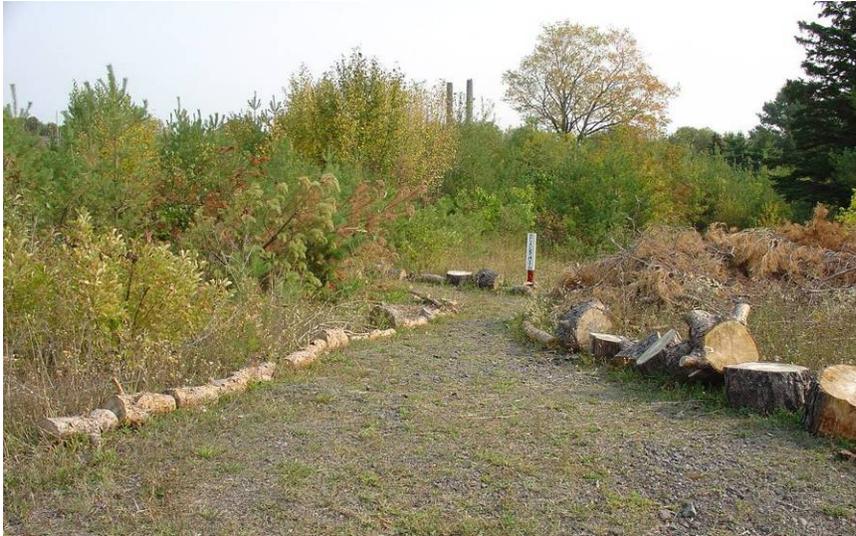
**Figure 3- 24: The area between the cooling ponds and the supply house includes a recently added informal trail and sign for blacksmith, 2006 (source: QEA)**

- **Area between the Cooling Ponds and the Supply Office:** This area contains dense second-growth vegetation and extensive remains of railroad tracks, building foundations and discarded materials, and utility trenches related to the Quincy Mine operations (see Figure 3-24). The ground is extremely uneven and foundations and piles of pipes and bricks are disguised by the vegetative growth. Views in this area are also obscured by vegetation.

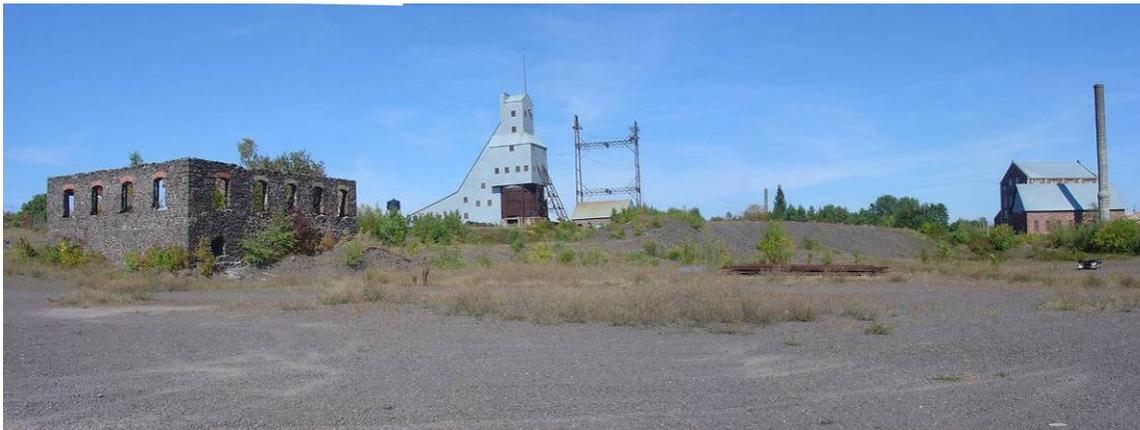
- **Area south of the No. 2 shaft-rockhouse with foundations and ruins:** This area contains remnants and foundations of several substantial mining buildings that are surrounded by a rocky landscape with uneven topography (see Figures 3-26 and 3-27). The area contains remnants of poor rock piles that have been mined recently to provide fill for road projects and gravel in the region. The removal of the rock has left an unusual landscape with rock piles and cut out areas. Vegetation includes herbaceous species among the rock and successional vegetation in clusters, especially inside and adjacent to the building foundations.

**Figure 3- 26: View looking north at the area south of No. 2 shaft-rockhouse with foundations and ruins, 2006 (source: QEA)**

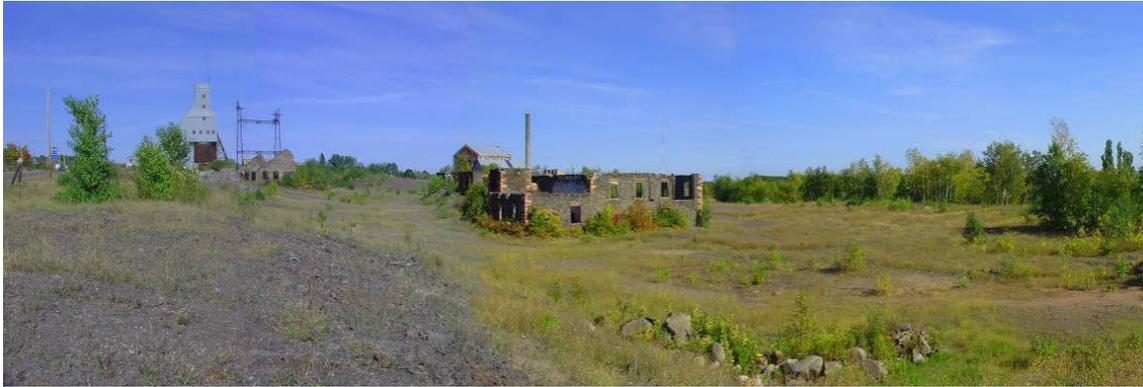
Figure 3- 27: View looking northeast at the area south of the No. 2 shaft-rockhouse, 2006 (source: QEA)

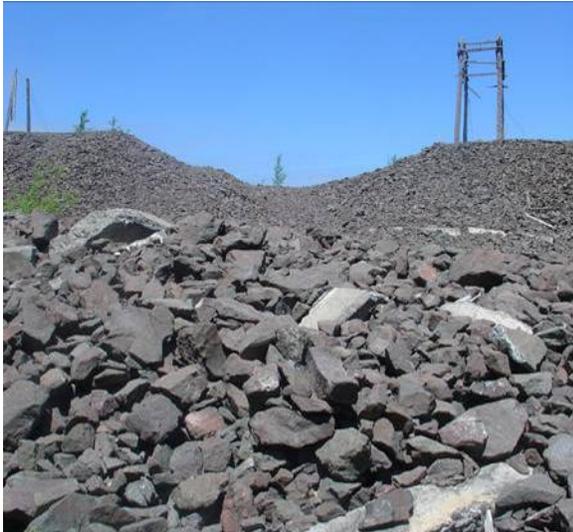
Figure 3- 30: Poor rock pile at No. 6 site, 2008 (source: QEA)

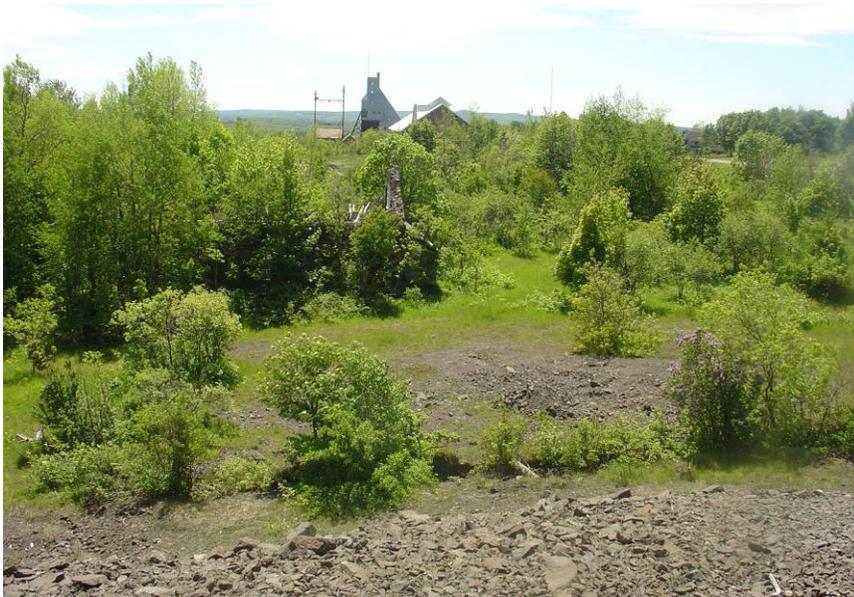
- **Rock Piles:** Throughout the region poor rock piles are being mined for road construction, and in some cases they have been disguised by vegetation (see Figure 3-29 through 3-32). Their loss as a visual landscape feature is changing the region’s identity to one that is not as easily associated with its historic mining activities.

Figure 3- 31: View of No. 6 site, Machine shop and No. 2 Shaftrock house from poor rock pile at No. 6 site, 2008 (source: QEA)

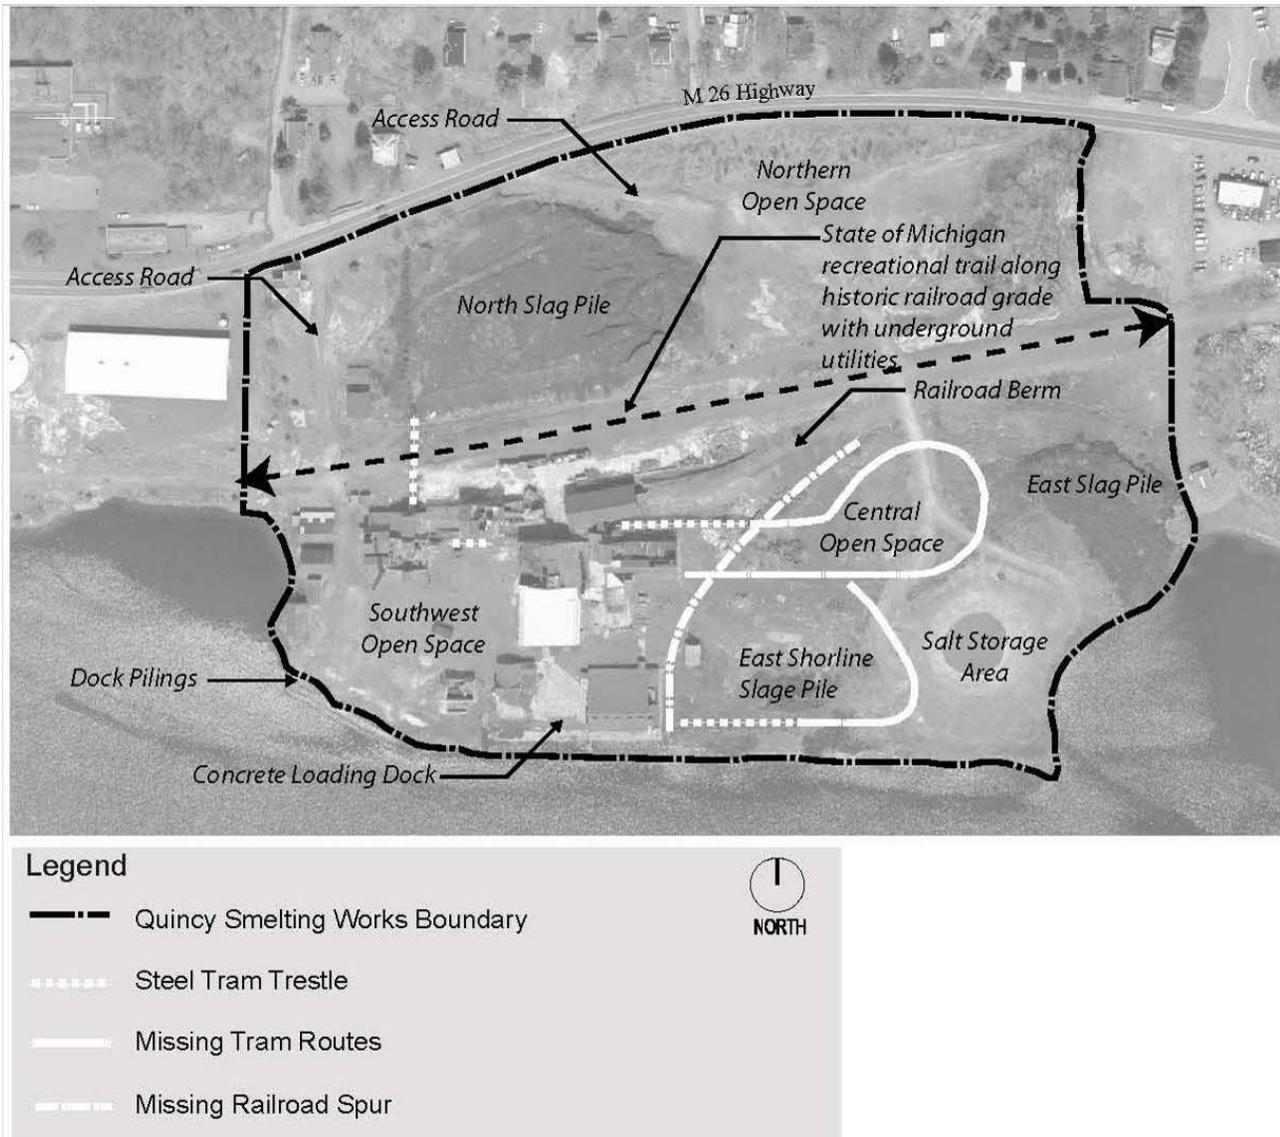
Figure 3- 32: Character Defining Landscape Features - Quincy Smelting Works

The Quincy Smelting Works is situated on the north side of Portage Lake, east of Hancock and south of Highway 26 (see figure 3-32 through 3-37). Its location positions it as a focal point along a very visible and dynamic waterfront environment. The site offers expansive views of the adjacent waterway and downtown Houghton. It also features more than thirty historic structures and several site features that represent the smelting process and once supported operations at the site. The conditions of these resources vary greatly but collectively represent how the complex functioned as part of the Quincy Mine Company. It is currently owned by Franklin Township and is an EPA superfund site.

Note: See HAER Drawings (1920 Site Plan) for building names and locations. Ground conditions that contribute to industrial site character are described in the report narrative.

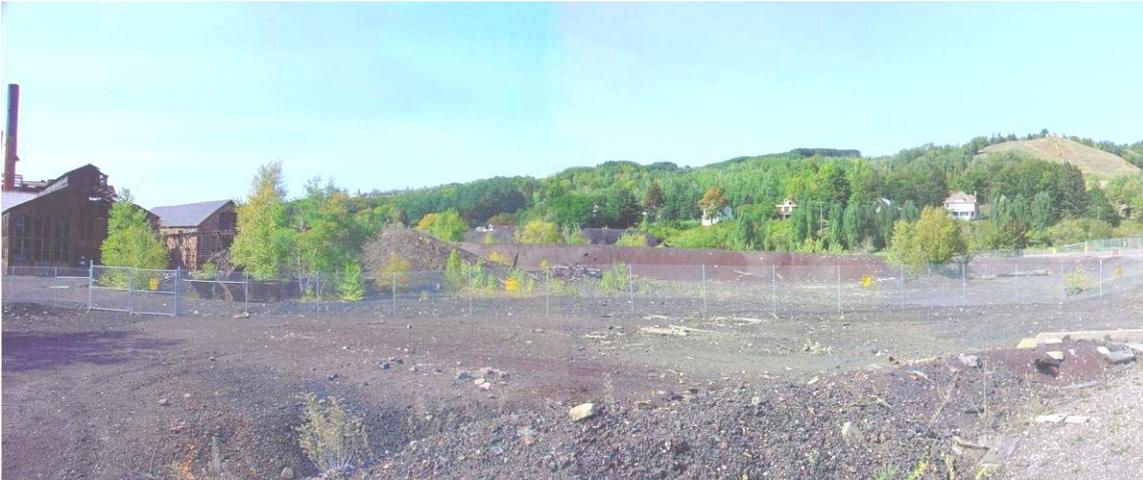
regarding hazards – features that remain from U.S. Environmental Protection Agency efforts to remove asbestos and other hazardous materials from the site. The fence remains around the core structural complex, even after a much more complete abatement of asbestos in the buildings was carried out by the EPA in 2008. The fence has reduced, but not eliminated, problems associated with trespassing, looting and vandalism. Similar asbestos abatement was also conducted by EPA at the barn and garage where temporary fencing was removed.

Figure 3-34: Looking northwest toward chain link fence encircling the Quincy smelter core, downhill ski operation in background (source: QEA)

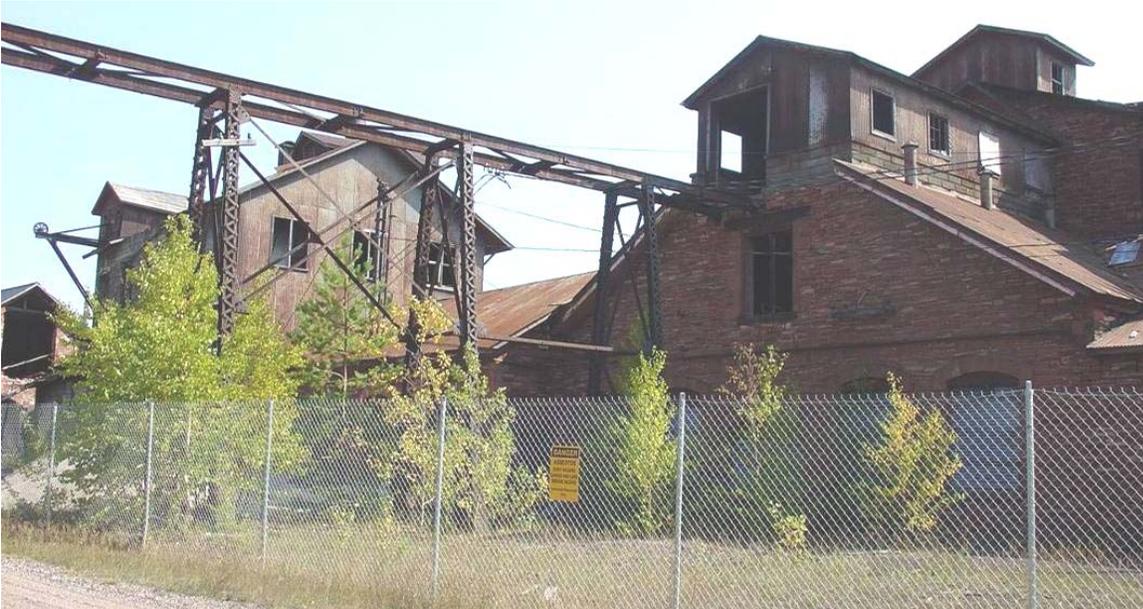
Figure 3- 37: North elevation of the cupola furnace building at the Quincy smelter (source: QEA)

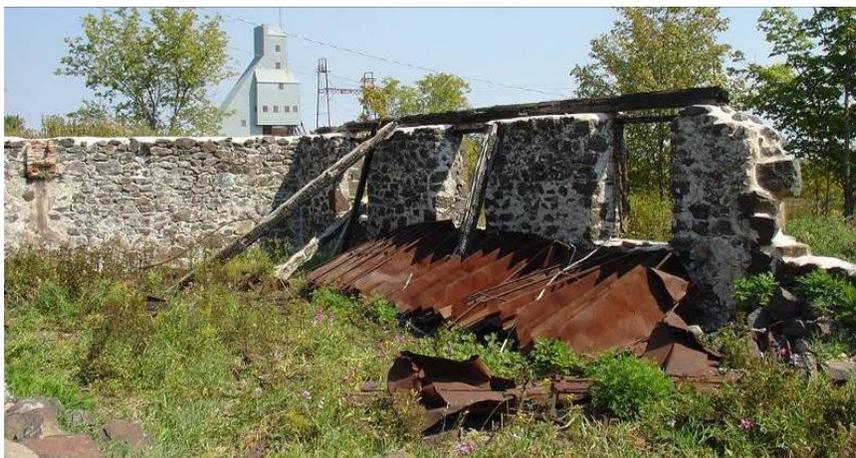
The Quincy dryhouse is located on the northwest side of U.S. 41, directly across the road from the Quincy Mine site (see Figures 3-39 through 3-44). This area is divided by the No.2 Road, which leads from U.S. 41 to Frenchtown Road. The area contains the foundation and partial walls of the dryhouse, as well as foundations of a mine captain’s office and several houses . The dryhouse and other foundations were stabilized in 2005. The repair mortar offers greater visual contrast against the basalt stone than unrepaired or unstabilized portions of the structure, however, time and weathering may reduce the contrast in materials. The mortar used for these repairs was carefully selected to ensure that it would not damage historic materials. In order to stabilize the dryhouse ruin, a mortar wash was applied as a cap. Globbs of mortar remain inside and outside the structure—left over from the stabilization effort. The area is also home to a few contemporary features. A radio tower and three small service buildings are located to the northwest of the dryhouse (see Figure 3-42). A large, green “Portage Health” sign is located near the intersection of U.S. 41 and Campus Drive (see Figure 3-44) at the former bathhouse site. The sign negatively impacts views of historic resources and their setting on Quincy Hill.

**Figure 3- 39: Northeast interior view of dryhouse foundation with No. 2 shaft-rockhouse in background, 2006 (source: QEA)**

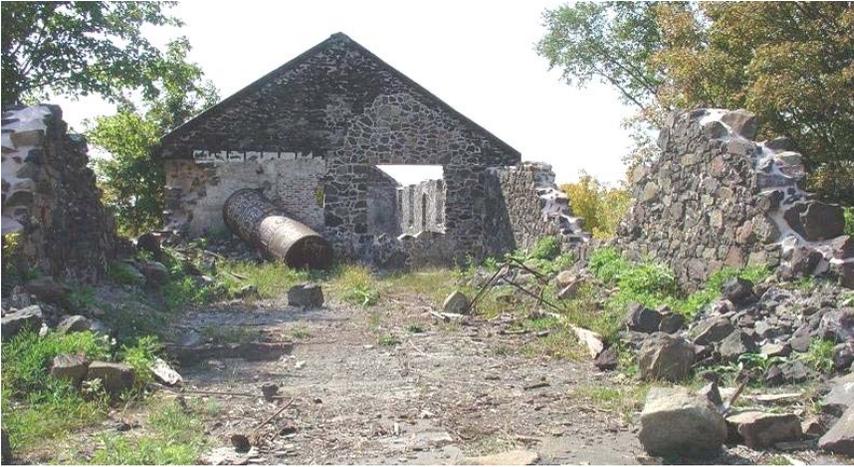
Figure 3-40: View looking south at interior of dryhouse foundation, 2006 (source: QEA)

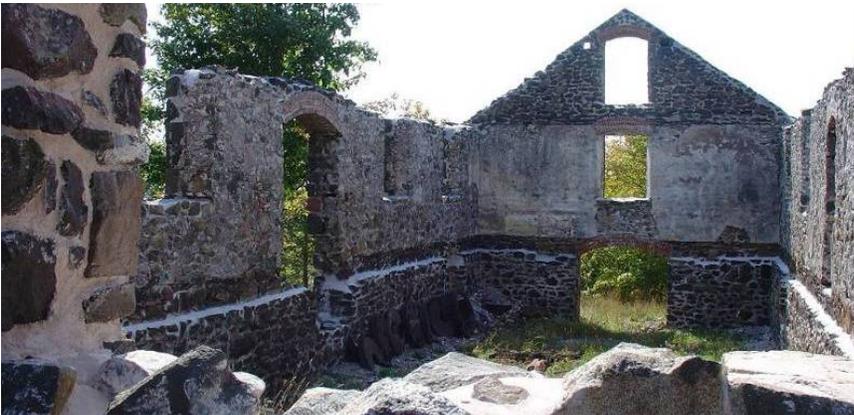
Figure 3-41: View facing south interior of dryhouse foundation after stabilization, 2006 (source: QEA)

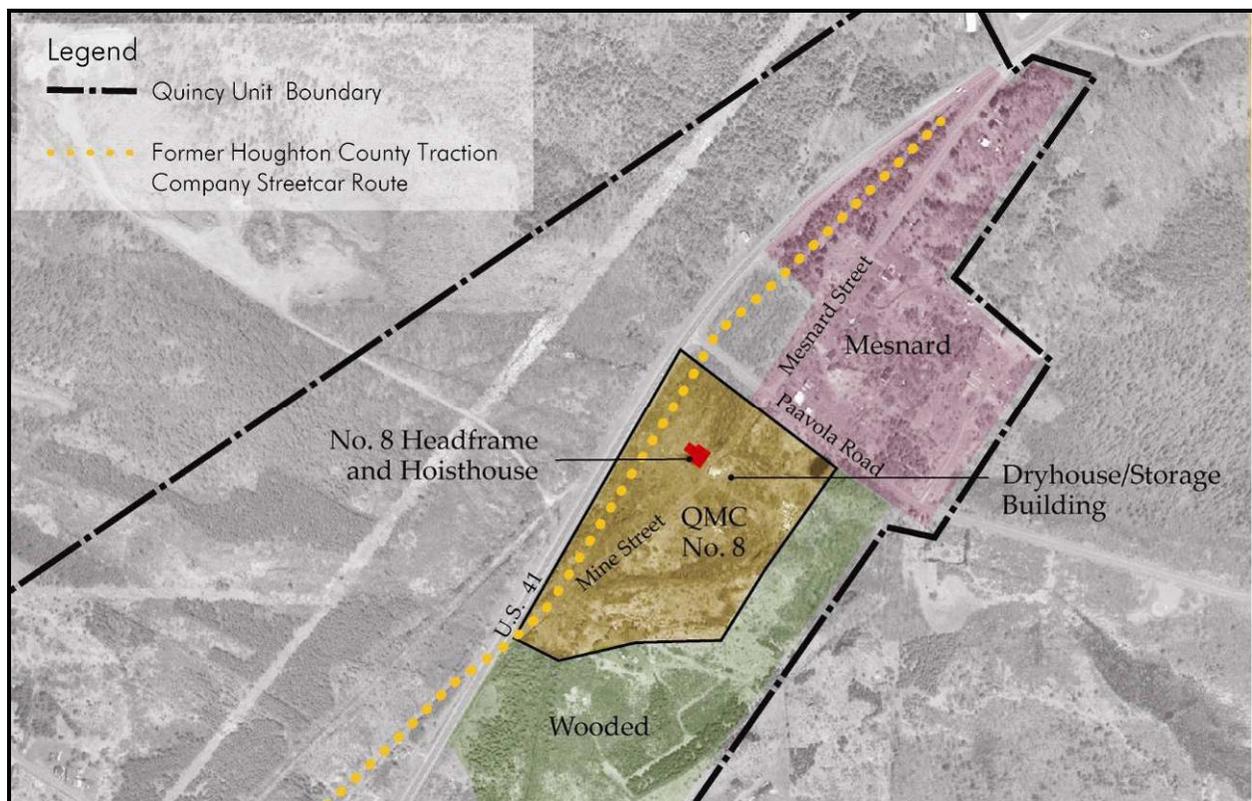
Figure 3- 45: No. 8 Landscape Character Area

The No. 8 landscape character area is located in the northern portion of the Quincy Unit at the end of Mine Street (see Figure 3-45). Positioned on the east side of U.S. 41, the area is separated from the road by dense successional vegetation. Mine Street is an asphalt road that is in poor condition. Historic resources located in this area include the No. 8 headframe and hoisthouse, as well as a large dryhouse/storage building (see Figures 3-46 through 3-47). Southwest of the headframe are extensive remnants of historic structures, including large drylaid poor rock walls with decaying wood beams and other remnants of the mining operations. A historic streetcar grade is visible in the area. Northeast of the headframe, remnants of the mining activities include a poor rock pile, disturbed ground and scattered refuse piles (including large pieces of concrete and steel). The poor rock pile has evidence of recent extensive digging. There are overhead electric lines and power poles on the east side of Mine Street and a utility substation with three large transformers enclosed in a chainlink fence on the north side of the storage building.

This area was re-used and altered by Homestake during their 1976 mining operation and therefore provides a more recent view of copper mining on the Keweenaw than the No. 2 area. Vegetation growing here is mostly deciduous volunteer species, with some fruit trees.

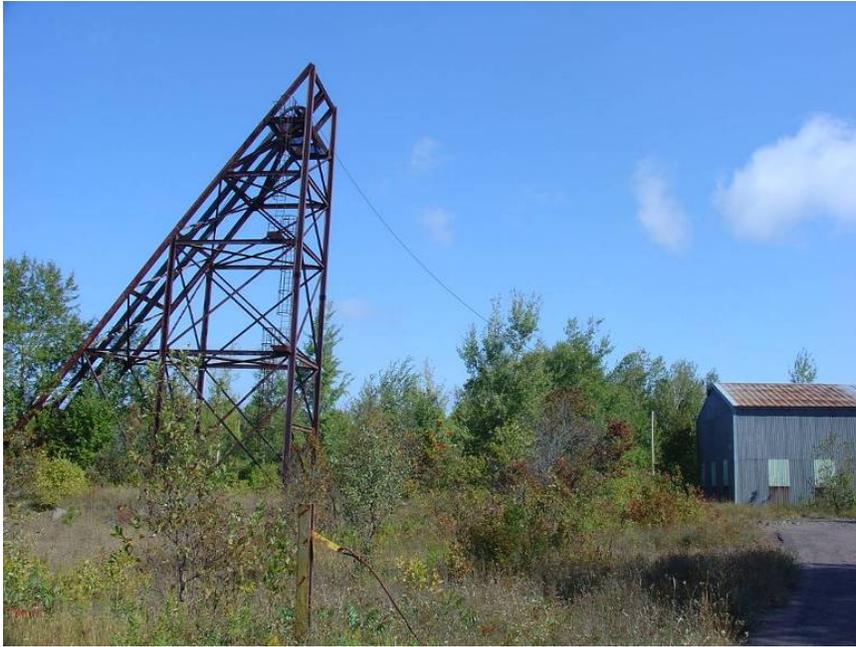
Figure 3- 46: No. 8 headframe and hoist house at No. 8 (source: QEA)

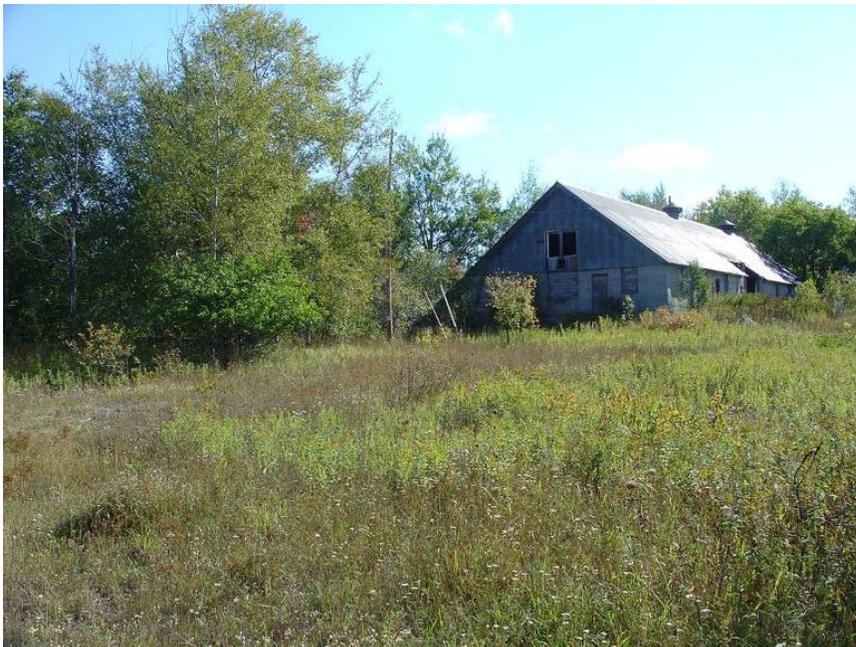
Figure 3- 47: Dryhouse/Storage building at No. 8, 2006 (source: QEA)

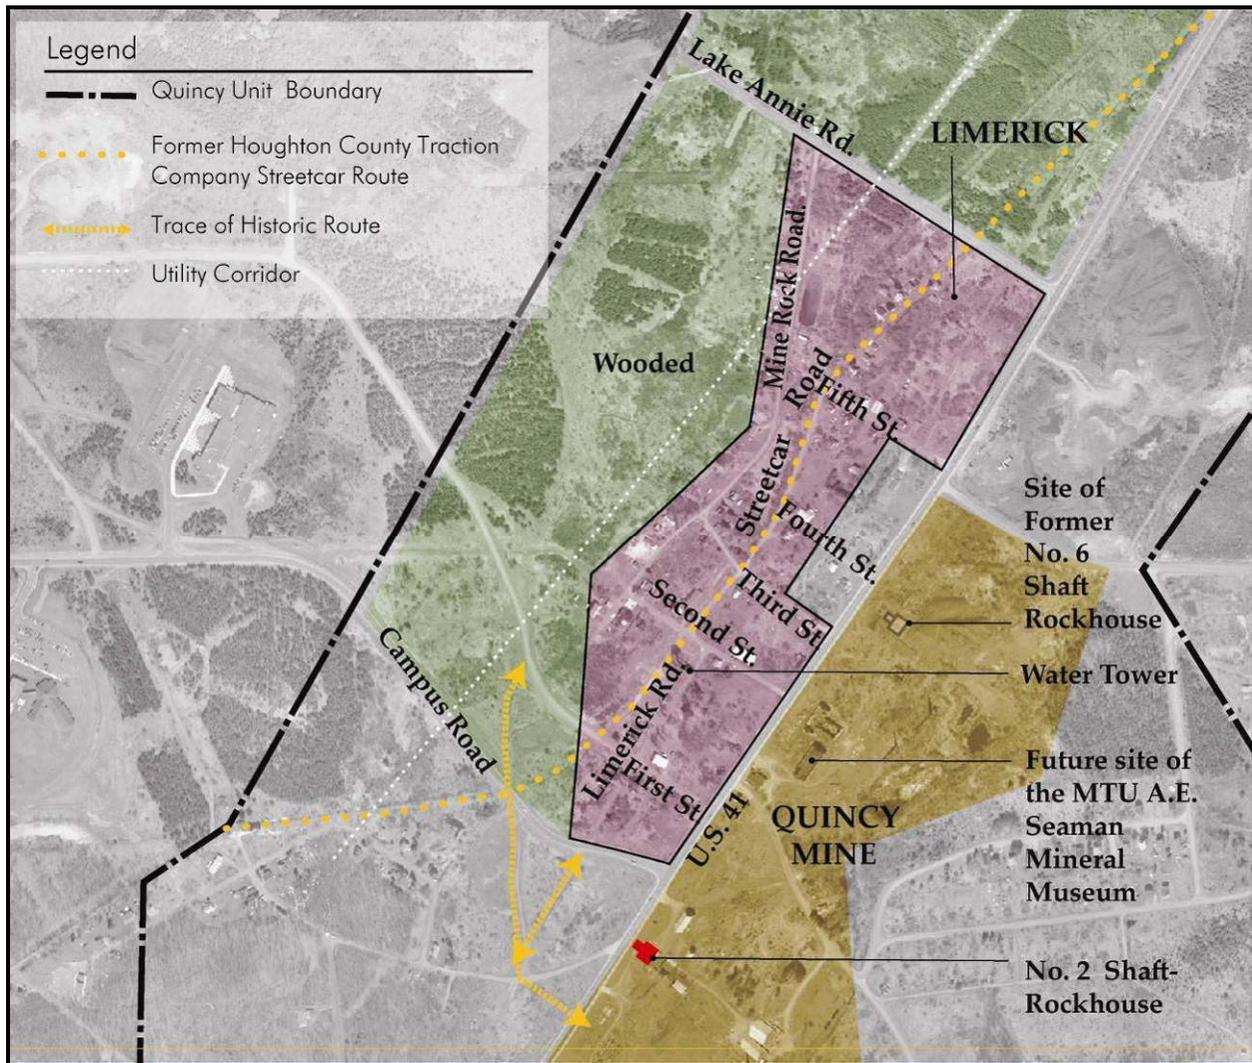
Figure 3-49: Limerick Landscape Character Area

The Limerick location is a rugged residential locality of mixed character connected by a grid of streets (see Figure 3-49). Some properties within the location convey a strong sense of history through their integrity and setting (as seen in Figure 3-50) while others introduce layers of varied land uses, building additions and landscape alterations unrelated to their historic character.

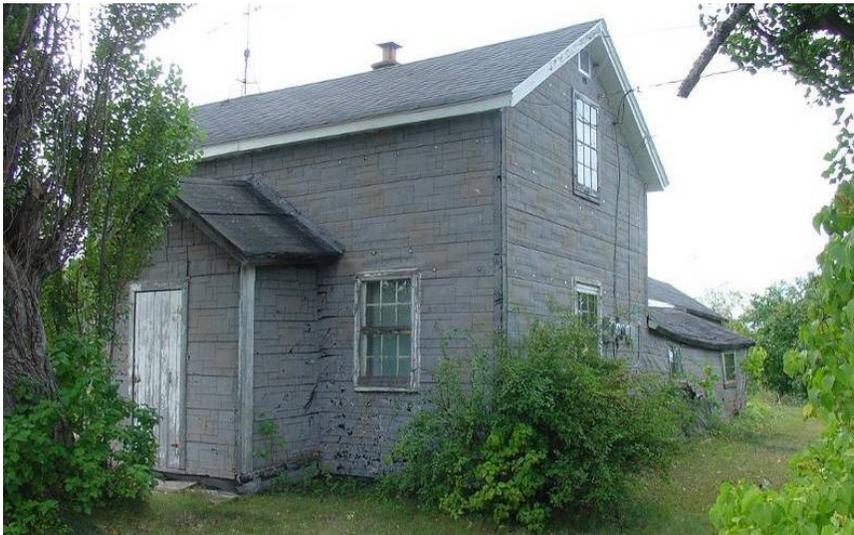
Figure 3- 50: Company house at 157 Limerick Road (Emergency Address, 49841), 2006 (source: QEA)

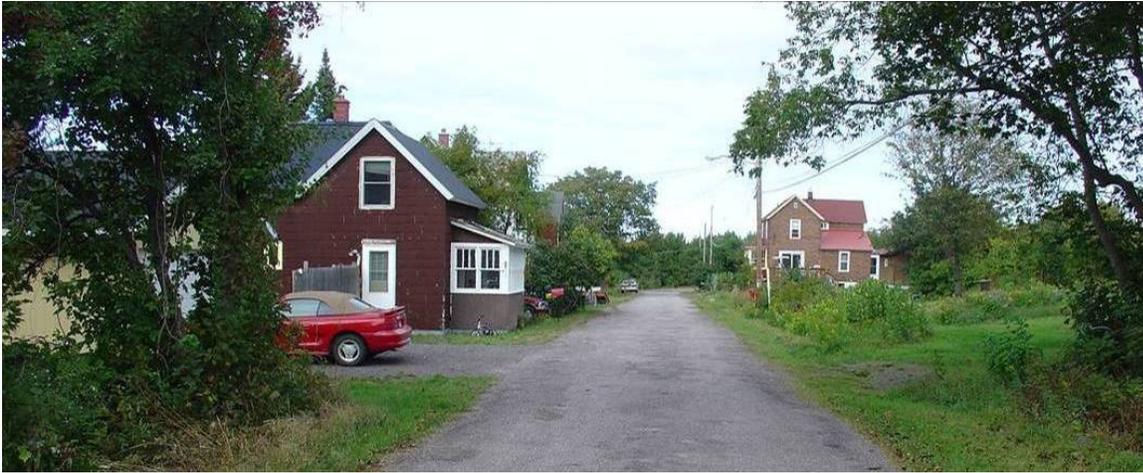
At *Streetcar Road* the majority of the residences are historic, occupied, and in good condition (see Figure 3-51). This is a small, dense, rural residential street with play areas, outbuildings (mostly non-historic) vegetable gardens, flower beds, lawn ornaments, and successional woodland vegetation surrounding mown lawns.

Figure 3- 51: North portion of Streetcar Road, facing North, 2006 (source: QEA)

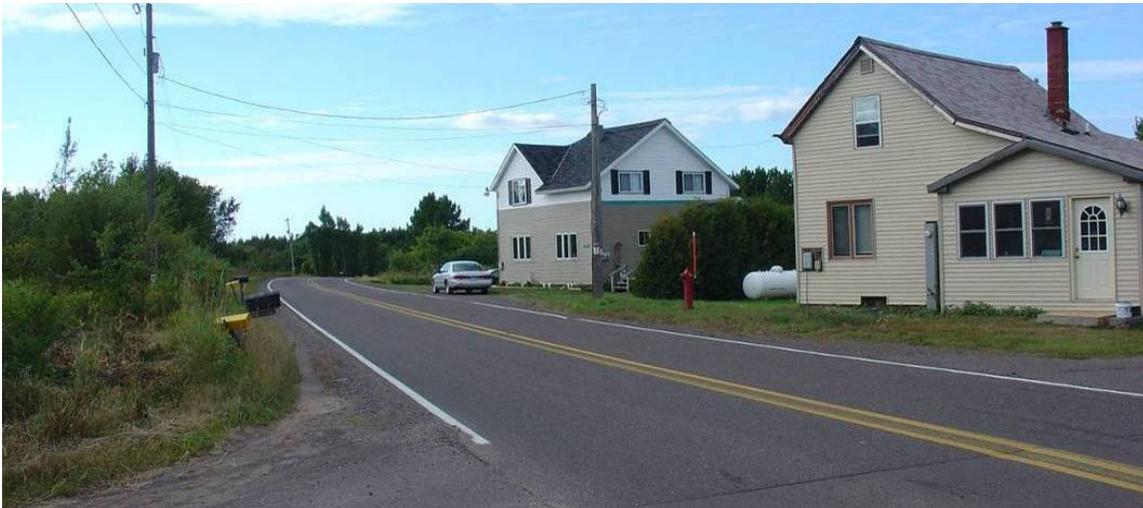
Figure 3- 52: View of houses north of Lake Annie Road from the Mine Rock Road intersection, 2006 (source: QEA)

*Lake Annie Road* is bordered on the north and south by dense wooded areas displaying a rural character (see Figure 3-52). There are two historic houses at the intersection of Lake Annie and Mine Rock roads that are clad in aluminum siding. Both are two story structures with gable roofs and extensive additions.
