## Chapter III: Existing Conditions / Affected Environment

The project area for this Cultural Landscape Report is defined by the boundary of the Quincy Unit of Keweenaw National Historical Park as described in Chapter I. The Torch Lake area is not included within the boundary of the Quincy Unit. Chapter II: Landscape History, addresses the Torch Lake area to help readers understand the comprehensive landscape development related to the corporate history of the Quincy Mining Company. Because the Torch Lake area is not within the project area, it is not covered by the Existing Conditions, Landscape Analysis, or Recommended Treatment sections of this Cultural Landscape Report.

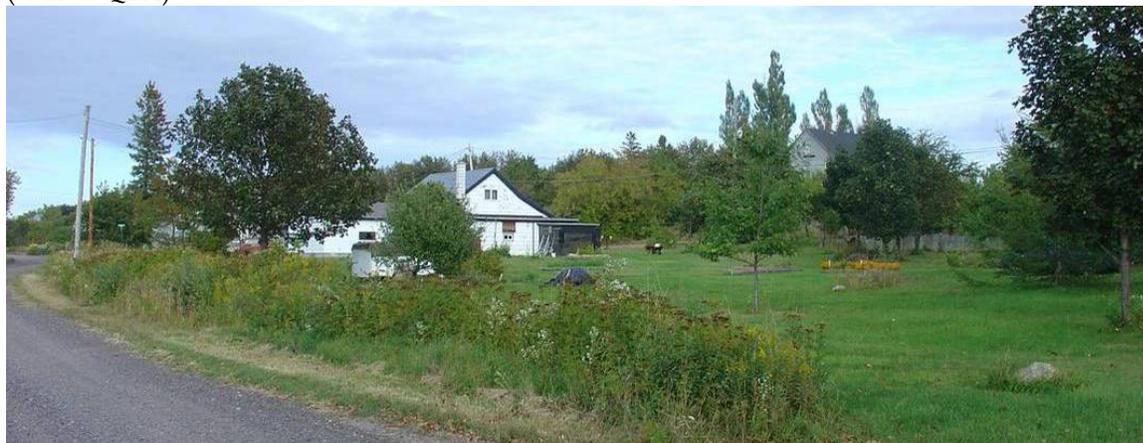
*Mine Rock Road* extends southwest from Lake Annie Road (see Figure 3-53). The eastern portion of the road is bordered on both sides by dense vegetation including mature apples trees, white pine, poplar, and buckthorn. The vegetation opens to reveal a small cluster of houses surrounded by open areas of tall herbaceous species and scattered woody plants. A cluster of homes at the southern end of the road includes ornamental side and backyards with camp sites, play areas and gardens.

Figure 3- 53: South end of Mine Rock Road neighborhood, 2006 (source: QEA)

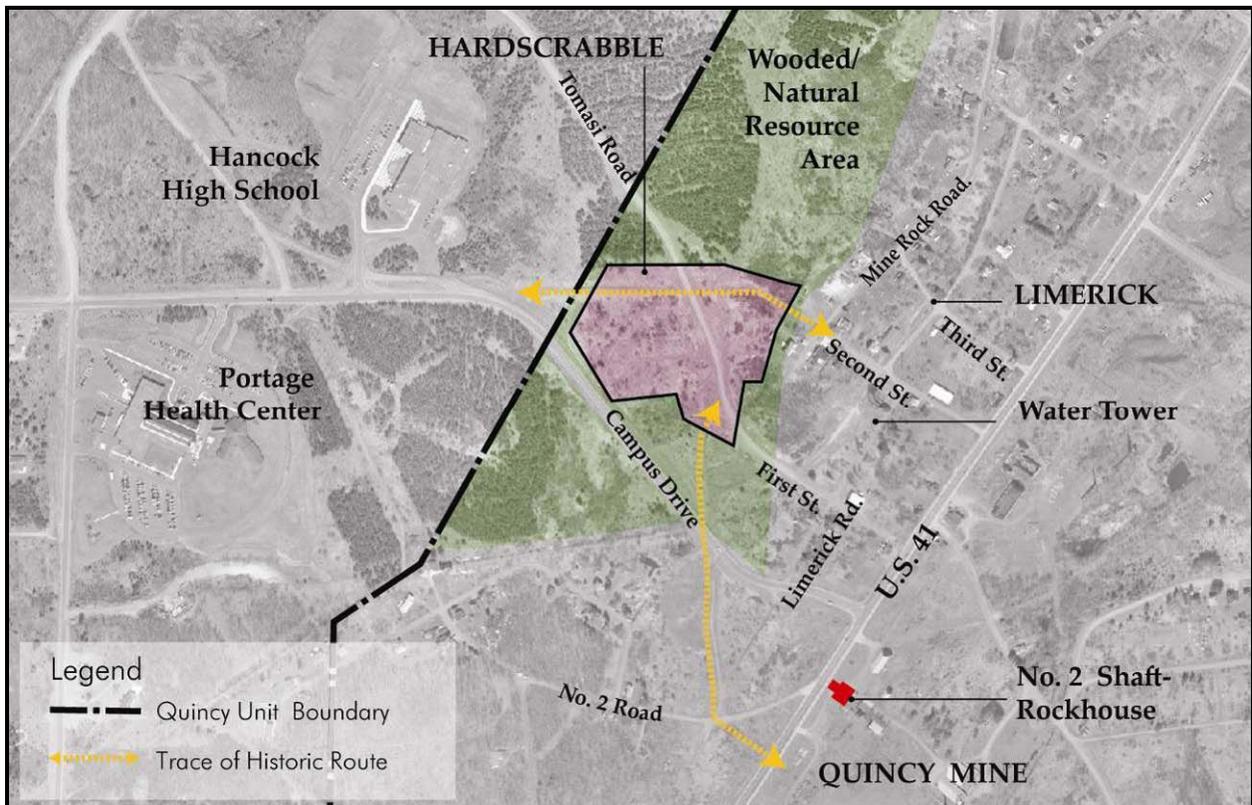
Figure 3- 54: Hardscrabble Landscape Character Area

The Hardscrabble housing location is situated immediately north of Campus Drive and west of Limerick (see Figure 3-54). Today this area is void of buildings. The landscape has been disturbed by excavations and regrading. Herbaceous vegetation and successional woody plants obscure former circulation routes and remnants of company housing (see Figure 3-55). A few Lombardy poplar, lilacs, perennials and apple trees may be indicative of the previous domestic activities in this area as they help to delineate residential and circulation patterns. The building foundations of Hardscrabble are only visible within thick pockets of vegetation.

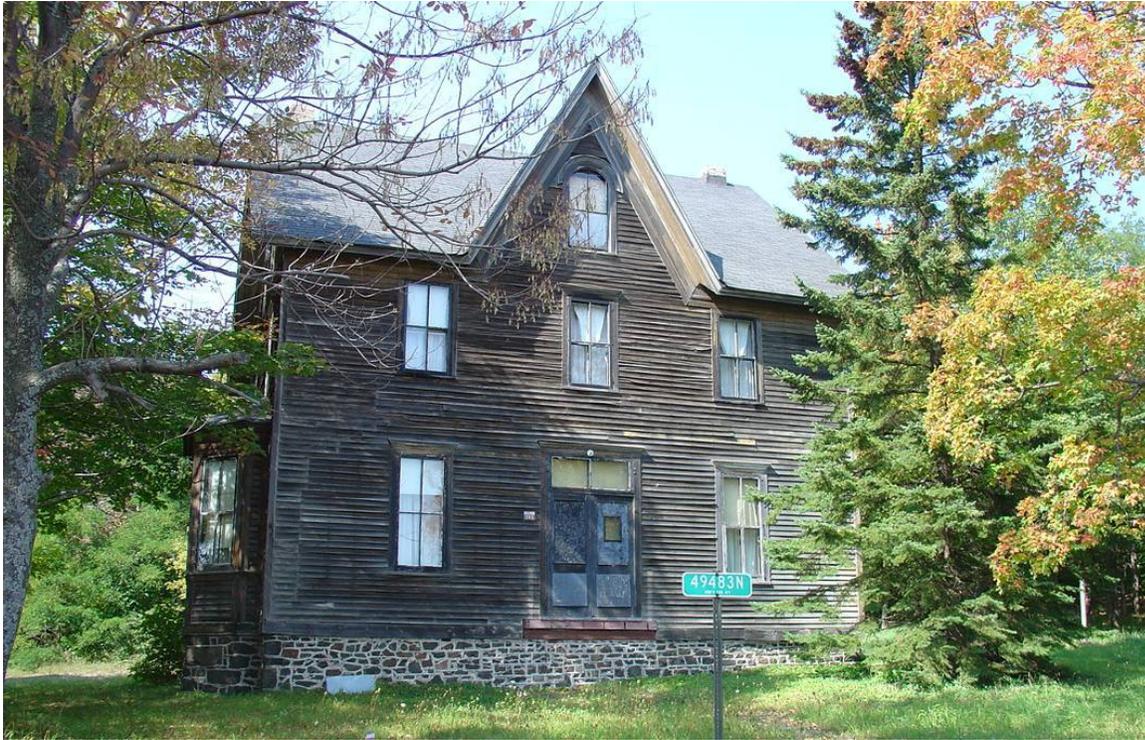
**Figure 3- 71: Mine Captain's home in Frenchtown, south corner U.S. 41 and Frenchtown Road, 2006**  
(source: QEA)

Frenchtown is a small, thickly wooded housing location on Frenchtown Road. The area is located northwest of the intersection of Frenchtown Road and U.S. 41 and northeast of the Superintendent's residence (see Figures 3-70 and 3-71). Frenchtown Road is a two lane asphalt road that connects Sing Sing and Raasio Road to Quincy's mine surface works. Three historic residences, larger than most worker housing built by Quincy, are located on the north side of the road and share similar lot size, orientation and front yard setback. Across the street are small outbuildings used as garages and storage sheds. The homes are surrounded by woodland vegetation including several mature maples, ash, poplar, arborvitae, viburnum and an occasional spruce. Traveling Frenchtown Road toward the mine presents a dramatic view of the Huron Mountains beyond Keweenaw Bay on the horizon. The historic road trace of County Road is evident between U.S. 41 and Frenchtown. South of the intersection of Frenchtown road and U.S. 41 is a vacant mine captain's home that remains with few alterations and displays high integrity, including the mature shade trees presumed to be from the period of occupation (see Figure 3-71).

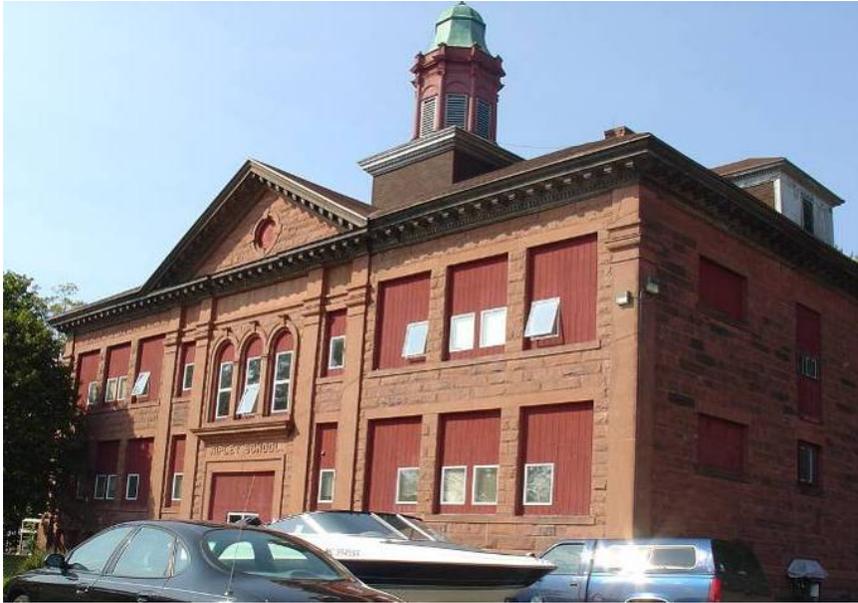
**Figure 3- 73: Looking northwest toward former historic Ripley school, converted to apartments, 2006** (source: QEA)

The historic Ripley school is located at the east unit boundary, west of existing housing. The school has been converted into apartments and reinforces the historic character of the adjacent neighborhood, and provides a strong architectural centerpiece for neighbors.

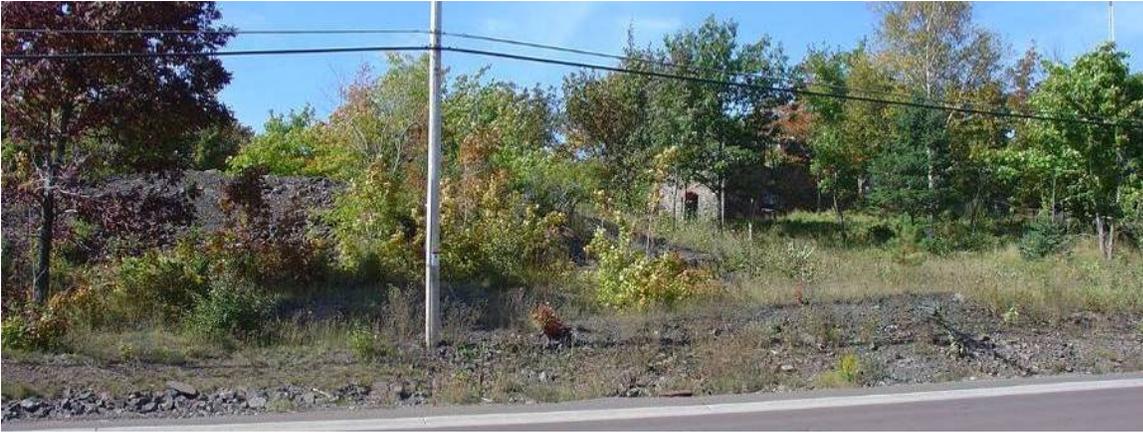
Figure 3- 85: Poor rock-pile west of U.S. 41, south of the Quincy dry house ruins (source: QEA)
