Chapter IV: Landscape Analysis

The project area for this Cultural Landscape Report is defined by the boundary of the Quincy Unit of Keweenaw National Historical Park as described in Chapter I. The Torch Lake area is not included within the boundary of the Quincy Unit. Chapter II: Landscape History, addresses the Torch Lake area to help readers understand the comprehensive landscape development related to the corporate history of the Quincy Mining Company. Because the Torch Lake area is not within the project area, it is not covered by the Existing Conditions, Landscape Analysis, or Recommended Treatment sections of this Cultural Landscape Report.

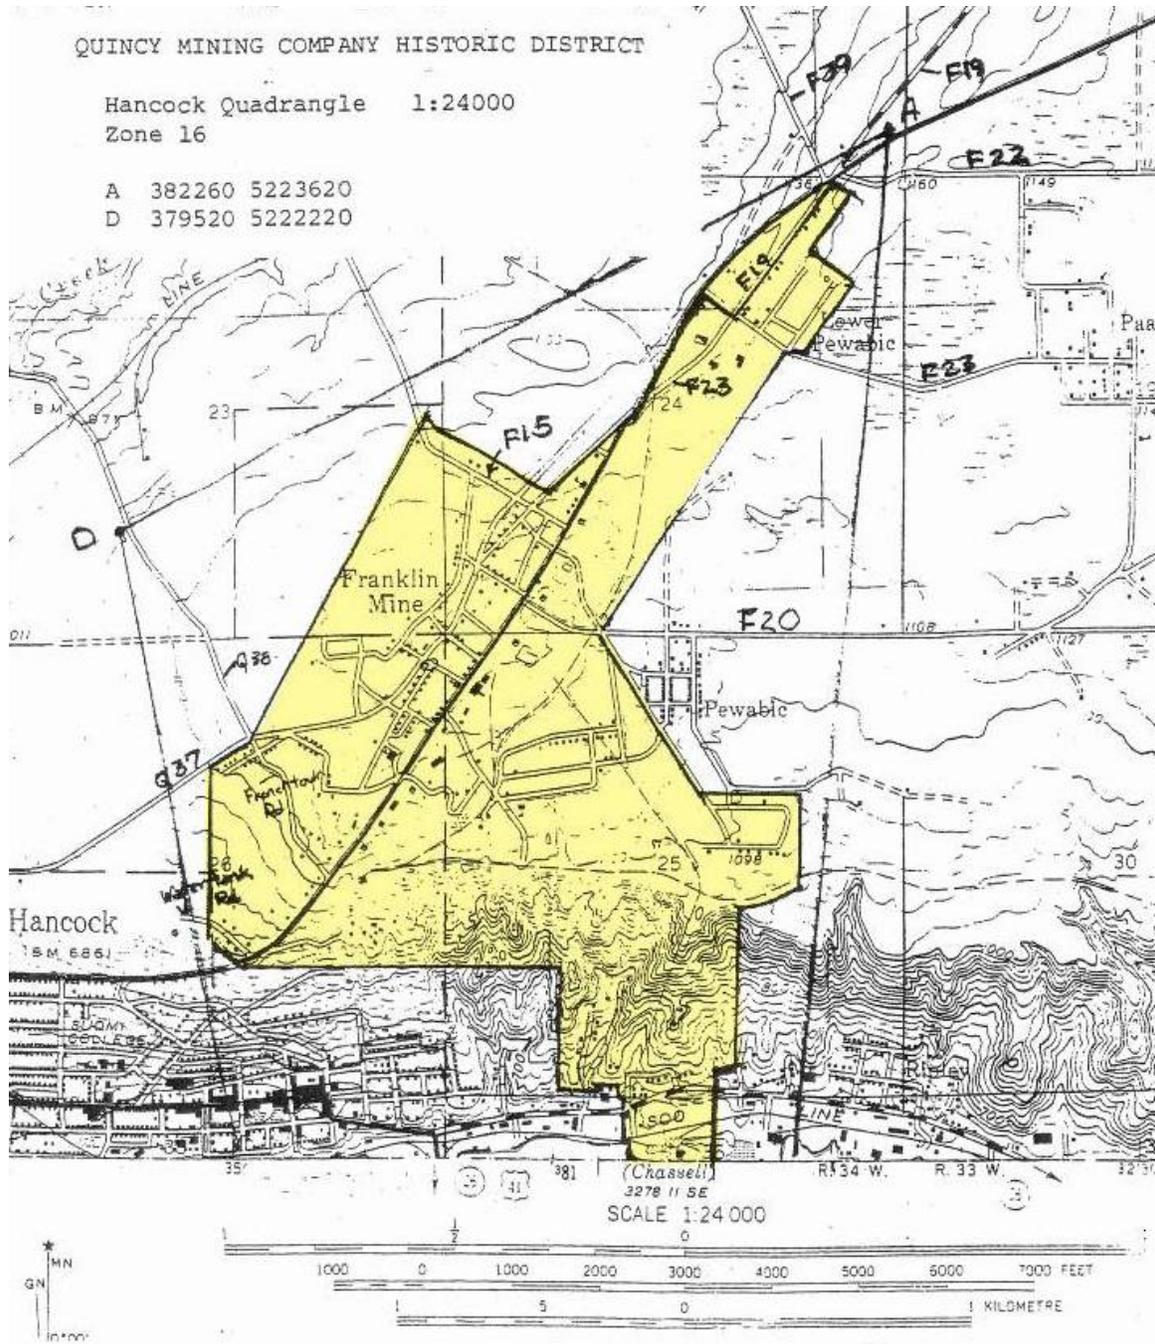
Figure 4-1: Quincy Mining Company Historic District, NHL boundary (district highlighted in yellow by QEA)

The district boundary includes extant resources directly connected with the Quincy mining operations including locations of mine shafts and buildings. In addition, it includes part of Quincy Hill, which connects the mining area with the Quincy Smelting Works and the administrative and residential structures that represent the support services necessary for the mining operations. The nomination includes both a detailed written description of the boundary and a map illustrating its location (see Figure 4-1). When Keweenaw National Historical Park was established in 1992, the boundaries of the Quincy Unit of the park were defined to closely reflect the National Historic Landmark District boundary. However, the park boundaries have not yet been finalized.

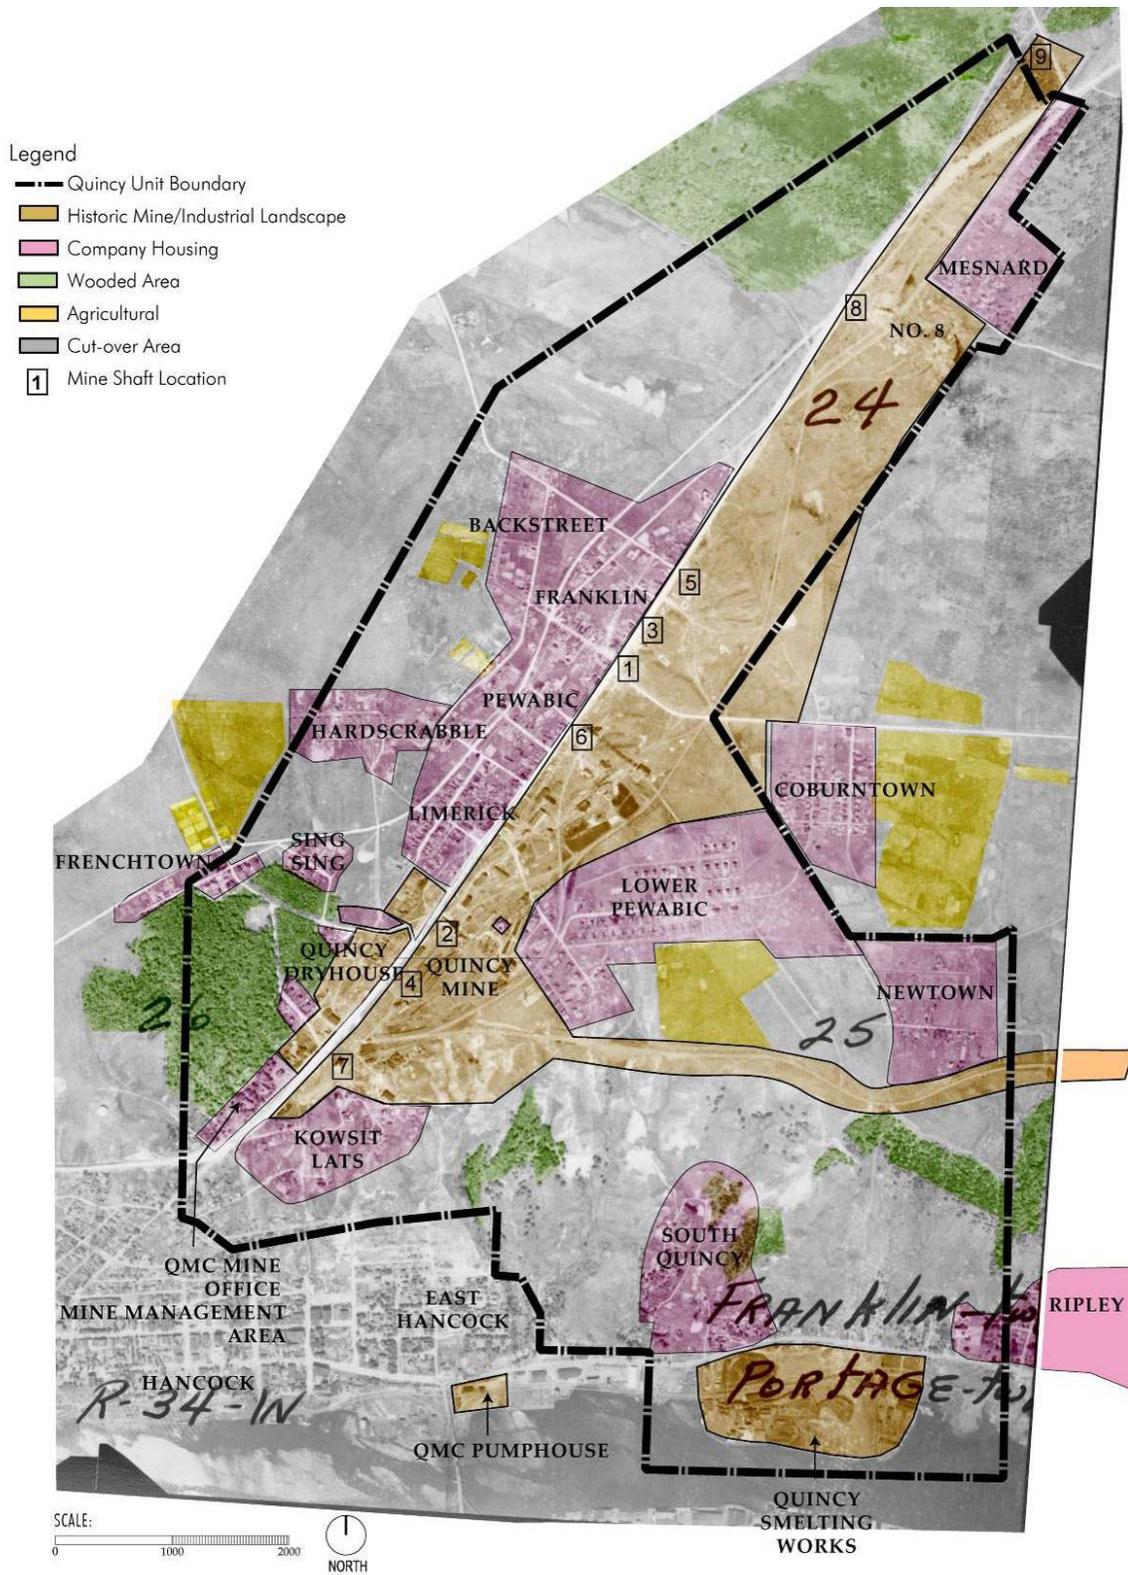
Figure 4-2: Quincy Unit Land Use, Peak Mining Period 1900-1910

During the peak mining period between 1900-1910 for the Quincy Mining Company (QMC), the majority of the Quincy Unit landscape was comprised of two distinct land uses, industrial/mine related and company housing. The industrial/mine land-use areas consisted of numerous shaft-rockhouses, hoist houses, other mine related buildings, a multitude of railroad tracks and trestles, cooling ponds, the Quincy Smelting Works, and expansive poor rock piles. The company housing consisted of several QMC housing locations on Quincy Hill and South Quincy and Ripley near the Quincy Smelting Works. Many of these housing locations were developed with uniform housing and fenced yards. Other housing locations contained less regimented layouts with varying architectural styles, lot sizes and setbacks. From 1900 to 1920 industrial/mine related and company housing land uses dominated the unit and agricultural land use was also present (see Figure 4-2).⁵

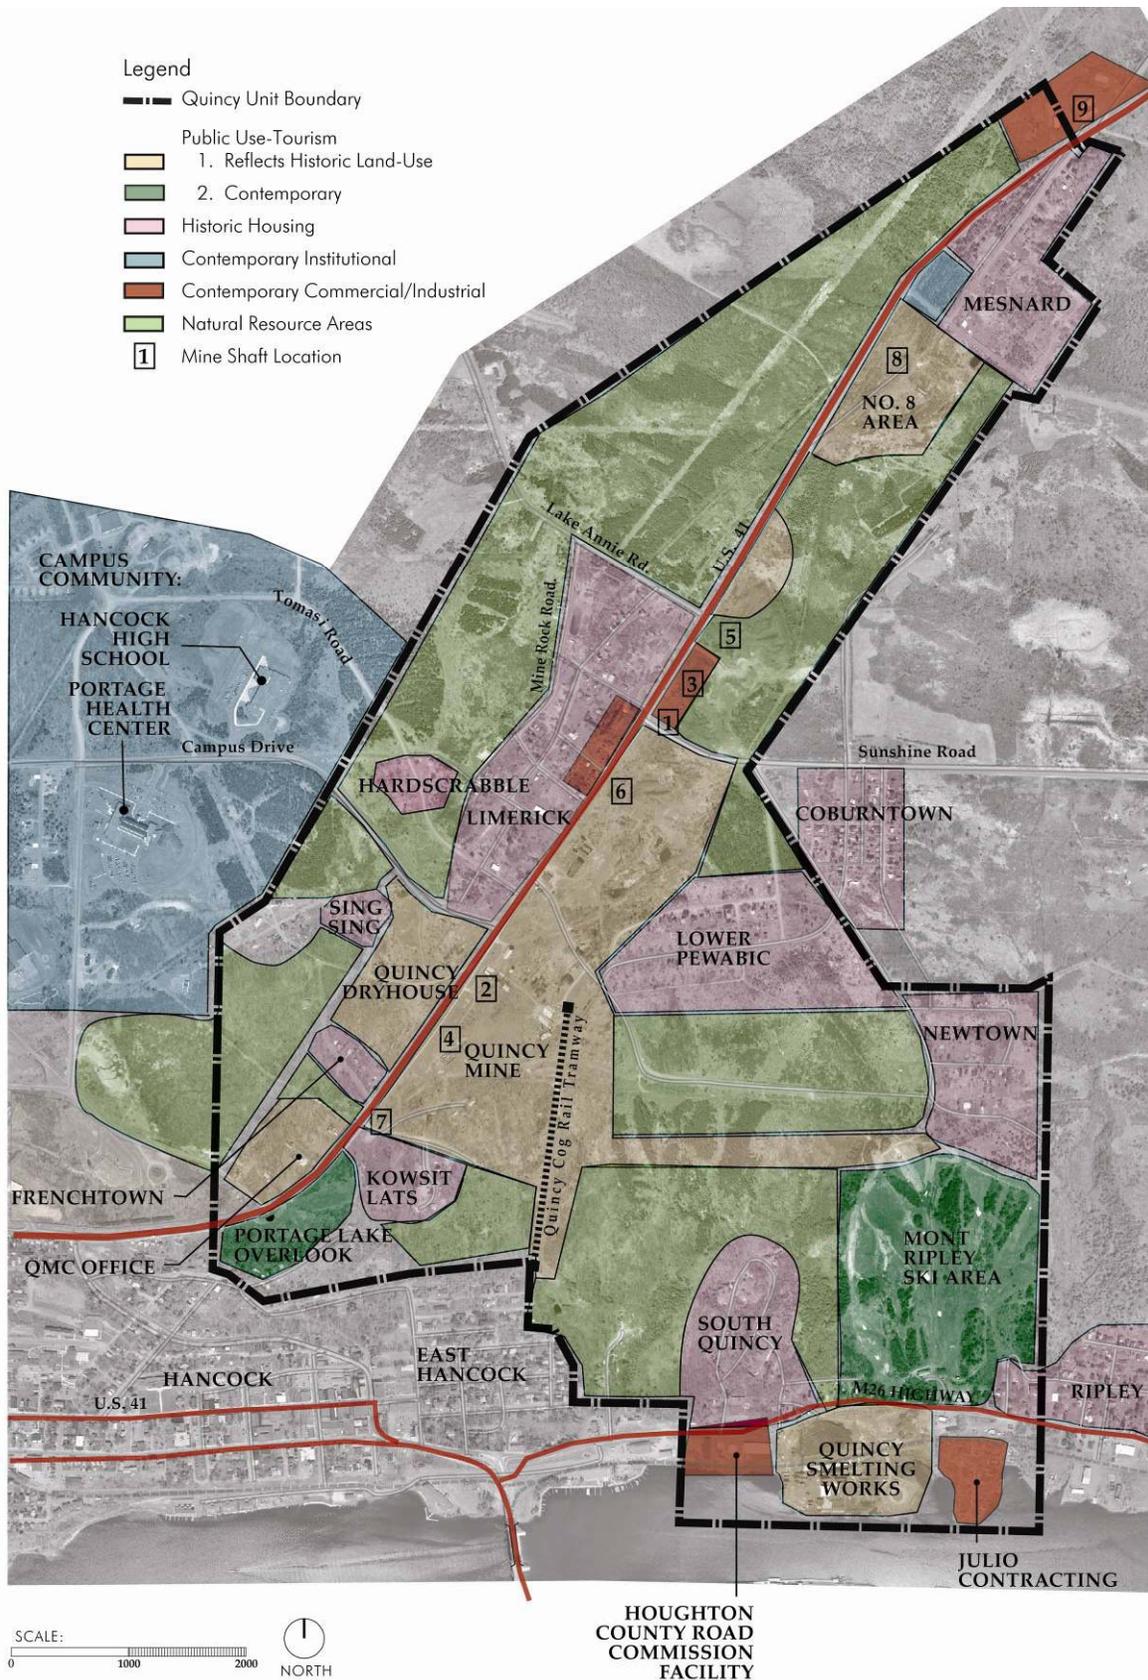
Figure 4- 3: Quincy Unit, Existing Land Use

With the decline of the copper industry beginning in the late 1920s, the Quincy Mining Company progressively scaled back mining operations and eventually closed in 1945. Today, the landscapes within the Quincy Unit are used for residential, commercial, industrial, institutional and recreational purposes (see Figure 4-3).

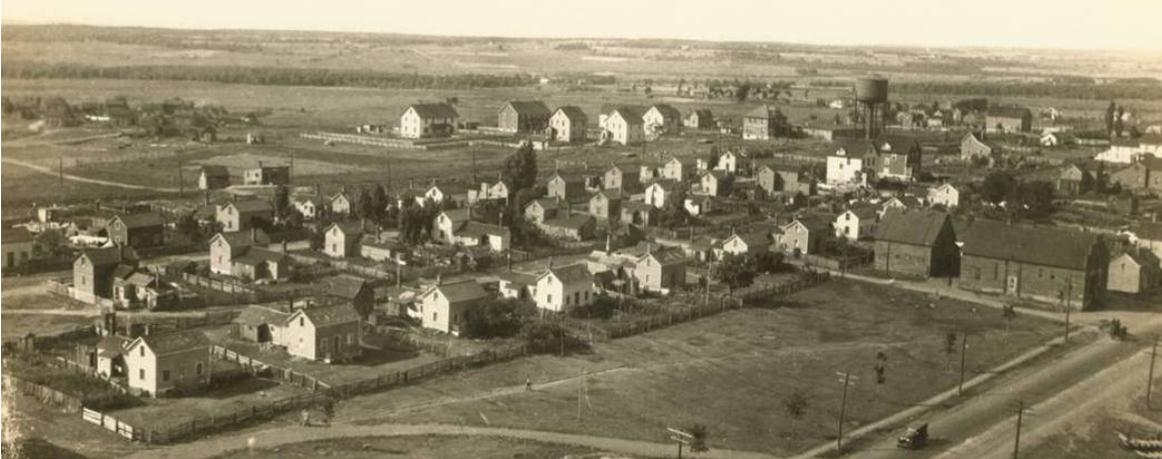
Figure 4- 5: Historic view north toward Limerick, from No. 2 shaft-rockhouse, ca. 1920s; the Backstreet neighborhood is in the background to the left of the water tower. Possible agricultural land use can be seen on the upper left portion of the photograph (source: KEWE Archives, photo 1-6)

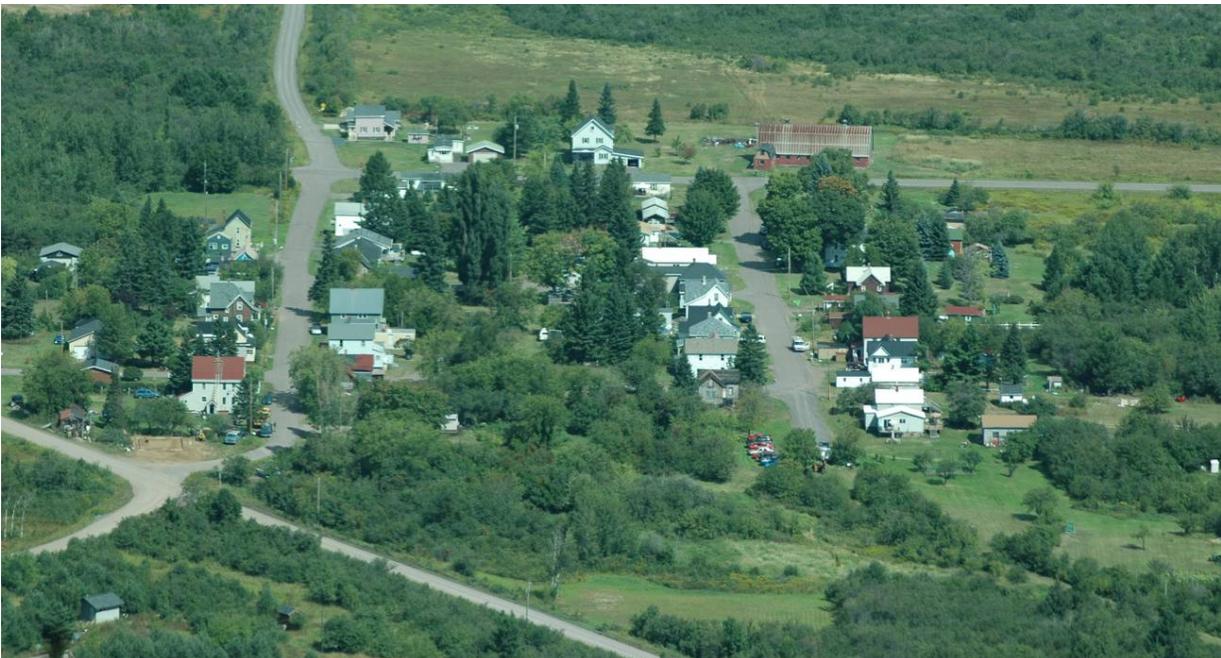
Figure 4- 6: Contemporary oblique view of Coburntown (source: Rob Wood, Wood Ronsaville Harlin, Inc., August 2005)

Residential land use maintains a presence in the unit. Remnant company housing locations display a variety of conditions. These include the locations on Quincy Hill: Lower Pewabic, Sing Sing, Coburntown, Ripley, and the historic housing locations of Limerick, Pewabic, Franklin, and Backstreet, herein described as a singular residential area. Some former company housing locations or portions of them have been abandoned and are in varying stages of succession to woodland. These include Frenchtown, Mesnard, a portion of Lower Pewabic (section constructed prior to 1864), and Hardscrabble. The historic land use of these former housing locations is represented by landscape remnants that include building foundations, domestic vegetation, and remnant road traces (see Figures 4-5 through 4-8). Raasio Road, a small enclave of contemporary housing, has supplanted a section of the historic Frenchtown neighborhood. Historic vernacular housing locations are also present. These include Kowsit Lats and the residences on Frenchtown Road. Shantytown, another hillside neighborhood, was absorbed into the city of Hancock by the early 1900s.

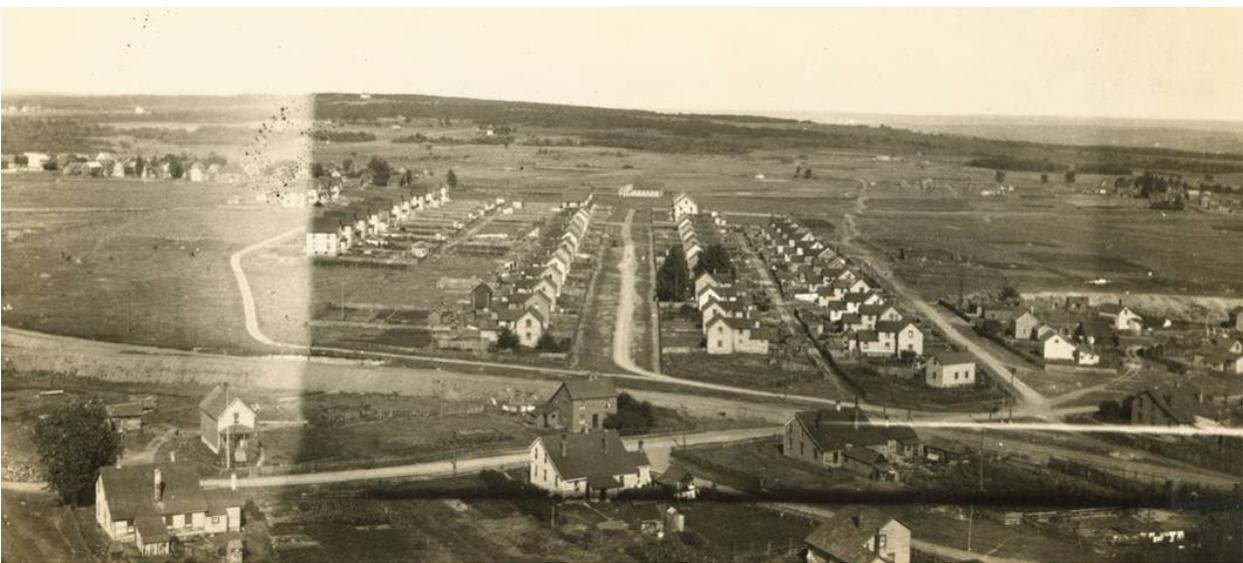
Figure 4- 7: Historic view of Lower Pewabic from the No.2 shaft-rockhouse, facing east/northeast, ca.1910-1930 (source: Keweenaw National Historical Park archives)

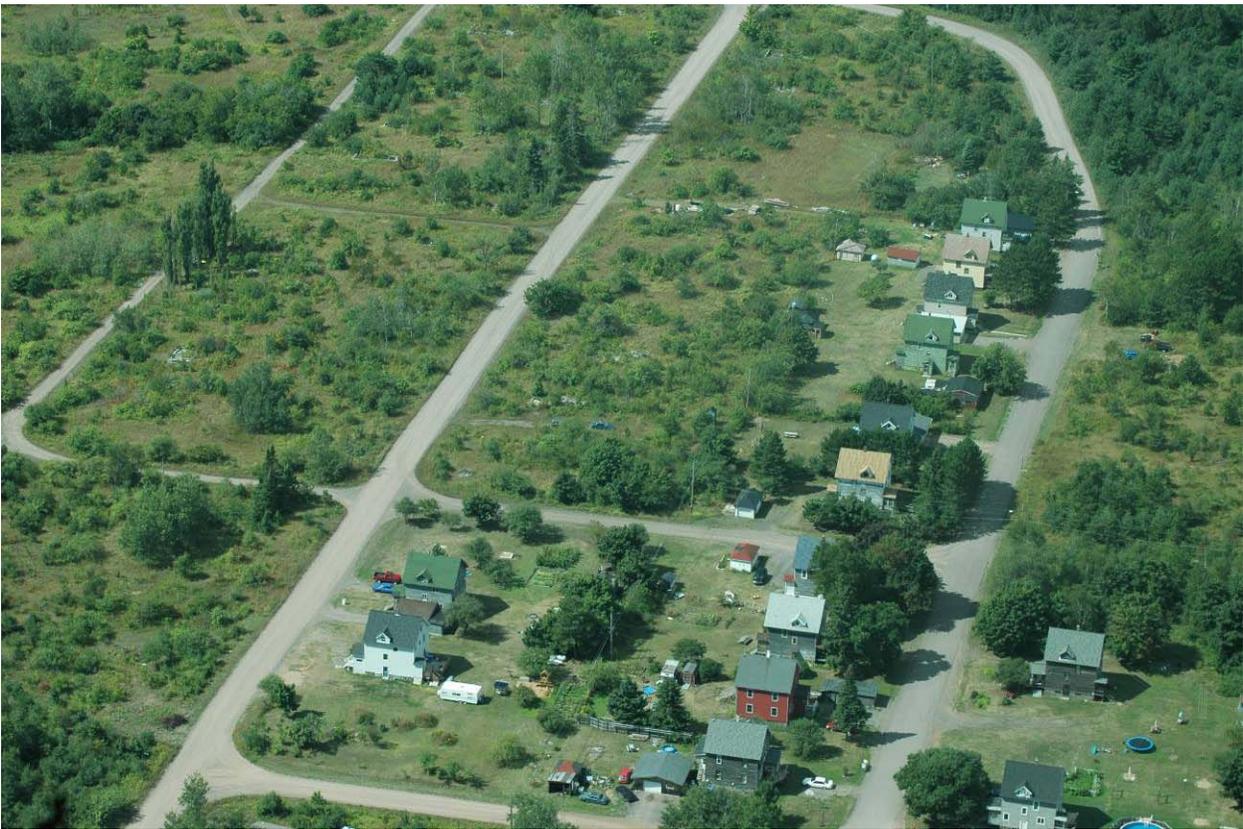
Figure 4- 8: Contemporary oblique view of Lower Pewabic, facing southwest (source: Rob Wood, Wood Ronsaville Harlin, Inc., August 2005)

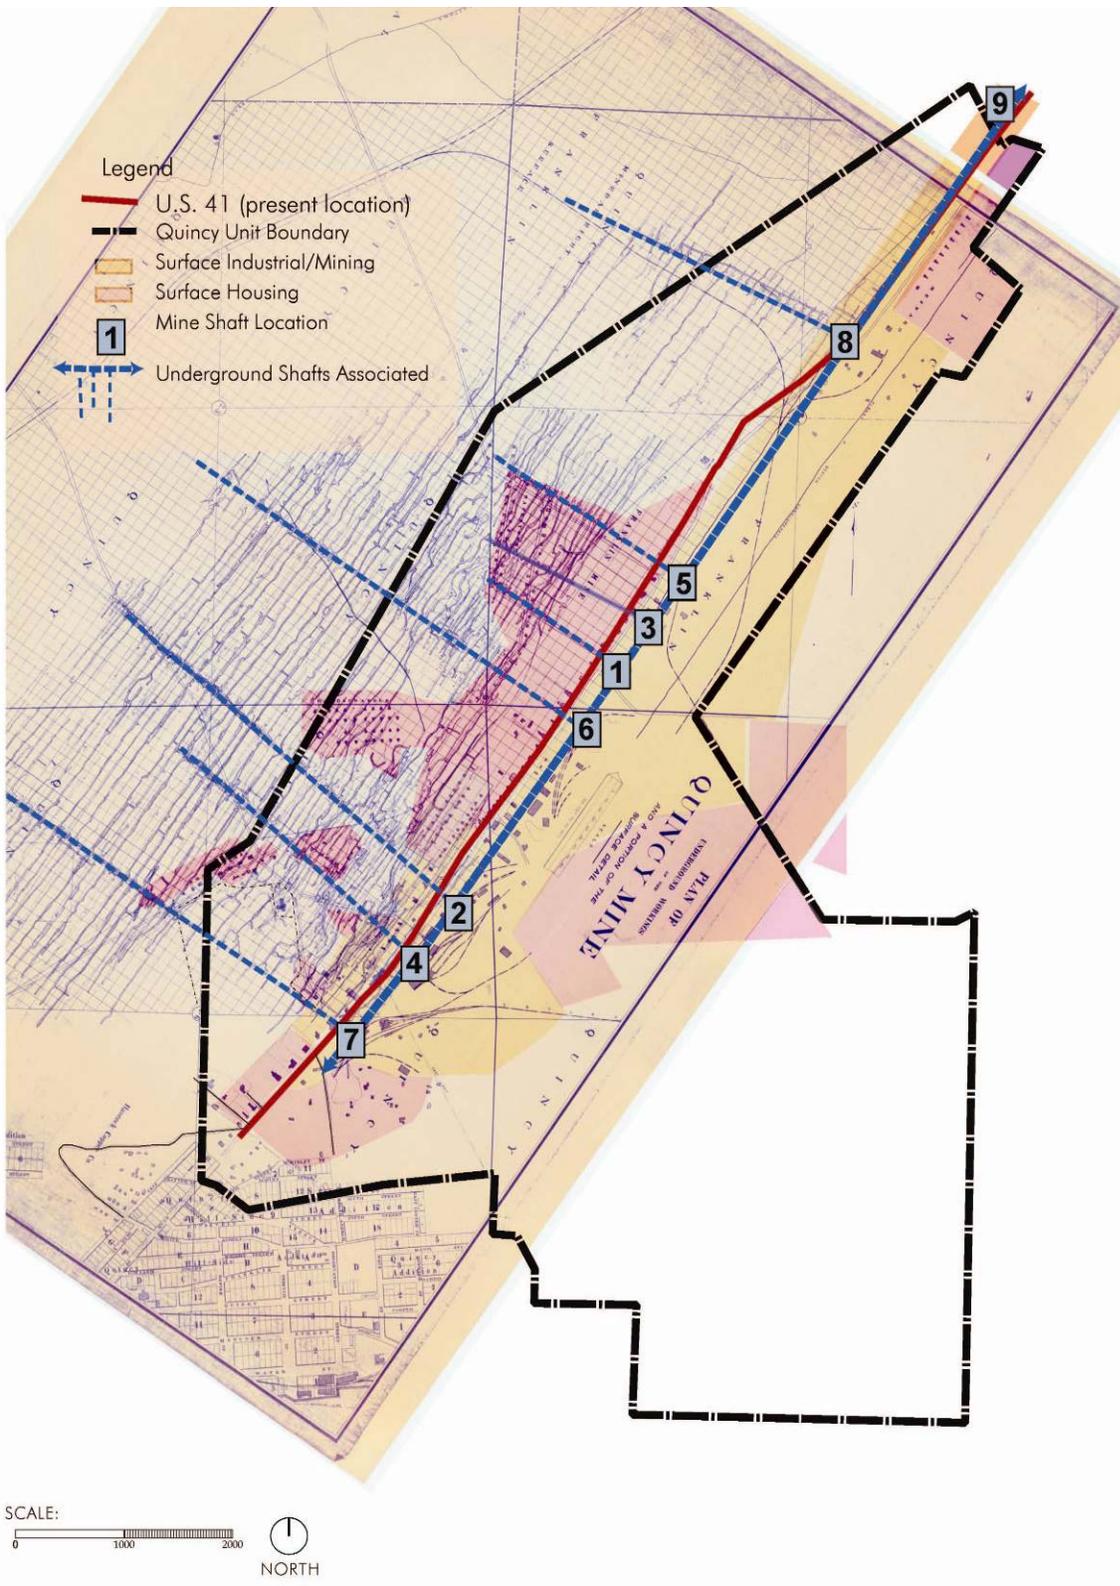
Figure 4- 9: Quincy Unit 1920 land use overlaid on “The Underground Workings of the Quincy Mine and a Portion of the Surface Detail,” ca. 1900s (added graphics by QEA 2007).

Historically, the underground resources of the Pewabic, Franklin, and Quincy mining companies determined the broad-scale aboveground spatial organization of landscape features related to the mining operations. Belowground the Pewabic Lode extended from shaft-rockhouse No. 7 at the crest of Quincy Hill, northward to shaft-rockhouse No. 9 in Mesnard. Shafts led to drifts that extended a network of horizontal tunnels parallel to U.S. 41 amidst the Pewabic lode and beneath the extensive company housing locations to the west. The intense network of rock crushing shaft-rockhouses, hoist houses, multitude of railroad tracks and trestles, cooling ponds, and expansive poor rock piles were located east of the spine of the Pewabic Lode (see Figure 4-9).

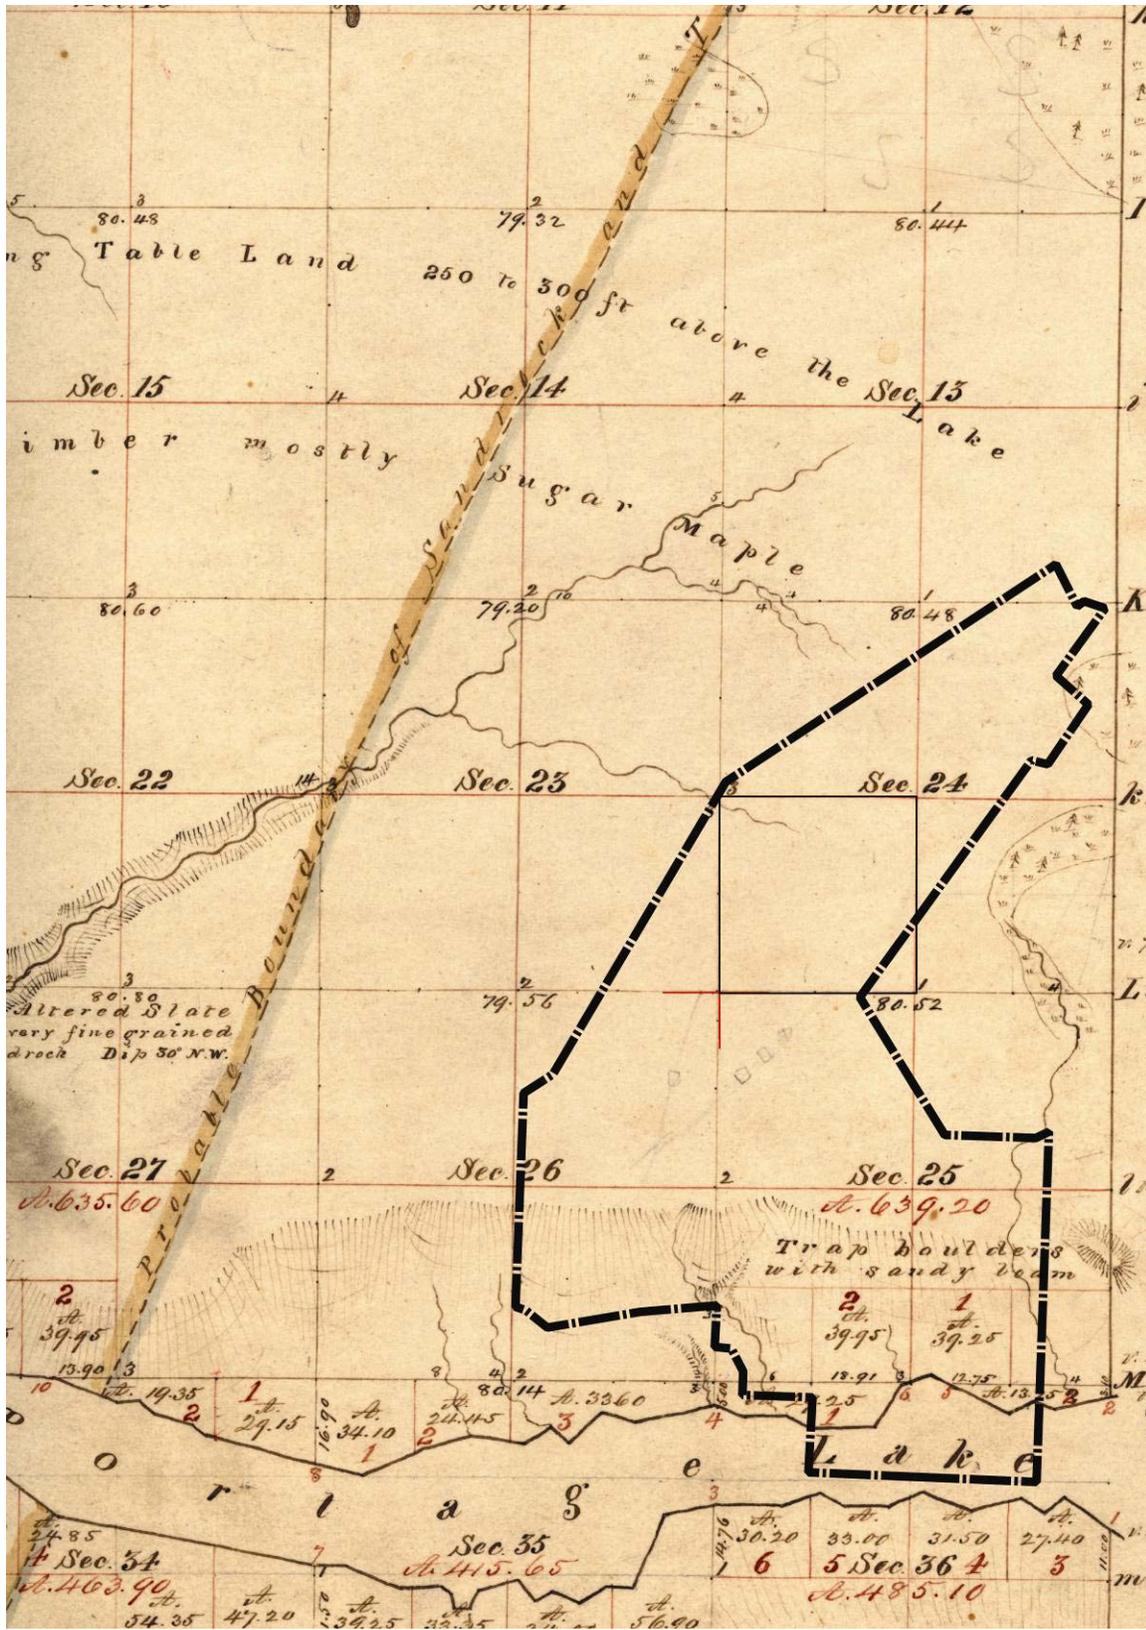
Figure 4-11: Portion of the William A. Burt and Bela Hubbard survey drawing (1845) with the existing Quincy Unit boundary added by QEA 2007 (source for map: KEWE archives)

When Hubbard and Burt surveyed the Keweenaw in 1845, they indicated the presence of an abundant growth of sugar maple, birch, fir, oak and white pine as well as some swamp or marshland. Although their notes regarding vegetation are not detailed, one can gather from the survey drawing notations that the area now within the Quincy Unit included the general vegetative features described (see Figure 4-11).

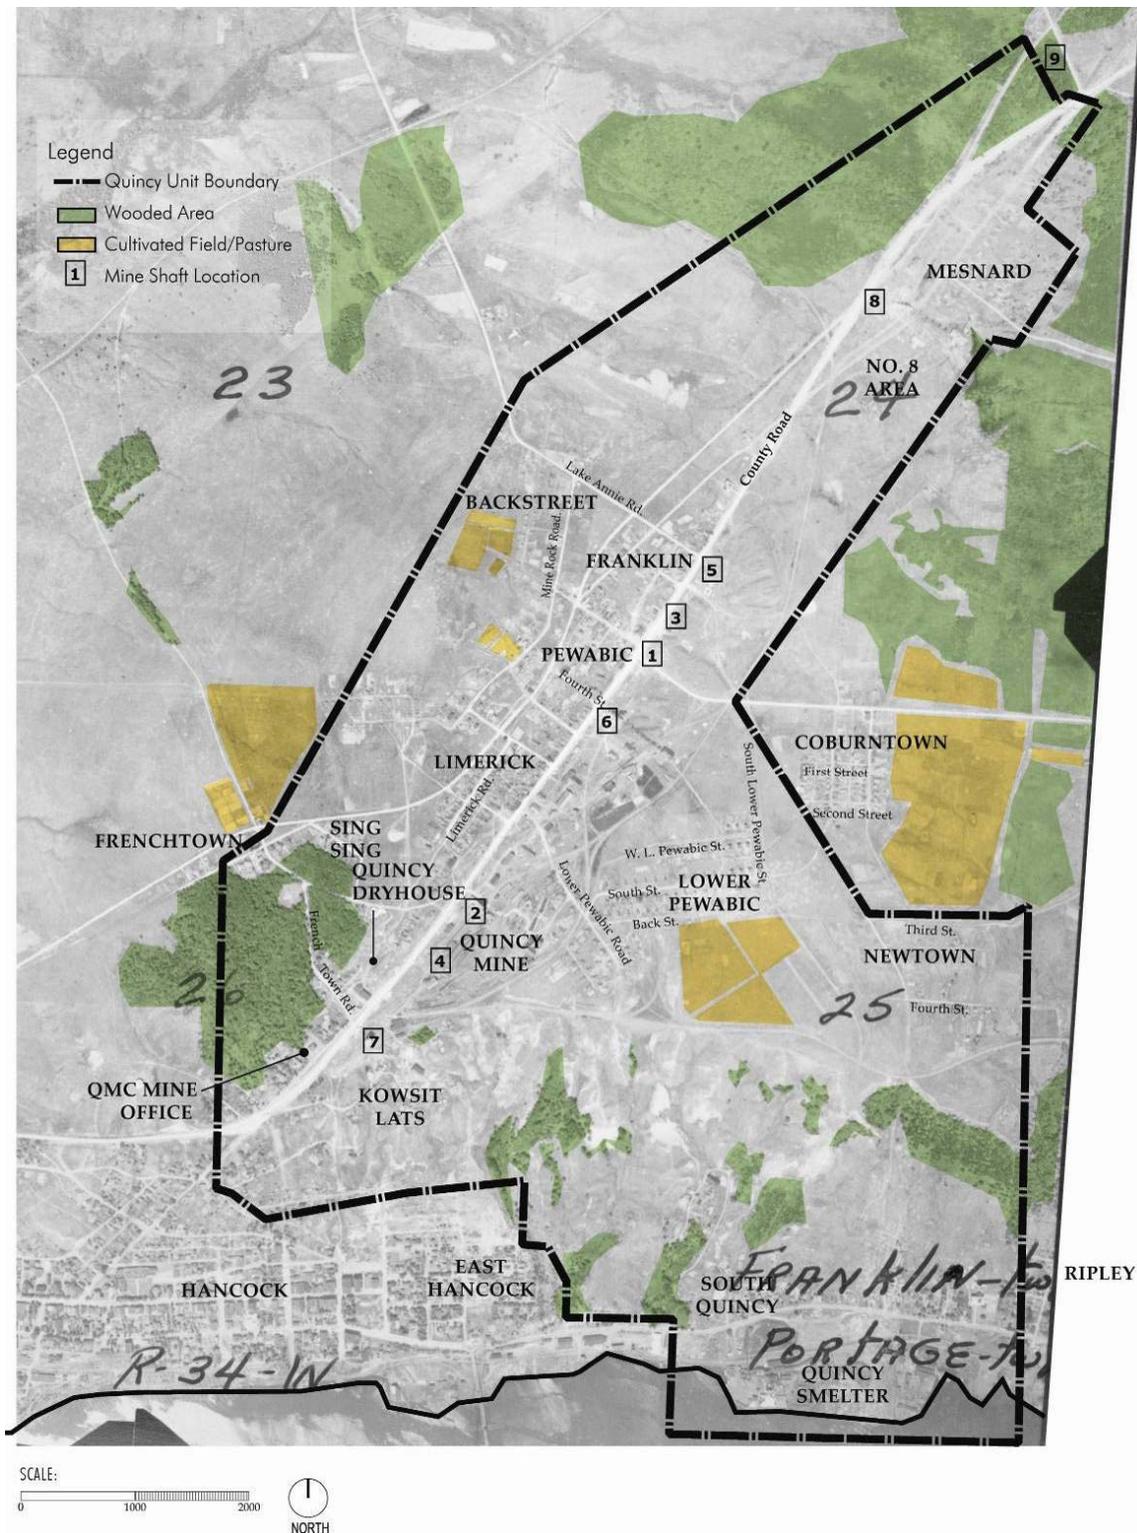
Figure 4- 12: Quincy Unit, Vegetation 1920s-1930s

Large portions of native vegetation were gradually removed with the spread of mining operations and development of housing locations on Quincy Hill. Trees were cut to clear land for development and to provide building materials and fuel.⁶ By the peak of the mining period, only small clusters of woodland remained. These were surrounded by an industrial landscape which included practically no vegetation, and residential areas that included small amounts of ornamental plants, fruit trees, and vegetable gardens. Although areas were set aside for agriculture, it is not clear how much of the Quincy farm was located within the current Quincy Unit. Nevertheless, agricultural uses occurred in the close vicinity. These included small orchards, pasture and cultivated fields. Analysis of an aerial photograph taken in ca. 1920s-1930s shows the approximate extent of wooded and agricultural vegetation during that period (see Figure 4-12).

Within the Quincy Unit today vegetation is much more prevalent than it was during the height of mining activities (compare Figure 4-12 to Figure 4-13). Abandoned industrial and company housing sites are overgrown with volunteer herbaceous and woody plants that can obscure cultural patterns on the landscape including ruins of buildings, poor rock piles, views, small scale features, and patterns of circulation. The second-growth woodlands are sometimes read as undeveloped wild areas by those who do not understand the history of the region or do not investigate closely enough to notice the crumbling foundations, crisscrossing abandoned rail lines, broken bottles, and remnants of gardens.

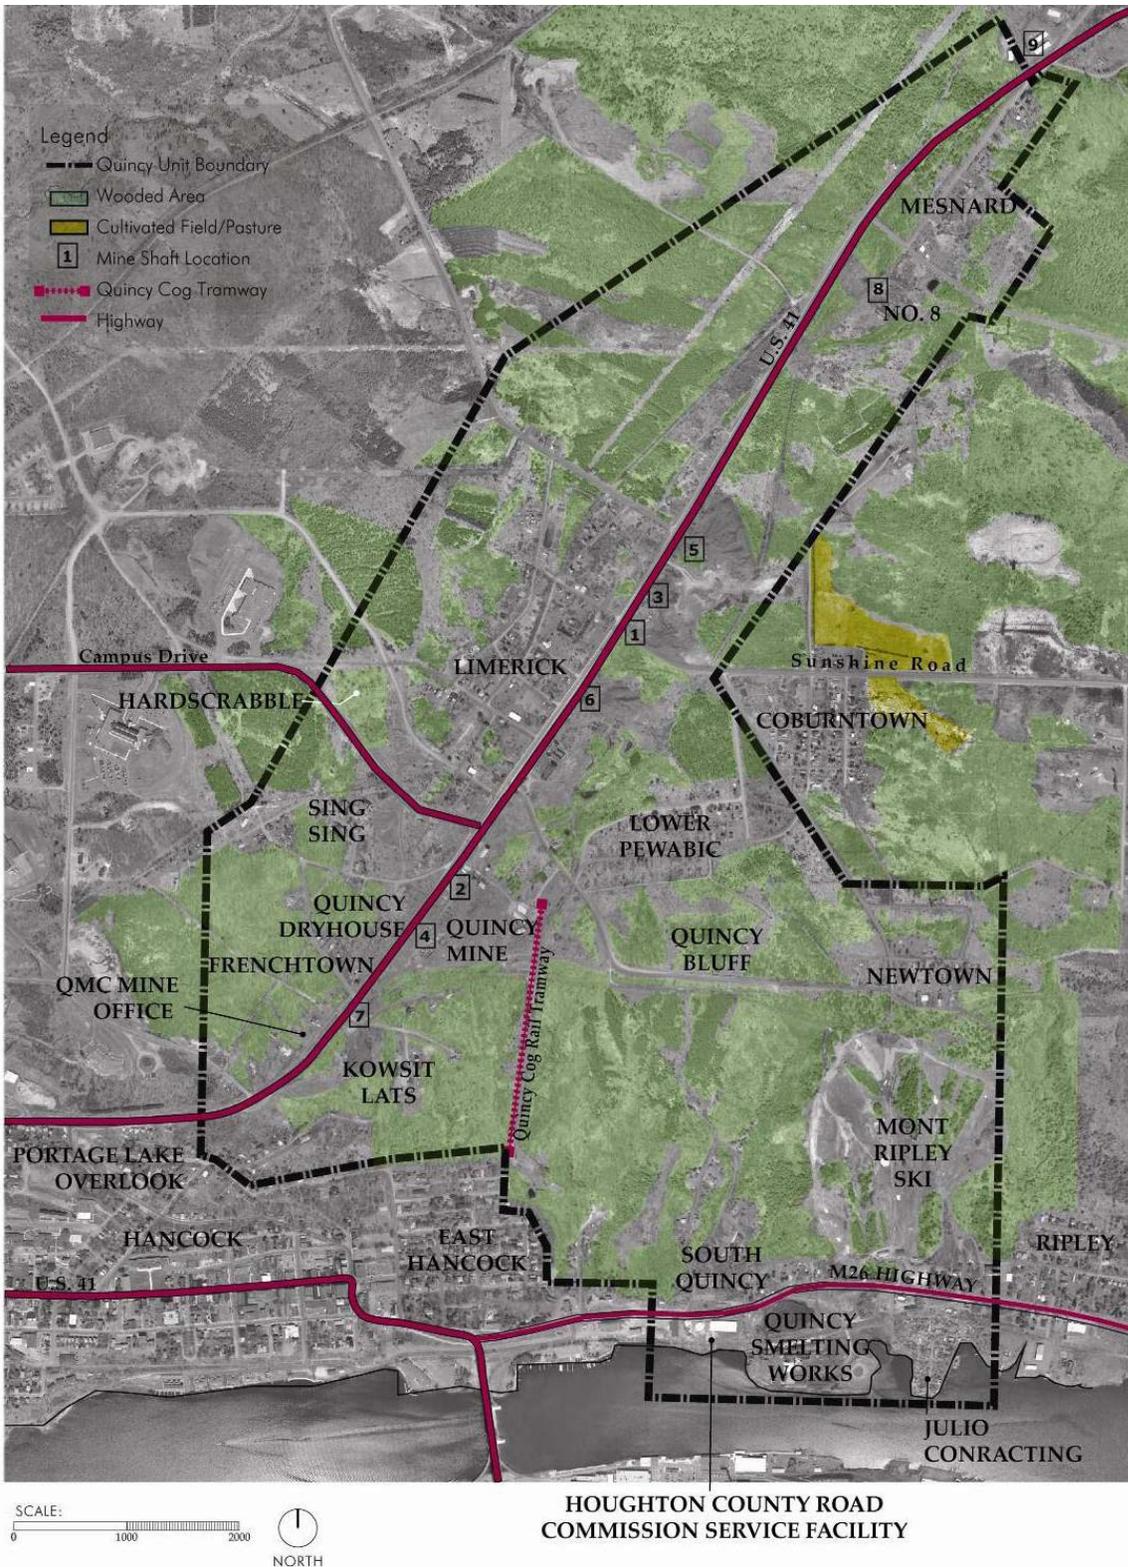
Figure 4-13: Quincy Unit Current Vegetation

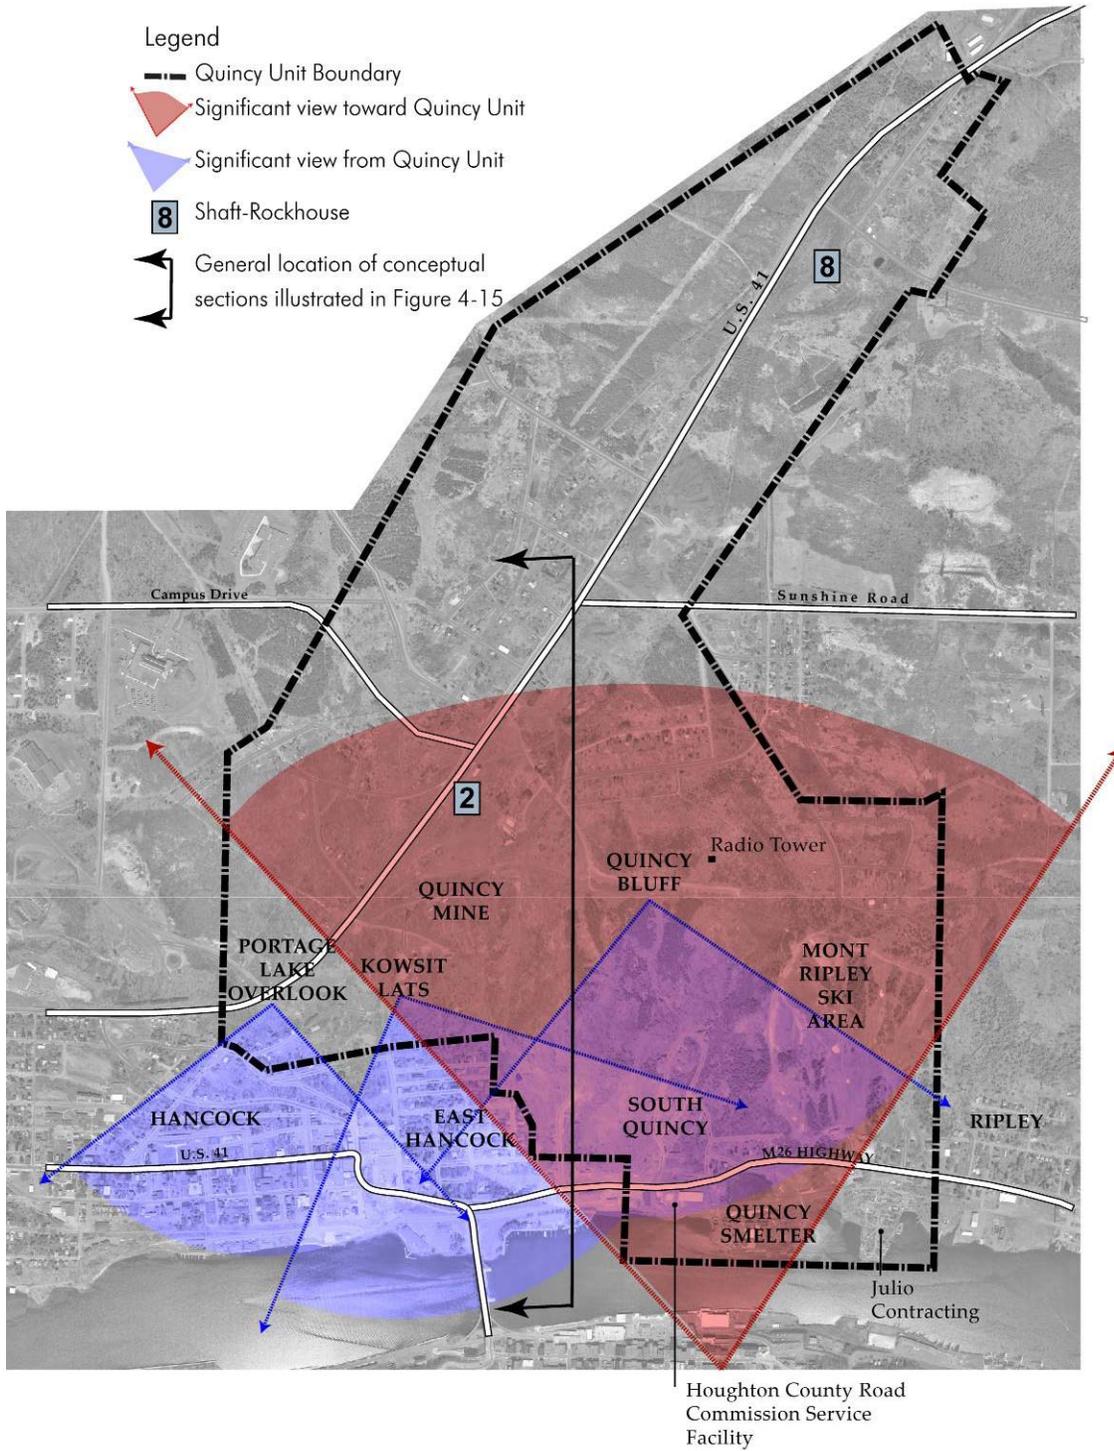
Figure 4-14: Quincy Unit, Significant Views

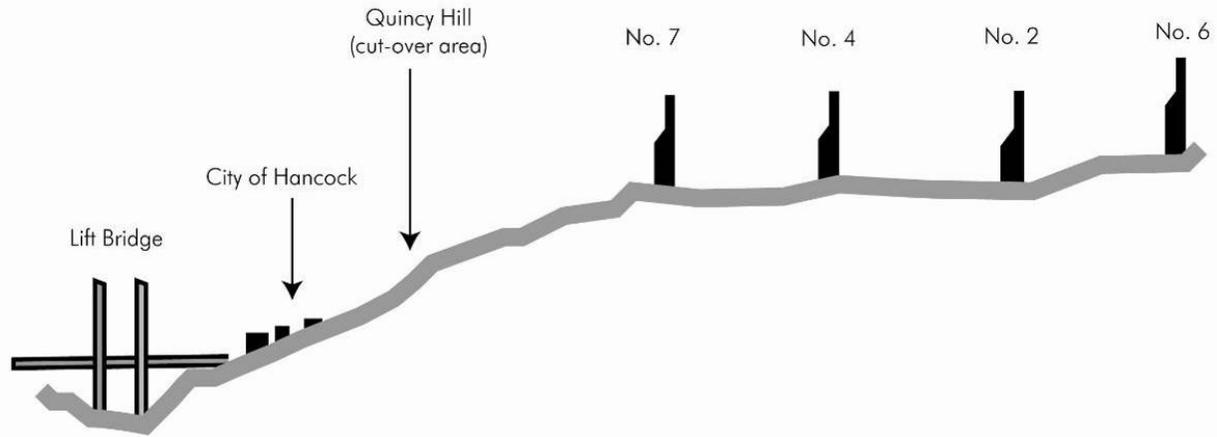
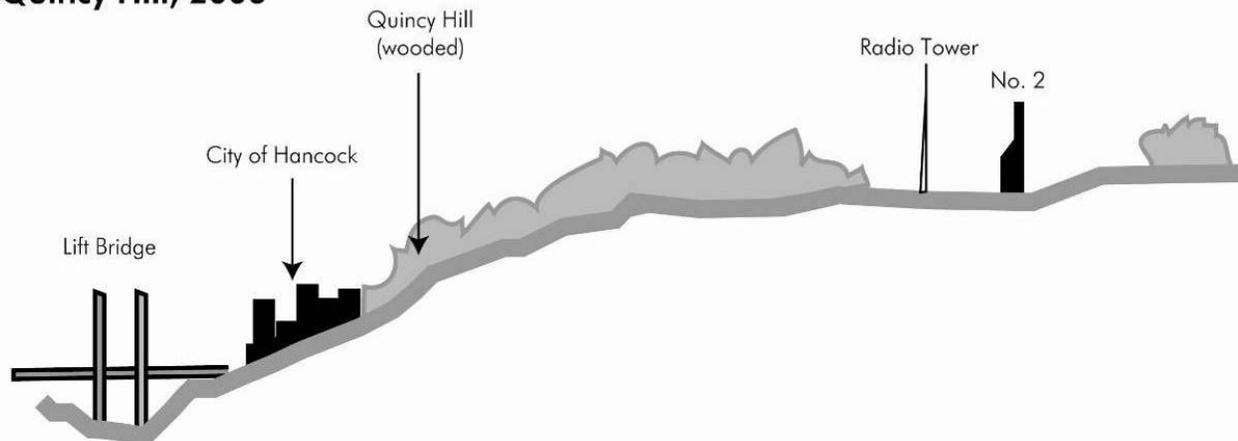
Figure 4-15: Conceptual Section/Elevation of Quincy Hill, Topography and Views (the general location of the section is illustrated in Figure 4-14)

The topography of the unit, including the dramatic six hundred foot descent from the crest of Quincy Hill to Portage Lake, afforded a commanding visual setting for mining operations. From the late 1860s onward, a progression of photographs captured these views, providing historic documentation of the mining operations, vegetation, housing, and development along Portage Lake. At present, these views offer visitors a broad visual overview of the region and communicate the historic spatial relationships between the lake, the hill, the mining operations, and the mining housing locations. Specifically they include the view north from the city of Houghton toward Quincy Hill and the panoramic views from the Portage Lake Overlook, Kowsit Lats, and Quincy Hill south and east toward Portage Lake and the city of Houghton (see Figure 4-14). During the peak mining era a series of shaft-rockhouses visually dominated mining operations on Quincy Hill. Today the No. 2 shaft-rockhouse is the dominant visual legacy of this previous mining era (see Figures 4-15 and 4-16). In particular, the No.2 shaft-rockhouse provides an identifiable visual landmark from as far away as Chassell when traveling on U.S. 41 and the from the South Range when traveling on M-26.

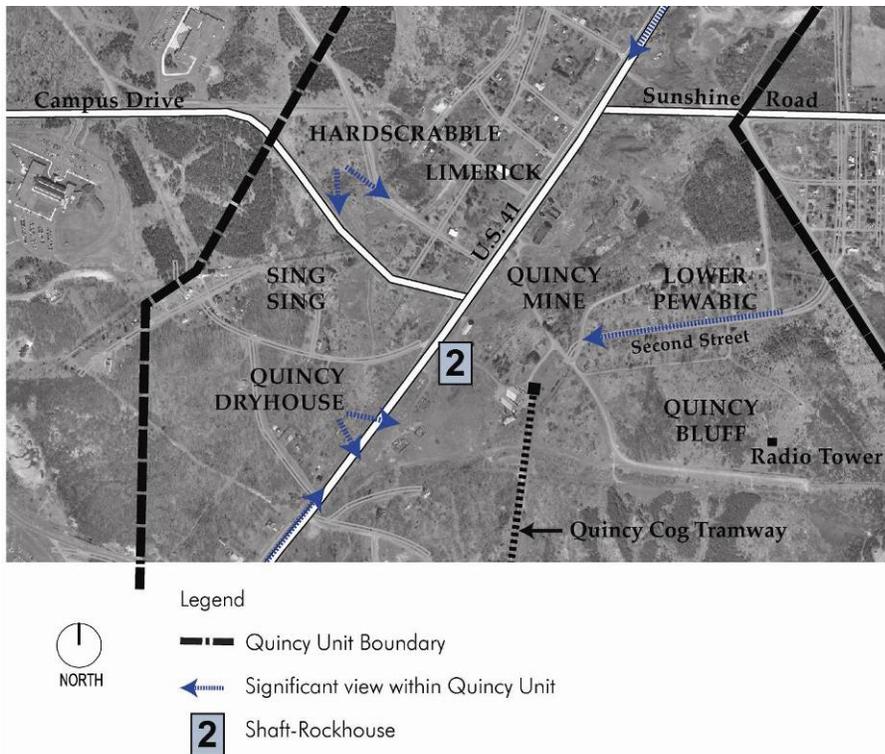
Figure 4-17a: Significant views within the Historic Industrial Core

Views within the Quincy Unit are also significant. They create visual connections between historic landscape character areas within the Historic Industrial Core (see Figure 4-17a). The view west from South Street in Lower Pewabic toward the No. 2 shaft-rockhouse communicates the symbolic visual and physical association of mining operations with company housing locations. The view eastward from the dryhouse landscape character area toward former mining operations east of U.S. 41 and beyond visually connects mining operations on the hill. These views have potential significance as interpretative resources for the park.

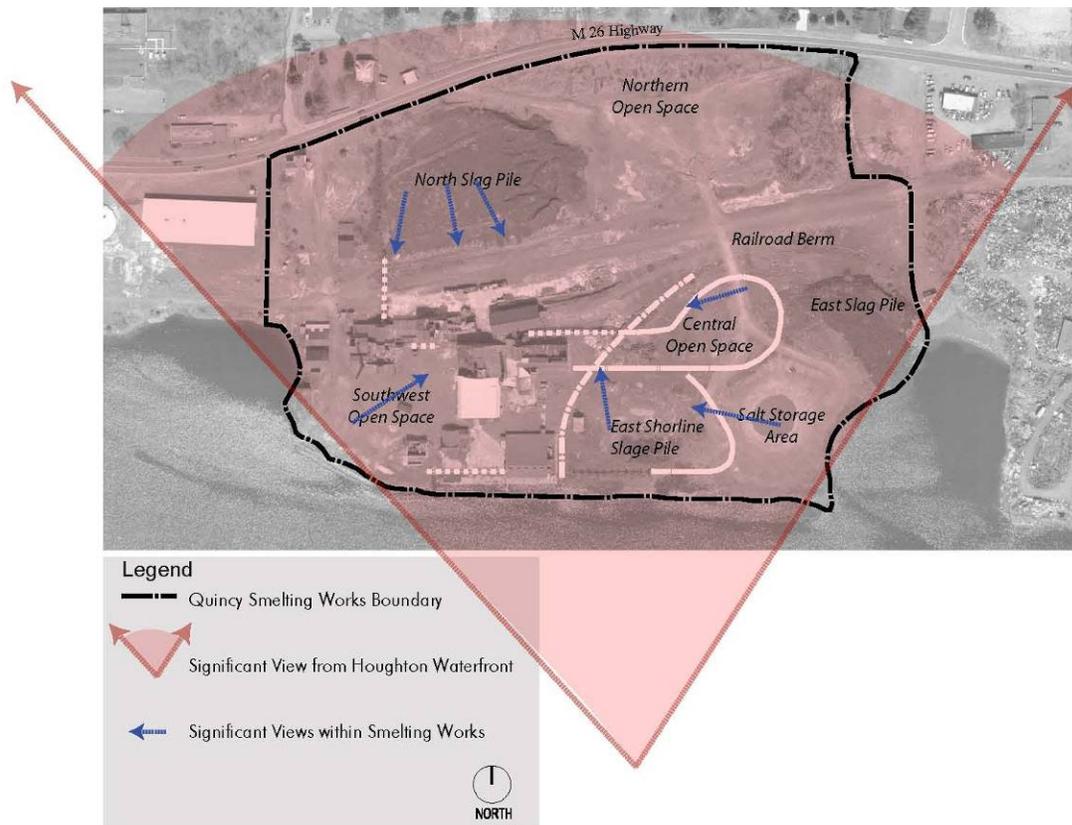
Figure 4-17b: Significant views associated with the Quincy Smelting Works

Views of the Quincy Smelting Works on Portage Lake from Houghton provide a dramatic overview of the resources present in this character area (see Figure 4-17b). Within the Quincy Smelting Works, significant views include striking vantage points from the top of the north slag pile facing the buildings to the south. Views into the building complex from the southwest open space, east shoreline slag pile, salt storage area, and central open space all provide glimpses of historic features that illustrate aspects of the historic functions of the facility.
