Chapter IV: Landscape Analysis

The project area for this Cultural Landscape Report is defined by the boundary of the Quincy Unit of Keweenaw National Historical Park as described in Chapter I. The Torch Lake area is not included within the boundary of the Quincy Unit. Chapter II: Landscape History, addresses the Torch Lake area to help readers understand the comprehensive landscape development related to the corporate history of the Quincy Mining Company. Because the Torch Lake area is not within the project area, it is not covered by the Existing Conditions, Landscape Analysis, or Recommended Treatment sections of this Cultural Landscape Report.

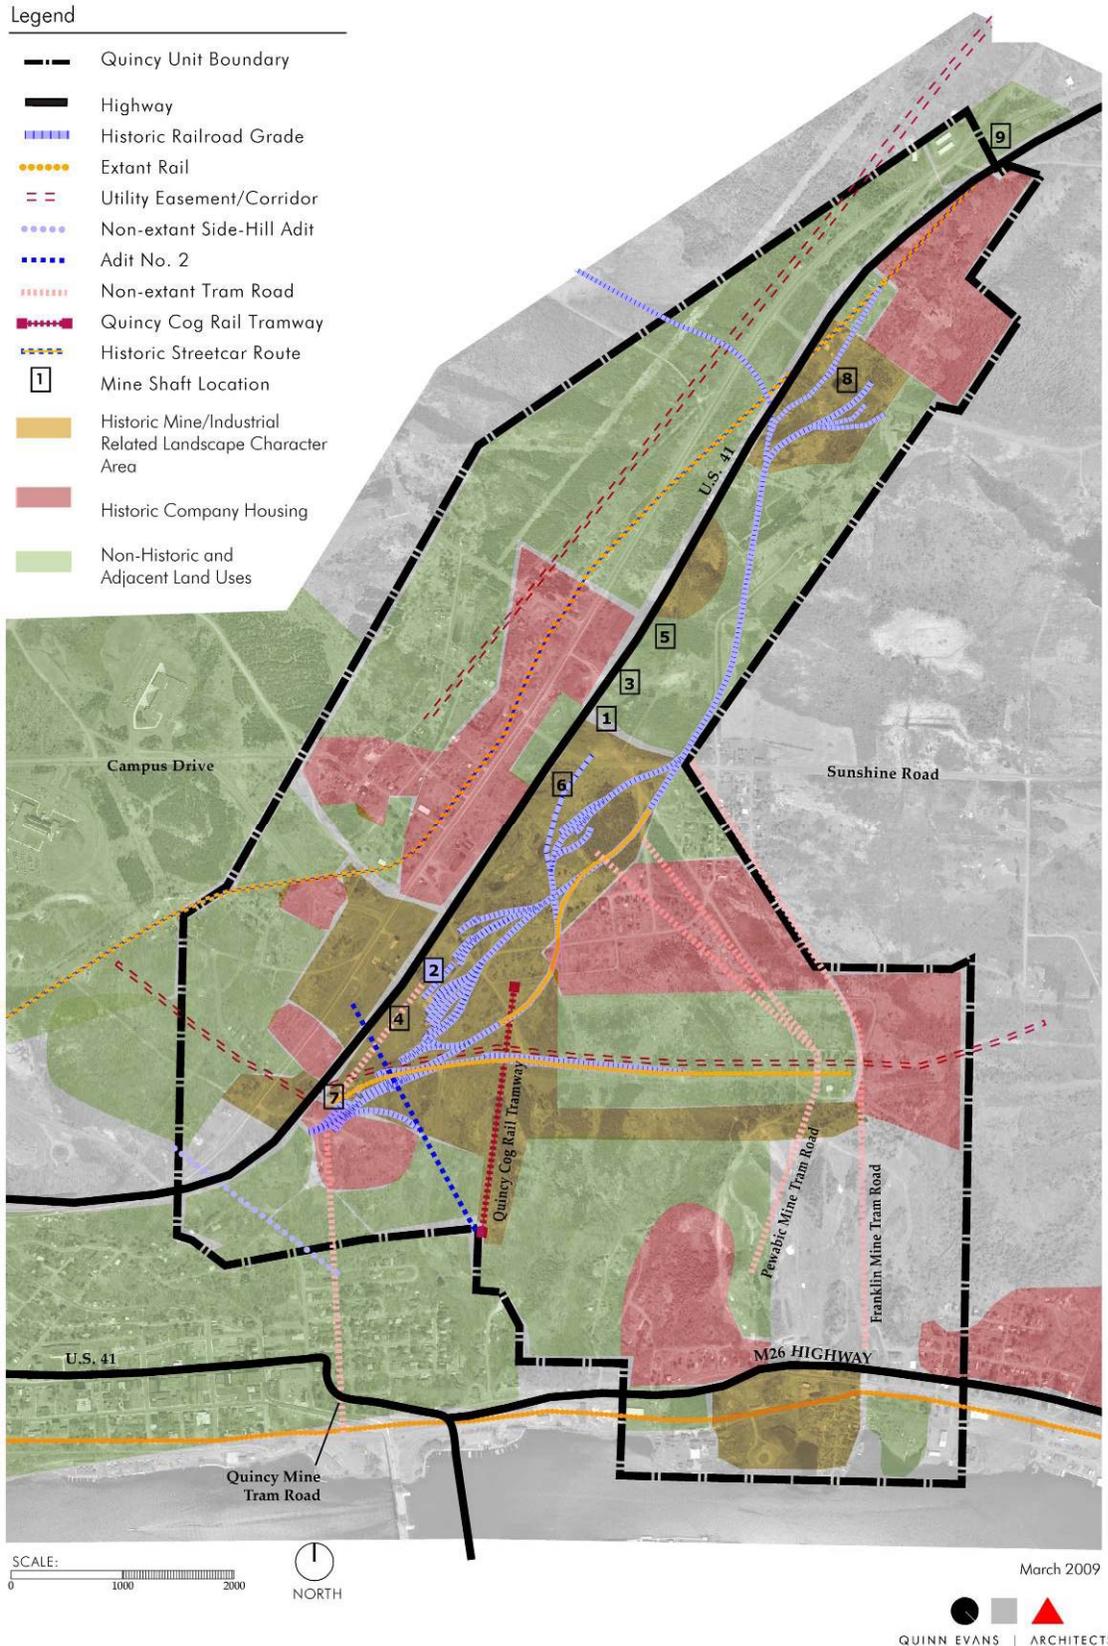
Figure 4- 18: Quincy Unit, Railway, Tram, and Streetcar Routes Analysis

Initially, a tram road carried counter-weighted tram cars filled with copper rock from the Quincy Mine down to the Stamp Mill at Portage Lake. The Pewabic and Franklin mining companies also had tram roads that descended from their mines on Quincy Hill to mining operations bordering Portage Lake. By 1890 the new Quincy stamp mill was constructed on Torch Lake. The Quincy and Torch Lake Railroad was built to link the Quincy Mine operations with the stamp mill. The tram roads that crossed Quincy Hill were made obsolete by developments at Torch Lake and the use of rail routes to move copper rock in the area (compare Figures 4-18 and 4-19). Although the former location of the Quincy tram road was once a visual dividing line between the city of Hancock and East Hancock, currently the route has been absorbed into the city of Hancock and is no longer a significant resource for the unit. The former Franklin and Pewabic tram roads further east, are also no longer present. The northern portion of the Franklin Tram Road is now an angled road between Coburntown and Lower Pewabic. The southern portion once bisected Quincy Hill along a ridge line that extended down toward Portage Lake, in an area now occupied by the Mont Ripley Ski Area. The Pewabic Tram Road also extended down a ridge line on Quincy Hill. Today, subtle traces of the tram road are visible as it traverses the eastern edge of Lower Pewabic down through the Mont Ripley Ski Resort. However, no significant remnant of either route is present today. The existing Cog Tramway, operated by the Quincy Mine Hoist Association, does not follow any of the historic former tram routes. It is a compatible feature because it connects two significant historic resources, the No. 2 Hoist House complex and the No. 2 adit.

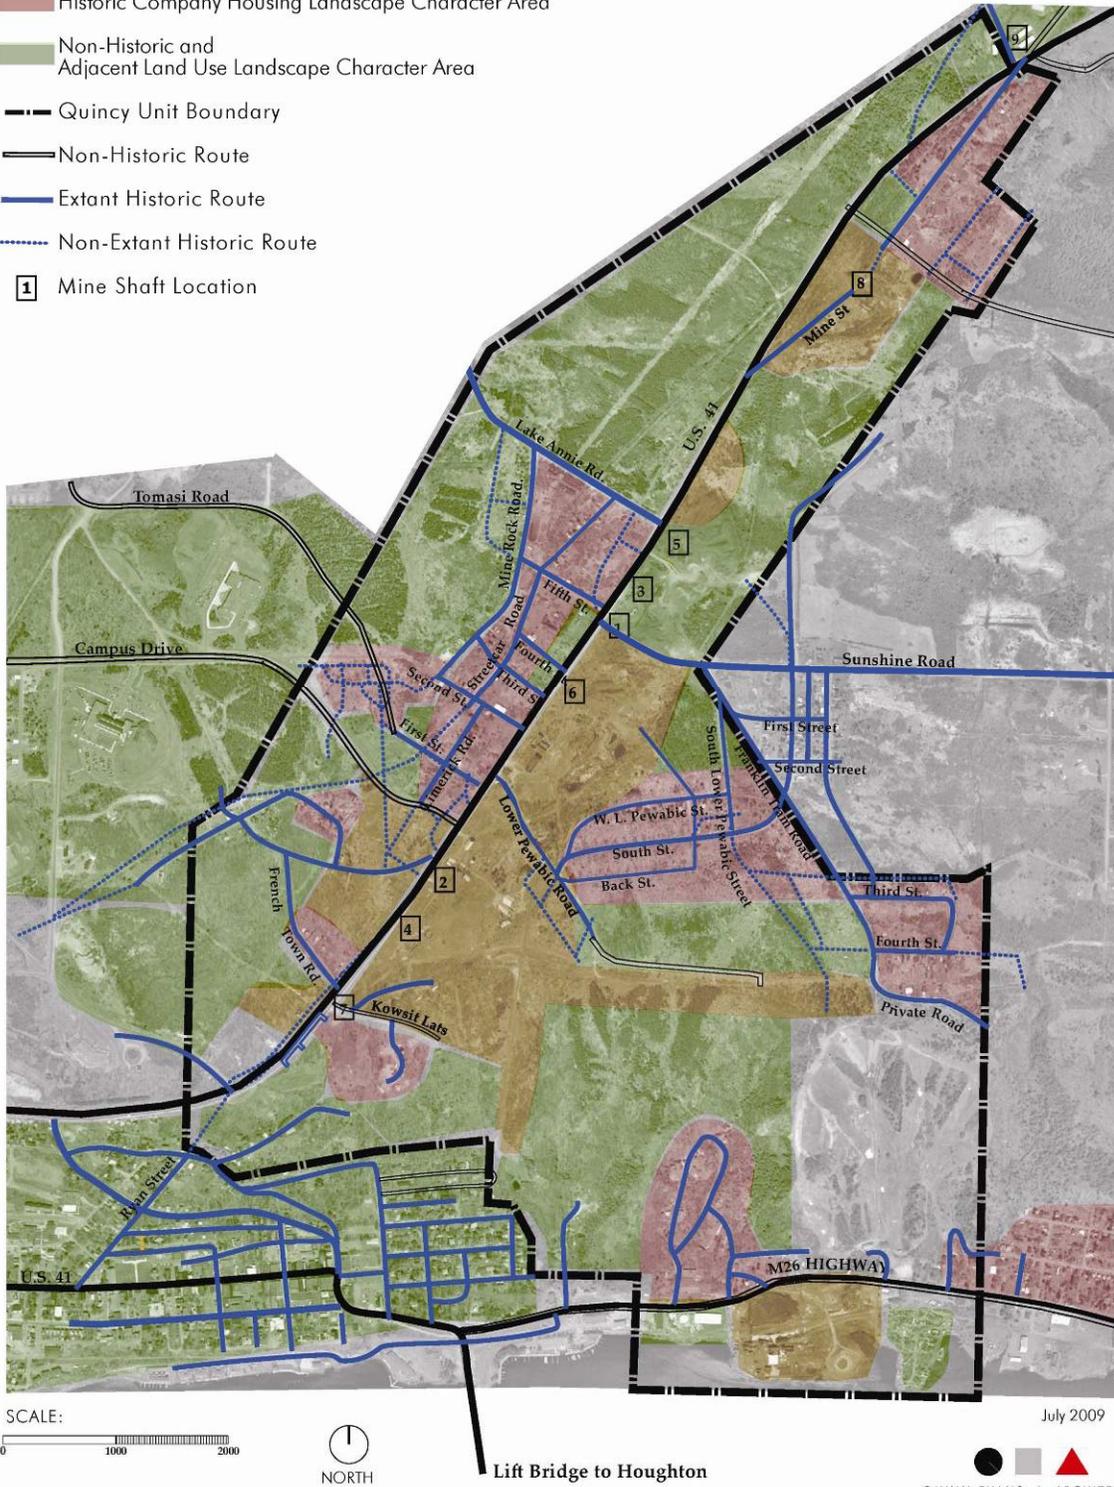
Figure 4- 19: Quincy Unit, Road Analysis

In the early stages of mine development, crude wagon roads linked the city of Hancock with the mine operations on the hill. Calumet Road (U.S. 41), the major north/south vehicular connection for the Keewenaw Peninsula paralleled the Pewabic Lode. Over time roads were established to and within the company housing locations. Topography influenced road development. After the mining operations closed in 1945 several company housing locations were abandoned. Today, traces of roads in sections of Lower Pewabic, Backstreet, Hardscrabble, Frenchtown, and Mesnard orient visitors to the development pattern and sites of these housing locations. Other housing locations, including Limerick, Pewabic, and Franklin, retain many of their historic routes. Although the streetcar route that once extended from Hancock northeast to Mesnard is no longer extant, a small section is now a road within the Limerick/Pewabic housing locations. It is appropriately named Streetcar Road. The influence of the contemporary institutional land-use is apparent within the western half of the unit. New roads including Campus Drive dominate the area.

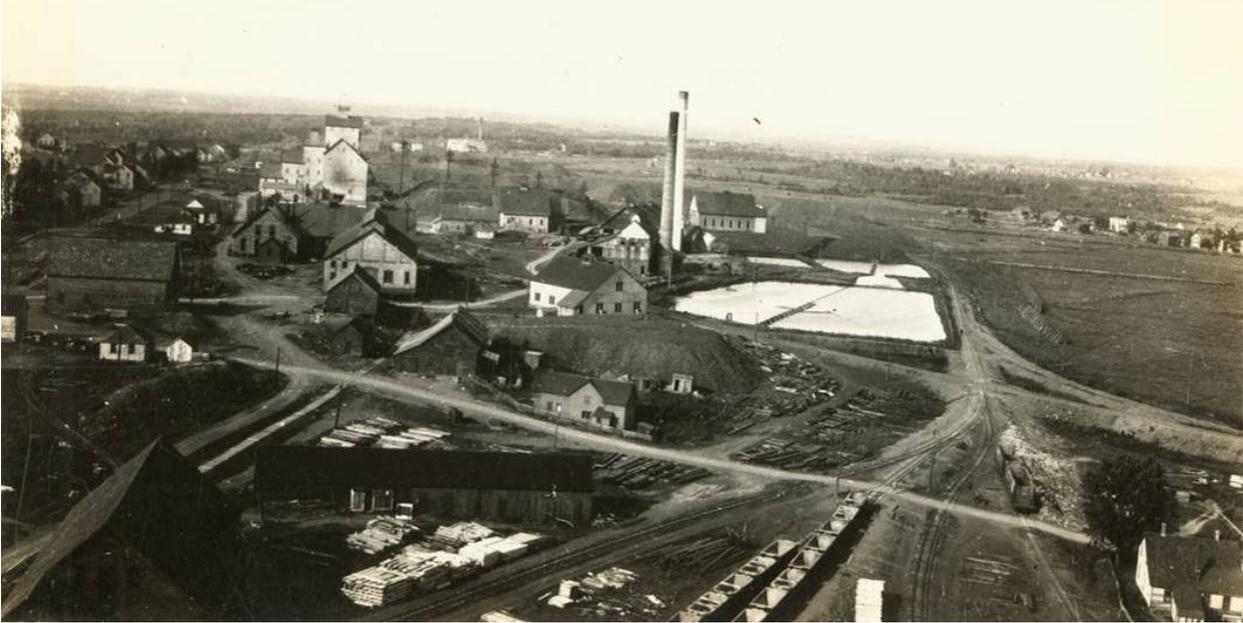
Figure 4- 20: View north from No. 2 shaft-rockhouse toward No. 6; the Blacksmith Shop and Machine Shed are on the left, railroad routes bisect the site, ca 1915 (source: KEWE archives)

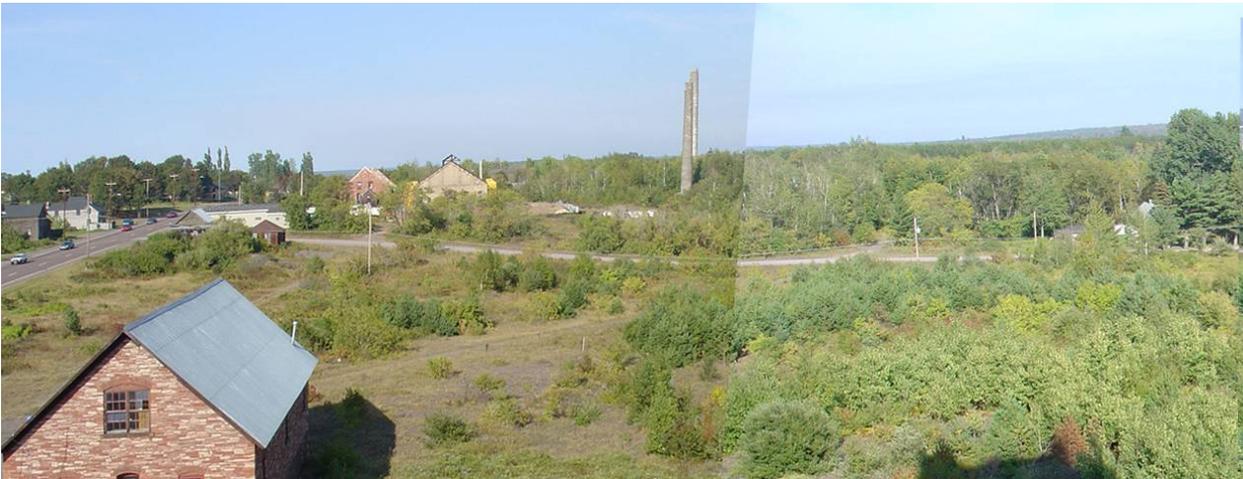
Figure 4- 21: View north from No. 2 shaft-rockhouse toward the former location of No. 6, subtle railroad grades are the only remnants of a concentrated network of railroad routes that historically was present, 2006 (source: QEA)

The 1880s brought the railroad to the Keweenaw Peninsula. In 1886 the Mineral Range Railroad constructed a branch line to Quincy (see 1886-1888 Period of Change Plan in Chapter II). By the 1890s a complex network of rail routes bisected the Quincy Mine, linking the various functions of the mine operations (see Figure 4-20).⁷ Today only a few remnants of this network are extant. These include traces of railroad grades, the few remaining rail lines, remnants of trestles, and some rolling stock (see Figure 4-21).
