Great Smoky Mountains National Park

Buildings & Infrastructure Existing Conditions Report

October 2004

United States Department
Of the Interior
National Park Service

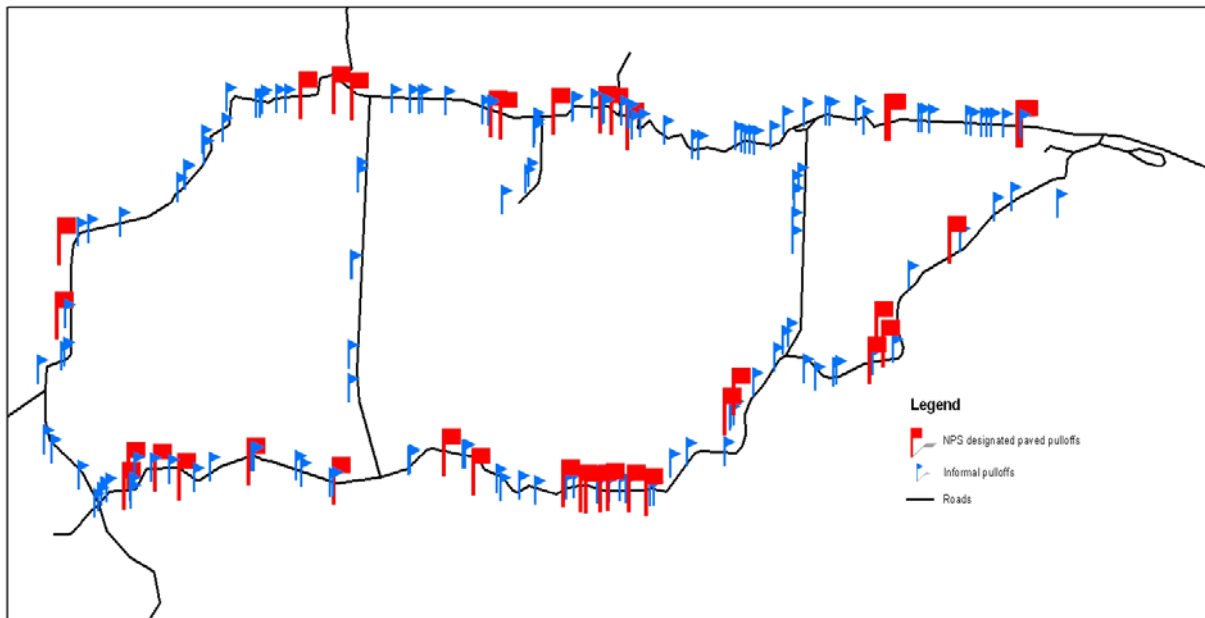
Figure 3: Vehicle Pull-Offs along the Cades Cove Loop Road

A significant number of vehicle pull-offs have been created along the Loop Road. Pull-off areas designated by the National Park Service for visitor use are paved and depicted with a “red flag” on Figure 3. These 37 paved pull-offs have been established to accommodate visitors who want to view wildlife, hike, or visit historic structures.

Unfortunately, many visitors pull off the road whenever they see wildlife. Thus, over the years, a significant number of “informal” pull-off areas have been created. (These are depicted on Figure 3 with a square icon.) As use of these informal pull-offs has increased, maintenance workers have added management logs or boulders to restrict their use and have filled in ruts and mud holes with gravel.

For this plan, field reconnaissance was undertaken to document the number and locations of pull-off areas, and 139 unpaved pull-off areas were accounted for. The fieldwork undertaken to identify these areas provided the means to estimate the capacity of these pull-off areas to accommodate vehicles. It is estimated that these areas can serve 200 to 250 vehicles.

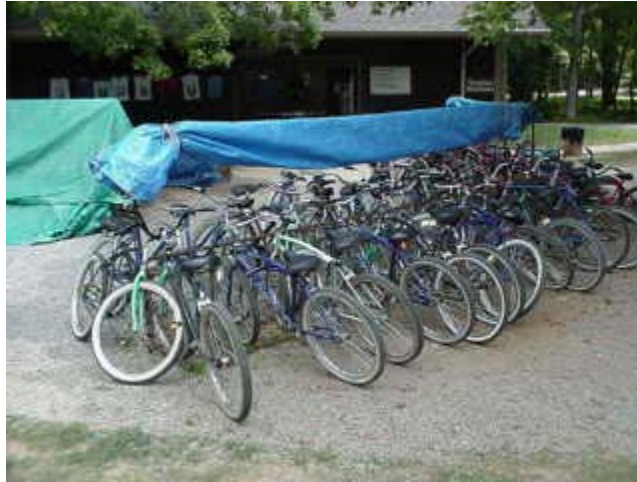
Campstore

The campstore area is made up of two buildings. The first is a retail store providing food and basic supplies for campground and other visitors. It also includes the amphitheater, which is incorporated into this building under a large “A” frame roof structure. A second building, located east of the store, is used for storing firewood and contains a covered space for vending machines and the administrative area for the bicycle rental service. Bicycles available for rent are stored in the open between this building and the campstore and are covered with tarps (see below). The store is privately operated through a concession agreement with the National Park Service.

The restrooms in this building are heavily used, especially on weekends, and are generally inadequate given the current demand. A study in 2003 found peak use for men at 1,782 people on weekdays and 2,398 on weekend days. For women, these peak figures were 3,308 on weekdays and 4,070 on weekend days. The heavy demand is significant given a common complaint voiced in the 1998 visitor survey about a general lack of restroom facilities in the Cove.

Space in the store is generally too limited to adequately display the items the store is authorized to sell. For example, food is available, but seating is not available for food customers. Similarly, the aisles are narrow and it is difficult for customers to move through the store during busy periods. Inventory storage space is also limited.

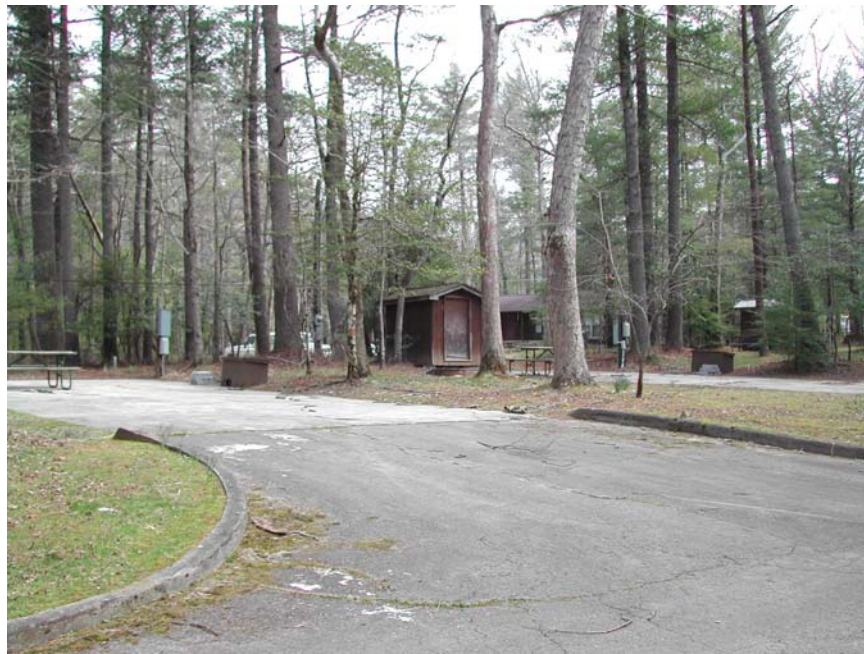
Residential Structure (Building 423)

A second structure originally designed as a residence is located adjacent to the Resource Education building. This building is currently used to house All Taxa Biodiversity Inventory (ATBI) personnel. It is similar in age, size, and function as Building 354.

Although Buildings 354 and 423 are no longer used for housing, they are in an area designated for housing in the Cove. While the structures meet current demand, they are crowded and cannot accommodate expanded program needs. Moreover, these structures were not designed for their current uses and, as a result, do not function as well as similarly-sized facilities designed for them.

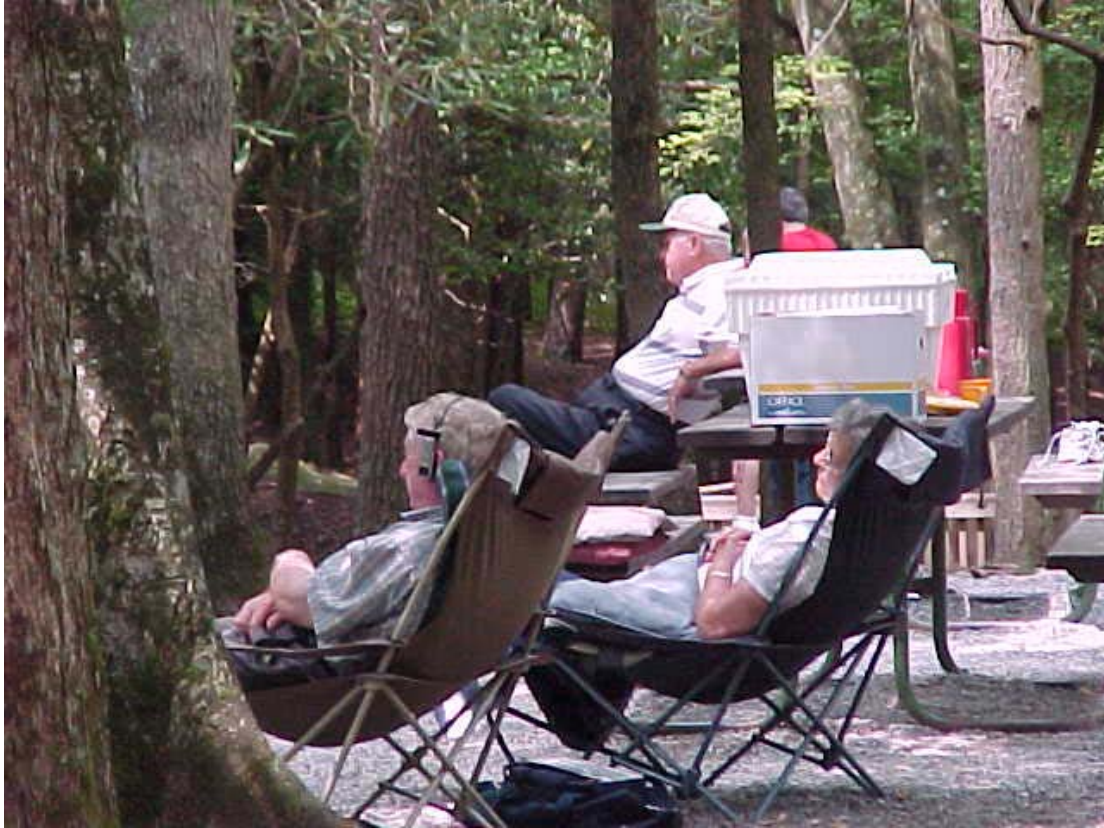
There are two comfort stations (restrooms) located in the picnic area. These buildings are approximately 350 square feet in size and were designed and built in the late 1950s to early 1960s. Each building includes four stalls for women and three urinals and two stalls for men.

The picnic area is open year round, although one of the comfort stations is closed during off-peak visitation periods. Although many large groups use this area, it is not designed to serve large numbers of people.

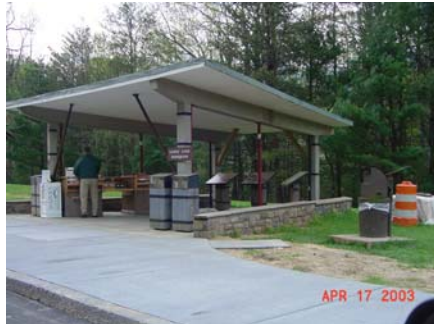
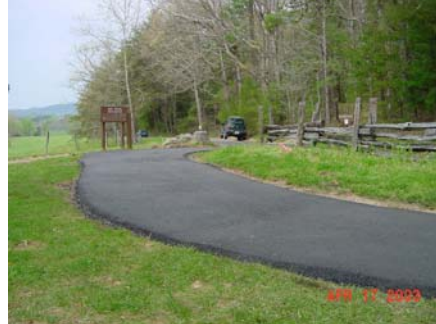
Two areas have been developed to augment the visitor experience. These include the developed area at the east end of the Cove and the Cable Mill area. The developed area includes the Visitor Orientation Shelter (located at the beginning of the Loop Road). This is a small (12' by 12') open air shelter. It is constructed of short stone

walls and posts supporting a sloped roof. This shelter provides minimal orientation to the Loop Road. This area also includes a small paved area and sign that provides orientation information for bicyclist riding the Loop Road.

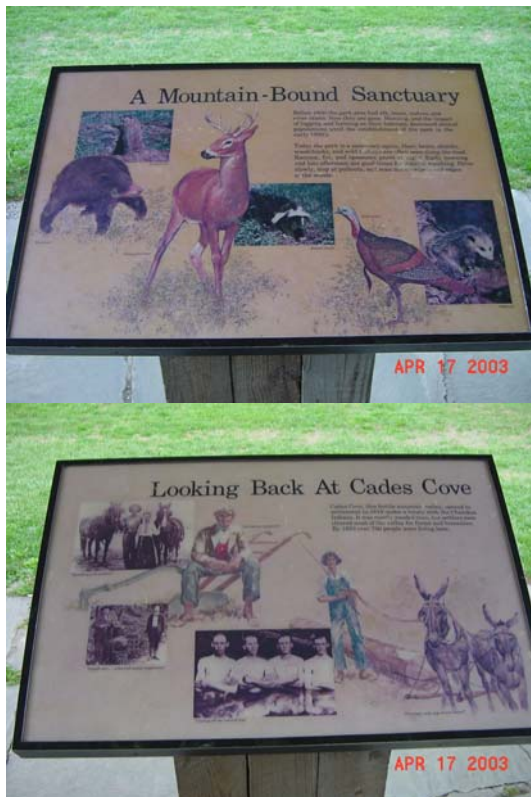
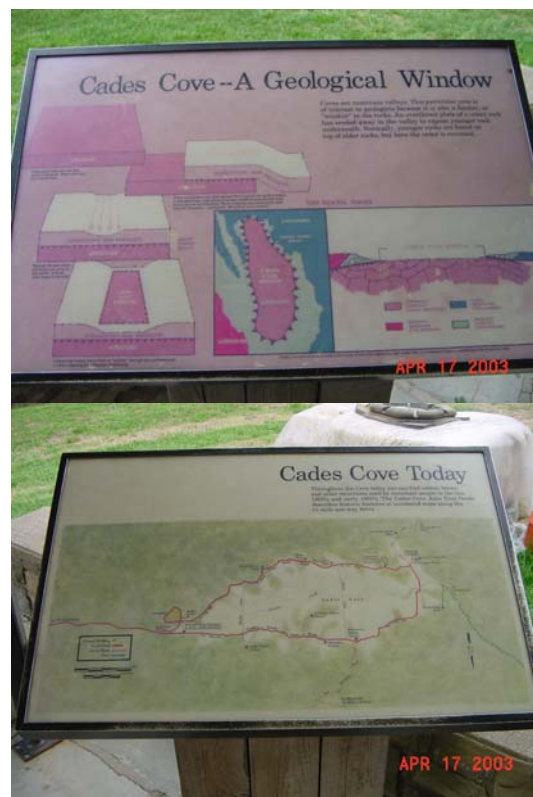
A limited number of interpretive signs are located in the study area. These include a series of signs at the Visitor Orientation shelter that provide the visitor with information on the geology, wildlife, settlement history, and NPS management activities being undertaken in the Cove today.

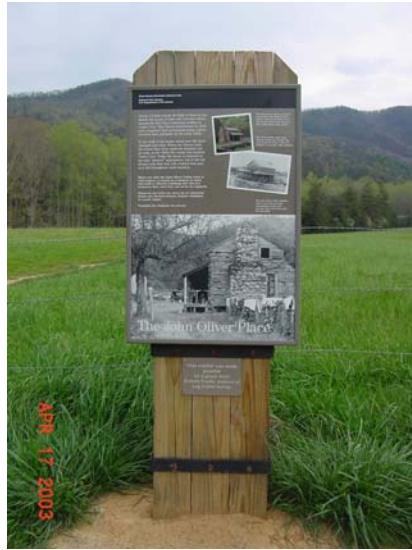
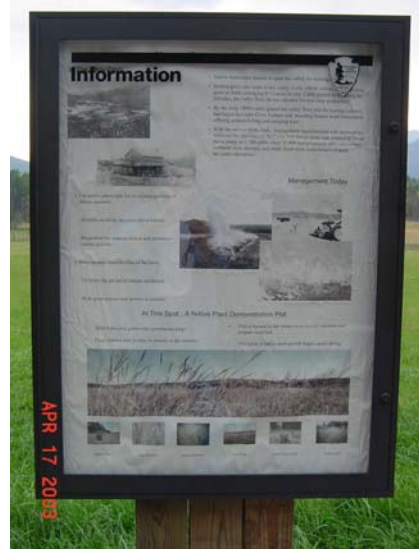
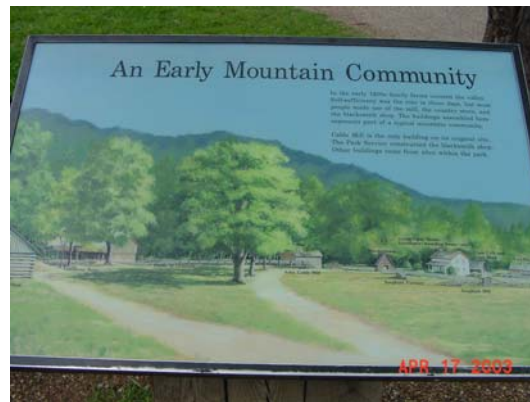
There are also a limited number of interpretive signs located at the Oliver Cabin, Main Viewing Area, and Cable Mill. These are depicted in the following photos:

There is also an interpretive sign related to the self guided Cades Cove Nature Trail. The style and design of these interpretive signs are similar and fit into the 'rustic' settlement theme of Cades Cove.

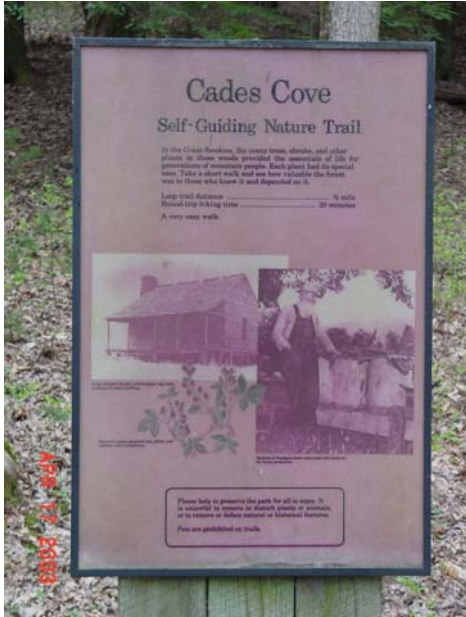
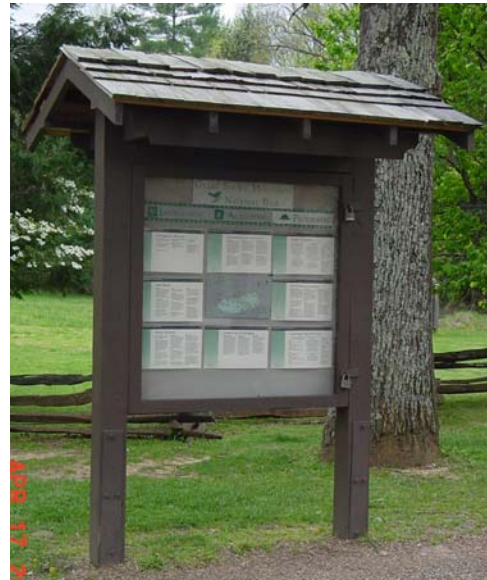
One of the primary issues with interpretive materials within Cades Cove is that there is not enough information being provided to the visitor. A balance between interpretive signing and other methods is needed to educate visitors on the Cove's resources as well as appropriate visitation activities in the Cove. It is recommended that a "Master Sign" plan that covers both interpretation, informational, and traffic control sign needs be a part of the next phase of this project.

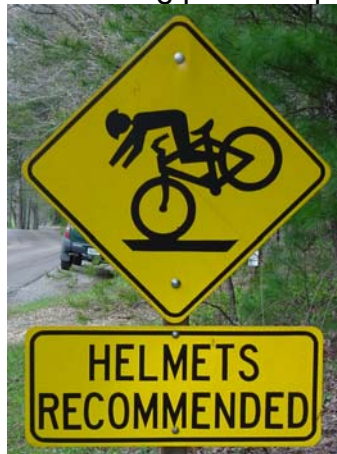
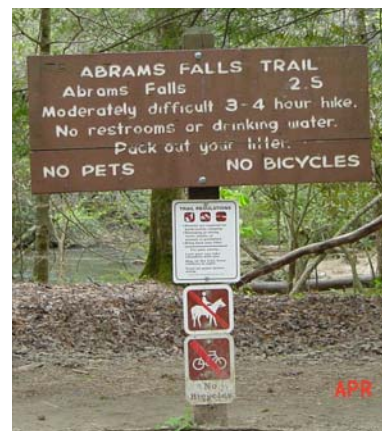
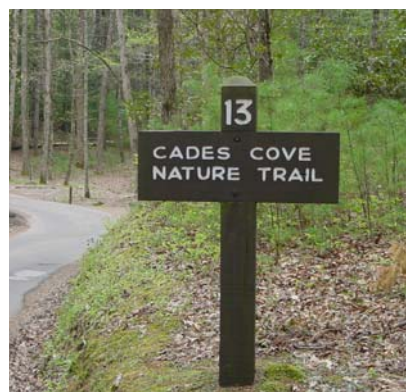
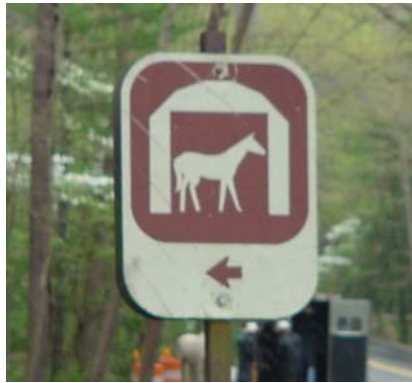
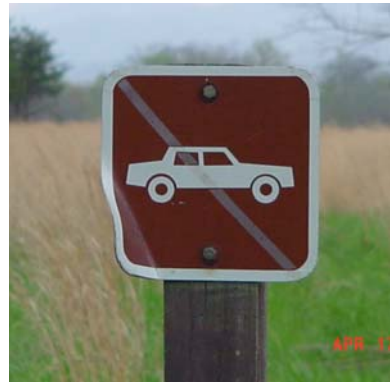
Within the Cove are directional signs, informational signs, traffic control signs and warning signs that vary in type style and nature. These are located along the Loop Road as well as on Sparks and Hyatt lanes (with fewer on these roads than on the Loop Road). The following photos depict some of these signs:

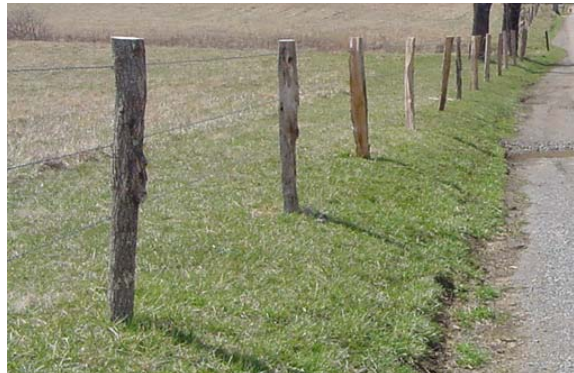
Post and wire fence is the predominant small scale landscape feature within the Cove. This type of fence is used primarily to keep private vehicles from gaining access to the fields and it is consistent with the rural agricultural areas. However, the wire fence requires constant maintenance because visitors often bend the non-barbed portions down or push posts over the wire to gain access to the fields.

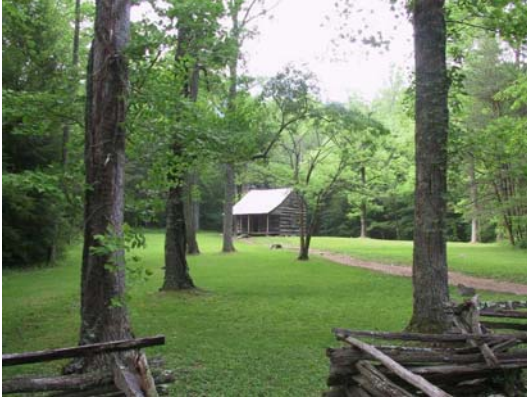
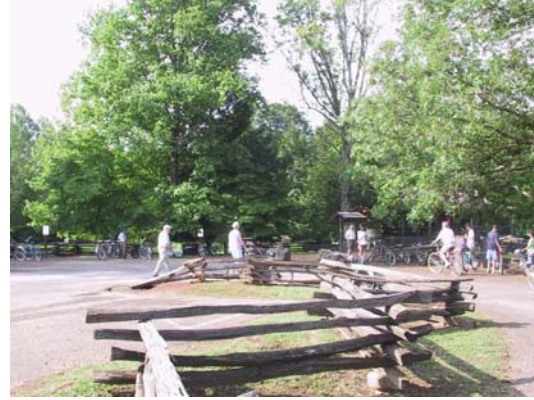
Another style of fencing is the worm or snake fencing that is made from rough hewn logs and can be seen at the entry to the Loop Road as well as at exhibit sites. It may be used to accent historic sites and can be found at the beginning of the Loop Road, around parking areas related to cabins and churches, and at the Cable Mill Visitor Center. The fencing is representative of the settlement era.

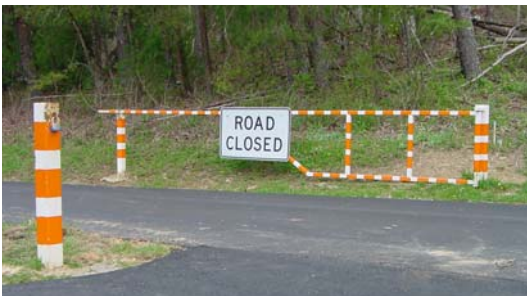
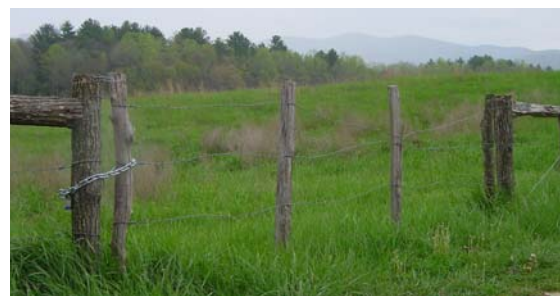
There are two types of management gates in Cades Cove. Steel post gates are used along Laurel Creek Road and at the entry to the Loop Road (and other locations such as Sparks and Hyatt lane). These gates are constructed to effectively close a road to vehicle traffic.

The second is related to managing access to the valley floor. These gates have been installed in conjunction with wire fencing and are used by park staff for field management and research access. (Sample photos are provided below and Figure 5 is a map identifying the location of gates.)

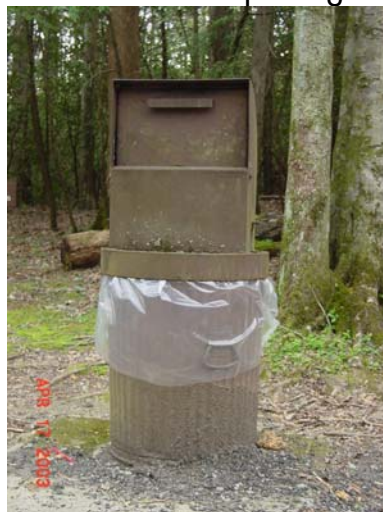
Garbage cans are located at larger visitor areas such as the visitor orientation and Cable Mill area. These are small bear proof garbage cans are illustrated below.
