National Park Service  
Cultural Landscapes Inventory  
2009

Washington Monument Grounds  
Washington Monument

Washington Monument Grounds  
 Washington Monument

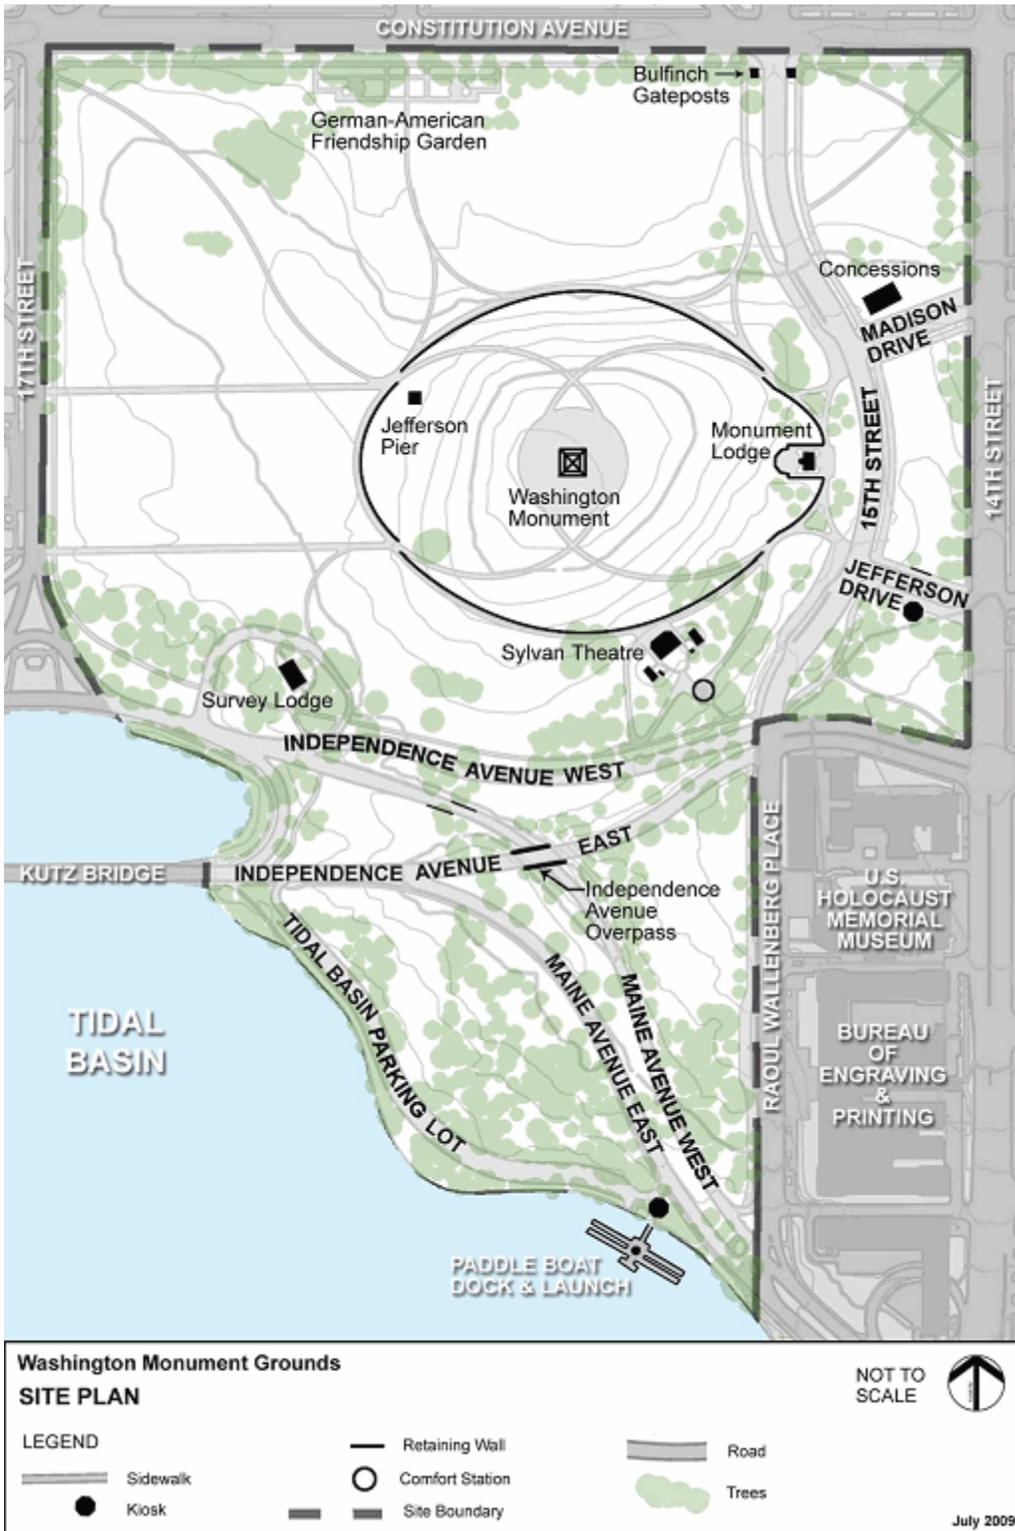
*Site Plan, Washington Monument Grounds 2009*

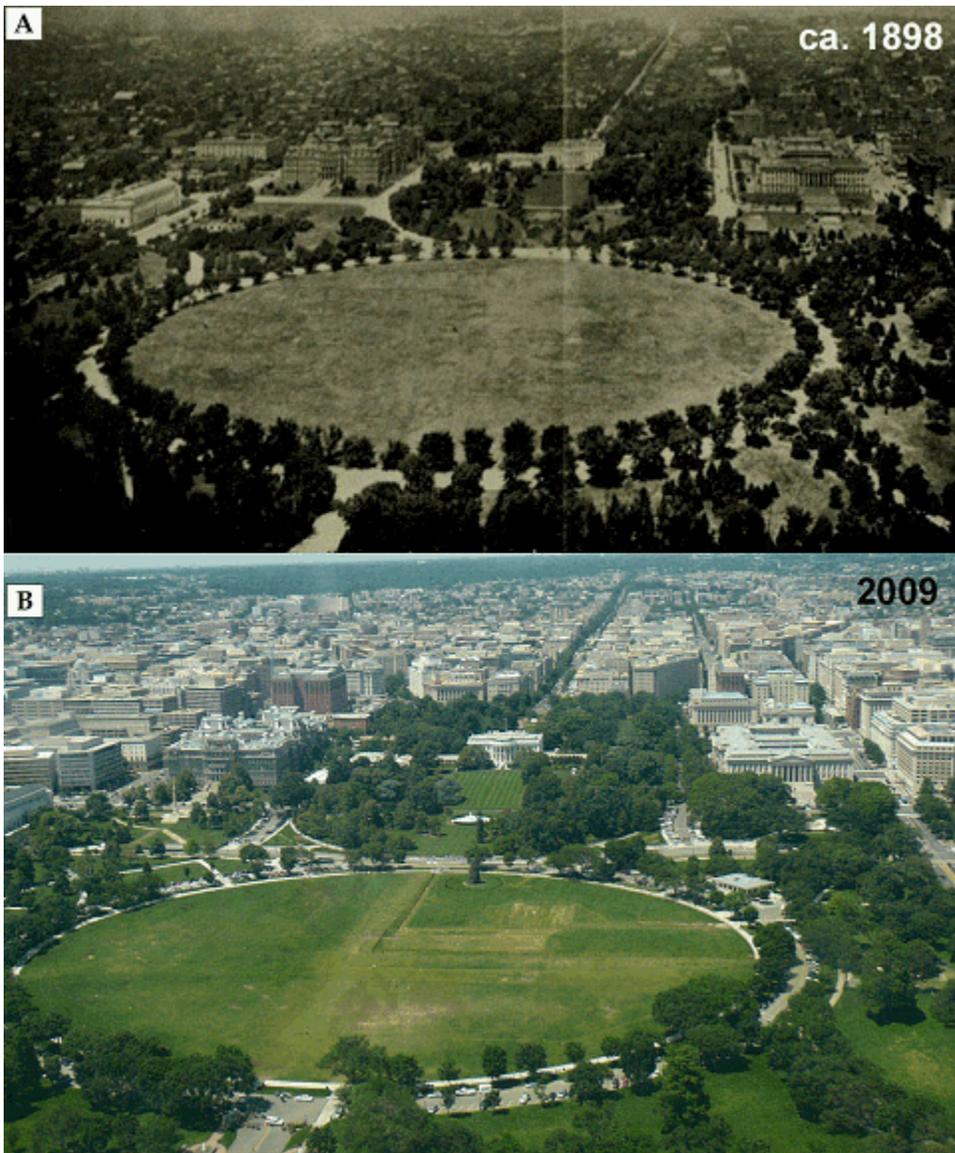
*View north from the top of the Washington Monument to the White House (A. Report of the Chief of Engineers, 1898 and, B. NCR CLP 2009).*

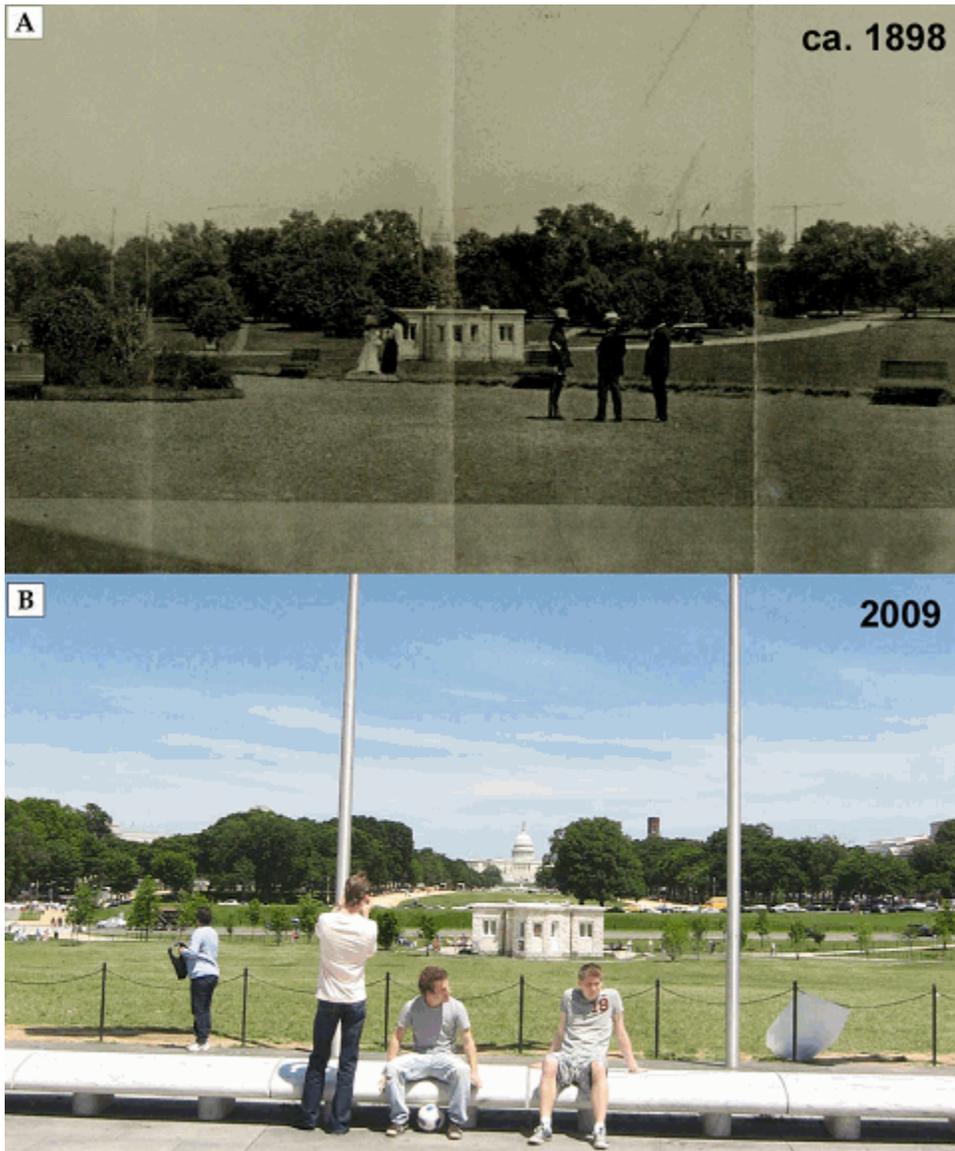
*View east from the base of the Monument to the Mall and U.S. Capitol (A. Report of the Chief of Engineers, 1898 and, B. NCR CLP 2009).*

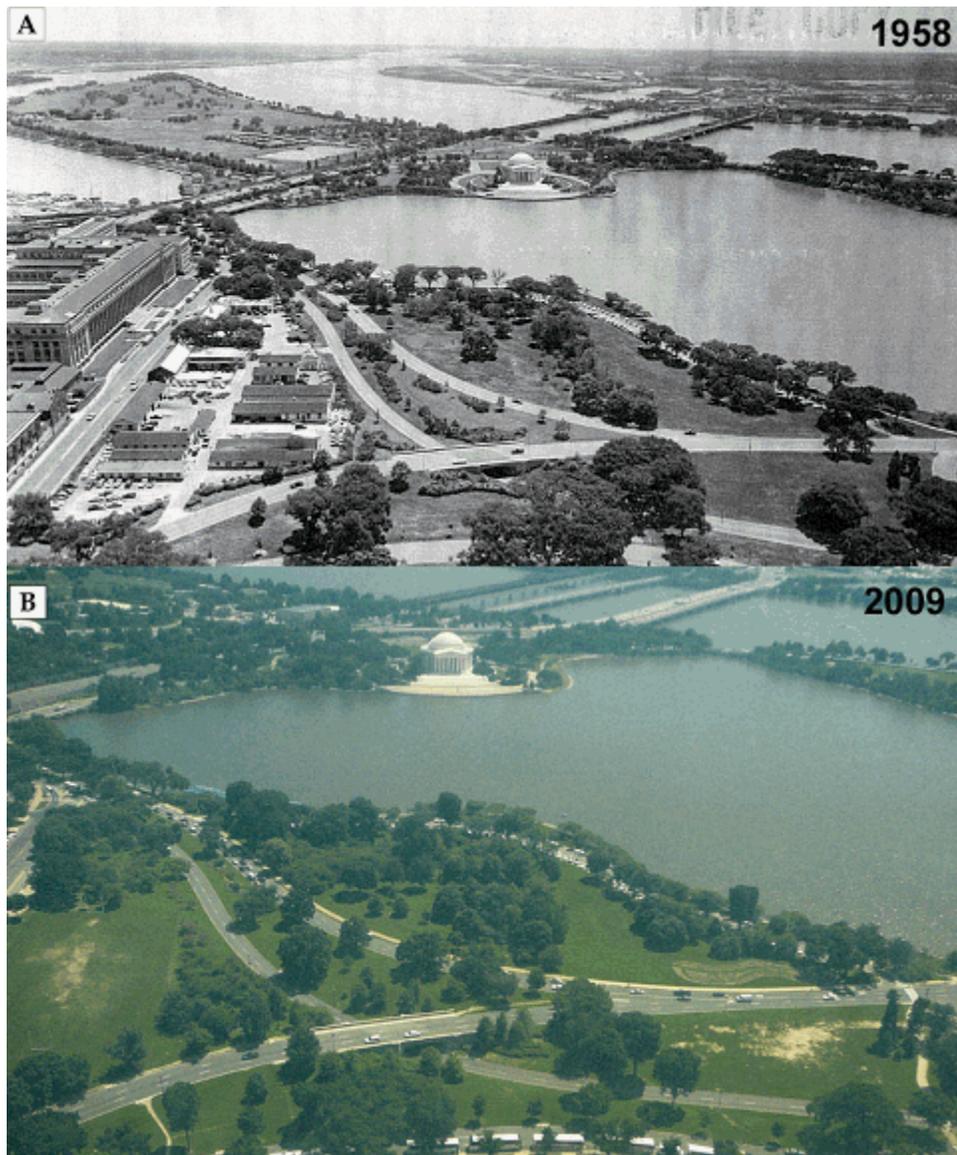
*View south from the top of the Monument to the Thomas Jefferson Memorial. The 1958 view includes remaining shops that were removed in 1962 (A. National Park Service, Abbie Rowe, May 14, 1958 and, B. NCR CLP 2009).*

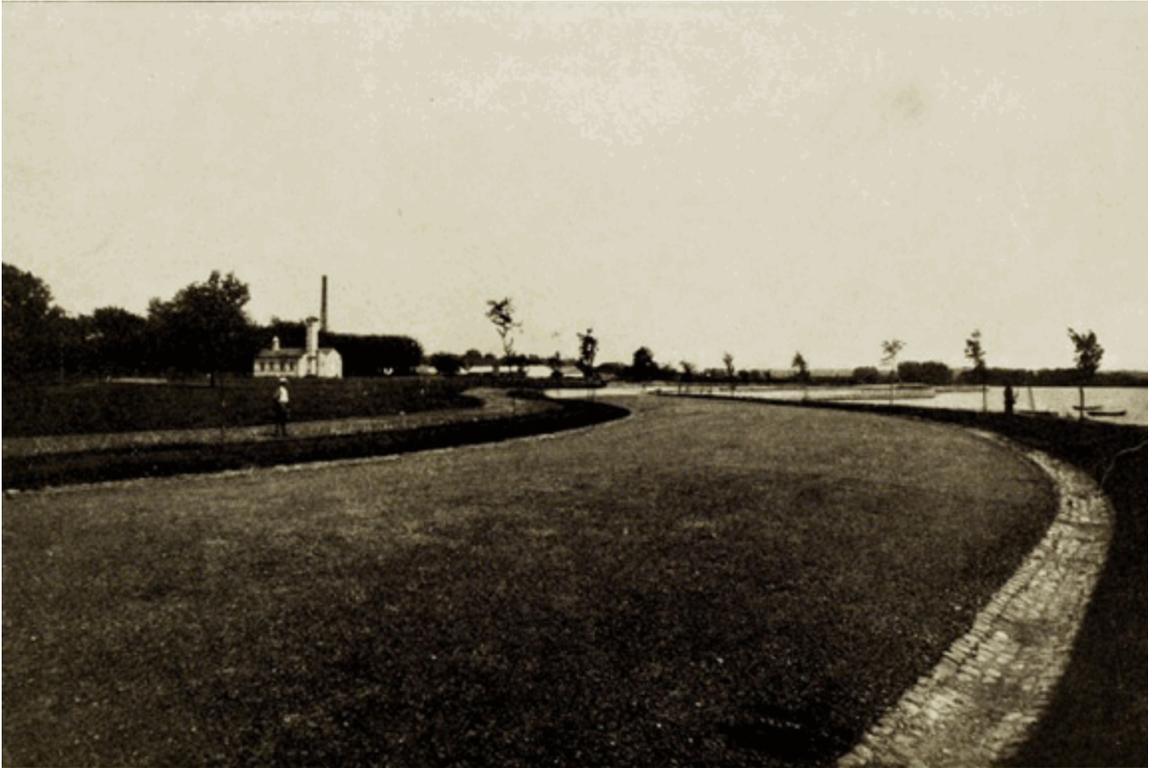
*Photograph of the Survey Lodge and the newly created River Road that connected 17th Street to 15th Street (Report of the Chief of Engineers, 1903).*

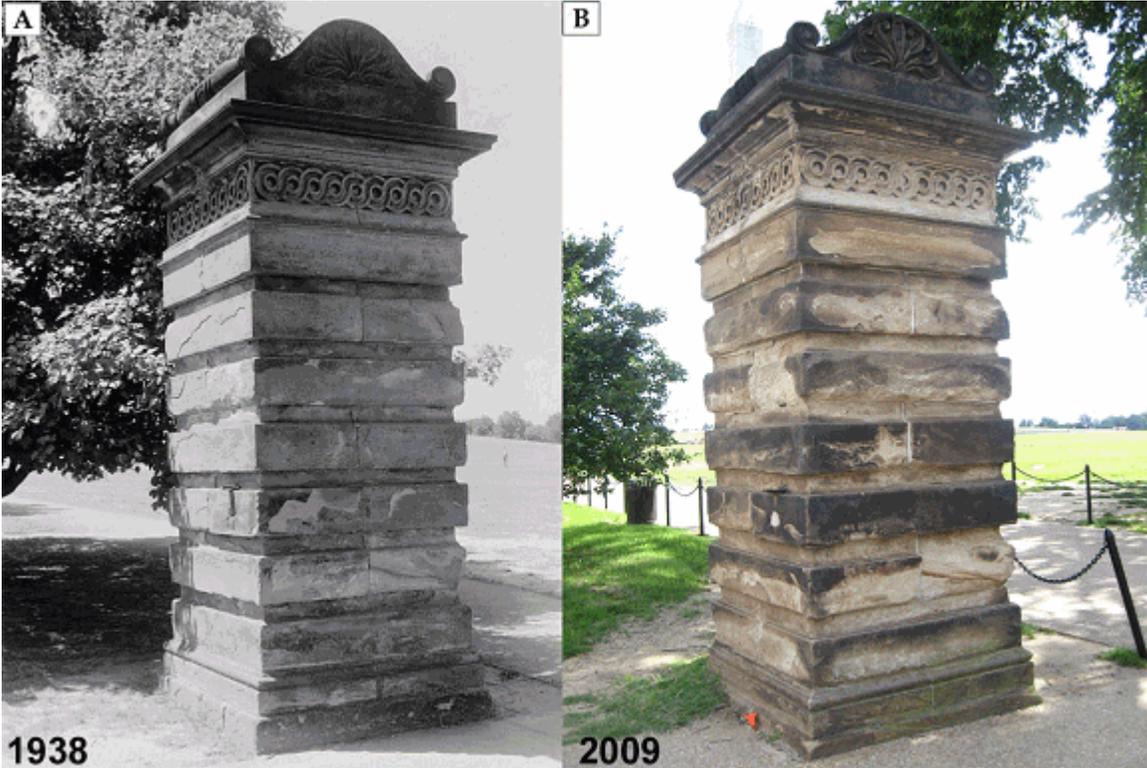
*Bulfinch gatepost at the southwest corner of 15th Street and Constitution Avenue (A. HABS, Thomas T. Waterman, 1938 and, B. NCR CLP 2009).*

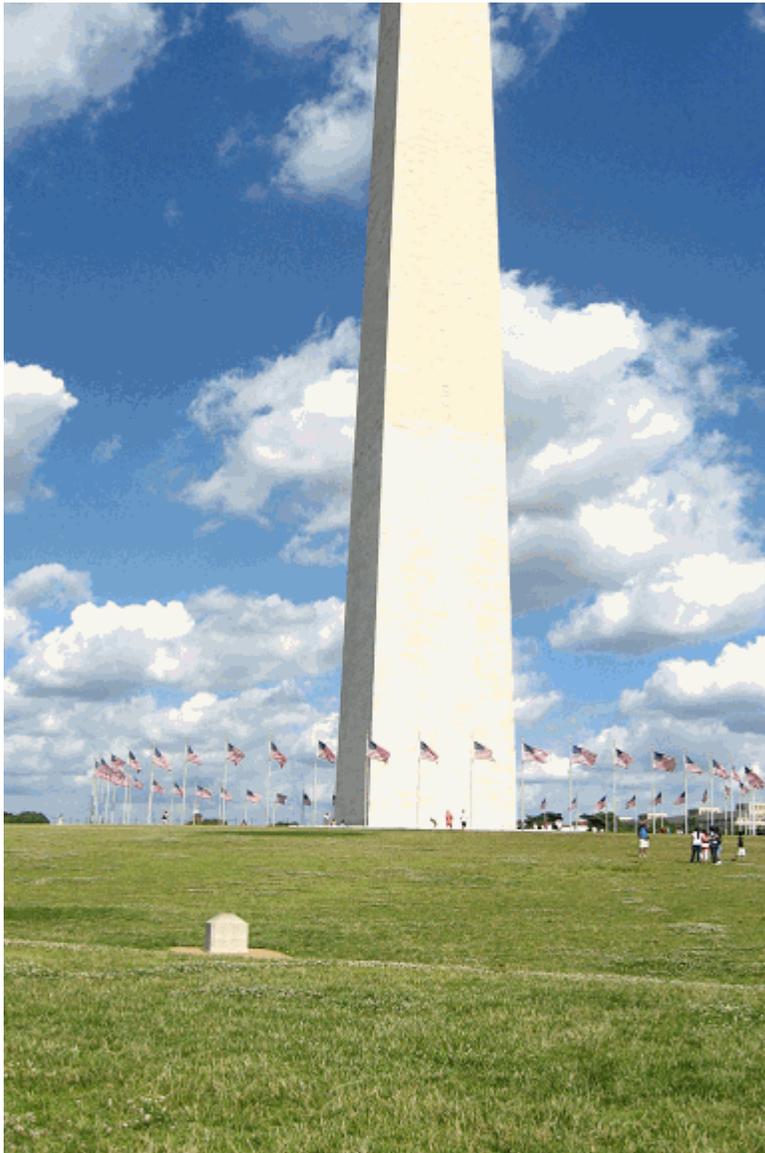
*Washington Monument and Jefferson Pier (NCR CLP 2009).*

“The location of the intersection of the two axes or meridian—one extending south from the White House, and the other west from the Capitol—was first demarcated in 1793 with a wooden post. The stone Jefferson Pier replaced the wooden posts in 1804. The present marker is a replacement for the original, which was unintentionally destroyed in 1872 (CLR 2003:4-20).” In 1889, the stone was re-erected as it stands today. The pier is a two-foot by two-foot block of granite, 3 feet, 3 inches tall. Its western face was inscribed: “Position of Jefferson / Pier Erected Dec 18, 1804. / Recovered and Re-erected / Dec 2, 1889 / District of Columbia.” It is located 371.6 feet west and 123.17 feet north of the Washington Monument.

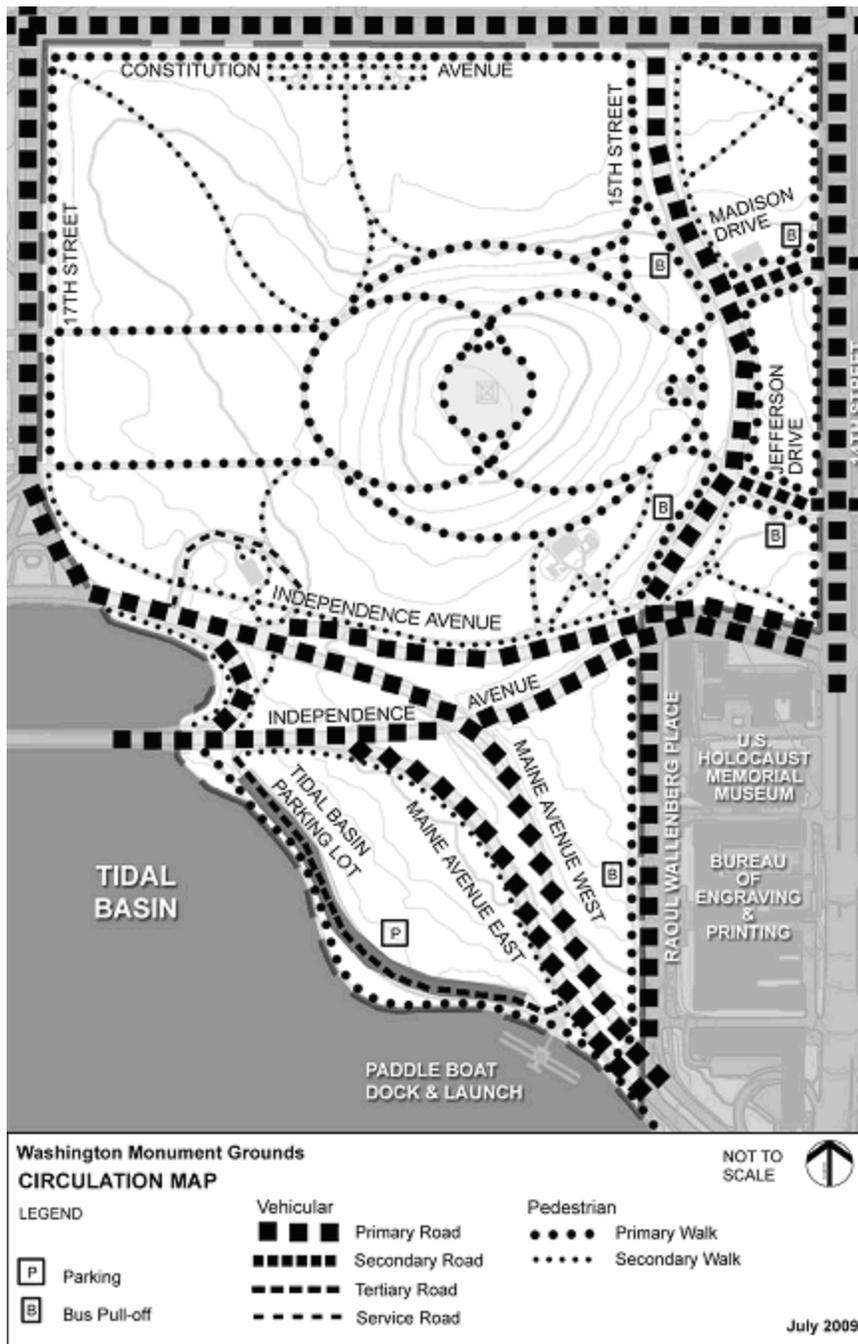
*Existing conditions circulation map.*

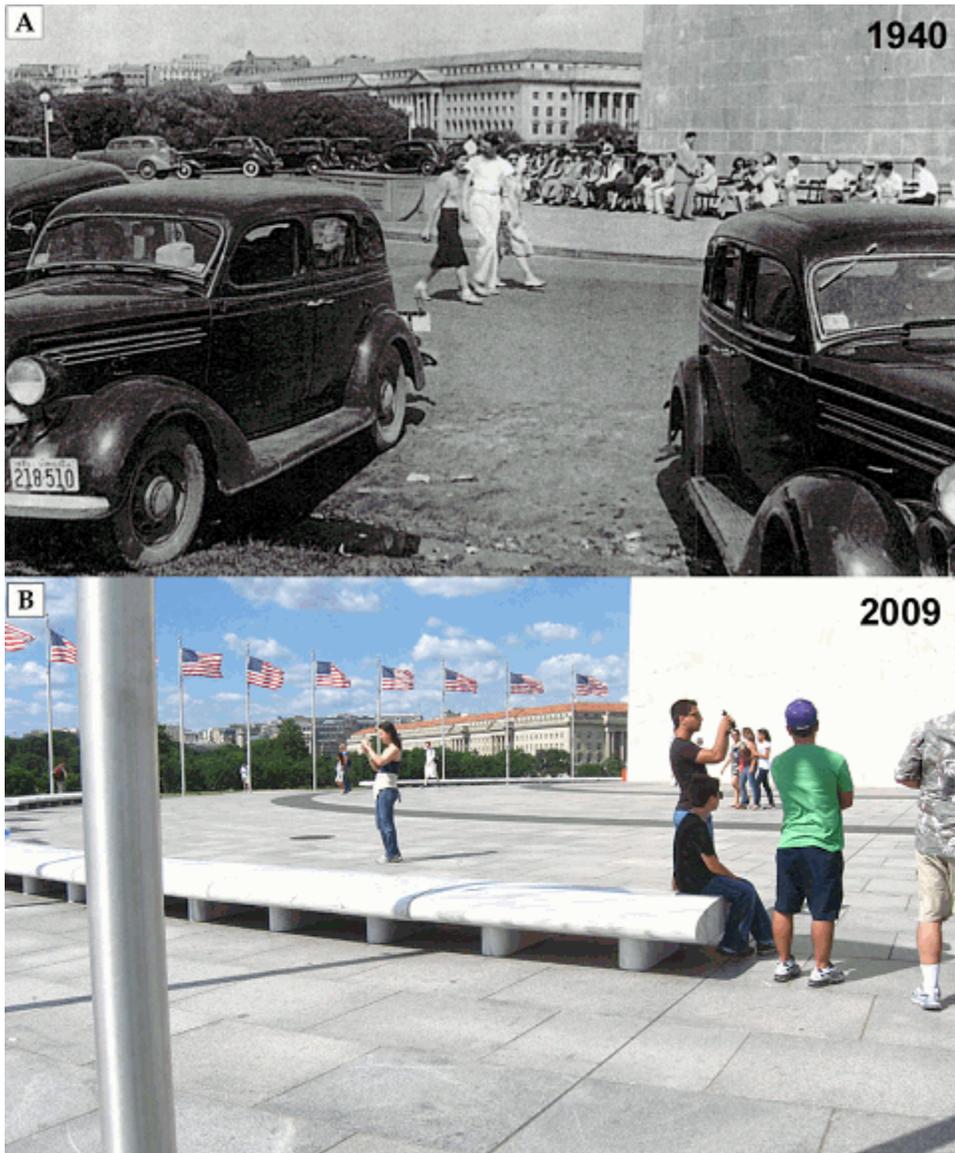
*West side of the Monument plaza (A. “Monument Grounds – Rear of Monument”, September 1940 and, B. NCR CLP 2009).*

The current monument plaza was created as part of the 2004-2005 grounds security improvements. The original size of the plaza was retained, but the concrete and asphalt surface was replaced with the two colors of granite. It is comprised of three concentric circles of lighter granite (Ash Rose), between which the darker colored granite (Mesabi Black) was placed.

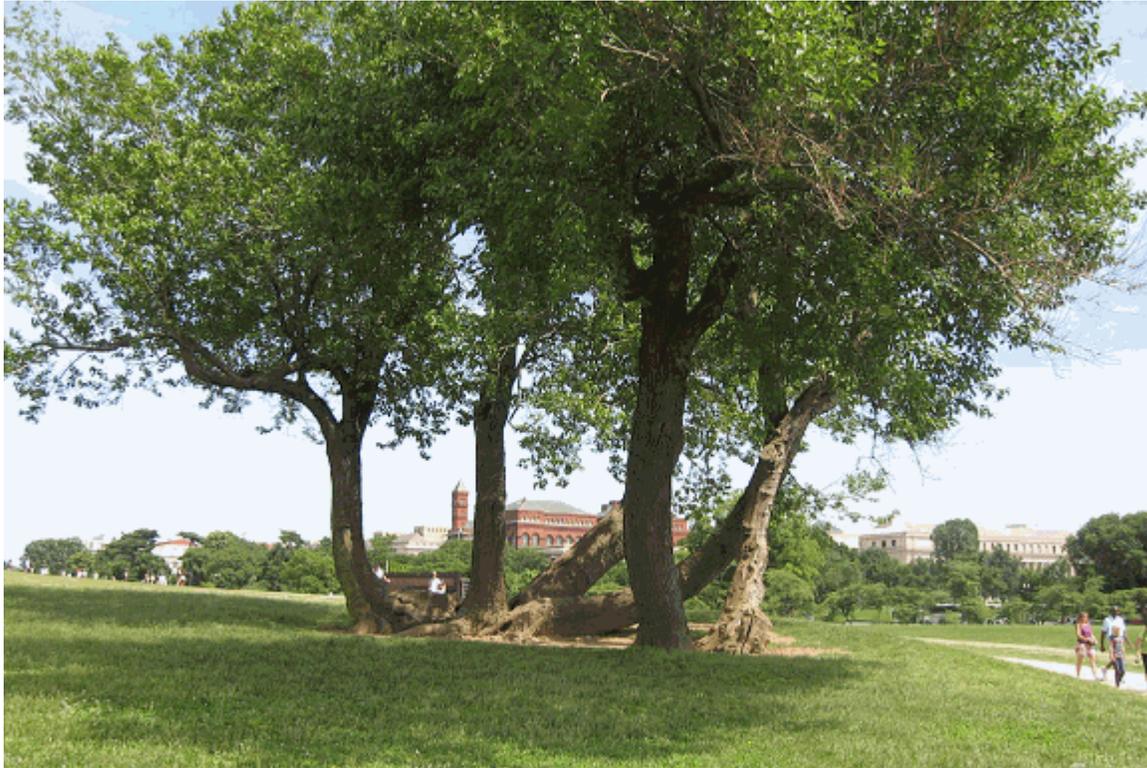
*Historic mulberry trees located southwest of the Washington Monument (NCR CLP 2009).*

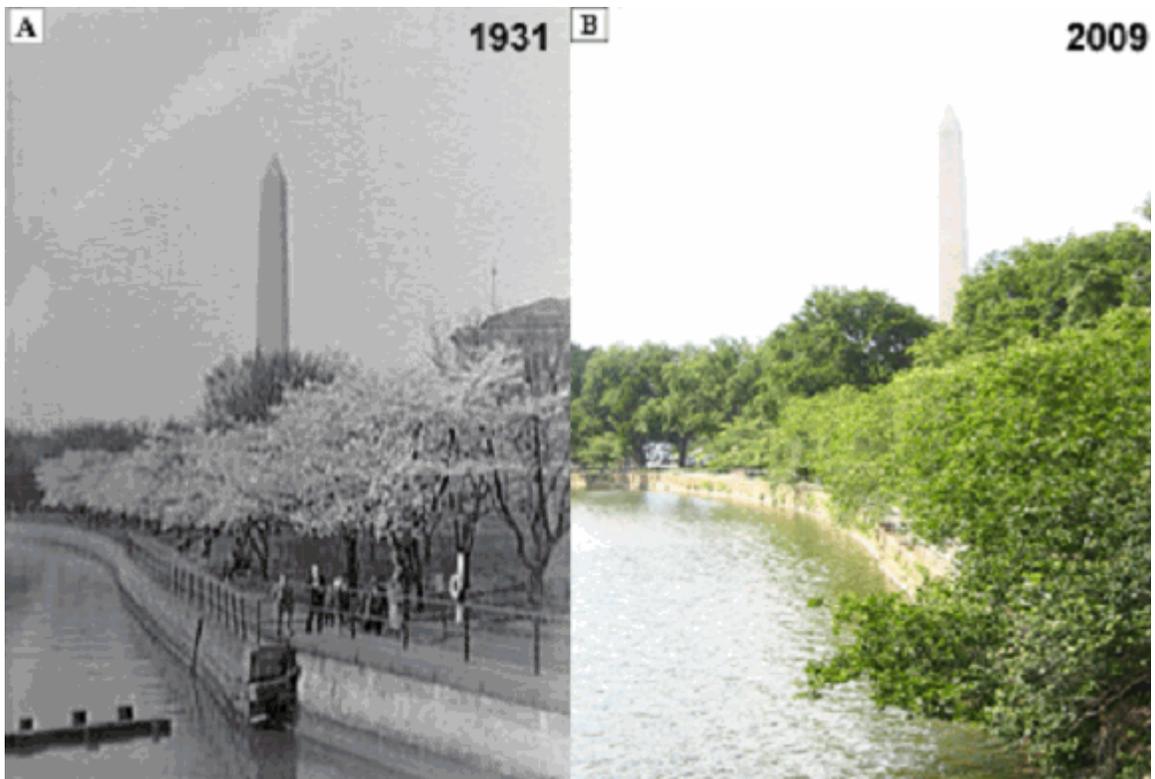
*Tidal Basin seawall along the southern edge of the Washington Monument Grounds (A. LC-H812- 1186-003 and, B. NCR CLP 2009).*

AD 1895 - 1896	Built	Construction of the Tidal Basin seawall began in April 1895 and was completed in September 1896.
	Built	A new brick propagating house was erected (130' x 8' x 8'). An addition on the south side of the building was constructed of old materials (130' x 9' x 8'). The grounds were graded and plant benches were constructed for the new carnation house that was built during July and August 1896.
AD 1896 - 1897	Built	One of the old greenhouses in the propagating gardens was replaced by a new, glass structure.
AD 1898 - 1899	Built	A new greenhouse was built at the propagating gardens, measuring 112 feet long and 25 feet wide. A heated pit was added to the propagating house. The pit was constructed of brick and measured 130 feet long, 12 feet wide, and three feet deep.

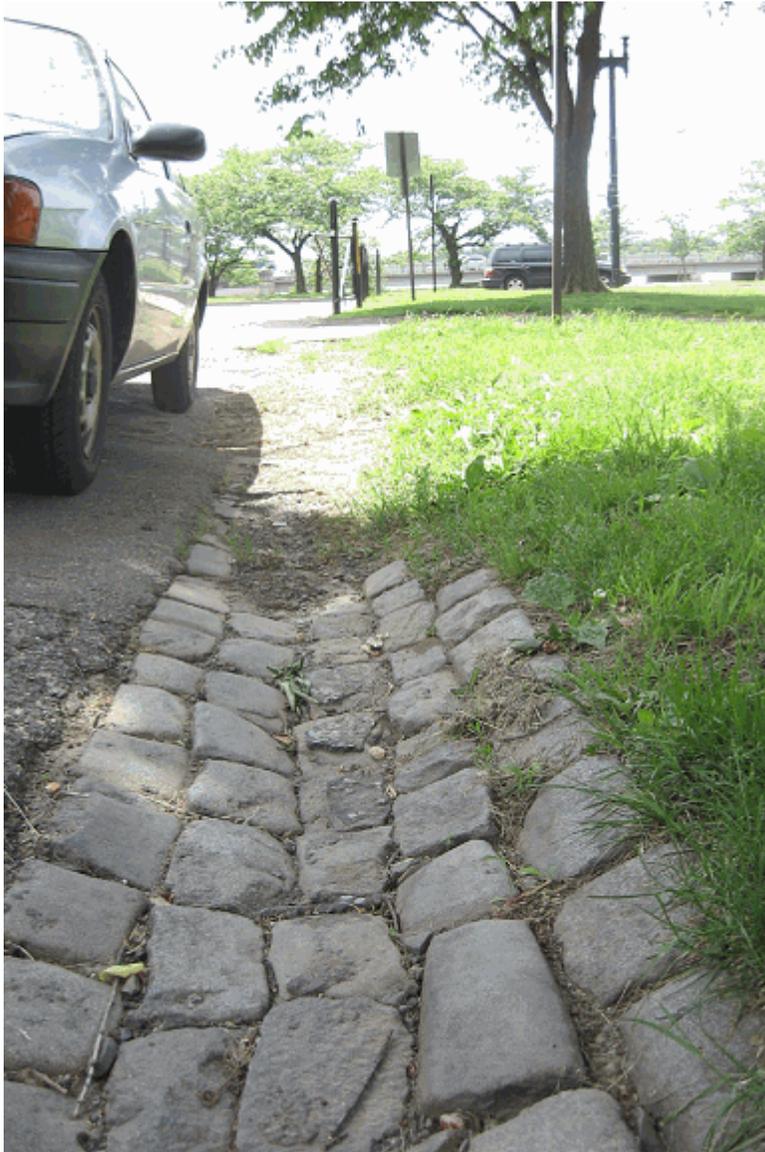
*Stone-lined drainage ditch along the Survey Lodge service drive (NCR CLP 2009).*
