## C&H Activities (*Industrial Core*)—1871-1889

Keweenaw National Historical Park  
Cultural Landscape Report & Environmental Assessment

## 1871-1889 Period of Change Plan

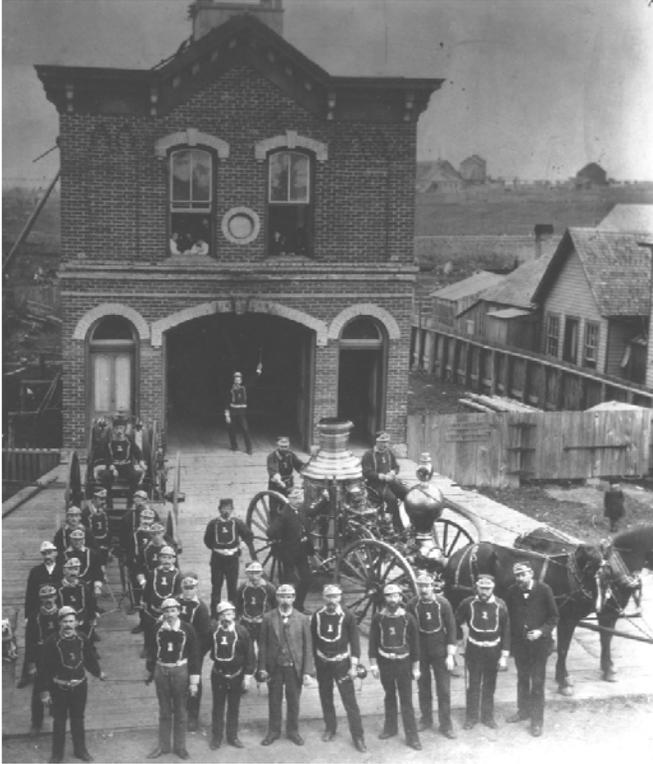
1  
2 **Figure II - 8: Old Red Jacket Fire Department and Town Hall, 336 Fifth Street,**  
3 **Red Jacket/Calumet, ca. 1880** (source: NPS, Keweenaw NHP, Andrew C. Curto  
4 Collection, Album 8, #011)  
5

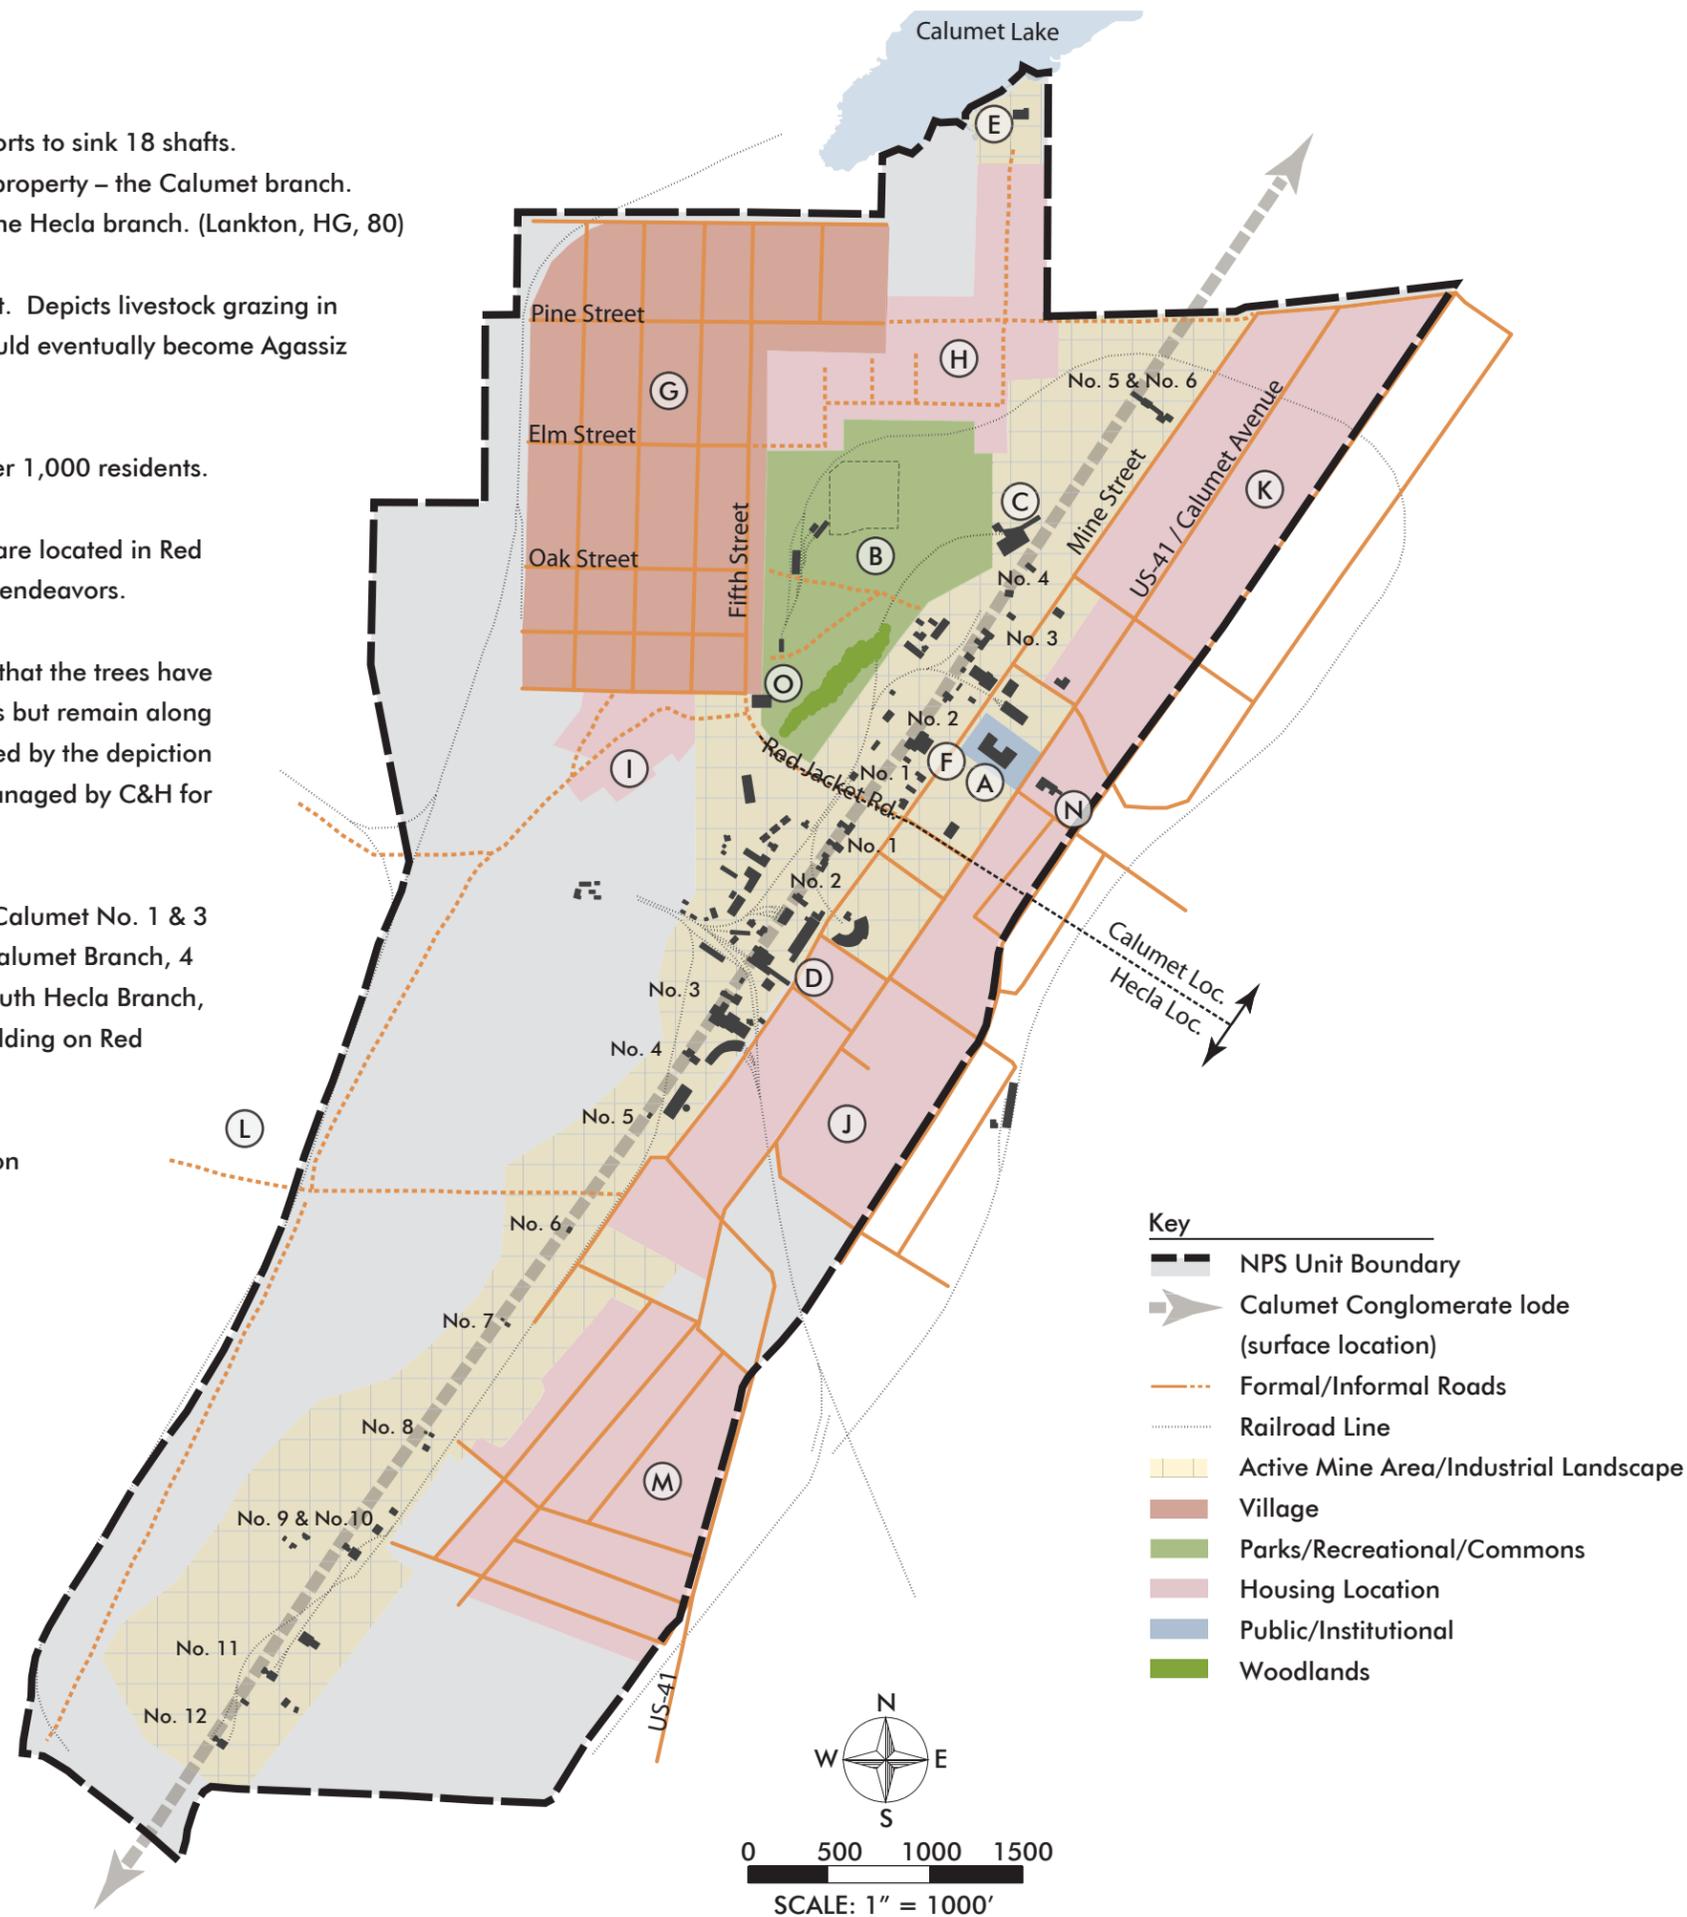
Figure II-9

### **Figure II - 9: Calumet Period of Change Plan, 1871-1889**

#### **Sources for Figure II-9: Calumet Period of Change Plan, 1871-1889**

- Lithograph, Birds Eye View of Calumet, Hecla and Red Jacket, 1871 (NPS, Keweenaw NHP, Jack Foster Collection, Series I (001), Sub-series A (C and H), Sub-series (01) Library, #016)

- Map, Calumet and Hecla Mine Location 1886
- Lithograph, Birds Eye View of Calumet, Hecla and Red Jacket, 1881 (NPS, Keweenaw NHP, Jack Foster Collection, Series I (001), Sub-series A (C and H), Sub-series (01) Library, #015)

- Photo, Old Washington School, 1875 (NPS, Keweenaw NHP, Jack Foster Collection, Series I (001), Sub-series A (C and H), Sub-series (01) Library, #048)

- Photo, Calumet and Hecla Mining Co. Calumet No. 3 Shaft Mine Fire, 1888 (NPS, Keweenaw NHP, Jack Foster Collection, Series I (001), Sub-series A (C and H), Sub-series (01) Library, #084, (1~1))

- Photo, Bluejacket Taken from the Smokestack at Calumet, 1885 (NPS, Keweenaw NHP, Andrew C. Curto Collection, Album 5, 019)
- Photo, Calumet and Tamarack Location from Calumet Stack-Isler, 1885 (NPS, Keweenaw NHP, Andrew C. Curto Collection, Album 12, #006)

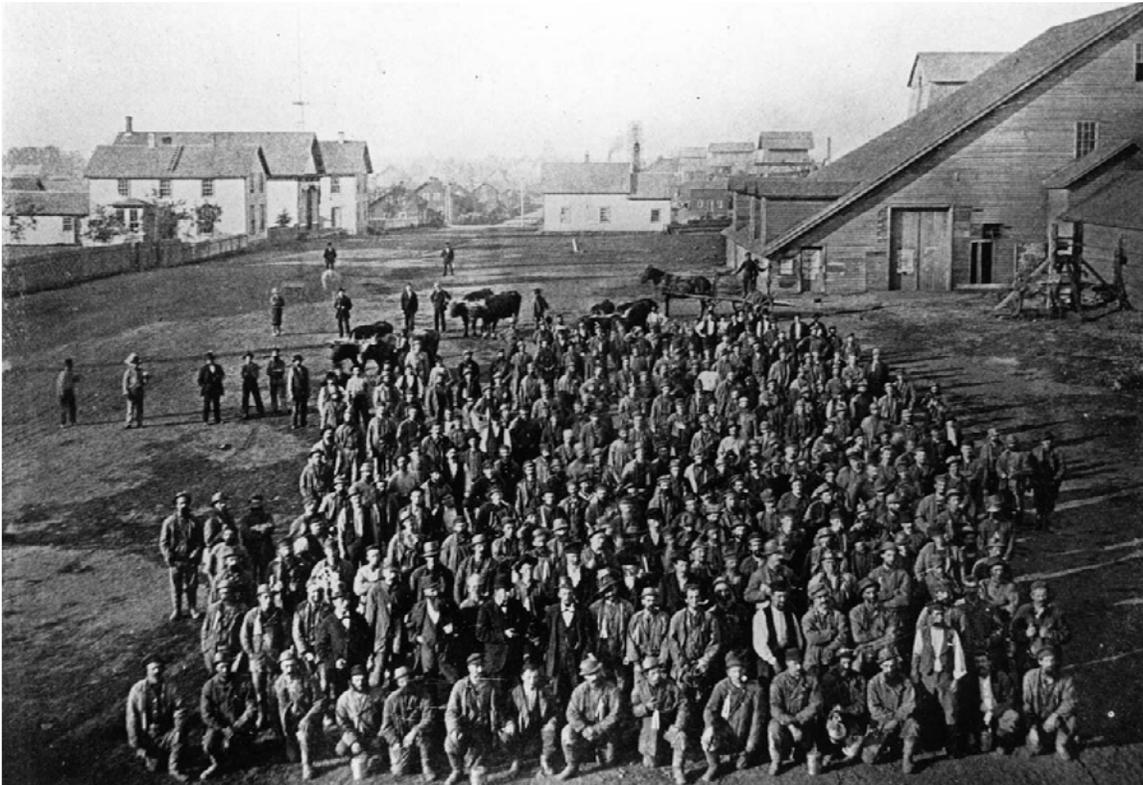
19  
20 **Figure II - 10: Day and night shift of C&H Mine on Mine Street in Calumet, 1874.**  
21 (source: NPS, Keweenaw NHP, Andrew C. Curto Collection, Album 12, #116 and #118)  
22

1 By 1880, the majority of the non-industrial activities had moved from Mine Street to the  
2 Village of Red Jacket. Mine Street was highly developed and functioned as the primary  
3 circulation spine of the industrial core of the C&H mining activities (see Figures II-7  
4 through II-11). The route paralleled the Calumet Conglomerate lode, running in a  
5 southwest to northeast direction. This alignment was initially established on the surface  
6 by the alignment of the shafts along the angle of the lode. Mine Street and the other  
7 streets on C&H property were aligned with this common angle, running either parallel or  
8 perpendicular to it. Tramroads were constructed at the same angle and tramcars  
9 transported rock from the shafthouses to the rockhouses. The two rockhouses were  
10 adjacent to railroad lines allowing trains to load material to be conveyed to the stamp  
11 mills at Lake Linden. Other industrial structures present included two large engine

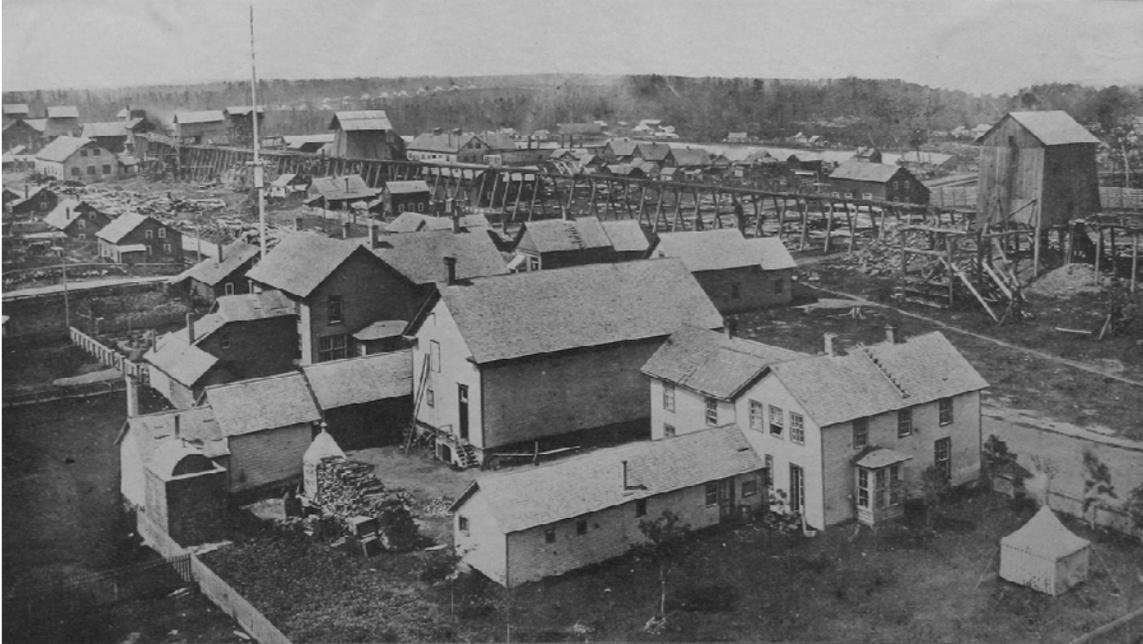
1  
2 **Figure II - 11: Calumet housing adjacent to the industrial works, ca. 1880** (source:  
3 Smithsonian, 201001 14 057, Frank Klepetko Album)  
4  
5  
6

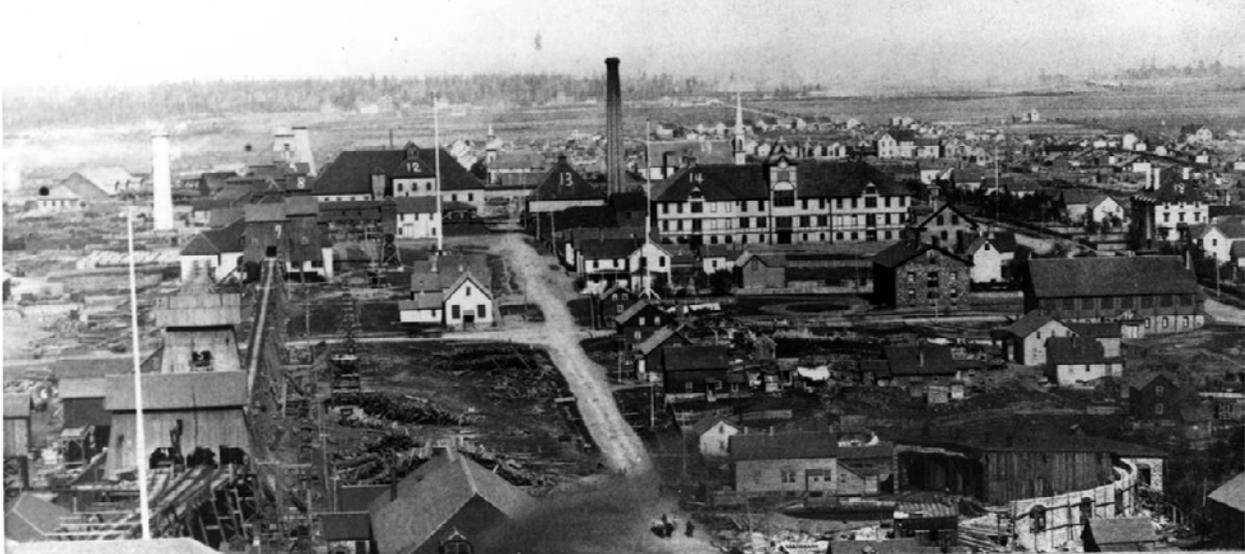
1  
2 **Figure II - 13: Mine Street looking north, 1888.** (source: NPS, Keweenaw NHP, Jack  
3 Foster Collection, Series II Assembled Albums (002), Book 16, #003; also in Jack Foster  
4 Collection, Series I (001), Sub-series A (C and H), Sub-series (01) Library, #406)  
5

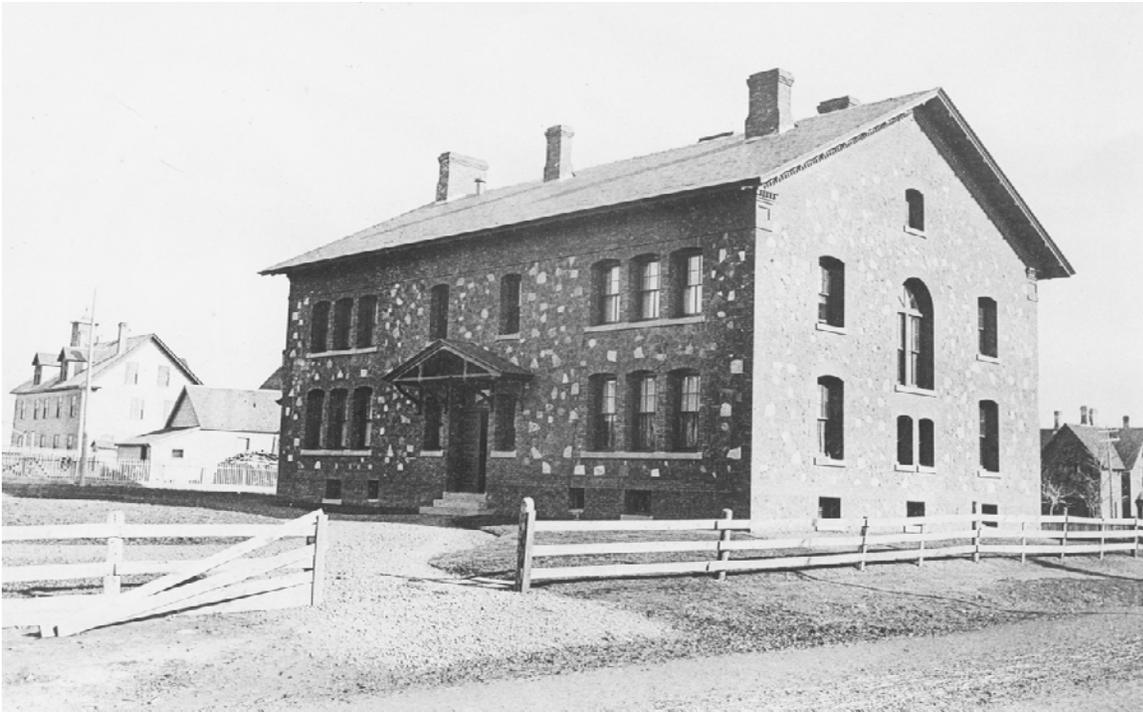
6  
7 **Figure II - 14: The general office of the C&H Mining Company was constructed**  
8 **using poor rock from the mines. Note the lawn and fence, ca. 1885.** (source: NPS,  
9 Keweenaw NHP, Jack Foster Collection, Series II Assembled Albums (002), Album 28,  
10 [C&H General Offices] R. Acton)  
11
