1 **Overall Project Area - Views**

10
11 This section includes photographs of existing views, indicated as “EV- .” The locations of these
12 views are illustrated in Figure III-36: “Calumet Unit Existing Views.” Also included are historic
13 views, indicated as “HV-“ and illustrated in Figure III-37: “Calumet Unit Historic Views.” Each
14 image includes a caption and brief statement regarding the view. When possible, views are
15 groups to allow comparison of changes to views over time, as well as common characteristics
16 throughout the unit. Additional statements addressing these comparisons are found at the bottom
17 of the page associated with the images they address.

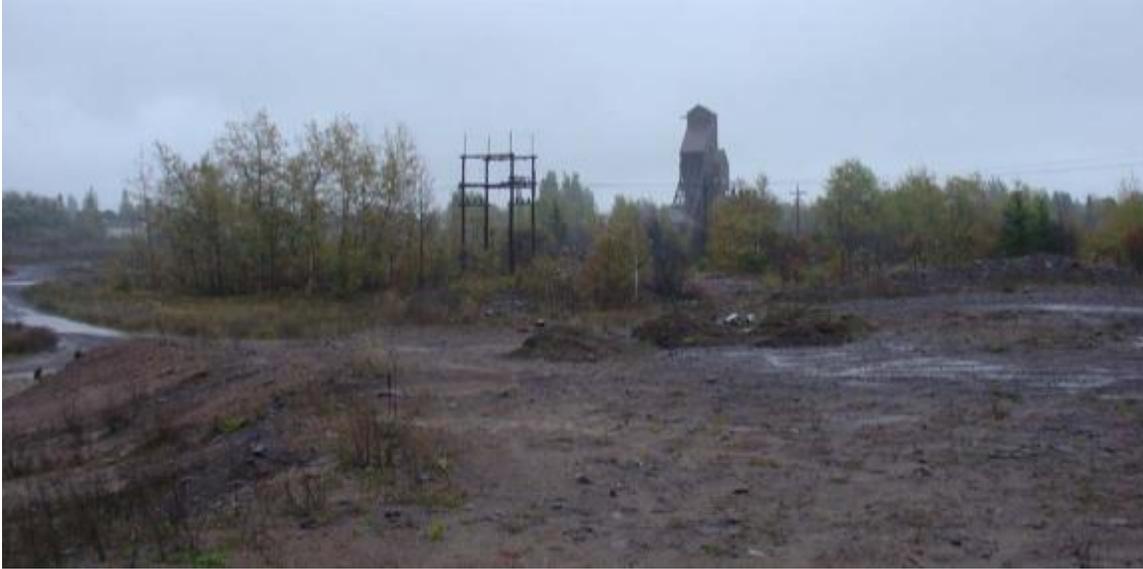
1
2 **Figure III- 12: EV.1 / Existing View 1, Osceola No. 13, shaft-rockhouse, 2010**
3 (source: QEA 7345)

4 View facing east from near Mine Street illustrates the Osceola shaft/rockhouse number 13 and
5 surrounding landscape. The area includes uneven ground with stockpiles of rock and dirt, areas
6 where volunteer vegetation has grown, an unimproved road, and overhead utility lines.

14
15 Both of the views above are somewhat similar to the character of views within the industrial
16 corridor during the historic periods. The main difference is the lack of industrial equipment and
17 activities as well as the addition of vegetation that would not have been present historically. The
18 rugged character of the area represents the historic character that is difficult to capture with
19 manicured landscapes.

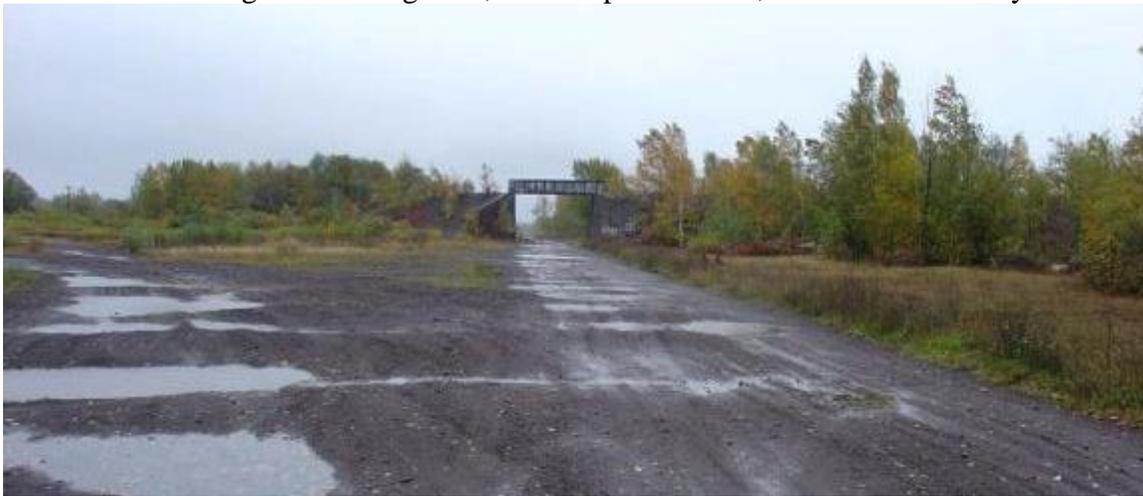
7
8 **Figure III- 13: EV.3 / Existing View 3, Railroad Corridor facing north, 2010**
9 (source: QEA 7384)

10 The railroad corridor includes a roughly graded atv/snowmobile route surfaced in gravel and dirt.
11 There are many large potholes and irregularities in the route. The railroad overpass is a remnant
12 of a historic industrial feature related to the movement of mine materials. The edges of the
13 corridor include volunteer vegetation and industrial artifacts.

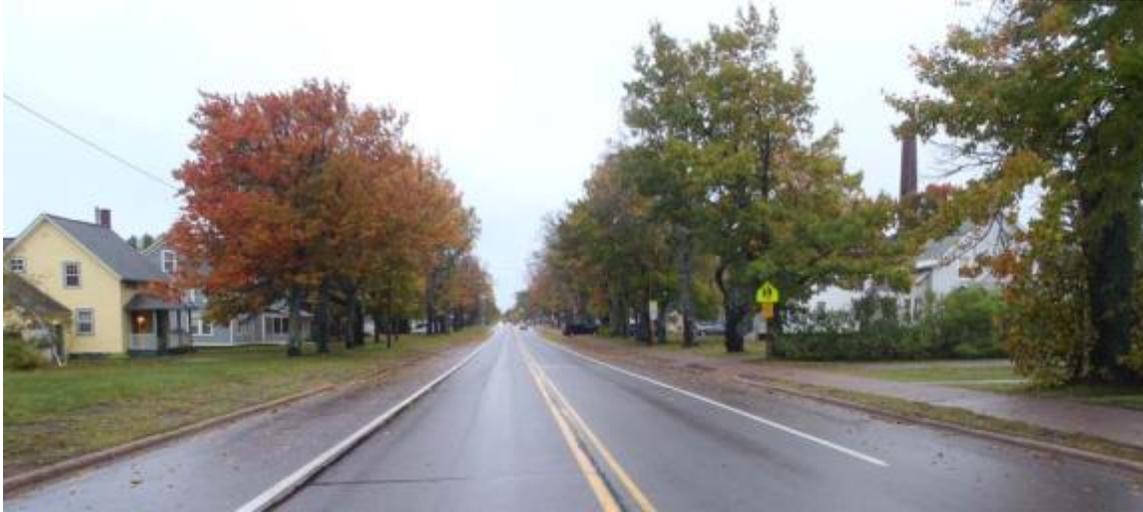
1
2 **Figure III- 14: EV.5 / Existing View 5, Calumet Avenue facing south, 2010**

4 Calumet Avenue/U.S. 41 is a primary transportation route through the region. Entering the
5 Calumet unit from the north (heading south) on this road, the residential character of Calumet is
6 apparent. While this character is also apparent when heading in a northerly direction, the view is
7 pronounced when heading south, due to the slope of the landscape. The consistent set back of
8 the houses, presence of lawns, sidewalks, and street trees, all contribute to the character of this
9 corridor. This portion of U.S. 41 presents a unique character compared to the highway north and
10 south of Calumet. In other areas, views from the highway alternate between dense woodland and
11 commercial strip development.

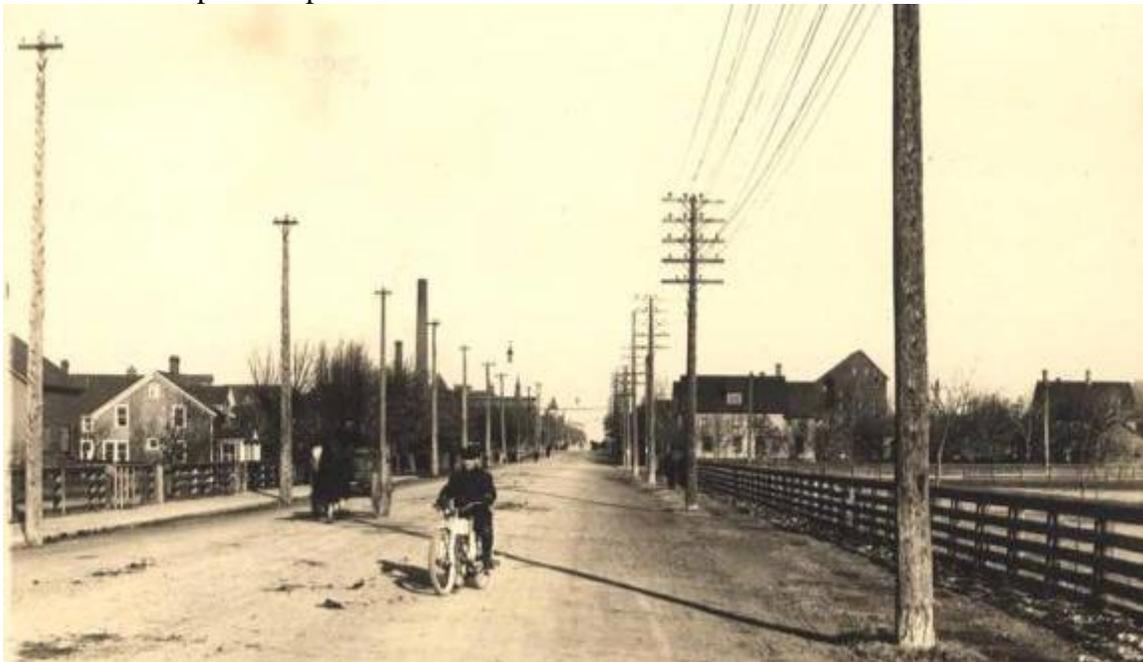
12
13 **Figure III- 15: HV.6 / Historic View 6, Calumet Avenue facing North, 1910** (source:

15 Calumet Avenue during the historic period was already a major regional transportation route.
16 Fences were likely used to keep livestock from wandering into the road.

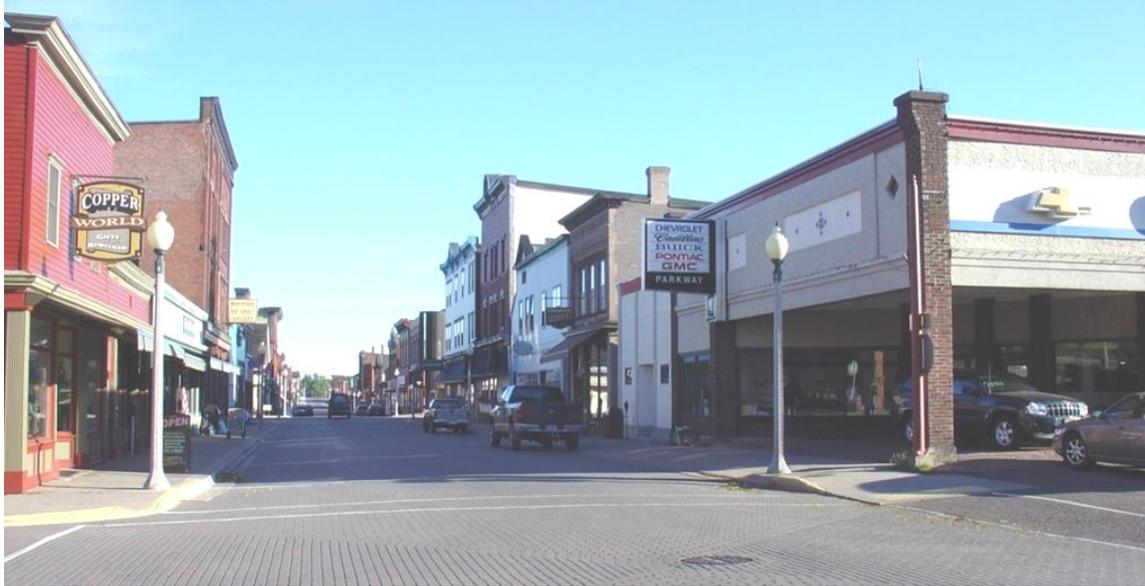
1
2 **Figure III- 16: EV.8 / Existing View 8, Fifth Street at Scott Street facing north,**
3 **November 2010** (source: QEA 6456)
4 Upon turning the corner from Red Jacket Road to Fifth Street, views include the historic
5 downtown scene. Although the car dealership at the corner of Scott and Fifth is incongruent with
6 the historic character, the historic storefronts, brick paving, historic style light fixtures and
7 consistent building massing establish a strong historic setting.

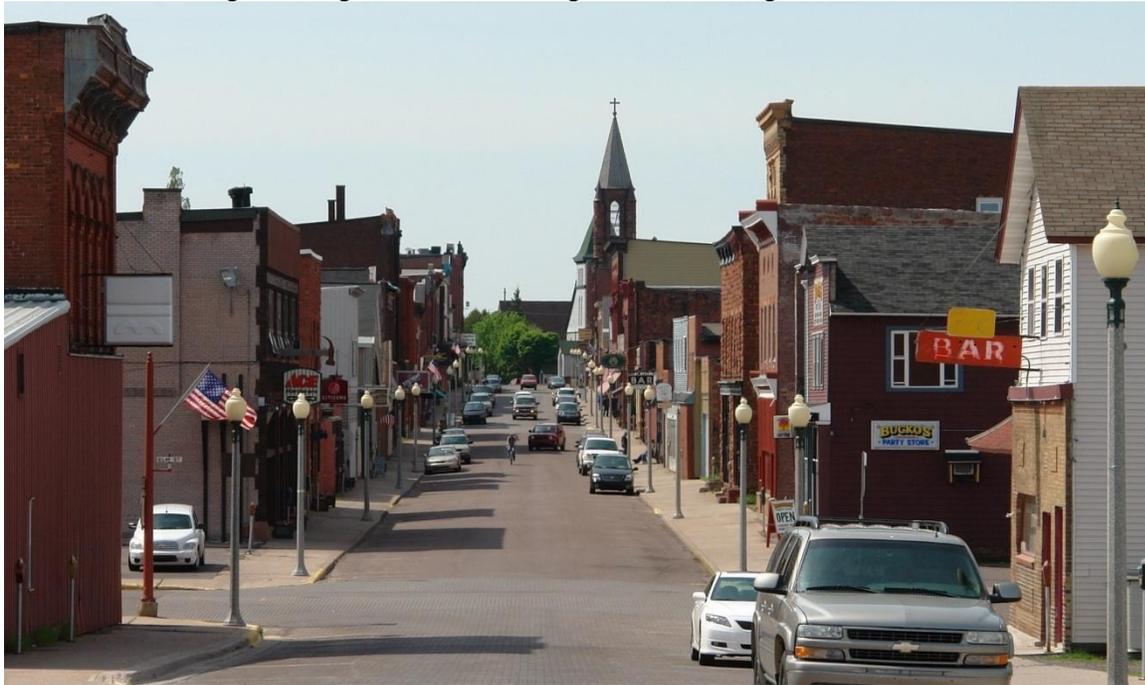
8
9 **Figure III- 17: EV.9 / Existing View 9, Fifth Street facing south, June 2011**
10 (source: QEA 9062)
11 The view of the Fifth Street facing south is enhanced by the rise in topography toward Elm
12 Street. The historic storefronts, brick paving, historic style light fixtures and consistent building
13 massing establish a strong historic setting. Non-historic building materials, signs and other
14 elements detract from the historic character but the overall impact is not substantial.

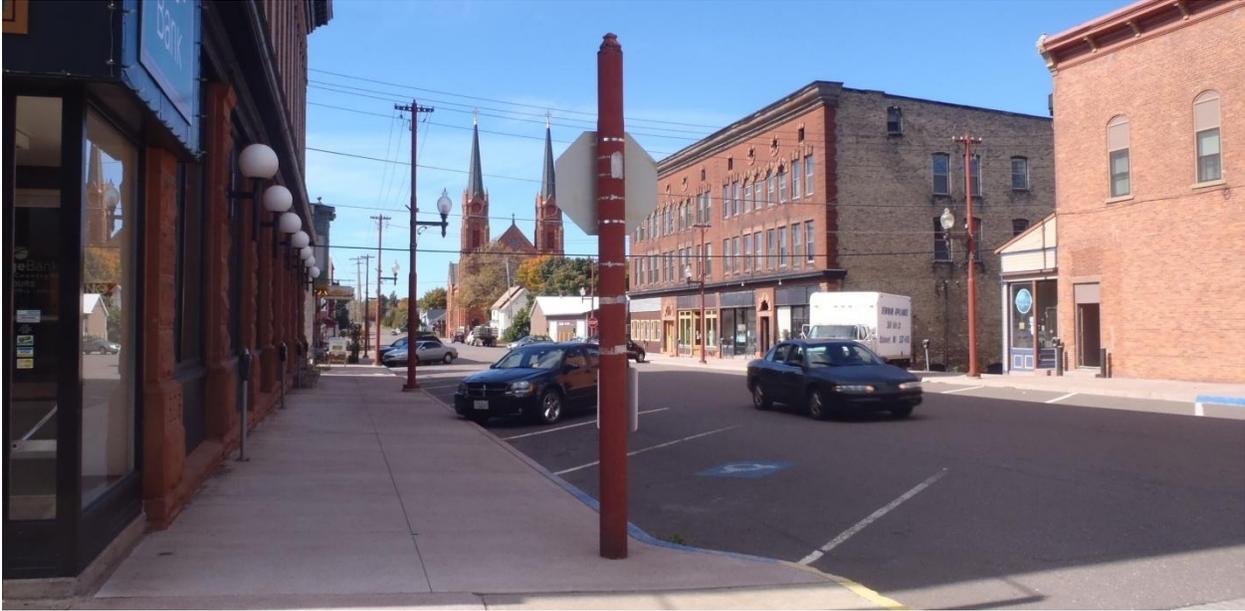
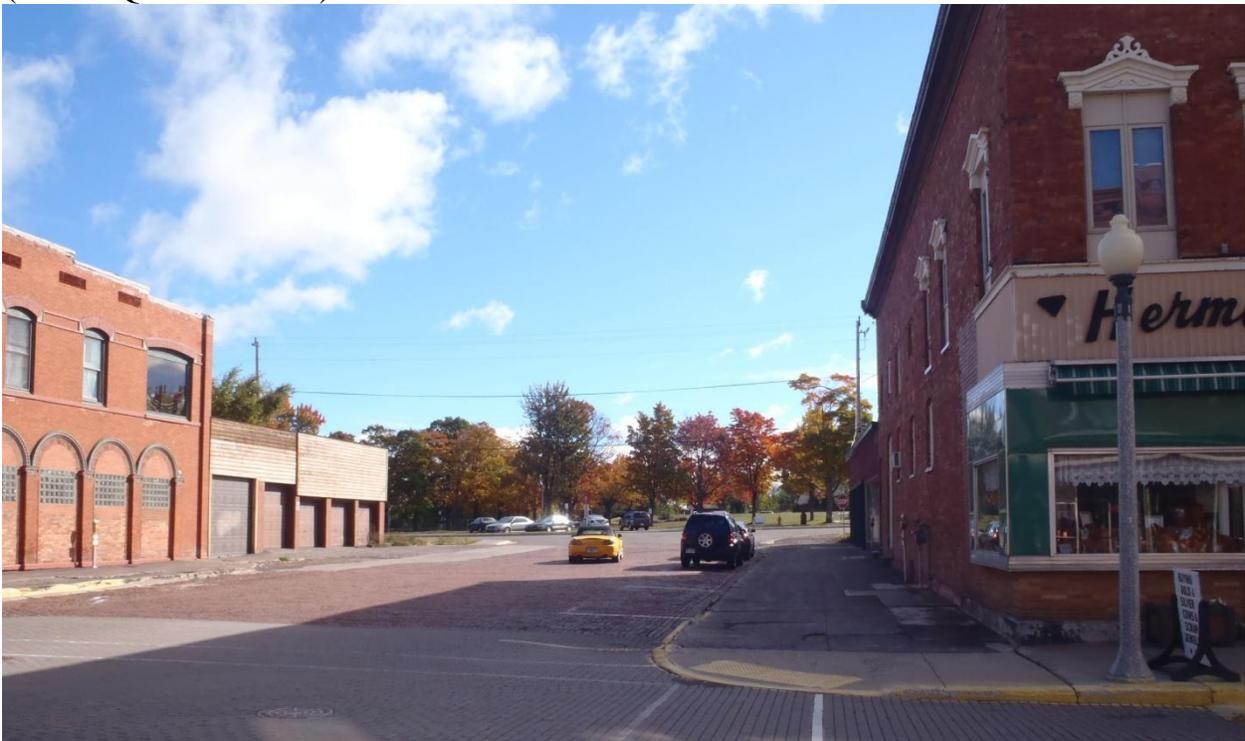
1
2 **Figure III- 18: EV.10a / Existing View 10a, Oak Street facing west, September 2010**
3 (source: QEA P9220148)

4
5 **Figure III- 19: EV.10b / Existing View 10b, Oak Street at Fifth Street facing east,**
6 **September 2010** (source: QEA P9220147)

7
8 The Oak Street corridor between the Mineral Range Depot and Agassiz Park includes important
9 visual connections for the community. The majority of the corridor is flanked by extant historic
10 buildings including commercial properties in the blocks between Fourth Street and Seventh
11 Street, and historic residences from Seventh Street to Ninth Street. St. Paul's church is clearly
12 viewed from both directions and provides a strong anchor for views.

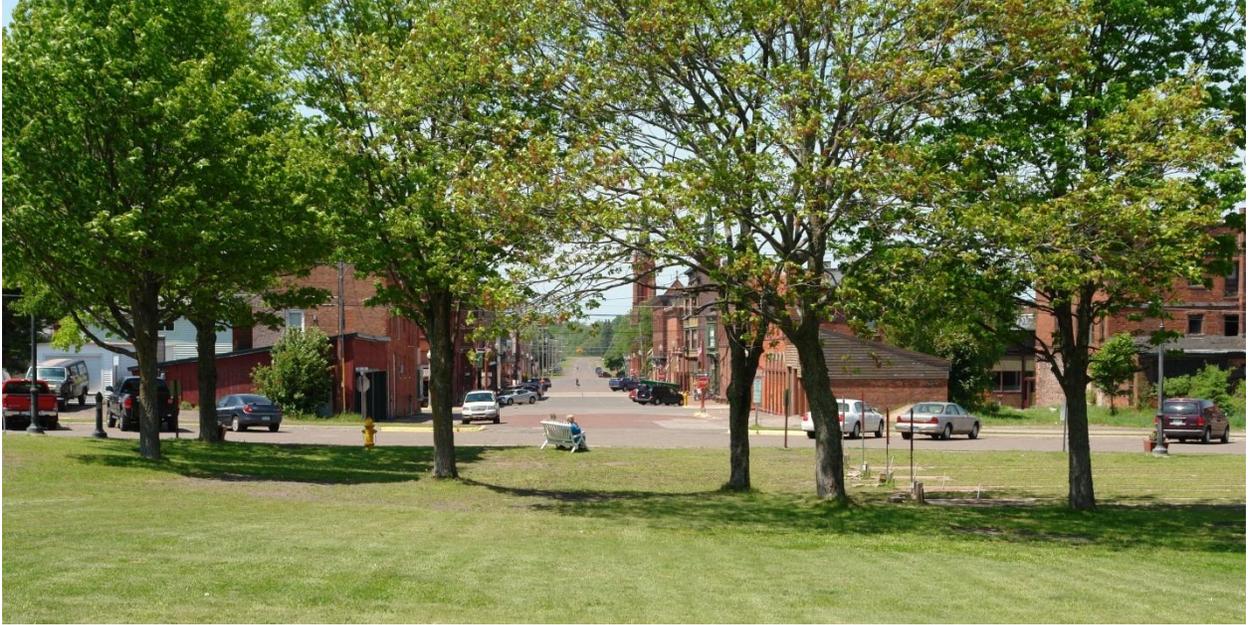
1
2 **Figure III- 20: EV.2a / Existing View 2a, View of Oak Street from within Agassiz Park**
3 **facing west, June 2011** (source: QEA 9121)
4 From Agassiz Park, the long-range view along Oak Street includes the commercial buildings
5 along the street and the steeples at St. Paul’s Church. This important connection between
6 Agassiz Park and downtown Calumet is not clearly addressed at the park, Fourth Street or Oak
7 Street.
8

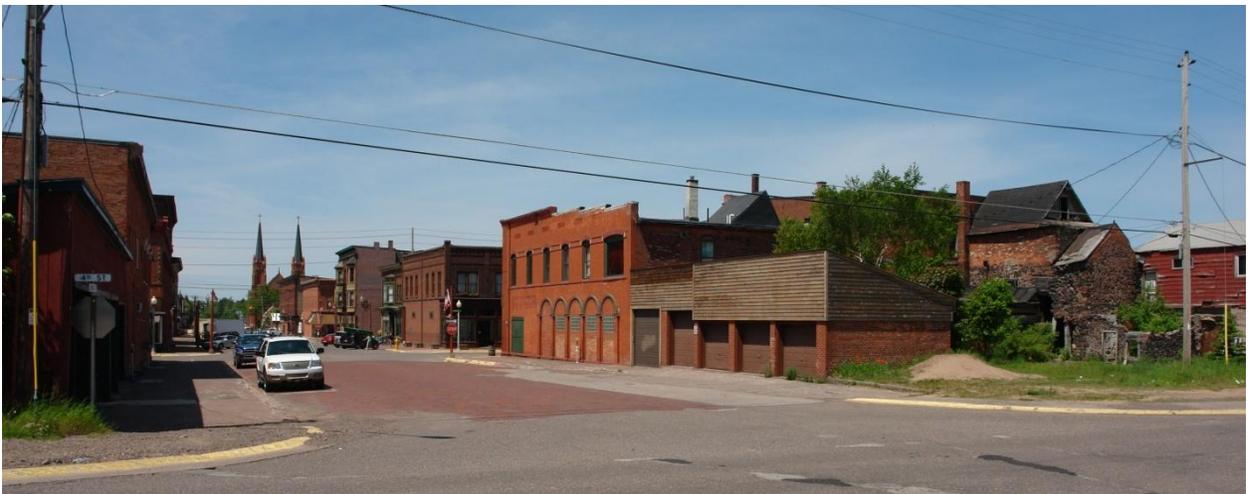
9
10 **Figure III- 21: EV.2b / Existing View 2b, View of Oak Street from Agassiz Park at Fourth**
11 **Street facing west, June 2011** (source: QEA 9110)
12 The current conditions along Fourth Street and Oak Street do not encourage pedestrian oriented
13 activities. The street is wide and does not include crosswalks, the parking area at the park does
14 not include clearly defined pedestrian zones. The buildings do not include welcoming facades
15 along Fourth or Oak in this block.
16
17
18

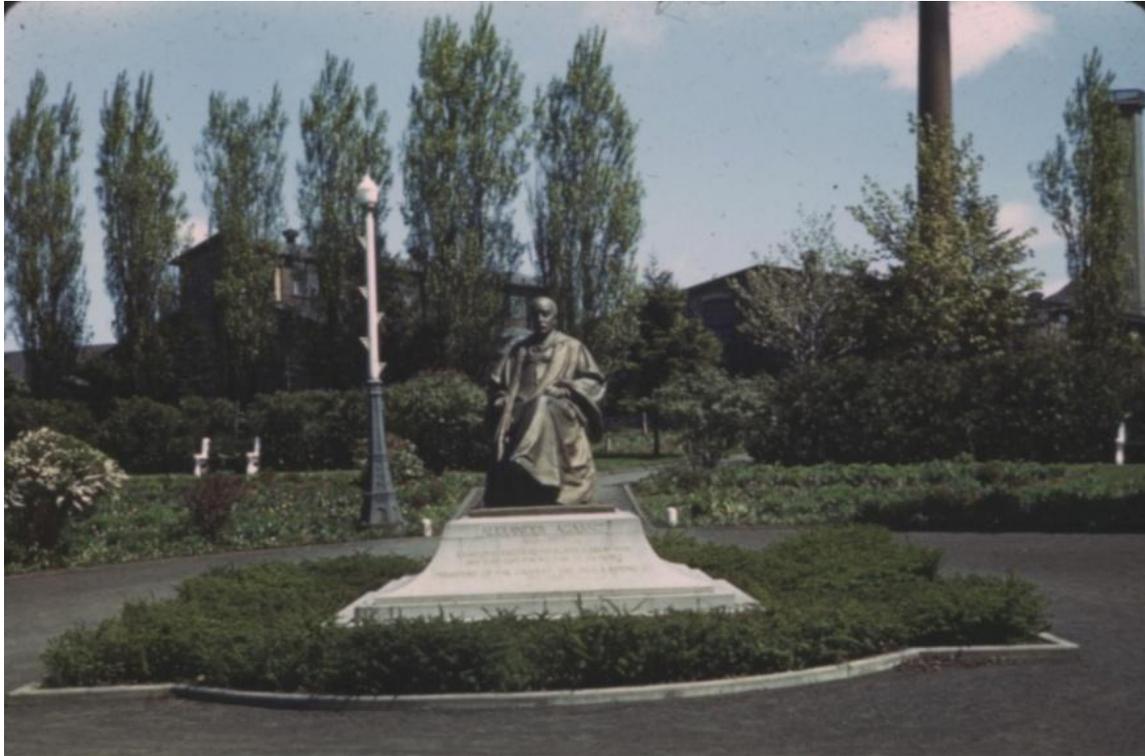
1
2 **Figure III- 22: HV.1 / Historic View 1, View of Agassiz Memorial statue and surrounding**
3 **plaza in Agassiz Park, facing northeast, ca. 1940** (source: NPS, Keweenaw NHP, LaMuth
4 Collection, Kodachrome Slides)

5 The statue and plaza provided a focal point for the park and a pivotal pedestrian link between the
6 industrial core and downtown Calumet. The vegetation was well maintained and provided a
7 pleasant environment for community members.

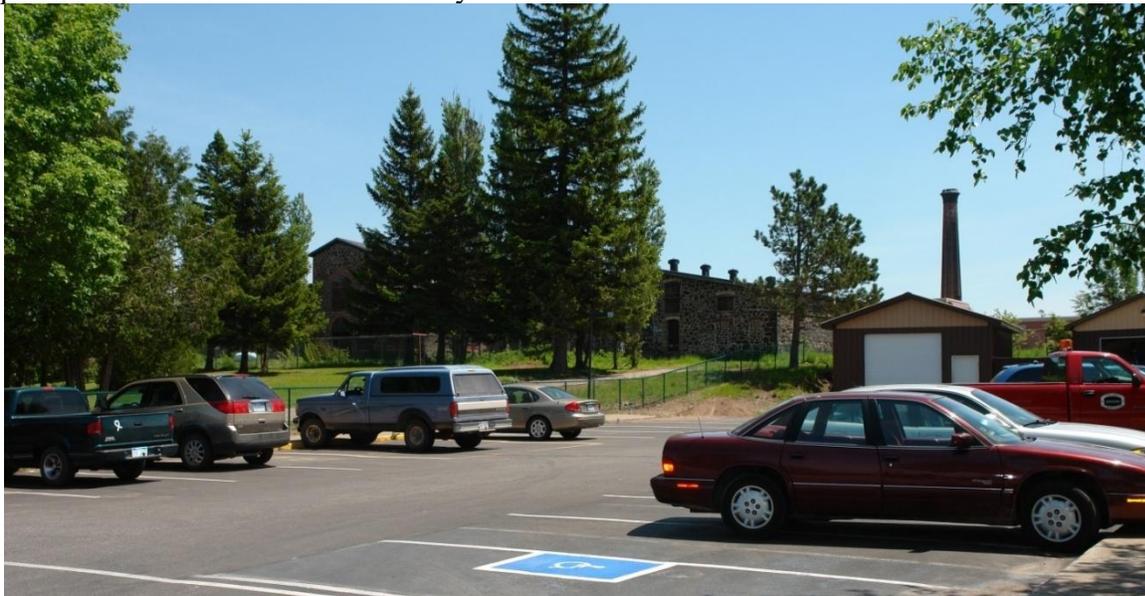
8
9 **Figure III- 23: EV.12/ Existing View 12, Parking lot at former site of Agassiz Memorial**
10 **plaza, June 2011 (similar view point as HV.1)** (source: QEA 9151)

11 A parking lot and maintenance sheds are currently situated on the former site of the Agassiz
12 Memorial statue and plaza.

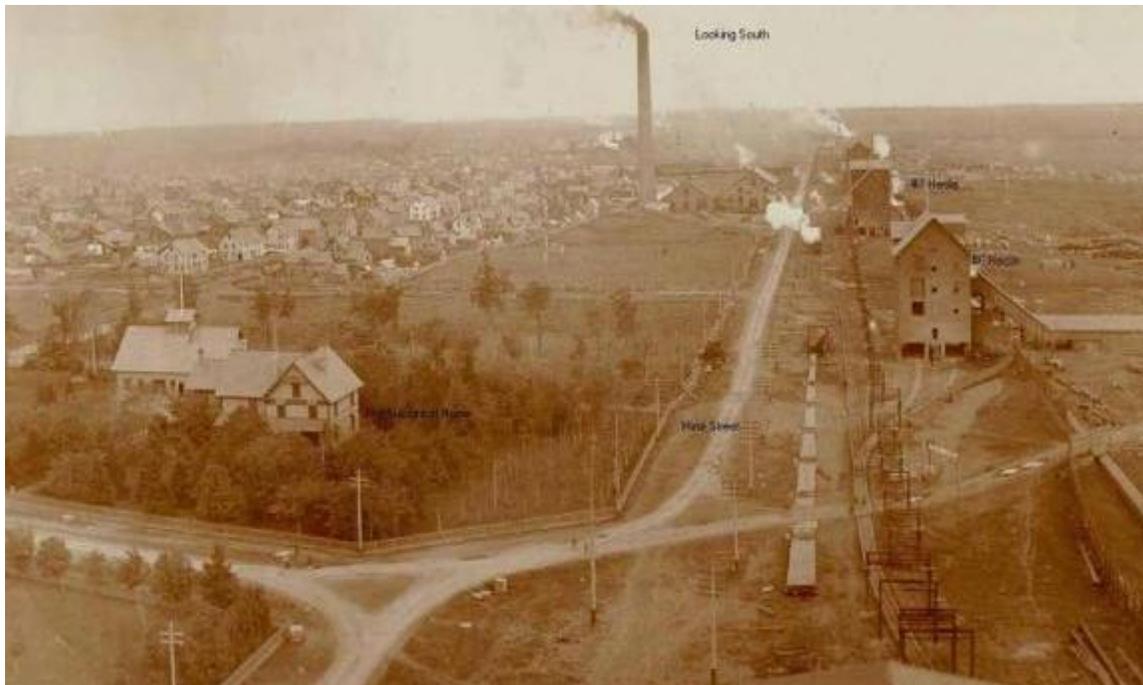
1
2 **Figure III- 24: HV.2 / Historic View 2, Hecla/Mine Street looking South, 1893**
3 (source: NPS, Keweenaw NHP, Mason Collection)
4 Mine Street in 1893 included the Hecla shafthouses, a tram route, work areas, stockpiles of
5 materials, and the street itself. Note the fence on the east (left) side of the street. It appears that
6 the area to the east (left) of Mine Street was not yet being used for industrial activities.

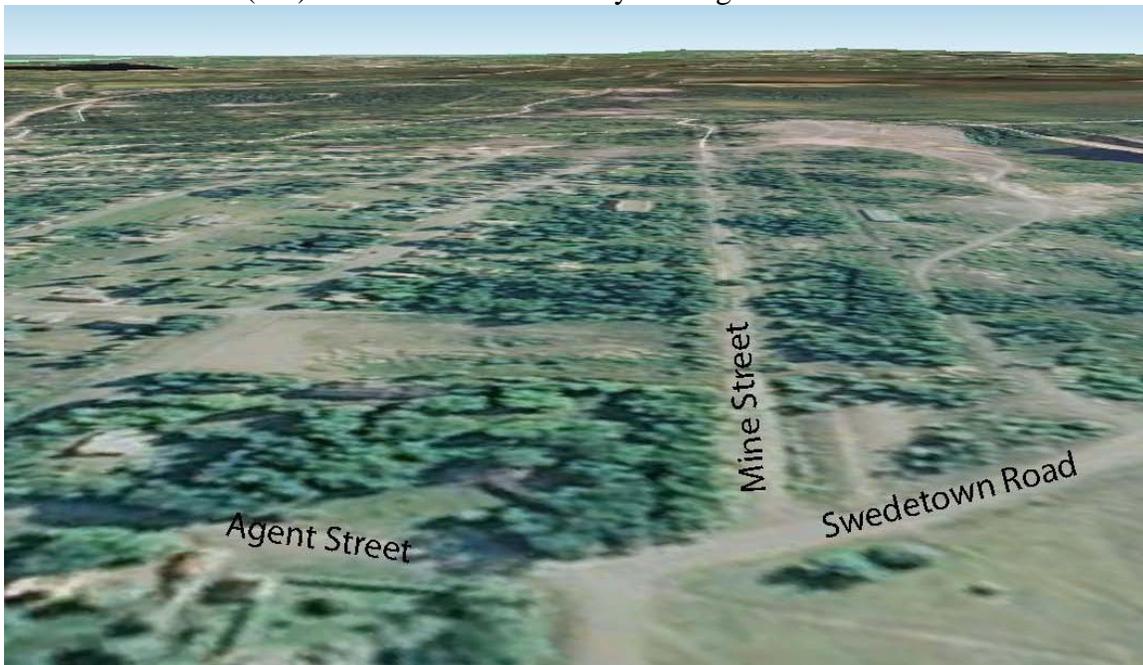
7
8 **Figure III- 25: EV.13 / Existing View 13, Mine Street looking South, 2012 (similar view as**
9 **HV.2)** (source: QEA, base image from Google earth)
10 The street alignments have not changed and traces of the industrial buildings exist in the form of
11 foundations on the north (right) side of Mine Street. The corridor provides an opportunity to
12 interpret historic use and provide recreational activities.

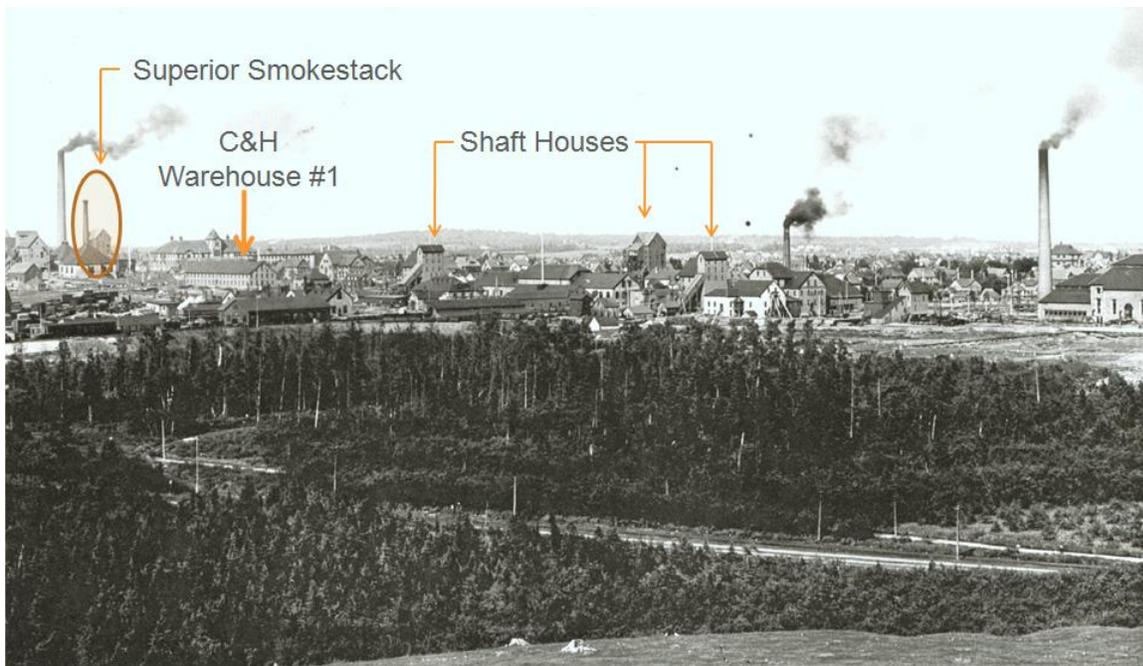
1
2 **Figure III- 26: HV.3 / Historic View 3, Calumet and Hecla from Swedetown**
3 (source: Keweenaw NHP archives)
4 Viewed from the highpoint of Swedetown, Calumet was highly developed during the historic
5 period. Vertical elements within the landscape added to long-distance views and gave visual
6 cues related to the industrial and community activities. Smokestacks, shaft houses, and church
7 steeples were especially prominent during the historic periods.
8

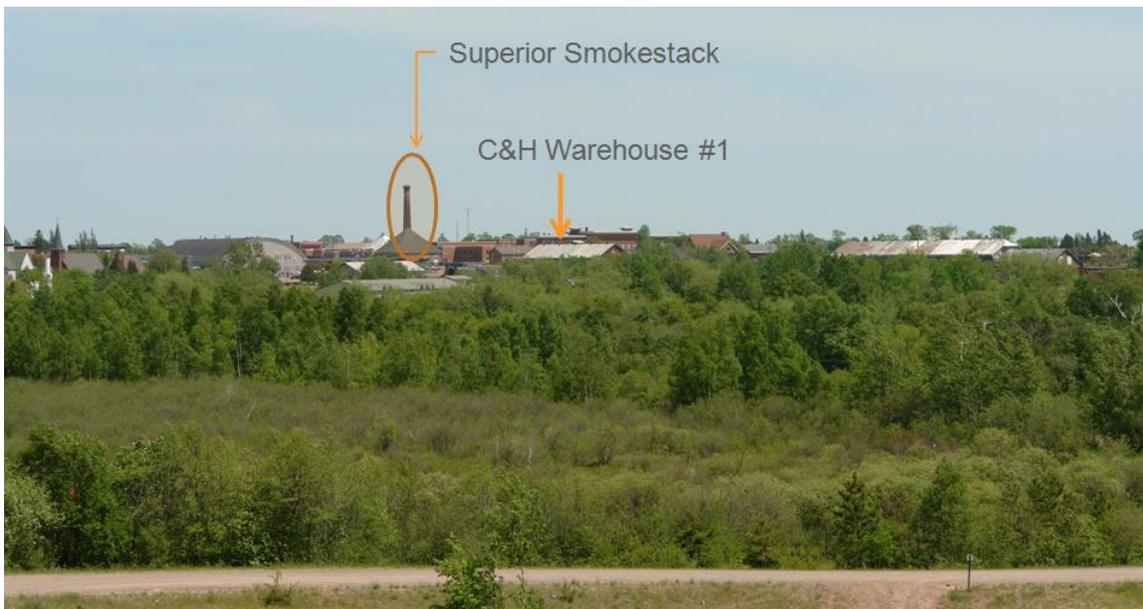
9
10 **Figure III- 27: EV.11: Existing View 11, Overview of Calumet skyline from Swedetown,**
11 **facing northeast, June 2011** (source: QEA 9171)
12 Today, many of the vertical elements, including shaft houses and smokestacks, are no longer
13 extant. The Superior Smokestack and several churches in the Village of Calumet continue to
14 provide visual reference points.

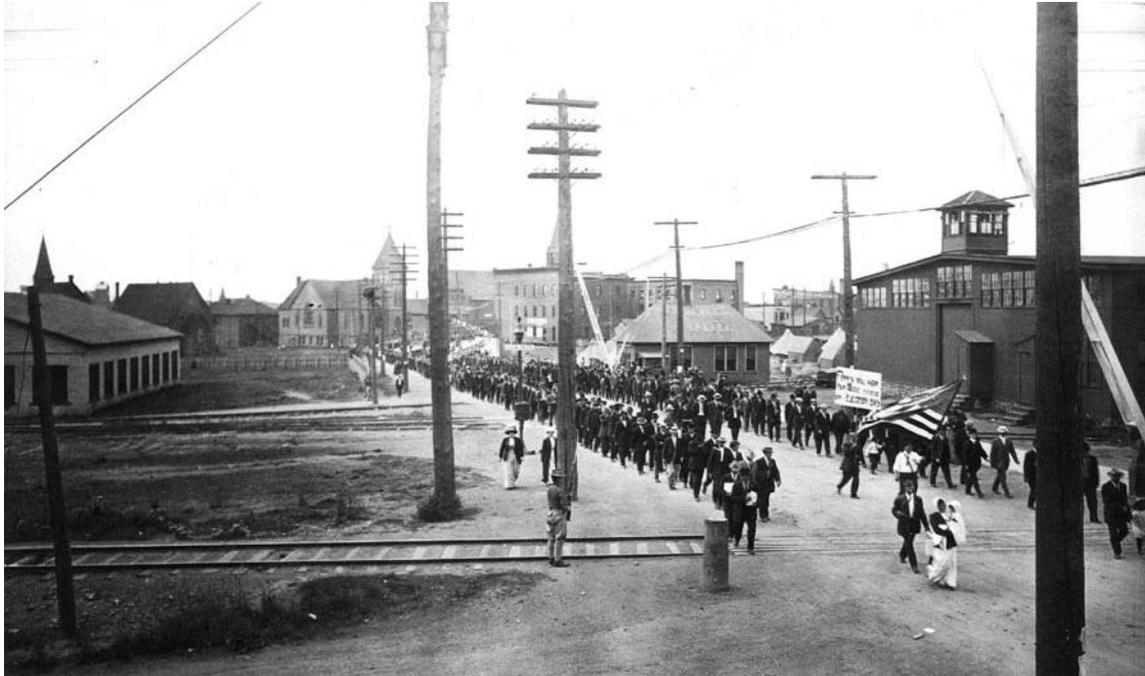
1
2 **Figure III- 28: HV.5a / Historic View 5a, Red Jacket Road facing northwest, 1913**

4 Red Jacket Road was an important corridor linking the company property to private development
5 in Calumet. It served as the main east-west vehicular and pedestrian corridor from the Village to
6 Calumet Avenue. Since it cut across the industrial corridor, Red Jacket Road was crossed by
7 many railroad tracks, roads, and utility facilities during the historic period. These north-south
8 oriented linear features accentuated the importance of movement along the industrial core.

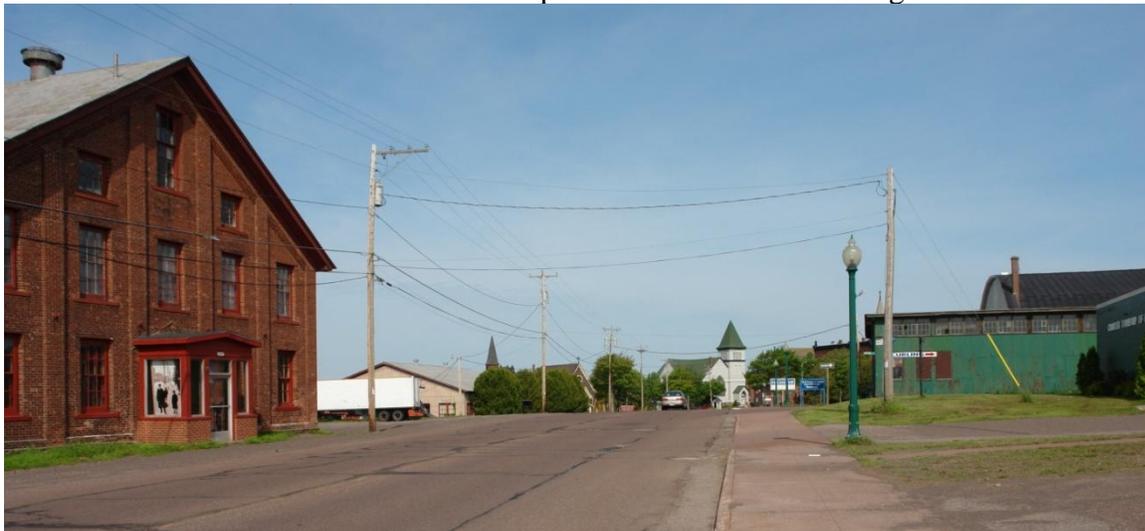
9
10 **Figure III- 29: EV.7a Existing View 7, Red Jacket Road facing northwest, June 2011**

12 Red Jacket Road is the primary entrance corridor for park visitors. Heading northwest along the
13 corridor Temple Square and the First Presbyterian Church draw the eye to the end of the
14 corridor. The north-south features present historically are no longer apparent. The road is very
15 wide and there are large areas that have no curbs or sidewalks. Sidewalks that do exist are
16 interrupted by multiple curb cuts for driveways.

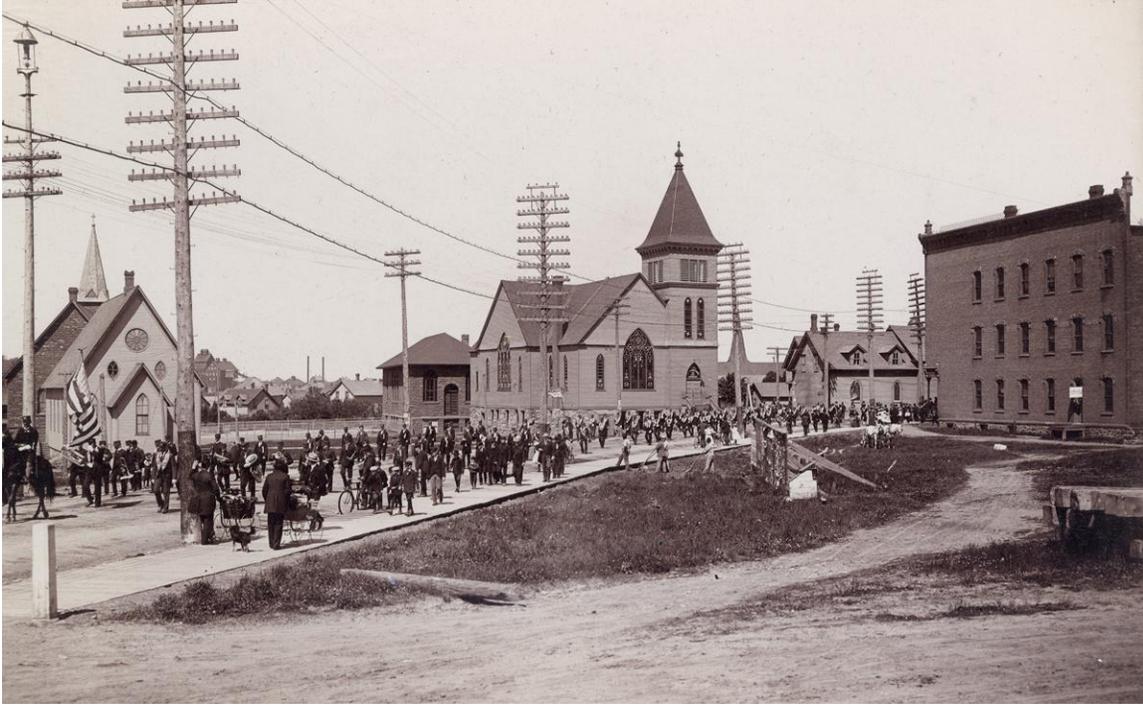
1
2 **Figure III- 30: HV.5b / Historic View 5b, Temple Square from Red Jacket Road, ca. 1918**
3 (source: NPS, Keweenaw NHP, Non-KEWE Collection, 4320, 4-HCHS)
4 Red Jacket Road was an important corridor linking the company property to private development
5 in Calumet. The intersection of Red Jacket Road and Fifth Street was a key connector made
6 visually distinct by the numerous churches in Temple Square. A board walkway was located on
7 the north side of Red Jacket Road for pedestrians. The triangular area in the foreground was
8 unfinished and some images show it used for parking during events.

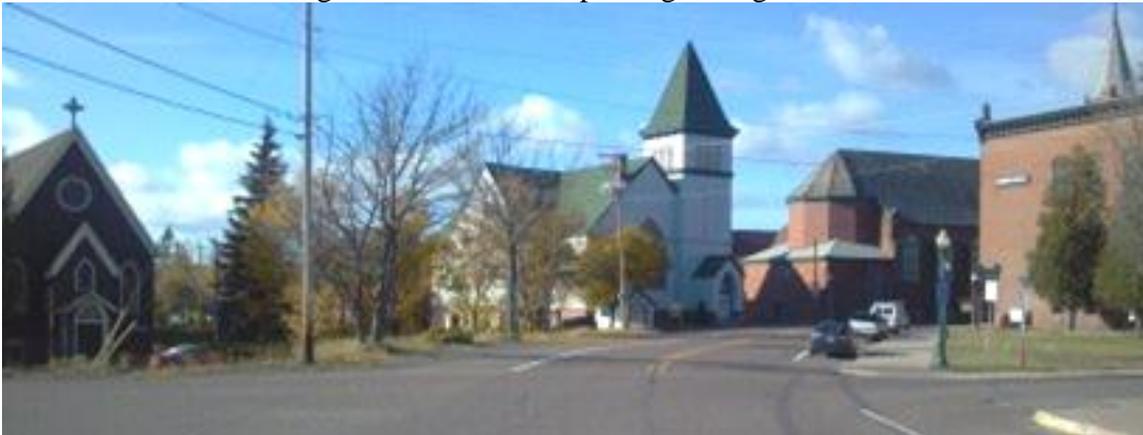
9
10 **Figure III- 31: EV.7b Existing View 7b, Temple Square from Red Jacket Road facing**
11 **northwest, June 2011, Current View near HV.5b** (source: QEA 1320347406820)
12 Heading northwest along the corridor, Temple Square and the First Presbyterian Church continue
13 to draw the eye to the end of the corridor. There is more vegetation present today in the area.
14 The vegetation partially screens views of the buildings. The alignment of the road is similar to
15 its historic condition, and a concrete sidewalk is located on the north side of the street in the
16 location of the historic boardwalk. Red Jacket Road park (at the corner of Fifth and Red Jacket
17 and adjacent to the Calumet Visitor Center) is more level and includes lawn and mature cedars.

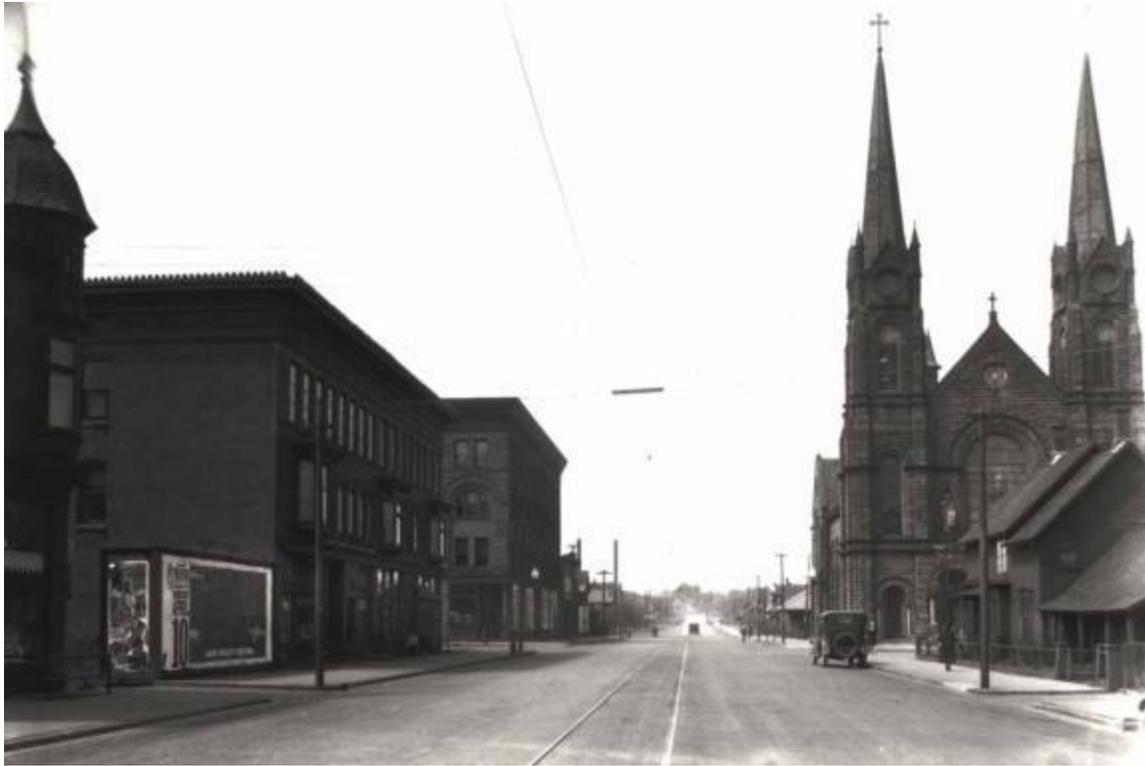
1
2 **Figure III- 32: HV.7 / Historic View 7, Corner of Oak Street and Eighth Street, facing west**
3 (source: NPS, Keweenaw NHP, Curto Collection, Album 8, #028)
4 The Village of Calumet was a well developed metropolis during the period of significance. St.
5 Paul's church is on the right side of the image, the street car tracks are in the center of Oak
6 Street, and three-story commercial buildings line the left side of the street.

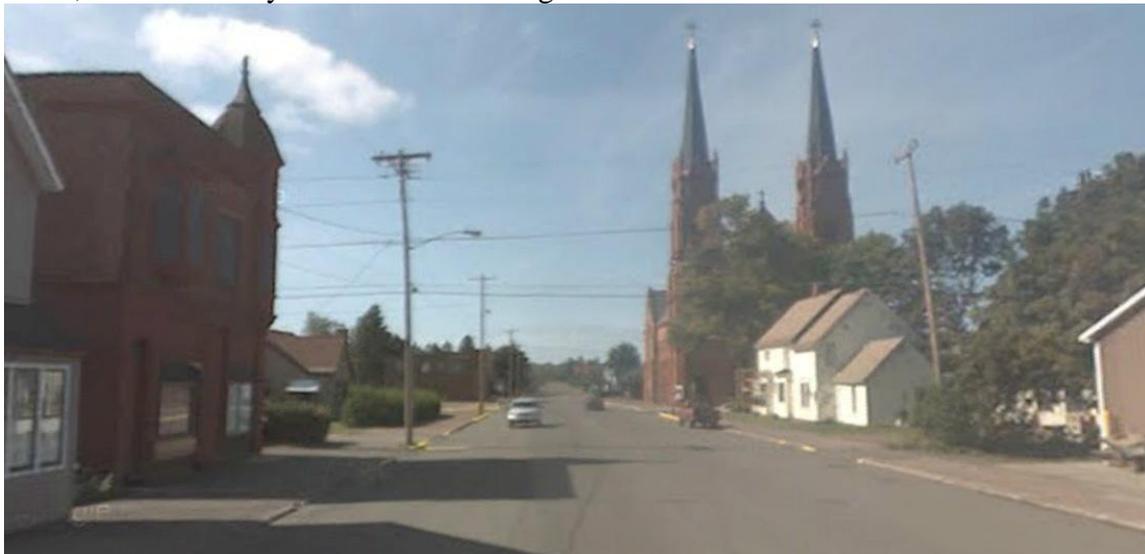
7
8 **Figure III- 33: EV.10c / Existing View 10c, Corner of Oak Street and Eighth Street, facing**
9 **west (Current View at HV.7)** (source: QEA Oak Street St.Pauls)
10 St.Paul's church remains an iconic figure on Oak Street. Remaining commercial buildings help
11 to retain form and scale along the corridor, however the replacement of several commercial
12 buildings with smaller residences has changed the feeling of the street somewhat.

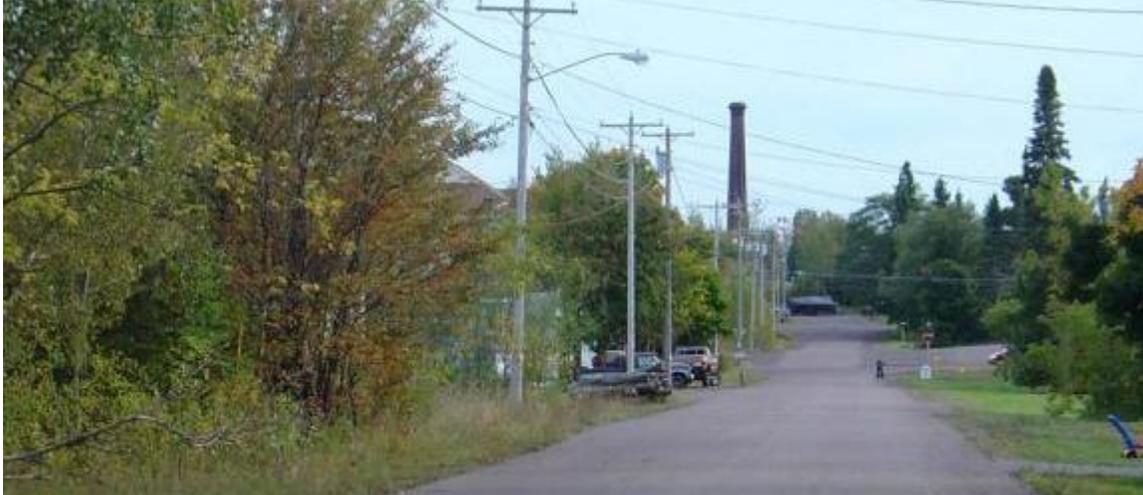
1
2 **Figure III- 34: EV.4 / Existing View 4, Waterworks Road facing south, 2010**
3 (source: QEA 6935)
4 From this vantage point just south of Calumet Lake, the remaining C&H smokestack is visible
5 beyond the vegetation and residential street in the foreground.

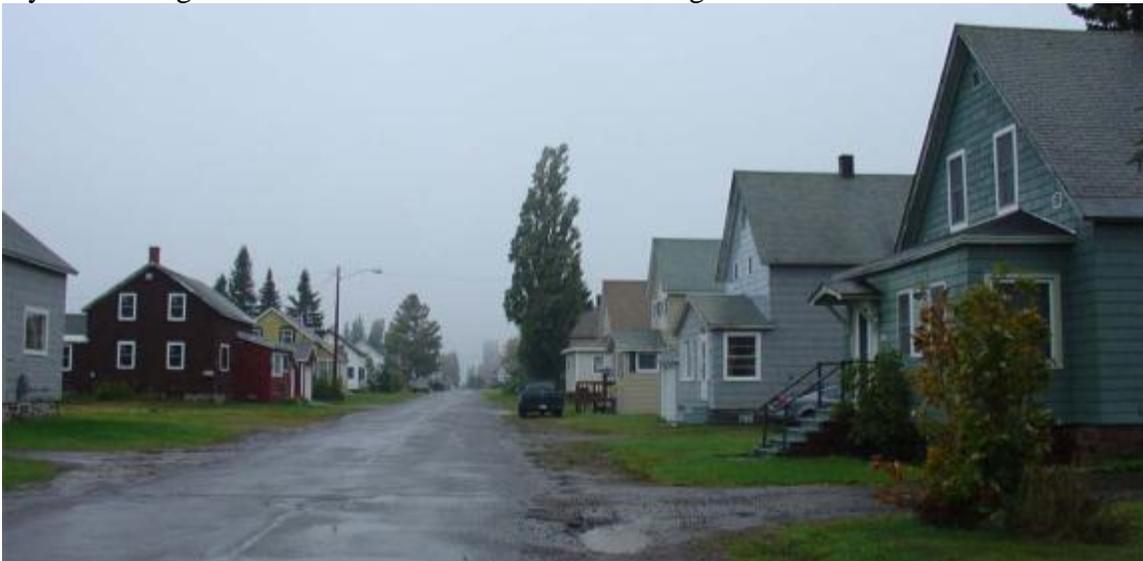
6
7 **Figure III- 35: EV.6 / Existing View 6, Raymbaultown-Log Street facing south toward**
8 **Osceola No. 13 Area, 2010** (source: QEA 7277)
9 Log Street in Raymbaultown presents a typical housing location. The road edges are irregular
10 and no curbs are present. Houses are situated close to the road edge and the spaces between
11 houses and the road are often used for parking. Very little vegetation is present in this area. The
12 houses are modest one and one-half and two story structures; several of the same model are
13 located adjacent to each other.
14
