1 **South Mine Street Corridor – Existing Conditions and Landscape Analysis**

Keweenaw National Historical Park
Cultural Landscape Report & Environmental Assessment

1 **Table III-7: Buildings, South Mine Street Corridor**

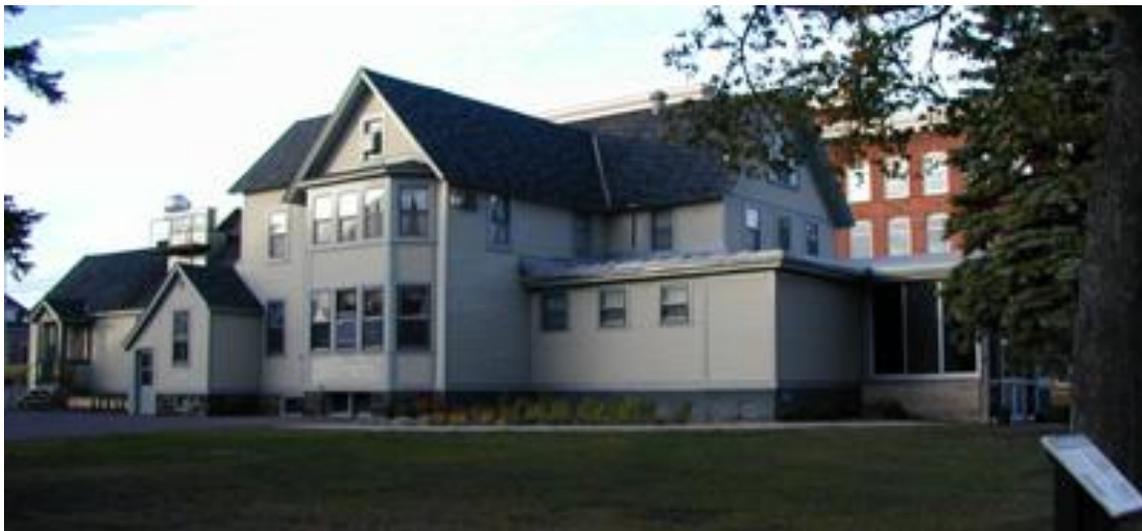
Figure III- 39: Miscowaubic Club, south elevation (source: <http://miscowaubik.org/> accessed 25 March 2011)

Map Key	Building	Figure #	Contributing/ Non-cont.	Rationale
A	Miscowaubik Club	III-39	Contributing	Originally a mine captain's house, the building became the home of the Miscowaubik Club, a social club, in 1903.
B	Keweenaw National Historical Park Headquarters (C&H General Office Building)	III-40	Contributing	C&H General Office Building 1887-1968.
C	Barbara Kettle Gundlach Shelter (Agassiz House)	III-41	Contributing	Summer residence of Alexander Agassiz during the period of significance. Currently used for a housing shelter.
D	C-L-K School Bus Maintenance Building	III-42	Contributing	C&H power station
E	AT&T Calumet Central Office	III-43	Non-cont.	Constructed after the end of the period of significance.
F	Township Office	III-44	Non-cont.	Constructed after the end of the period of significance.
G	Township/School Garage (C&H Warehouse No. 2)	III-45	Contributing	Built as part of C&H Mining Company operations. Today the warehouse is utilized by Calumet Township (owner) and the Public Schools of C-L-K as a maintenance and storage facility.

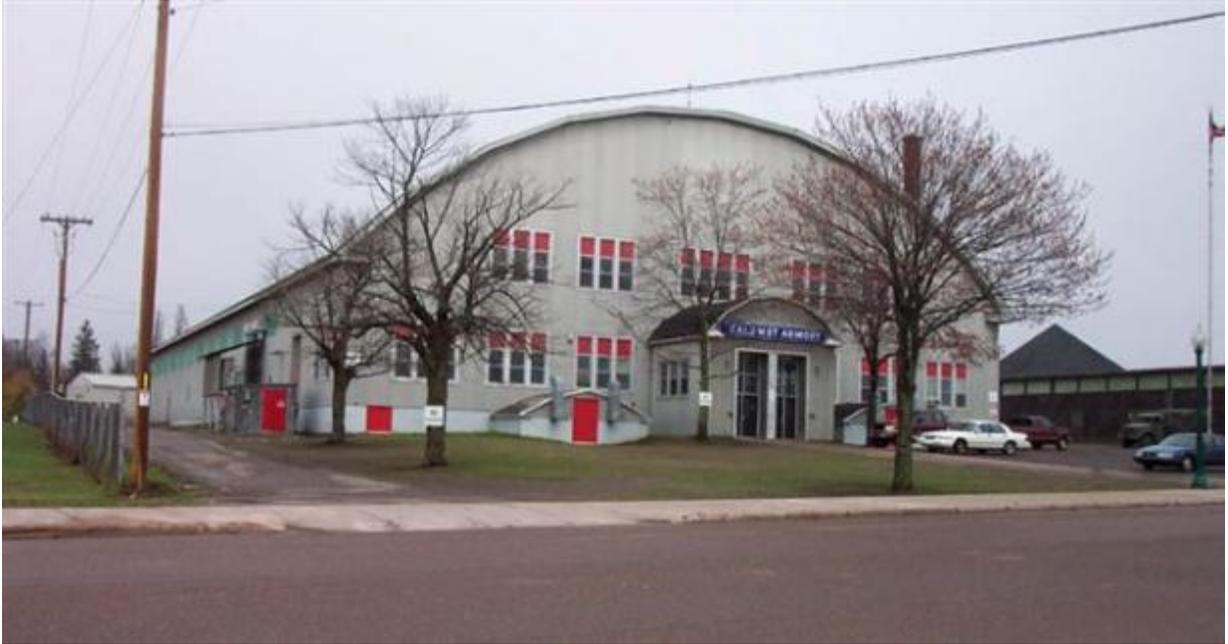
Figure III- 46: Calumet Colosseum, south elevation (source: http://www.cchockeyhistory.org/CLKimages/CalArmory_s.jpg accessed 25 March 2011)

H	Calumet Colosseum	III-46	Contributing	Built in 1913 as a hockey rink with a removable floor for roller-skating. Still in use today, it is the oldest operating indoor rink in the world. ⁴
I	Farmers & Merchants Mutual Fire Insurance Company	III-47	Non-cont.	Built after end of period of significance.
J	Calumet Visitor Center (Union Building)	III-48	Contributing	Built for community during period of significance.
K	Keweenaw Heritage Center / St. Anne's Church	III-49	Contributing	Built for community during period of significance.

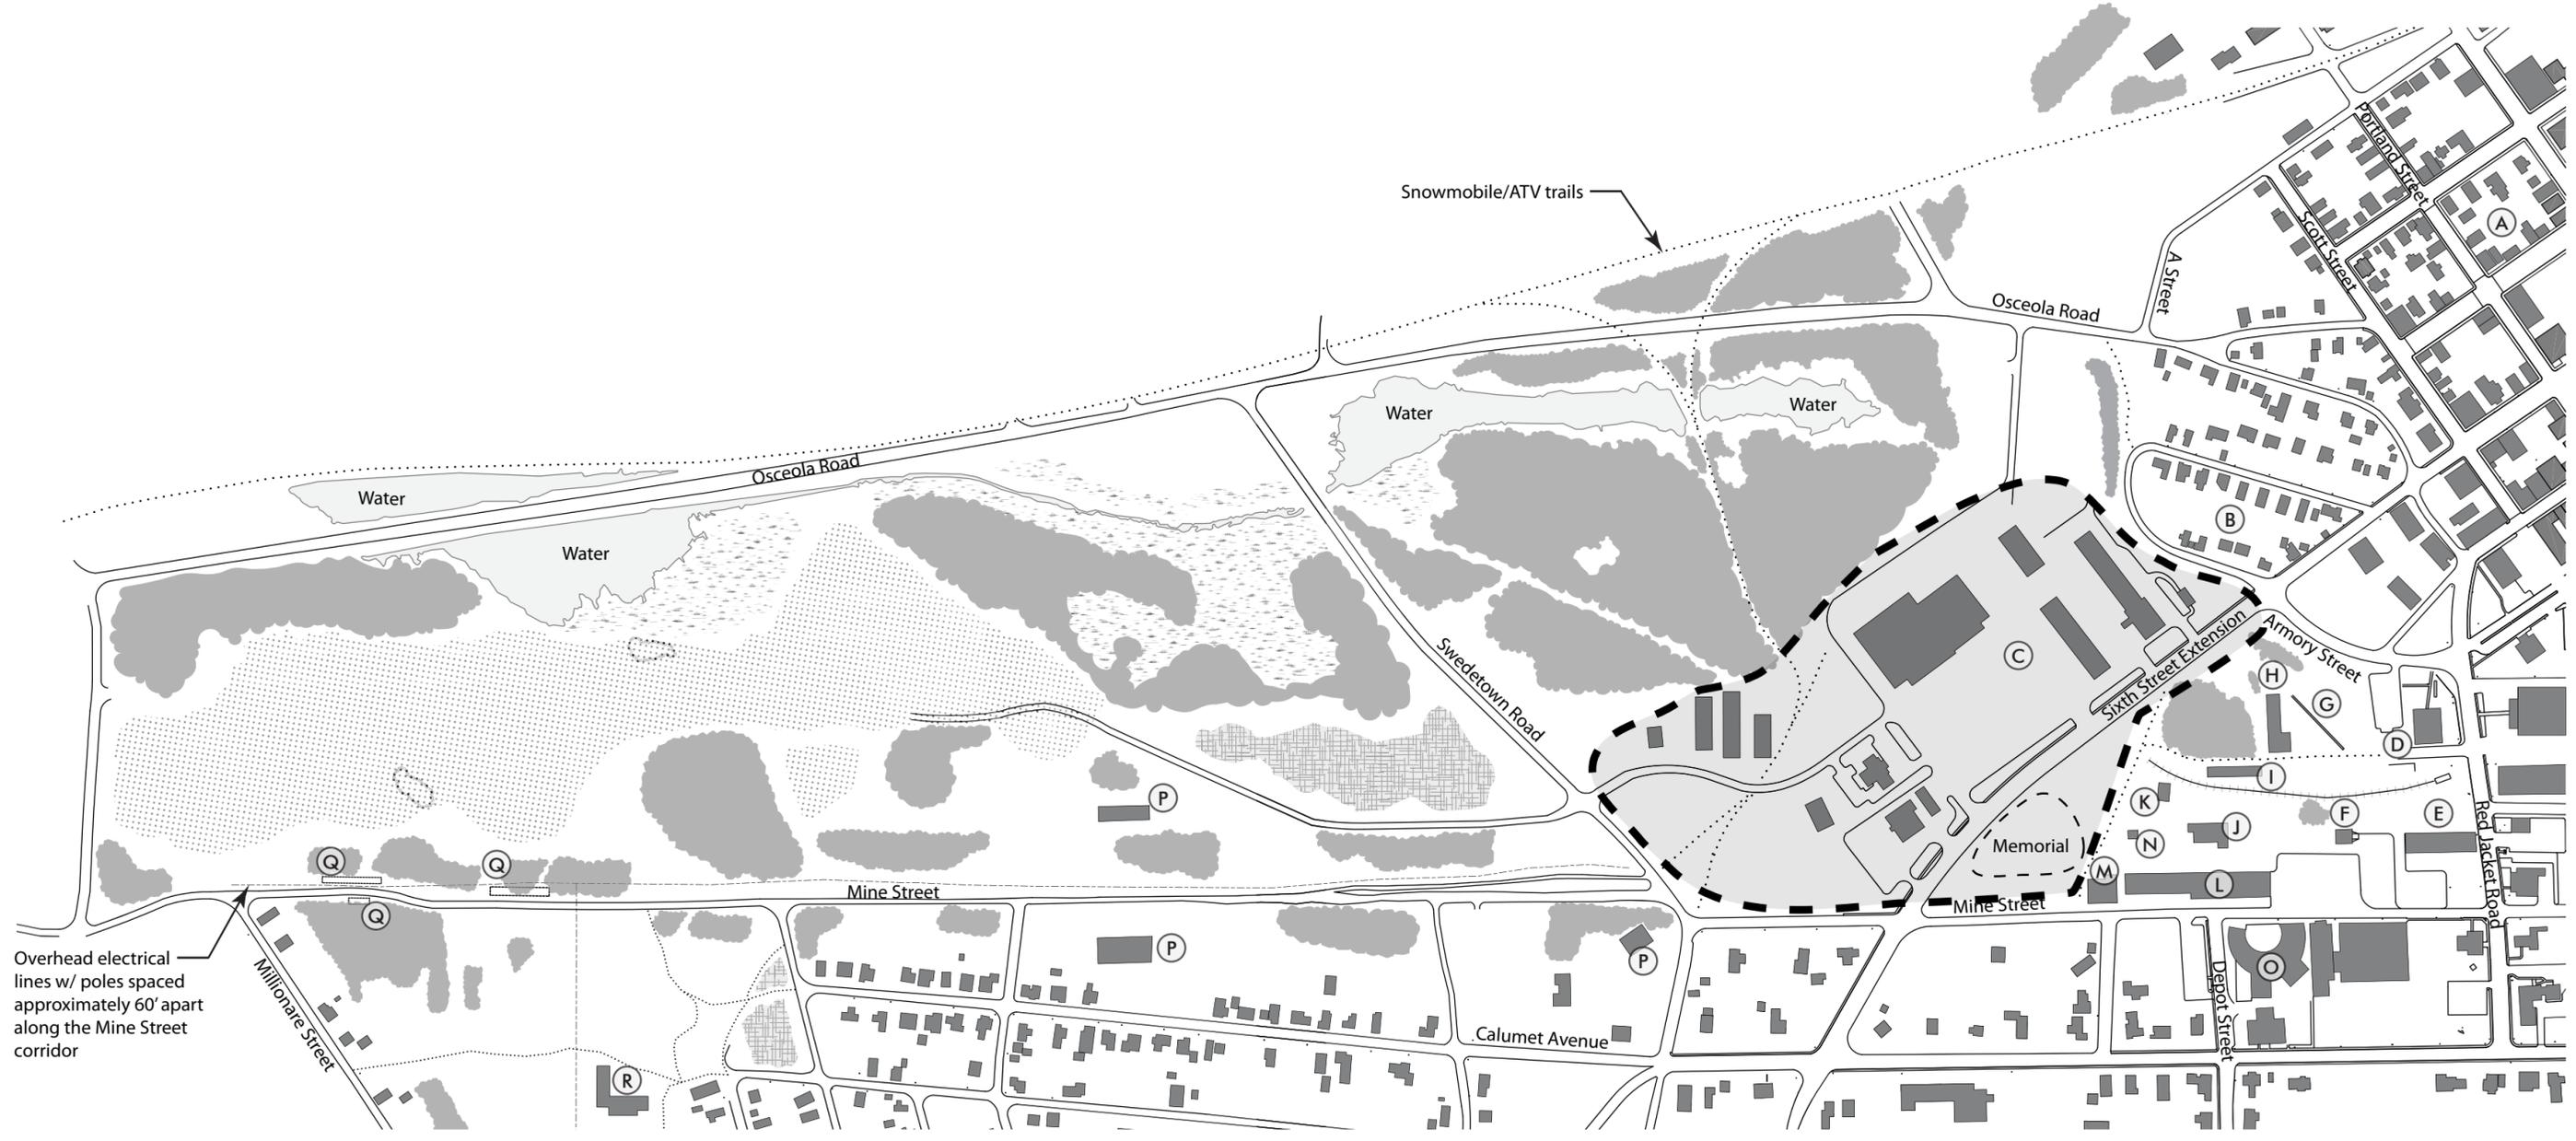
Figure III-59

Figure III- 59: South Mine Street Corridor, Existing Conditions (source: QEA)

Overhead electrical lines w/ poles spaced approximately 60' apart along the Mine Street corridor

4
5 The South Mine Street Corridor, illustrated in Figure III-48, is located south of Red Jacket Road
6 and extends along Mine Street to the southwestern portion of the unit (see Figure III-1). South of
7 the Sixth Street Extension, the corridor widens to the west, extending to the western edge of the
8 unit. The corridor contains significant historic buildings and landscape features related to the
9 C&H Mining Company operations. There is also a large area of new development associated
10 with the Sixth Street Extension that is non-contributing. The Mine Street Station development
11 includes a motel, gas station, fast food restaurant, strip mall, department store and grocery store,
12 all surrounding a large parking lot adjacent to the Sixth Street Extension. These developments
13 include large illuminated signs. Finally there are broad open areas used for stockpiling materials
14 and extraction of gravel and dirt at the southwestern portion of the corridor (see Table III-7).

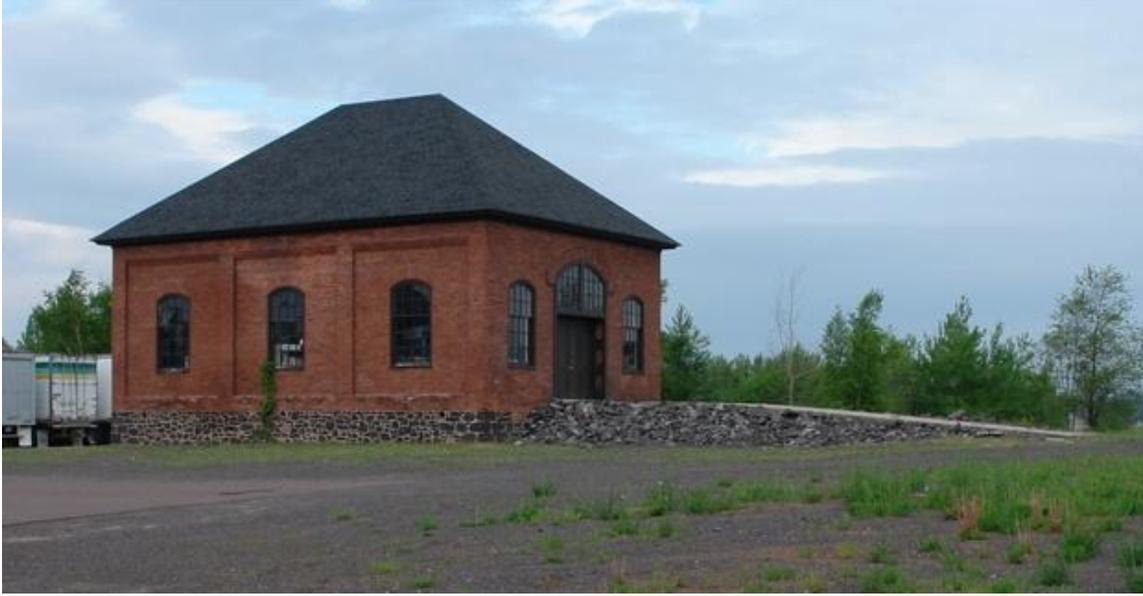
Figure III- 60: C&H Man Engine House/Warehouse No. 3, 2011 (source: QEA 08453)

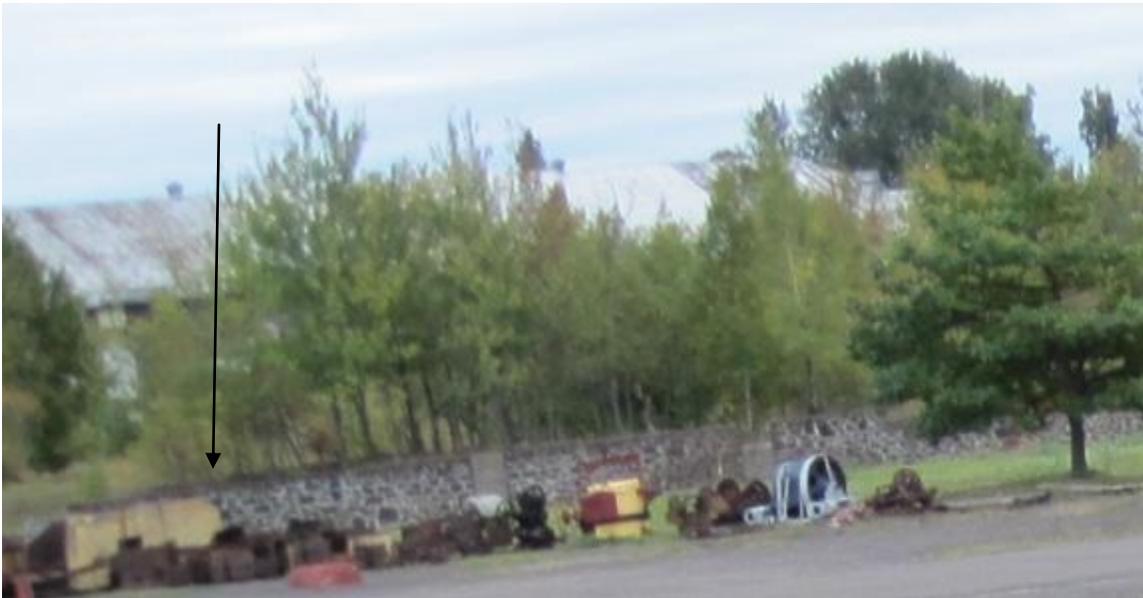
Figure III- 61: C&H Stone retaining wall, facing southeast. The parking lot in the foreground is the site where the Foundry stood, 2010 (source: QEA 0545)

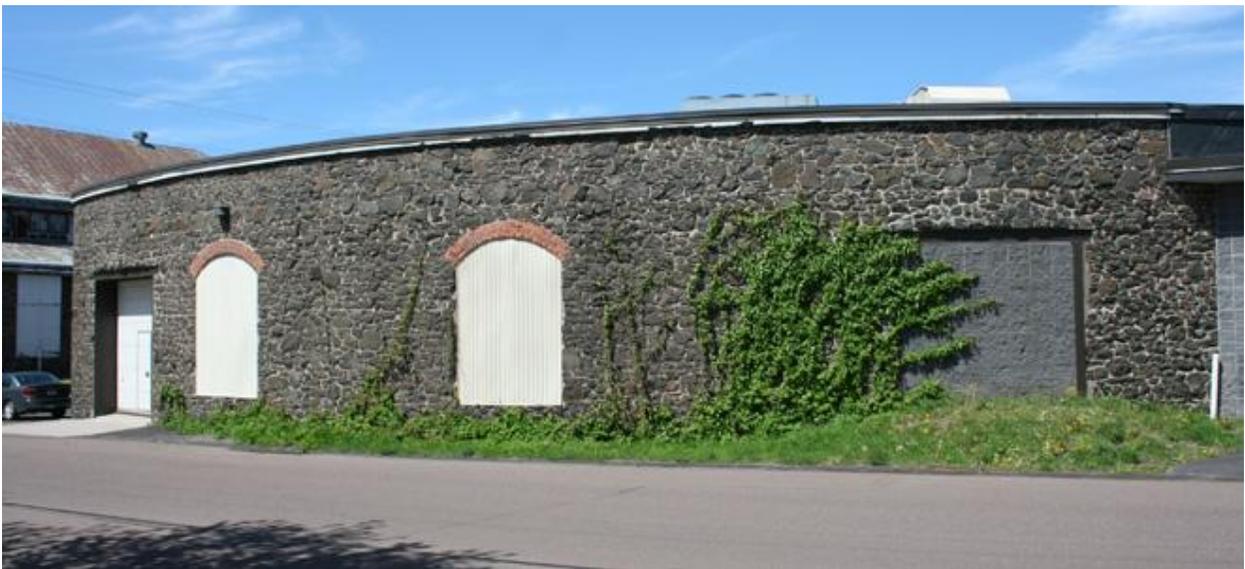
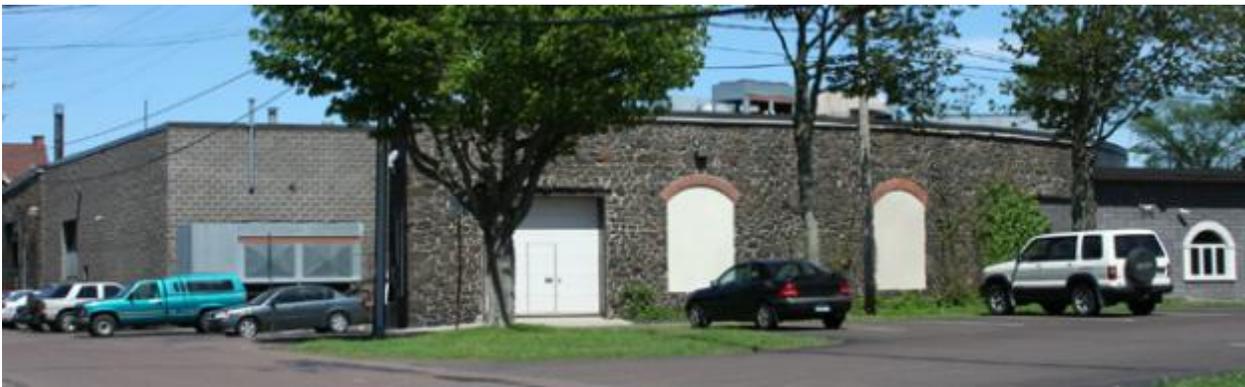
Figure III- 69: C&H Round House (source: <http://keweenawfreeguide.com/ch-roundhouse/>, accessed 25 March 2011)

M	Hecla Fire Station	III-67	contributing	Part of C&H mining operations.
N	C&H Railroad Shack	III-65	Contributing	Part of C&H mining operations.
O	C&H Round House	III-69	Contributing	Built 1888 to service locomotives. Additions in 1902 and 1907. Altered ca. 2000 for Calumet Electronics Corporation headquarters.

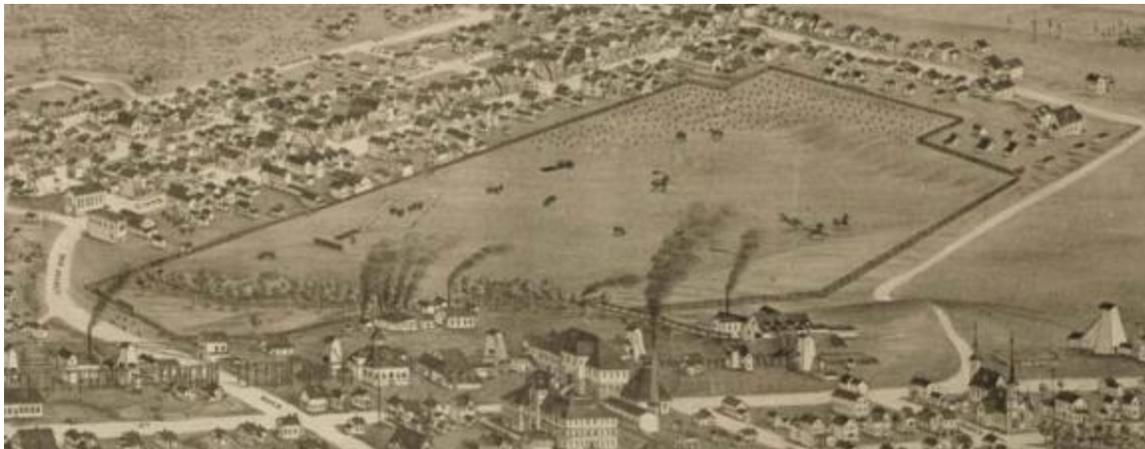
Figure III- 71: Detail of Calumet Commons, (future site of Agassiz Park) from Birds Eye View of Calumet, Hecla and Red Jacket, 1881. (source: NPS, Keweenaw NHP, Non-KEWE Collection)

9 The property known today as Agassiz Park contained a village commons used for grazing
10 livestock during the early portion of the period of significance (see Figures III-70-73). In 1881 a
11 fence enclosed the entire area, keeping livestock from wandering (see Figure III-71). By 1886
12 pedestrian paths connected the downtown commercial district with the C&H mine site through
13 the park, a railroad track was present at the northwestern portion of the parcel, materials were
14 being stockpiled along the eastern edge of the site, and a fence had been added to enclose a
15 baseball field at the north end of the property (see Figures III-72 and 73). The property was
16 associated with sports, recreation, and leisure events for many years prior to the 1913-1914
17 strike, when a tent camp was established on the site for the Michigan militiamen who were
18 encamped in Calumet to subdue violence. The existing landscape does not retain integrity for
