APPENDIX D
ARCHEOLOGICAL SURVEYS

January 11, 2013

Subject: Trip report on archeological testing of proposed beach access ramps, parking lots, and interdunal road.

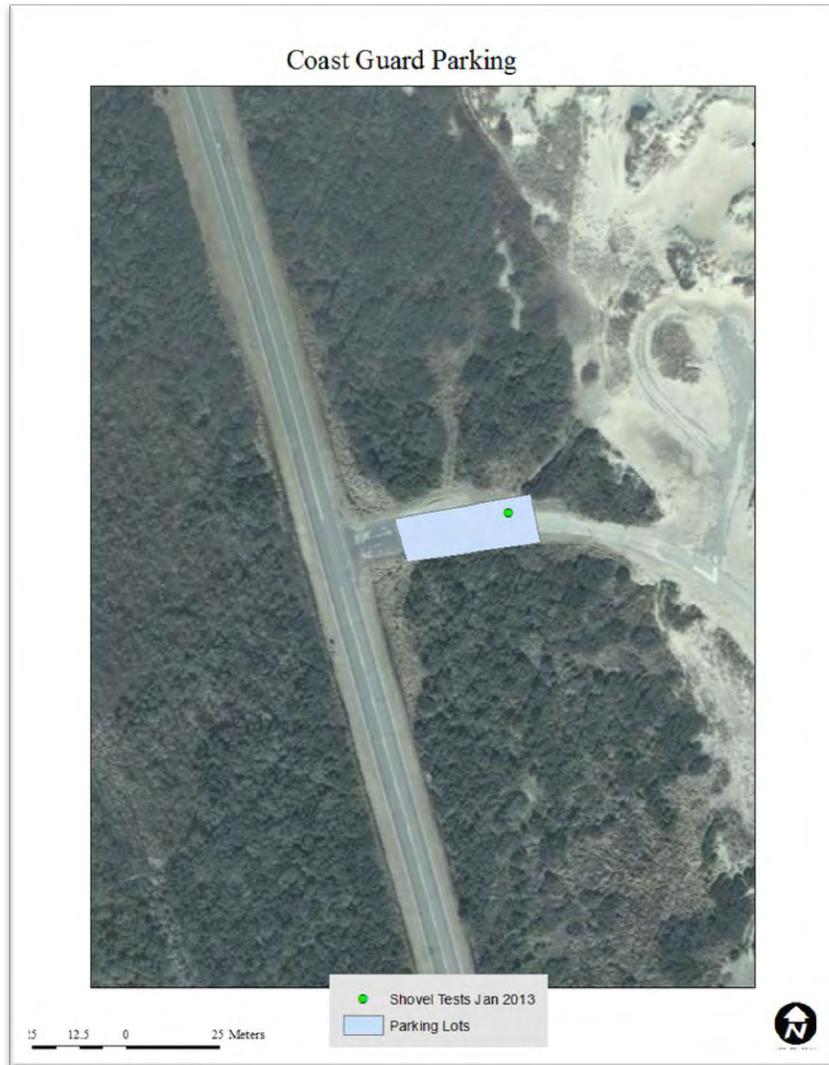
Site 1. A 10-car parking lot is proposed at the former site of the U.S. Coast Guard Station on Bodie Island. An existing paved parking lot will be expanded to the east approximately 20 M. The area has been previously disturbed from an access road leading to the beach. A single shovel test was excavated within the proposed expansion area. No artifacts were recovered. ASMIS site CAHA00033.000 the Bodie Island Coast Guard Station Complex lies 75 meters away to the east/northeast. No actions described in this plan would affect CAHA00033.000.

Figure 1. Proposed Coast Guard parking lot expansion.

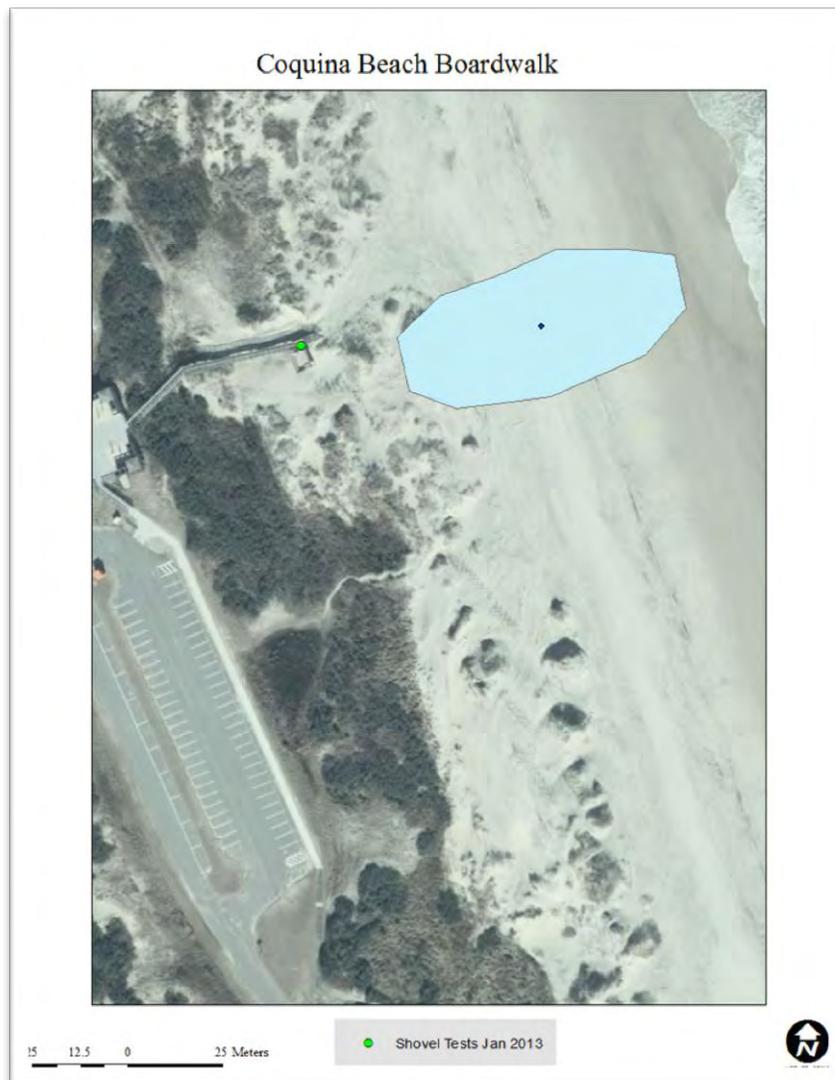
Site 2. A handicap accessible boardwalk at Coquina Beach on Bodie Island is proposed. A single shovel test at the base of the existing boardwalk was excavated. No artifacts were recovered. The Laura Barnes interpretive shipwreck is approximately 50M from the proposed boardwalk. In 1973, the National Park Service moved the shipwreck to its present location as an interpretive display for the visiting public.

Technically the Laura A. Barnes is no longer an archeological site having been removed from its original context. Consequently the proposed boardwalk construction is not considered an adverse effect.

Figure 2. Proposed boardwalk and perimeters of interpretive shipwreck.

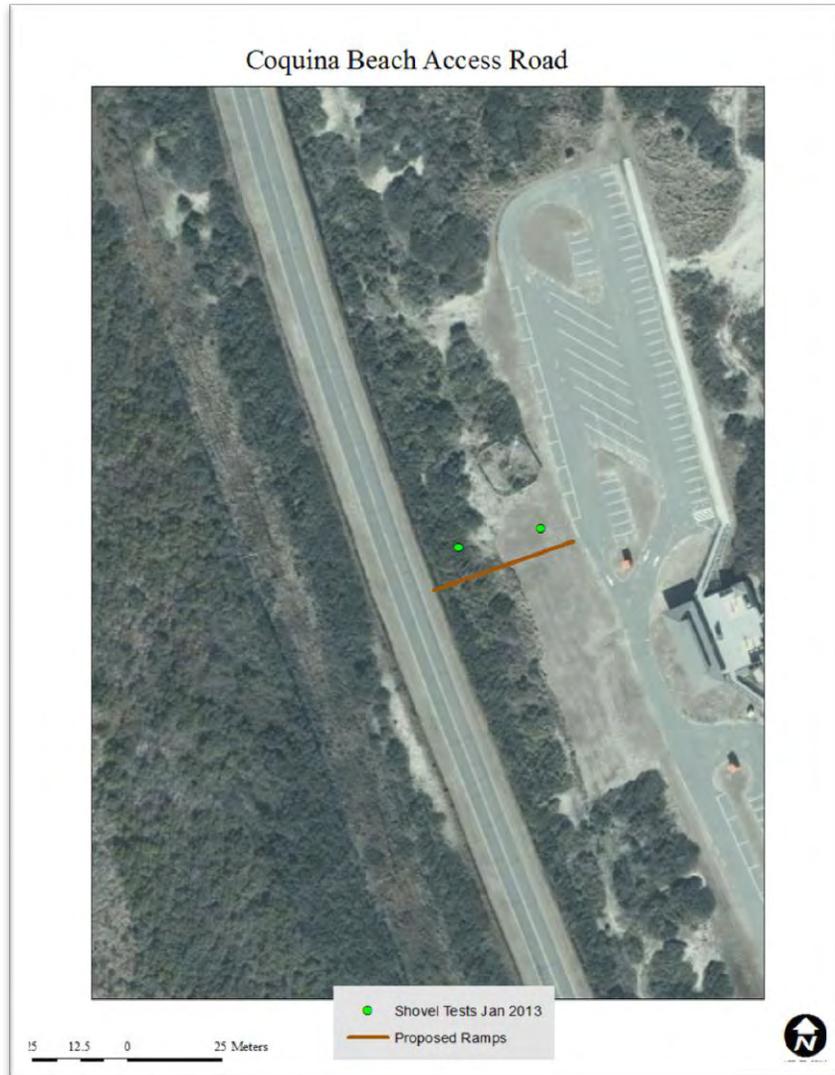
Site 3. An additional access road from NC 12 to the off-road vehicle (ORV) fee station at Coquina Beach is proposed Figure 3. The shovel testing was offset due to the presence of a drain field in the location of the proposed road. The access road will need to be moved to the north to correspond with the area archeologically tested area or risk destroying the drain field.

Figure 3. Coquina Beach Access Road.

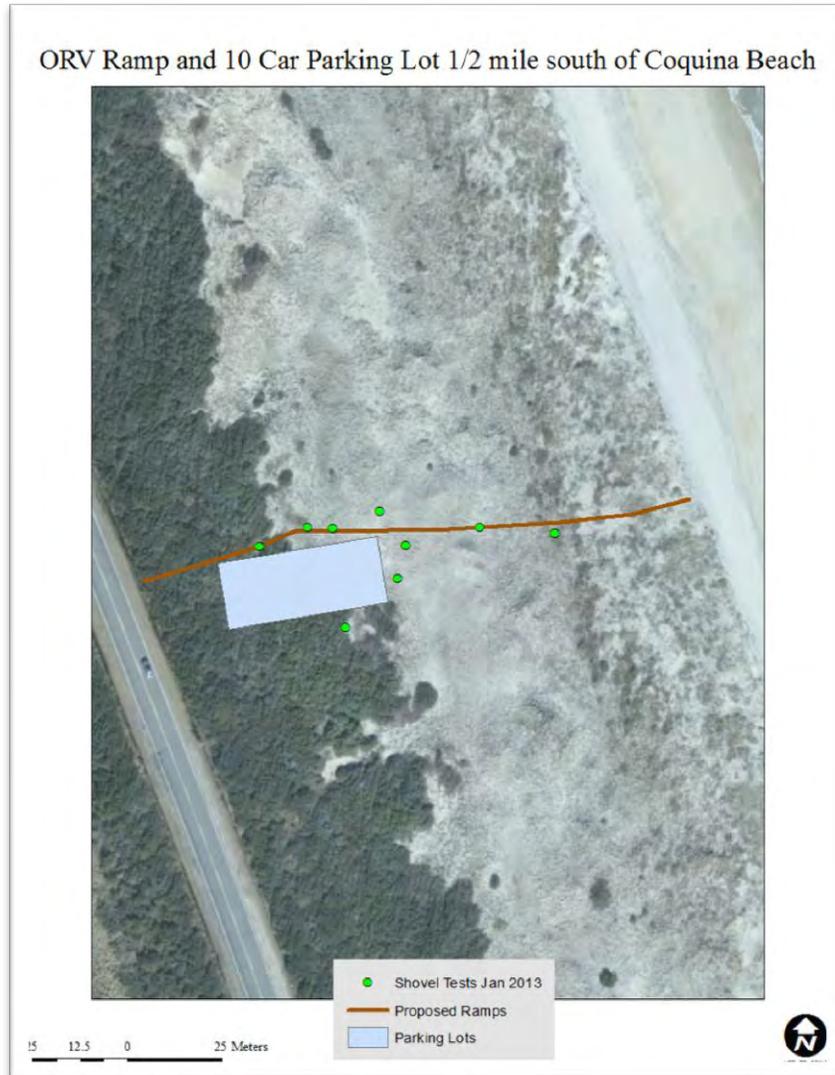
Site 4 is a proposed ORV ramp and 10-car parking area 0.5 miles south of Coquina Beach. Close interval shovel testing was performed along the eastern edge of the proposed parking lot since the western edge was inaccessible due to vegetative growth. The proposed ramp was tested until the artificially created dune was reached.

Figure 4. 10 car parking lot and access ramp ½ mile south of Coquina Beach.

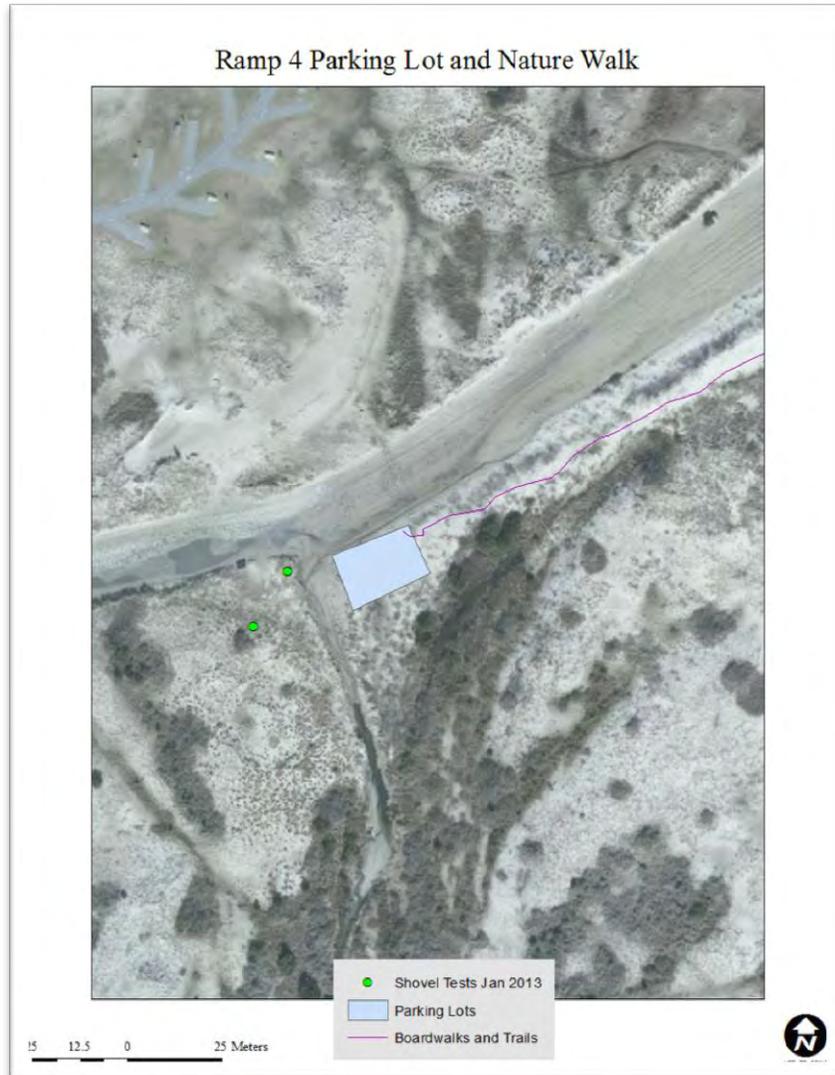
Site 5 is a proposed 10-car parking area and foot trail at Ramp 4. Shovel testing occurred west of the proposed location on the map due to concerns of rare plant occurrences within the area, particularly *Yucca gloriosa*. No shovel testing occurred for the planned nature walk since no ground disturbing activities associated with this feature is proposed.

Figure 5. Ramp 4 parking lot.

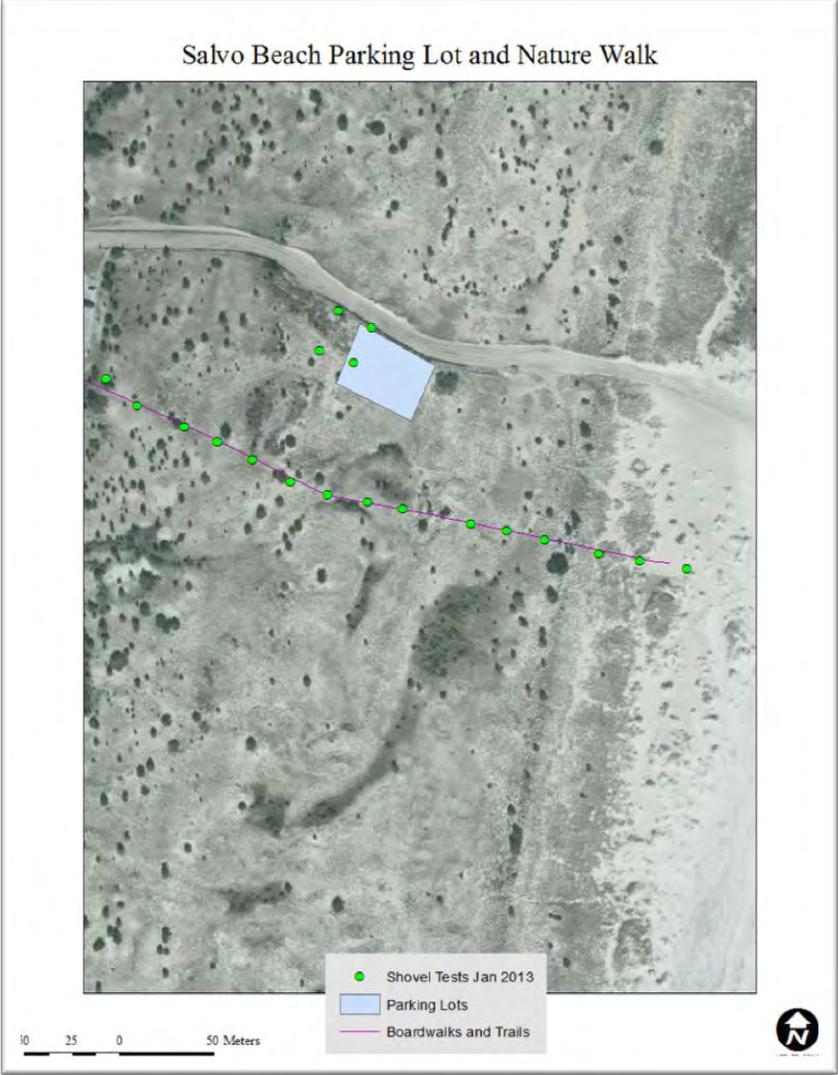
Site 6 is a proposed 20-car parking area and handicap accessible boardwalk at Ramp 23 (ca. 0.3 mi S of Salvo). A total of 15 shovel tests were dug for the proposed boardwalk and an additional 4 shovel tests were excavated for the proposed parking area. No artifacts were recovered from any shovel tests. At Salvo Beach the proposed handicap accessible boardwalk terminates 50M east of ASMIS site CAHA00055.000 Salvo Beachside coin scatter. This resource consists of an isolated rectangular glass bottle and several water worn American coins from the 20th century. They were recovered in 2003 from the beach east of Salvo Campground in an area where the sand dunes had been washed away by Hurricane Isabel's storm surge. The coins consist of three quarters (minted in 1985, 1982, and 1943), three dimes (all too water worn to date), one nickel (too worn to date), and four pennies (minted 1979, 1968, 1967, and one too worn to date). At the moment, there is nothing to indicate that the items recovered at this location are anything other than modern in age except possibly for the rectangular

glass bottle which bears the mold seams of a machine-made container. Since no ground disturbing activities will occur within 50M of the site the proposed actions are not considered adverse.

Figure 6. Salvo beach parking lot and handicap accessible boardwalk.

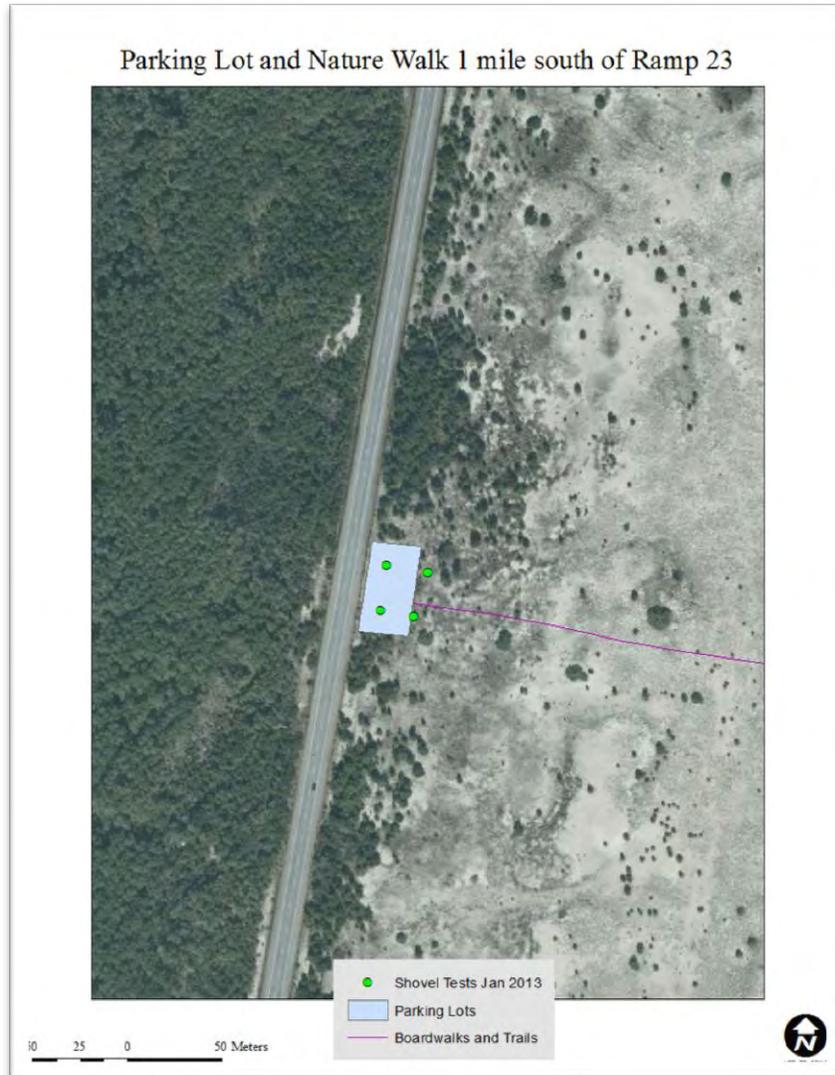
Site 7 is a 10-car parking lot about 1.0 mile south of Ramp 23 with foot trail to beach. A total of four shovel tests were excavated at this location with no artifacts recovered. The foot trail was not tested since no construction or ground disturbance is required.

Figure 7. 10 car parking lot and nature trail one mile south of Ramp 23.

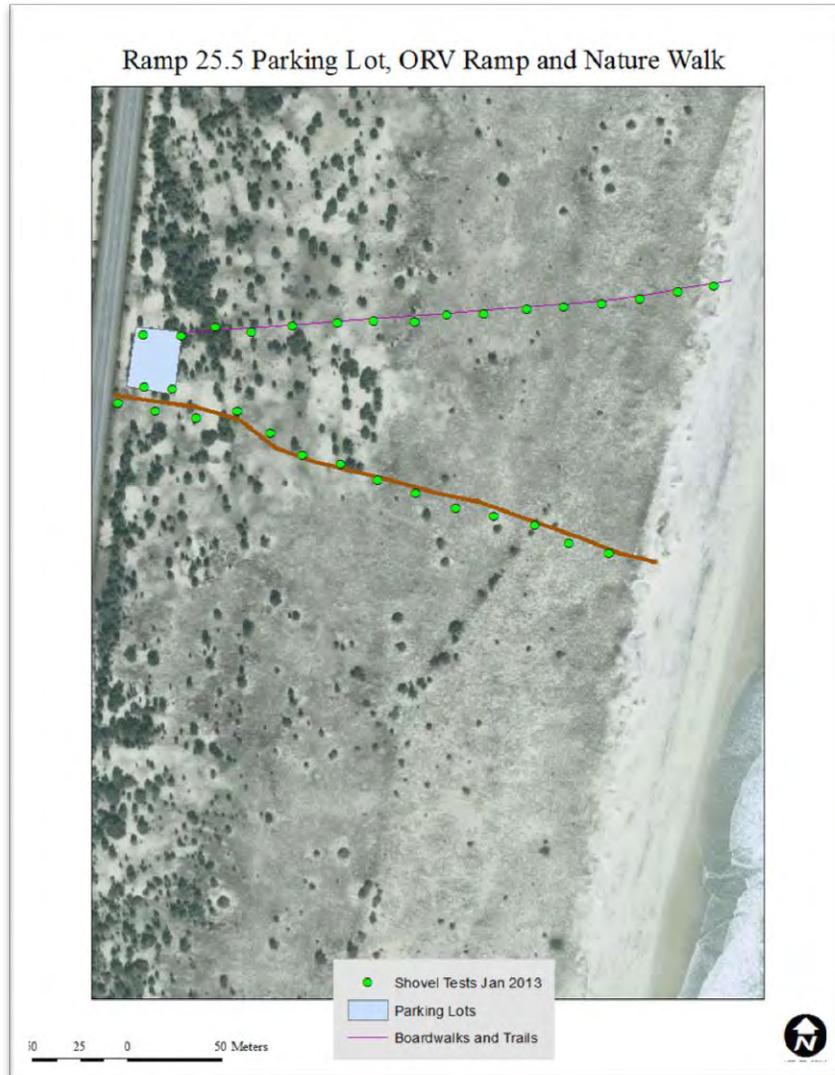
Site 8 is an ORV Ramp 25.5 with foot trail or boardwalk to the beach. Because of some confusion regarding whether or not a boardwalk was to be placed here or a nature trail, both areas were archeologically tested. A total of 32 shovel tests were excavated for the proposed actions. No artifacts were recovered.

Figure 8. Ramp 25.5 parking lot, ORV ramp and boardwalk.

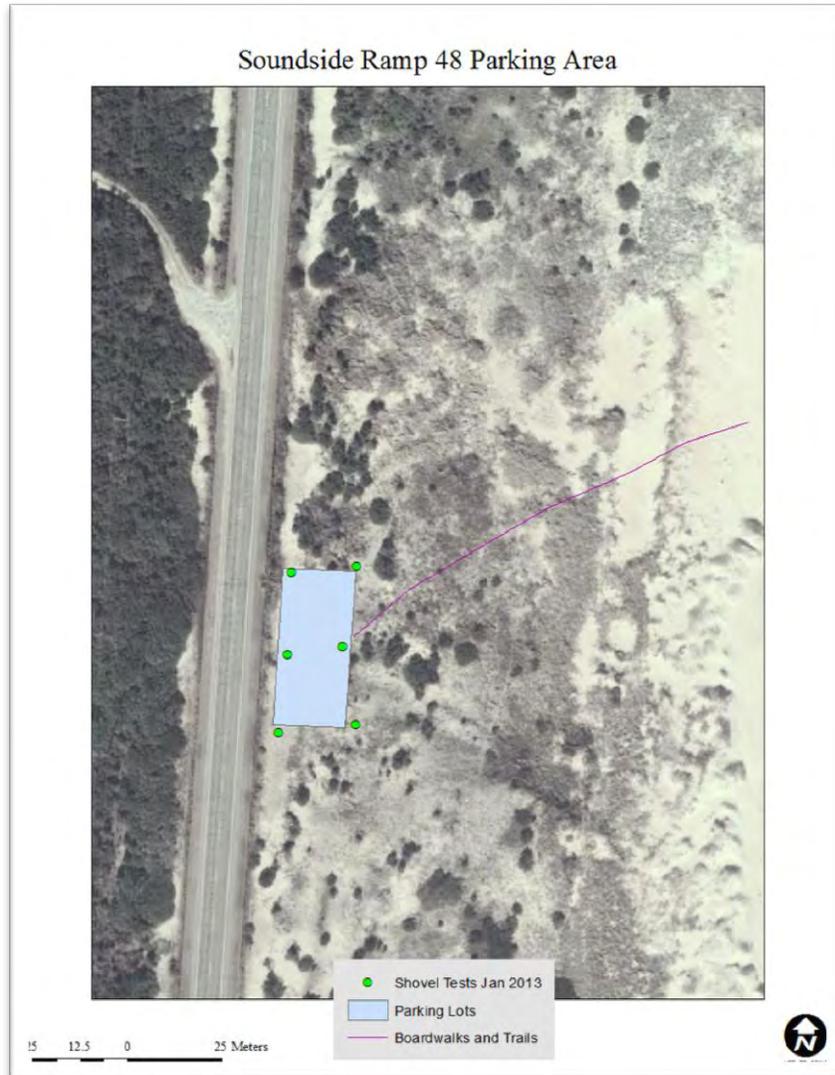
Site 9 is a proposed 5-car parking area at soundside Ramp 48. A total of 6 shovel tests were excavated at the location proposed for the 40Mx20M parking area. No artifacts were recovered from the shovel tests. A nature trail would leave the parking lot. The trail was not tested.

Figure 9. 5 car parking area at soundside Ramp 48.

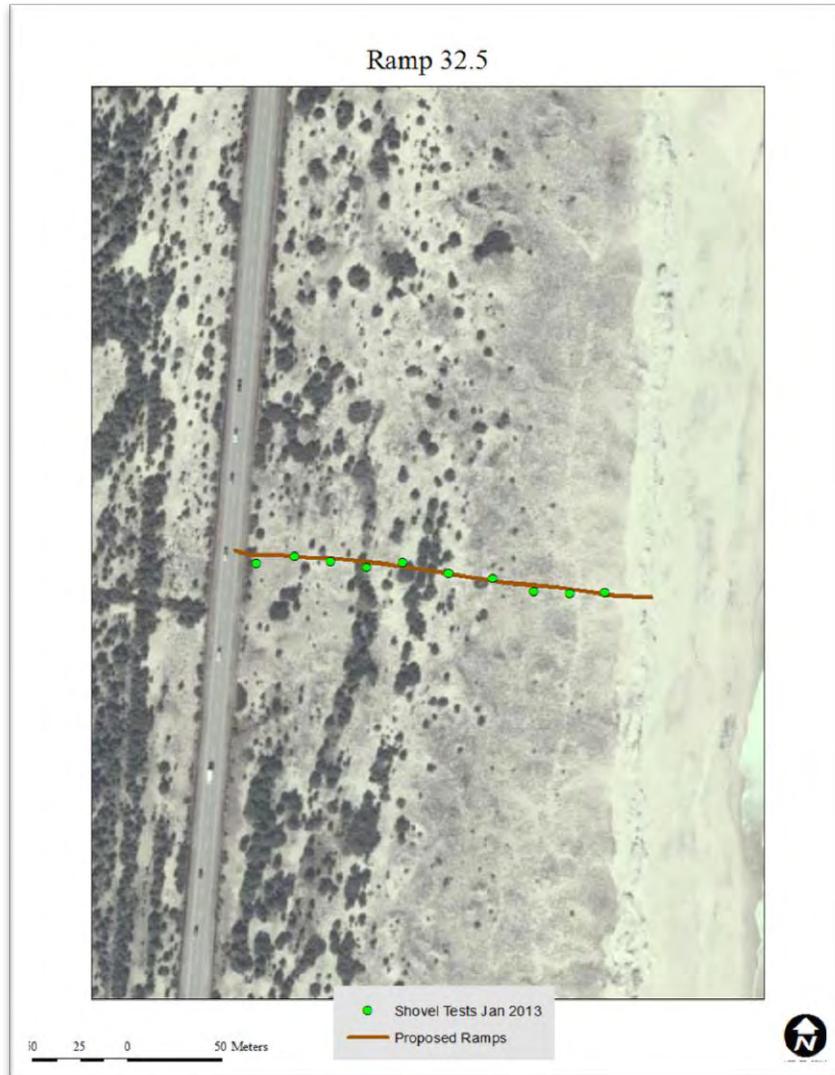
Area 10 is a proposed ORV ramp at 32.5. A total of 10 shovel tests were excavated for the proposed ramp. No artifacts were recovered from any of the shovel tests.

Figure 10. Proposed ramp at 32.5.

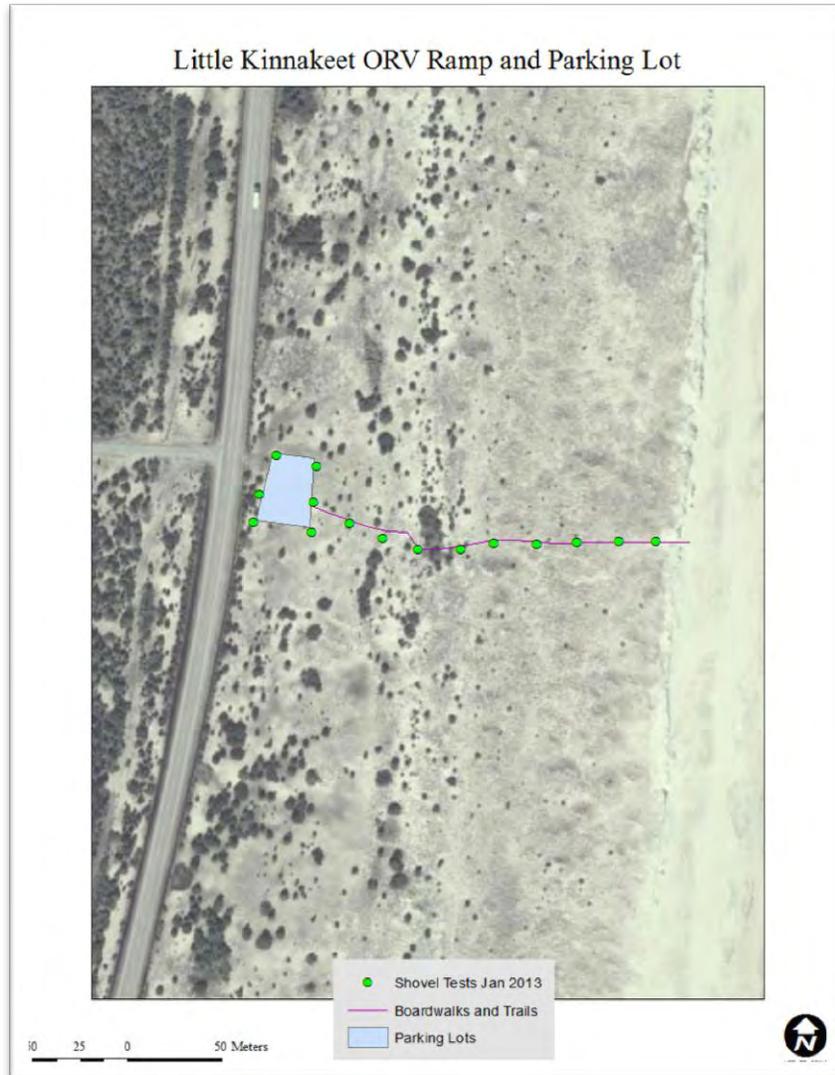
Site 11 is a proposed ORV ramp at 32.5 (Little Kinnakeet) with a 10-car parking lot and foot trail to the beach. A total of 6 shovel tests were excavated for the 25Mx40M parking lot with an additional 9 shovel tests dug for the proposed ORV ramp/trail. No artifacts were recovered. The proposed parking lot and ORV ramp/trail is located approximately 200M and across NC 12 from the Little Kinnakeet Life-Saving Station CAHA00038.000. None of the proposed actions would affect this known site.

Figure 11. Little Kinnakeet parking lot and ORV ramp/trail.

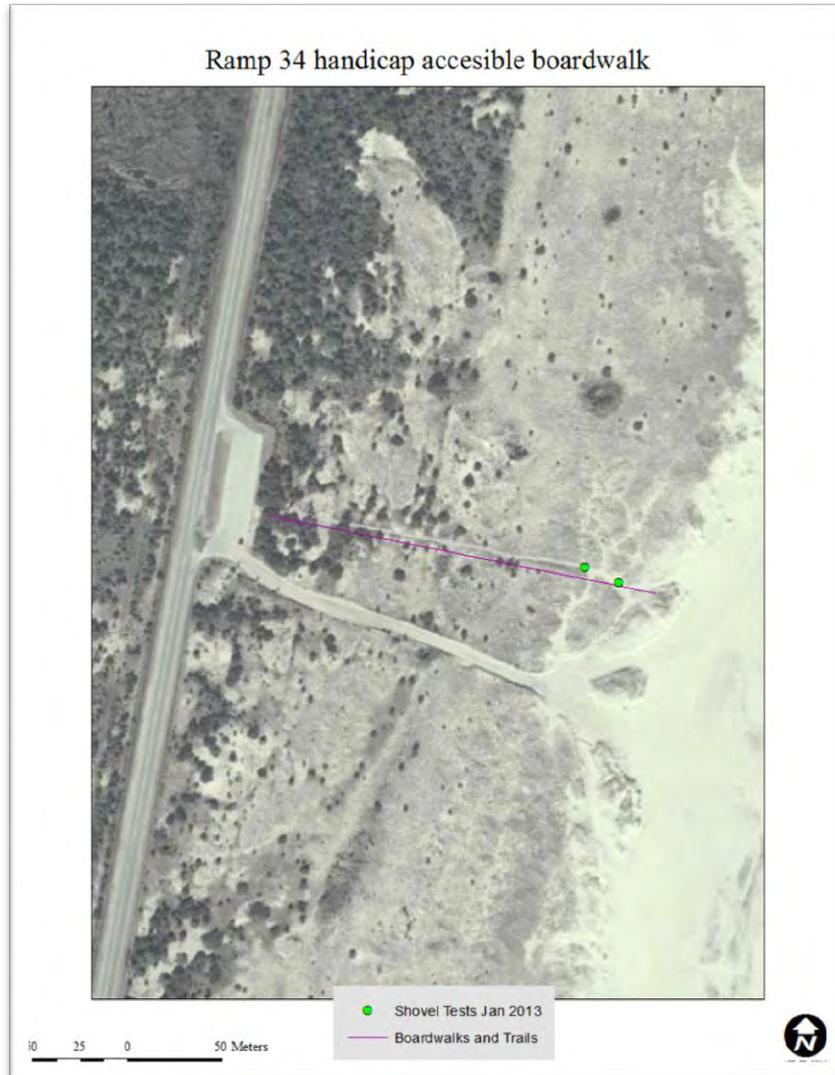
Site 12 is a proposed handicap accessible boardwalk at Ramp 34. An existing handicap accessible boardwalk will be extended approximately 40 more meters to the east. Two shovel tests were excavated for the proposed boardwalk extension with no artifacts recovered.

Figure 12. Proposed boardwalk extension.

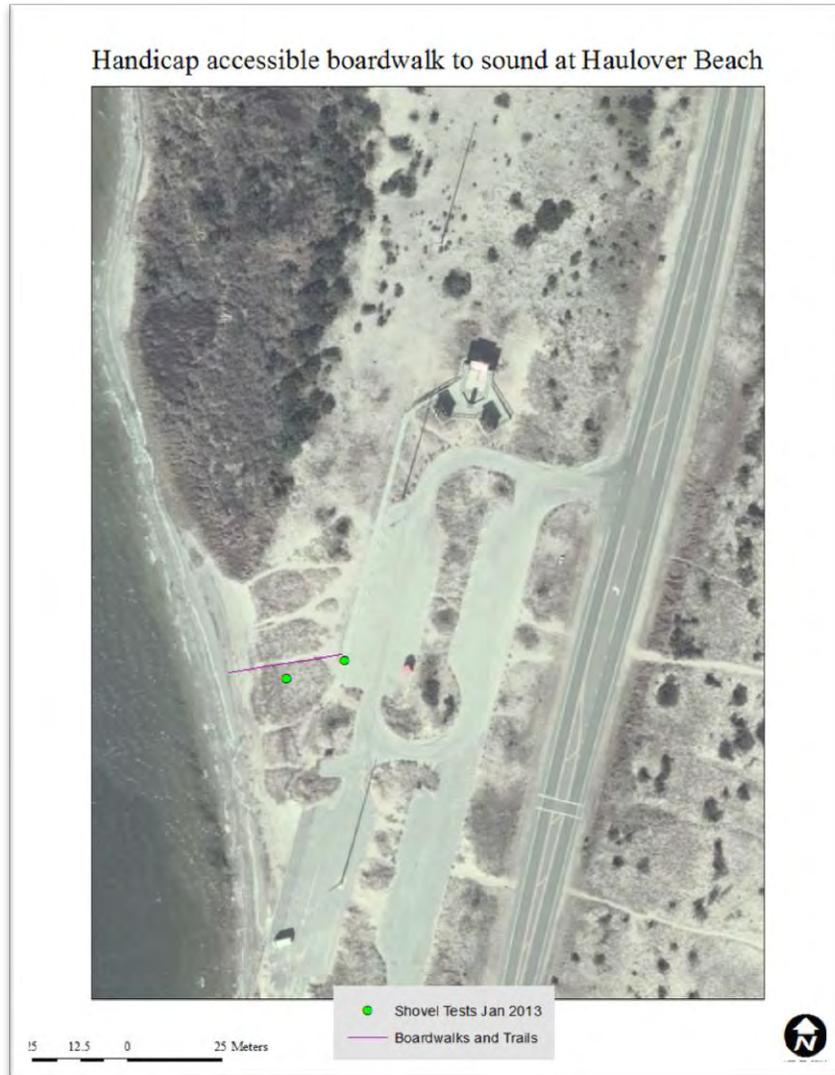
Site 13 is a handicap accessible boardwalk to sound at Haulover Beach Parking Area. The proposed handicap accessible boardwalk will extend from an existing parking lot to the edge of the sound. Two shovel tests were excavated with negative results.

Figure 13. Proposed handicap accessible boardwalk to sound at Haulover Beach.

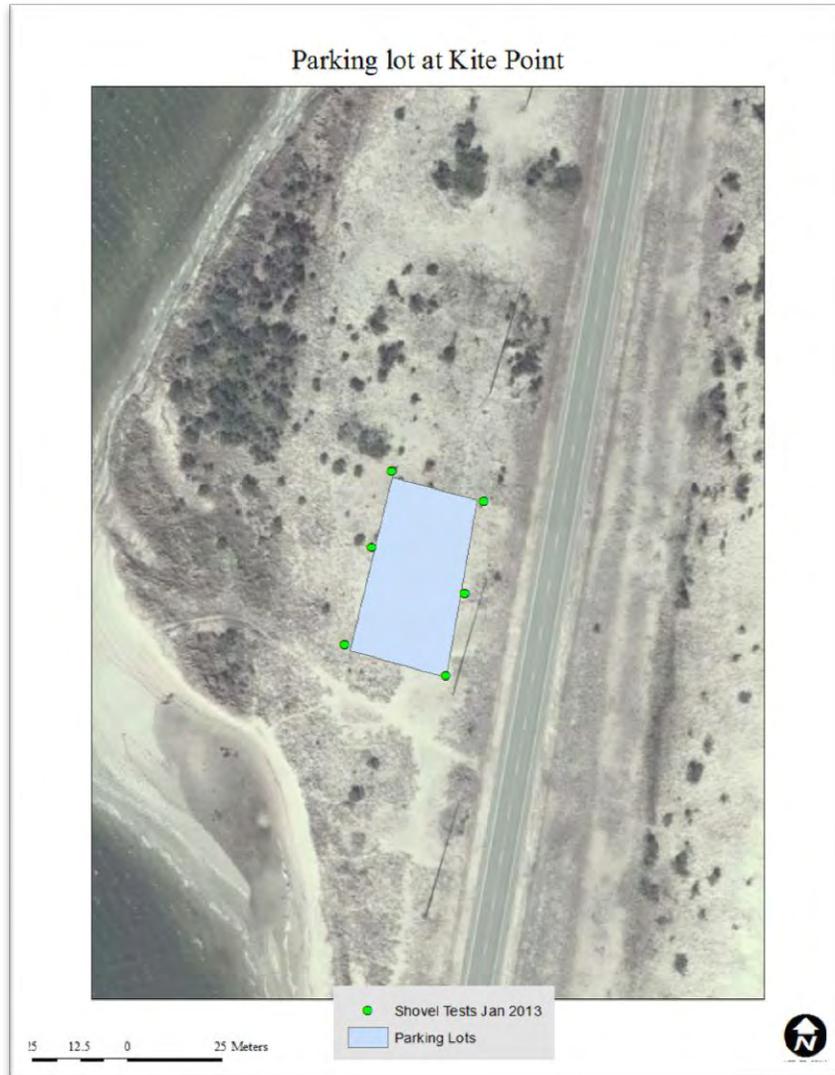
Site 14 is a 15-car parking area on the west side of highway near Kite Point. The 25Mx50M parking lot was archeologically tested with a total of 6 shovel tests all of which were negative for cultural material.

Figure 14. Proposed parking lot at Kite Point.

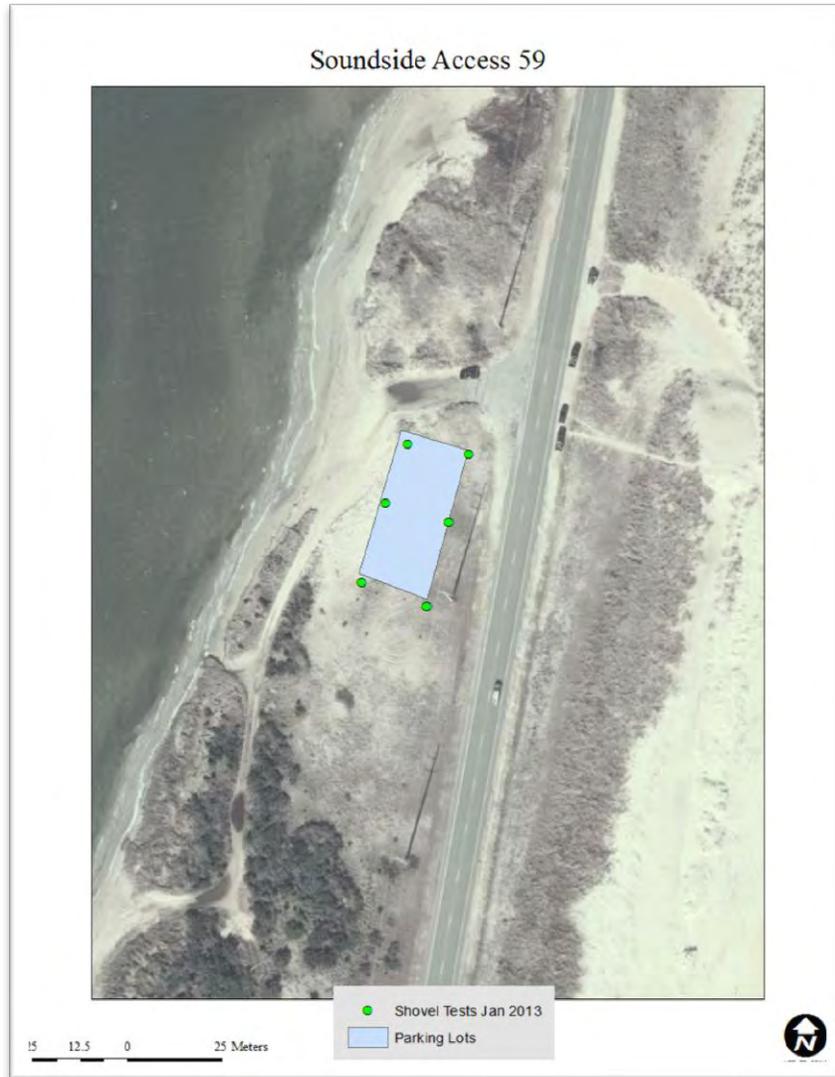
Site 15 is a proposed 10-car parking area at soundside access 59 with foot trail from highway to beach. Six shovel tests were excavated in the area of the proposed parking lot. No shovel tests were excavated for the foot trail.

Figure 15. Soundside Access 59 proposed parking lot.

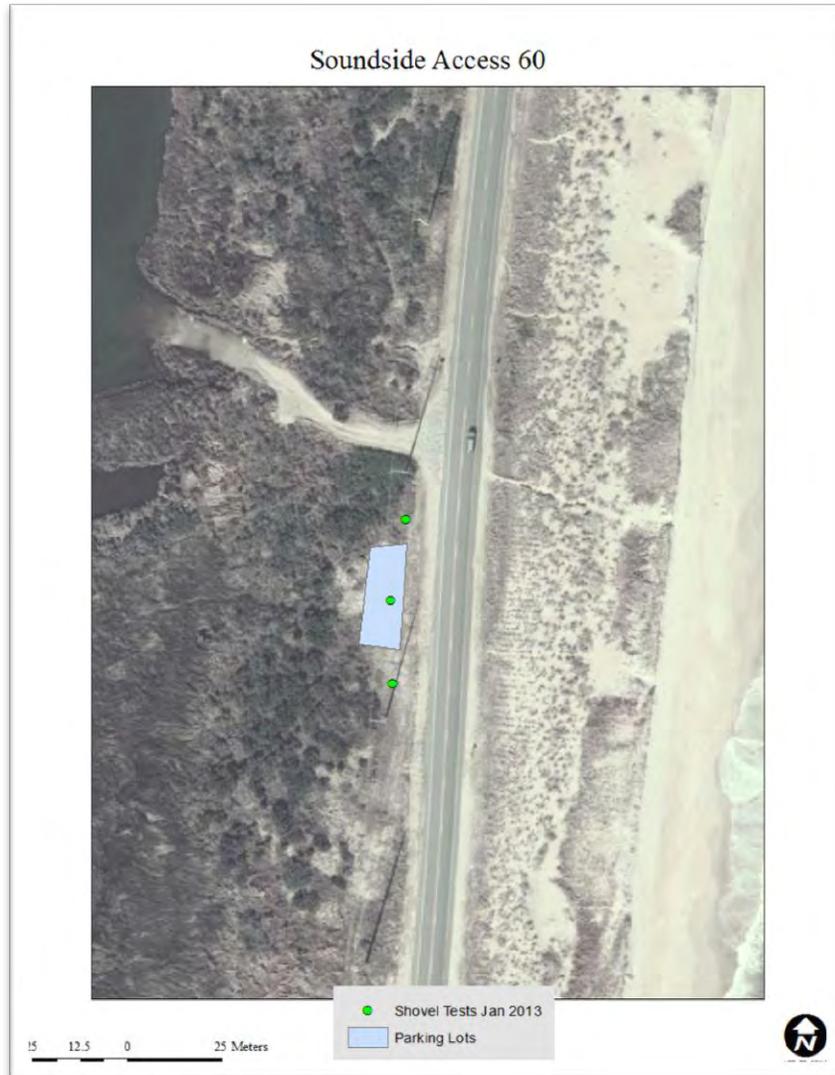
Site 16 is a proposed 5-car parking area west side of highway at/near soundside access 60. The 10Mx25M parking lot was tested by excavating three shovel tests all of which were negative for cultural remains.

Figure 16. Soundside 60 proposed parking area.

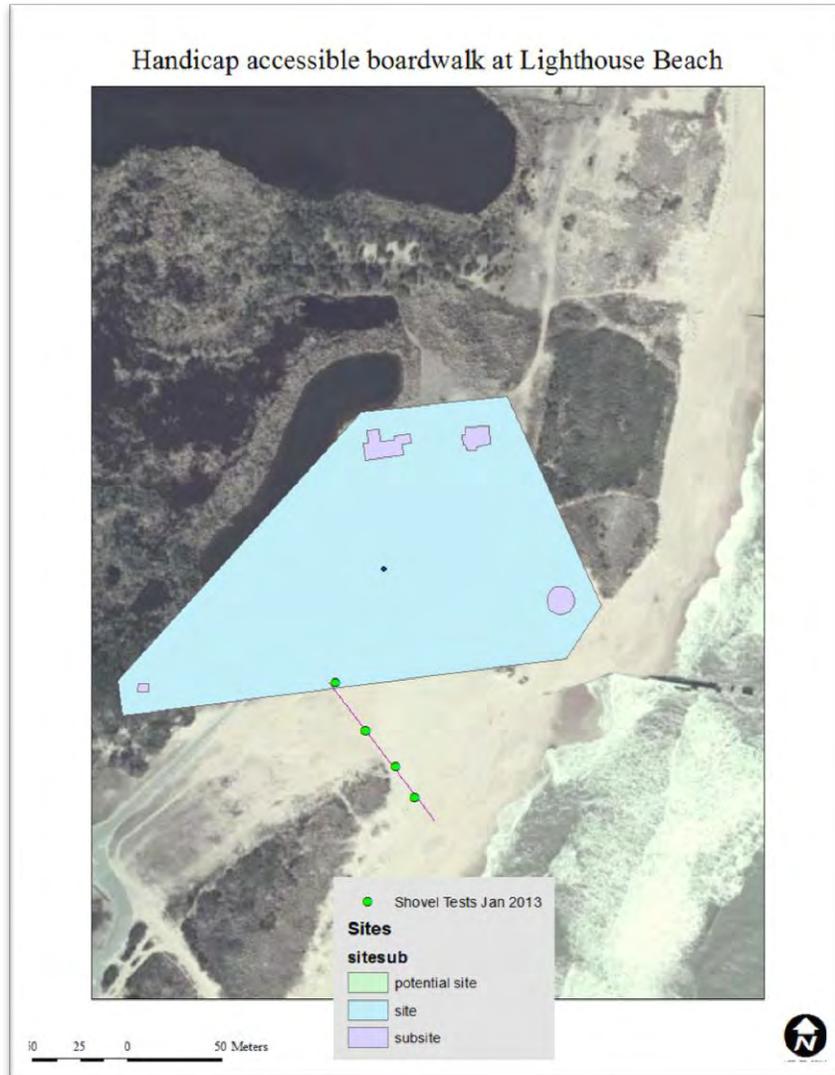
Site 17 is a proposed handicap accessible boardwalk at Lighthouse Beach. The proposed boardwalk will begin within the site boundary for CAHA00034.000 the original location for the Cape Hatteras Lighthouse. The northwest most shovel test was excavated within the boundary of CAHA00034.000. This shovel test as well as the remaining three were negative for artifacts.

Figure 17. ADA accessible boardwalk at Lighthouse Beach.

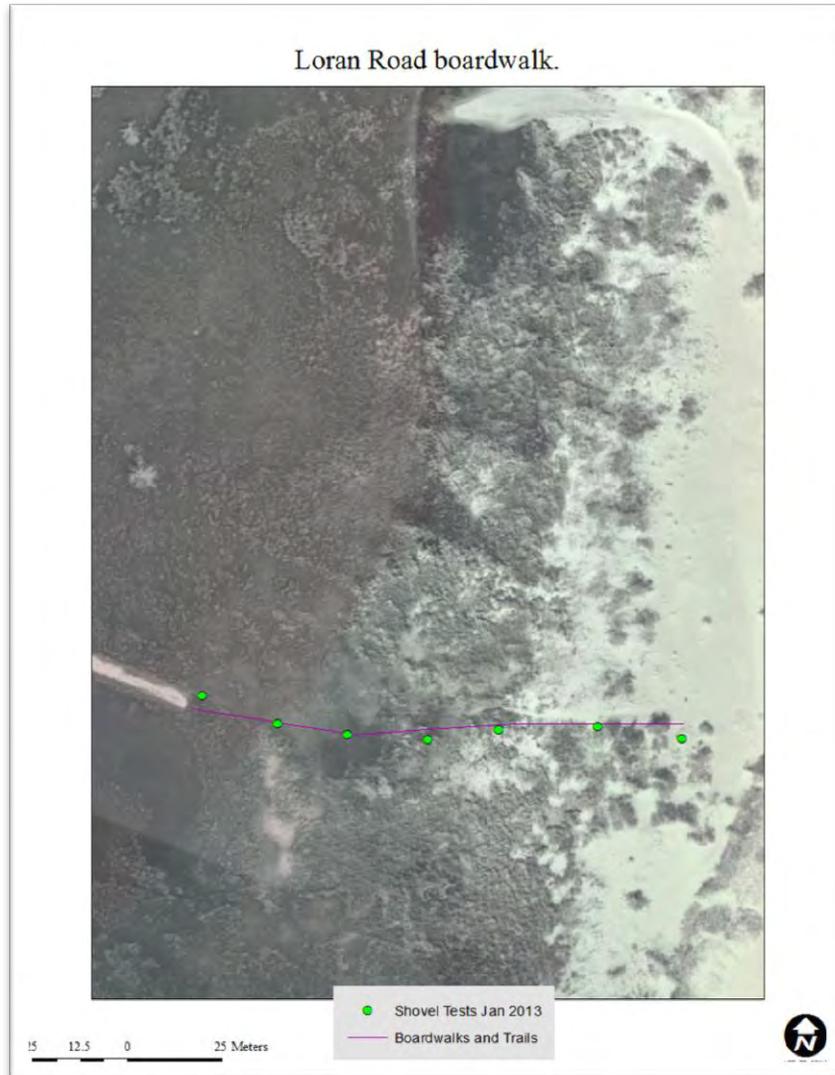
Site 18 is a proposed 5-car parking area at Loran Road w/ new handicap accessible boardwalk to the beach. The proposed 5 car parking lot at the intersection of Loran Road and Lighthouse was not archeologically tested as both Loran and Lighthouse roads were obviously constructed of fill and the proposed parking lot would also need to be trucked in fill since the area proposed for the parking lot is currently a wetland.

Figure 18. Proposed ADA accessible boardwalk at Loran Road.

The ADA compatible boardwalk was tested with a total of seven shovel tests all of which were negative for artifacts.

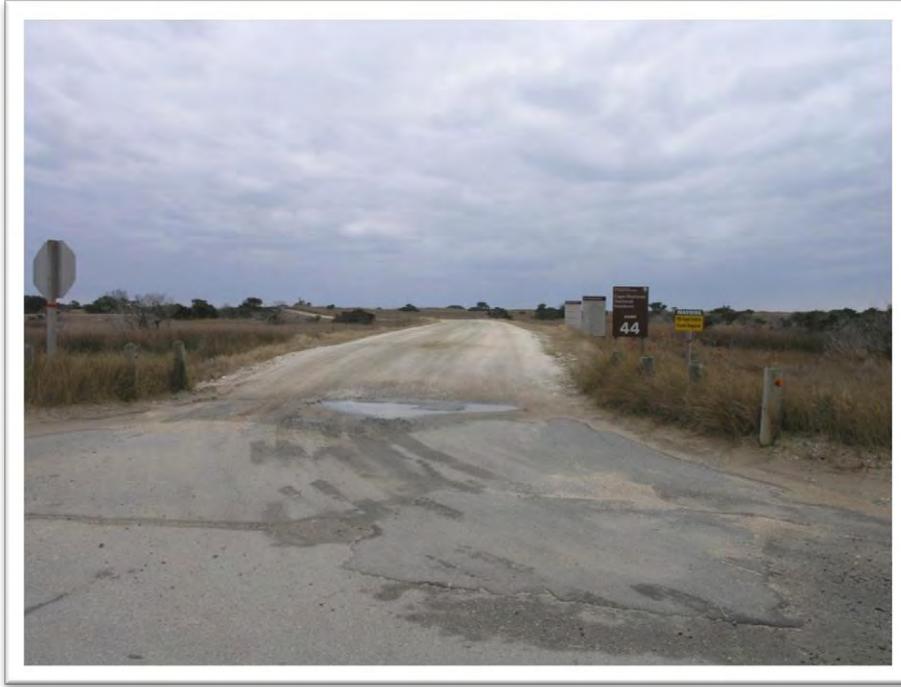
Site 19 is a proposed elevated section of Lighthouse Road to address flooding at Ramps 43 and 44. No shovel tests were excavated for this proposed action since no ground disturbing activities are anticipated. The current road is trucked in fill surrounded by wetland.

Figure 19. Ramp 44. Note wetlands on either side of current road.

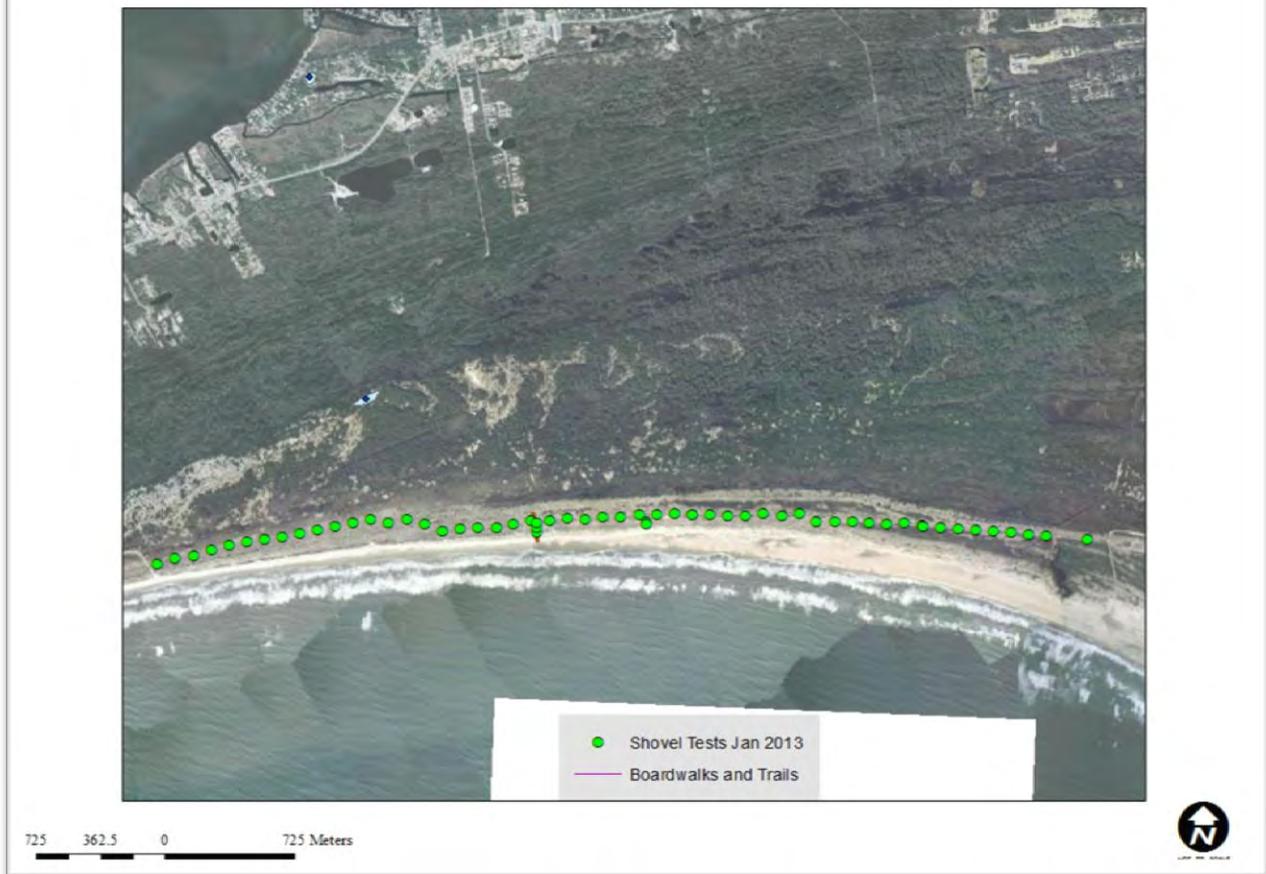
Interdunal Road (IDR) between Ramp 45 and 49 w/ new ORV Ramp 47.5 to the beach

Site 20 is a proposed 5.2KM interdunal road (IDR) between Ramp 45 and 49 w/ new ORV Ramp 47.5 to the beach. Testing along the proposed corridor was conducted at a 100M interval instead of the 20M interval used at all other sites due to the low probability of locating prehistoric or historic sites. A total of 52 shovel tests were excavated along the proposed route for the IDR. An additional three shovel tests were also excavated for the proposed ramp at or near 47.5. All shovel tests were negative for cultural remains.

Figure 20. IDR and Ramp 47.5 testing.

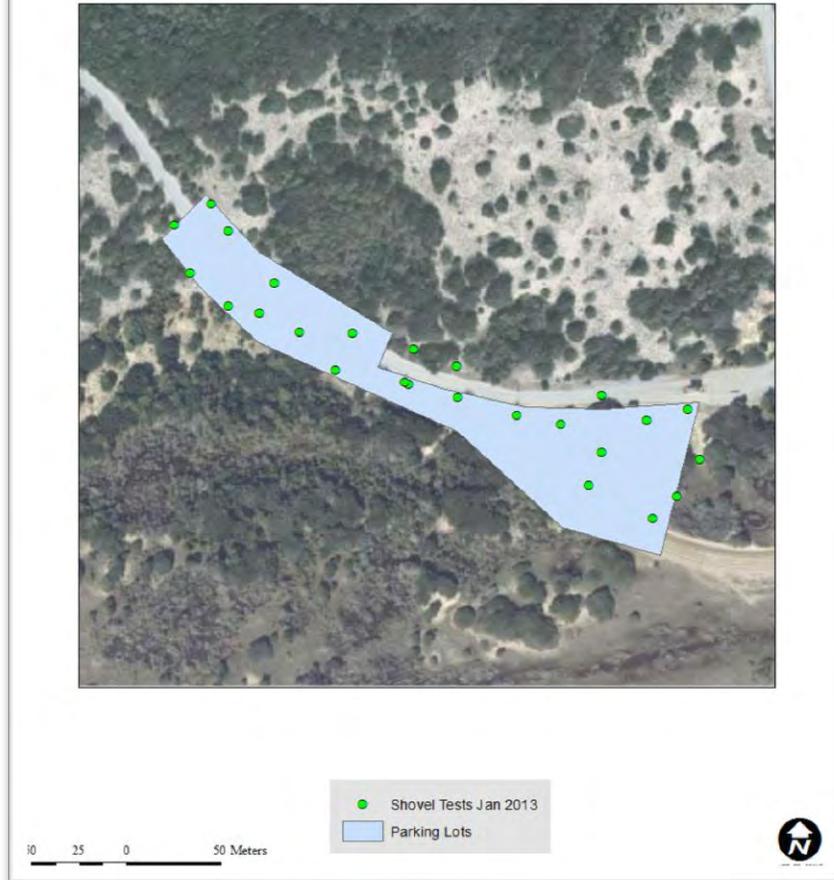
Widen Ramp 49 and add connector road
and 5-car parking lot to Billy Mitchell Rd.
near Frisco Campground

Site 21 is a proposal to widen Ramp 49 and add connector road and 5-car parking lot to Billy Mitchell Rd. near Frisco Campground. 24 shovel tests were excavated along Billy Mitchell Rd. None were positive for cultural remains.

Figure 21. Proposed Ramp 49 widening and addition to connector road and 5-car parking lot to Billy Mitchell Rd. near Frisco Campground.

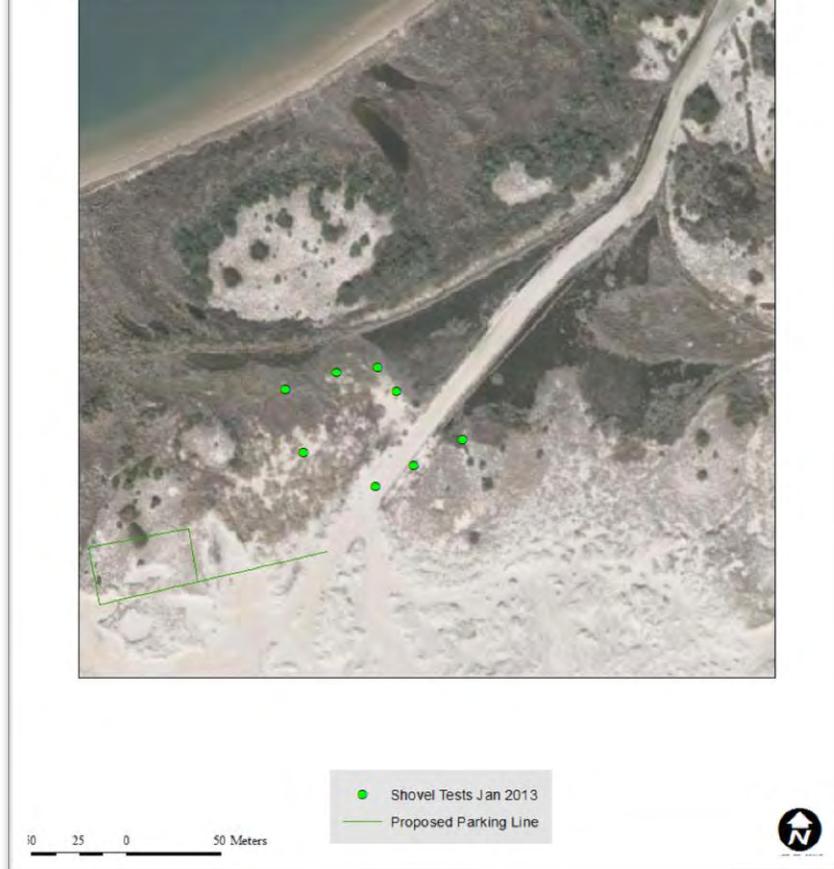
Proposed unimproved 20-car parking area
near the Pole Road/Spur Road intersection

Site 22 is a proposed unimproved 20-car parking area near the Pole Road/Spur Road intersection. Since Hurricane Sandy much of the western portion of Hatteras Island where the parking lot was proposed is no longer there. 2010 orthoimagery was used for the figures in this report and do not reflect the most current aeriels. For that reason testing occurred further east. A total of eight shovel tests were excavated. No artifacts were recovered.

Figure 22. Proposed unimproved parking area at Pole Road/Spur Road intersection.
