APPENDIX D
ARCHEOLOGICAL SURVEYS

January 11, 2013

Subject: Trip report on archeological testing of proposed beach access ramps, parking lots, and interdunal road.

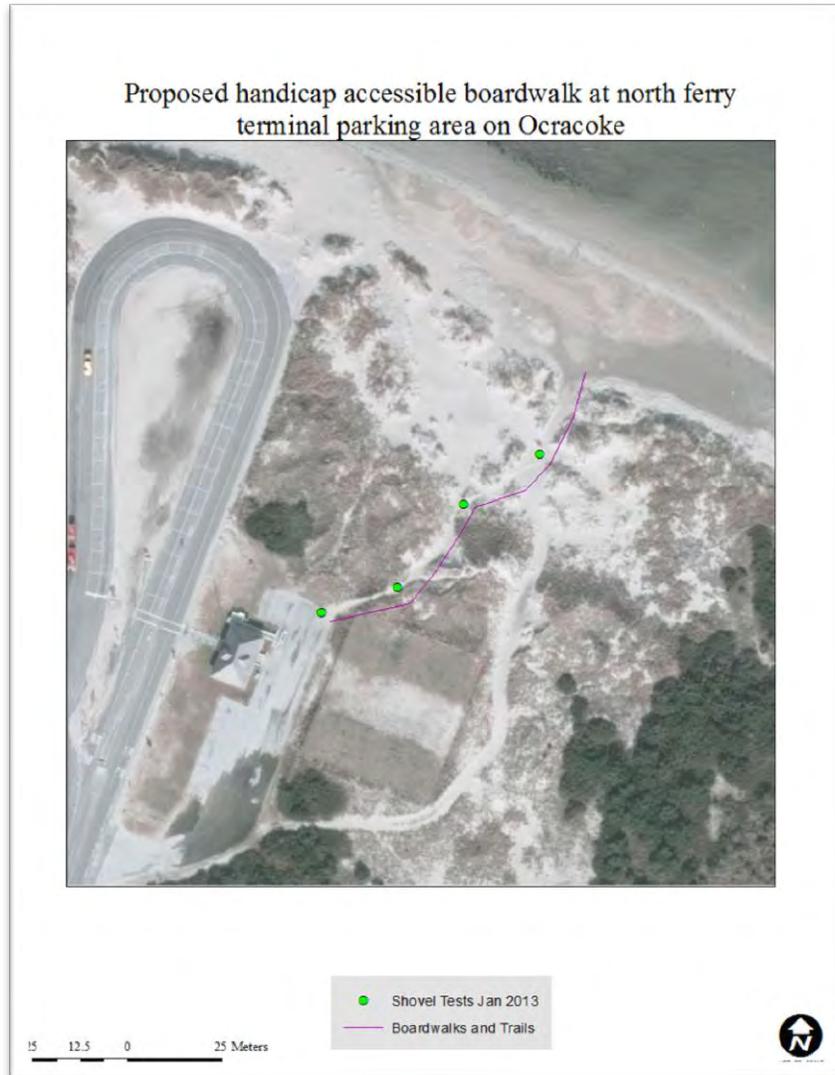
Site 23 is a handicap accessible boardwalk at the north ferry terminal parking area on Ocracoke Island. Four shovel tests were excavated along the proposed route. All shovel tests were negative.

Figure 23. Proposed ADA compliant boardwalk at North Ferry Ocracoke Island.

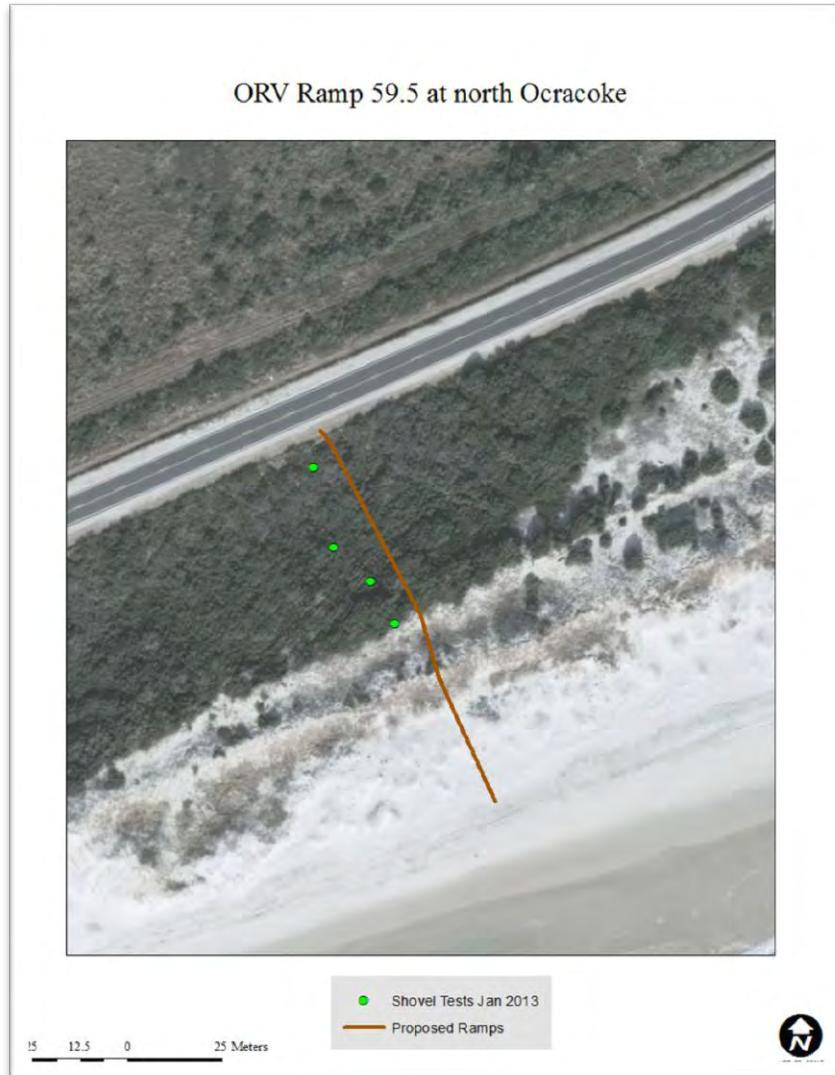
Site 24 is a ramp leading east connecting NC 12 with the beach. Four shovel tests were excavated and none were positive for cultural remains.

Figure 24. ORV Ramp 59.5 at north Ocracoke

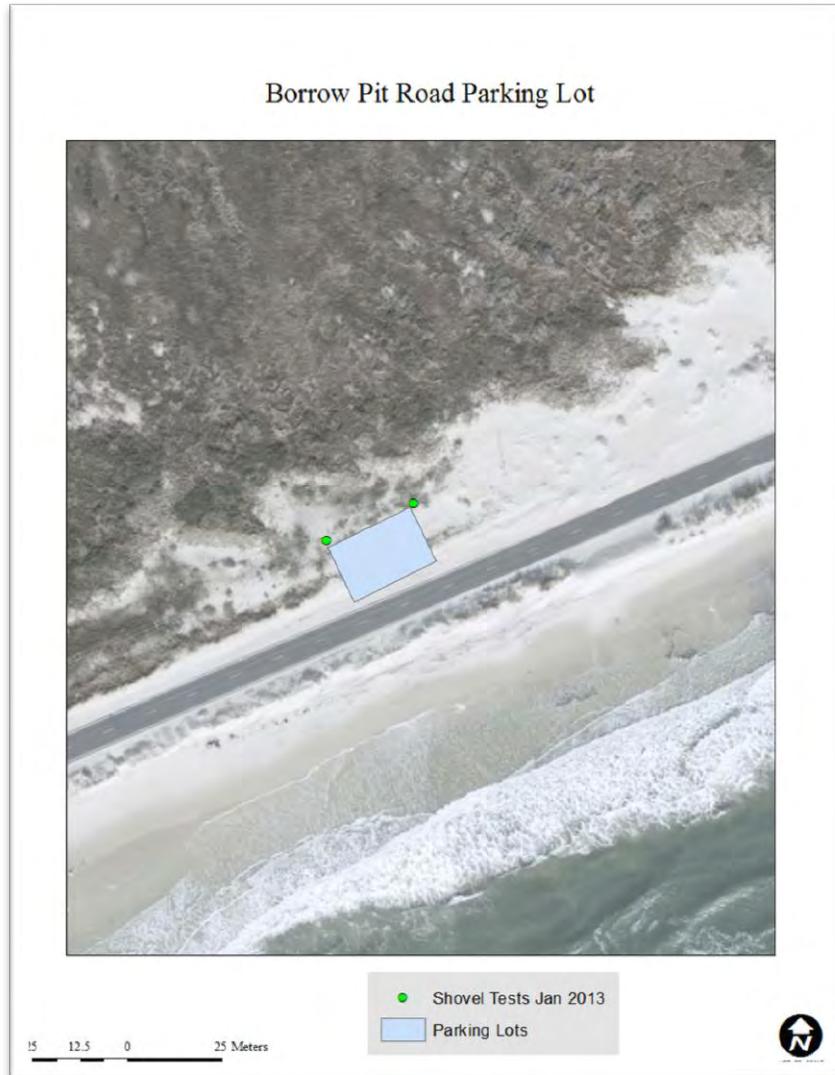
Site 25 is a proposed 5-car parking area at the west/north side of highway entrance of Borrow Pit Road. The approximately 15MX25M parking lot was tested with two shovel tests both of which were negative for artifacts.

Figure 25. Borrow Pit Road Parking lot.
