**ANADROMOUS FISH SURVEYS WITHIN THE  
BROOKS EAST CORRIDOR SURVEY AREA, ALASKA**

June 2013

- Objective 1: Document the stream habitat conditions in waterbodies associated with potential bridge crossings along the Brooks East Corridor
- Objective 2: Integrate stream habitat and fish presence data from the study area to determine potential impacts of bridge construction on stream habitat

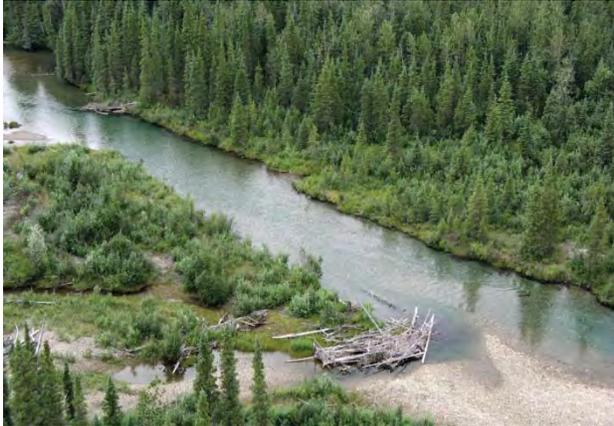
Plate 1. Aerial view of the chum salmon spawning area documented within an unnamed tributary to the Mauneluk River, Alaska, July 2012.

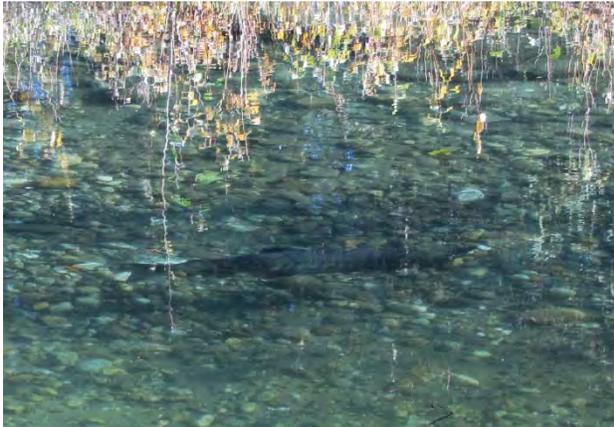
Plate 3. Chum salmon spawning area documented within the Reed River, Alaska, July 2012.

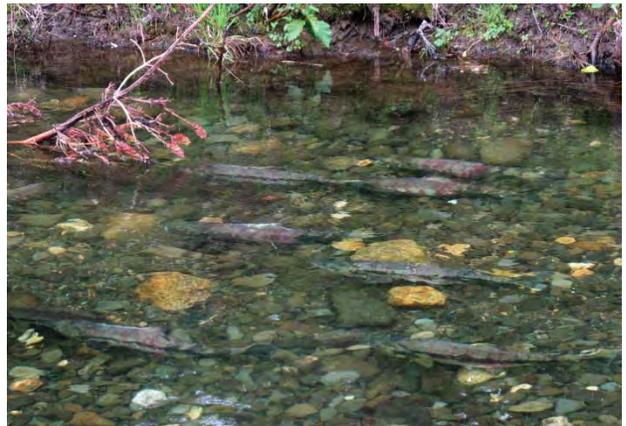
Plate 6. Chum salmon spawning area documented within the Hogatza River, Alaska, July 2012.

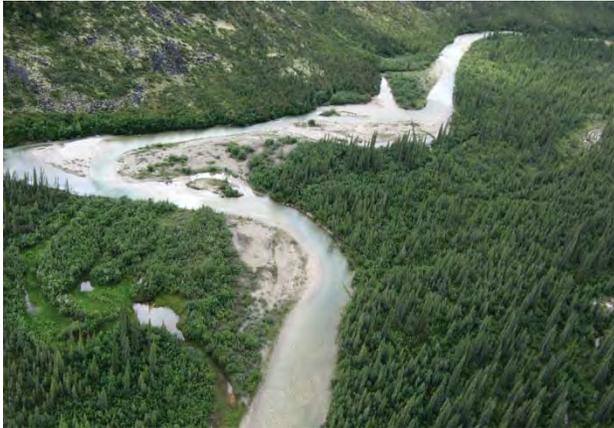
Plate 7. Aerial view of the chum salmon spawning area documented within an unnamed tributary to the Alatna River, Alaska, July 2012.

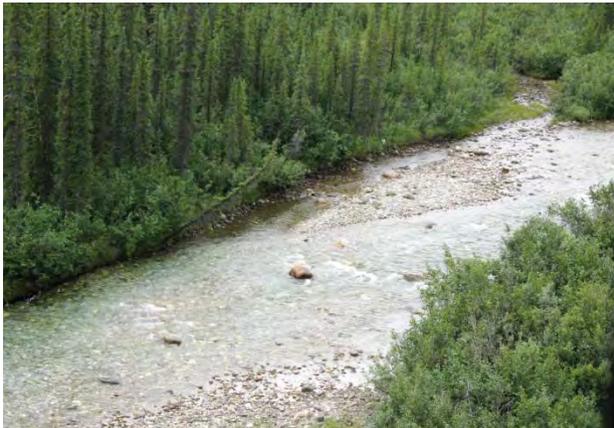
Plate 9. Aerial view of the Chinook salmon spawning area documented within an unnamed tributary to the Alatna River, Alaska, July 2012.

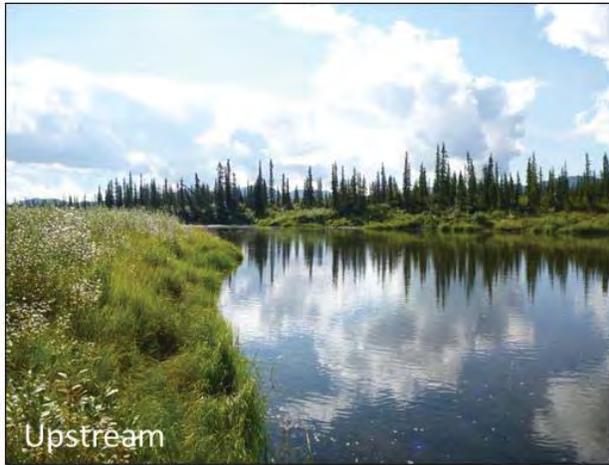
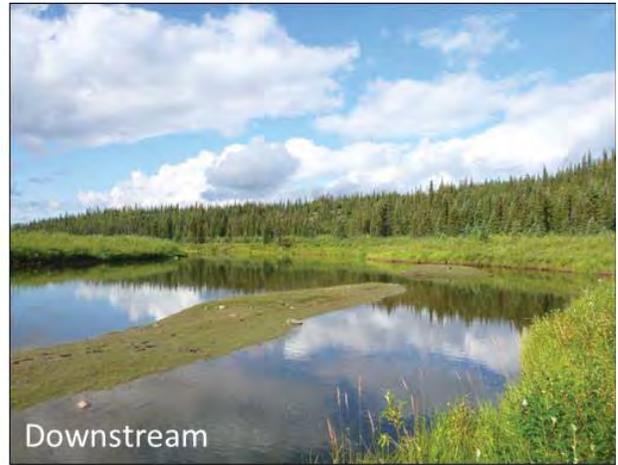
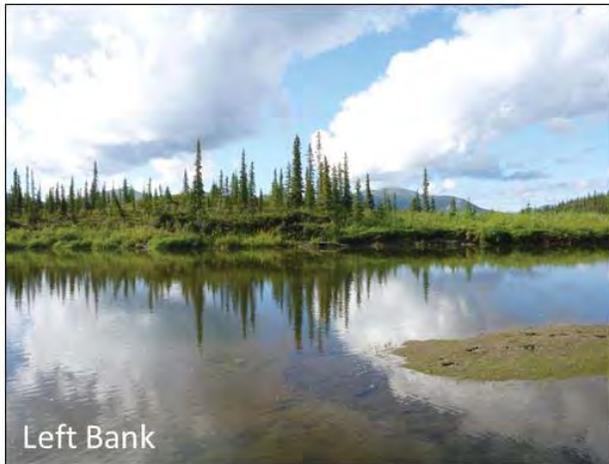
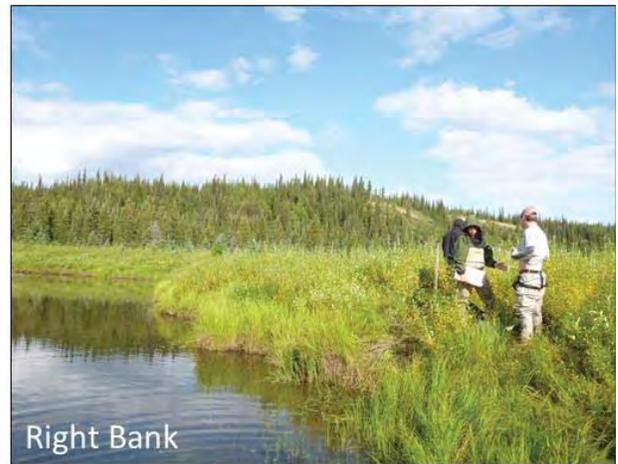
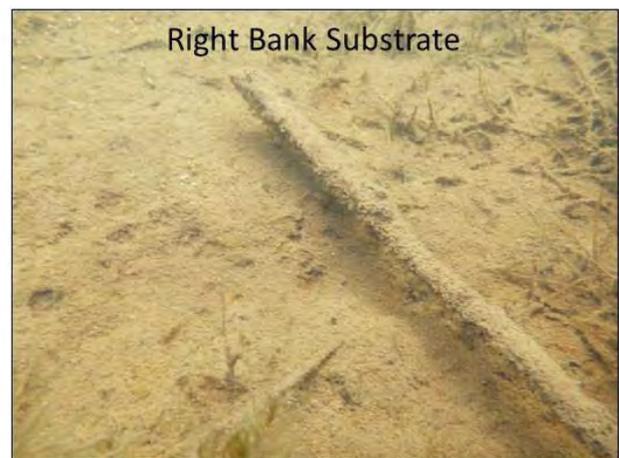
Plate 1. Stream channel characteristics, riparian habitat, and instream substrate composition at transect SH-T1-13, Shungnak River, Brooks East Corridor, Alaska, August 2013.

ABR mapped and characterized the stream crossing reach and performed 3 instream habitat transect surveys on 12 August 2013 (Figure 3, Appendix B) (Plates 1–3). Most of the 2,000-ft reach at the Shungnak River crossing is a shallow (less than 1 m) riffle-run flow regime composed of boulder, cobble, gravel, and sand substrate. However, Transect 1 (SH-T1-13) is representative of the slackwater pool habitat available in this reach and substrate composition was dominated by fine sediment (80% silt and clay) rendering most of this transect unwadeable

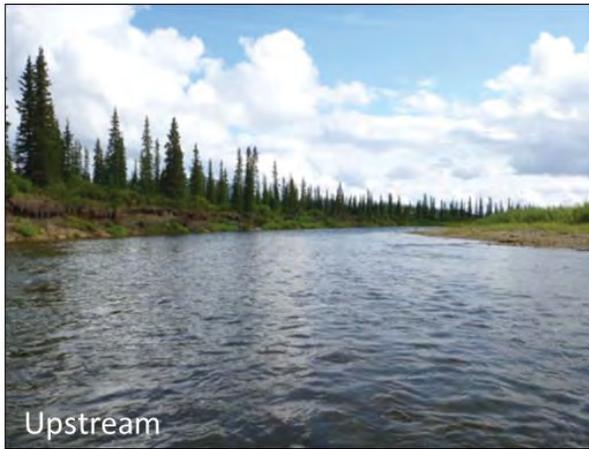
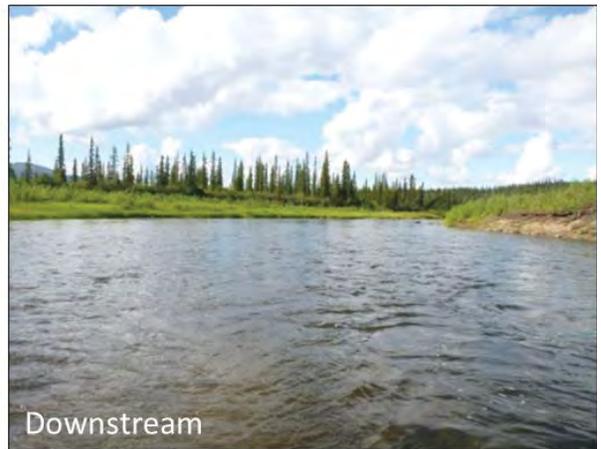
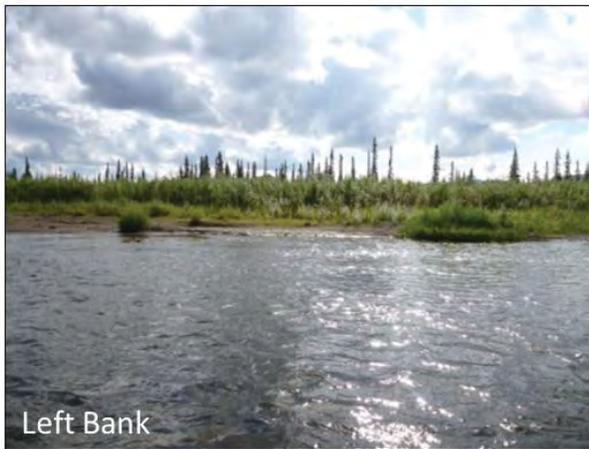
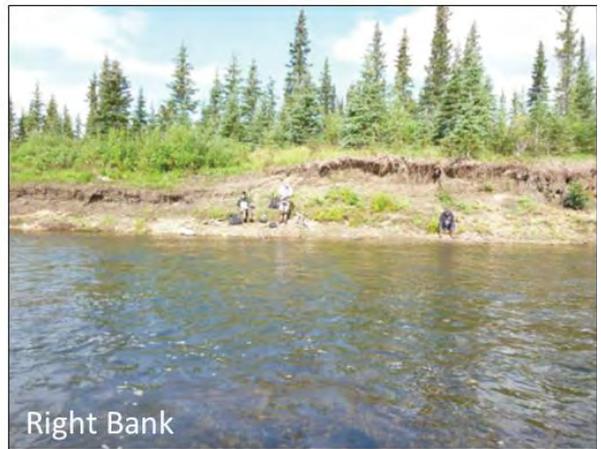
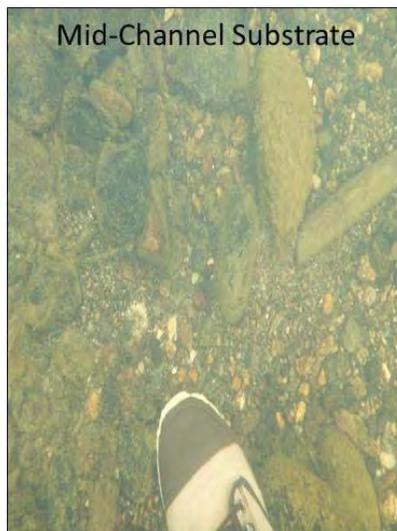
Plate 2. Stream channel characteristics, riparian habitat, and instream substrate composition at transect SH-T2-13, Shungnak River, Brooks East Corridor, Alaska, August 2013.

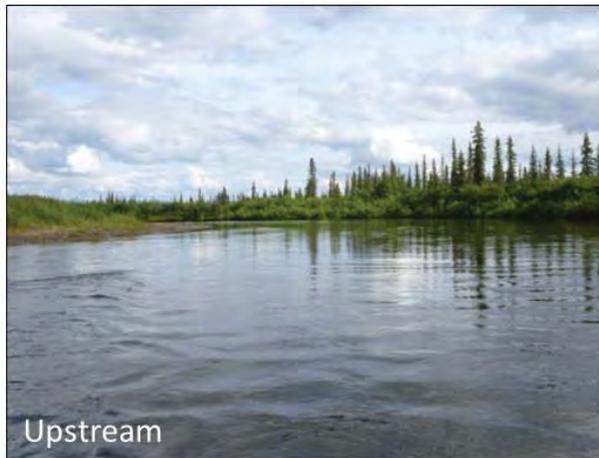
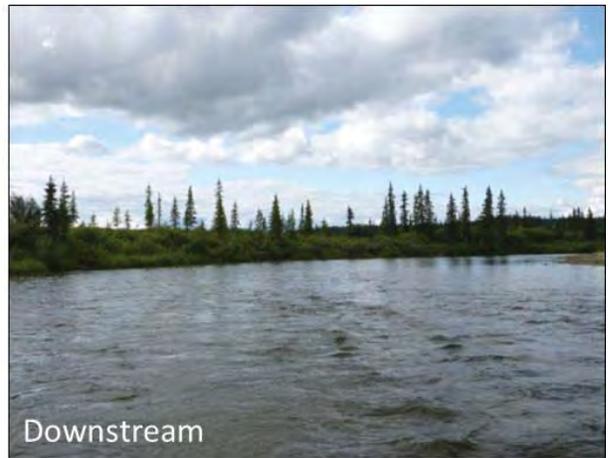
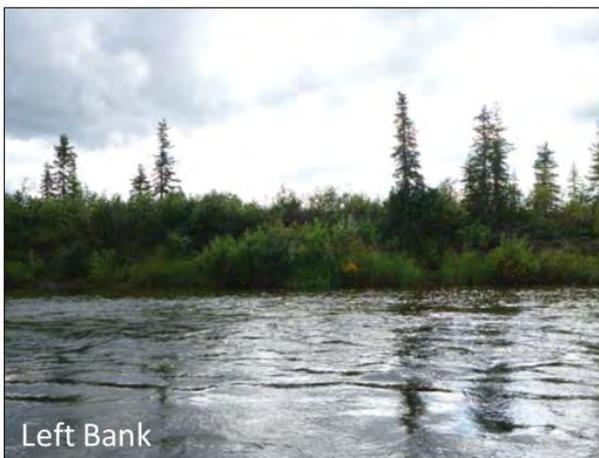
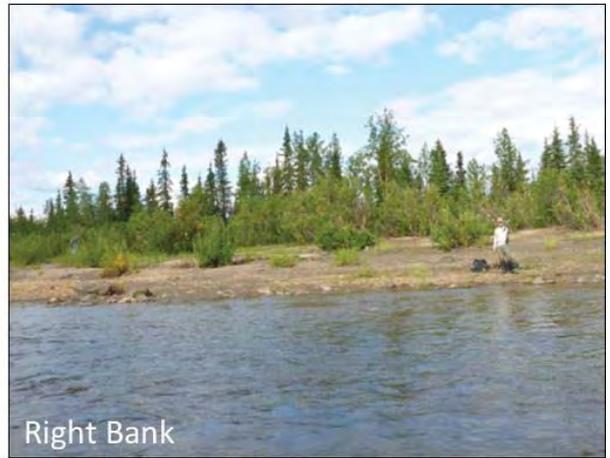
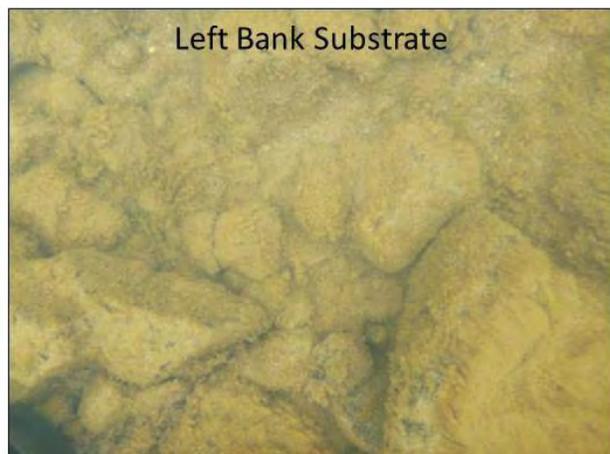
Plate 3. Stream channel characteristics, riparian habitat, and instream substrate composition at transect SH-T3-13, Shungnak River, Brooks East Corridor, Alaska, August 2013.

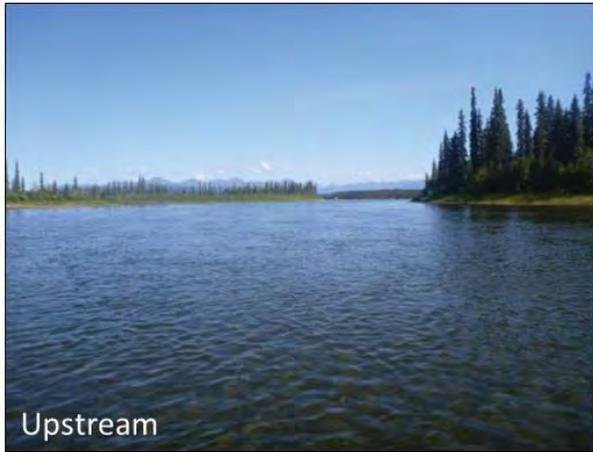
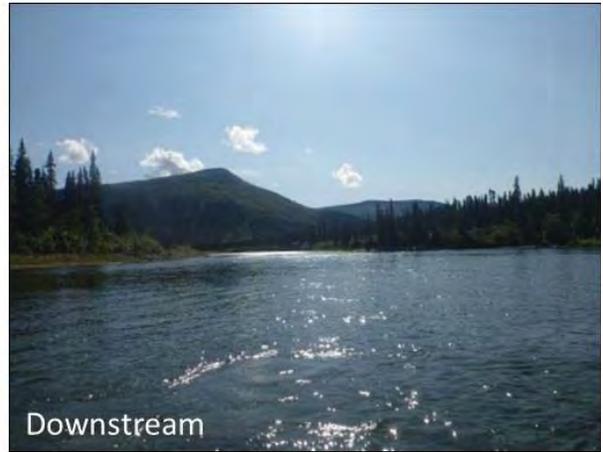
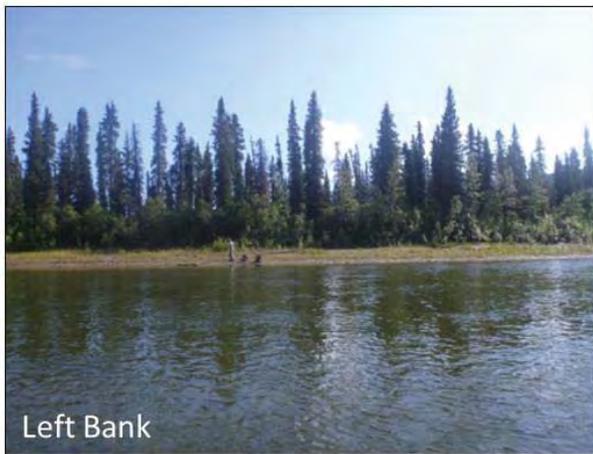
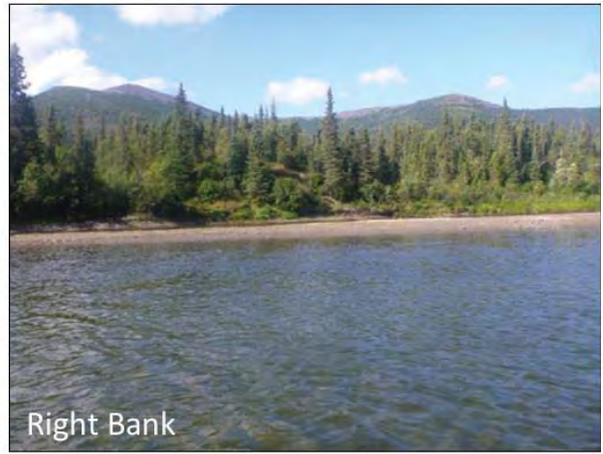
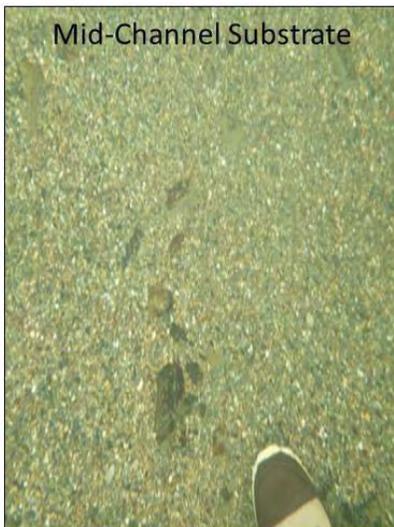
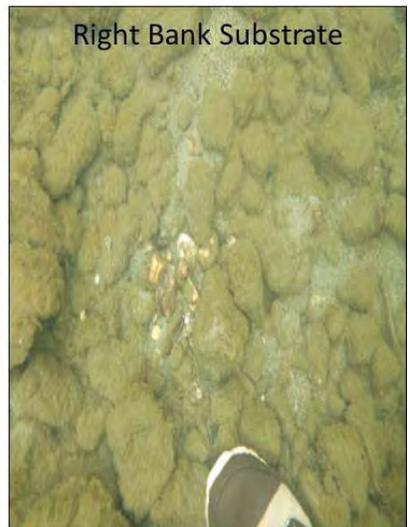
Plate 4. Stream channel characteristics, riparian habitat, and instream substrate composition at transect KG-T1-13, Kogoluktuk River, Brooks East Corridor, Alaska, August 2013.

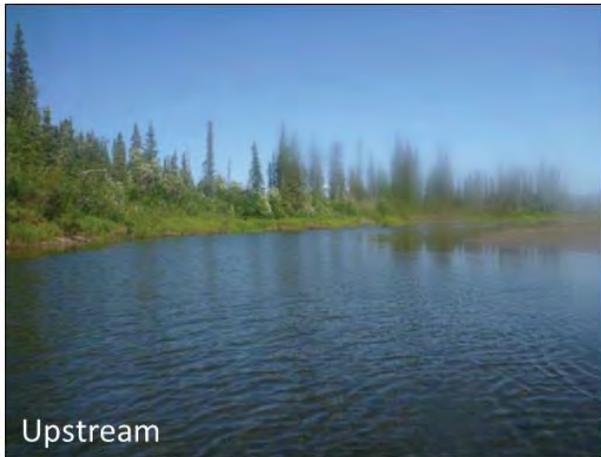
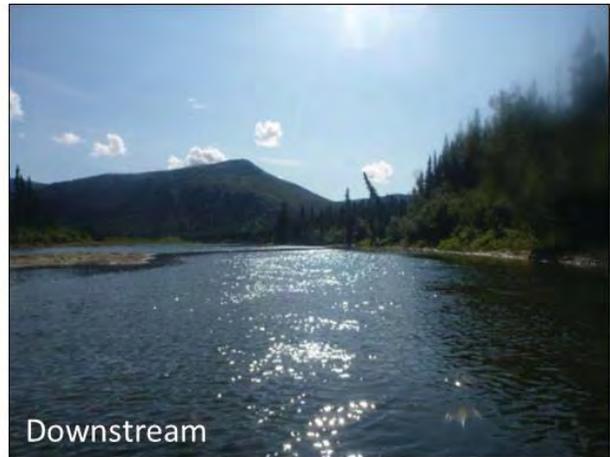
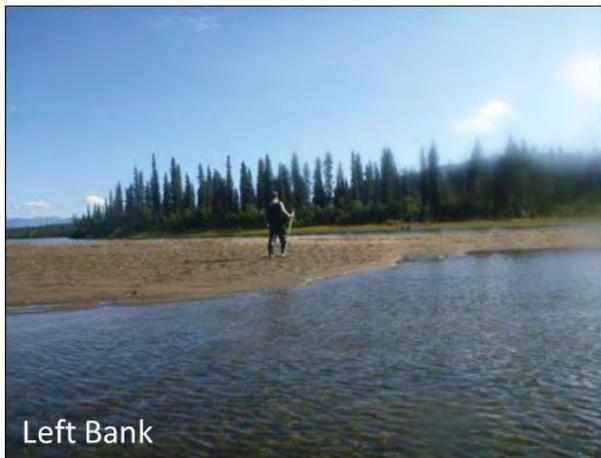
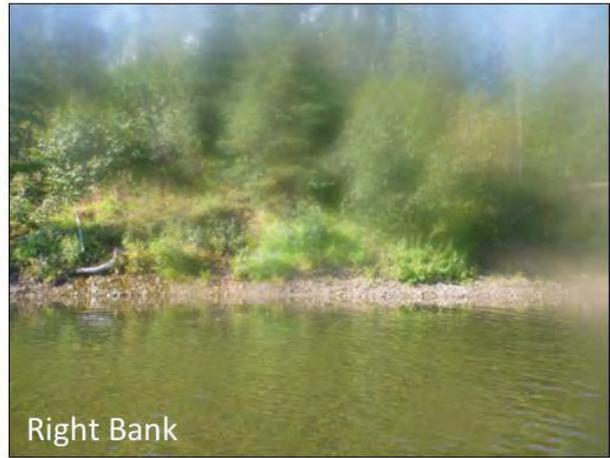
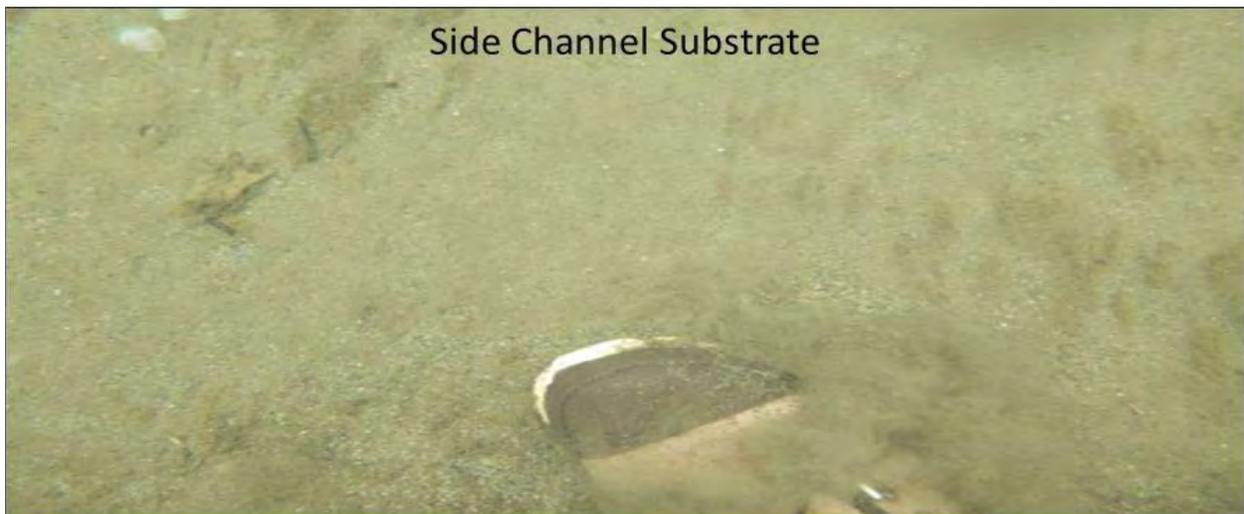
Plate 5. Stream channel characteristics, riparian habitat, and instream substrate composition of side-channel habitat at KG-T1-13, Kogoluktuk River, Brooks East Corridor, Alaska, August 2013.

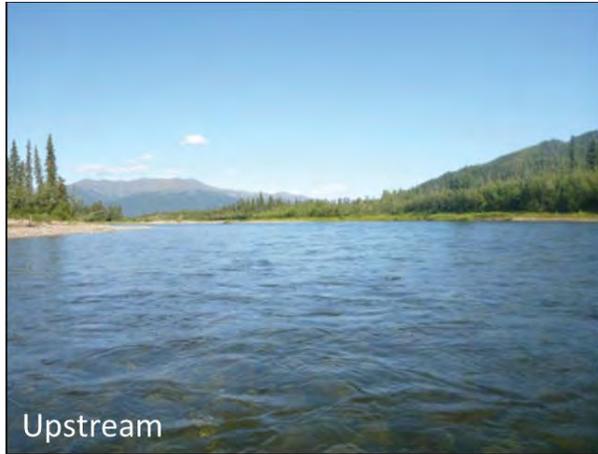
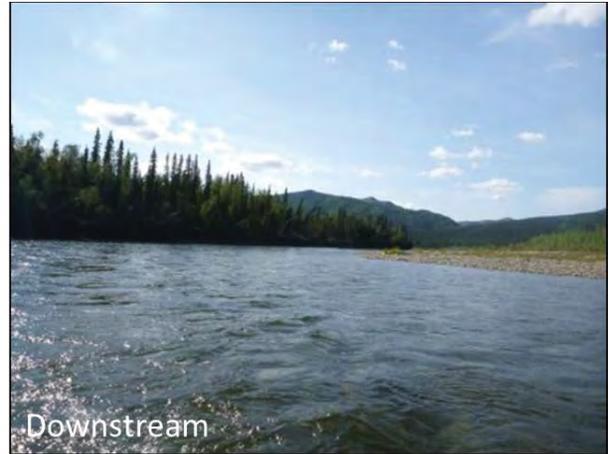
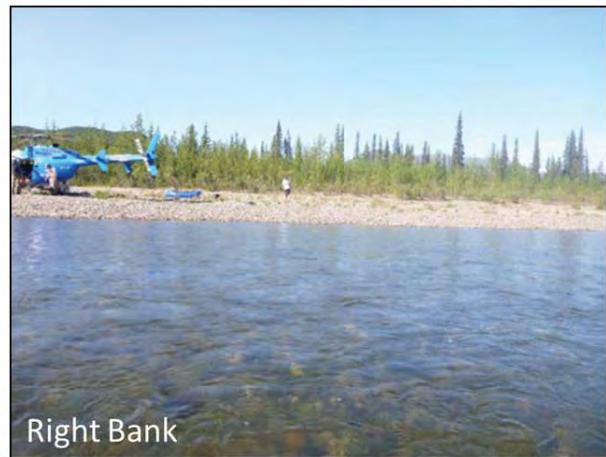
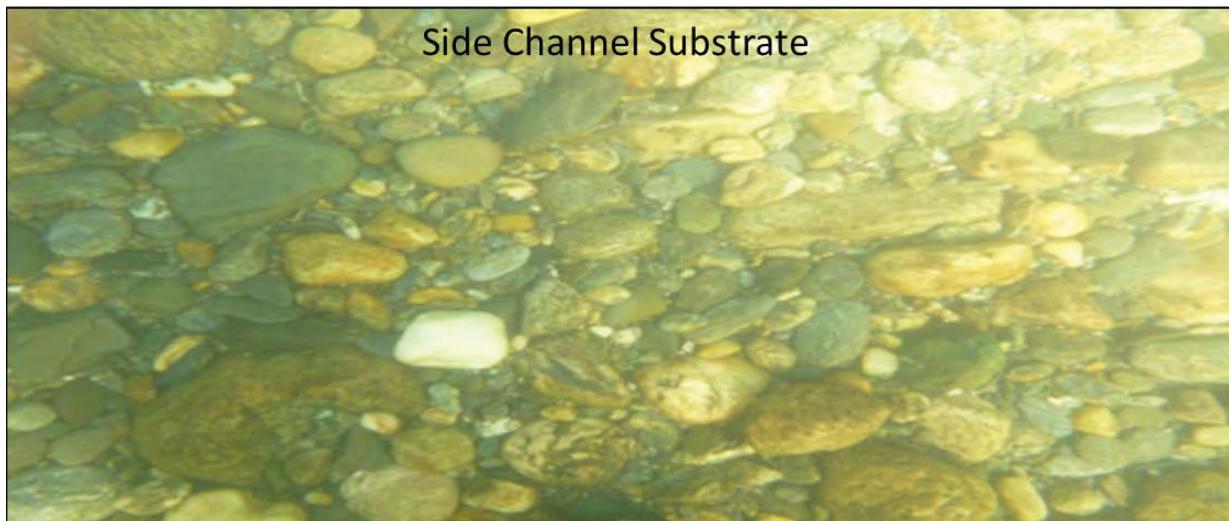
Plate 6. Stream channel characteristics, riparian habitat, and instream substrate composition at transect KG-T2-13, Kogoluktuk River, Brooks East Corridor, Alaska, August 2013.

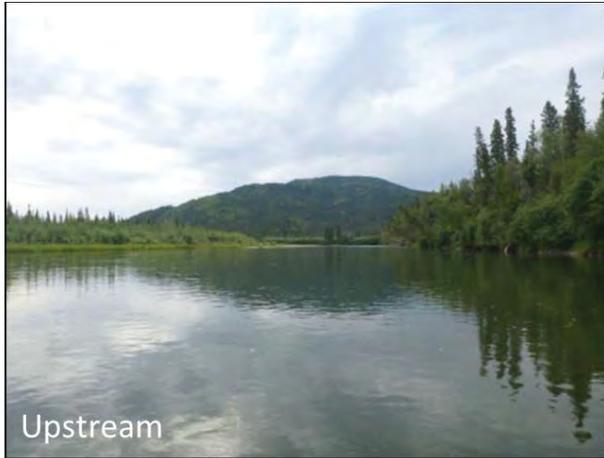
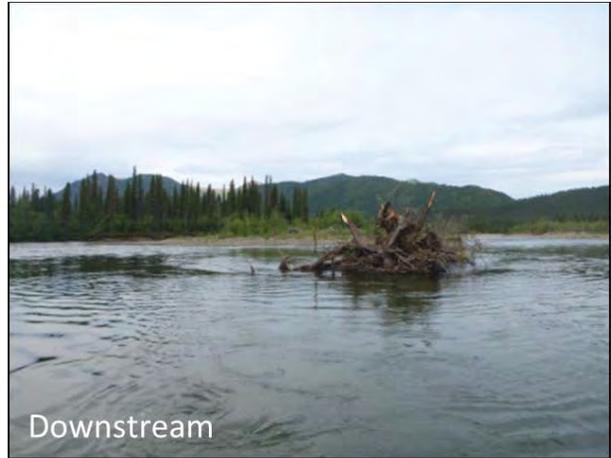
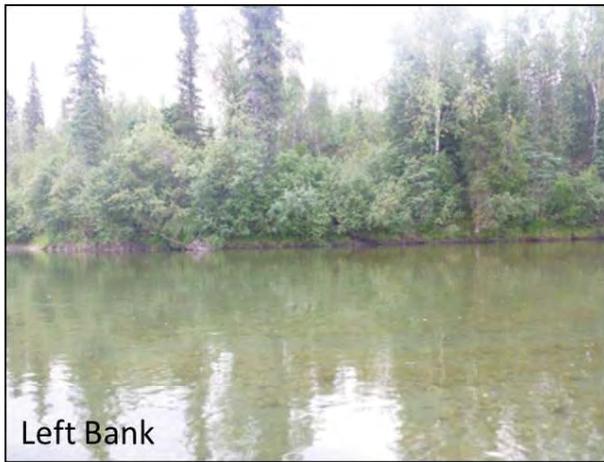
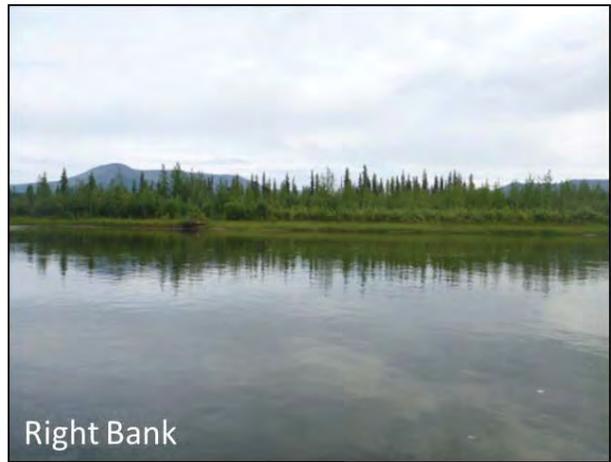
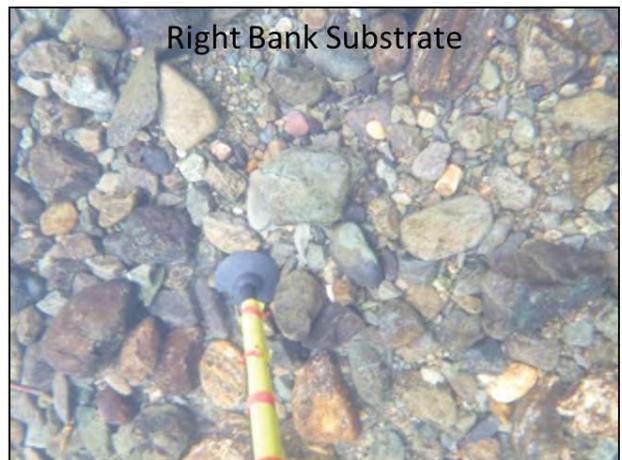
Plate 7. Stream channel characteristics, riparian habitat, and instream substrate composition at partial transect (MN-T1-13) on the Mauneluk River, Brooks East Corridor, Alaska, August 2013.

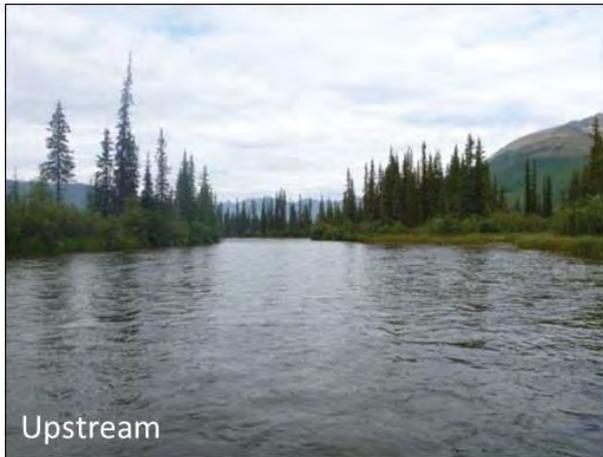
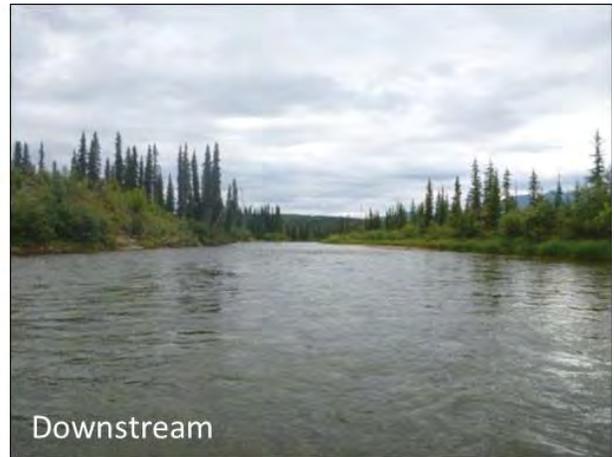
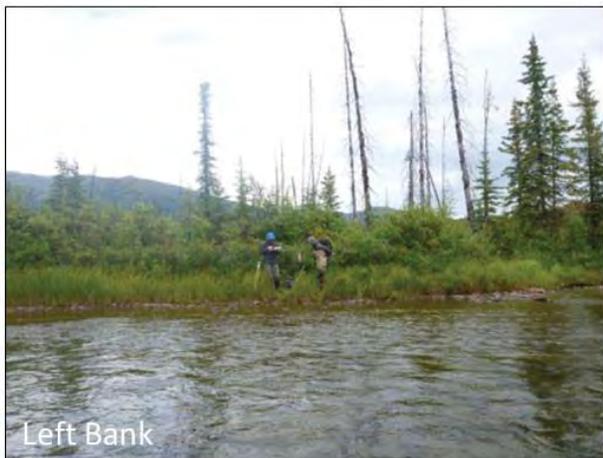
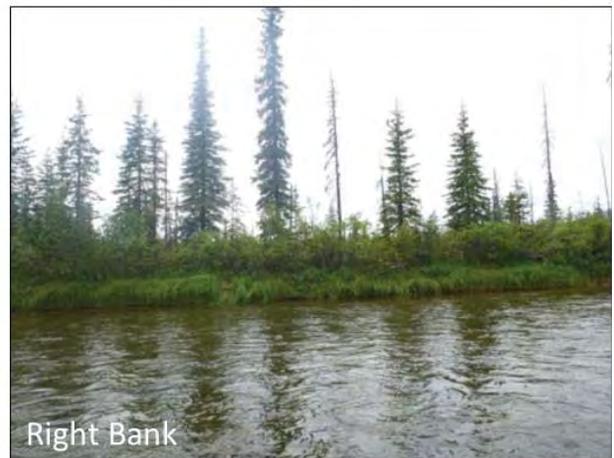
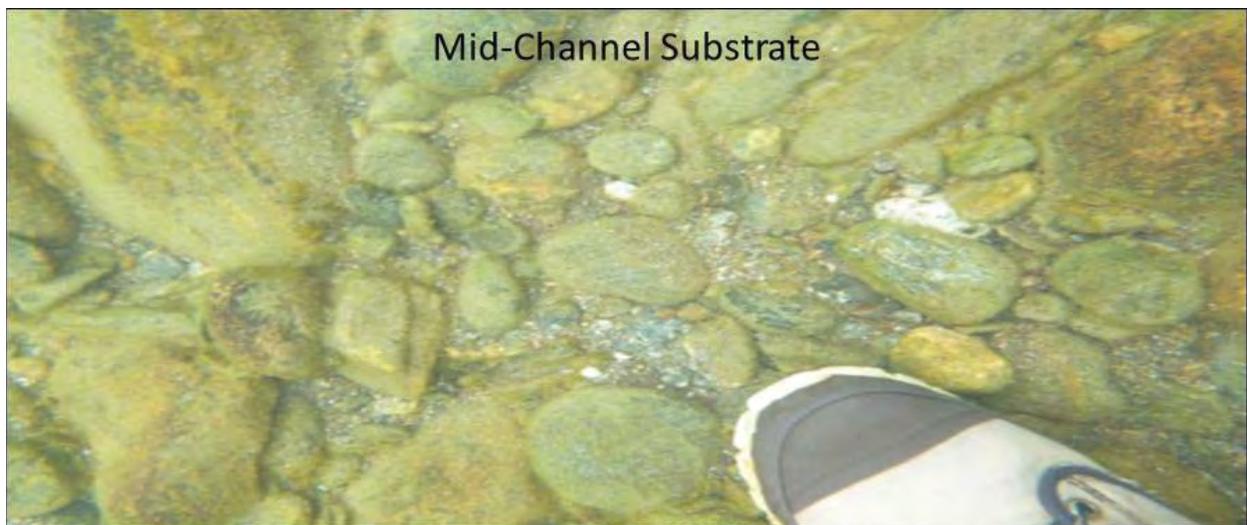
Plate 8. Stream channel characteristics, riparian habitat, and instream substrate composition at partial transect (MN-T2-13) on the Mauneluk River, Brooks East Corridor, Alaska, August 2013.

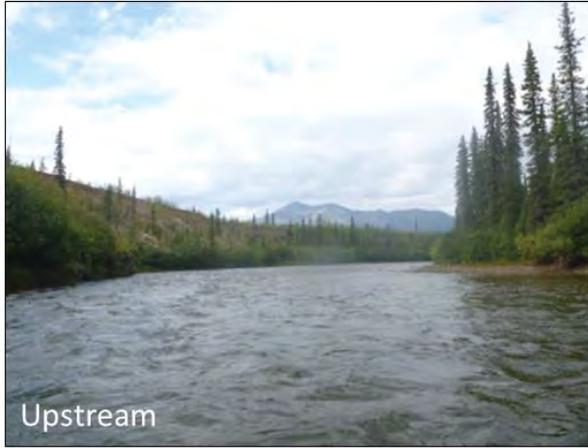
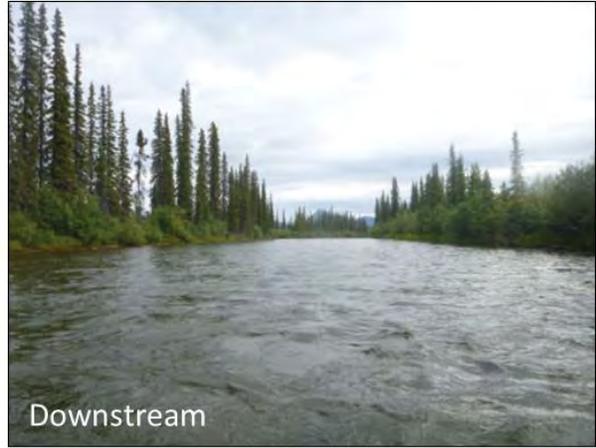
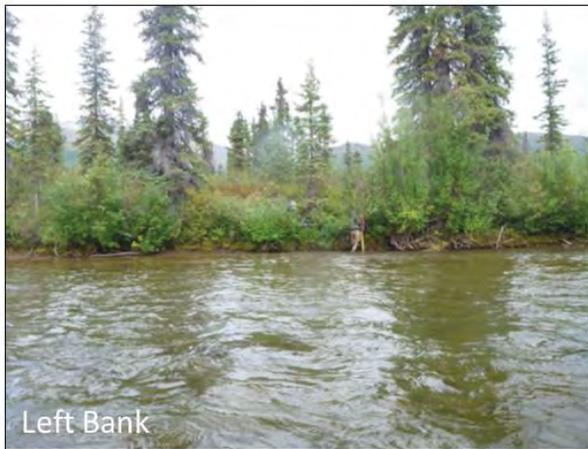
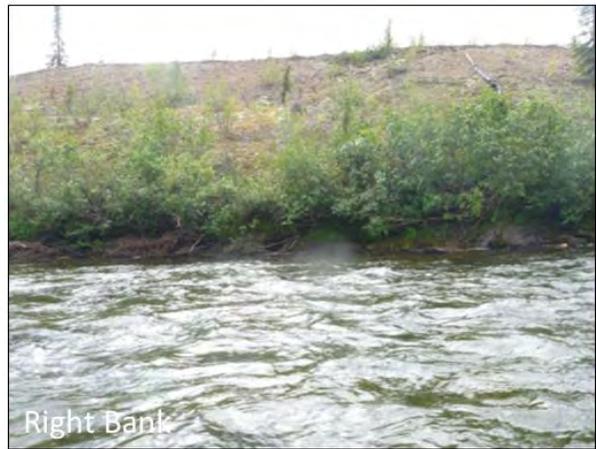
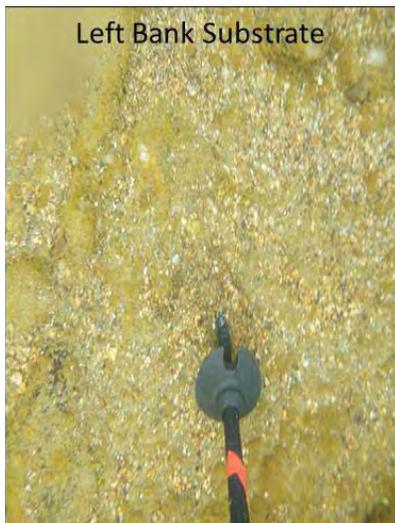
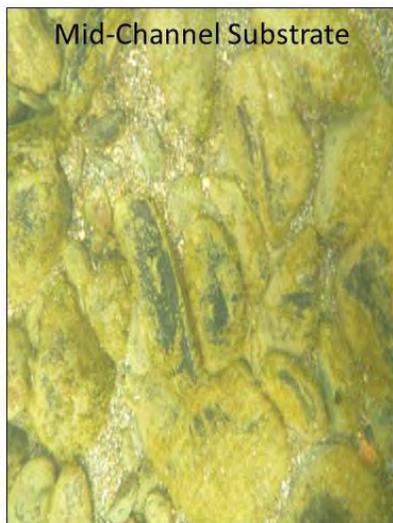
Plate 9. Stream channel characteristics, riparian habitat, and instream substrate composition at transect BV-T1-13, Beaver Creek, Brooks East Corridor, Alaska, August 2013.

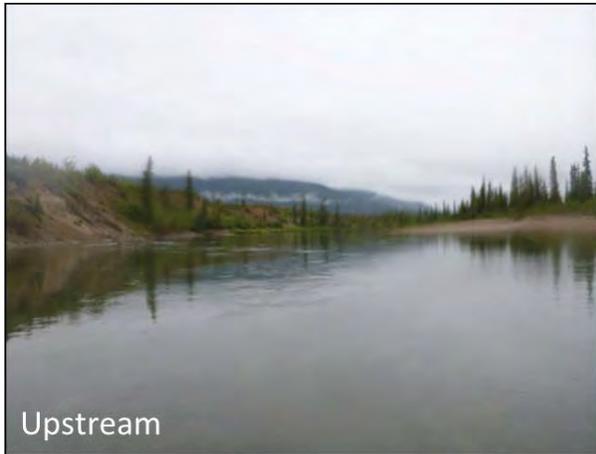
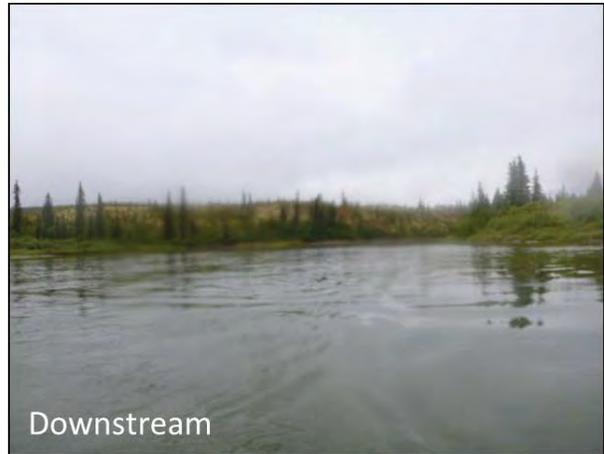
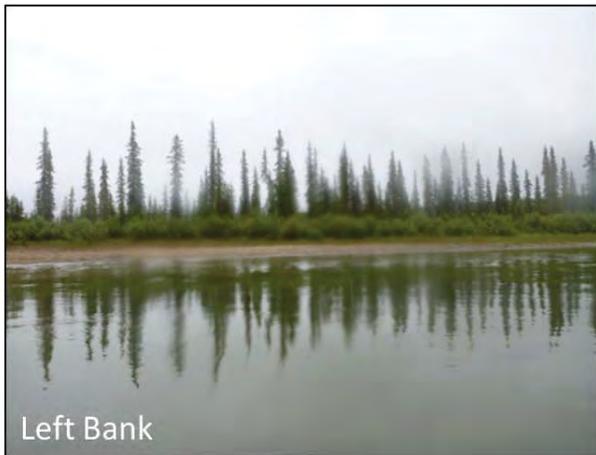
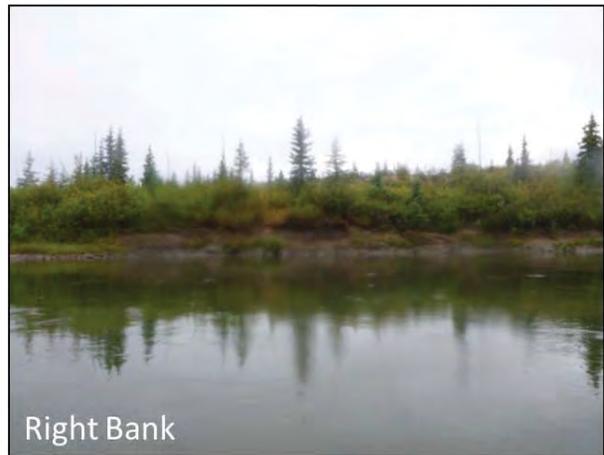
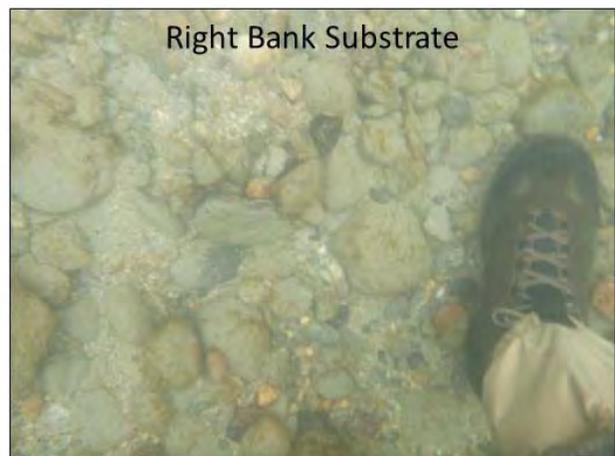
Plate 10. Stream channel characteristics, riparian habitat, and instream substrate composition at transect BV-T2-13, Beaver Creek, Brooks East Corridor, Alaska, August 2013.

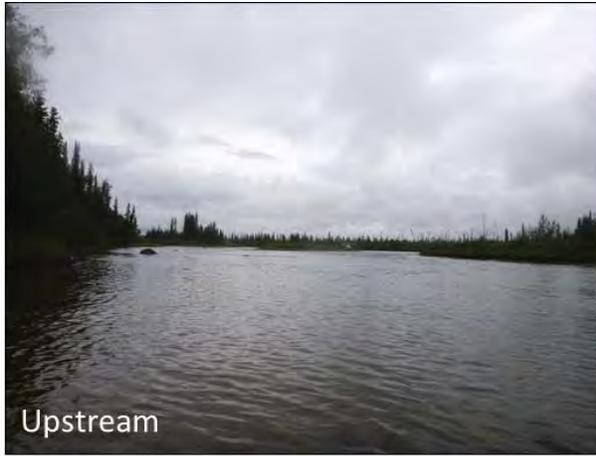
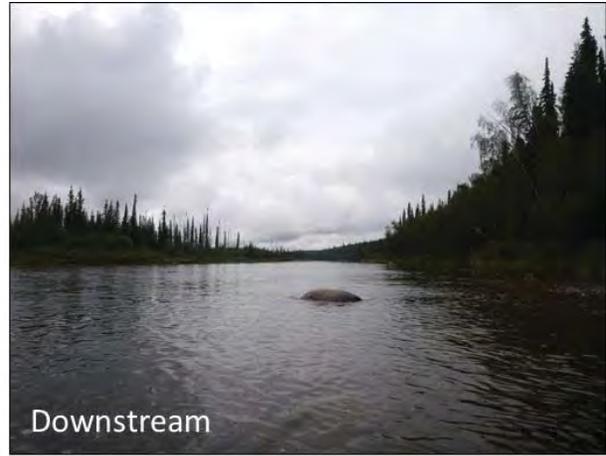
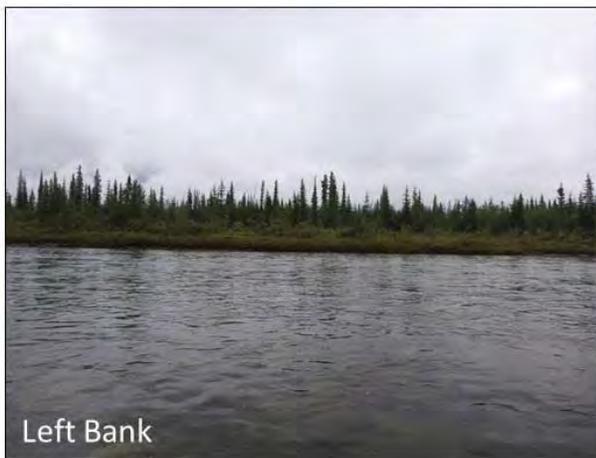
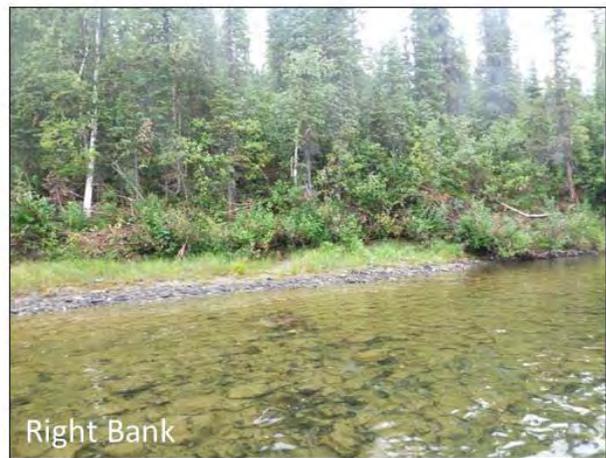
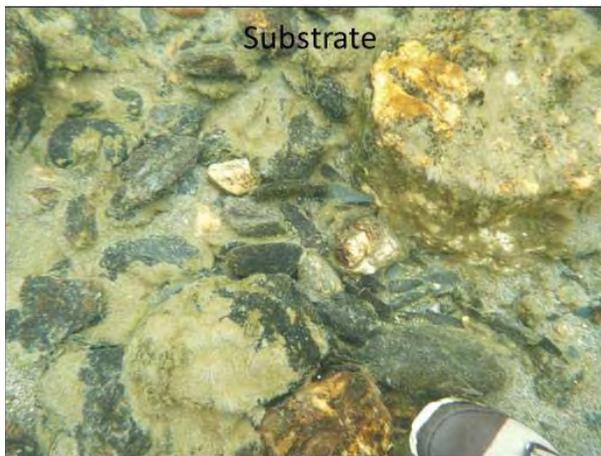
Plate 13. Stream channel characteristics, riparian habitat, and instream substrate composition at an observation point on the Kobuk River, Brooks East Corridor, Alaska, August 2013.

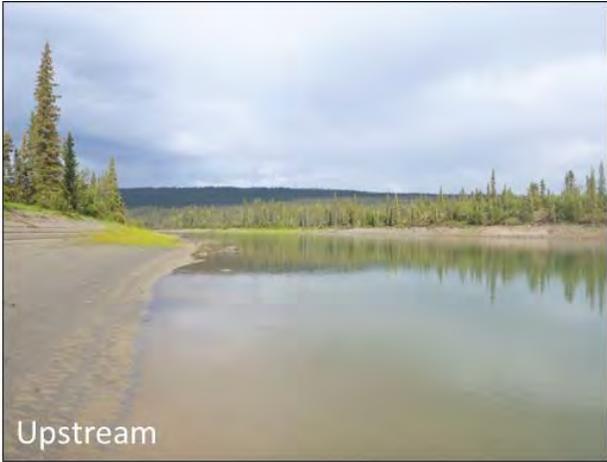
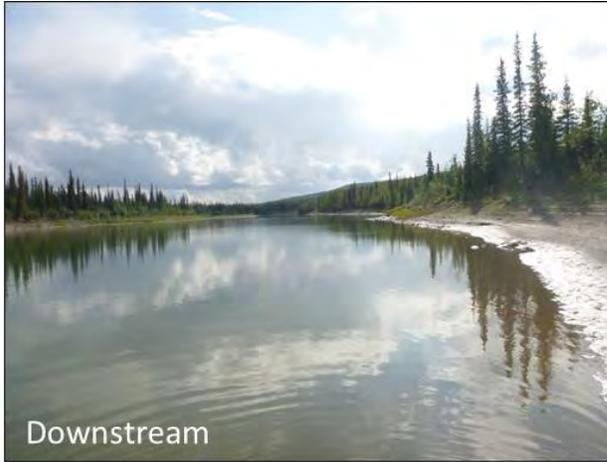
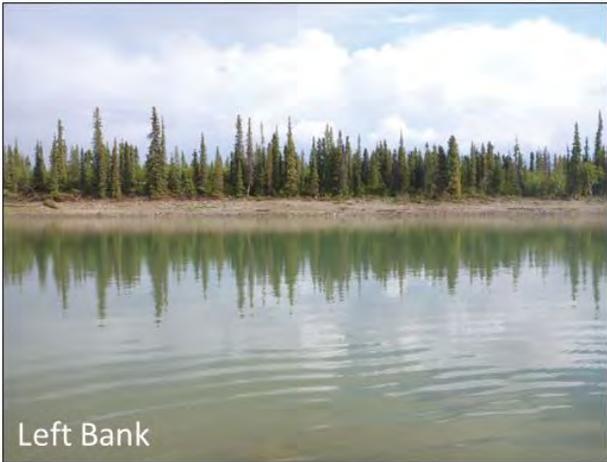
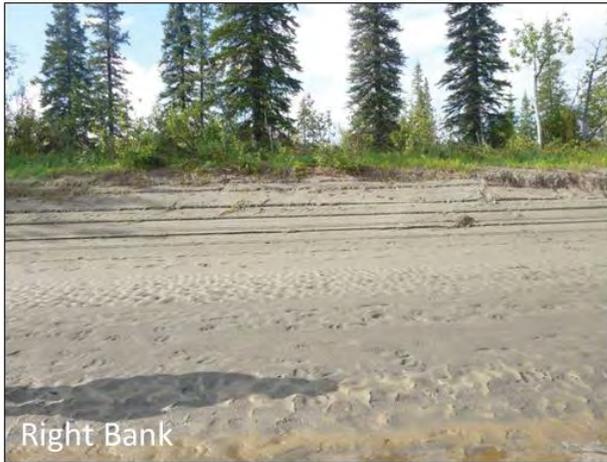
Plate 14. Stream channel characteristics and riparian habitat at observation point AL-T1-13 on the Alatna River, Brooks East Corridor, Alaska, August 2013.

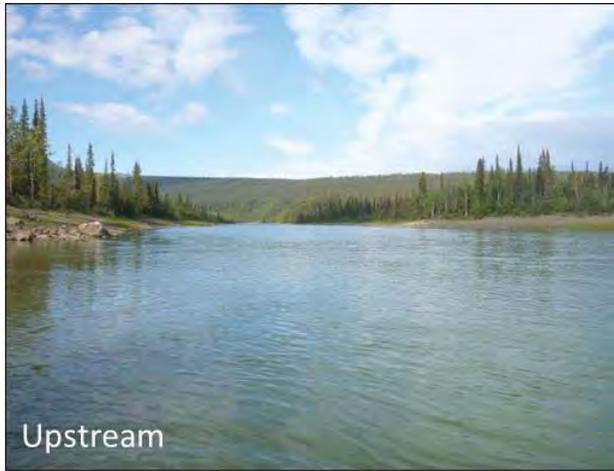
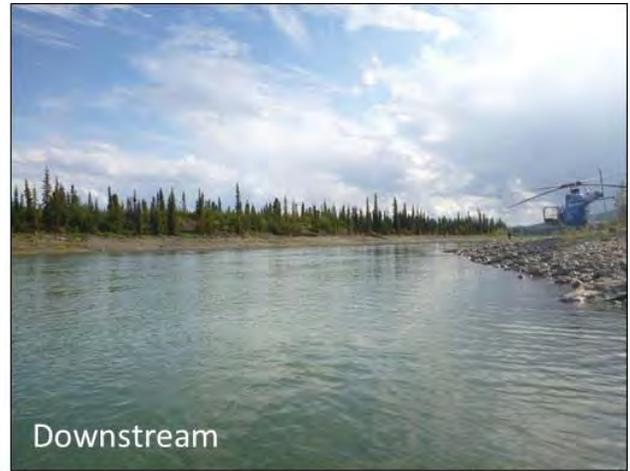
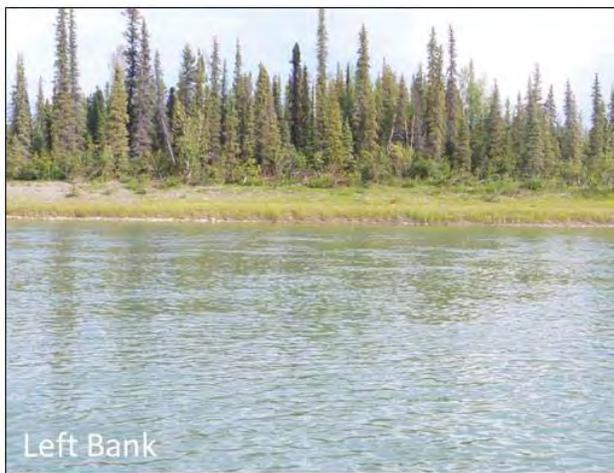
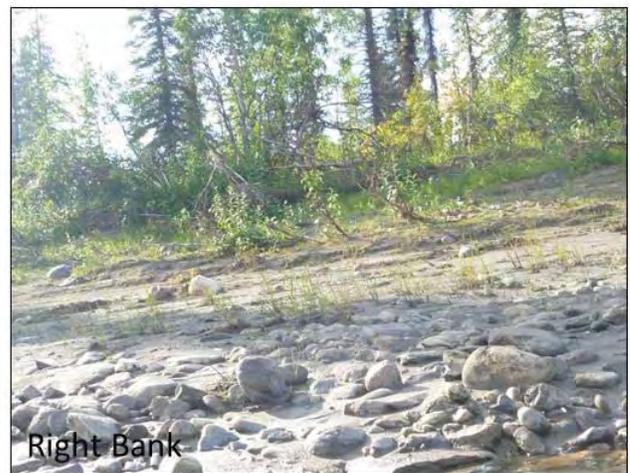
Plate 15. Stream channel characteristics and riparian habitat at observation point AL-T2-13, Alatna River, Brooks East Corridor, Alaska, August 2013.

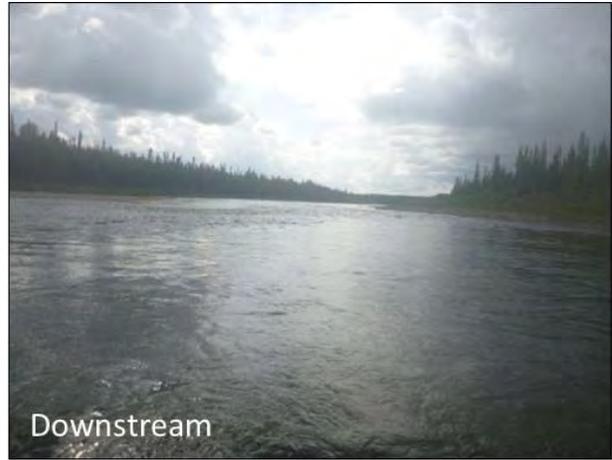
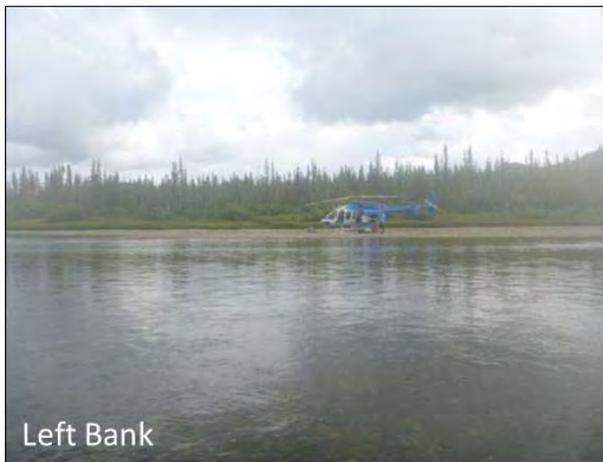
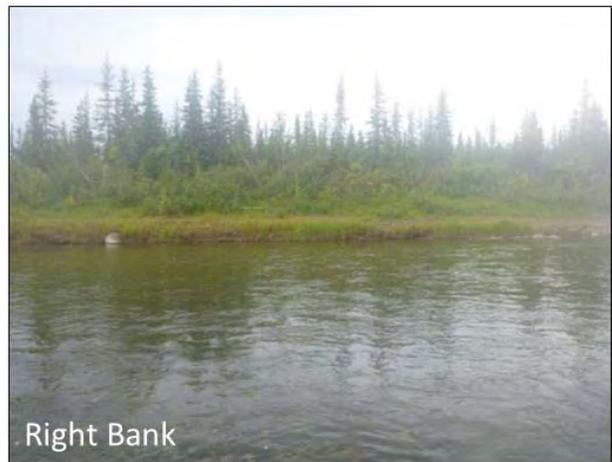
Plate 16. Stream channel characteristics, riparian habitat, and instream substrate composition at transect MF-T1-13, Malamute Fork Alatna River, Brooks East Corridor, Alaska, August 2013.
