**ANADROMOUS FISH SURVEYS WITHIN THE  
BROOKS EAST CORRIDOR SURVEY AREA, ALASKA**

June 2013

- Objective 1: Document the stream habitat conditions in waterbodies associated with potential bridge crossings along the Brooks East Corridor
- Objective 2: Integrate stream habitat and fish presence data from the study area to determine potential impacts of bridge construction on stream habitat

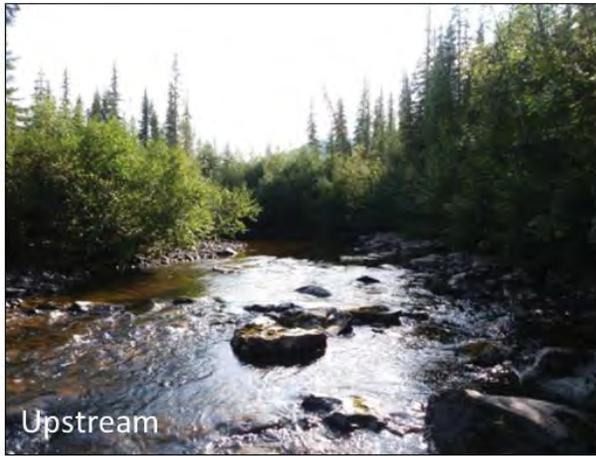
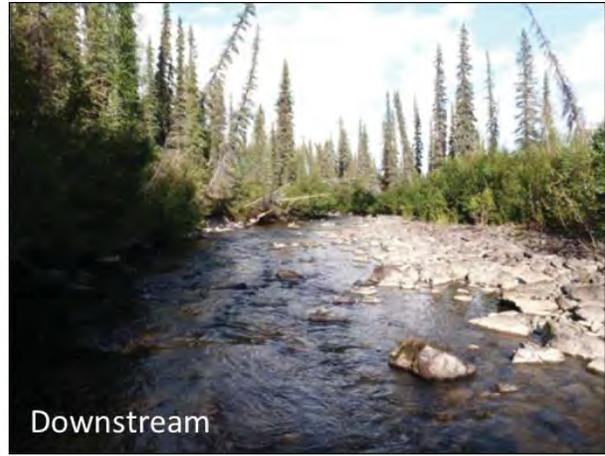
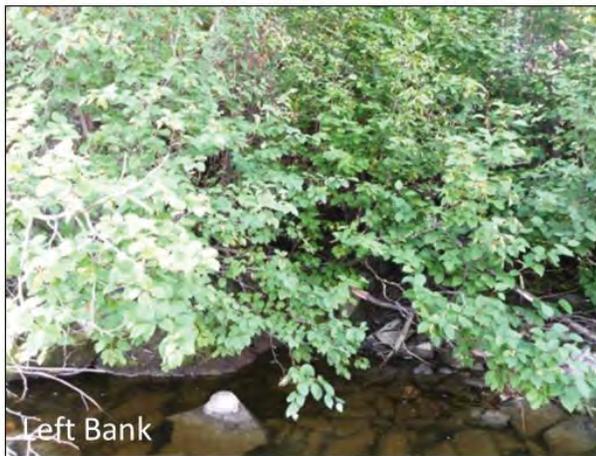
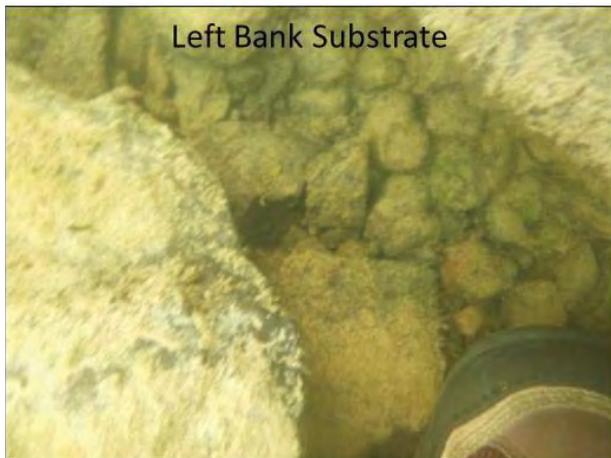
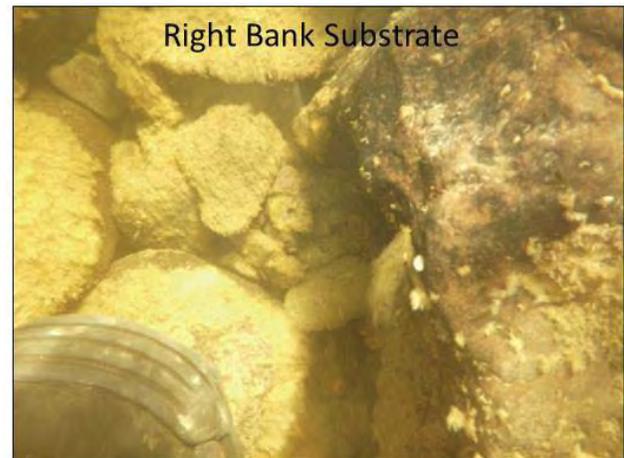
Plate 17. Stream channel characteristics, riparian habitat, and instream substrate composition at transect UN18-T1-13, unnamed tributary to the Malamute Fork Alatna River, Brooks East Corridor, Alaska, August 2013.

ABR mapped and characterized stream habitat in UN18 on 16 August 2013. The stream is distinguished from other waterbodies surveyed in 2013 both in terms of its low average discharge ( $\sim 0.5 \text{ m}^3/\text{s}$ ) and its sinuosity (Figure 11, Appendix B) (Plates 17–18). ABR collected data at 2 habitat survey transects (UN18-T1 and UN18-T2-13) representative of the mostly riffle-run-pool flow regime. Transect 1 was located in a shallow (less than 35 cm deep) riffle with instream substrate composed of boulder (50%), cobble (30%), gravel (15%), and sparse sand (5%). The substrate at Transect 1 did not appear to be appropriate for spawning salmon. Transect

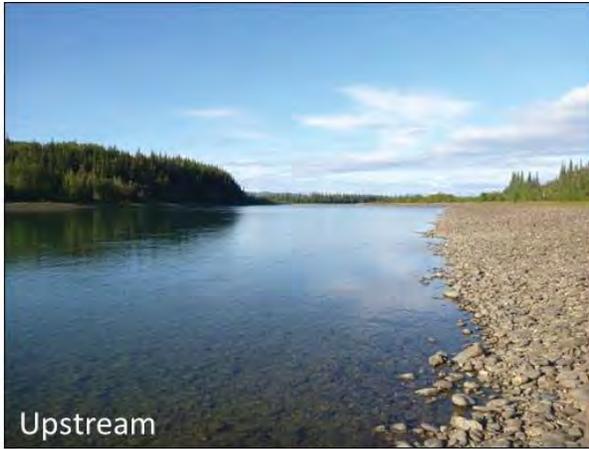
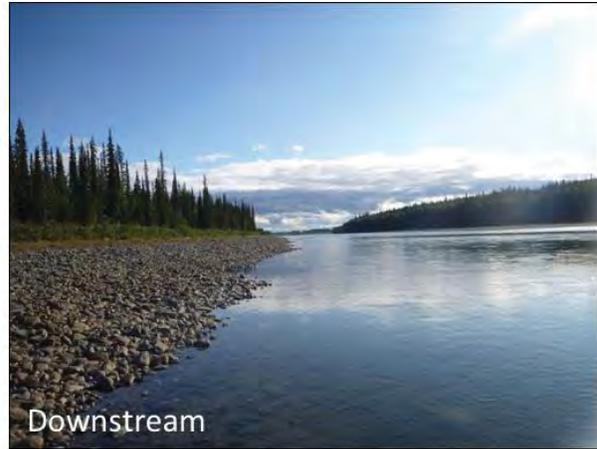
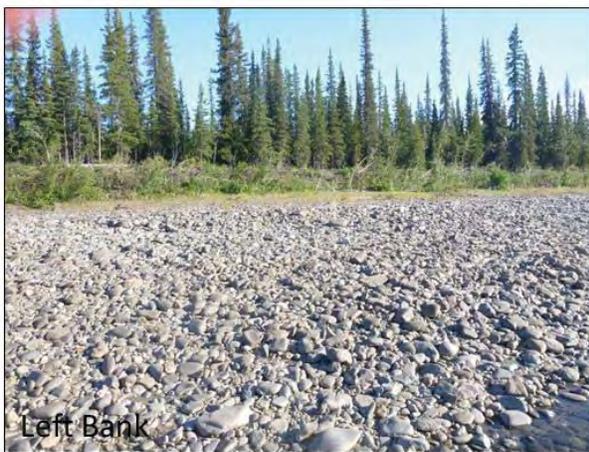
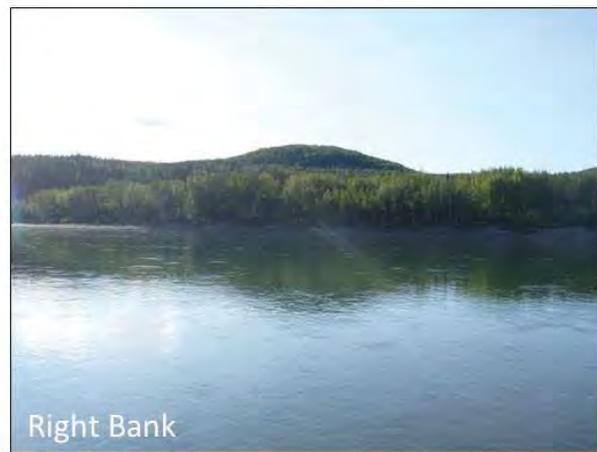
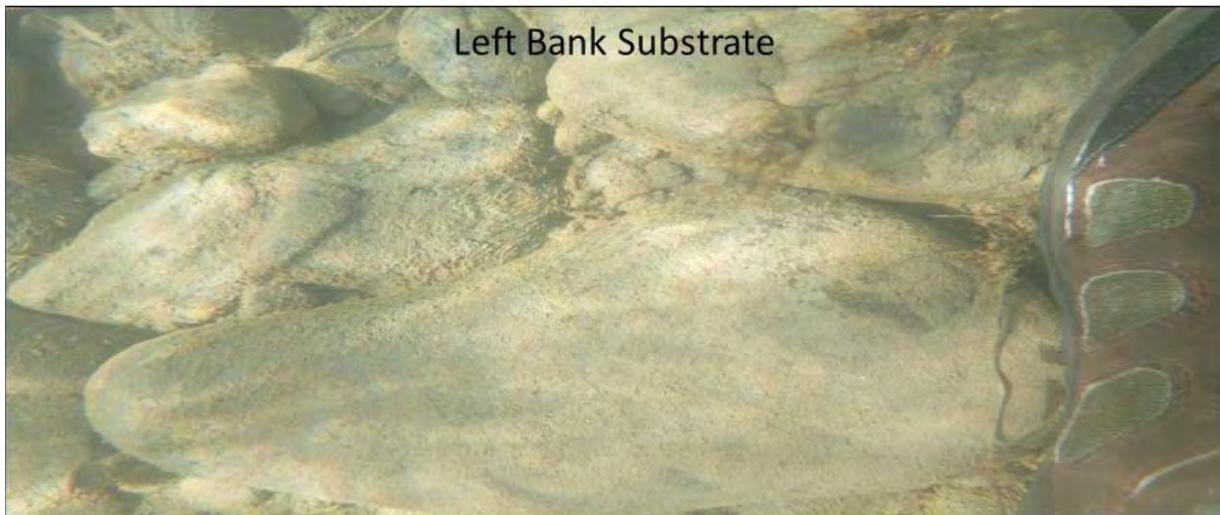
Plate 19. Stream channel characteristics, riparian habitat, and instream substrate composition at observation points on the Koyukuk River, Brooks East Corridor, Alaska, August 2013.

bank (Figure 12, Appendix B) (Plate 19). ABR floated the reach in a packraft to determine if wadeable transects were present, but none were observed. At the most upstream observation point, at a downstream inside bend in the river, substrate visible from the bank was predominantly sand, as might be expected at such a location where velocity decreases and sand settles out of the water column. Significant gravel and cobble instream substrate could be observed from the left bank along with moderate amounts of large and small woody debris. The left bank in this reach was composed of a large sand bar with little vegetation. Riparian vegetation on the right bank was dense and composed mainly of spruce and willow. The substrate at the second observation point, downstream between 2 proposed bridge crossings was composed of mostly sand, but transitioned to cobble, gravel, and boulder shortly downstream. Between the first and second observations points, the right bank vegetation transitioned from spruce to alder. Substrate composition at the farthest downstream observation point appeared to be composed of primarily of cobble, gravel, and boulder. Overall, this reach likely provides plentiful spawning and refuge habitat to many fishes, including salmon. The channel in this reach appears to have changed slightly between 1981 and 2012, mostly in the form of growing sandbars in upper and lower portions of the stream reach (Appendix C).

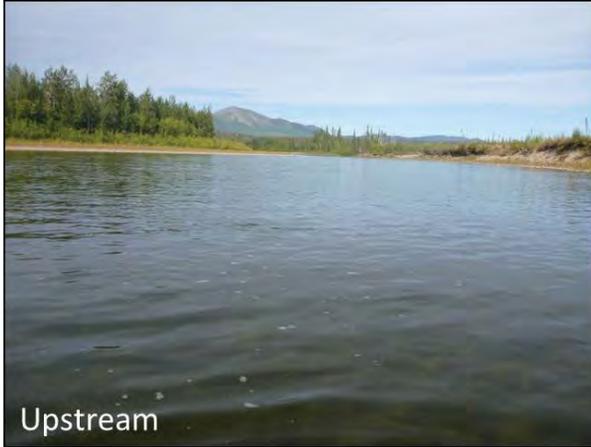
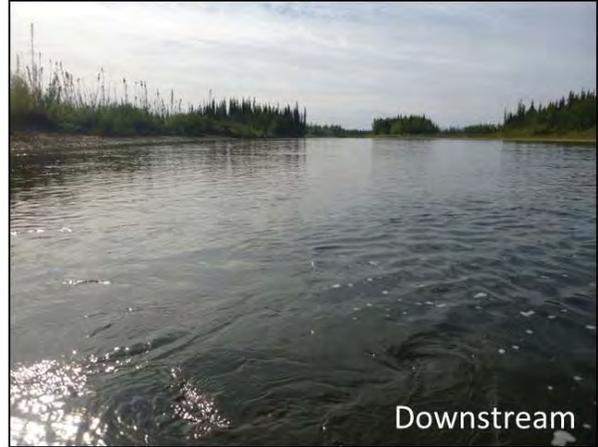
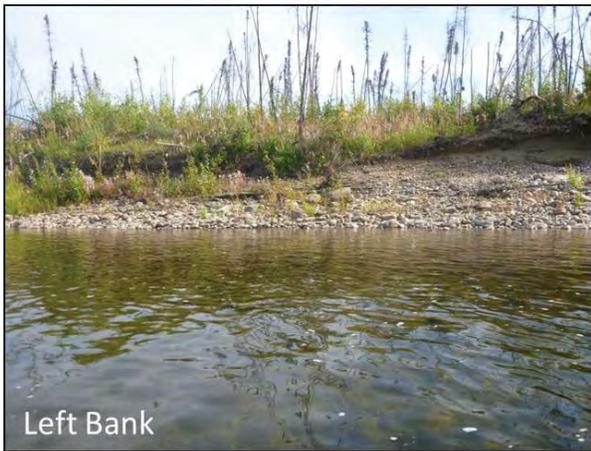
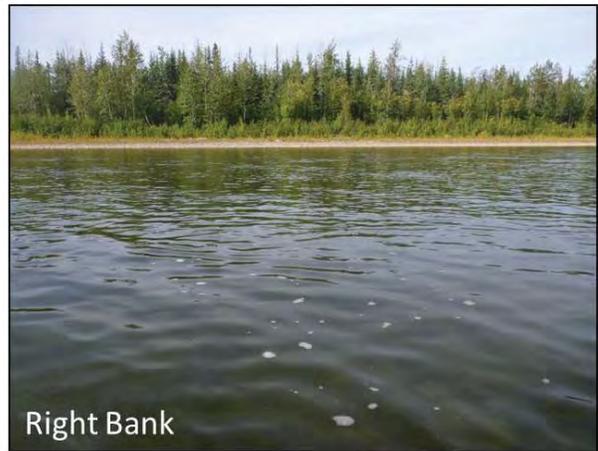
Plate 20. Stream channel characteristics, riparian habitat, and instream substrate composition at transect SF-T1-13, South Fork Koyukuk River, Brooks East Corridor, Alaska, August 2013.

ABR mapped and characterized the stream crossing reach and performed 1 stream habitat transect survey on 22 August 2013 (Figure 13, Appendix B) (Plates 20–21). The flow regime in the stream crossing reach was dominated by a mix of run and pool habitat, with run-riffle habitat in the mid-section of the reach. Flow was estimated to be 13.75 m<sup>3</sup>/s (Table 2). Transect 1 (SF-T1-13) was located at the proposed bridge crossing. Substrate along the transect was composed of cobble (40%), gravel (30%), boulder (15%), and sand (15%). This transect appeared to be

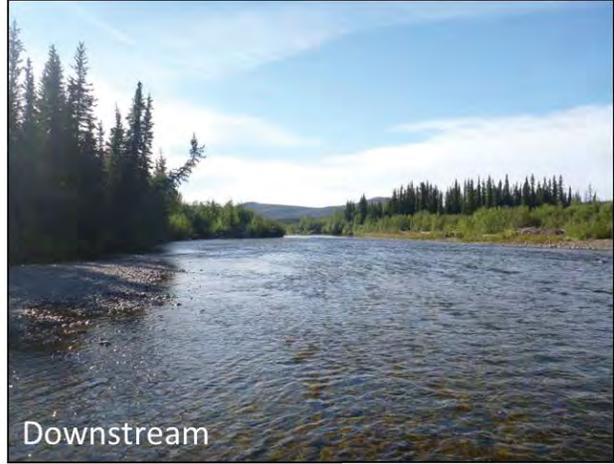
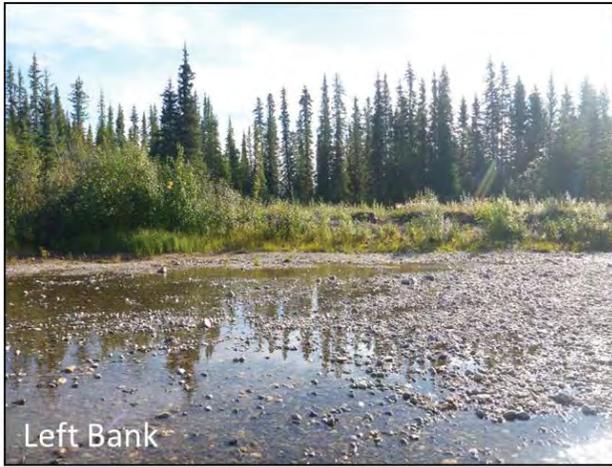
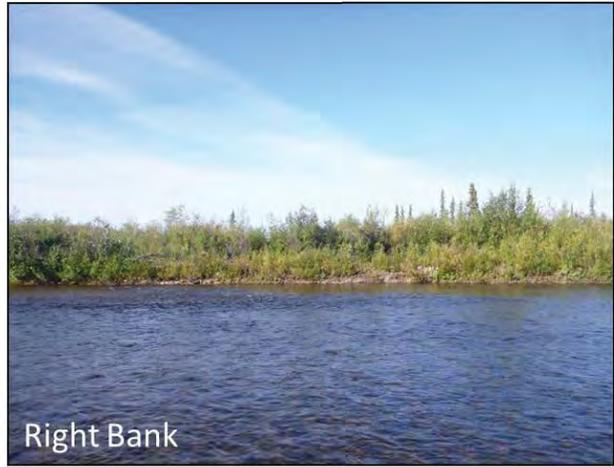
Plate 22. Stream channel characteristics, riparian habitat, and instream substrate composition at transect JM-T1-13, Jim River, Brooks East Corridor, Alaska, August 2013.

ABR mapped and characterized the stream crossing reach and performed 1 instream habitat transect survey on 22 August 2013 (Figure 14, Appendix B) (Plates 22–24). The reach had a diversity of stream flow habitat types including riffle-run-pool and run-glide sequences as well as side channel and backwater pool habitat. Transect 1 (JM-T1-13) was located immediately downstream of the proposed bridge crossing within a long run. The substrate was representative of much of the run and run-glide sequences and consisted of gravel (45%), cobble (35%), sand (15%), and boulder (5%) which should provide excellent fish spawning habitat. Instream cover

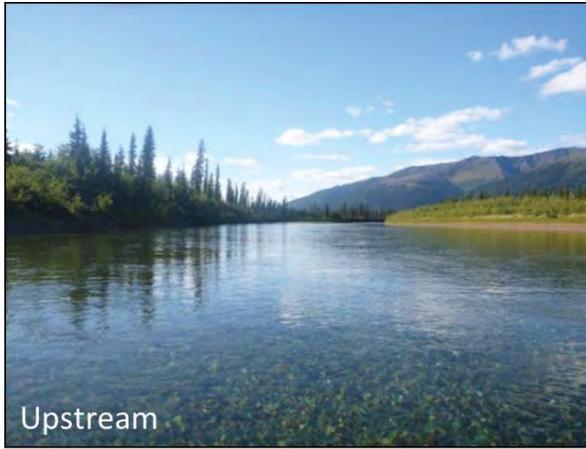
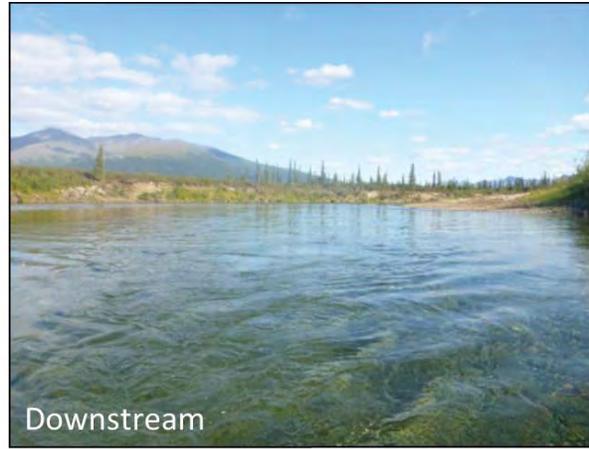
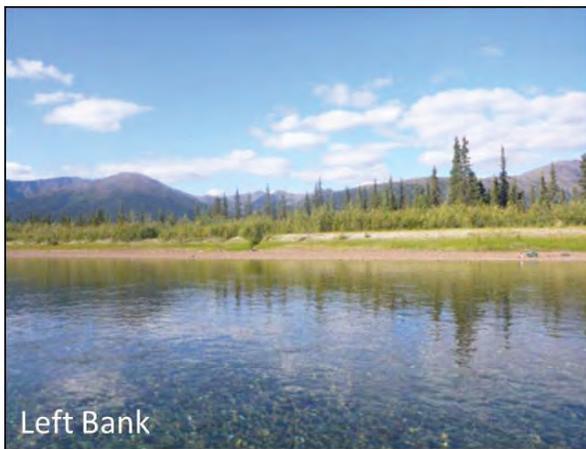
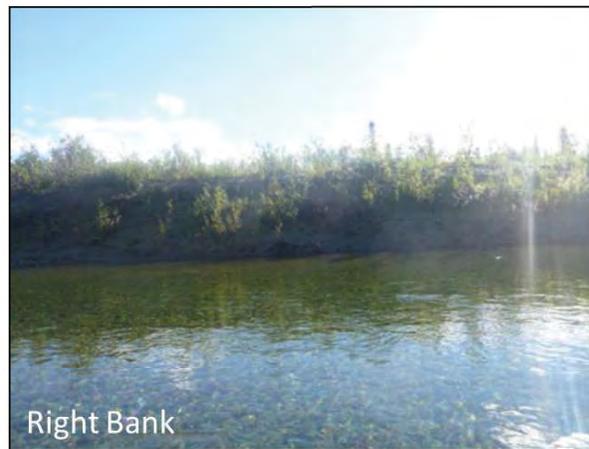
Plate 25. Stream channel characteristics, riparian habitat, and instream substrate composition at transect UN30-T1-13n, unnamed tributary to the Mauneluk River, Brooks East Corridor, Alaska, August 2013.

ABR mapped and characterized the stream reach and performed 1 instream habitat transect survey on 21 August 2013 (Figure 15, Appendix B) (Plates 25). The slightly sinuous stream reach was marked by predominance of run-riffle habitat with. Discharge was relatively low compared to other streams surveyed (3.85 m<sup>3</sup>/s) (Table 2). Instream substrate at Transect 1 (UN30-T1-13n) was representative of the reach as a whole and was composed of boulder (50%),

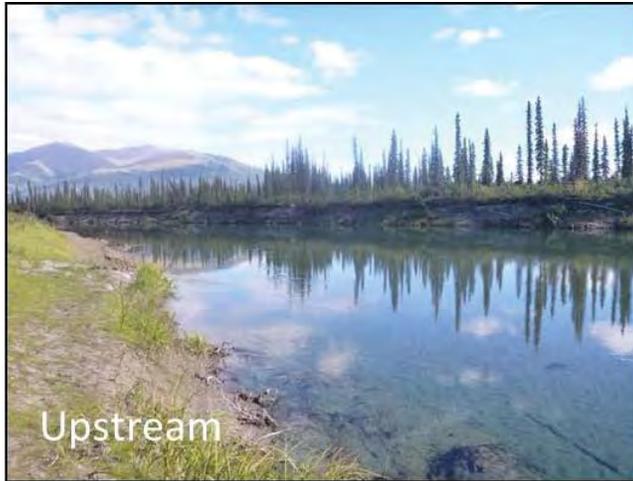
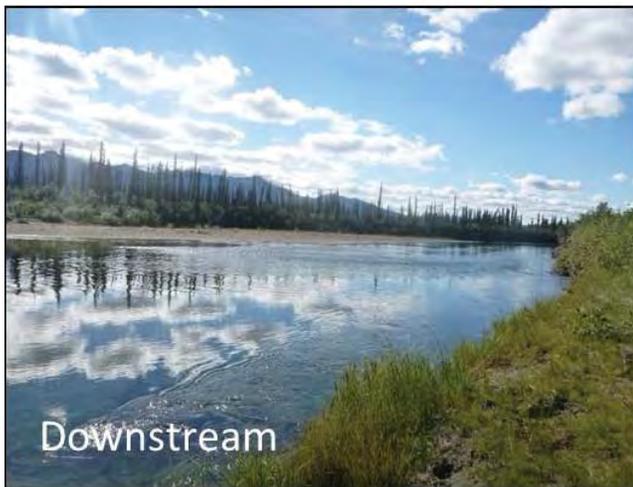
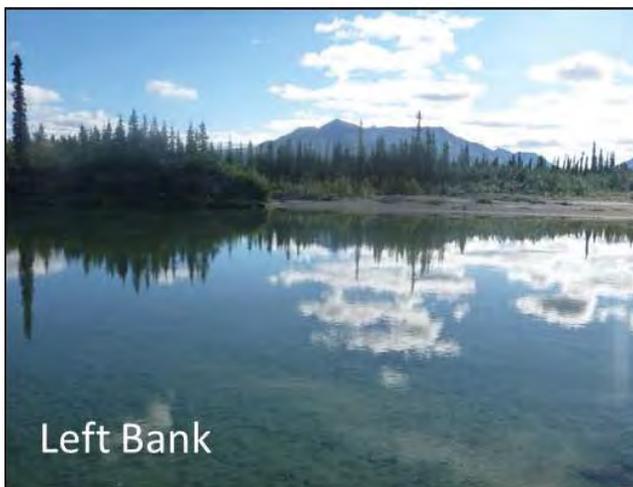
Plate 26. Stream channel characteristics, riparian habitat, and instream substrate composition at transect MN-T1-13n, Mauneluk River (northern option), Brooks East Corridor, Alaska, August 2013.

ABR mapped and characterized the stream crossing reach and performed 1 instream habitat transect survey on 21 August 2013 (Figure 16, Appendix B) (Plates 26–27). The flow regime of the reach was marked by almost uniform run-pool habitat with some riffle habitat in the downstream portion of the reach. Due to deep water (greater than 1 m) and what appeared to be uniform instream habitat, only 1 transect was surveyed in August 2013. Transect 1 (MN-T1-13n) was located in run-pool habitat representative of most of the reach. Discharge at the transect was 15.46 m<sup>3</sup>/s (Table 2). Substrate along Transect 1 was composed of gravel (65%), cobble (15%),

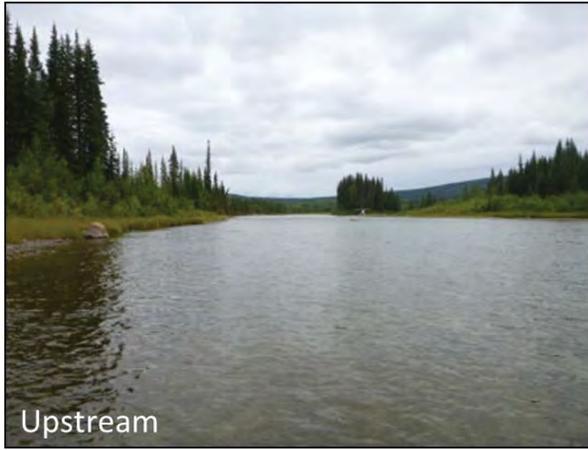
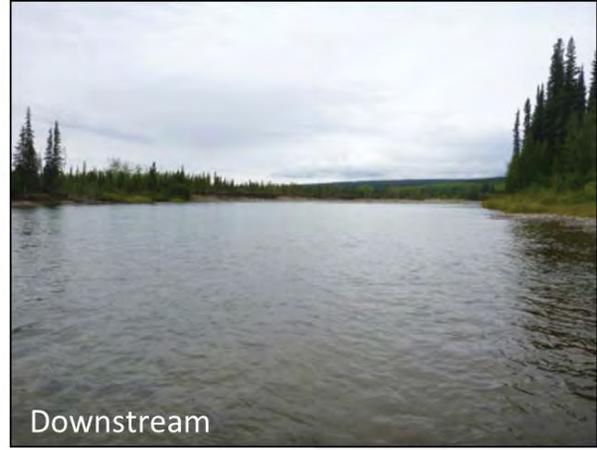
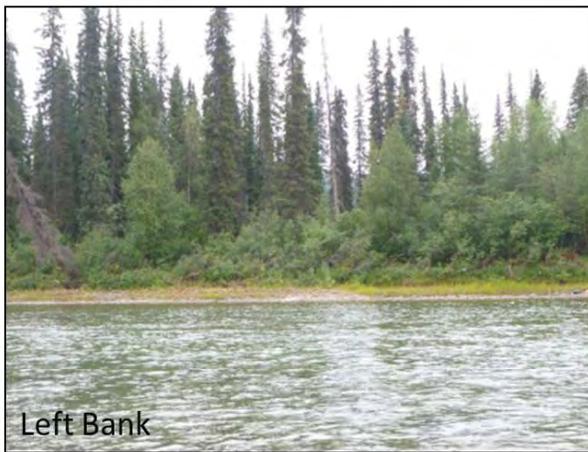
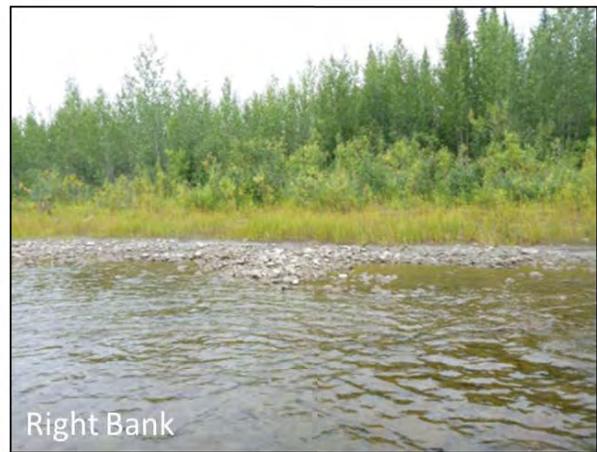
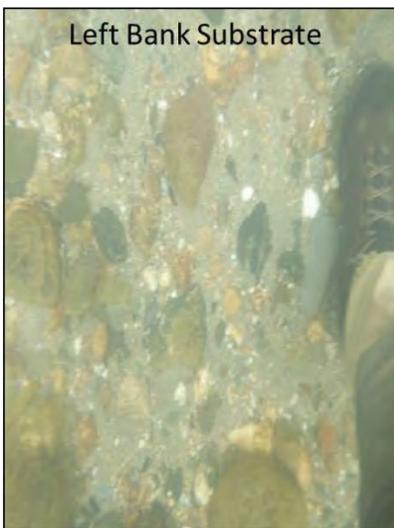
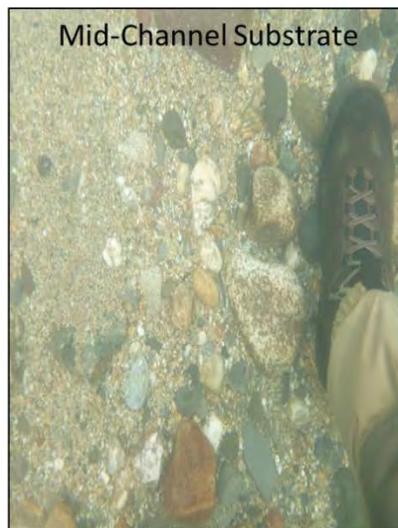
Plate 27. Stream channel characteristics and riparian habitat at observations points on the Mauneluk River (northern option), Brooks East Corridor, Alaska, August 2013.

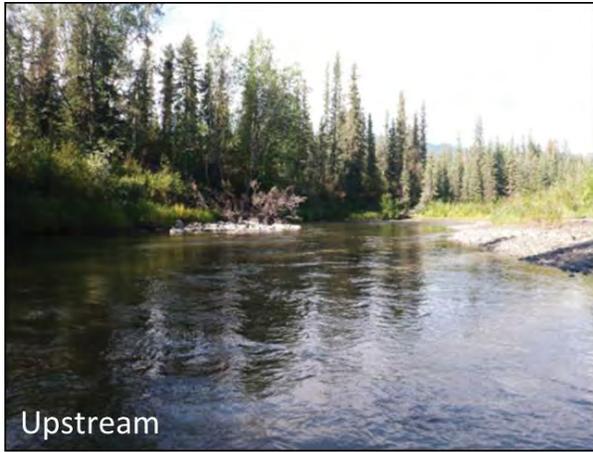
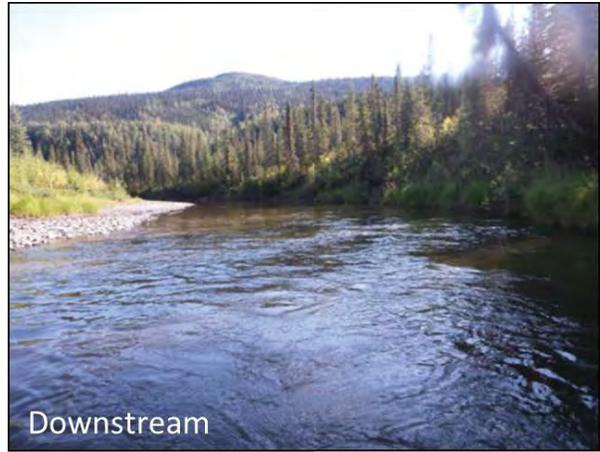
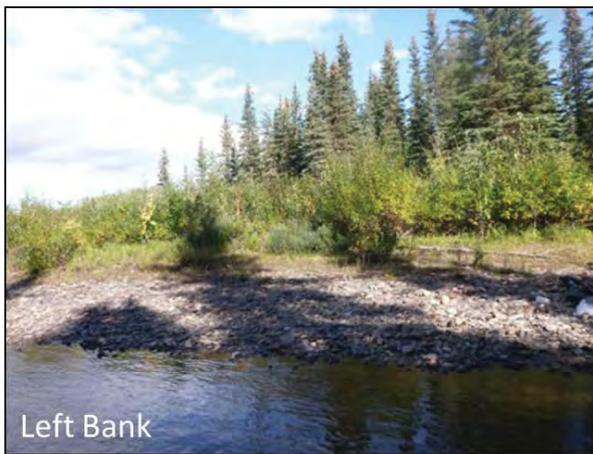
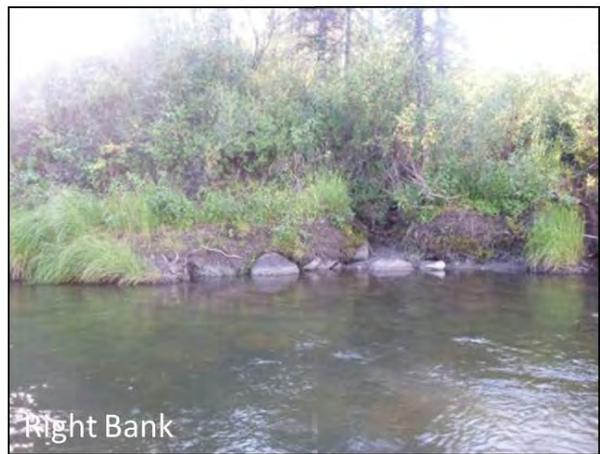
Plate 35. Stream channel characteristics, riparian habitat, and instream substrate composition at transect HJ-T1-13s, Helpmejack Creek (southern option), Brooks East Corridor, Alaska, August 2013.

ABR mapped and characterized the stream crossing reach and performed 3 instream habitat transect surveys on 18 August 2013 (Figure 20, Appendix B) (Plates 35–38). Helpmejack Creek is a sinuous stream with a riffle-run-pool flow regime. Transect 1 (HJ-T1-13s) was representative of pool habitat in the reach and instream substrate was composed of sand (40%), cobble (30%), silt (25%), and boulder (5%). While this is good refuge habitat it would not provide good substrate for spawning salmon due to the high percentage of silt present. Transect 2 (HJ-T1-13s) was located in a run section of stream and represented better fish spawning habitat with substrate composed of cobble (40%), boulder (30%), gravel (20%), sand (5%), and silt (5%). Transect 3 was located in a mixed run-pool habitat and was representative of the reach as a whole with substrate composed of cobble (50%), gravel (20%), silt (20%), and boulders (10%). In general, we saw more silt and sand on Helpmejack Creek than at other sample reaches in the corridor and habitats appeared to be less than ideal for spawning salmon. Discharge averaged 1.87 m<sup>3</sup>/s (Table 2).

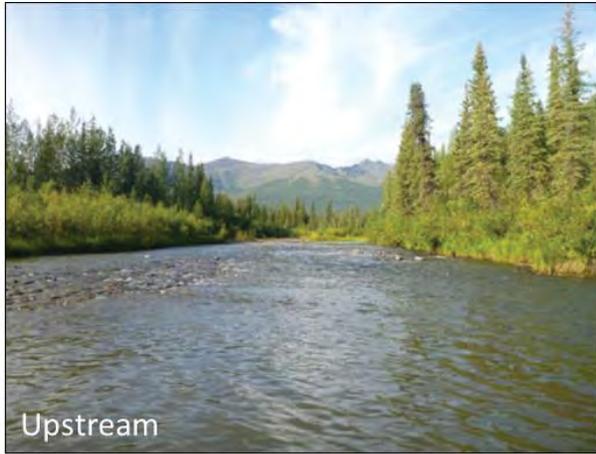
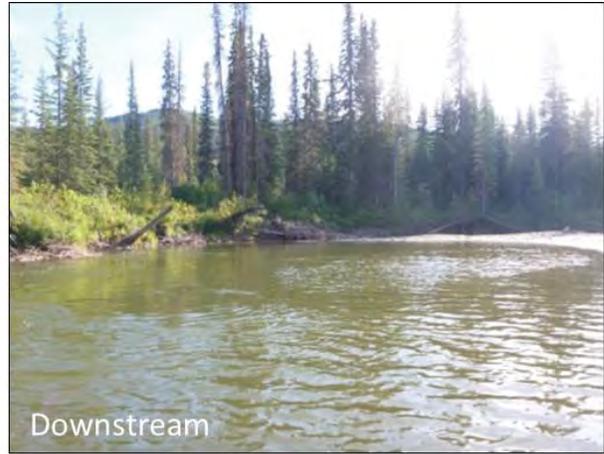
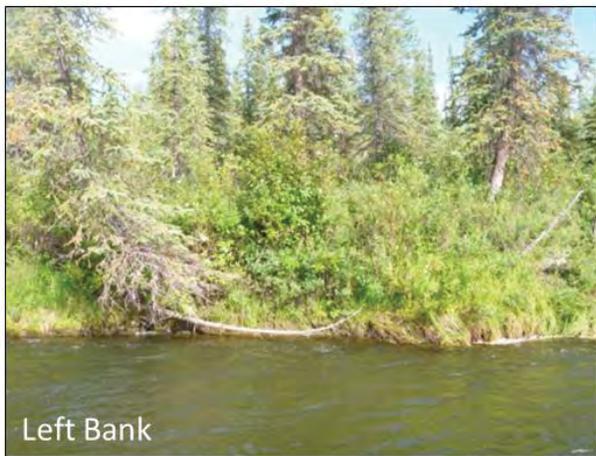
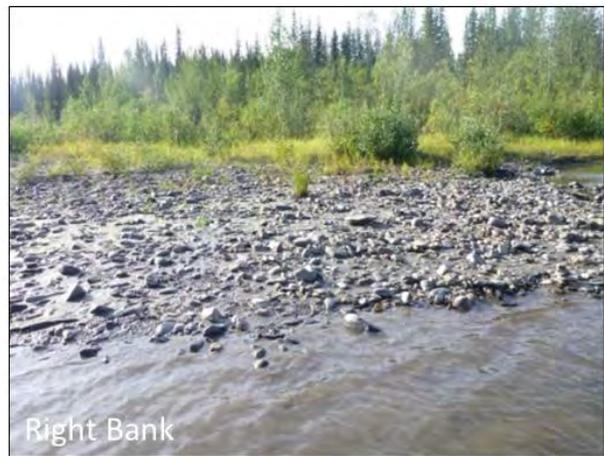
Plate 36. Stream channel characteristics, riparian habitat, and instream substrate composition at transect HJ-T2-13s, Helpmejack Creek (southern option), Brooks East Corridor, Alaska, August 2013.

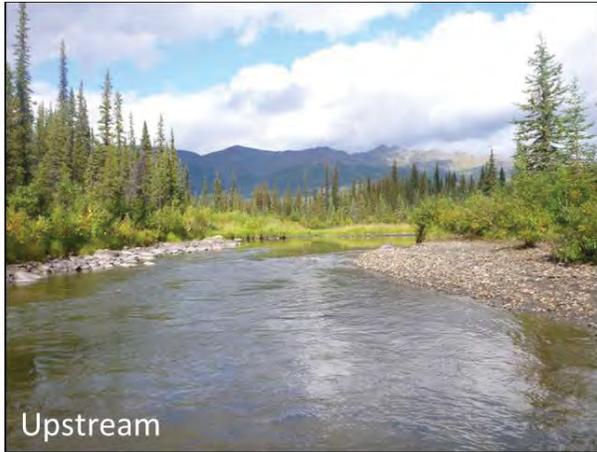
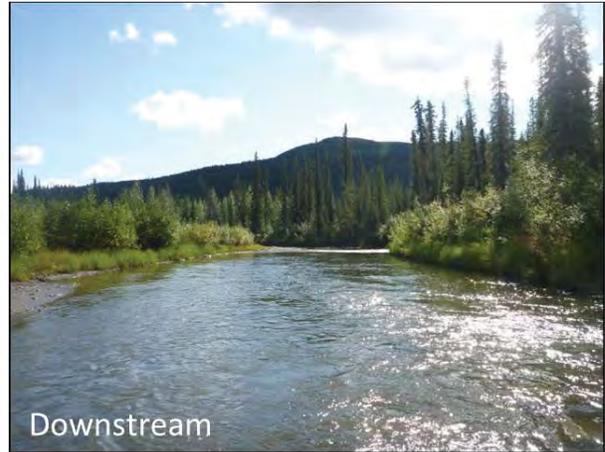
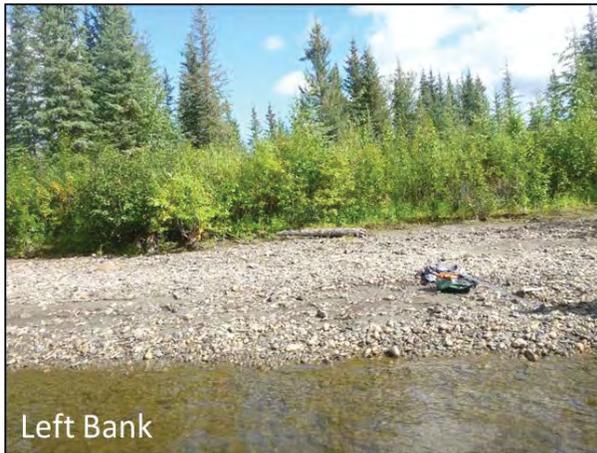
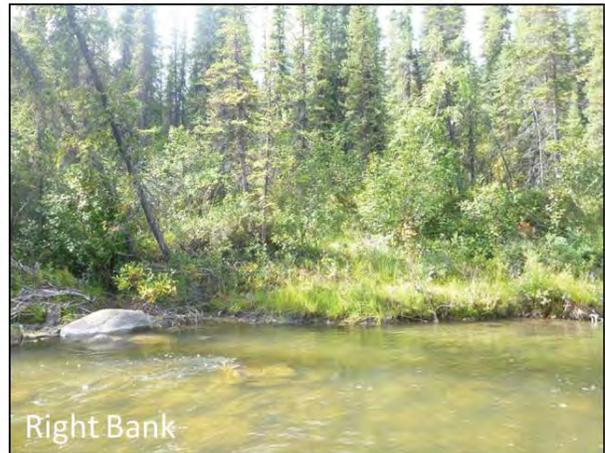
Plate 37. Stream channel characteristics and riparian habitat at transect HJ-T3-13s, Helpmejack Creek (southern option), Brooks East Corridor, Alaska, August 2013.

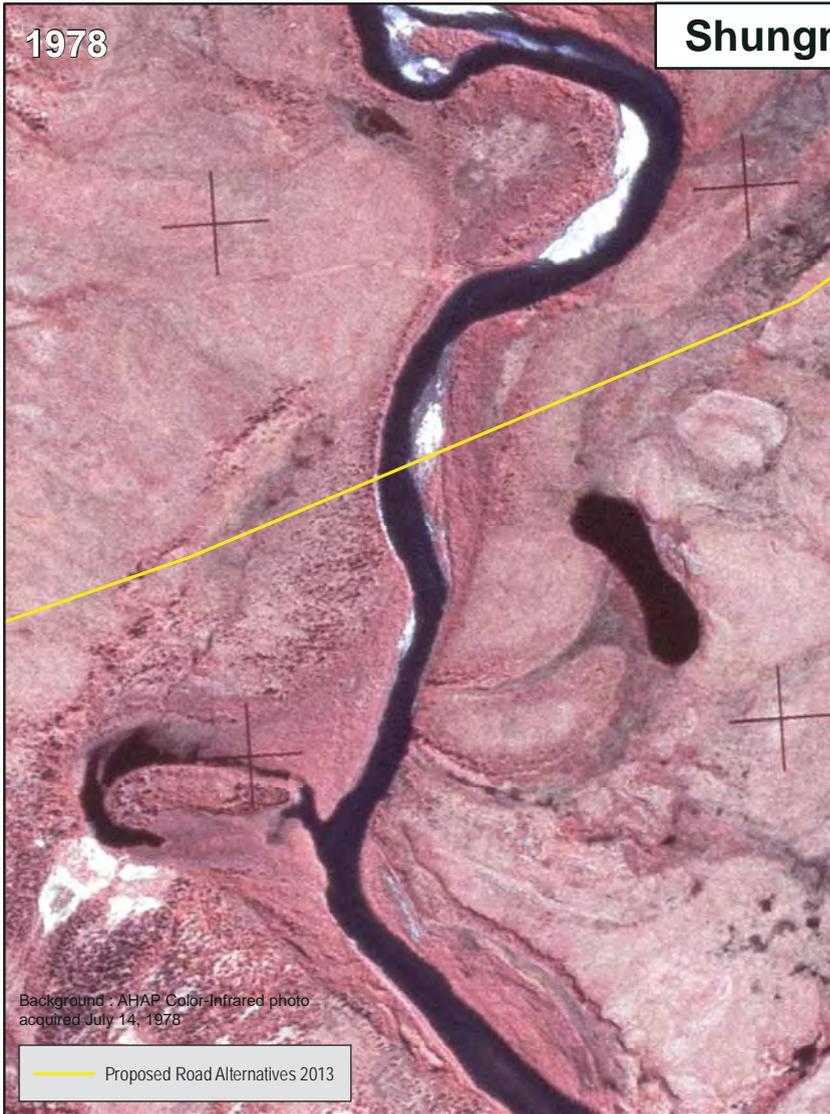
# Shungnak River

Background : AHAP Color-Infrared photo acquired July 14, 1978

— Proposed Road Alternatives 2013

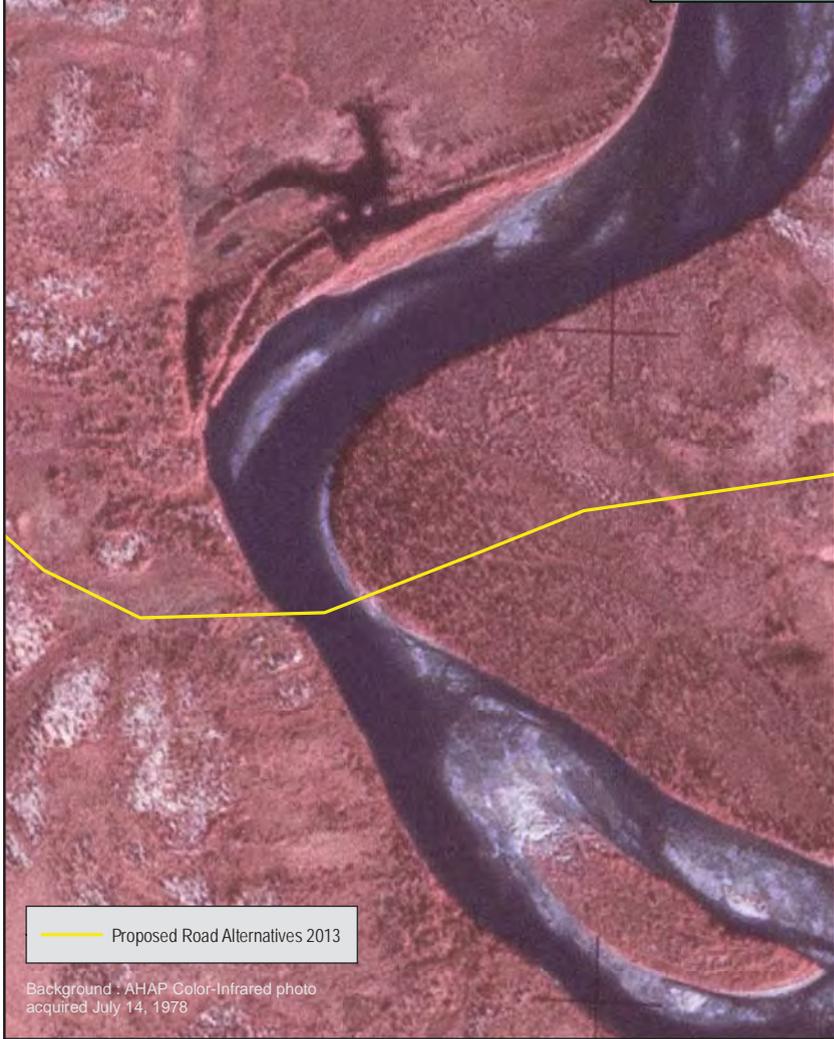
# Kogoluktuk River

— Proposed Road Alternatives 2013

Background : AHAP Color-Infrared photo  
acquired July 14, 1978

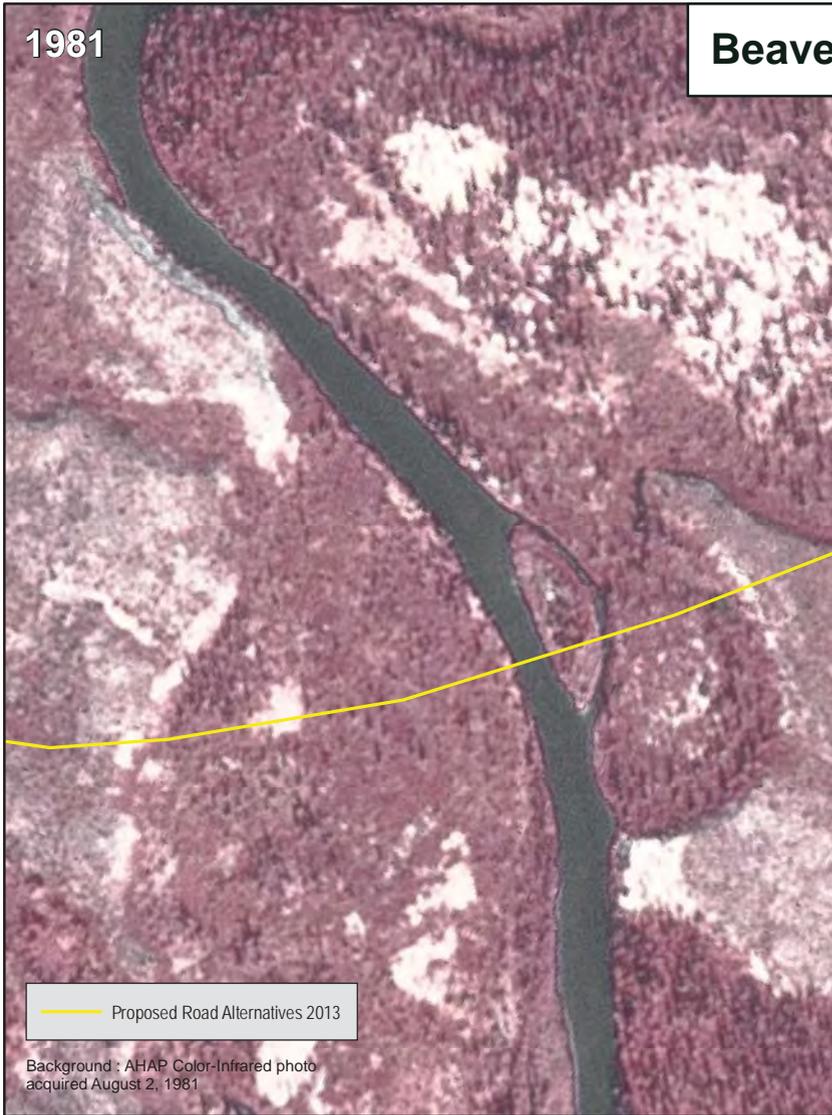
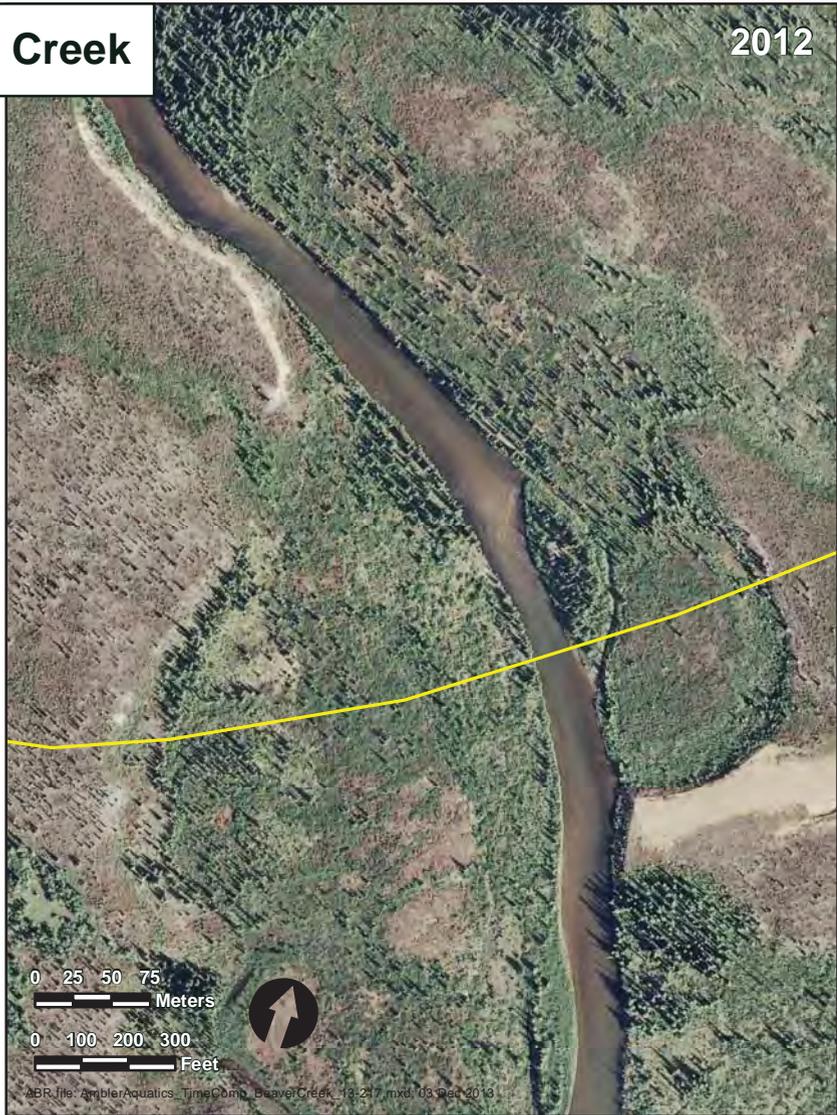
# Beaver Creek

— Proposed Road Alternatives 2013

Background : AHAP Color-Infrared photo  
acquired August 2, 1981

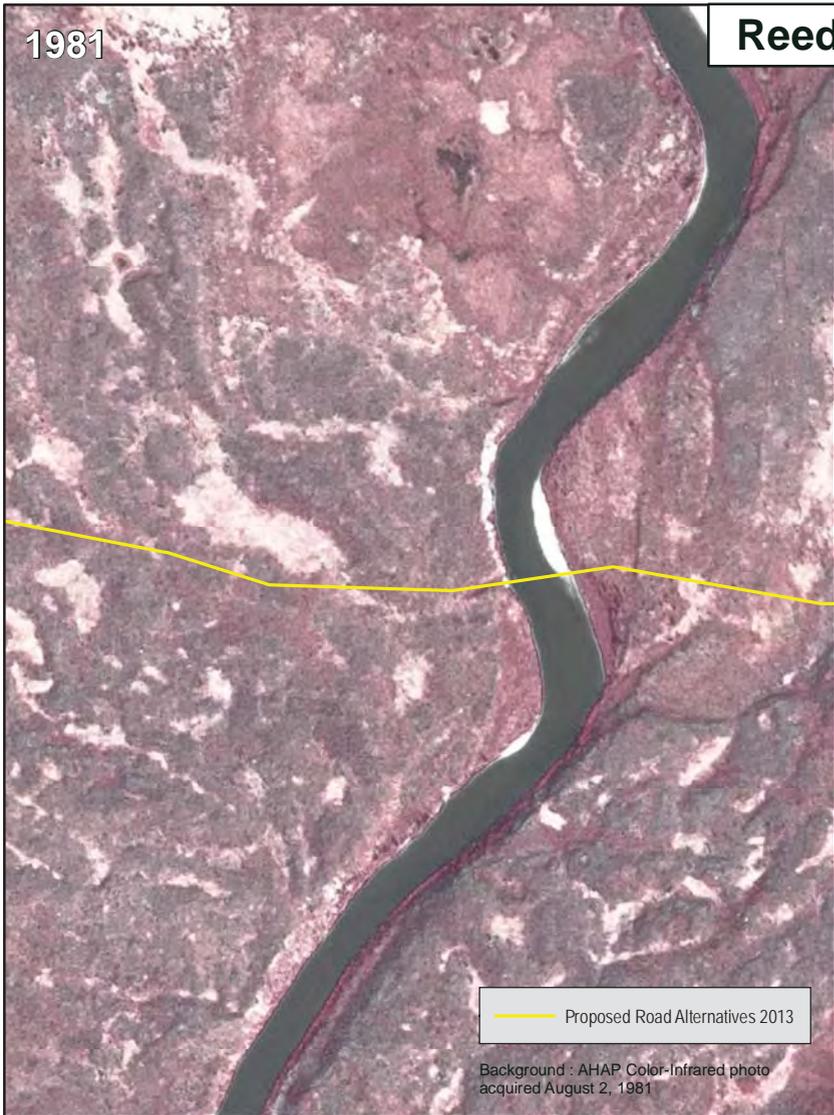
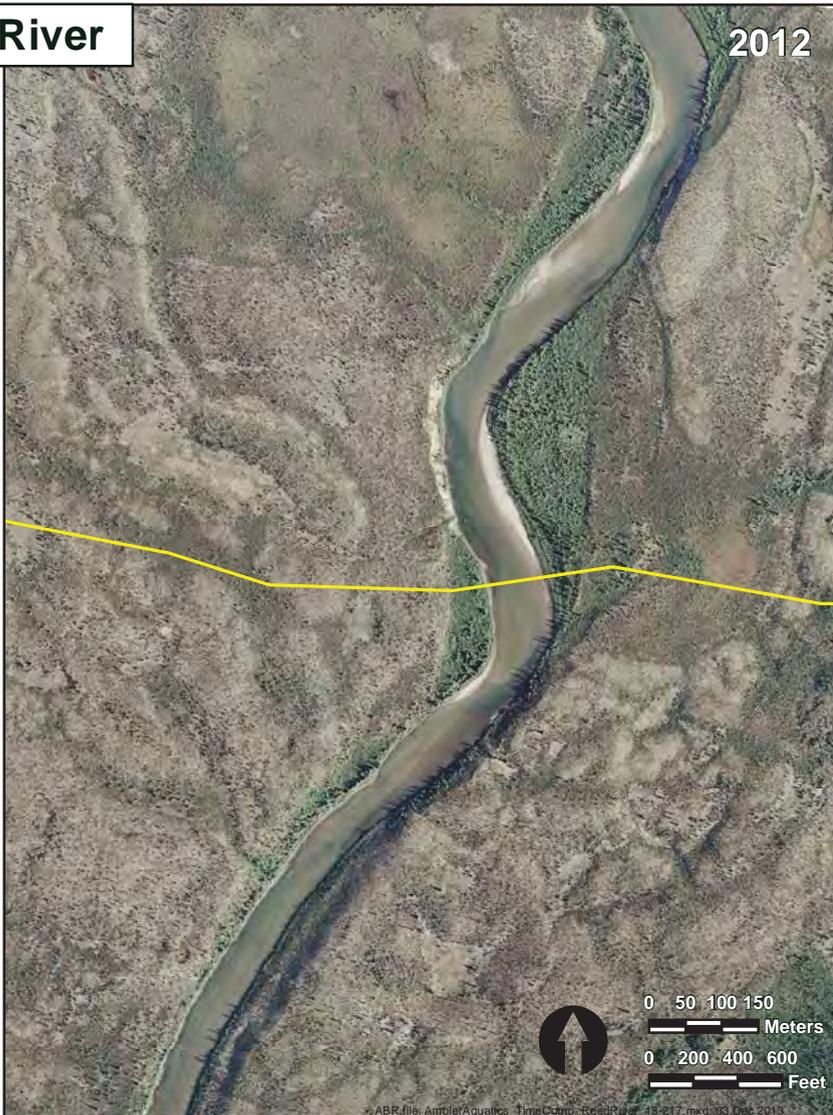
# Reed River

— Proposed Road Alternatives 2013

Background : AHAP Color-Infrared photo  
acquired August 2, 1981

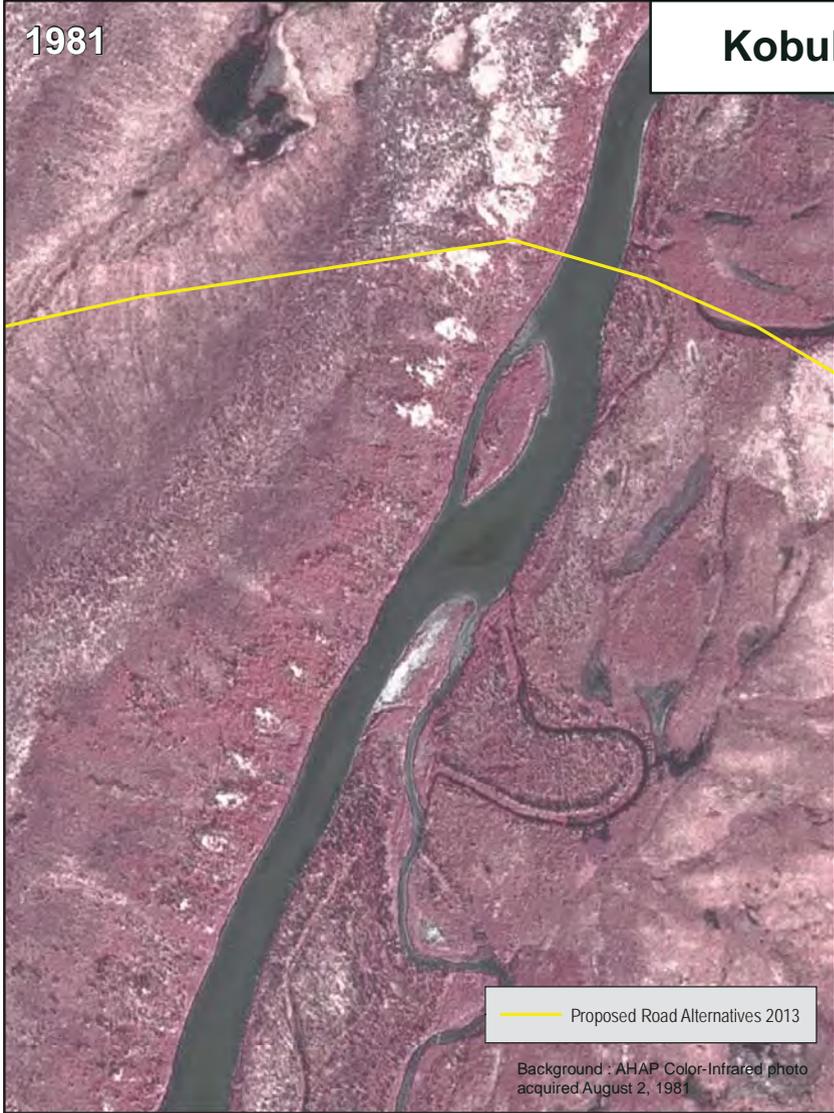
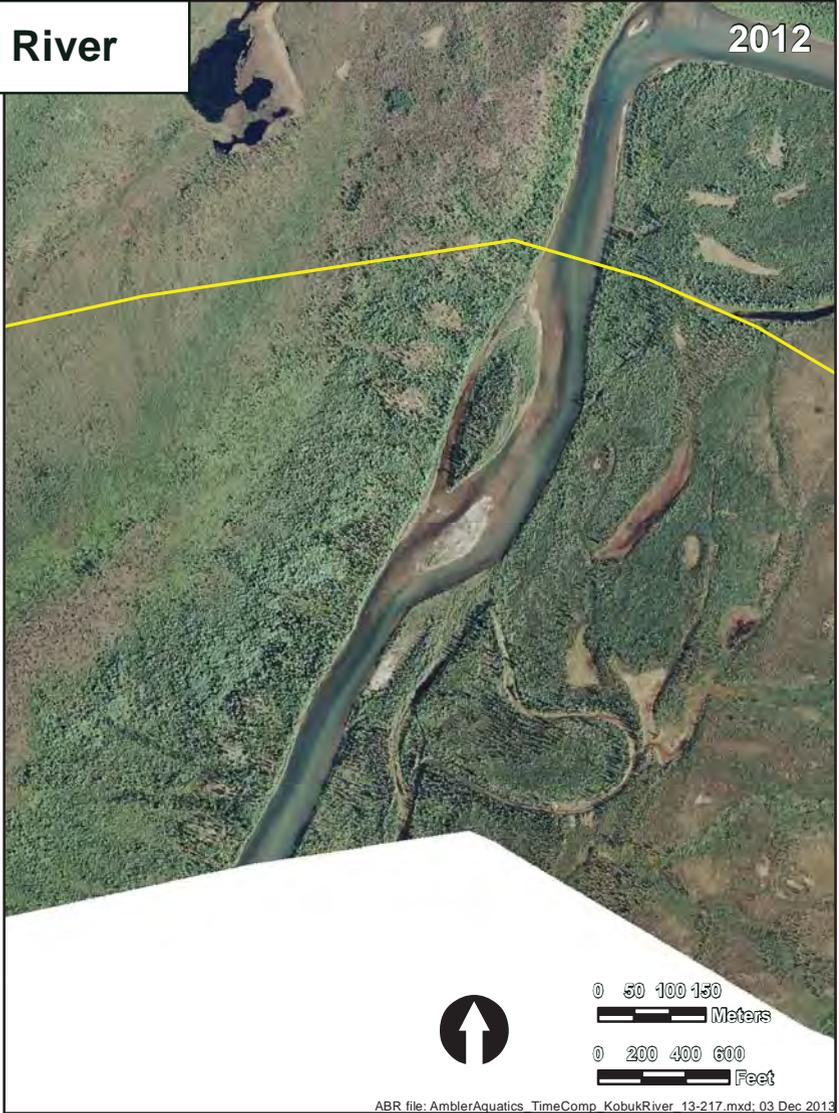
# Kobuk River

— Proposed Road Alternatives 2013

Background : AHAP Color-Infrared photo acquired August 2, 1981

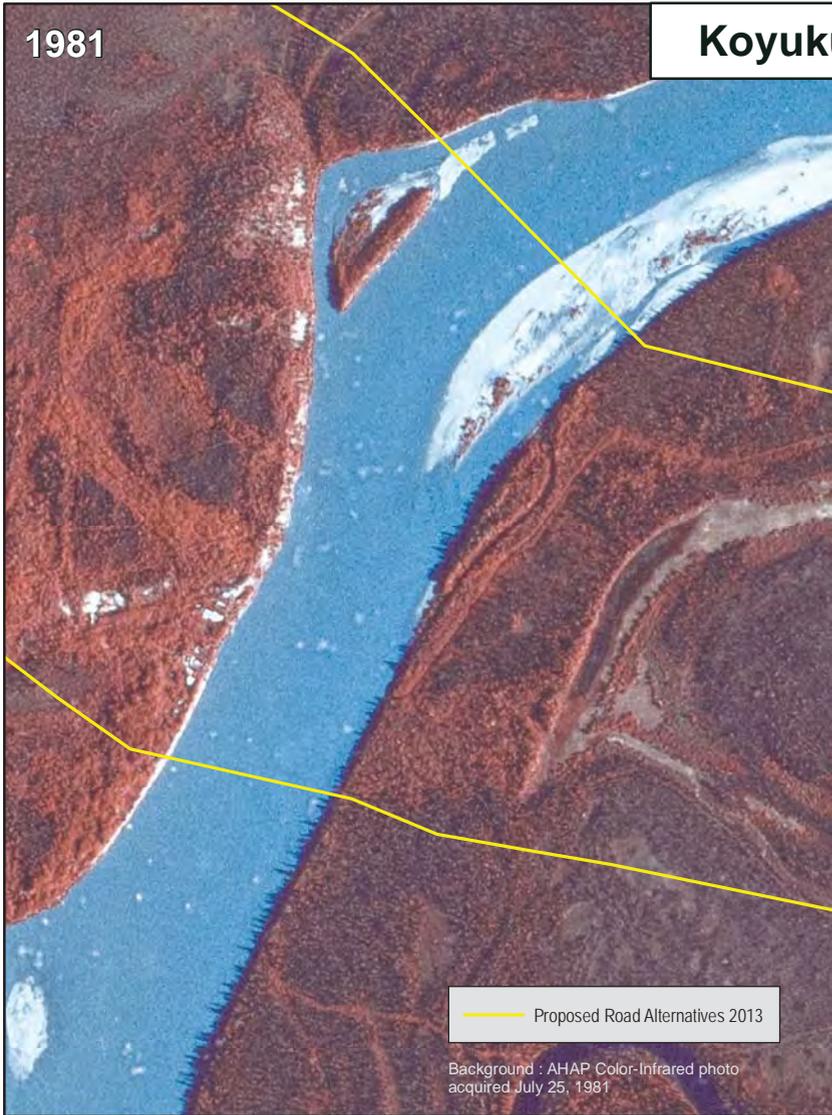
# Koyukuk River

— Proposed Road Alternatives 2013

Background : AHAP Color-Infrared photo  
acquired July 25, 1981
