**ANADROMOUS FISH SURVEYS WITHIN THE  
BROOKS EAST CORRIDOR SURVEY AREA, ALASKA**

June 2013

- Objective 1: Document the stream habitat conditions in waterbodies associated with potential bridge crossings along the Brooks East Corridor
- Objective 2: Integrate stream habitat and fish presence data from the study area to determine potential impacts of bridge construction on stream habitat

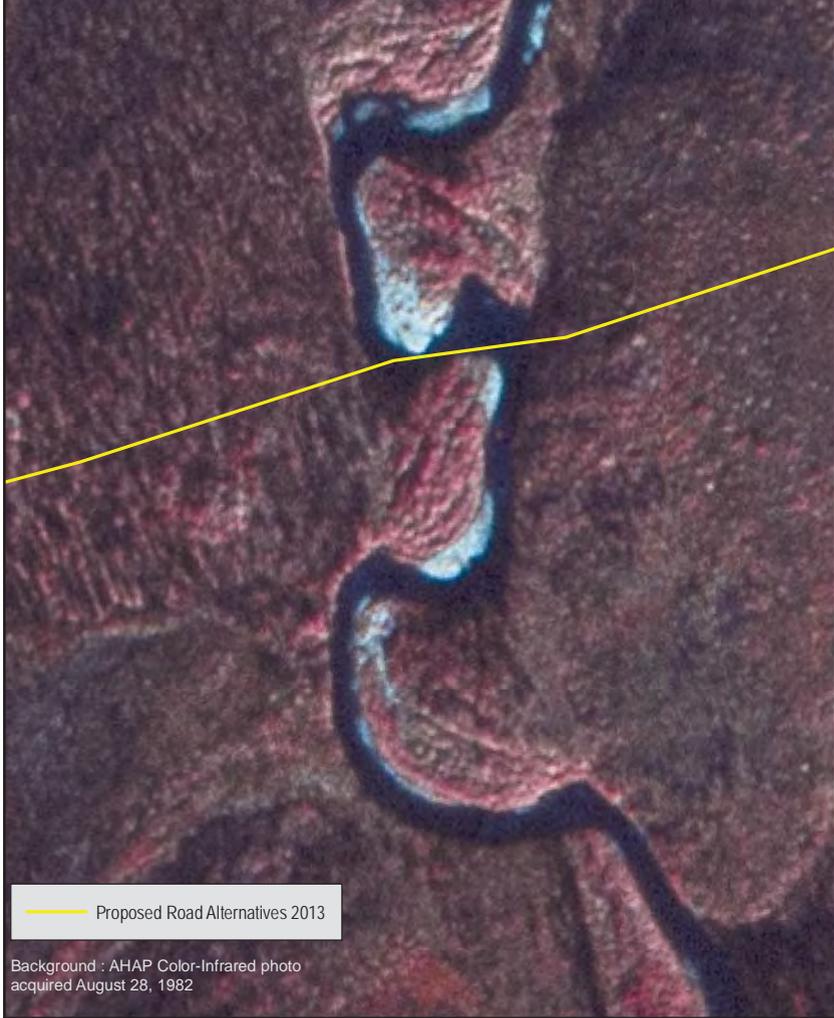
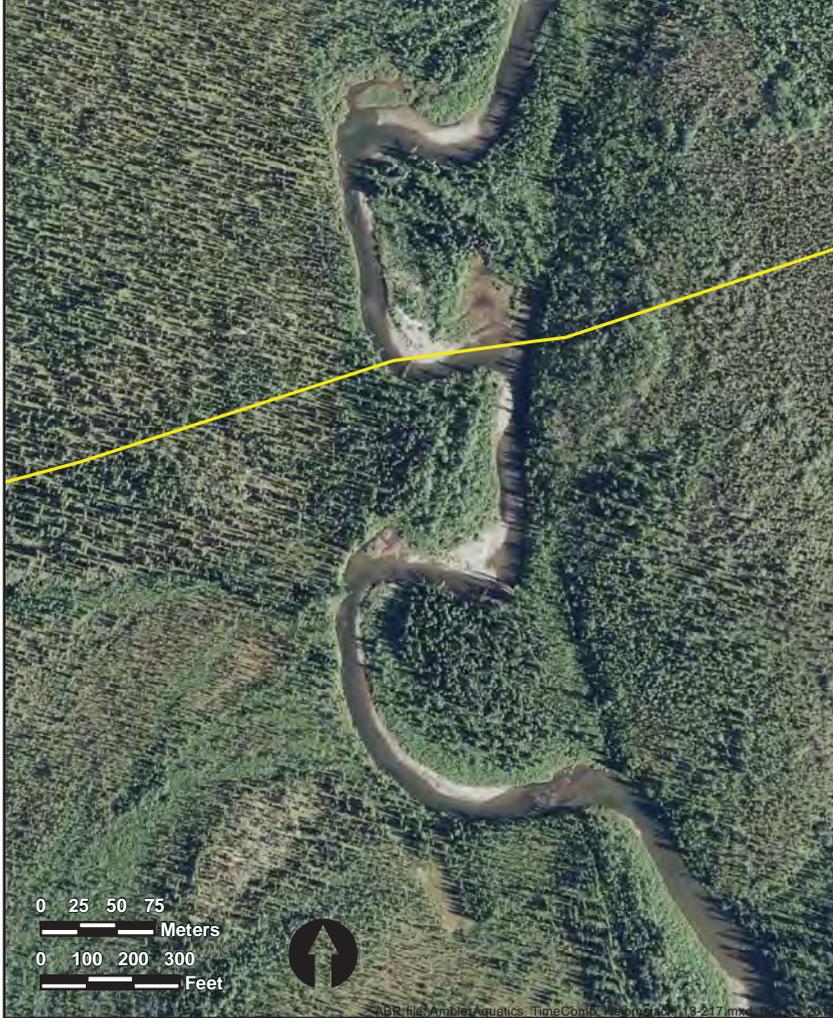
# Helpmejack Creek

— Proposed Road Alternatives 2013

Background : AHAP Color-Infrared photo  
acquired August 28, 1982
