**HISTORIC LANDSCAPE ANALYSIS  
AND DESIGN RECOMMENDATIONS  
FOR BOSTON, OHIO**

**Cuyahoga Valley National Recreation Area  
National Park Service  
September 1993**

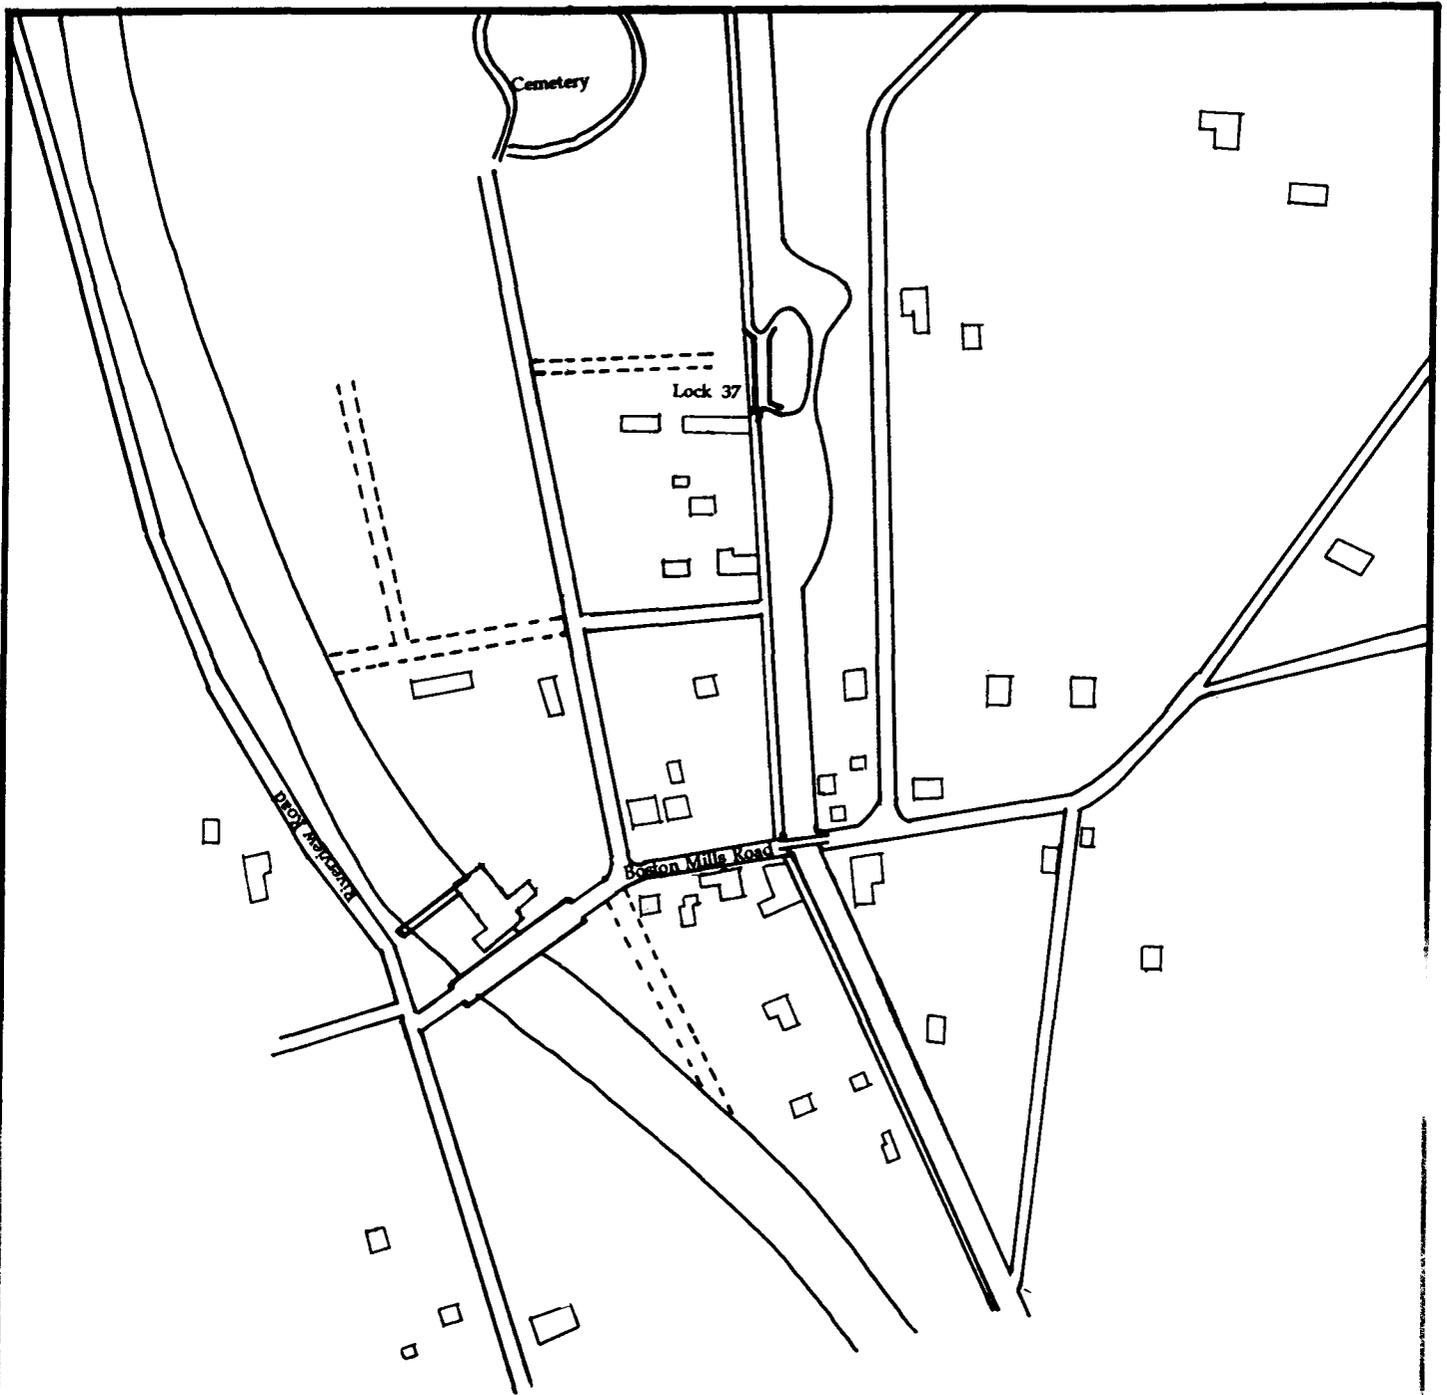
1840

This era (1827-1875) will be referred to as the "Canal Era" in this document. The map depicts Boston in 1840, at the height of canal activity, and is based on *The Diary of George C Stanford*, the 1856 Matthews and Tintor map of Boston Village, an 1852 tax assessor's plat map,

There is no pictorial documentation from this period to determine exactly which lands were cleared, farmed or pastured. An 1852 Plat map records that 50% of the land within the village was arable, 30% was pasture and 20% was woods.

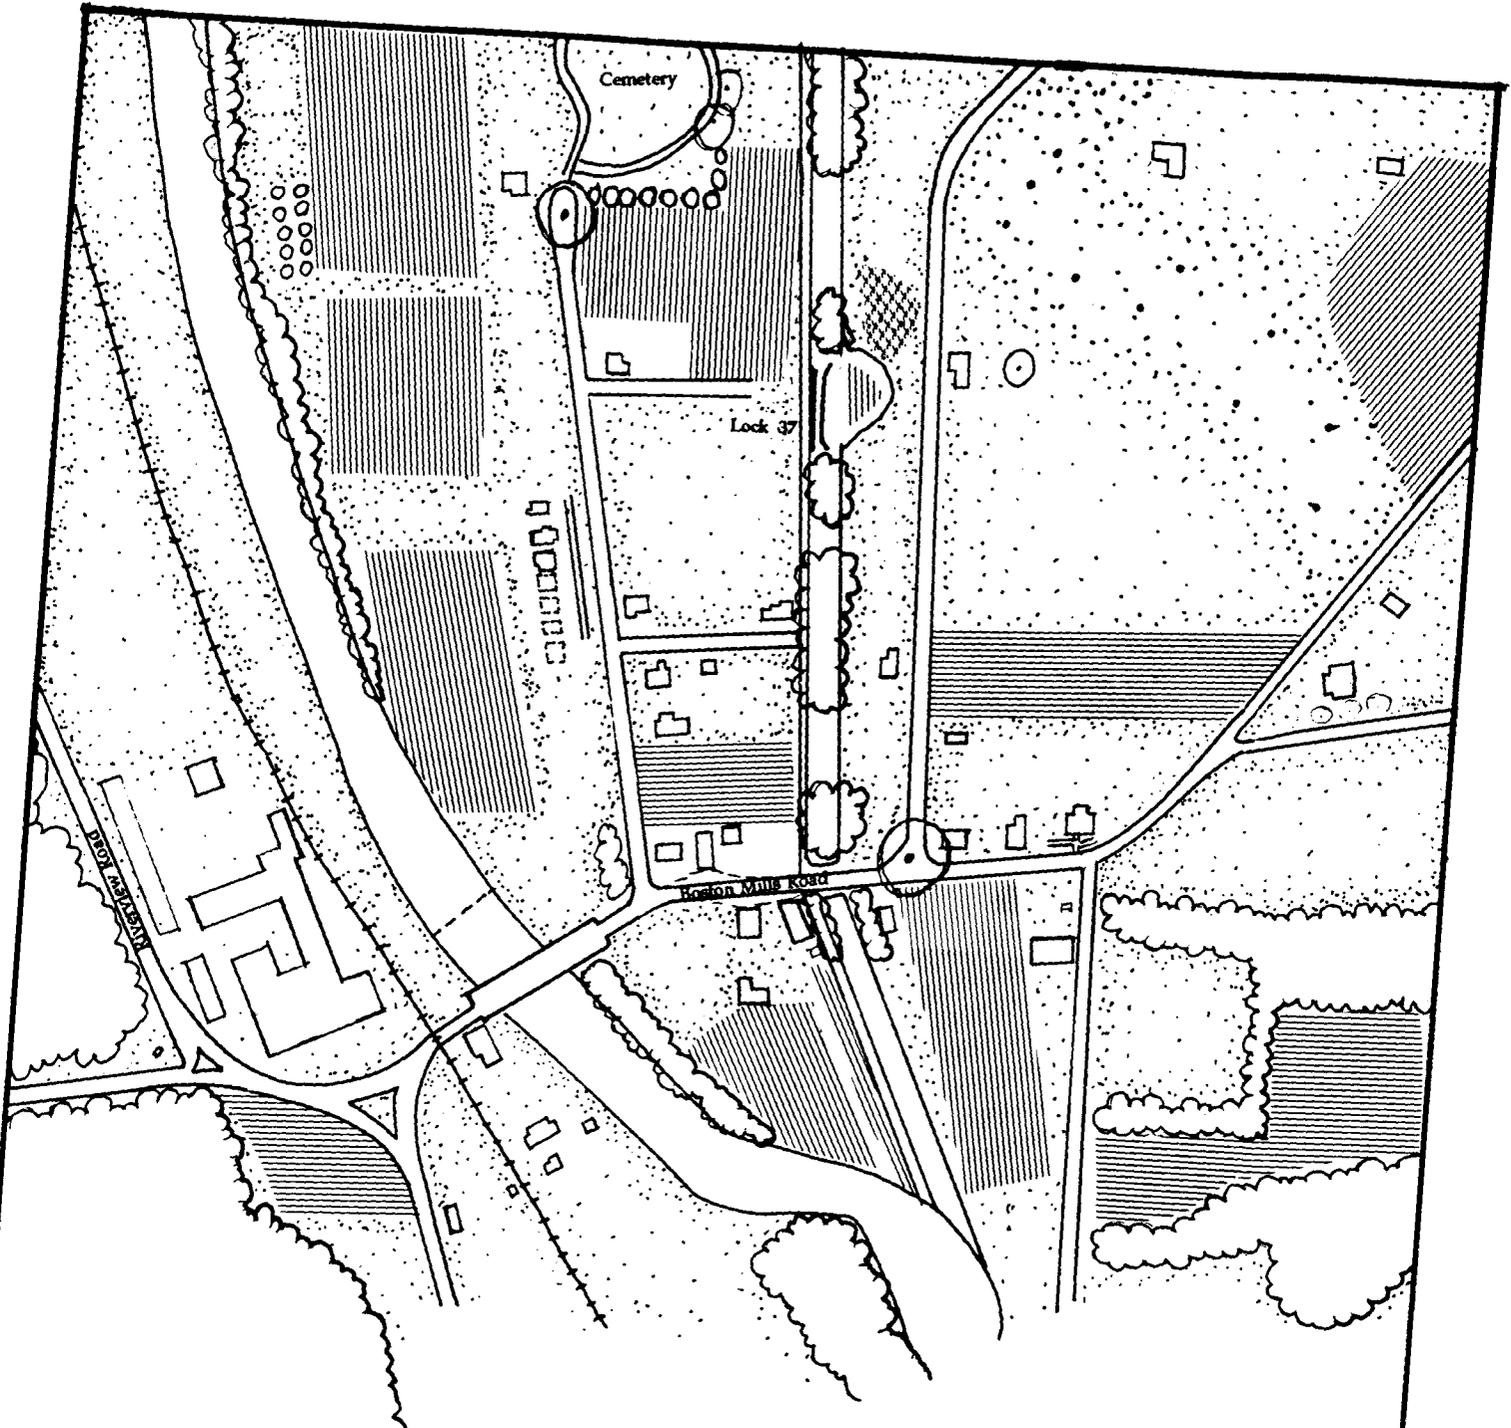
1930

Tilled fields
-

Cleared land
-

Company town houses destroyed in flood
-

Significant deciduous trees
-

Dense vegetation
-

Swamp

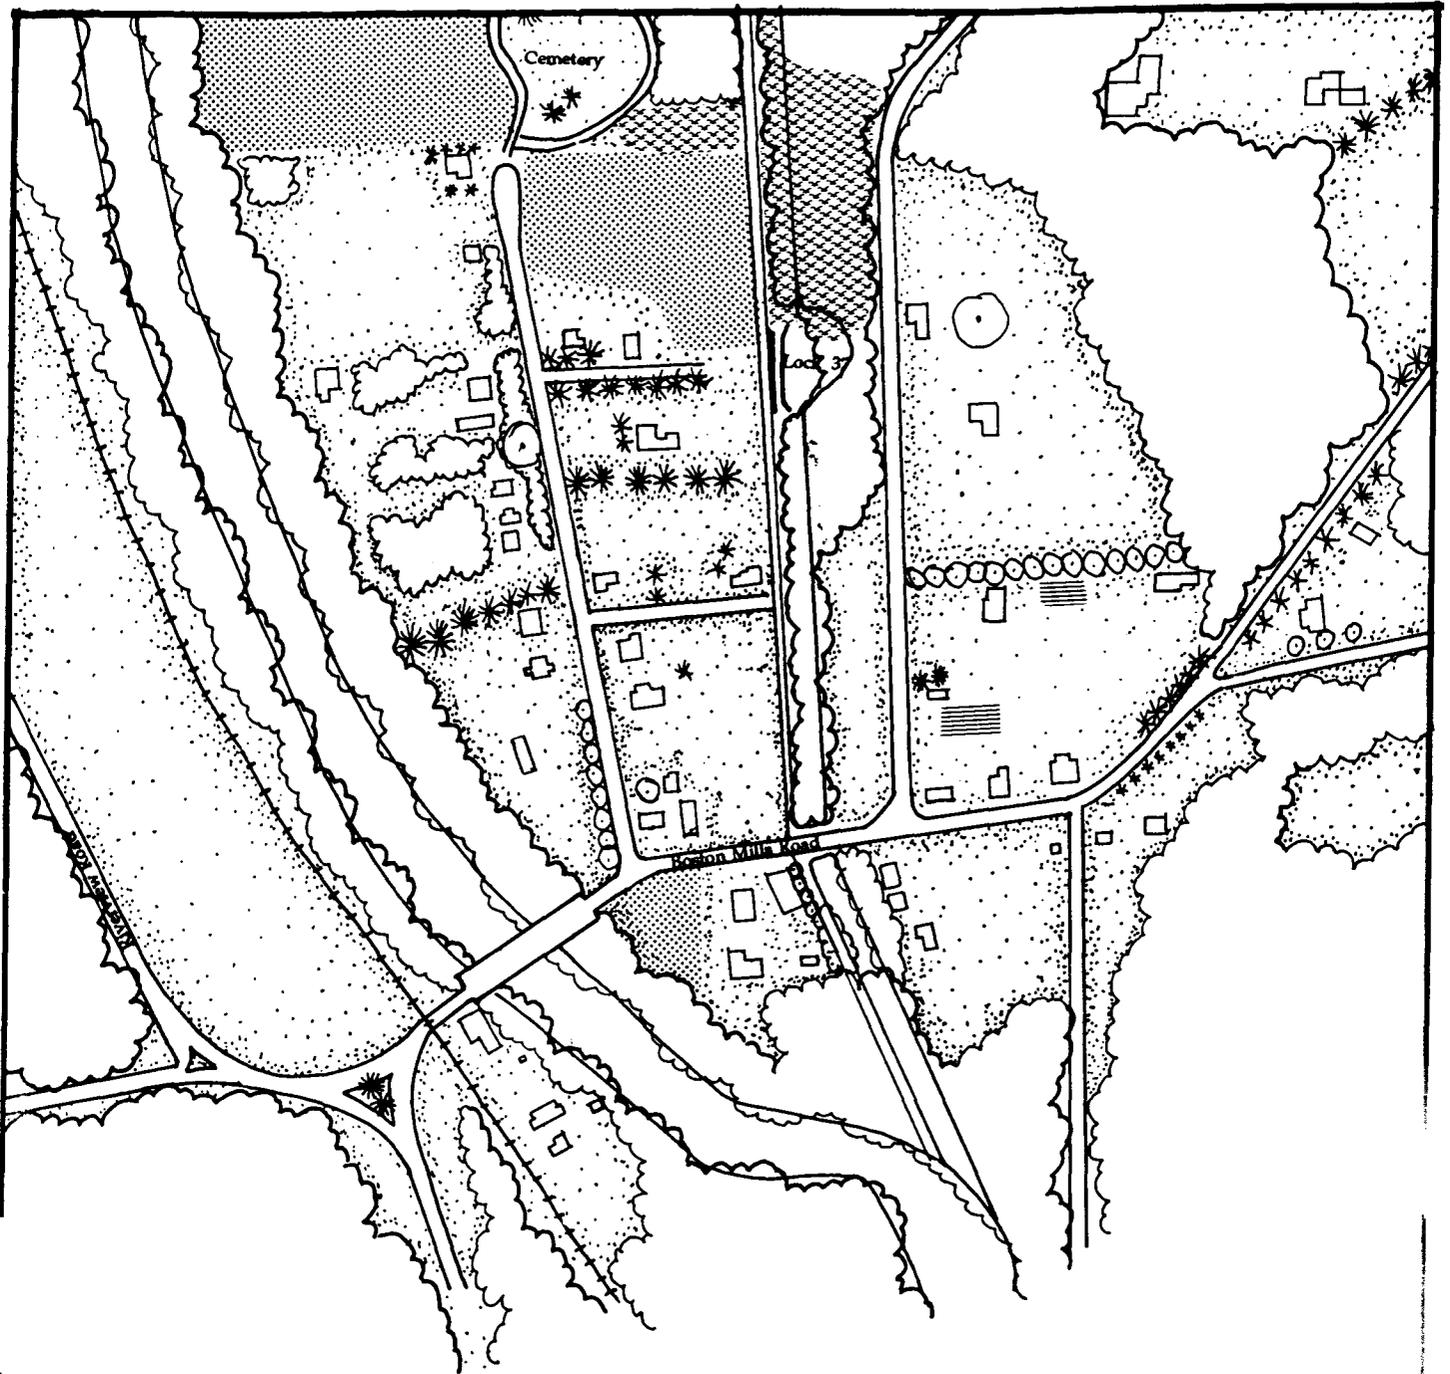
1993

Tilled fields

Dense vegetation

Cleared land

Significant deciduous trees

Vegetative succession / old field

Significant conifers

Swamp

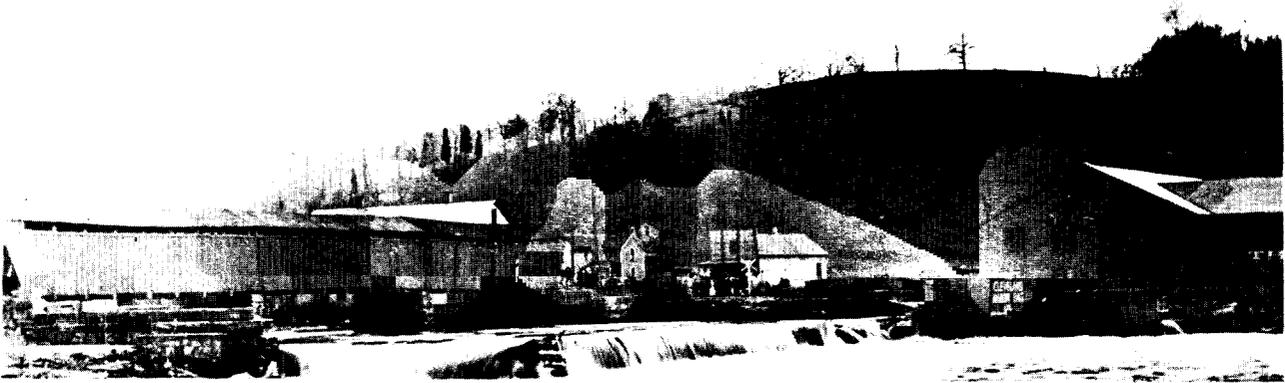
Prior to 1940, the entire watershed was open pastures and fields which fell within the visual boundary of Boston residents. Those same hills are now obscured by vegetation, and a visual boundary of Boston falls roughly along the historic district boundary. Now, the two highway bridges dominate the south side of the watershed from Boston, especially I-271.

While the current National Register Historic District boundary encompasses the heart of Boston, the visual and social boundaries of the historic community were much different. In terms of current integrity, the National Register Historic District Boundary is still most appropriate, but it is important to note that the residents' view of what makes up Boston reaches much further. These are people who lived in Boston all their lives and consider many elements outside the National Register boundaries to be part of Boston.

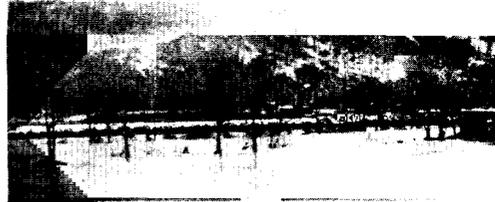
VIEW TO WEST OF HILLS AND RIVER  
IN 1913 FLOOD

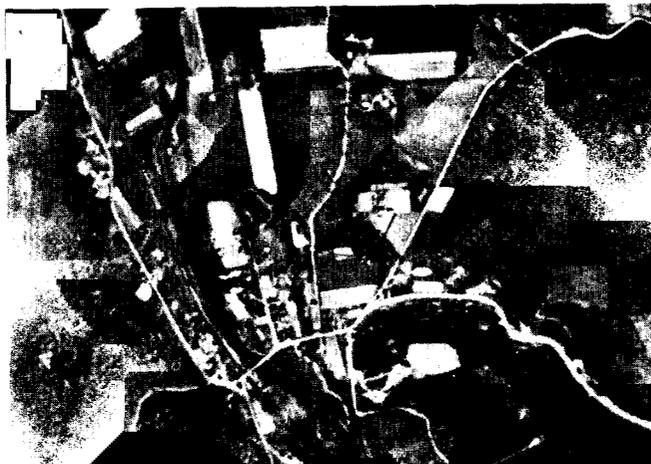
It is hard to determine an exact period when pasturing stopped and re-vegetation began, but the 1949 aerial photograph shows large areas of hillside devoid of scrubby vegetation, indicating that re-vegetation has been slow and gradual since then. There are no known endangered species of vegetation within the village of Boston. A large deer population presently lives in the park and with the extensive grazing of herbaceous material and shrubs, the hillsides around Boston may eventually regain some of the look they have had historically.

1949 AERIAL PHOTOGRAPH

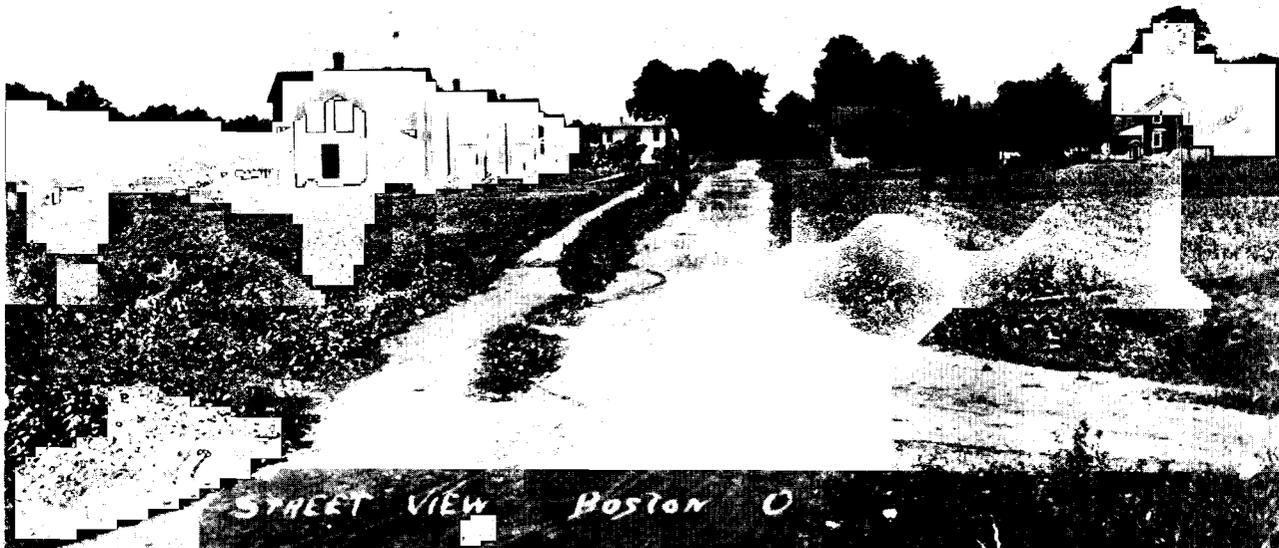
VIEW DOWN MAIN STREET CIRCA 1910

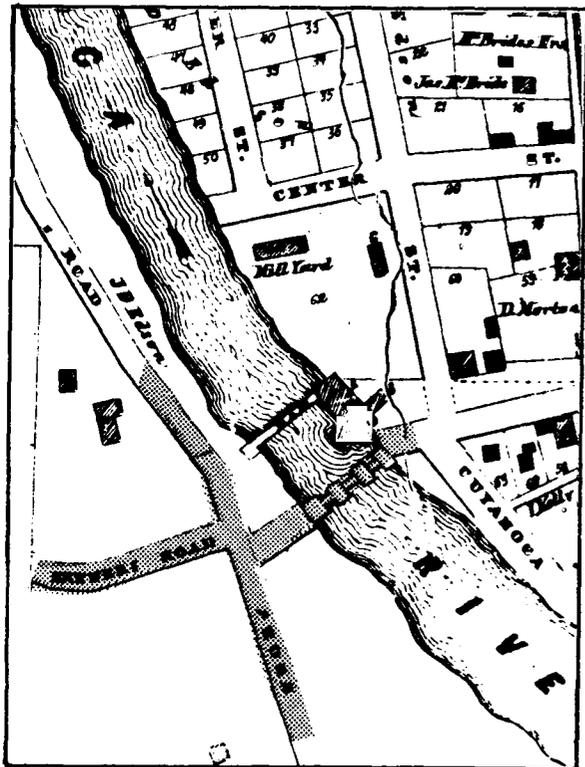
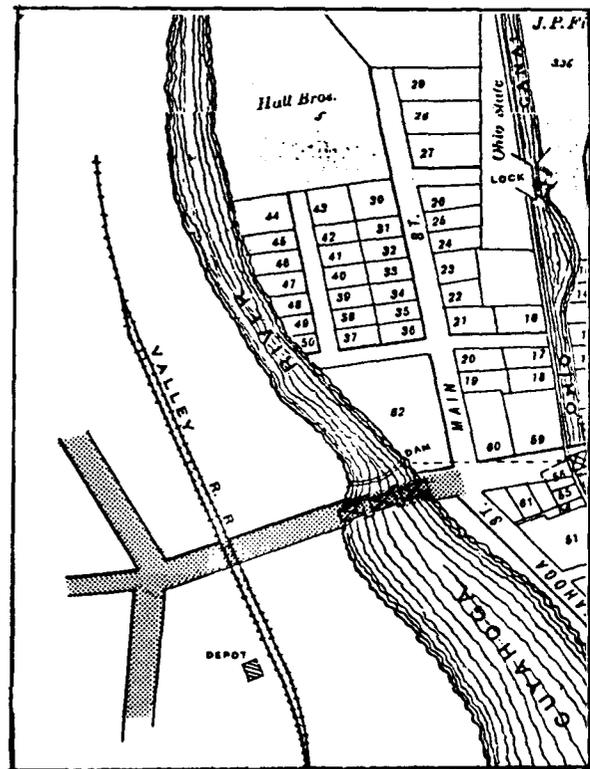
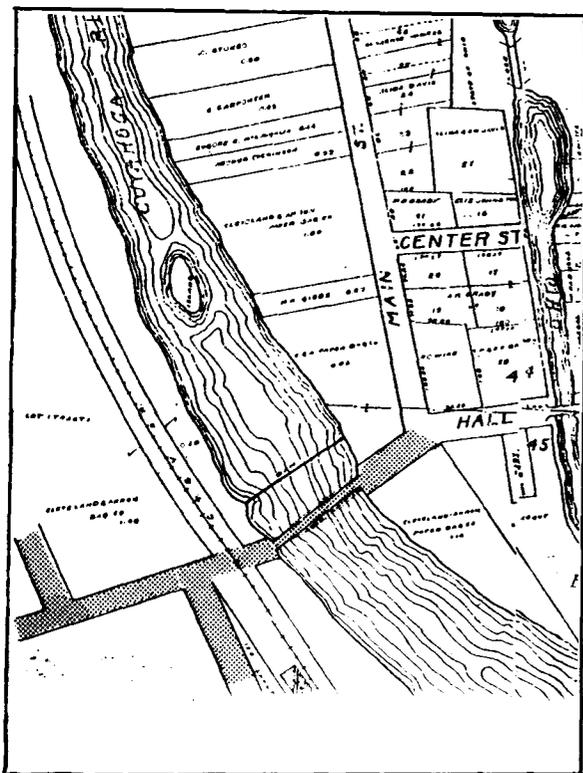
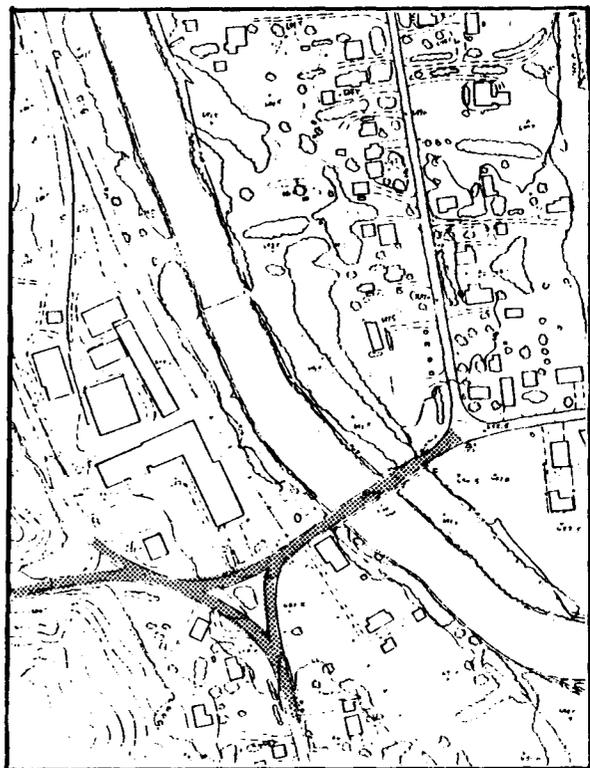
Riverview Road has been realigned through time as land needs have changed. The proposed realignment of Riverview Road follows an historic alignment, including the placement of the bridge. The bridge is located on top of the dam in an 1834 plat map. Riverview Road appears on a map for the first time in 1855, close to the river. By an 1890 map it had moved westward, and the Railroad had been built between it and the river. On the 1910 plat map, Riverview road was located in its present location. This may have had to do with the need of the Bag company to be directly adjacent to the railroad for shipping purposes.

Realignment of Riverview Road over time.

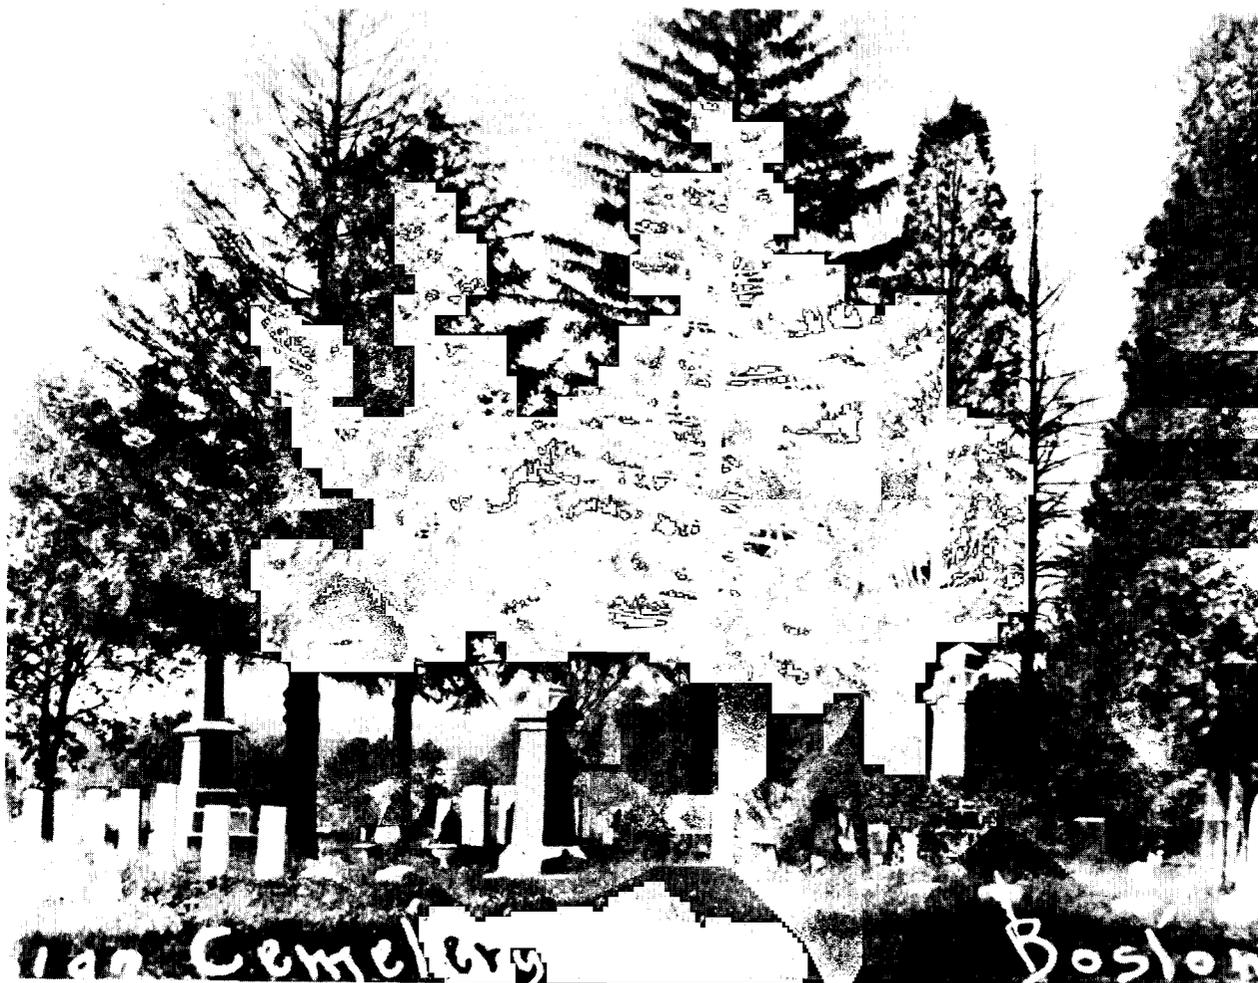
The Boston village cemetery is one of the best preserved cultural sites in town. Continued maintenance and preservation is encouraged, especially for the vintage trees found there (see appendix) Photos indicate the tree canopy was heavier in the past. It may be desirable to replant young trees before the remaining ones die. If the security situation has improved by the time the current fence needs replacing, that chain-link fence could be replaced with the historic rail fence seen in this photograph.

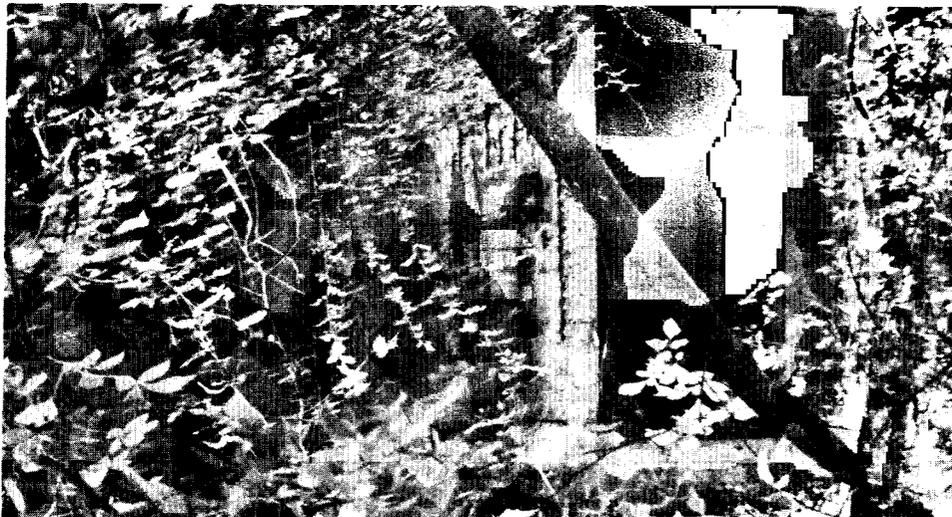
FILTER PLANT RUINS

Consideration might be given to stabilizing, restoring and interpreting water features such as the horse trough, turning basin, dam, and filter plant.

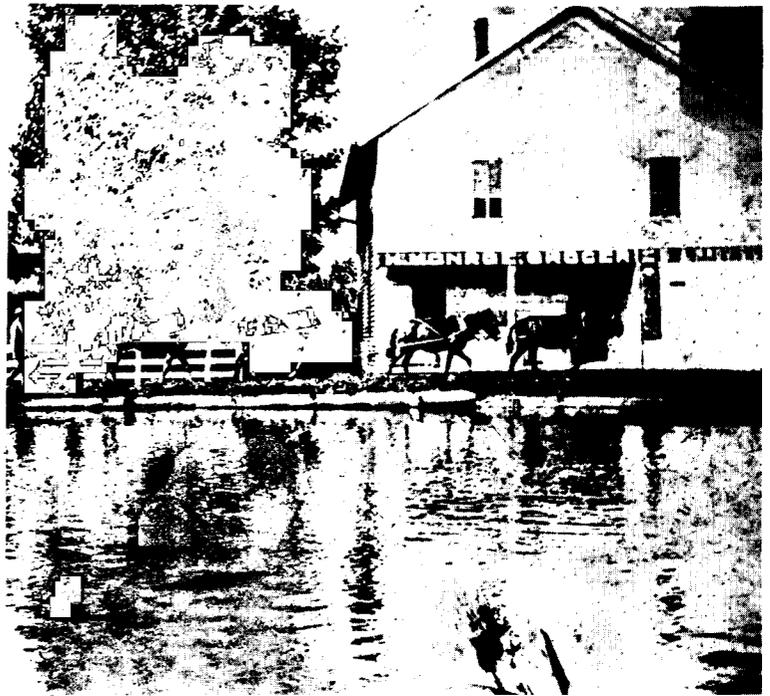
HISTORIC VIEW OF CANAL, NEAR LOCK

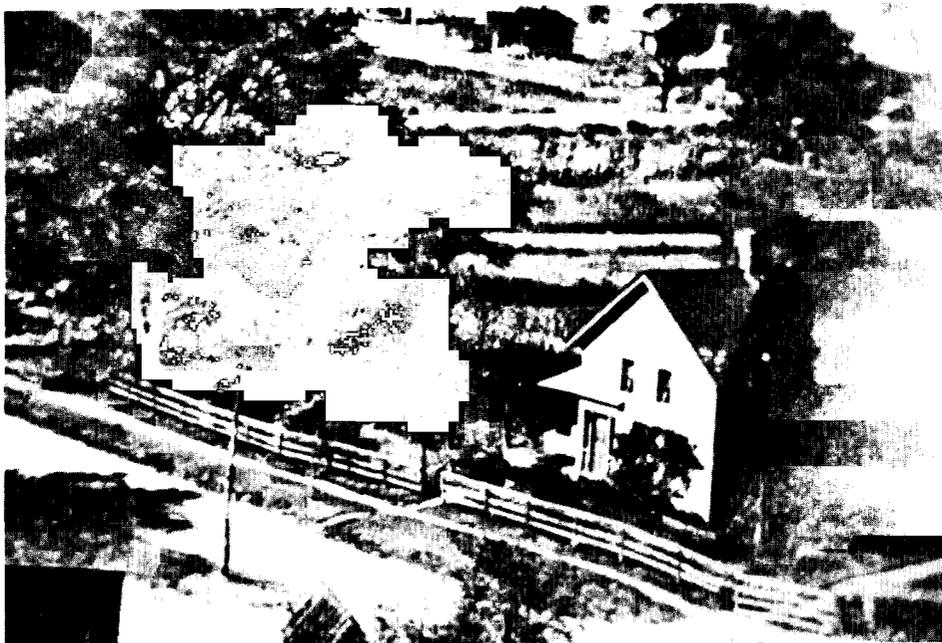
CONGER-JACKSON HOUSE WITH SIDEWALK

If the road width and alignment were changed, this would destroy part of Boston with much remaining integrity. Some ways to restore the historic look of the circulation routes are through keeping sidewalk and road edges irregular, either by the surfacing type, or where roads are already hard-surfaced, with a less manicured, softer vegetative edge line. Sidewalks are most appropriately designed rectilinear rather than curvilinear alignments running parallel to the street. Surface materials such as dirt or crushed limestone would be visually compatible with the road surfacing seen in historic photographs.

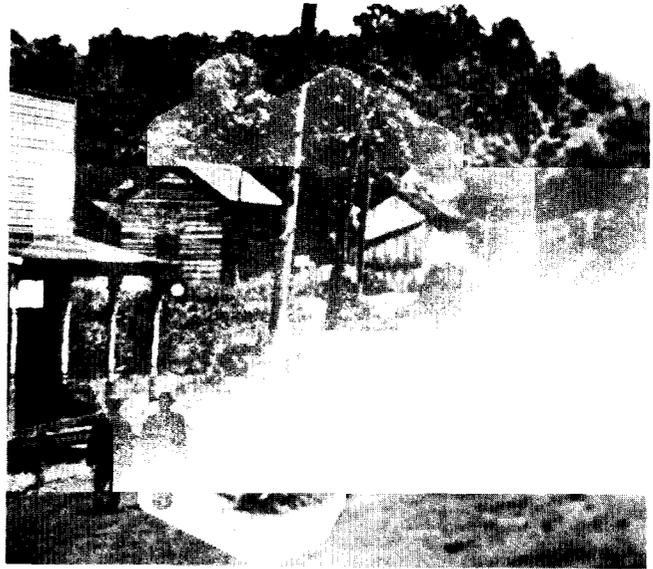
UTILITY POLES (CENTER)  
HITCHING POSTS (LEFT)

Consider attaching new signage, lighting, wayside or other outdoor exhibits to structures, rather than leaving them freestanding. This may require a change in zoning code. Simple and plain typefaces act to reflect the utilitarian nature of objects in Boston. The only items which were historically freestanding elements were wooden utility poles and hitching posts which were quite prominent in old photographs.

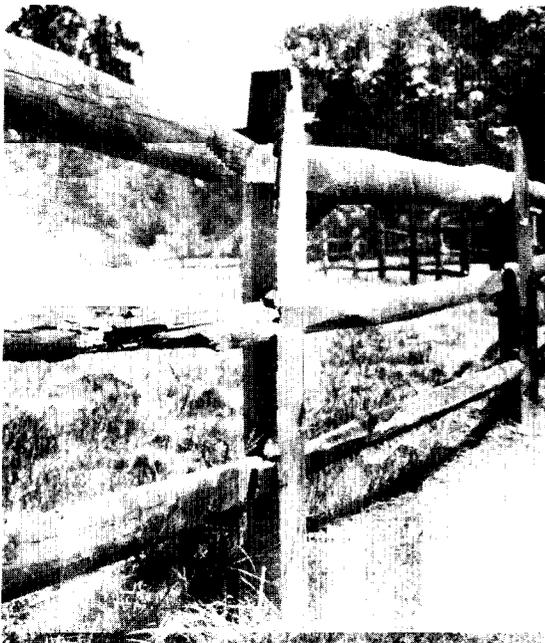
These are typical historic fence types in Boston and a compatible modern one. Any of these would be appropriate for contemporary use. Fences have not historically or recently been used to screen a backyard. Use of fences in Boston has been for utilitarian purposes, and fences used (wooden rail and wire) have been of open design, and did not obscure views in the landscape. Modern fences of this degree of transparency are appropriate, such as open designed wooden rail, barbed, twisted, or electric wire or black chain link. More urban fence types such as wrought iron or picket are inappropriate in Boston as well as fences used purely for decoration.

MODERN COMPATIBLE FENCE
