## **APPENDIX G: INVASIVE SPECIES RESOURCE REPORT**

# DOOMS-BREMO 230 KV TRANSMISSION LINE EA

Appalachian National Scenic Trail, Virginia  
Shenandoah National Park, Virginia

Invasive Species Report  
September 2012

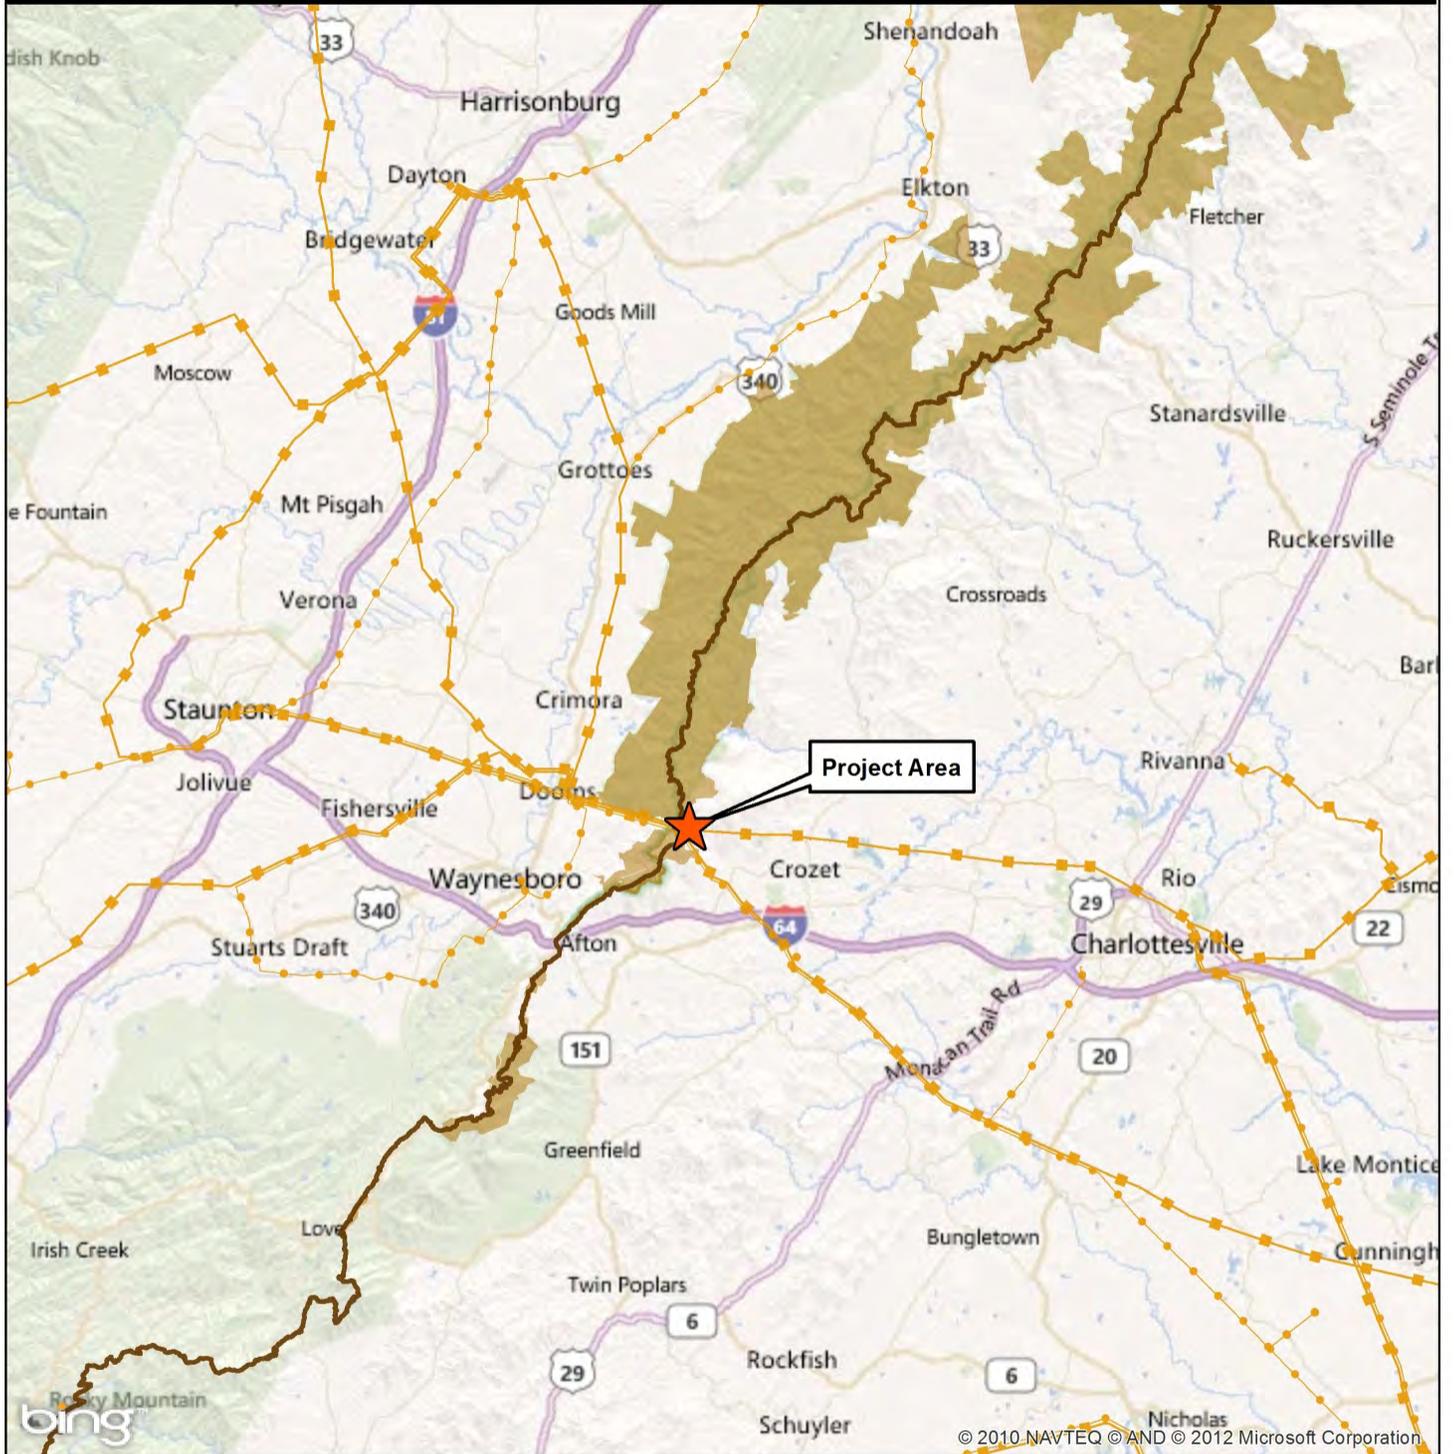
**Figure 1: Appalachian Trail and  
Shenandoah National Park  
Crossings Overview**

The Louis Berger Group, Inc. (LBG) was contracted to complete both the EA and necessary environmental surveys across NPS lands. The Dooms – Brems line crosses NPS lands in two locations, on three NPS parcels. The transmission line crosses approximately 525 feet of Shenandoah National Park land, immediately adjacent to approximately 740 feet of Appalachian National Scenic Trail property. At this crossing, the existing 115kV line is collocated with two other DVP transmission lines (one single-circuit 500kV and one double-circuit 230kV) in a 330-foot right-of-way. About 1 mile east of Skyline Drive, the Dooms – Brems line crosses approximately 1,600 feet of an additional Appalachian National Scenic Trail parcel. At this crossing, the existing 115kV line is collocated with one other DVP transmission line (one single-circuit 500kV) in a 250-foot right-of-way. Figure 1 depicts the general project location; figure 2 shows the areas of the two crossings.

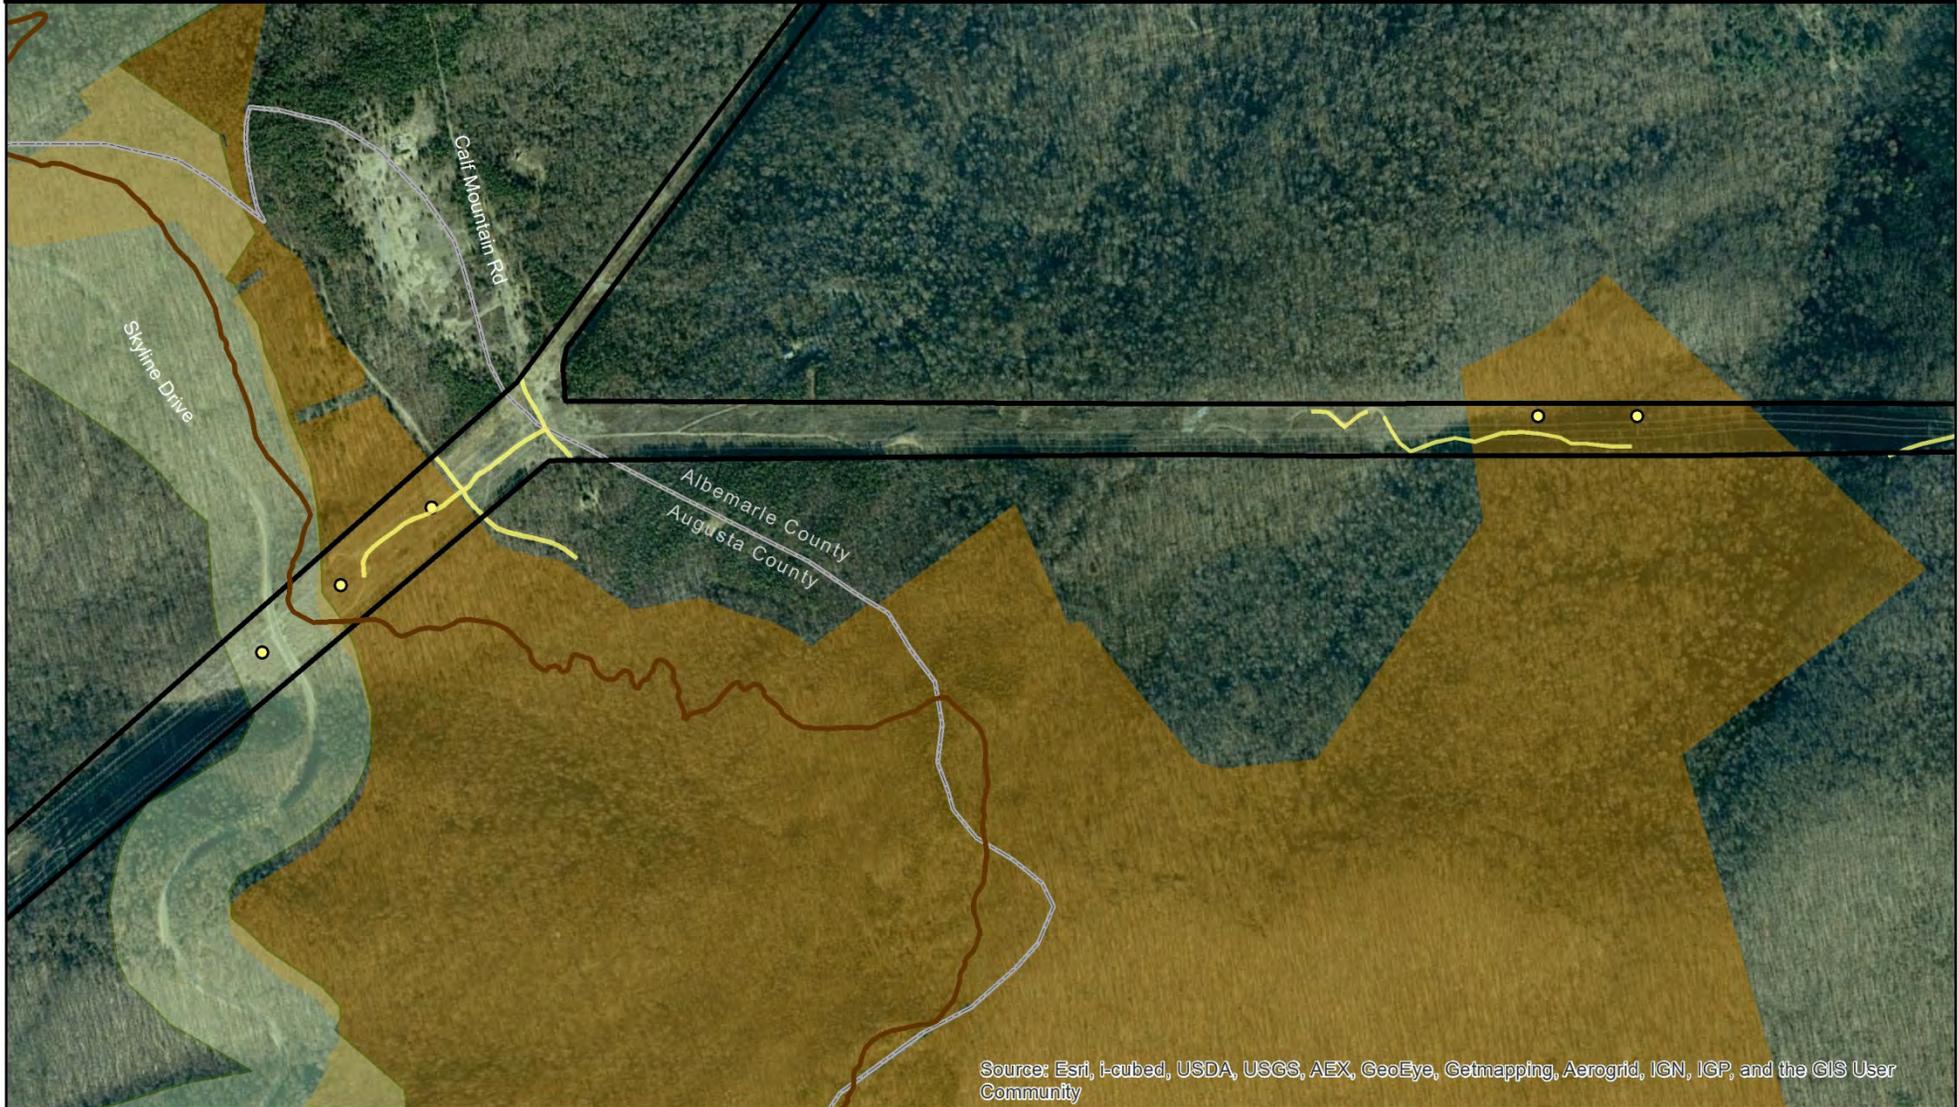
Figure 2: Skyline Drive and  
Appalachian Trail Crossing

A survey for the invasive exotic species was required to obtain a baseline of current conditions of such species in the project area. The area to be surveyed includes the existing right-of-way, the proposed access road locations within NPS lands, and 15 feet on either side of the right-of-way edge. The surveys areas are shown below in **Figure 2**.

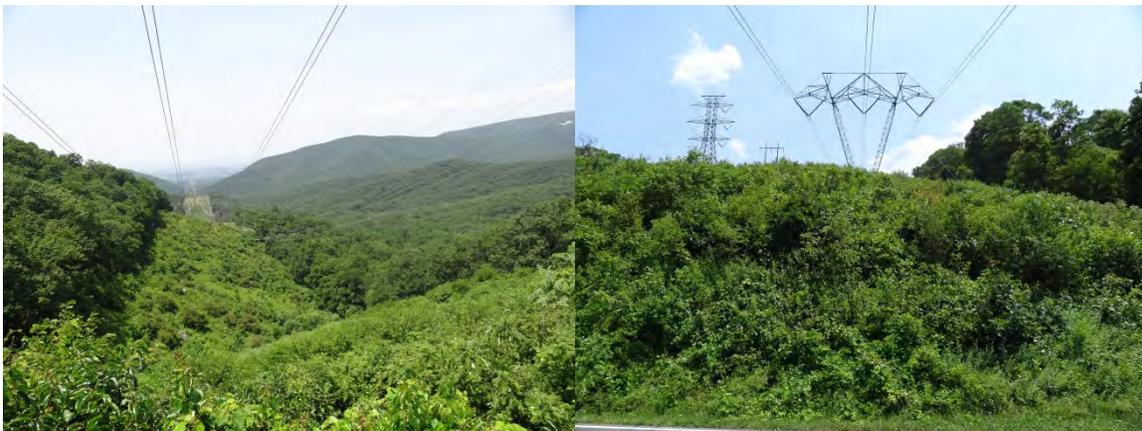
**Figure 3: Survey Area A - Looking west and east (respectively) from Skyline Drive**

The project was broken into two survey areas, Survey Area A (**Figures 3 and 5**) and Survey Area B (**Figures 4 and 6**). Survey Area A includes both parks, Skyline Drive and the Appalachian Trail. The parcel is accessible via Skyline Drive or Calf Mountain Road. Skyline Drive is located along the side of ridge, with a harsh 25% down slope to the west and east. While the terrain is very steep on either side of Skyline Drive, it levels off slightly east of the Appalachian Trail. Vegetation is low growing grasses and shrubs, approximately 3 to 5 feet tall. There is a cleared right-of-way access road from Calf Mountain Road to the west that cuts through the majority of the survey area, east of the Appalachian Trail.

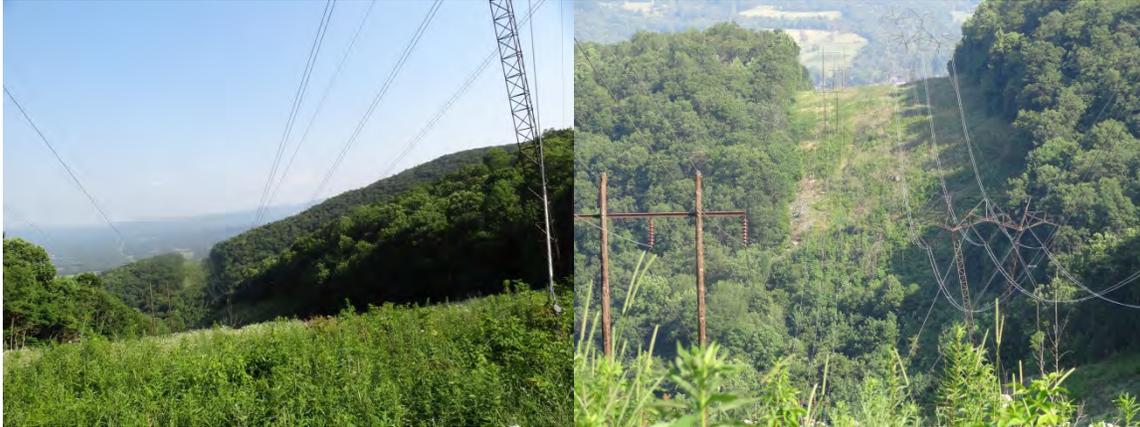
**Figure 4: Survey Area B – Looking northwest and southeast from survey area**

Survey Area B includes a small Appalachian National Scenic Trail parcel west of Survey Area A. Survey Area B consists of very rough terrain with thick vegetation. The right-of-way is located in an area of the ridge that slopes down both north and east on a 30% slope. Terrain and vegetation density becomes progressively steeper and denser, respectively, on the east side of the survey area closer to the base of the ridge.

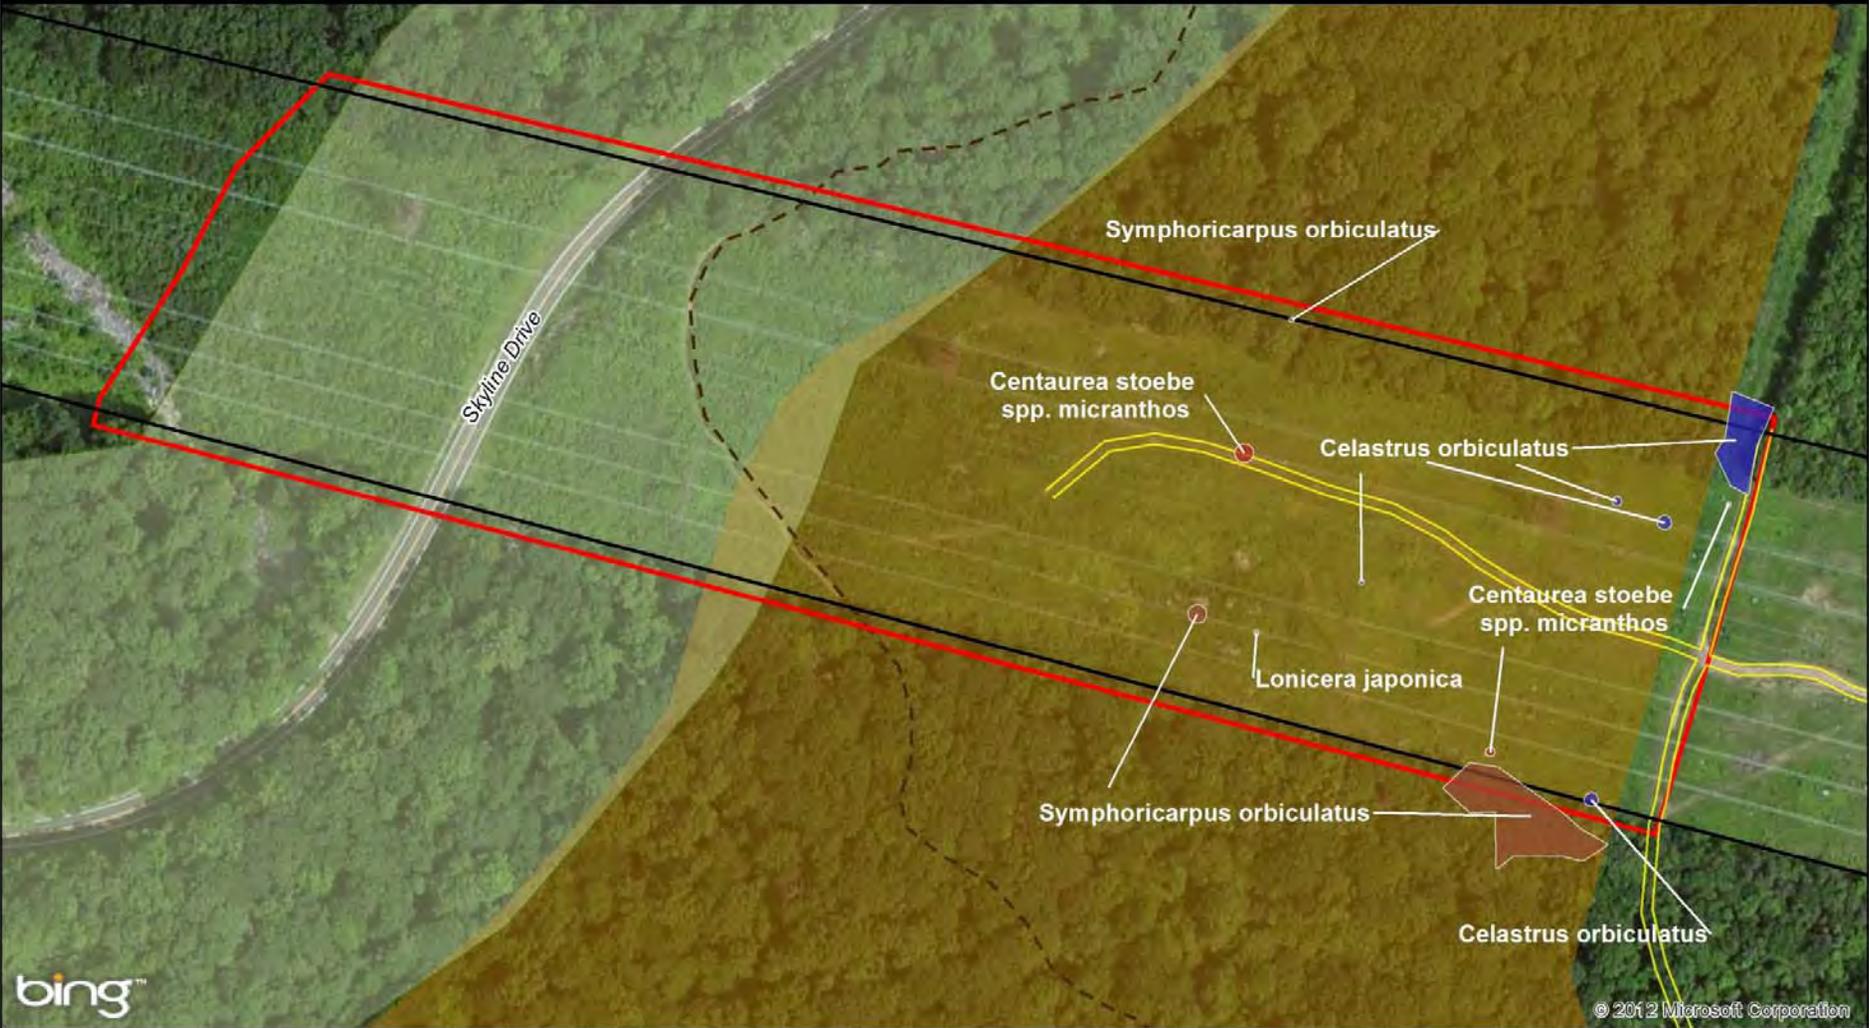
**Figure 7: Invasive Species  
 Survey Area A**

The first nine (9) species listed above occur in various size patches; sometimes as clones in the right-of-way. They are depicted as polygons named after one (e.g., Oriental bittersweet) or more (e.g., Japanese honeysuckle-wine raspberry) dominant species involved (**Figures 7 and 8**). Of these nine species, the spinny plumeless thistle, spotted knapweed, princesstree, Japanese honeysuckle, tree-of-heaven, Oriental bittersweet, and wine raspberry are the most abundant. They also occur as scattered individuals throughout much of the right-of-way. There was also substantial dead garlic mustard, both in and outside of the right-of-way. Being a biennial, this invasive was undoubtedly more noticeable in 2011. Because it can be quite aggressive, the site should be monitored for its presence again in 2013. A small patch of both the multiflora rose and sericea lespedeza were found, as were a few patches of Japanese barberry. The remaining three invasive species (common burdock, common mullein, and black locust) occur more scattered throughout the survey areas.

Although the catnip (*Nepeta cataria*) is not shown for Virginia on the *Mid-Atlantic Exotic Pest Plant Council list*, it is listed for Maryland, and it is quite aggressive at this site and probably should be considered an obnoxious invasive on the right-of-way. Likewise, the coralberry (*Symphoricarpos orbiculatus*) is not shown on the list for any mid-Atlantic state. However, Strausbaugh and Core (n.d.) mention that, although this species is a native in West Virginia, it is often cultivated and has widely escaped. Therefore, it might have done so on this right-of-way because a few dense patches exist. Overall, invasive exotic plants were not dominant at either location. Invasive exotics were fairly infrequent in Survey Area A, with denser and more numerous patches in Survey Area B.

Per Virginia DCR guidance, following a disturbance, planting and/or seeding of native species can establish a desirable natural community and preempt infestation by invasives. Whenever possible, native plant material should be from locally collected seeds or cuttings. After construction, DVP will restore the right-of-way with a native species mix, agreed upon by the NPS.

1. *Mechanical Control*, including, hand pulling, use of hand and power tools to cut, remove, mow, or rototill invasive plants
2. *Chemical Control*, including the use of EPA or NPS approved herbicides. Herbicides must be applied with extreme care and proper safety precautions.
3. *Biological Control*, by intentionally introducing an undomesticated enemy organism of the target species, usually an insect herbivore or a microbial pathogen. However, this method often results in undesirable or unintended effects (Heffernan 1998).

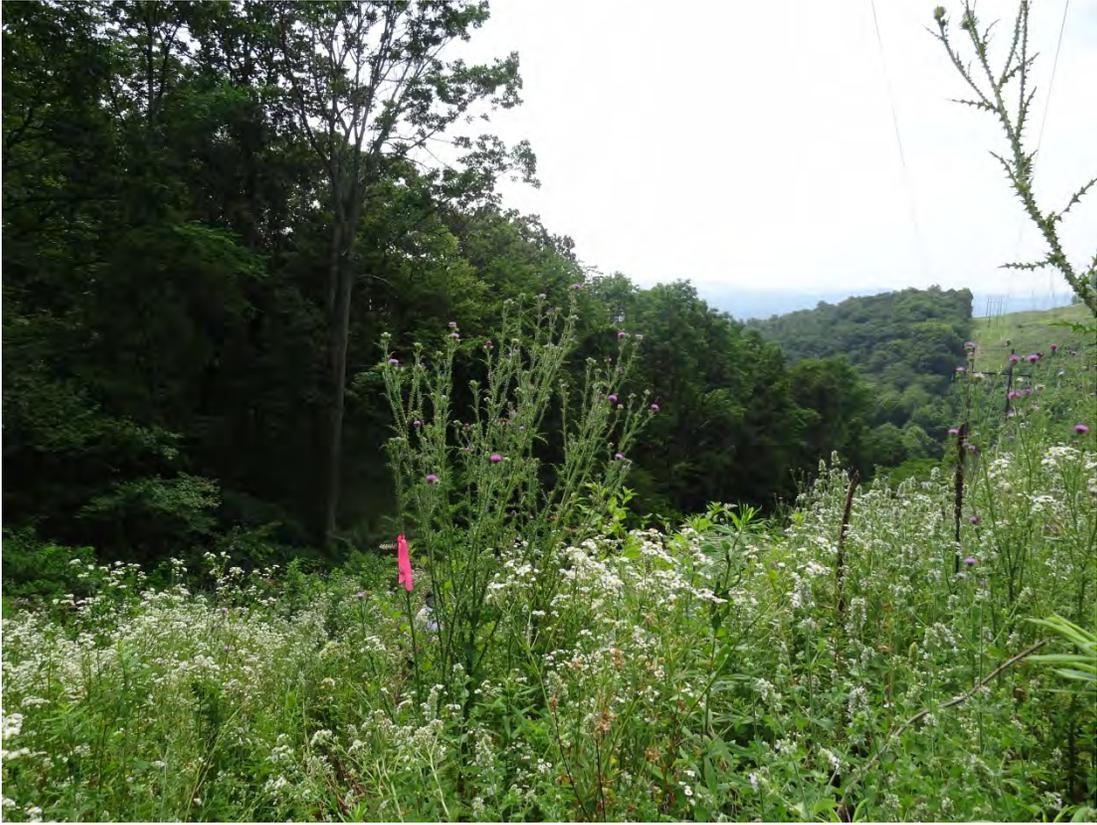
*Carduus acanthoides*

1. Spinny plumeless thistle (*Carduus acanthoides*)
2. Spotted knapweed (*Centaurea stoebe* spp. *micranthos*)
3. Princesstree (*Paulownia tomentosa*)
4. Japanese honeysuckle (*Lonicera japonica*)
5. Tree-of-heaven (*Ailanthus altissima*)
6. Oriental bittersweet (*Celastrus orbiculatus*)
7. Wine raspberry (*Rubus phoenicolasius*)
8. Multiflora rose (*Rosa multiflora*)
9. Sericea lespedeza (*Lespedeza cuneata*)
10. Common burdock (*Arctium minus*)
11. Japanese barberry (*Berberis thunbergii*)
12. Common mullein (*Verbascum thapsus*)
13. Black locust (*Robinia pseudoacacia*)
14. Garlic mustard (*Alliaria petiolata*)
