# Request for Expression of Interest Land Exchanges at Wilsonia, California Sequoia and Kings Canyon National Parks

# Wilsonia Properties

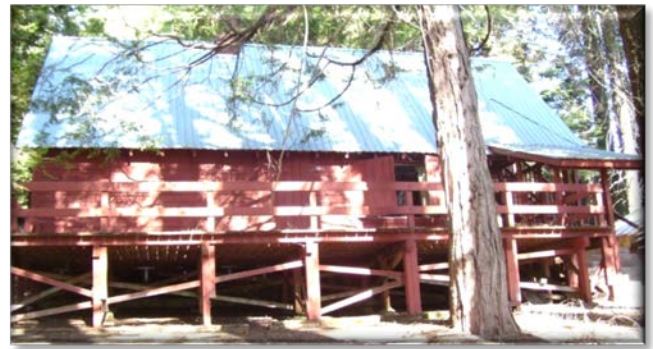
Figure 1

**1. Property: (108671) - 83688 Cedar (Epicurean House/Poochigian Cabin)**

Structure Size: 889 sf two-story main residential building.

thus the building may not be able to be brought up to minimum life-health-safety code for occupancy. The building is structurally sound and requires some minor work to stabilize and maintain the exterior of the building to acceptable industry standards for component life-cycles. The work includes exterior painting of shed and main residential building, exterior mortar work on the chimney, and demolition of the pit toilet, abandonment of the septic system and cut/cap of water lines, and exterior debris/garbage removal.

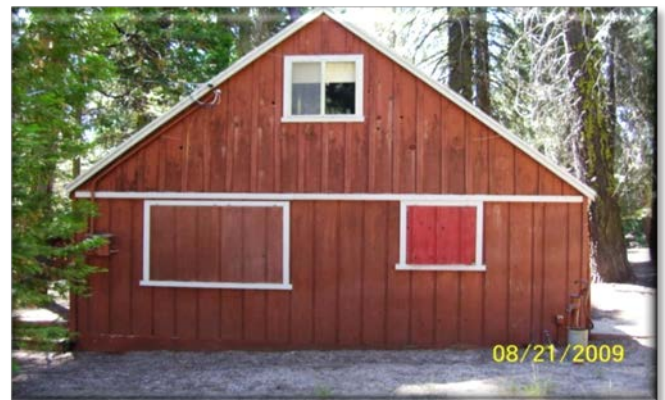
Figure 2

**2. Property: (111488) - 83733 Cedar Lane**

Structure: 677 sf two-story structure. Two bedrooms, one bathroom, kitchen and storage room. Foundation is post and pier

to meet current code requirements for water and wastewater; thus the building may not be able to be brought up to minimum life-health-safety code for occupancy. The building is structurally sound with the exception of several post pre-cast concrete foundations and requires some minor work to stabilize and maintain the exterior of the building to acceptable industry standards for component life-cycles. The work includes exterior painting and repair of 160 sf of siding rot, replace three missing snow shutters, abandonment of the septic system and proper demolition of the shallow well.

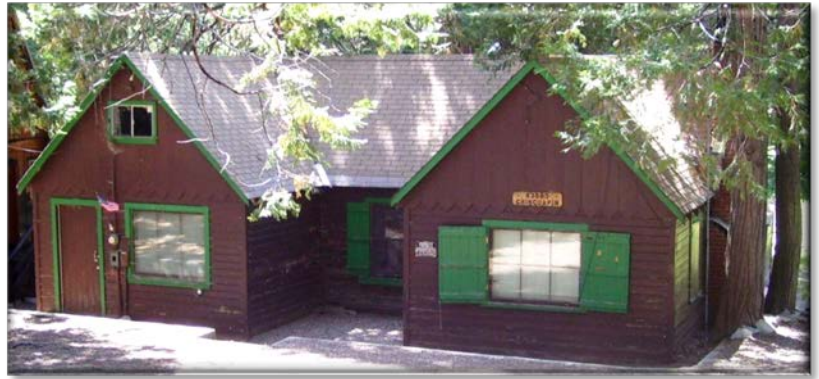
Figure 3

### 3. Property: (111495) - 83663 Chinquapin Lane

Structure: 806 sf one-story residential building.

The foundation system is post and pier.

be able to be rehabilitated to meet current code requirements for water and wastewater; thus the building may not be able to be brought up to minimum life-health-safety code for occupancy. The building has significant superstructure deficiencies in the foundation and potentially in the structural roof members; to include the structural failed deck on the north-west corner of the building. The exterior of the building is deteriorated and the extent that new siding and trim is required vs. a rehab of the siding. Additional work includes mortar work on the chimney, and demolition of the pit toilet, abandonment of the septic system and cut/cap of water lines, and exterior debris/garbage removal.

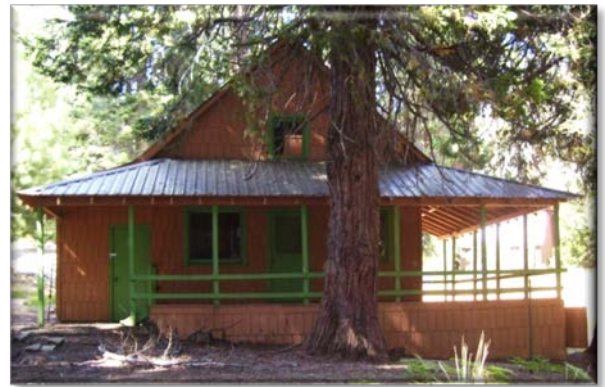
Figure 4

### 4. Property: (91967) - 83692 Fir (Postmaster's House)

Structure: 1,587 sf two-story residential structure. Three bedrooms, one bathroom, kitchen and living room. Foundation is post and pier system.

2009 Condition Assessment Summary and Recommended Repairs: The building may not be able to be rehabilitated to meet current code requirements for water and wastewater; thus the building may not be able to be brought up to minimum life-health-safety code for occupancy. The building has significant superstructure deficiencies in the foundation and potentially the second floor joists. The exterior of the building is deteriorated and the extent that new siding and trim is required vs. a rehabilitation of the siding within the next 1-3 years. Additional work includes deck and stair rehabilitation, demolition of the pressure tank building, repair exterior wall that was damaged by vehicle, abandonment of the septic system/dry sump

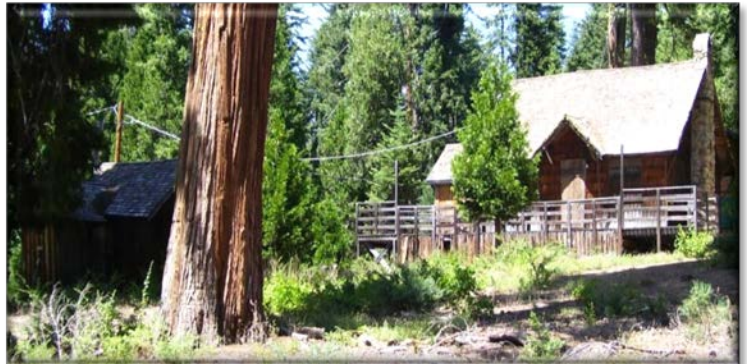
*Figure 5*

**5. Property: (111492) - 83619 Grant Lane**

Structure: 720 sf single story residential building with two bedrooms, two bathrooms, a kitchen and a living room. The foundation is post and pier.

2009 Condition Assessment Summary and Recommended Repairs: The building may not be able to be rehabilitated to meet current code requirements for water and wastewater; thus the building may not be able to be brought up to minimum life-health-safety code for occupancy. The building has moderate superstructure deficiencies in the building and deck foundation. The exterior of the building is in relative good condition and requires some siding repairs and repaint with next 1-3 years. Additional work includes deck rehabilitation, demolition of garage/storage building, abandonment of the septic system and cut/cap of line, abandonment of the well and cut/cup lines, replace roof, demolition of power back to pole, and exterior/interior debris/garbage removal.

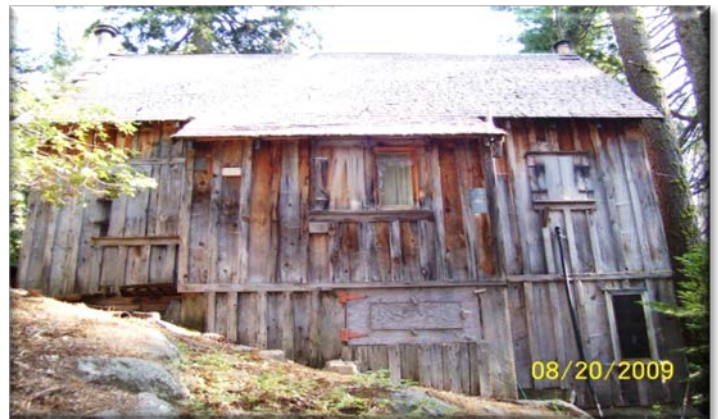
*Figure 6*

**6. Property: (111494) - 83740 Hazel**

Structure: 1,077 two-story residential building with two bedrooms, one bathroom and a kitchen and living room. The foundation is post and pier.

2009 Condition Assessment Summary and Recommended Repairs: The building may not be able to be rehabilitated to meet current code requirements for water and wastewater; thus the building may not be able to be brought up to minimum life-health-safety code for occupancy. The building is structurally failing in localized areas and the roof and siding are at the end or past their life-cycle. The multiple septic systems

and pit toilet require abandonment. There is a significant amount of garbage/debris around the lot, under the building and inside the building.

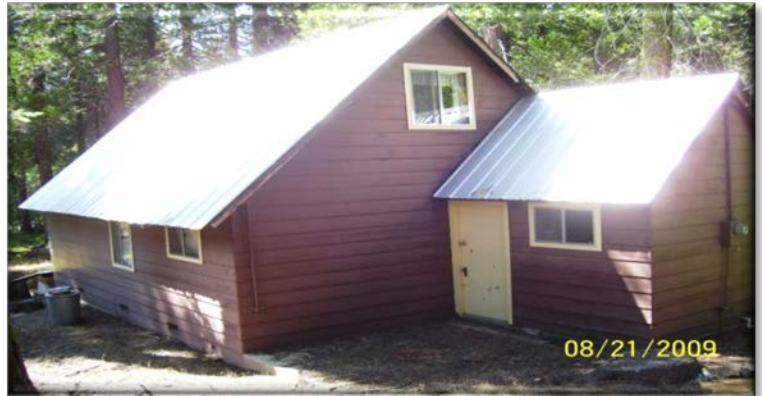
*Figure 7*

**7. Property: (111490) - 83736 Park Road**

Structure: 877 sf two-story residential building with three bedrooms, one bathroom a living room and kitchen. The foundation is post and pier with exterior concrete stem walls for the deck.

2009 Condition Assessment Summary and Recommended Repairs: The building can be rehabilitated to meet current code requirements for water and wastewater; and be brought up to minimum life-health-safety code for occupancy. The building is structurally sound and requires some minor work to stabilize and maintain the exterior of the building to acceptable industry standards for component life-cycles. The work includes exterior painting, exterior mortar work on the chimney, and demolition of the pit toilet, abandonment of the septic system and cut/cap of well and water lines, new flooring cover, minor electrical upgrades, demolition of deck and replace with new stair entry on north side of building, interior debris/garbage removal.

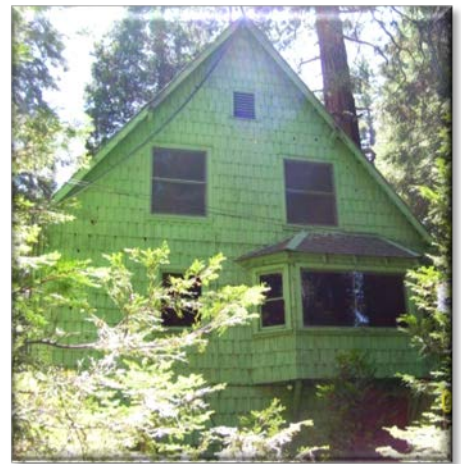
*Figure 8*

**8. Property: (111491) - 83681 President's Lane**

Structure: 1,385 sf residential building three bedrooms, two bathrooms, living room, kitchen and dining room. The foundation is post and pier.

2009 Condition Assessment Summary and Recommended Repairs: The building may not be able to be rehabilitated to meet current code requirements for water and wastewater; thus the building may not be able to be brought up to minimum life-health-safety code for occupancy. The building is structurally failing in localized areas and the roof and siding are at the end or past their life-cycle. The septic system requires abandonment. There is a fair amount of garbage/debris around the lot, under the building and inside the building.

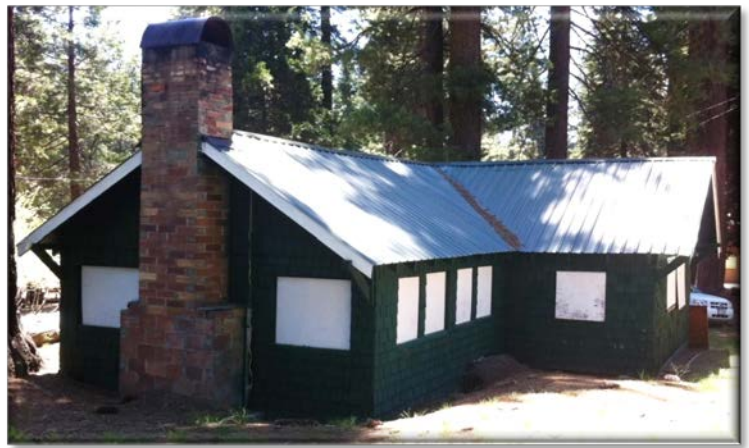
*Figure 9*

**9. Property: (230755) – 83708 Fir (Barkman Cabin)**

Structure: 662 sf single story residential building with one bedroom, one bathroom and a kitchen and living room.

2009 Condition Assessment Summary and Recommended Repairs: The building may not be able to be rehabilitated to meet current code requirements for water and wastewater; thus the building may not be able to be brought up to minimum life-health-safety code for occupancy. The building has moderate superstructure deficiencies in the building foundation and flooring system. The exterior of the building is in relative good condition and requires some siding repairs and repaint with next 1-3 years. Additional work includes demolition of abandonment of the septic system and cut/cap of line, abandonment of the well-cut/cup lines, replace roof, demolition of power back to pole, and exterior/interior debris/garbage removal.

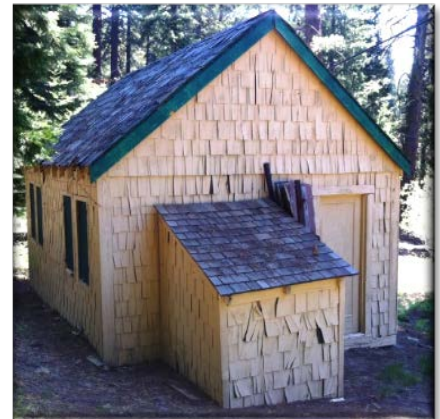
*Figure 10*

**10. Property: (230756) – 83708 Fir (Barkman Shed)**

Structure: 287 sf single story storage building. The building consists of two large storage rooms. The foundation is post and pier.

2009 Condition Assessment Summary and Recommended Repairs: The building may not be able to be rehabilitated to meet current code requirements for water and wastewater; thus the building may not be able to be brought up to minimum life-health-safety code for occupancy. The building has moderate superstructure deficiencies in the building foundation and flooring system. The exterior of the building is in moderate condition and requires some siding repairs and repaint with next 1-3 years. Additional work includes new roof, abandonment of the well-cut/cup lines, and demolition for well and interior debris/garbage removal.

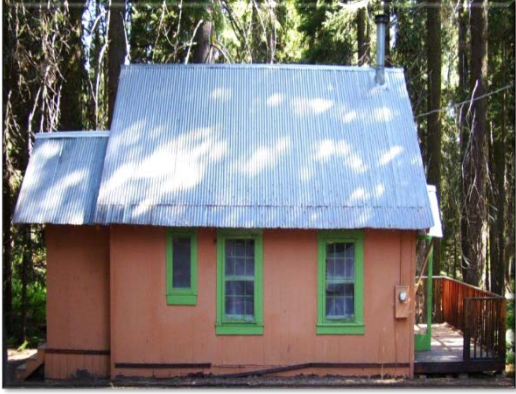
*Figure 11*

**11. Property: (91969) 83692 Fir (Next to Postmaster's House)**

Structure: 1,018 sf residential building with small addition consisting of two bedrooms, one bathroom, a kitchen and a living room. The foundation is post and pier.

The building may not be able to be rehabilitated to meet current code requirements for water and wastewater; thus the building may not be able to be brought up to minimum life-health-safety code for occupancy. The building is structurally failing in localized areas and the roof and siding are near the end of their life-cycle. The septic system requires abandonment. There is a significant amount of garbage/debris inside the building.
