## **APPENDIX B, SECTION 1**

### **VIRGINIA DEPARTMENT OF HISTORIC RESOURCES DATA SHARING SYSTEM FORMS**

Resource Name(s): Arlington Cemetery Tombstone Drain  
{ Descriptive }

*Resource Name(s):* Arlington National Cemetery Section 29 Foot  
Bridge South {Descriptive}

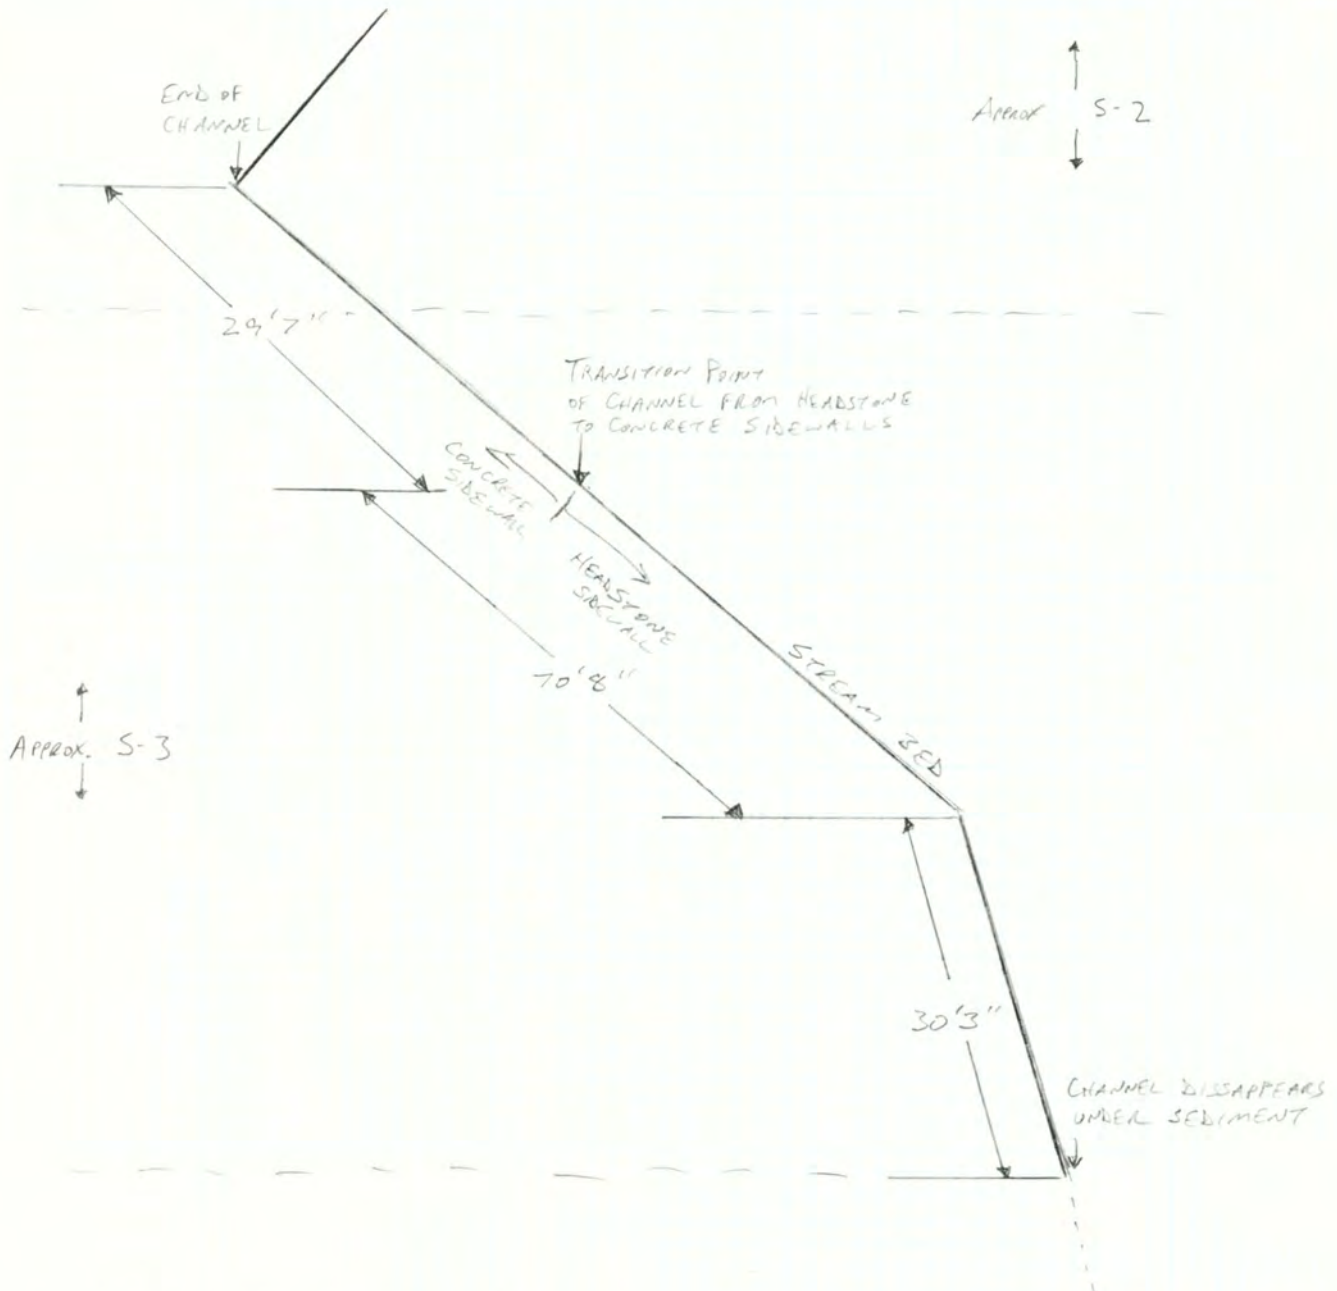
NOTE: RECOMMEND ADJUSTING S-3 TO INCLUDE ENTIRE STRETCH OF CHANNEL. AFTER WALKING GROUND & COMPARING TO MAP/DRAWING, S-2 SEEMS TO INCLUDE A PORTION OF THE CHANNEL EVEN THOUGH THE STATION CHART SAYS IT DOESN'T.

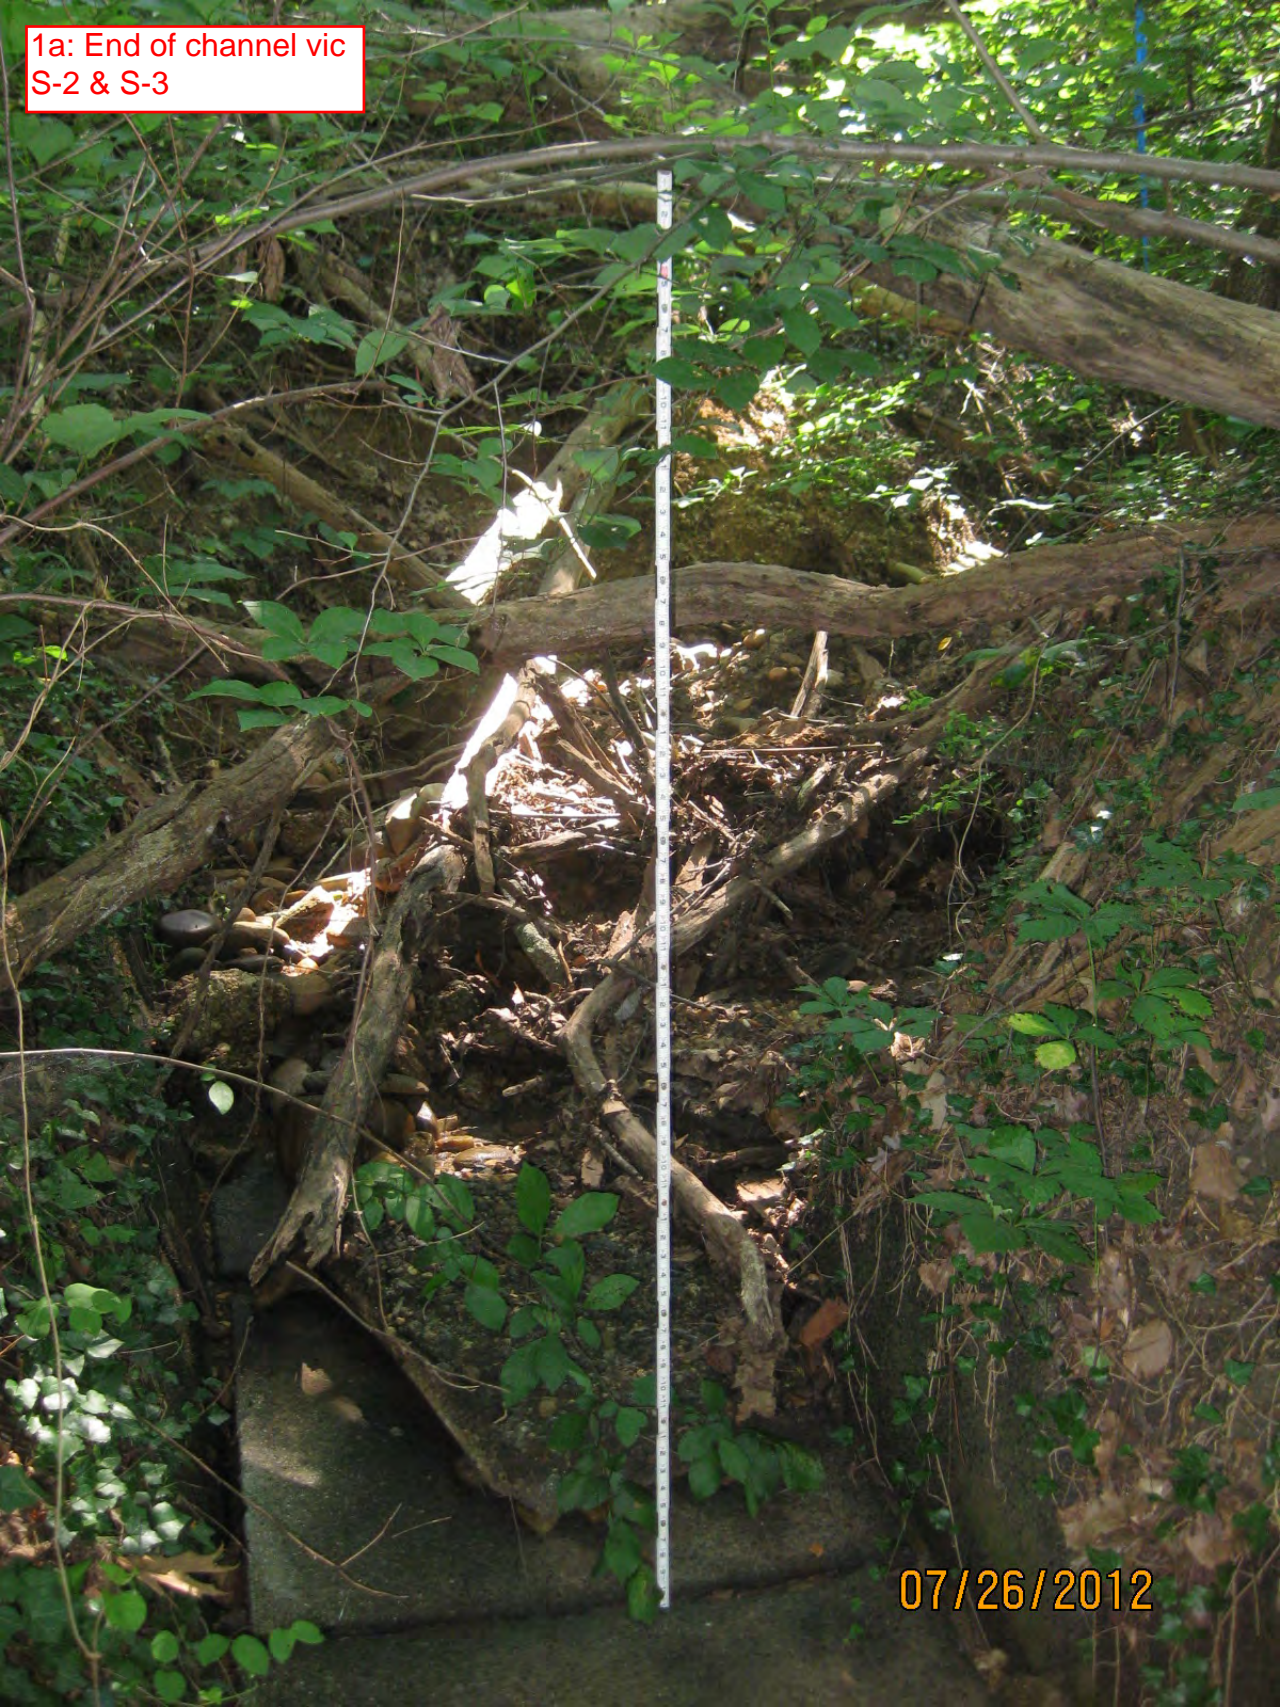
1a: End of channel vic  
S-2 & S-3

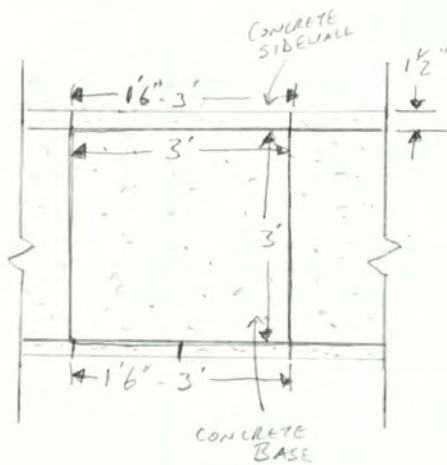
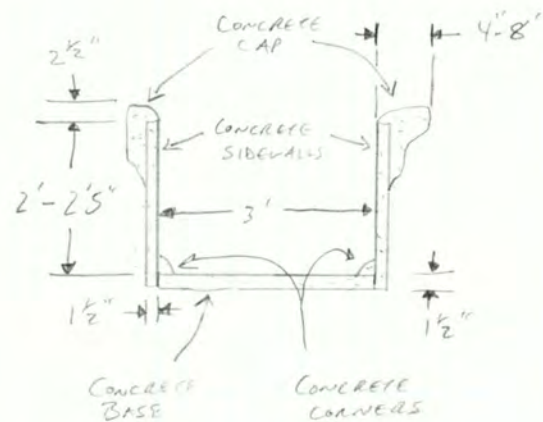
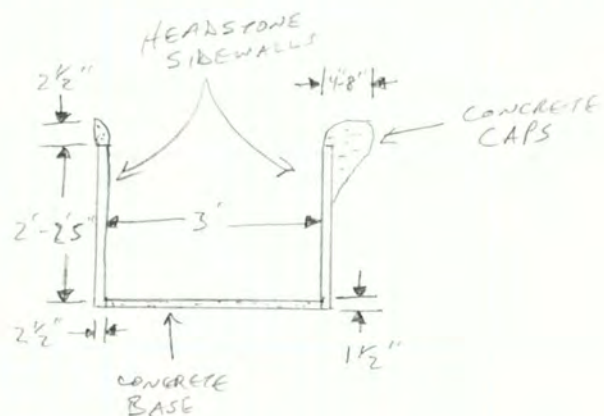
SECTION 1: PROFILE & PLAN DETAILS OF CHANNELS  
 \* NOT TO SCALE \*

Section 1: Section 1 travels a from South West to North East for a length of 131'6" consisting of a channel made from concrete pavers and headstones. The channel is broken into two sections based off the channel wall construction material. One section is 29'7" long and the channel wall is made of concrete pavers that are roughly 1 1/2" thick and vary in width from 1'6" to 3'. The remaining channel has walls that are constructed of headstones that are roughly 2 1/2" thick and vary in width from 10" to 1'2". The channel itself has a base of 3'x3'x1 1/2" concrete pavers. Along the top of the wall, there is a concrete cap roughly 2 1/2" high and varying between 4" and 8" thick that ties the side walls together. Concrete is also used along the back side of the walls to various depths and periodically along the inside edge. The North East section of the channel gradually drops below ground level and continues for an unknown length due to sediment build up.

CONCRETE SIDEWALL CHANNELPLAN

PROFILE

HEADSTONE SIDEWALL CHANNEL

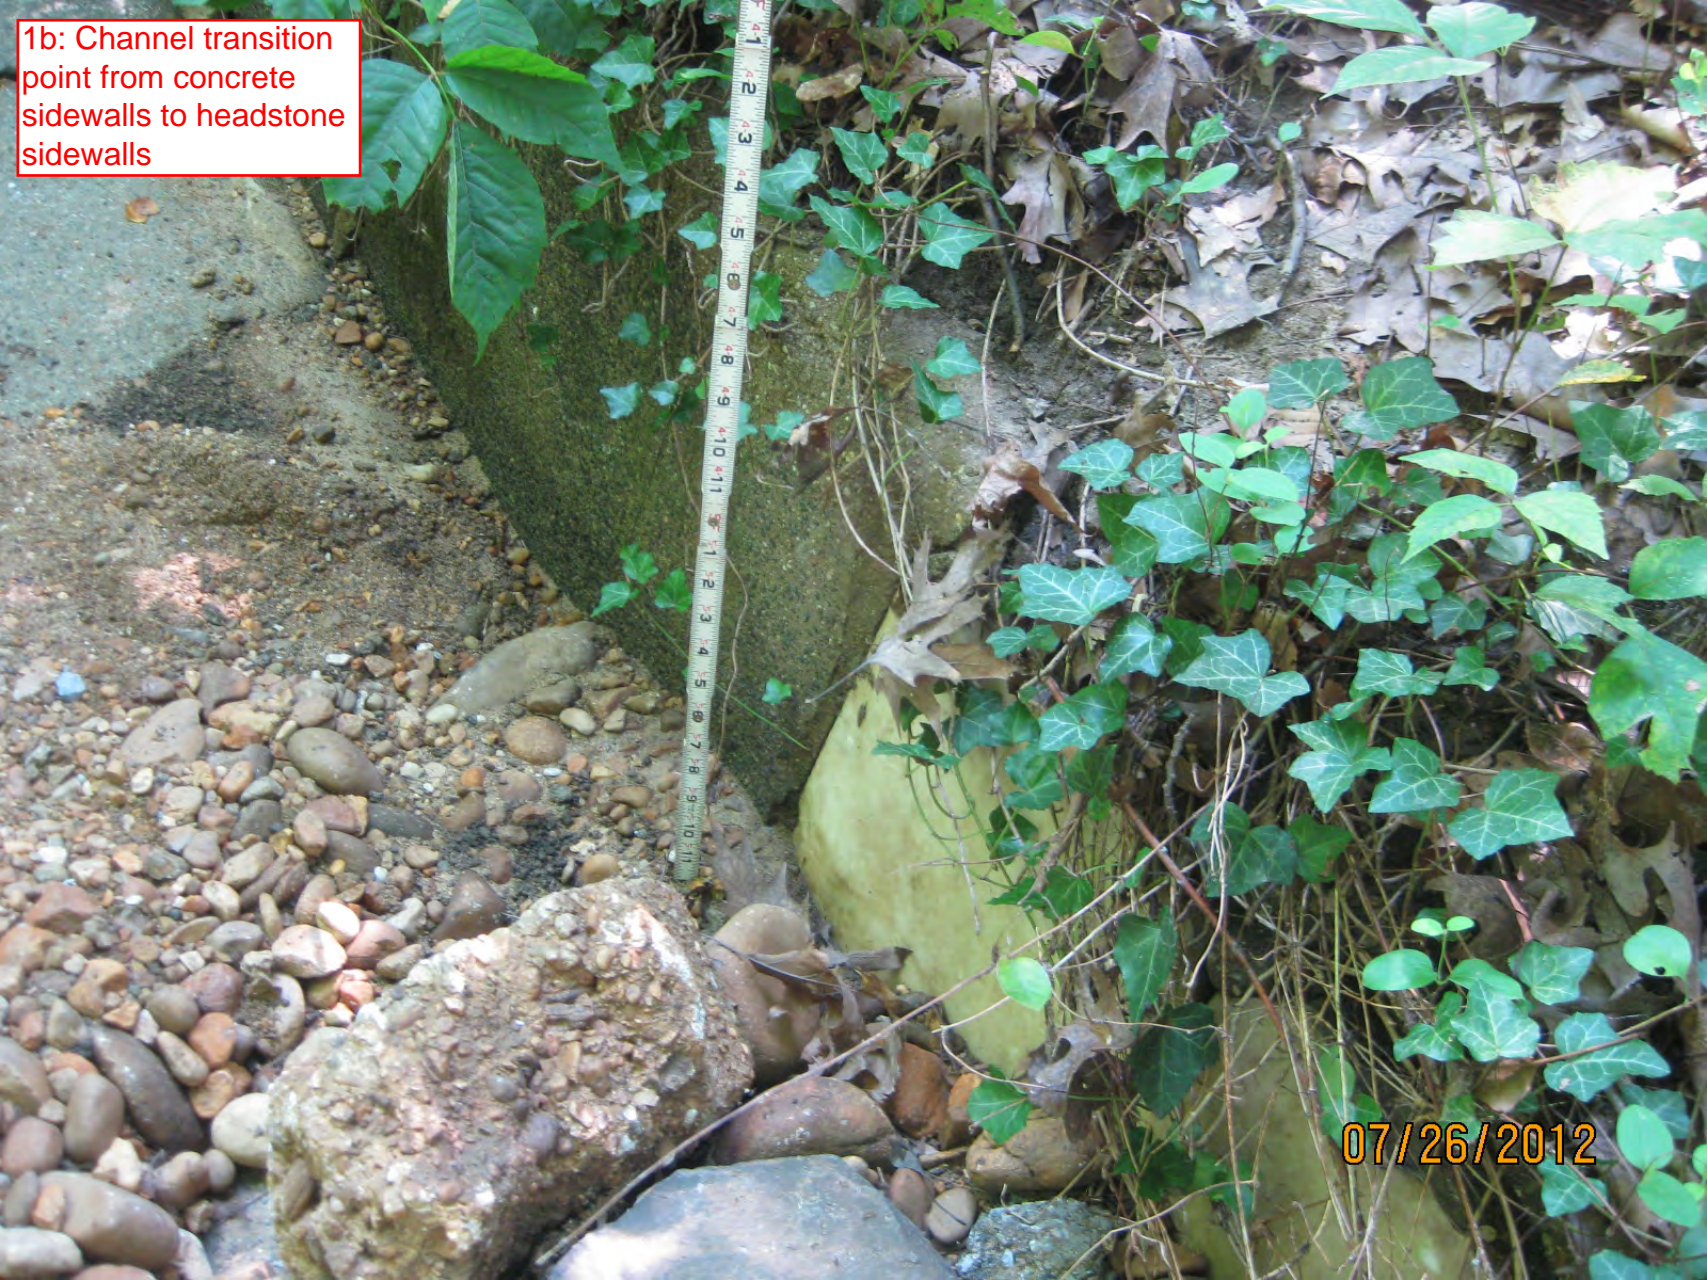
1b: Channel transition  
point from concrete  
sidewalls to headstone  
sidewalls

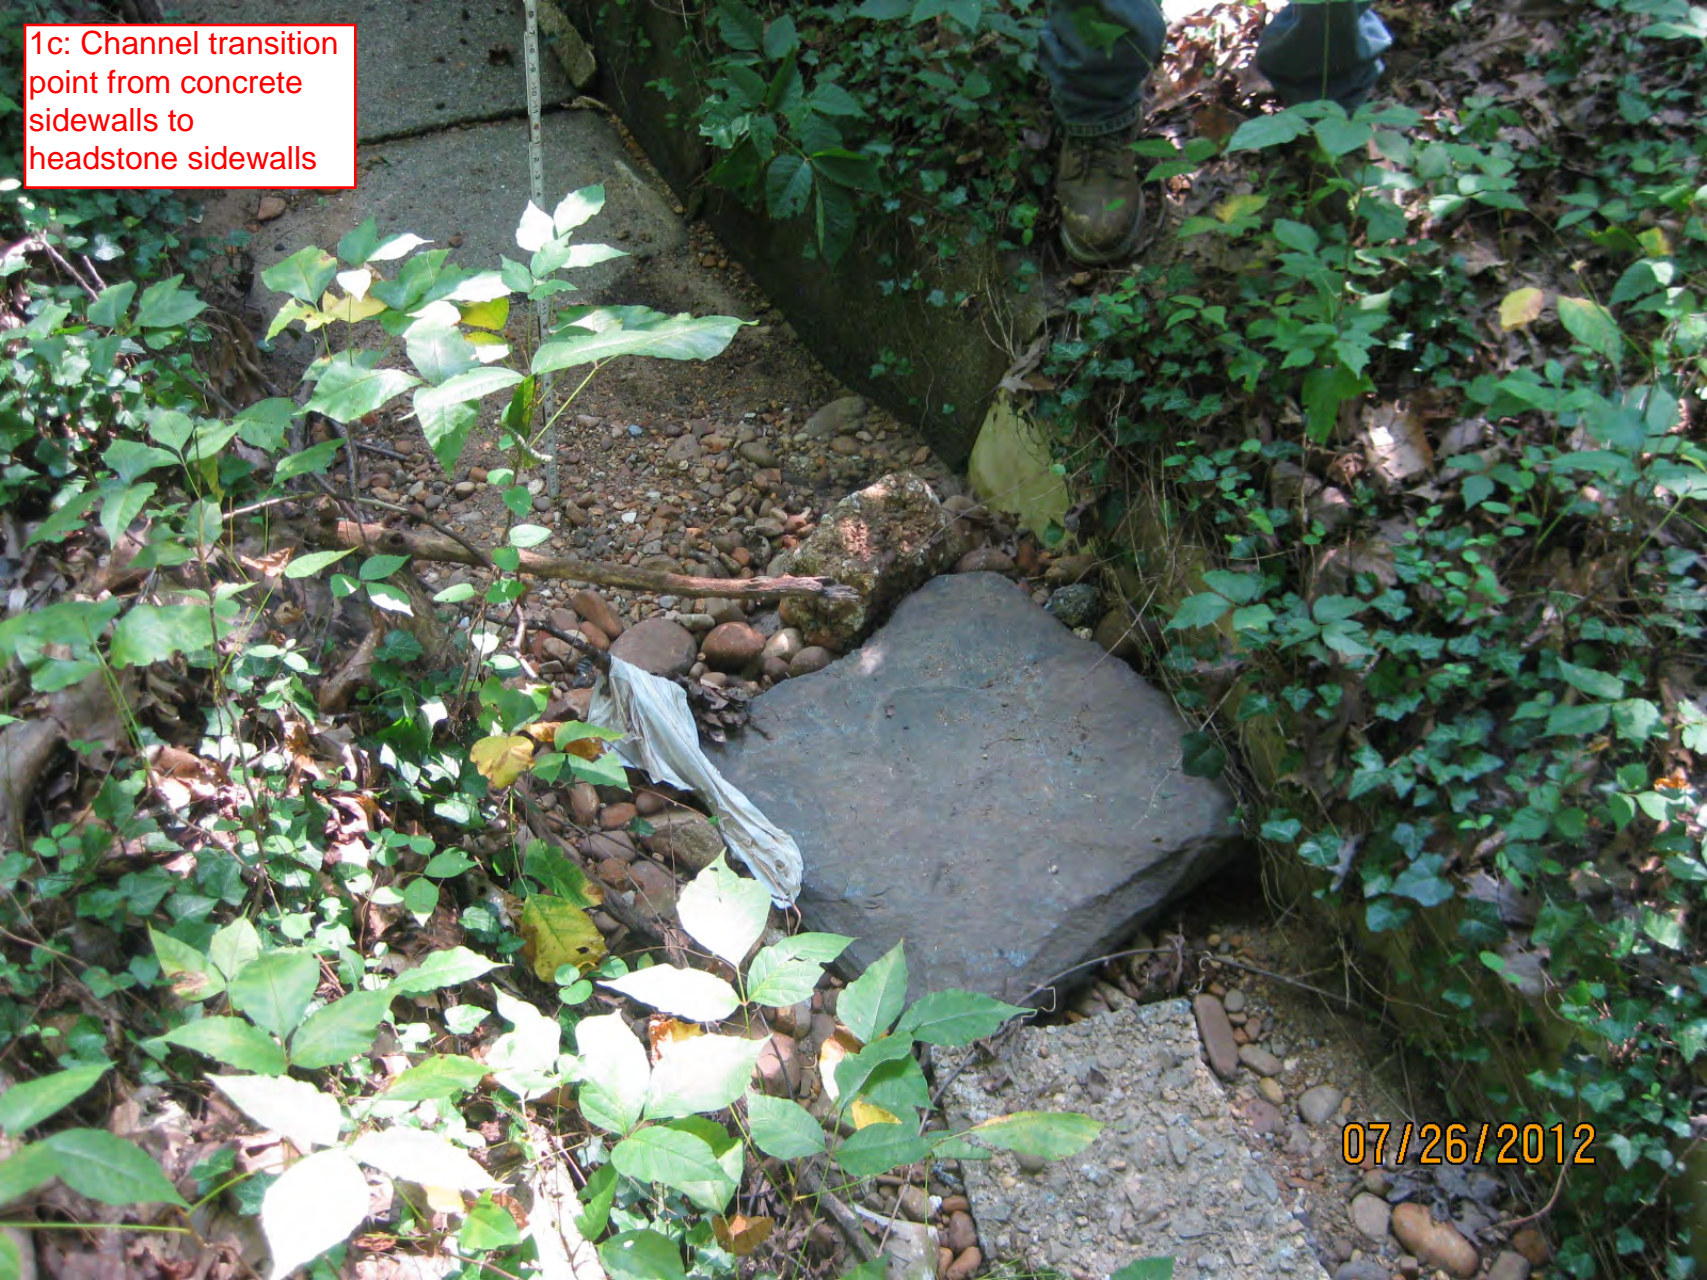
1c: Channel transition  
point from concrete  
sidewalls to  
headstone sidewalls

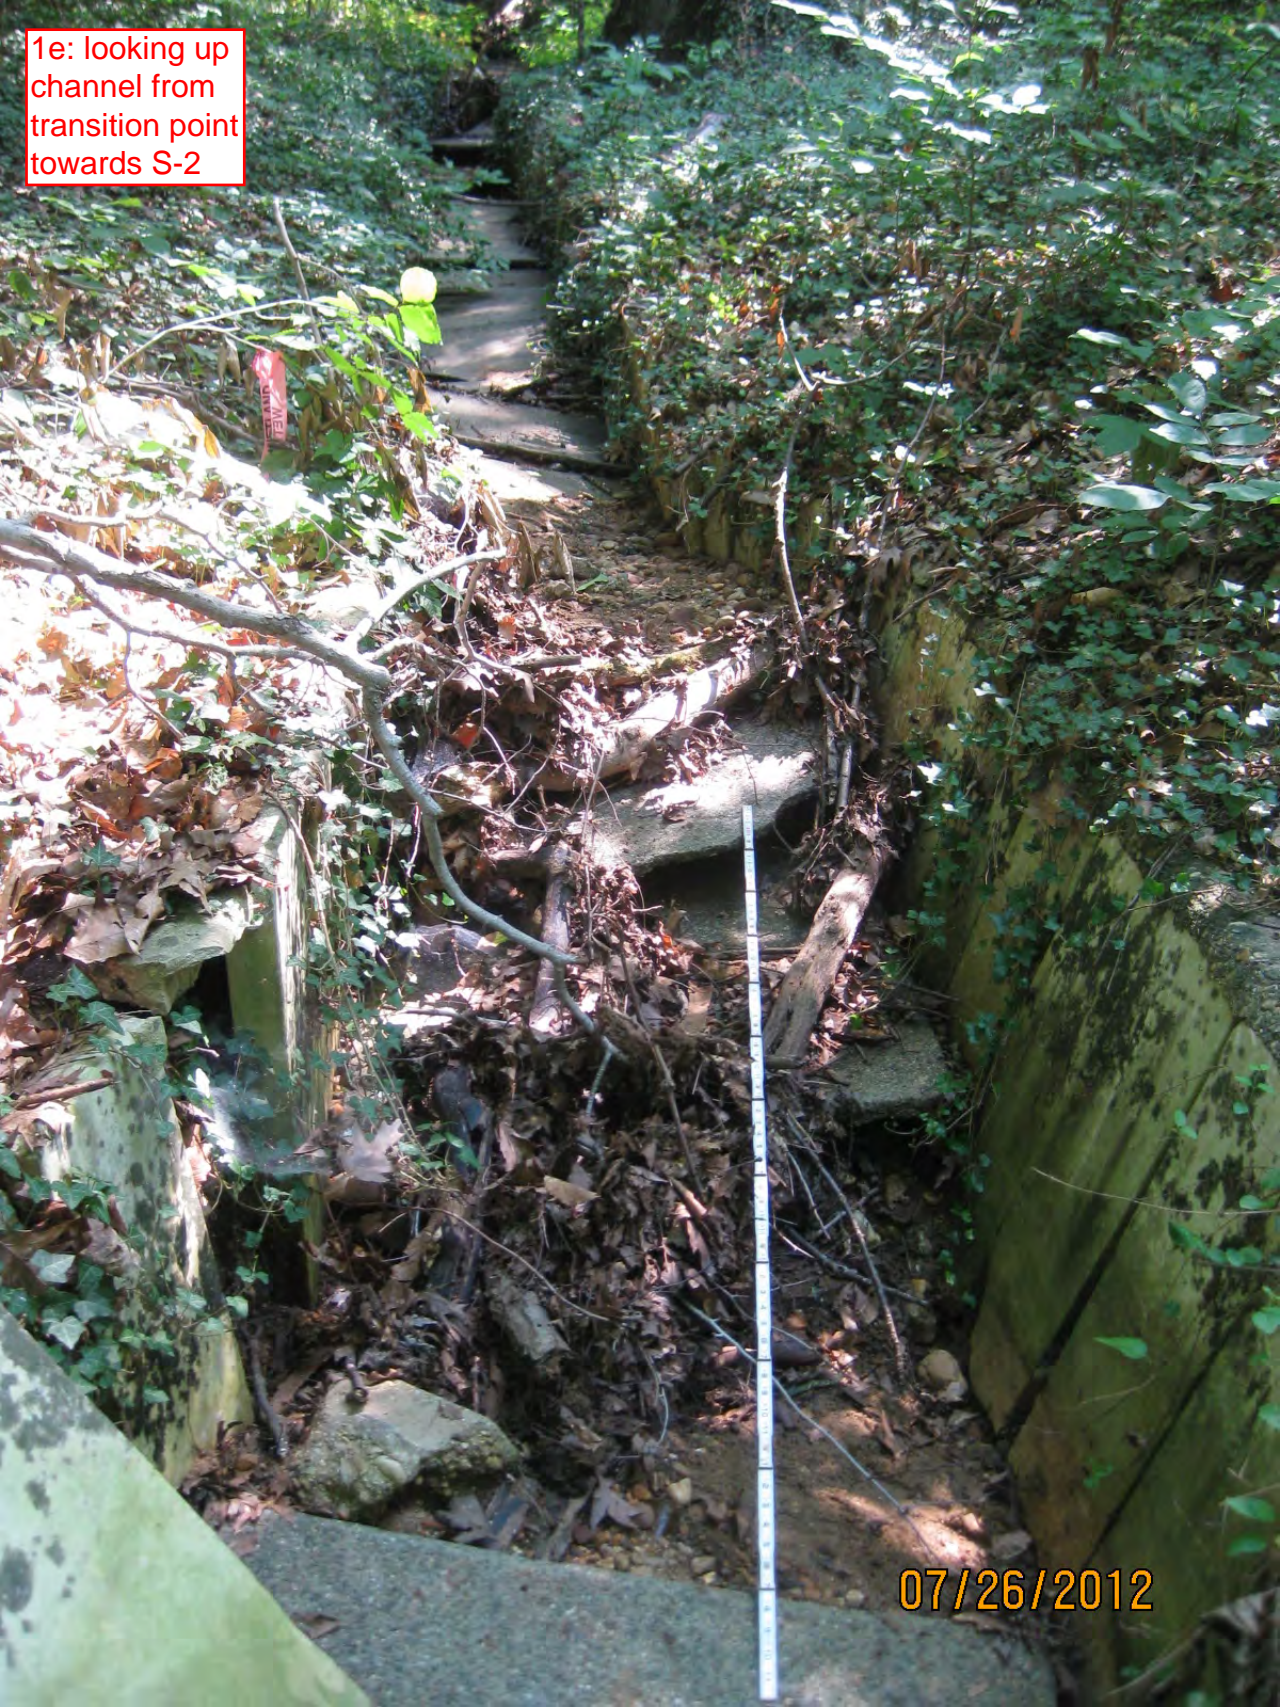
1e: looking up  
channel from  
transition point  
towards S-2

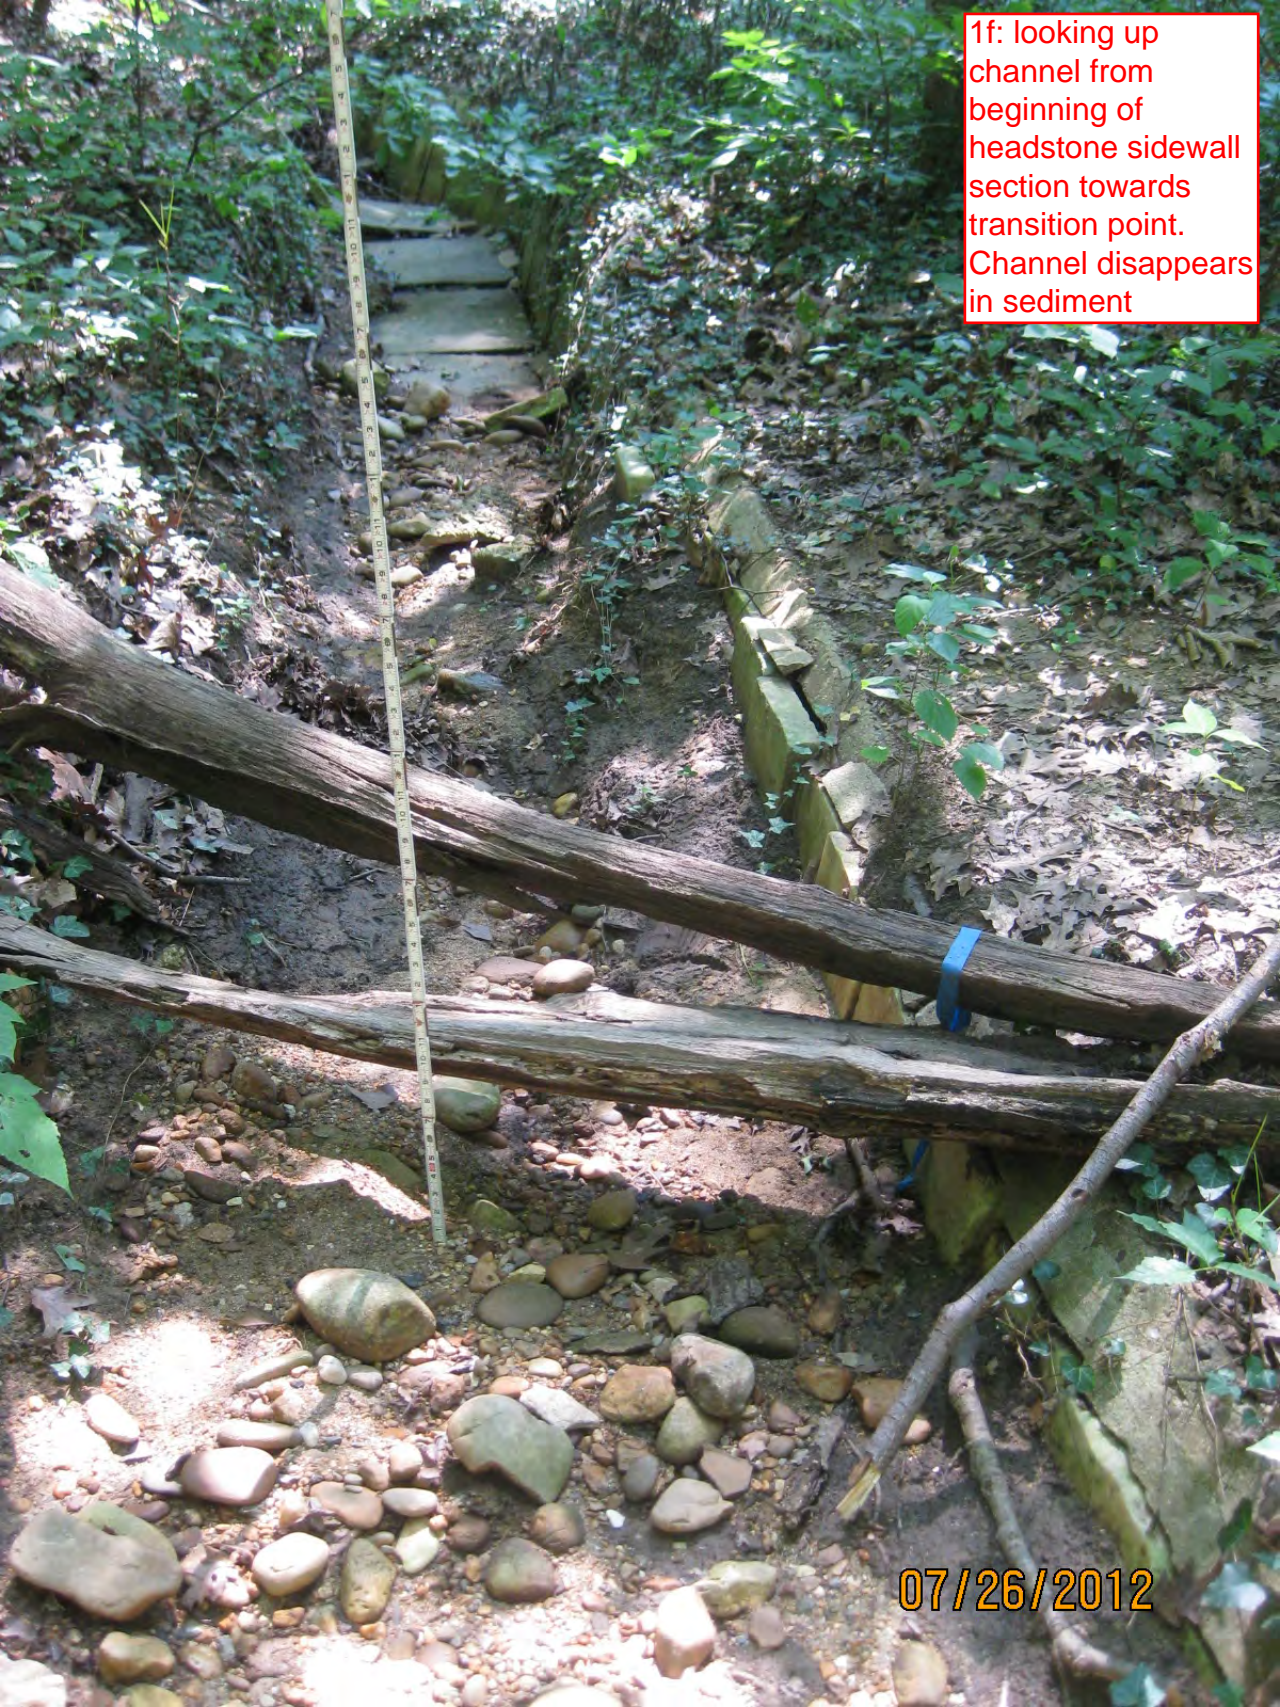
1f: looking up  
channel from  
beginning of  
headstone sidewall  
section towards  
transition point.  
Channel disappears  
in sediment

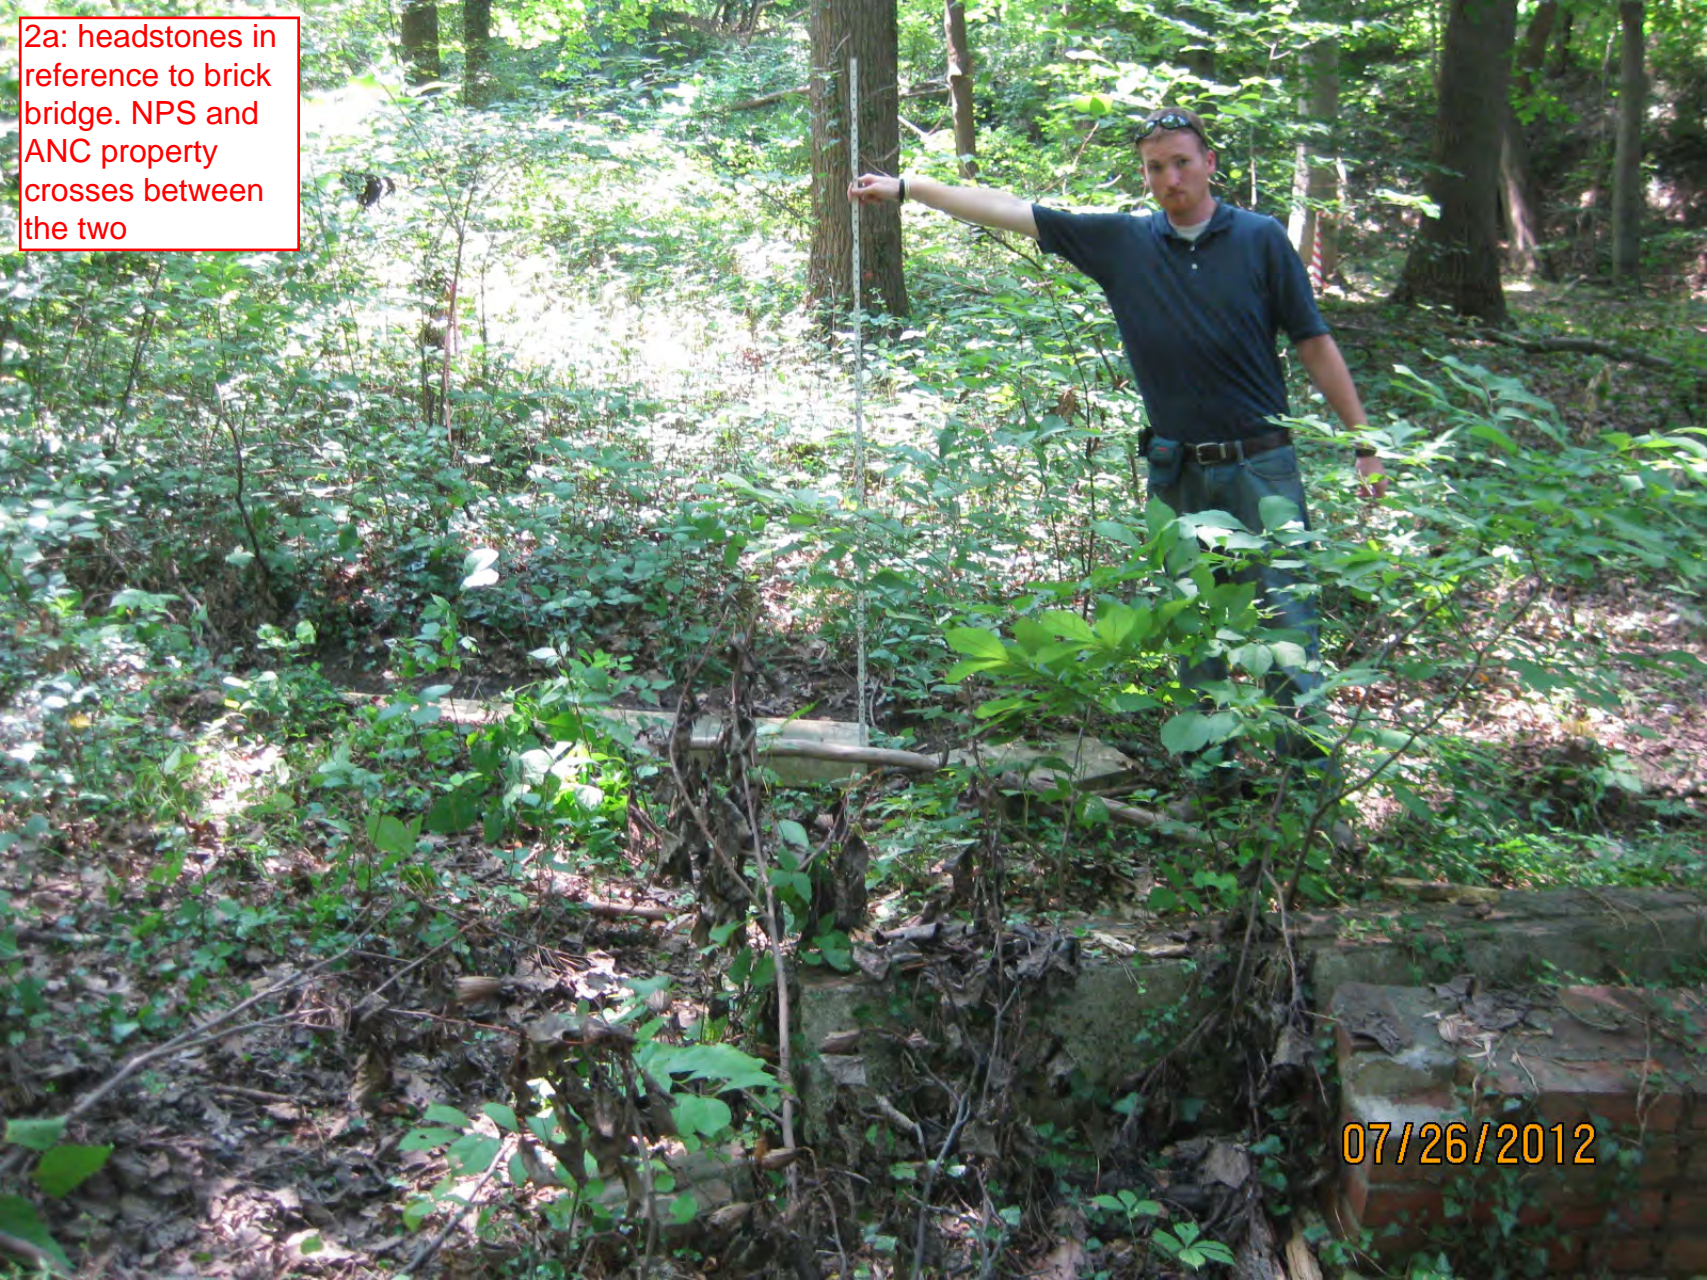
2a - 2c: NPS boundary includes section of 4 headstones located West of brick bridge

2a: headstones in  
reference to brick  
bridge. NPS and  
ANC property  
crosses between  
the two

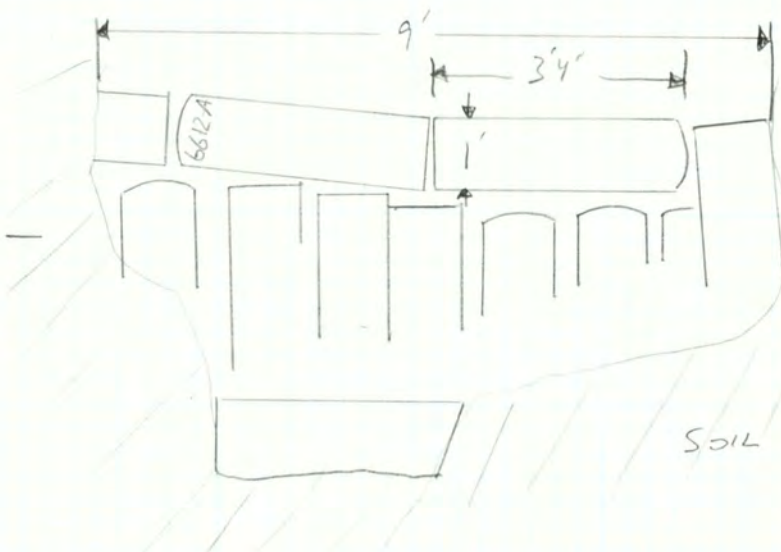
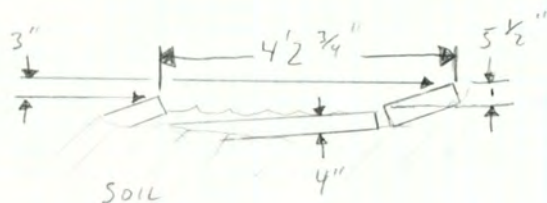
**ENGINEERING DIV.****BRANCH****SECTION**PROJECT MILLENNIUM AREA HEADSTONE REMOVALSUBJECT NPS FIELD DOCUMENTATIONBY \_\_\_\_\_ DATE 26 JUL 11 CHECKED \_\_\_\_\_PAGE 4 OF 4SECTION 3: HEADSTONE STREAM BED

PLAN

HEADSTONE  
STREAM BED  
APPEARS &  
DISAPPEARS FOR  
A TOTAL OF 89'  
FROM THE WESTERN  
TO EASTERN EDGE

PROFILE
