Topographic modifications associated with National Park Service ownership.

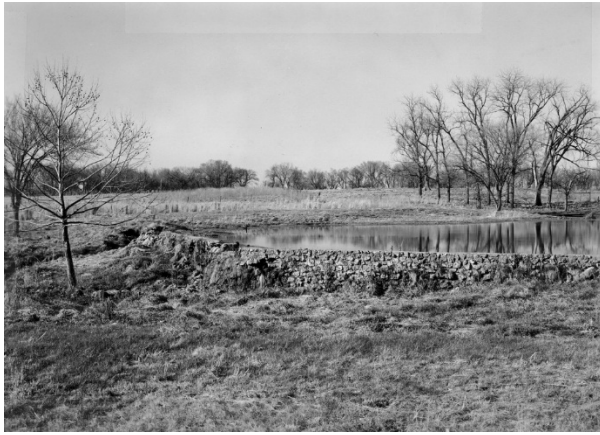
FIGURE 62. An earthen and stone dam was constructed during Shartel ownership to impound Williams Branch. Source: George Washington Carver National Monument photo collection.

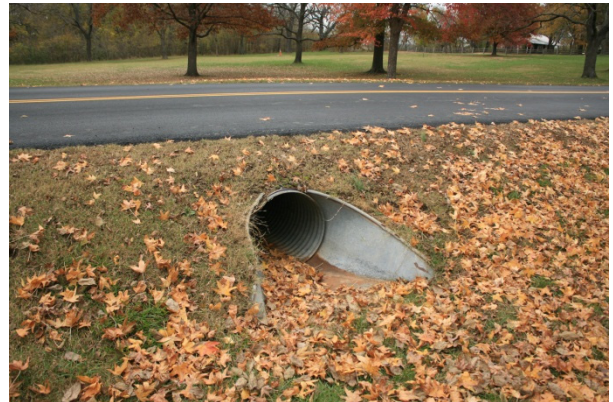
FIGURE 64. Swales and culverts convey storm water away from the entrance road.

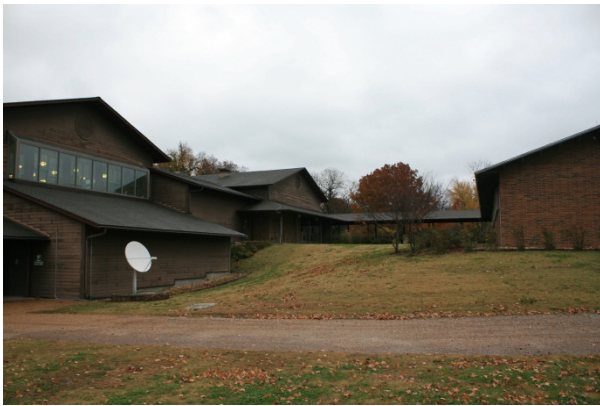
FIGURE 65. The expansion of the visitor center in 2007 required grading between the expanded building and the maintenance building.

designed to disturb as little ground as possible and required minimal grading. Work entailed establishing the foundation for the building and sculpting the landform between the expanded building and the maintenance building to create an evenly-sloped descending landform that would promote positive drainage (Figure 65). Grading between the buildings was not entirely successful; there is an isolated low spot at the southwestern corner of the visitor center where storm water collects and cannot drain. Current evidence of grading associated with the visitor center postdates the period of significance and does not contribute to the significance of the park landscape.

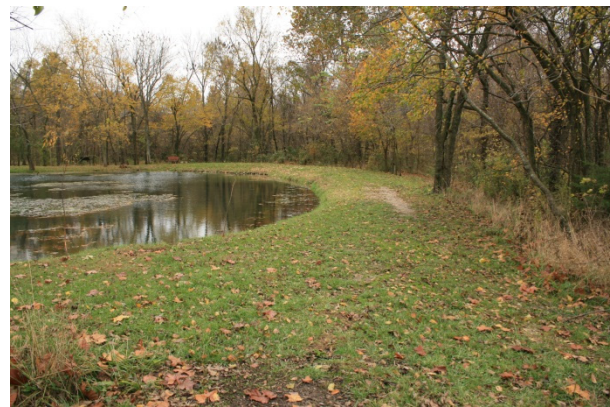
FIGURE 66. View of the earthen dam constructed across Williams Branch to create Williams Pond.

Williams Pond enlargement and rehabilitation of the earthen dam. In 1978, the National Park Service enlarged Williams Pond by excavating the impoundment area and reworking the earthen dam structure; the new dam enlarged the pond from approximately one-half to nearly three-quarters of an acre in size (Figure 66). In 1979, the National Park Service leveled the bank covering the area around the original dam. Excess sludge and dirt from the dredging project of the previous year was spread in two fields adjacent to the pond.²⁹¹ These grading efforts postdate the period of significance and do not contribute to the significance of the park landscape.

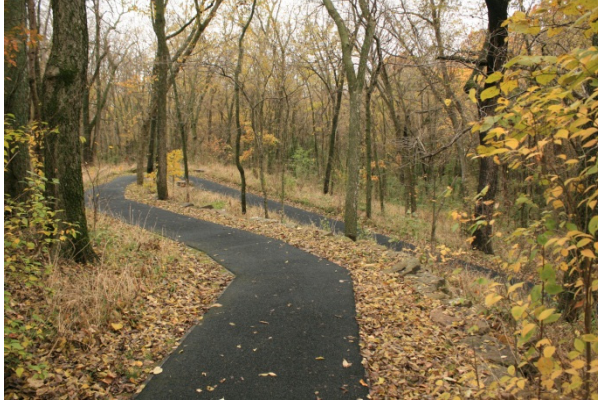
6 **FIGURE 67.** Portions of the Carver Trail feature
 7 switchbacks to meet universal accessibility guidelines.

Grading to construct the Carver Trail, including accessibility improvements. The Carver Trail was constructed as part of the initial development of the park circa 1953. The trail was graded to establish a smooth, evenly sloped route. Portions of the trail followed the Carver Branch stream corridor. Problems quickly emerged with erosion and accessibility of the trail. In order to diminish the steepness of some slopes, and to meet universal accessibility standards, sections of the trail have been realigned to form switchbacks and follow gentler terrain, particularly along the sloped terrain north of the birthplace cabin site (Figure 67). The new trail configuration required construction of low rock retaining walls and associated grading (Figure 68). The section located near the row of replanted walnut trees has also been rerouted and re-graded to accommodate universal accessibility. These trail improvements

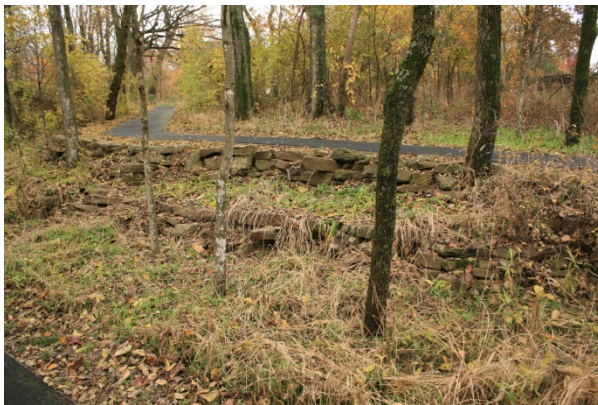
8 **FIGURE 68.** Low rock retaining walls and associated
 9 grading were used to support the switchbacks.

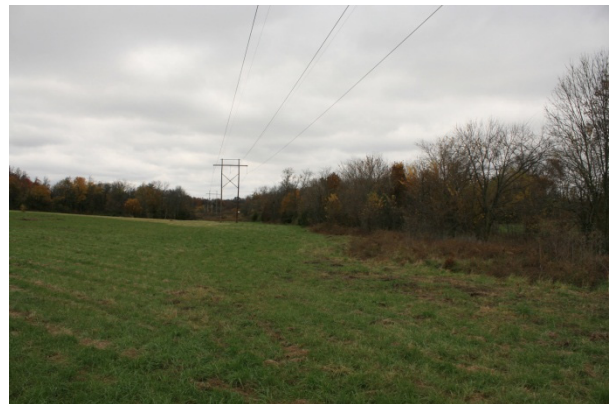
54 **FIGURE 72.** Overhead electrical lines in the southwest
55 portion of the site represent a utility land use.

44 **Utility.** Since the early park establishment period,
45 utilities have been an essential component of park
46 operations, including water, sewer, gas, telephone,
47 refuse collection, and electrical services
48 (Figure 72). Although the specific features built to
49 support park utility needs have changed over time,
50 this land use survives from the early park
51 development period of significance and
52 contributes to the significance of the park
53 landscape.

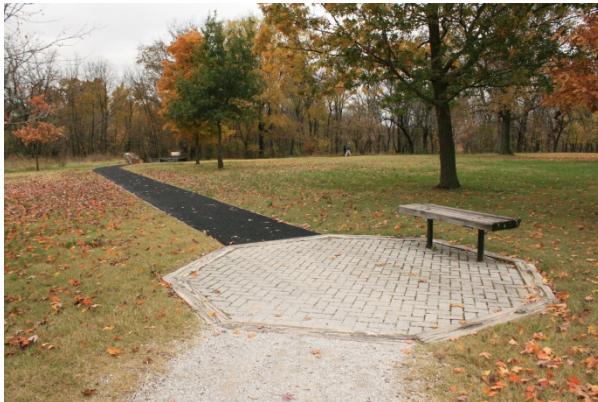
FIGURE 100. A concrete-block queuing area marks the Carver Trail trailhead.

The graveled area outside the north entrance to the visitor center features a series of paths that link the beginning and end of the Carver Trail, and the concrete walk that edges the visitor center.

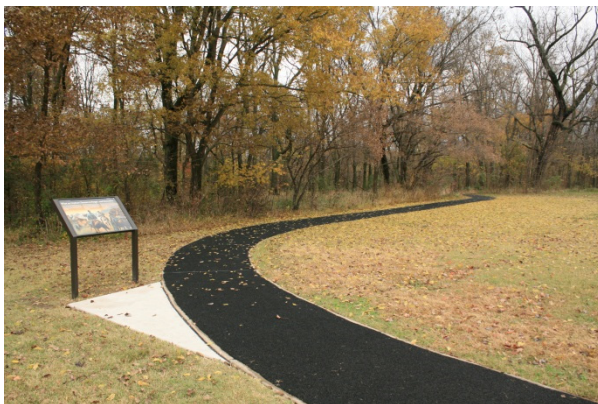
FIGURE 101. A portion of the trail features a rubberized surface set over concrete.

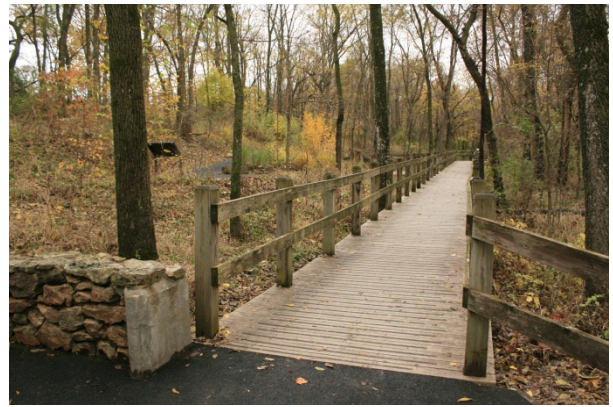
FIGURE 102. A boardwalk elevates the trail over the wet area associated with Carver Spring.

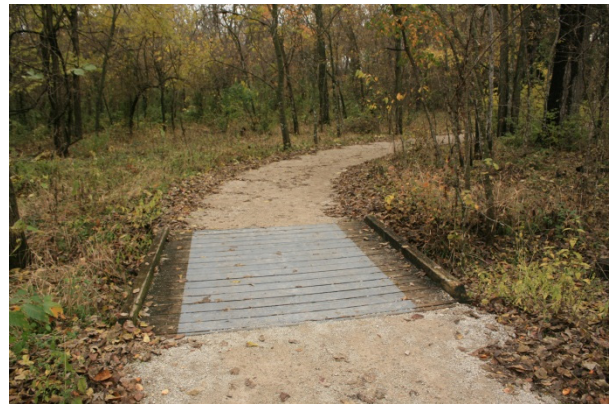
FIGURE 103. The trail is surfaced with gravel as it passes through the woodland, and is set with wooden footbridges where it passes over wet areas and ephemeral streams.

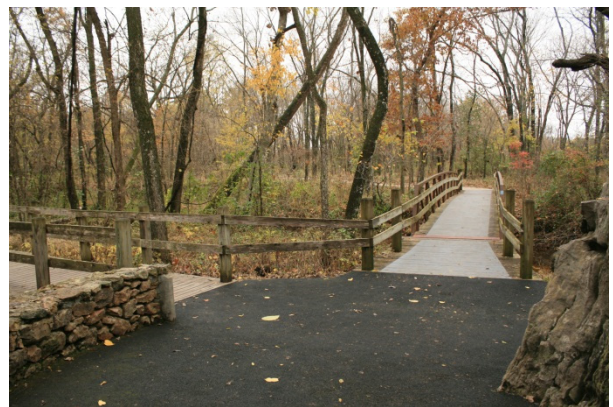
FIGURE 104. A prefabricated bridge conveys the trail over Carver Branch.

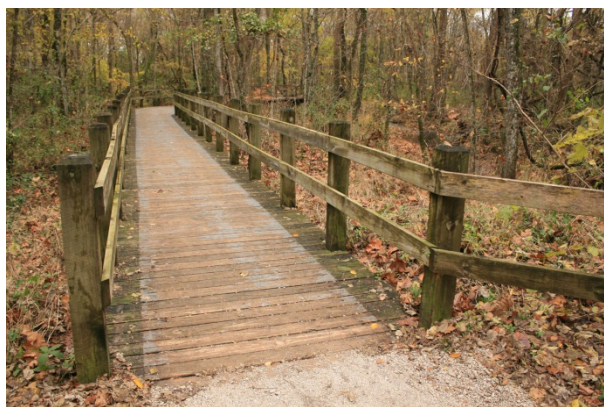
1 **FIGURE 105.** Boardwalk is used where the trail crosses
2 the confluence of Williams and Carver branches.

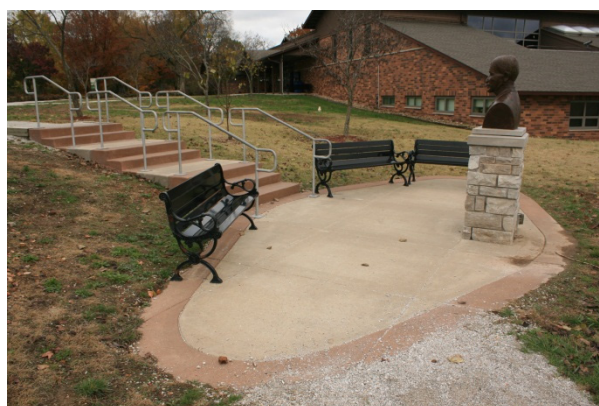
11 **FIGURE 110.** A concrete plaza and stairs edge the
12 Carver bust and mark the culmination of the Carver
13 Trail.
