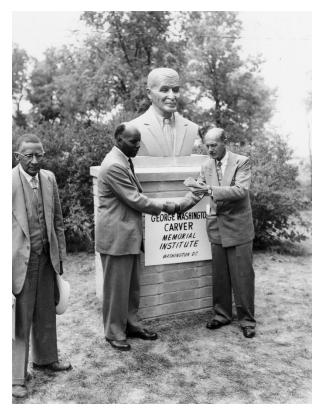
FIGURE 192. The Carver bust in its original location

- east of the birthplace cabin site. Source: George
- **Washington Carver National Monument photo**
- collection.

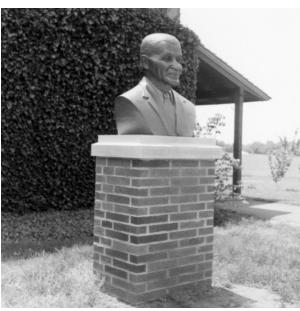
FIGURE 193. The Carver bust was moved in 1965 and

- reset on a brick base. Source: George Washington
- Carver National Monument photo collection.
