1 **Technical Synthesis Report for Physical and**
2 **Ecological Resources at Fire Island National Seashore**

3 Natural Resource Report **NPS/XXXX/NRR—2016/XXX**

Technical Synthesis Report for Physical and Ecological Resources at Fire Island National Seashore

August 2016

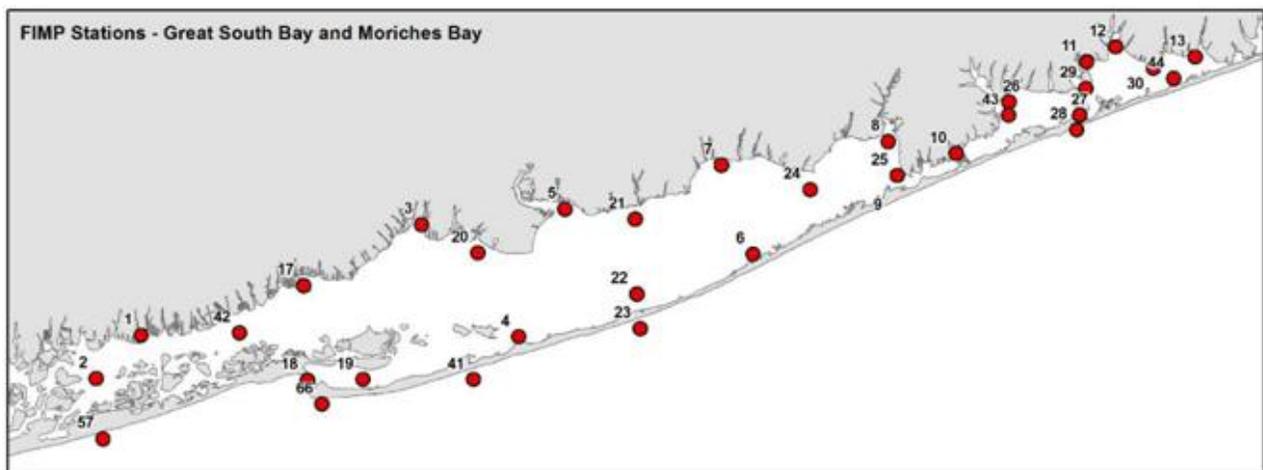
27
28 **Figure 2.** Storm water level output stations in Great South Bay and Moriches Bay from the USACE
29 modeling (Moffatt & Nichol and Canizares 2015).

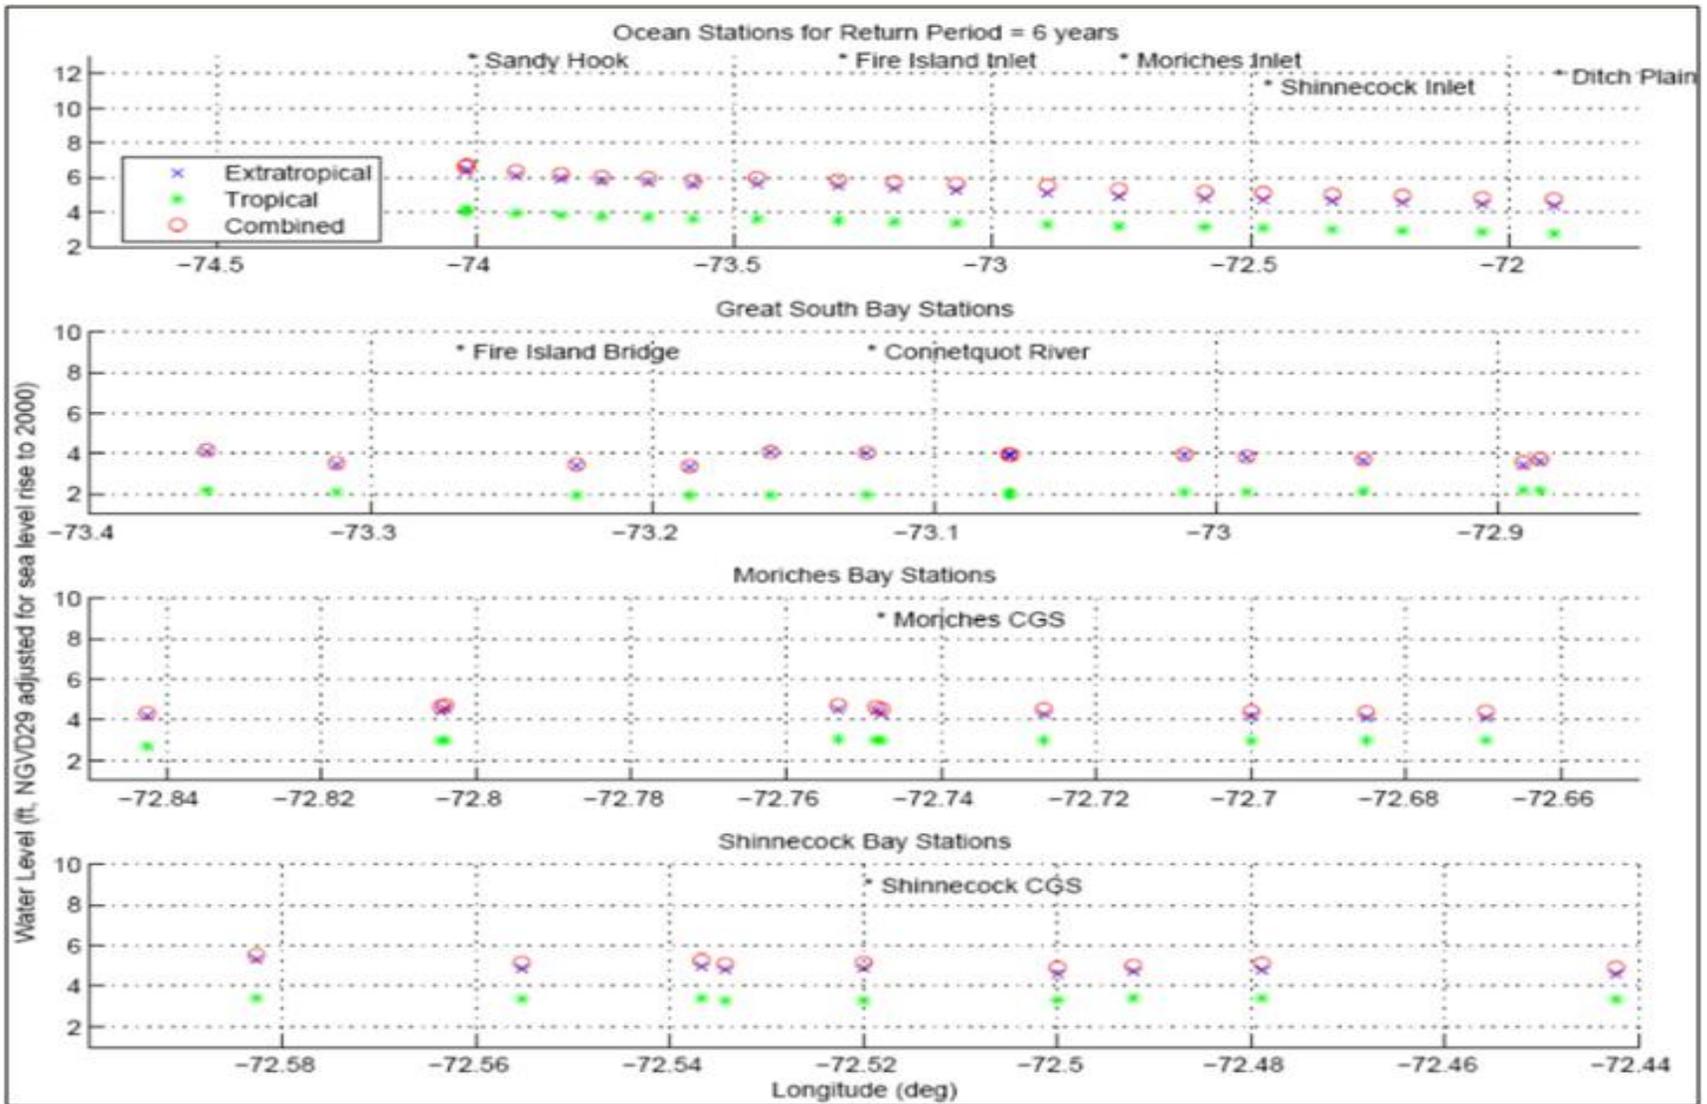
1
 2 **Figure 3.** Spatial distribution of 6-year return period peak water levels (in feet) for baseline conditions (pre Sandy) from USACE modeling (USACE
 3 2006a).

23 (3.9 and 4.9 feet) for the 6-year return period, between 1.8 and 2.1 meters (5.9 and 6.9 feet) for the
24 50-year return period, and between 2.0 and 2.3 meters (6.6 and 7.5 feet) for the 100-year return
25 period (Figures 3–5). Spatial variations in water levels within the bays were found to be consistent
26 with the bay’s geometry, inlet configurations, and exchange with adjacent water bodies.

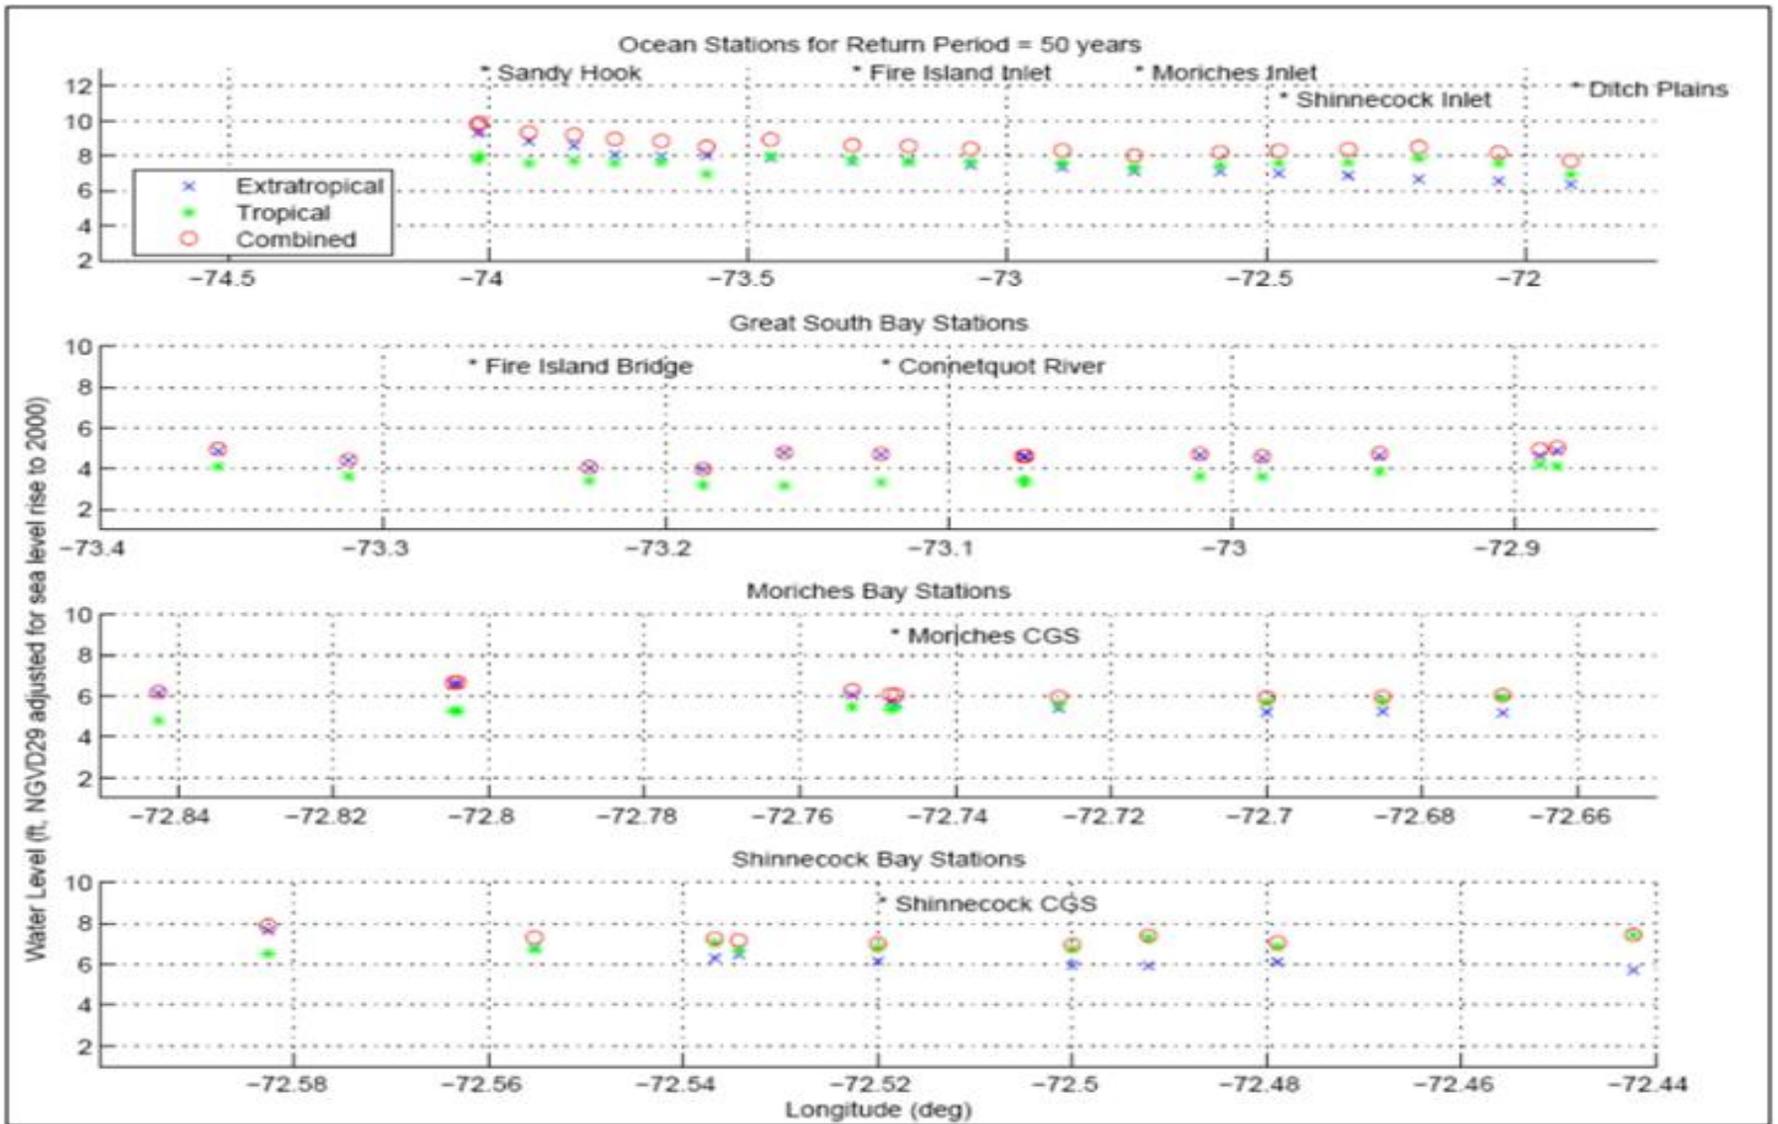
1
 2 **Figure 4.** Spatial distribution of 50-year return period peak water (in feet) levels for baseline conditions (pre Sandy) from USACE modeling
 3 (USACE 2006a).

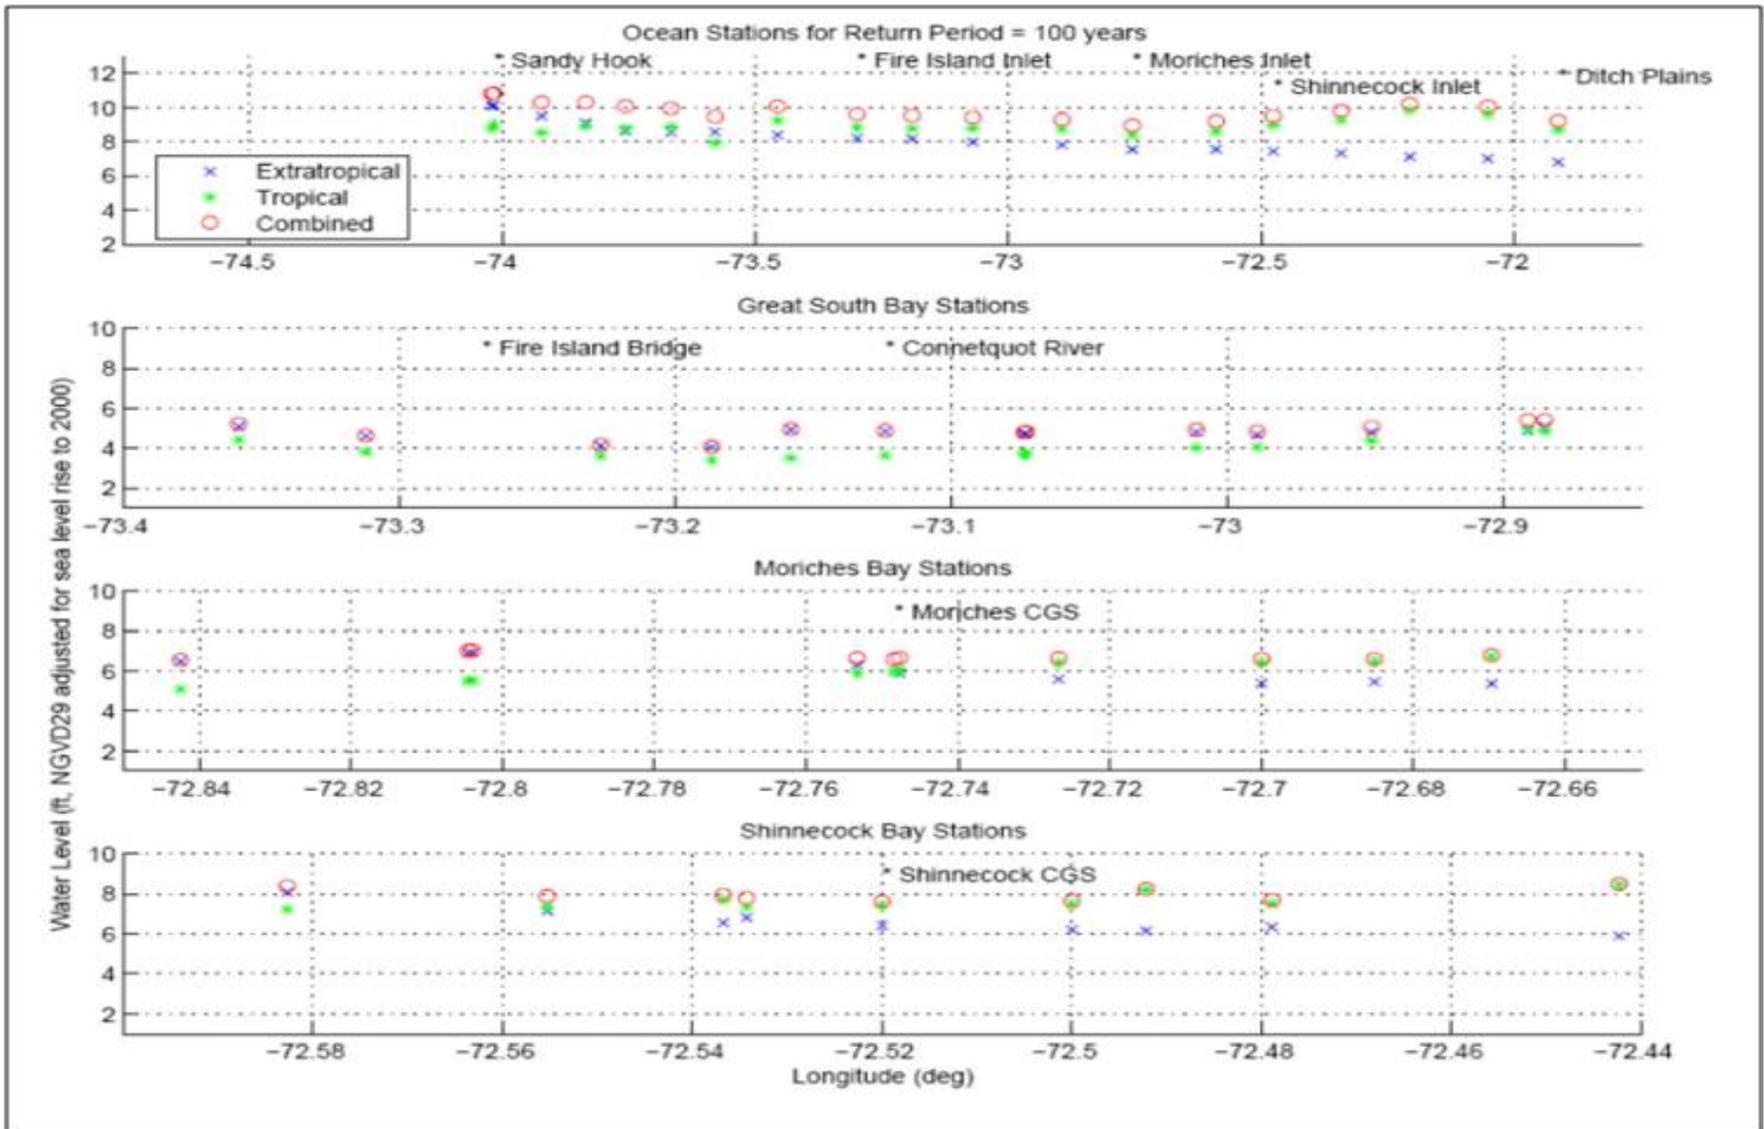
1
 2 **Figure 5.** Spatial distribution of 100-year return period peak water levels (in feet) for baseline conditions (pre Sandy) from USACE modeling
 3 (USACE 2006a).

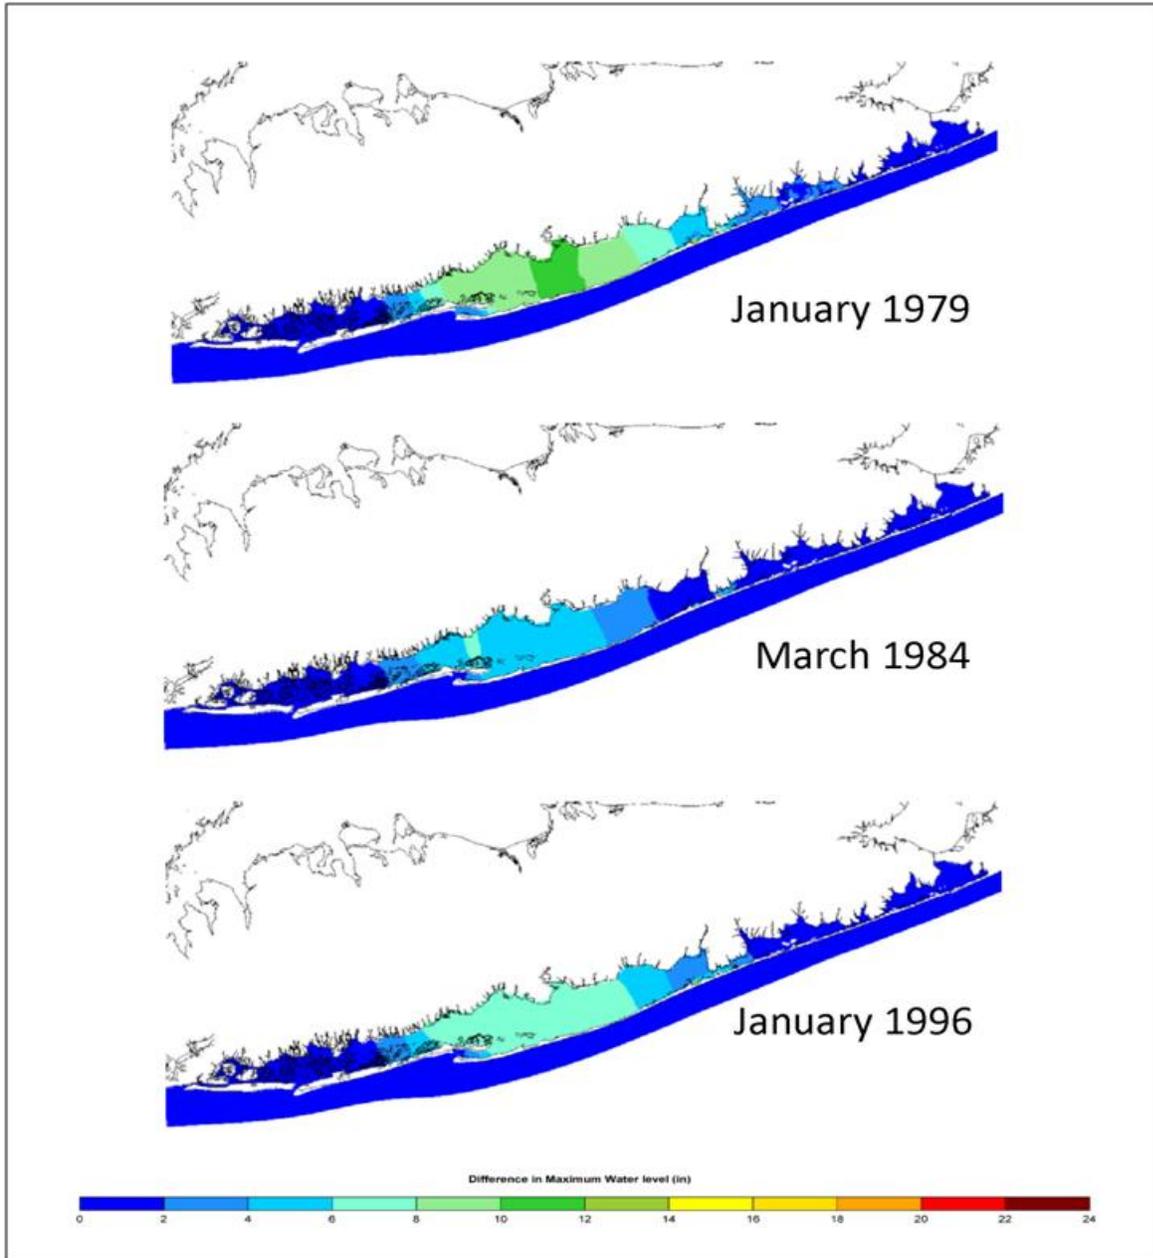
9
10 **Figure 6.** Comparison of modeled peak water levels during small storms with and without breach (Moffatt
11 & Nichol and Canizares 2015). Extratropical storms: January 1979, March 1984, and January 1996.

1 breach closed and the June 2014 BOC for these storm events were found to be as high as 25.4
2 centimeters (10 inches) during the smaller storm events and up to 55.9 centimeters (22.0 inches)
3 during the larger storm events (Figures 6 and 7). The highest water levels generally occurred near the
4 center of Great South Bay. The model predictions of increased water levels during storms represent
5 order of magnitude increases rather than absolute values. The dynamic and constantly changing
6 nature of the breach, including variations in morphology since the June 2014 survey which have
7 decreased the width, hinder predictions of absolute water levels with a numerical model; however the
8 order of magnitude for water level increases shown by the model is considered reliable.

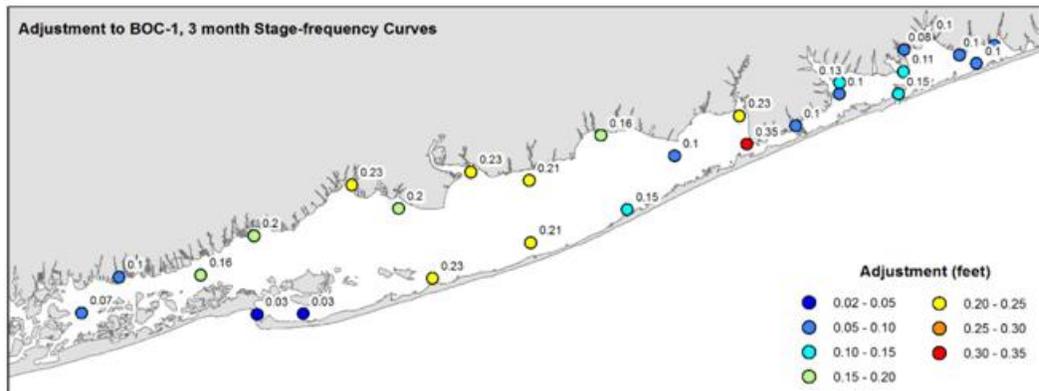
15
16 **Figure 8.** Adjustment values by station to BOC-1, 3-month stage frequency curves to reflect June 2014
17 breach open conditions.

11 model stations in Great South Bay and Moriches Bay were used to identify adjustments for shifting
12 the BOC-1 (3-month) stage frequency curves. Adjustments to the BOC-1 (3-month) curves varied by
13 station and generally ranged between 0.9 and 10.1 centimeters (0.4 and 4 inches), with the greatest
14 water level increases occurring in the vicinity of the wilderness breach (Figure 8).

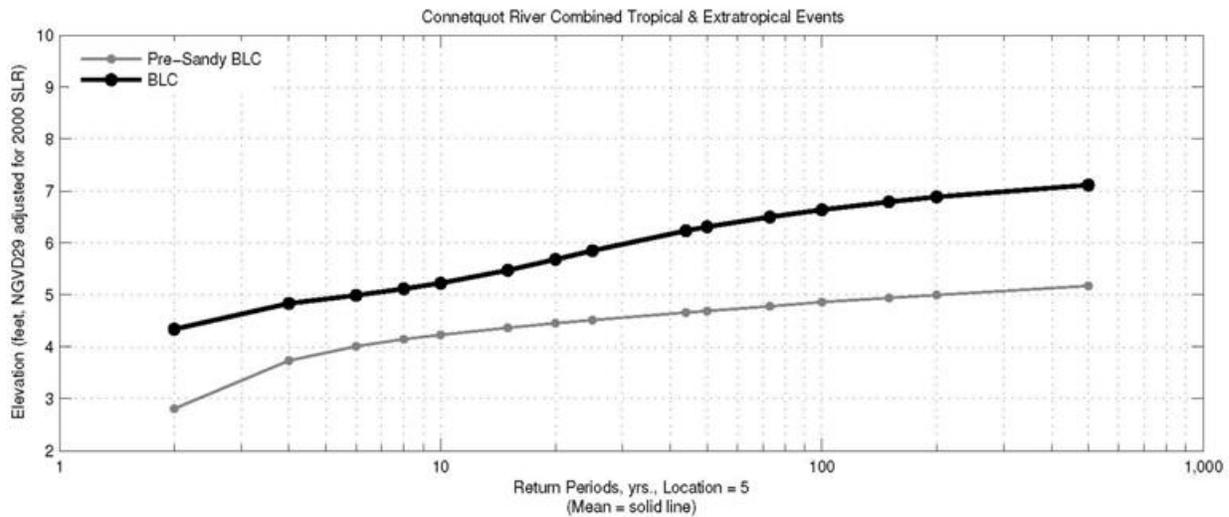
1
 2 **Figure 9.** Stage frequency curve for Station 5 near the Connetquot River showing differences in water
 3 levels between the 2006 Pre-Sandy baseline condition (no breach) and the 2014 baseline condition (with
 4 breach) conditions (Moffatt & Nichol and Canizares 2015).

18 Comparison between stage frequency curves for the 2006 and 2014 baseline conditions at stations
19 throughout Great South Bay and Moriches Bay showed a maximum 100-year return period water
20 level increase of 60 centimeters (23.6 inches) at Station 5 near the mouth of the Connetquot River
21 (Figure 9). Increases elsewhere in Great South Bay and Moriches Bay for the 100-year return period
22 were between 20 and 40 centimeters (7.9 and 15.7 inches).

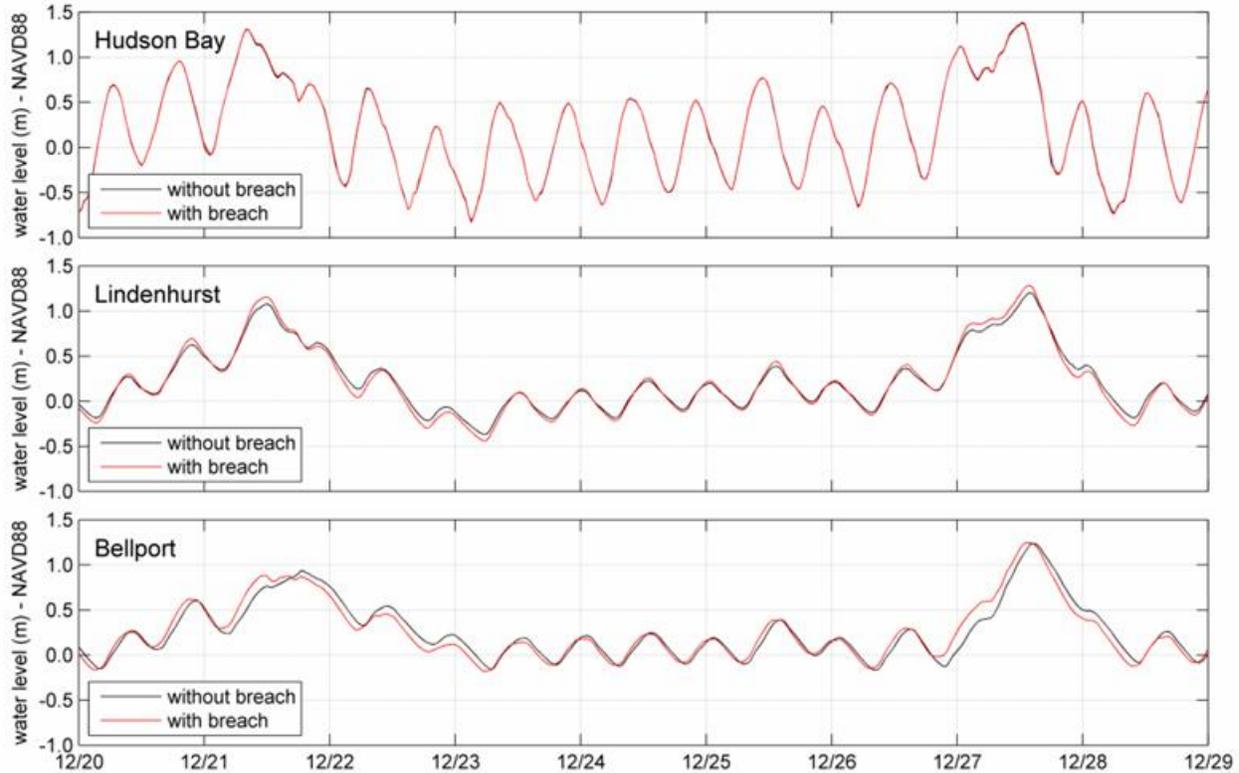
1
2 **Figure 10.** Comparison of computed (modeled) water levels with and without the breach for Hudson Bay,
3 Lindenhurst, and Bellport for the period of December 20–29, 2012 (van Ormondt et al. 2015).

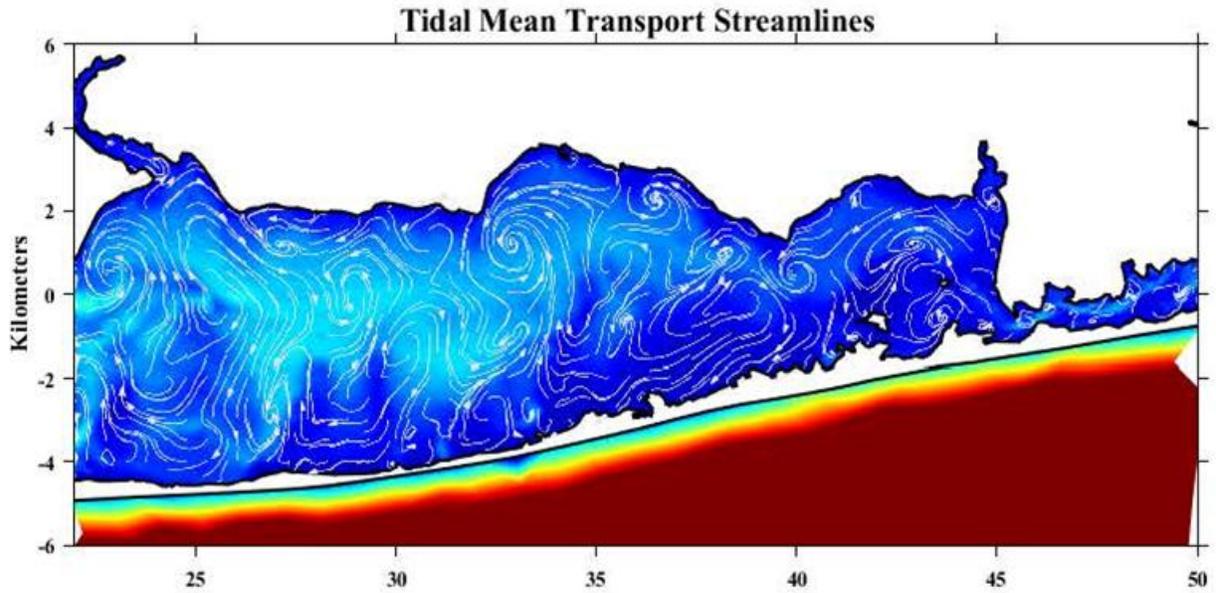
3
4 **Figure 11.** Tidal mean transport in eastern Great South Bay for the baseline condition (no breach) as
5 simulated by the School of Marine and Atmospheric Sciences Model Studies Finite Volume Coastal
6 Ocean Model for Great South Bay (SoMAS 2016).

1 associated eddy, and a large counterclockwise eddy was identified south of Patchogue (~33 to
2 34 kilometers (21 miles) on Figure 11).

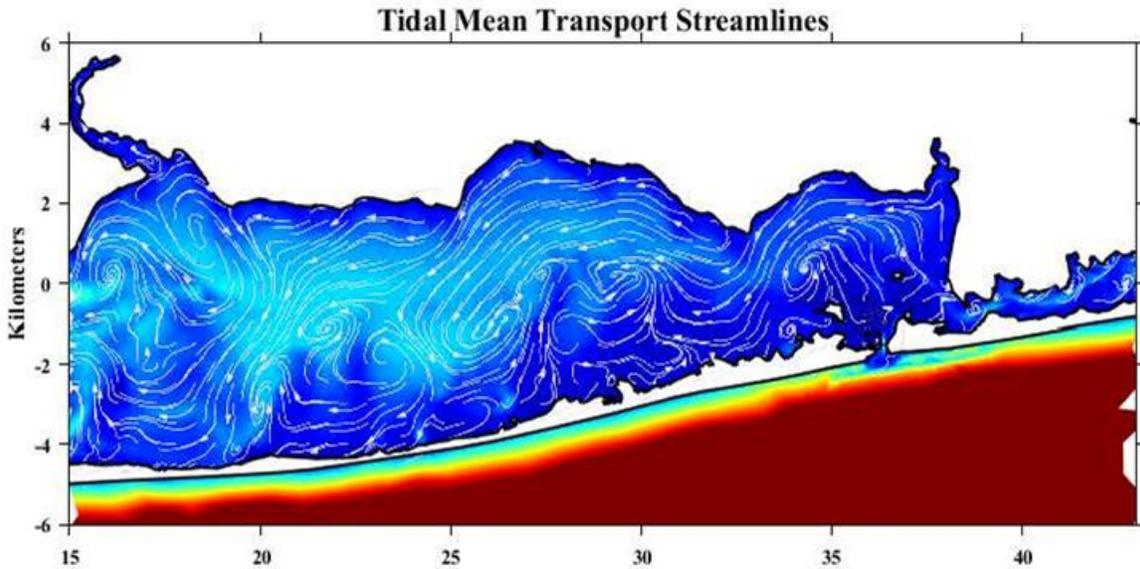
7
8 **Figure 12.** Tidal mean transport in eastern Great South Bay with the breach open as simulated by the
9 School of Marine and Atmospheric Sciences Model Studies Finite Volume Coastal Ocean Model for Great
10 South Bay (SoMAS 2016).

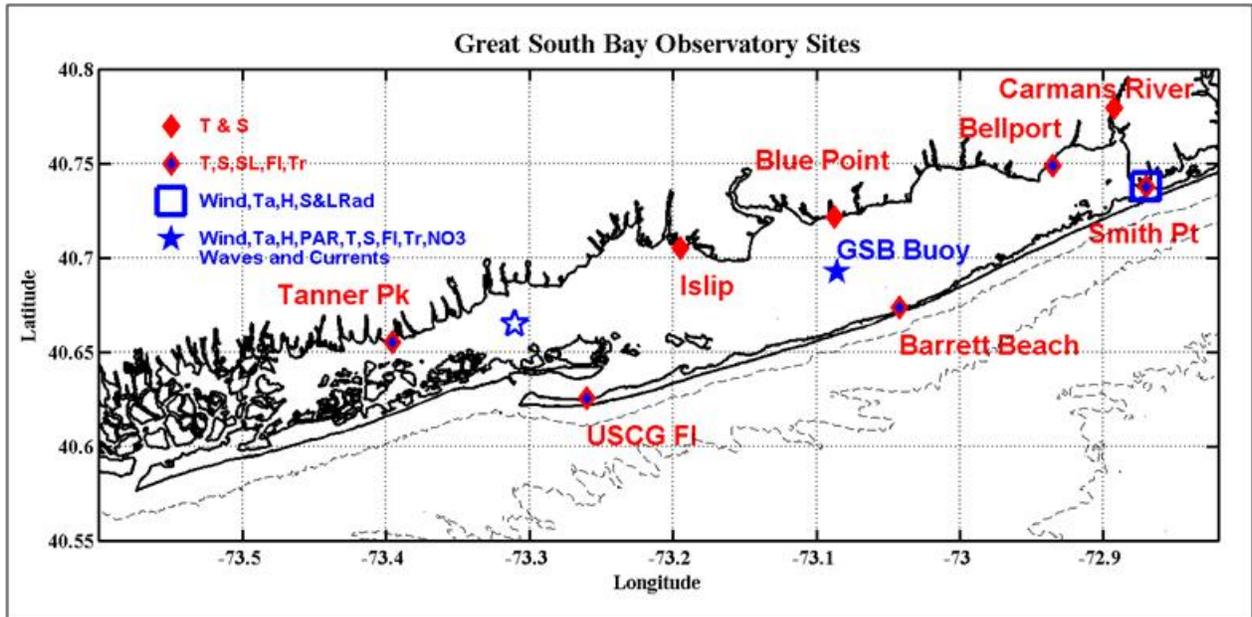
1
 2 **Figure 14.** Great South Bay observatory locations maintained by School of Marine and Atmospheric
 3 Sciences Model Studies (SoMAS 2016).

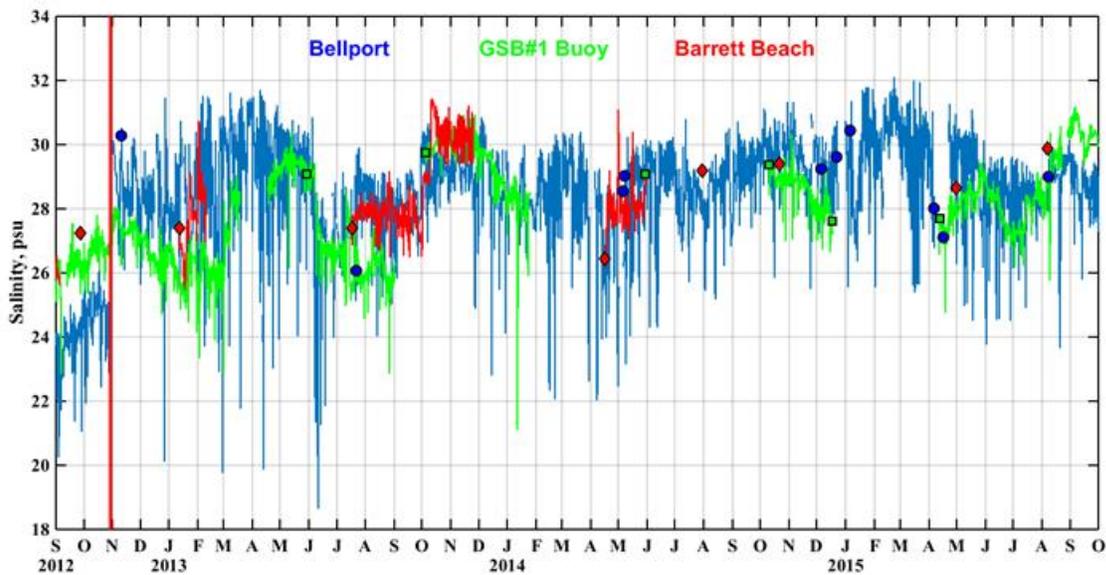
16
17 **Figure 15.** Salinity data in Great South Bay before and after the wilderness breach (Flagg pers. comm.
18 2016 (figure provided at workshop)).

12 comm. 2016). Bellport Bay has seen the greatest increase in average salinity since the breach
13 (+5 psu). Barrett Beach on Fire Island to the west of the breach has seen an increase of +2 psu and
14 measurements from the US Coast Guard Station at Fire Island Inlet show a negligible change in
15 salinity since the breach (Figure 16 a-c; Flagg pers. comm. 2016).

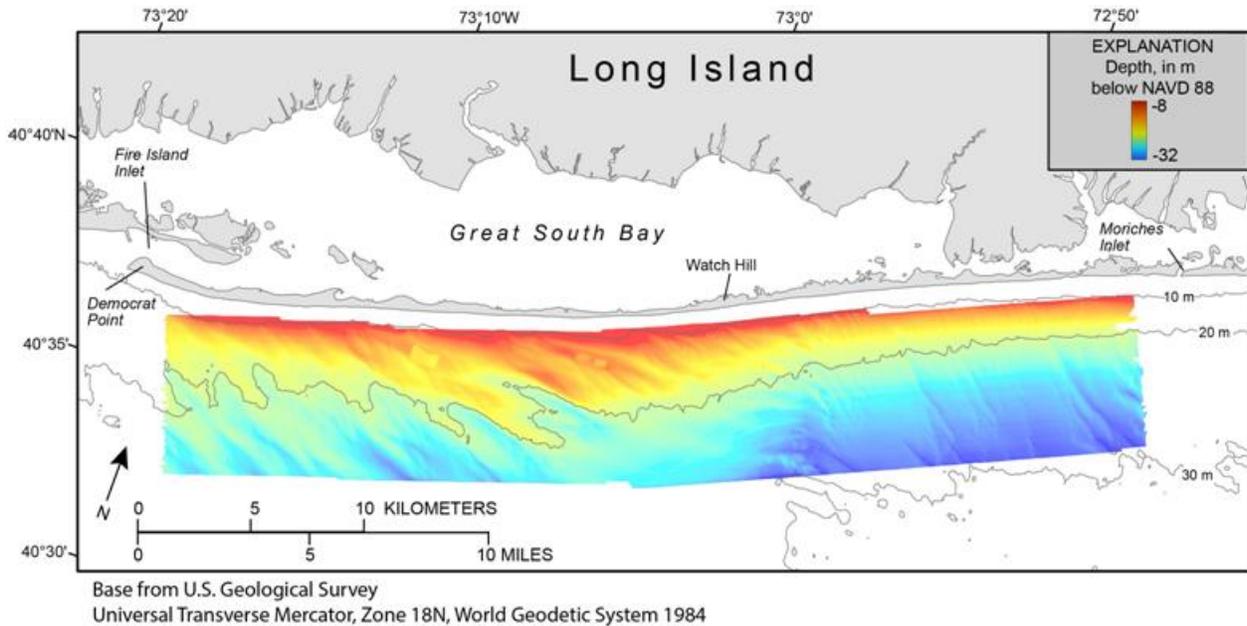
1
2
3 **Figure 17.** US Geological Survey bathymetric map shore-connected ridges along the western end of Fire
4 Island and a more planar shelf with straight and parallel contours on the eastern end.

26 The inner shelf at the eastern end of the Fire Island (east of Watch Hill) is characterized by relatively
27 straight and parallel contours (Figure 17; Schwab, Denny, Baldwin 2014a). This means that the
28 bathymetric contours are parallel with the shoreline, forming a uniformly sloping shelf. The
29 consistent nature of the bathymetry causes the incident waves to act uniformly across the inner shelf.
30 As waves approach the nearshore area and enter the surf zone, they interact with the nearshore bar
31 and this causes variations in wave energy along the shoreline (Nelson et al. in review). Since
32 formation of the wilderness breach, the ebb-tidal delta has caused a perturbation in the nearshore bar
33 system.

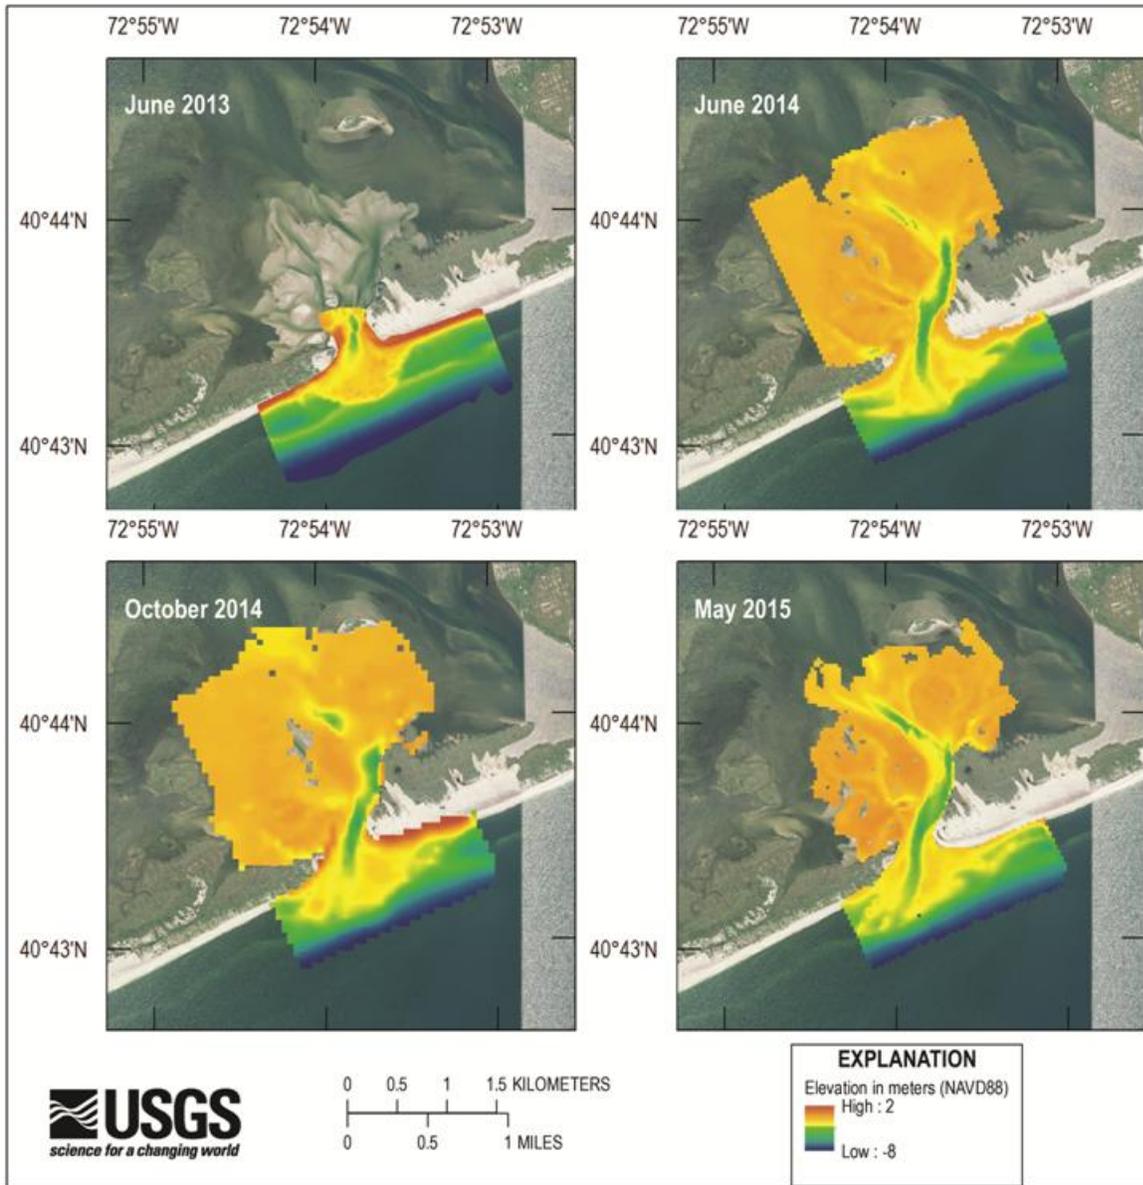
5
6 **Figure 18.** US Geological Survey bathymetric surveys of the breach and associated shoals from June
7 2013, June 2014, and October 2014 (Brownell et al. 2015; Nelson et al. 2016a and 2016b).

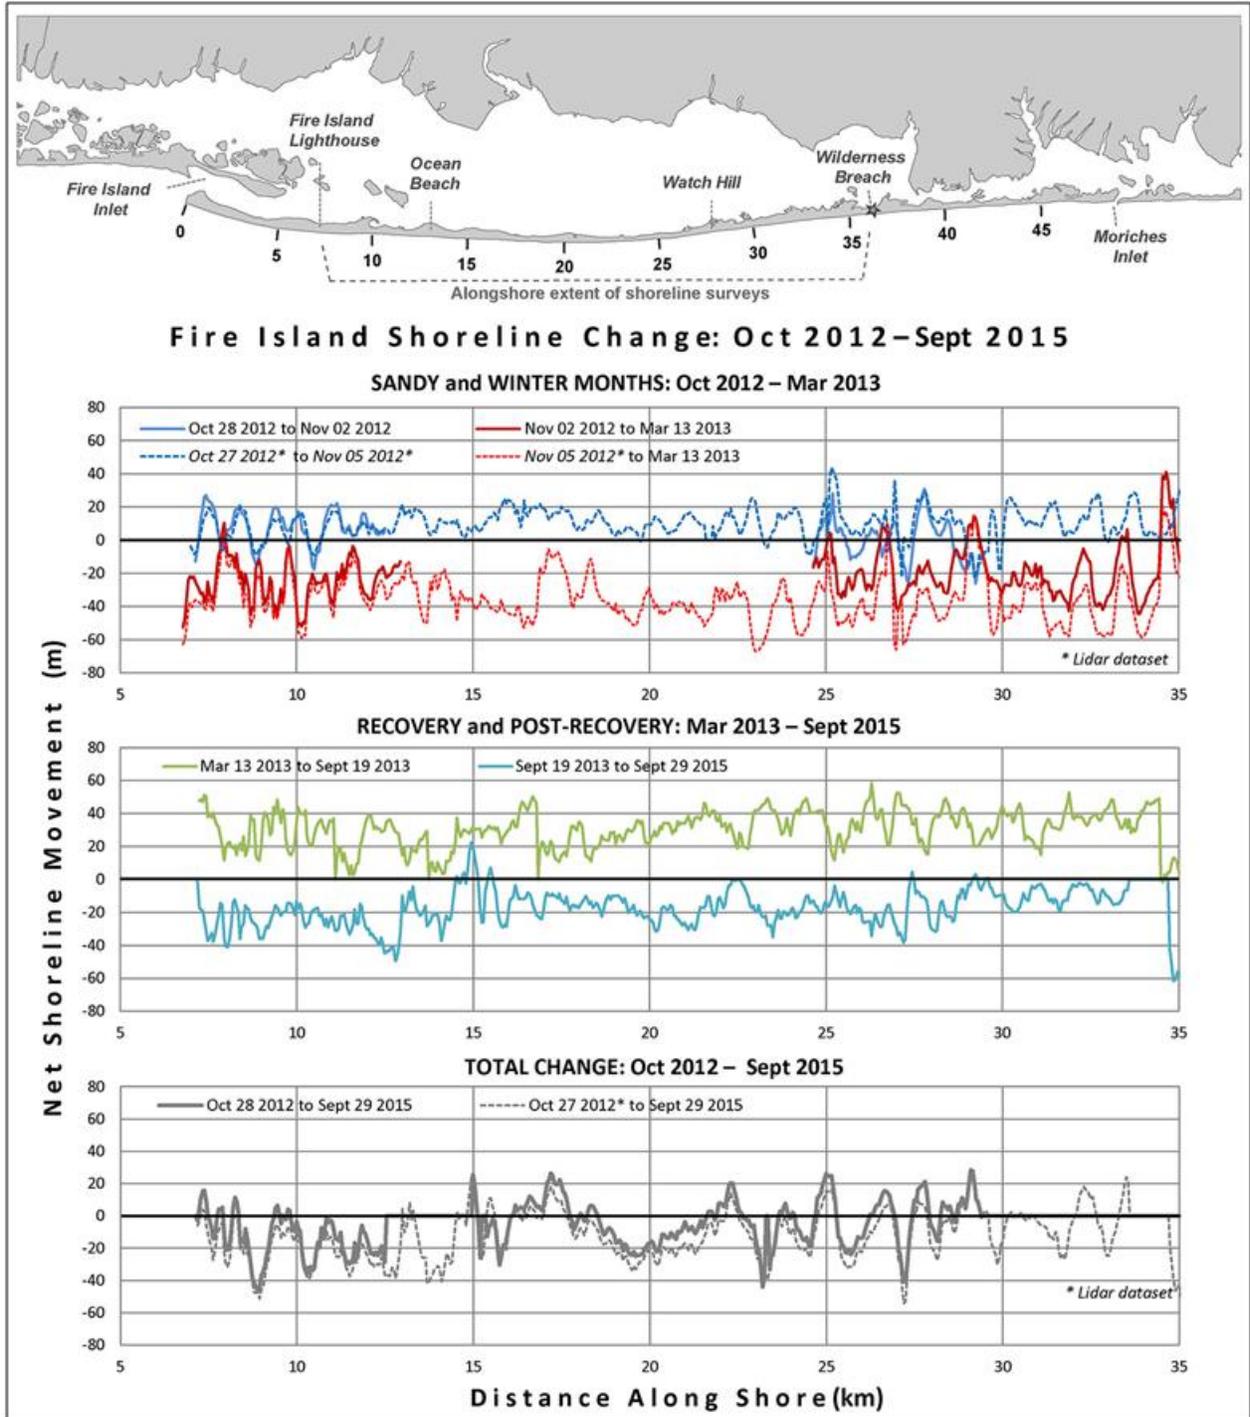
1
 2 **Figure 19.** US Geological Survey shoreline change data in the Fire Island National Seashore for the
 3 period October 2012 to September 2015 (USGS 2016a).
 4 The width of the breach and shallow nature of the flood tidal delta are primary factors that limit wave
 5 propagation from the open ocean through the breach to Great South Bay. Specific studies have not
 6 been conducted to evaluate this process, but general consensus at the January workshop was that

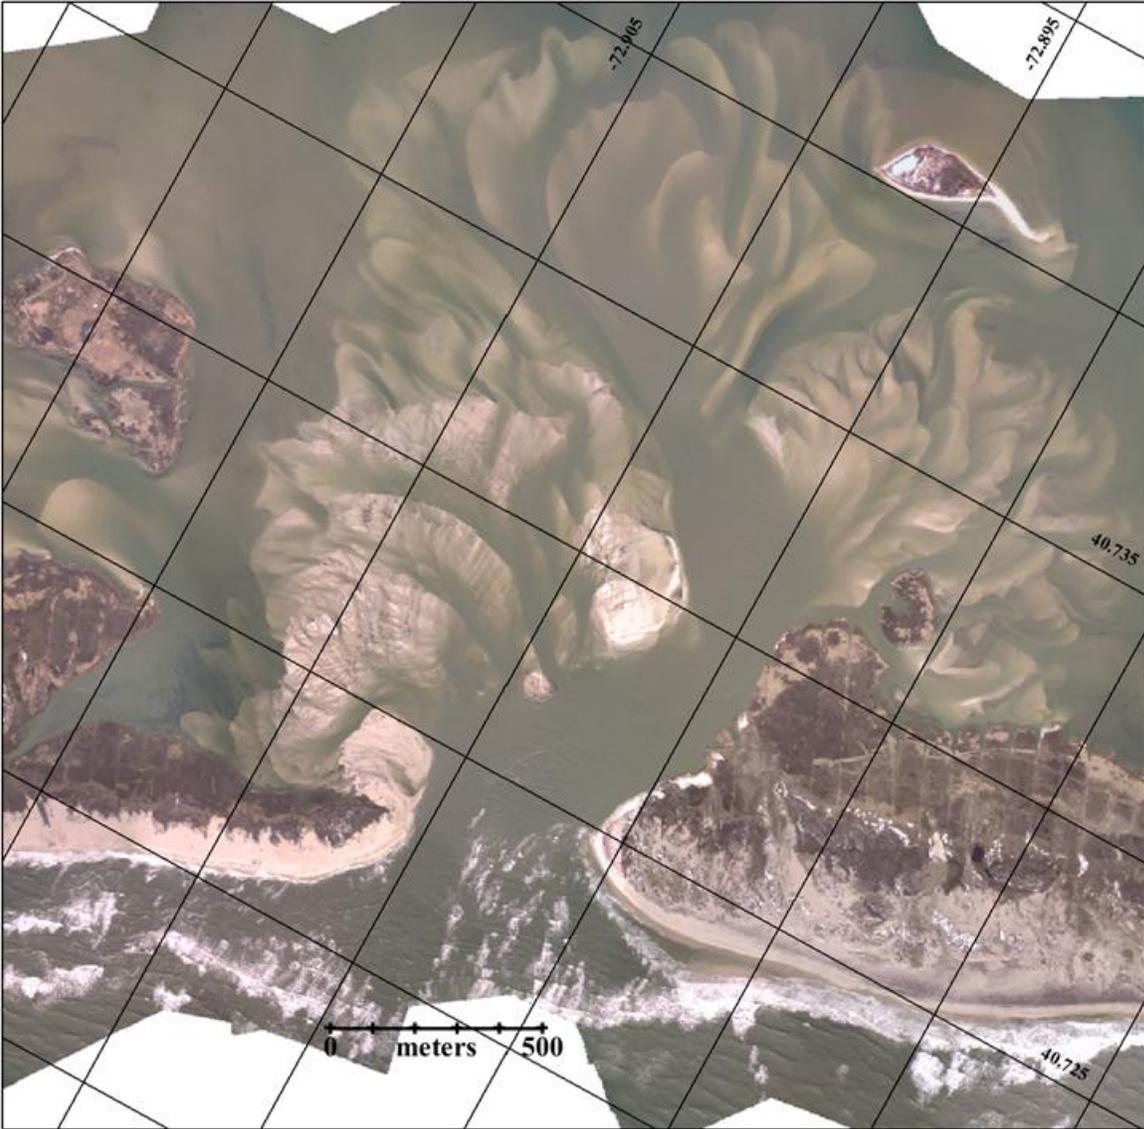
9
10 **Figure 20.** Jan. 31, 2016 aerial photo showing the configuration of the breach and the approximate width
11 of 500 meters (1,640 feet) (SoMAS 2016).

1 wave activity in the bay has not increased as a result of the breach. The current width of the breach at
2 approximately 500 meters (1,640 feet) provides a narrow window of exposure for Great South Bay
3 (Figure 16; SoMAS 2016), and any waves that enter the breach will be broken by the shallower
4 waters over the flood tidal delta (Figure 20). The potential for increased wave activity in Great South
5 Bay given a wider breach was also considered to be low, since the extent and shallow nature of the
6 flood shoals will provide protection. Based on these discussions, it was concluded that the potential
7 for increased shoreline erosion in Great South Bay as a result of wave propagation through the beach
8 was extremely low.

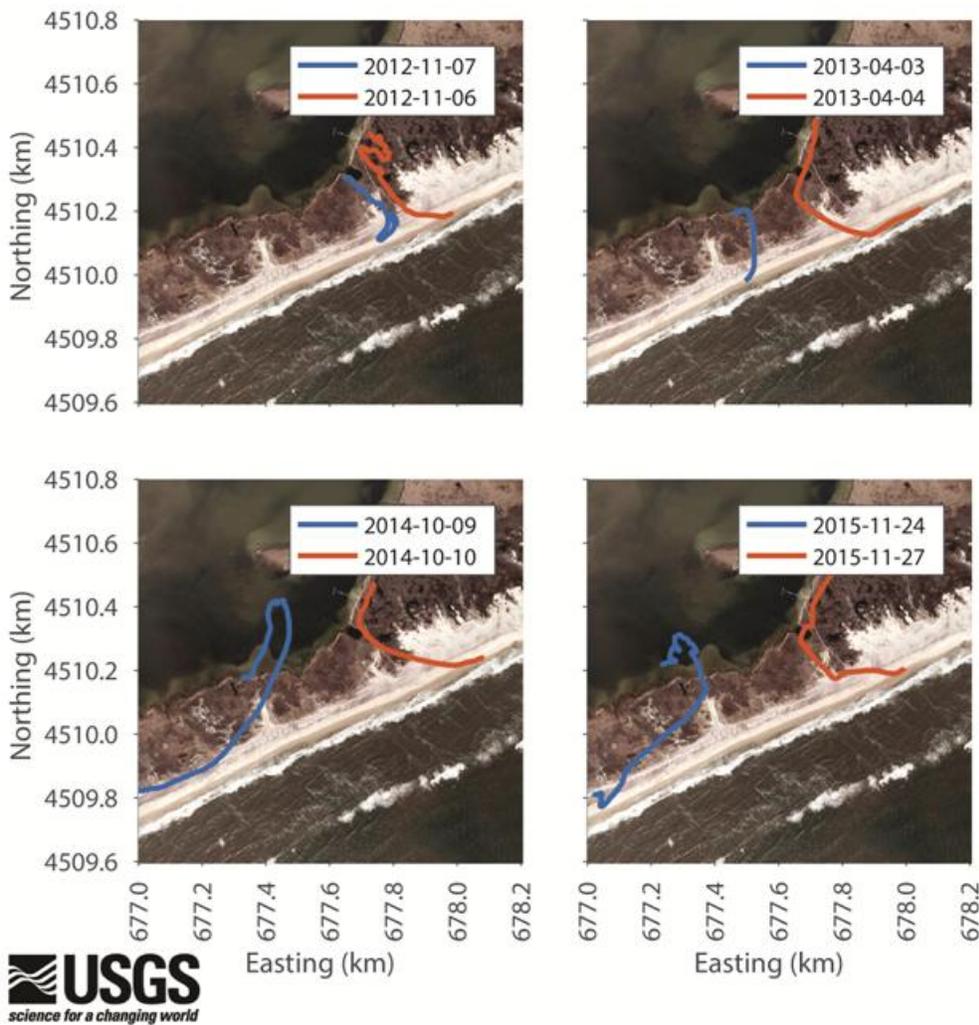
12 **Figure 23.** Breach shoreline change and width change between 2012 and October 2014 (Nelson et al.
13 2016).

2 Similar changes in breach geomorphology have been documented by Nelson et al. (2016b) and
3 Nelson et al. (in review). Shoreline surveys conducted immediately following Hurricane Sandy, and
4 again in April 2013 and October 2014 show the width of the breach has increased significantly since
5 initial formation (Figure 23). Results and analysis from a series of USGS and NPS surveys between
6 November 2012 and April 2015 show the width of the breach, measured at the narrowest point
7 between the two adjacent shorelines, increased steadily during the first year (Figure 24, top panel).
8 This was followed by small narrowing of the breach which continued with few fluctuations to April
9 2015. The fourth panel in Figure 24 shows the breach has migrated west since 2012, primarily
10 through erosion of the western shoreline and little change in the eastern shoreline.

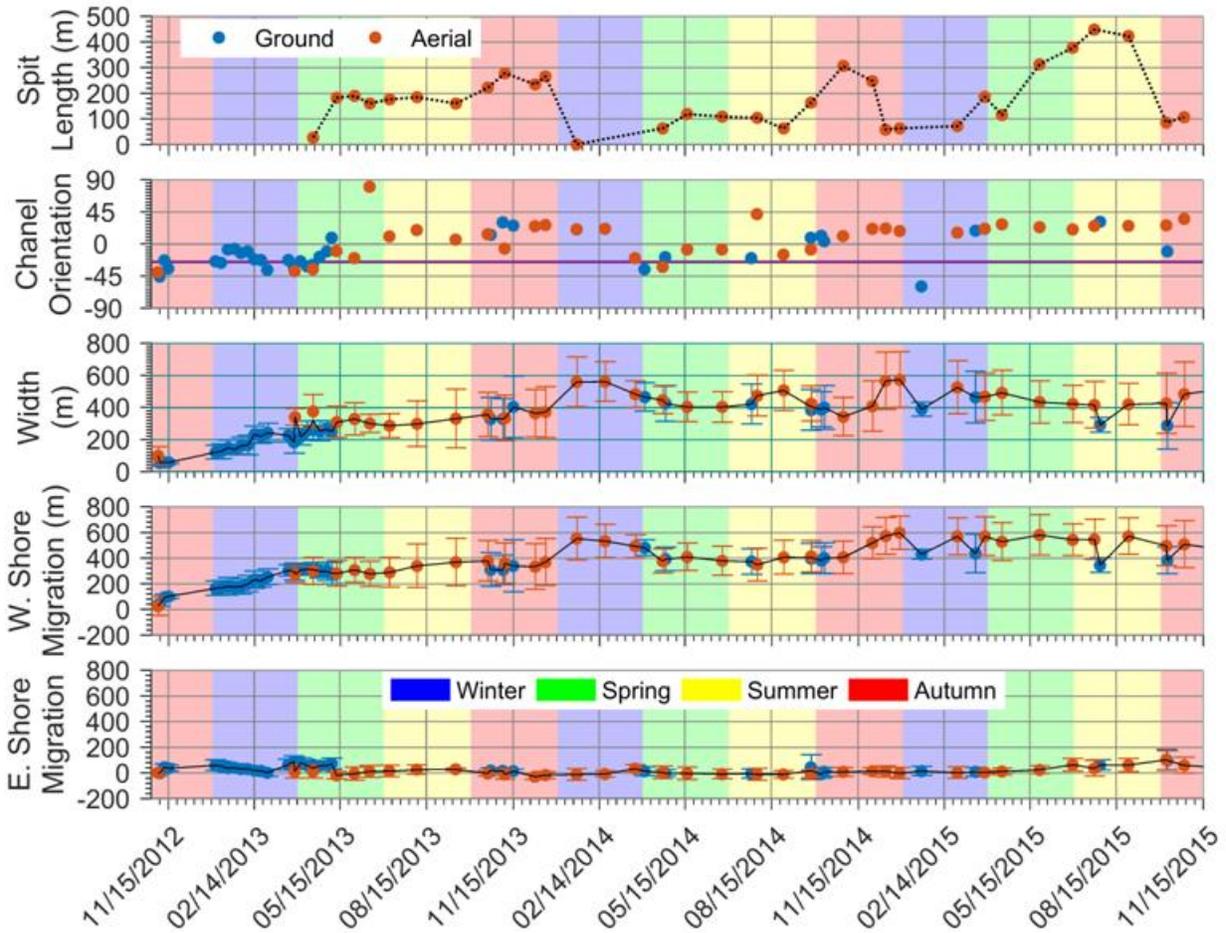
1
 2 **Figure 24.** Changes in breach width and migration patterns between November 2102 and November
 3 2015 (Hapke pers. comm. 2016).
