1 **Technical Synthesis Report for Physical and**
2 **Ecological Resources at Fire Island National Seashore**

3 Natural Resource Report **NPS/XXXX/NRR—2016/XXX**

Technical Synthesis Report for Physical and Ecological Resources at Fire Island National Seashore

August 2016

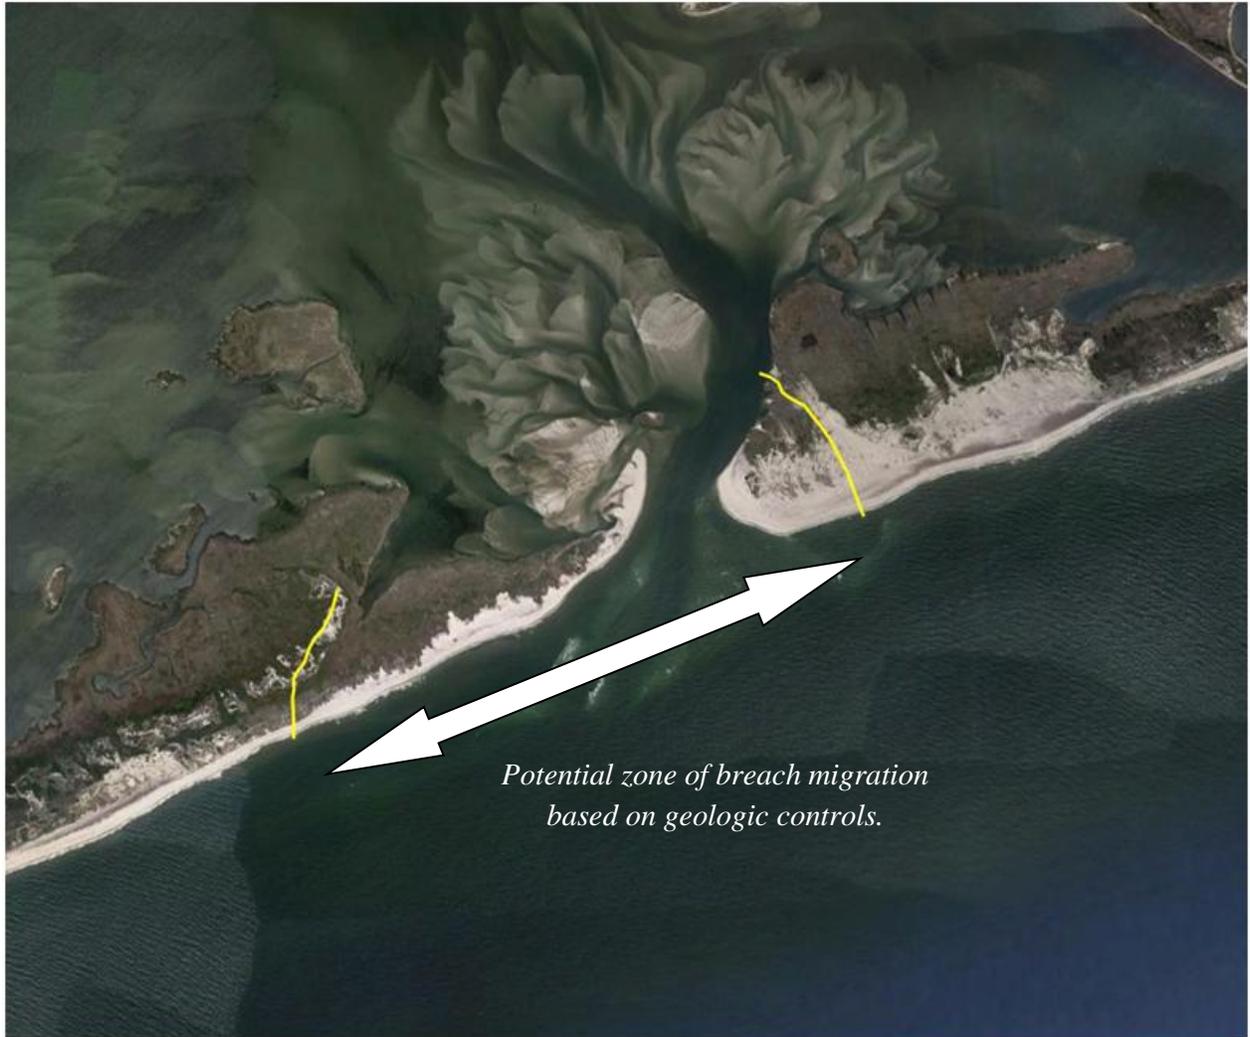
2 **Figure 25.** Projected zone of breach migration based on geologic controls identified through coring by
3 USGS. Photo from GoogleEarth, May 23, 2015.

4 The potential for continued changes in breach geomorphology was discussed at the January
 5 workshop, particularly with regard to breach width and continued westerly migration. There was
 6 general agreement that storm activity could result in widening, but uncertainty as to the ability of
 7 Great South Bay to maintain the breach in a wider configuration, especially since the two inlets at
 8 Fire Island and Moriches are stabilized through dredging. Primary controls on inlet migration were
 9 thought to be based on barrier beach stratigraphy documented in USGS unpublished sediment cores,
 10 which show erosion resistant materials located approximately 1.5 kilometers (0.9 miles) west of the
 11 breach centerline and in the marsh resource 0.5 kilometers (0.3 miles) east of the breach (Figure 25;
 12 Hapke pers. comm. 2016).

8 Prior to the breach there was little salt marsh vegetation located where the breach channel was
 9 initially formed; however, as the breach migrated to the west and may continue (Figure 25), salt
 10 marsh will be lost to the breach channel (Figure 46). Small portions of salt marsh were smothered by
 11 overwash sand deposition onto the marsh surface (Figure 42). These overwash areas may be
 12 platforms for future salt marsh establishment as sea-level continues to rise.

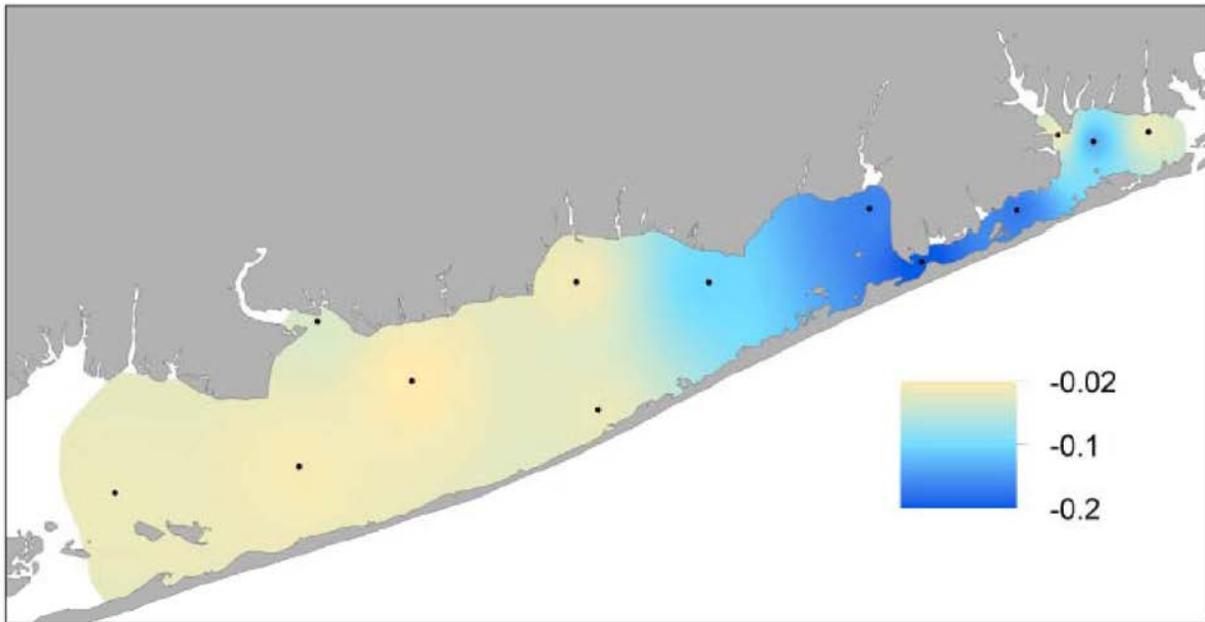
5
6 **Figure 26.** Change in total nitrogen (mg/L) from 2000 and 2008 versus 2013 (Gobler et al. 2014).

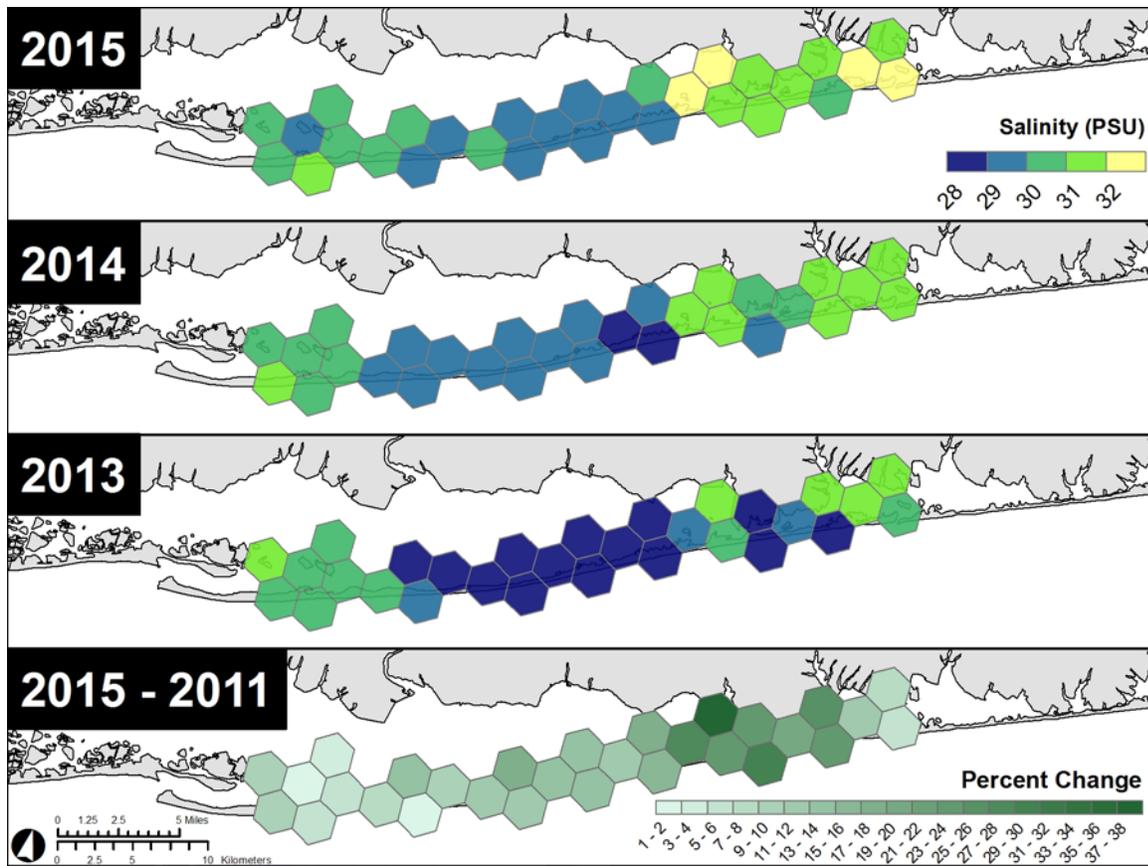
1
2 **Figure 27.** Salinity (2013, 2014, 2015) and change in salinity (2015–2011) (Heck and Peterson 2016).

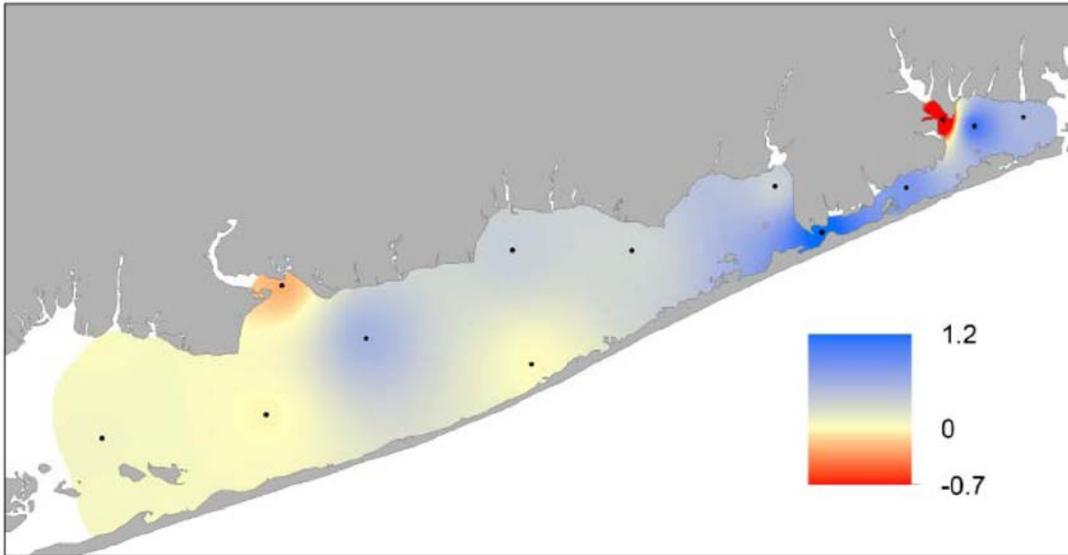
1
2 **Figure 31.** Change in dissolved oxygen (mg/L) from 2000 and 2008 versus 2013 (Gobler et al. 2014).

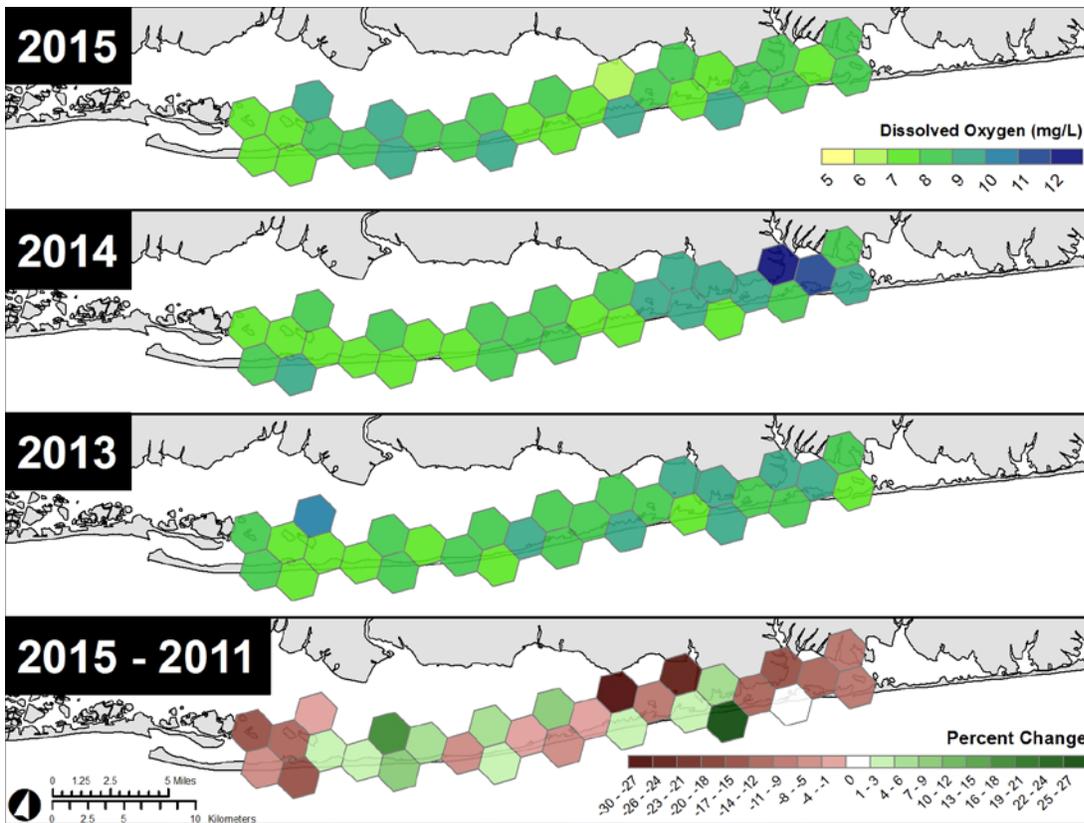
3
4 **Figure 32.** Dissolved oxygen (2013, 2014, 2015) and change in dissolved oxygen (2015–2011) (Heck
5 and Peterson 2016).

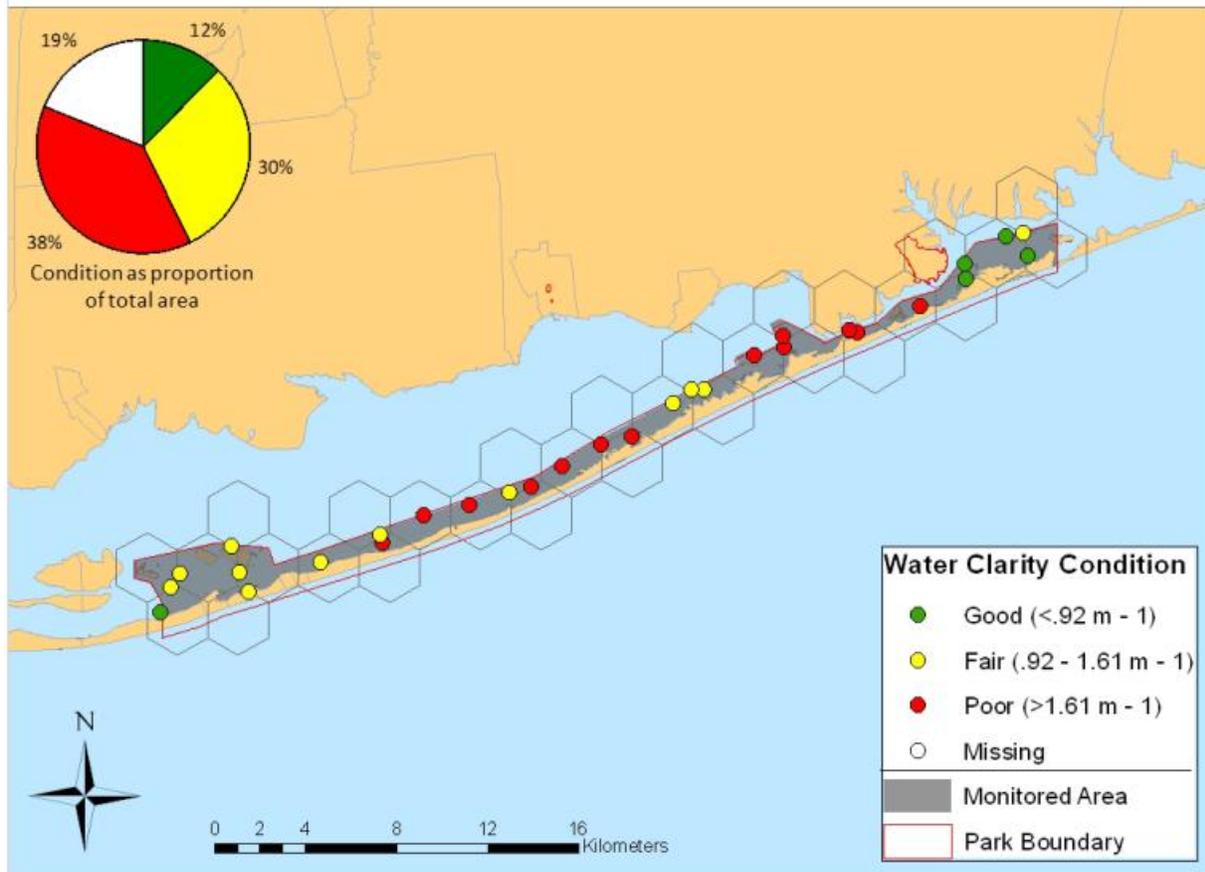
1
2 **Figure 33.** Water clarity conditions pre-breach at Fire Island National Seashore (Caldwell et al. 2015).

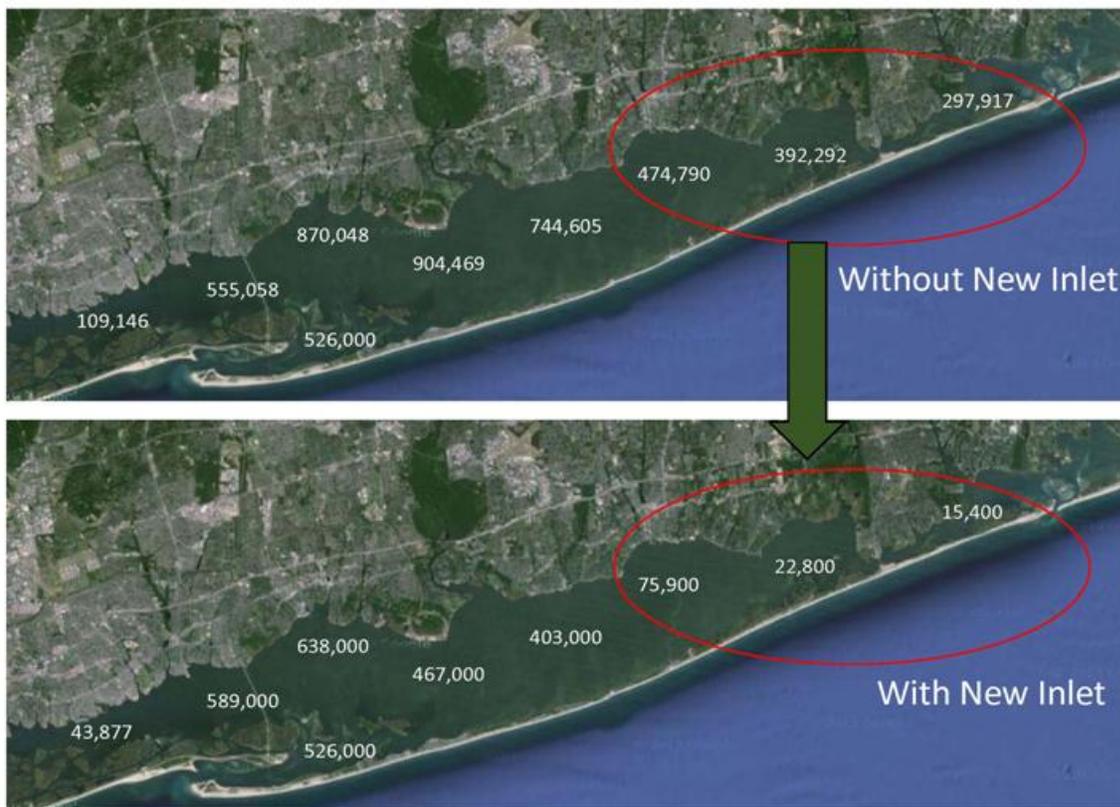
1
2 **Figure 37.** Brown tide (cells/mL) in Great South Bay, June 2013 (Gobler, Collier, and Lonsdale)

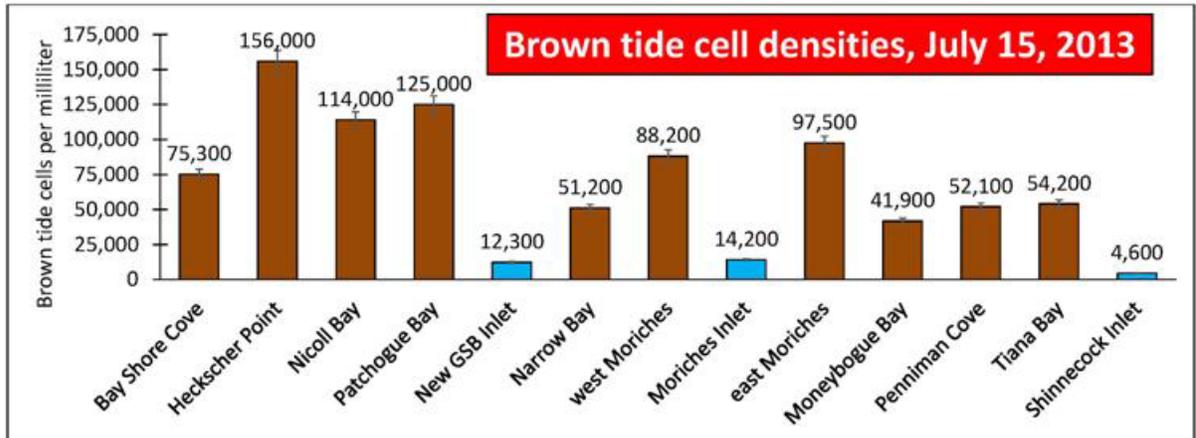
1
 2 **Figure 38.** Brown tide cells in the Great South Bay lagoon system during the brown tide bloom in July
 3 2013 (Gobler, Collier, and Lonsdale 2014).

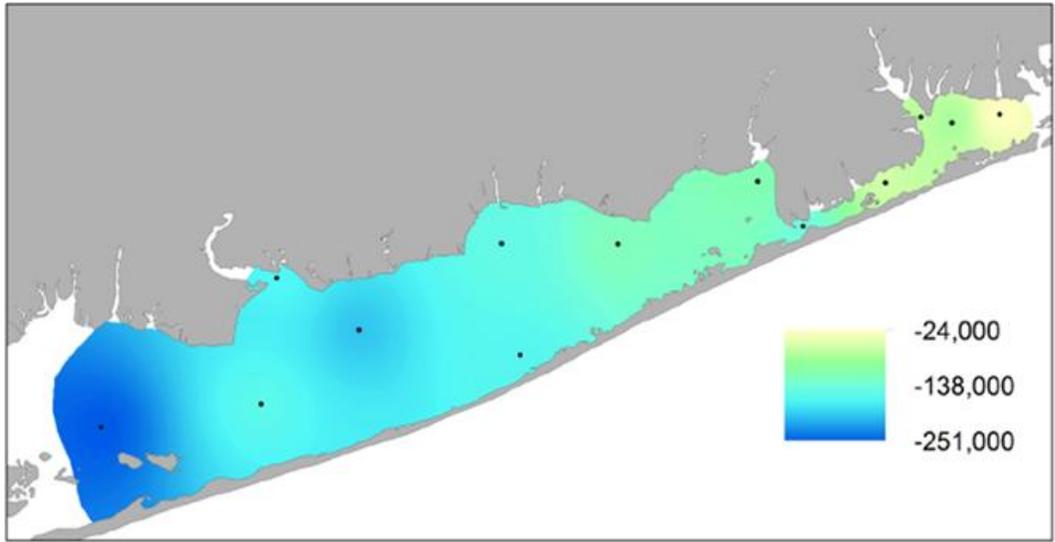
1
 2 **Figure 39.** Average decrease in brown tide cell density (cells/ml) in Great South Bay lagoon system in
 3 brown tide years, post-breach (2013) versus pre-breach (2000 and 2008).

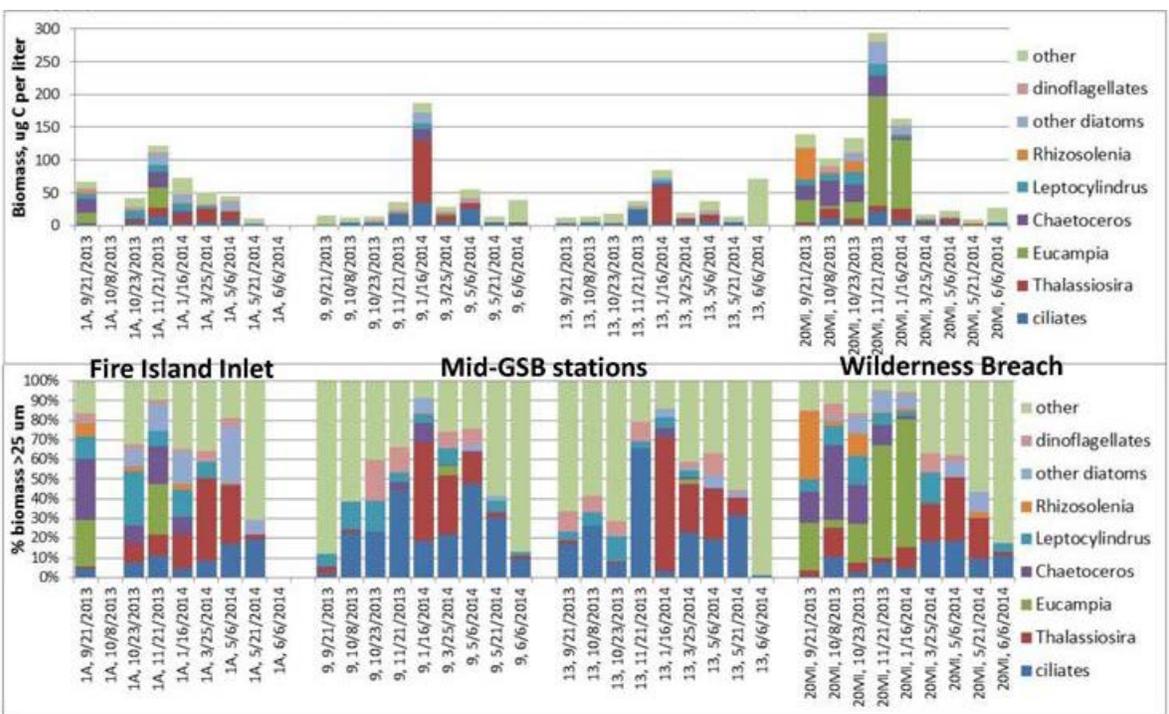
4
 5 **Figure 40.** Phytoplankton community composition at inlets and mid-bay stations, Fall–Winter 2015–2015.
 6 FlowCAM data collection and analysis by Yuriy Litvinenko and Jackie Collier.

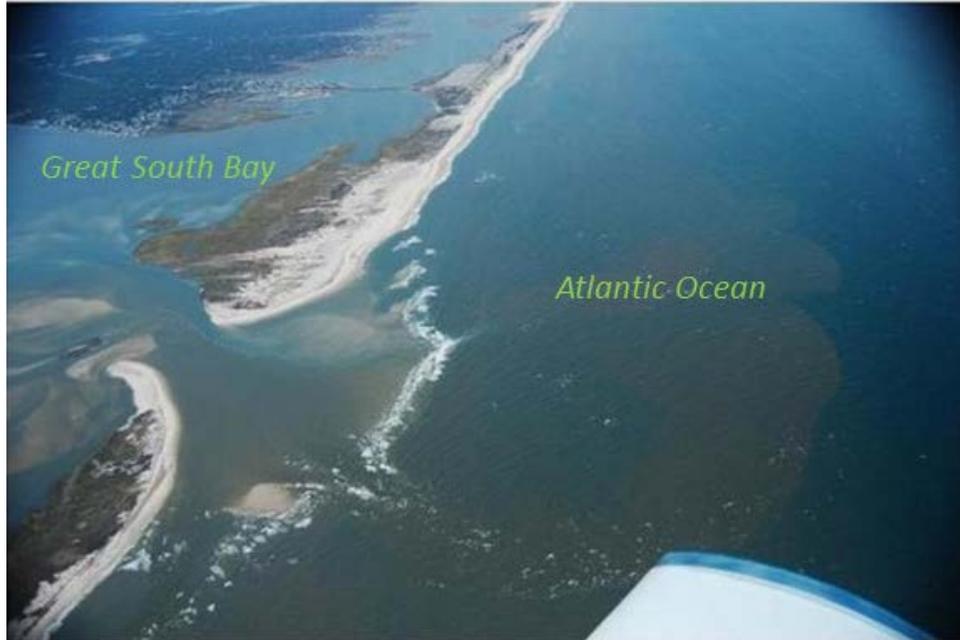
2 **Figure 41.** Wilderness breach exports brown tide (Fall 2014) (Gobler, Collier, and Lonsdale 2014).

13 Great South Bay. Aerial photographs of the breach site (Figure 41) captured in 2014 showed a
 14 “flushing out” of brown tide cells resulting from water exchange between the estuarine and oceanic
 15 environments.

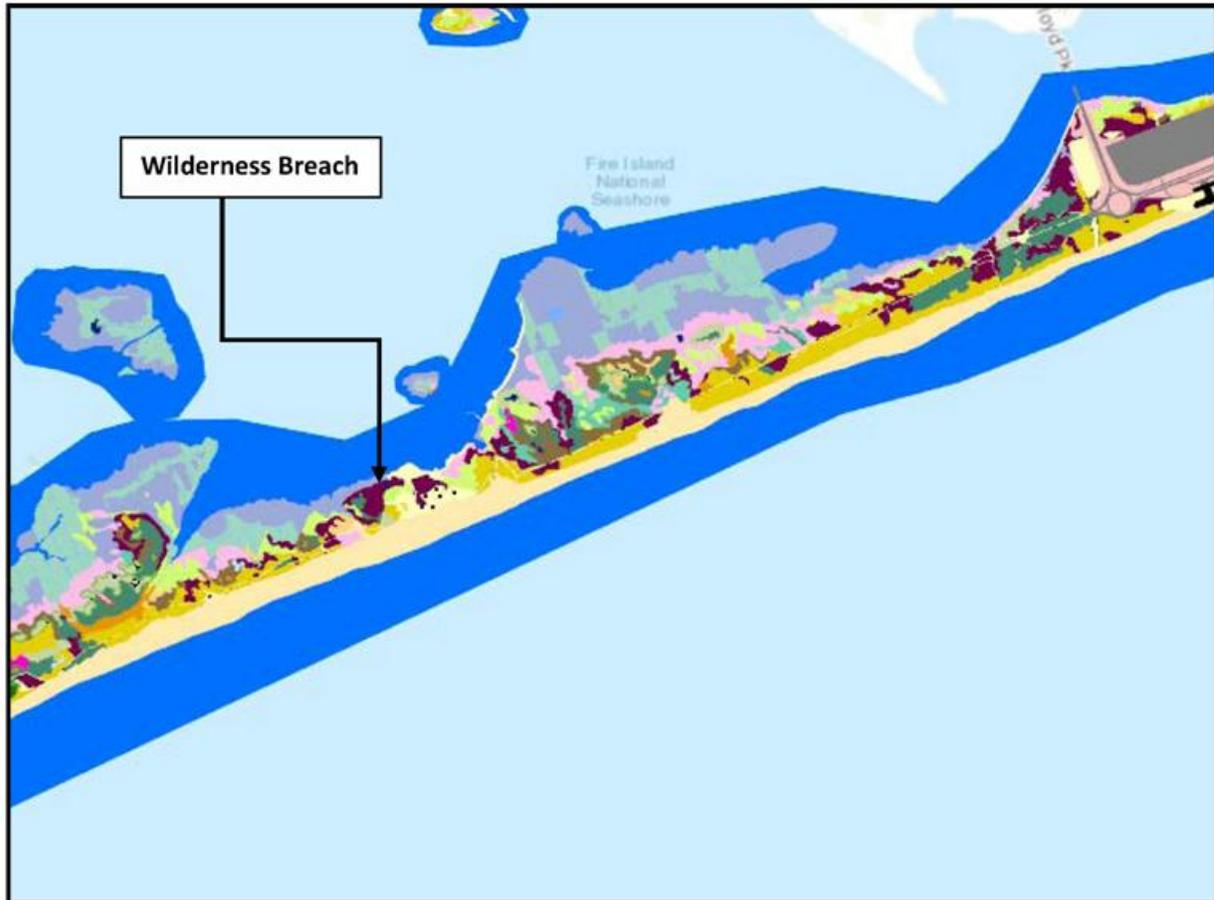
2 **Figure 46.** Breach area overflight and vegetation map showing overwash areas and affected habitats,
 3 including salt marsh. Figure shows the small amount of marsh vegetation affected by overwash.

4 Post-breach changes in sediment dynamics have occurred in the vicinity of the breach, and include
 5 the formation of the flood tide delta and overwash (Roman and Lynch pers. comm. 2016). Aside
 6 from localized overwash sand deposition on the marsh in the vicinity of the breach, there did not
 7 appear to be any widespread storm-related deposition onto the marsh surface, as noted from the lack
 8 of sediment accumulation above SET feldspar marker horizons (Figure 45) and the vegetation map
 9 with overwash areas indicated (Figure 46). The aerial extent of salt marsh affected by overwash was
 10 calculated using a GIS mapping tool that allowed the overwash areas (shown in the aerial photo on
 11 the left in Figure 46) to be superimposed on the vegetation map. Affected area was calculated as the
 12 sum of the area within polygons where salt marsh vegetation and overwash intersect. This analysis

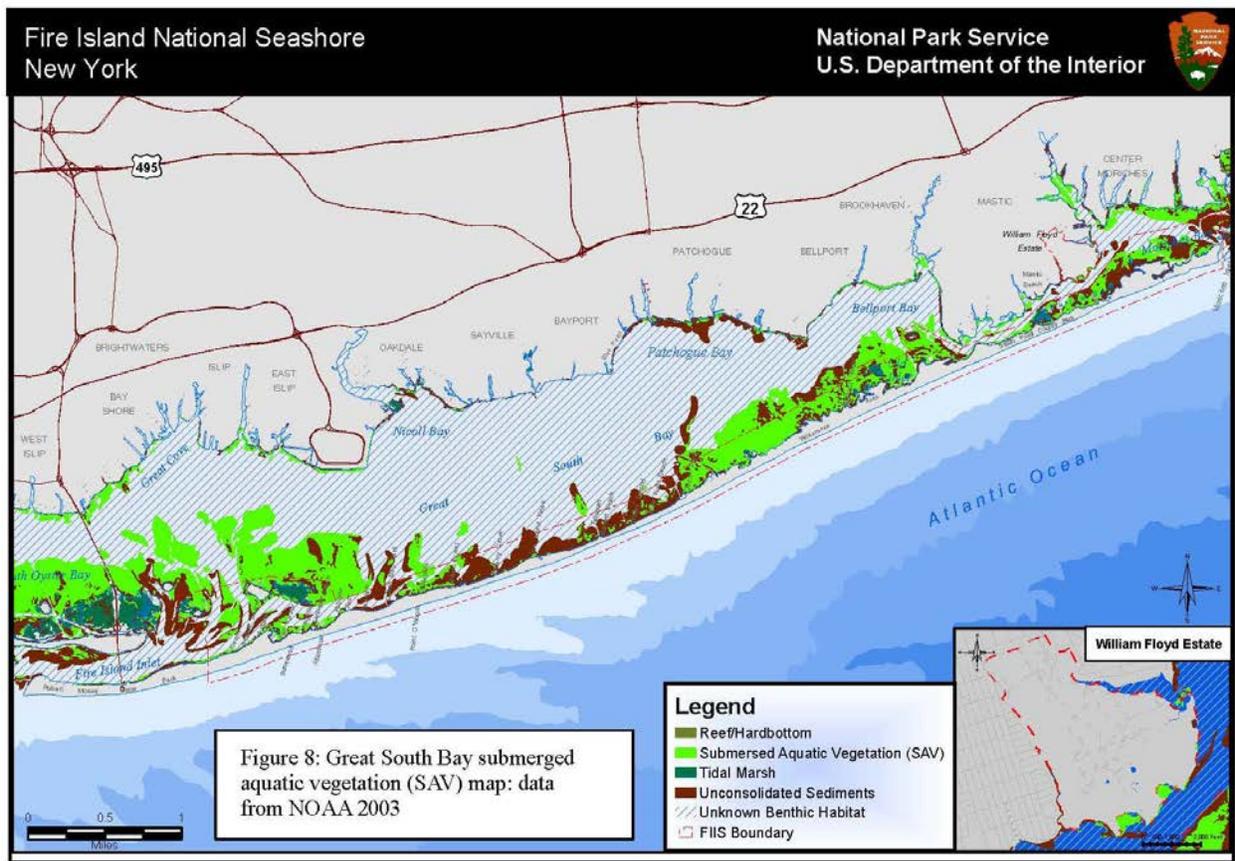
12
 13 **Figure 47.** Submerged aquatic vegetation distribution in south shore estuaries (based on data from
 14 NOAA 2003 and published in McElroy et al. 2009).

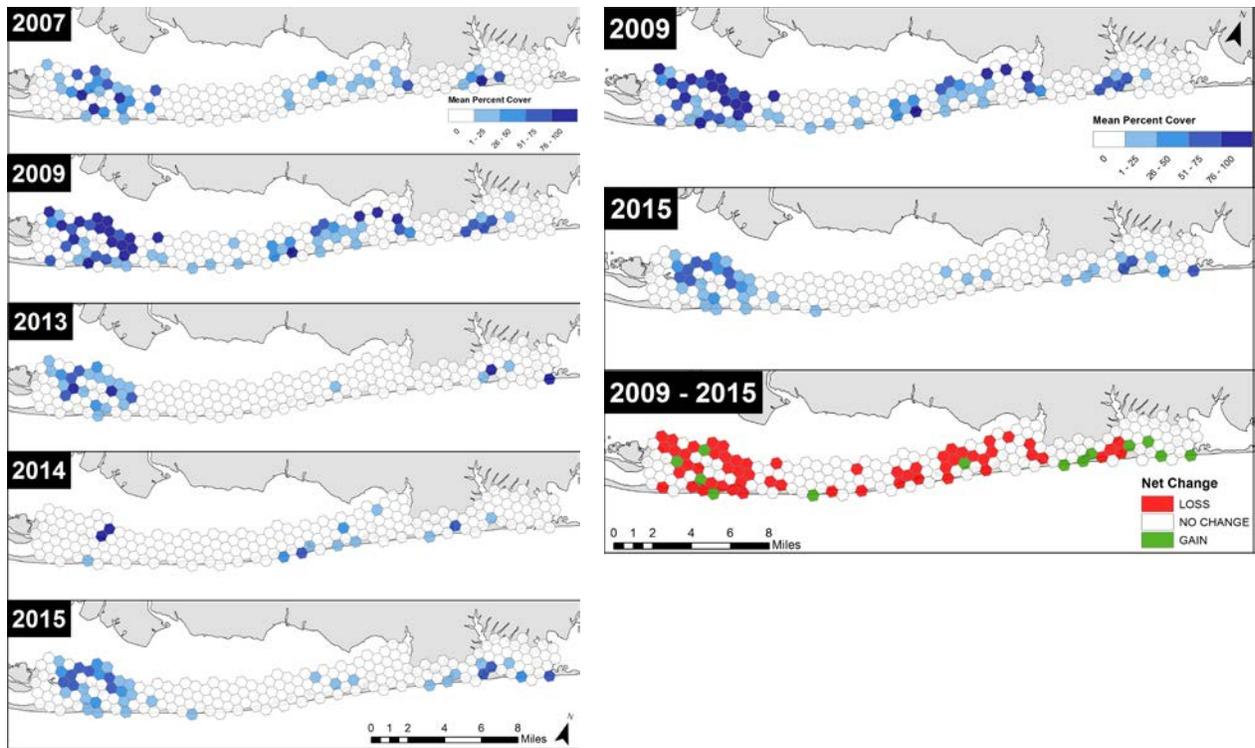
1 **Figure 49.** Eelgrass distribution 2007–2015 (left) and percent change 2009–2015 (right) (Peterson
 2 2015a, b).

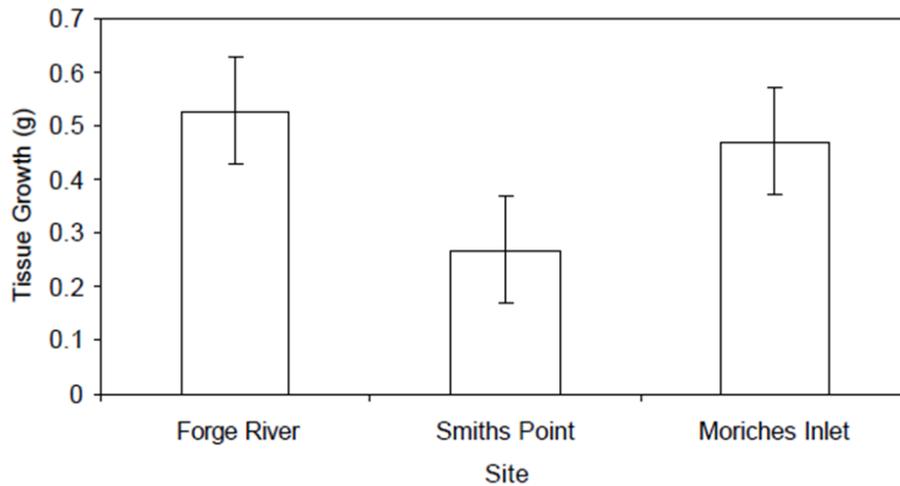
1
 2 **Figure 55.** Average clam dry weight for three sites at Moriches Bay, June 18, August 21, and October 20,
 3 2003 (Figure 4.7 from USACE 2004c).

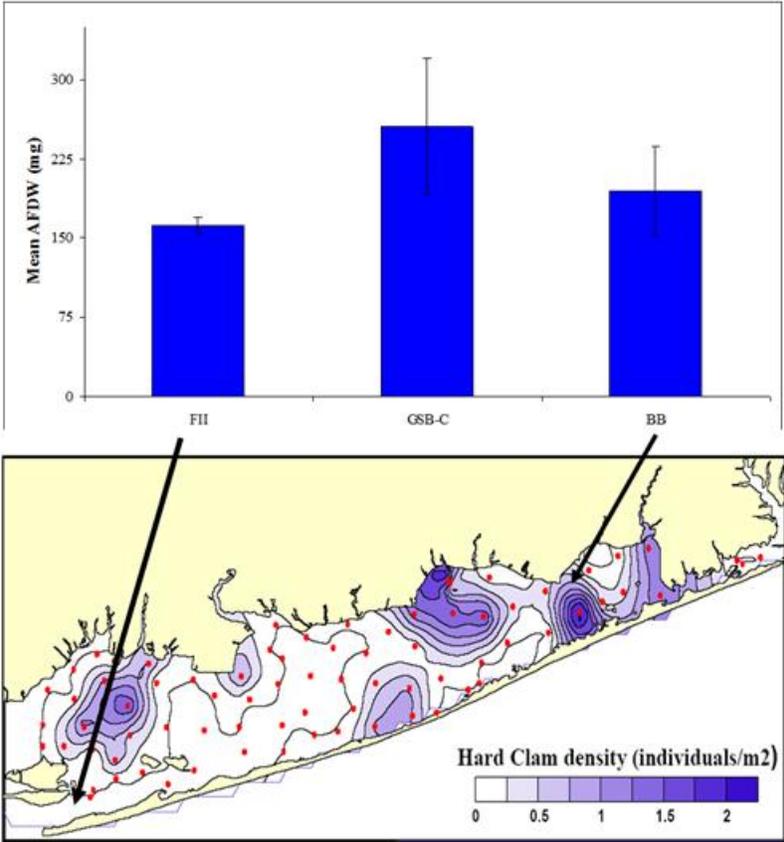
1
 2 **Figure 58.** Mean AFDW at each site (from Gobler 2014). Red dots indicate randomly selected sampling
 3 stations. BB=Bellport Bay, FII=Fire Island Inlet, and GSB-C=Central Great South Bay.

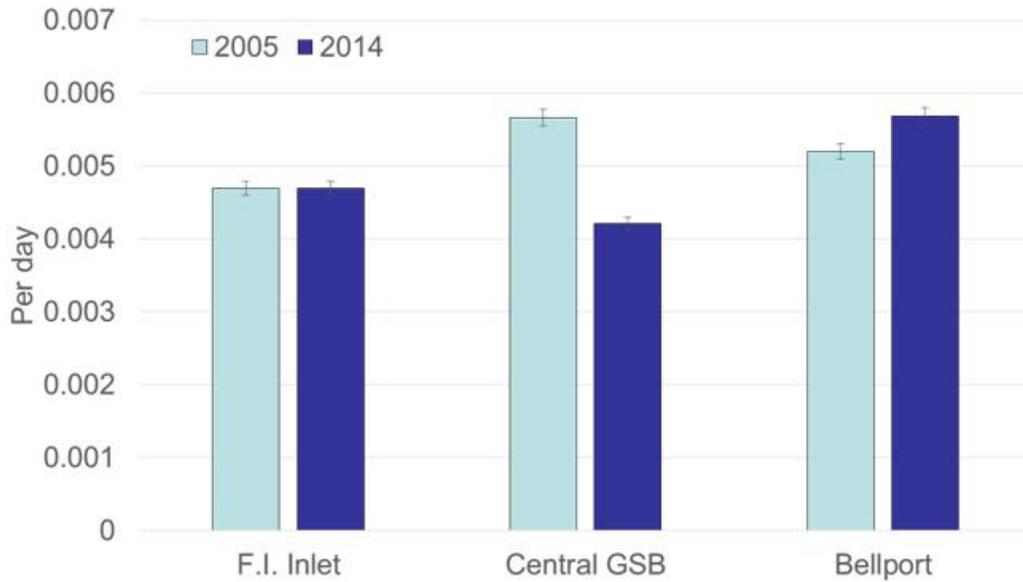
1
 2 **Figure 59.** Instantaneous growth rates of hard clams, 2005 versus 2014, most similar cohorts (from
 3 Gobler 2014).

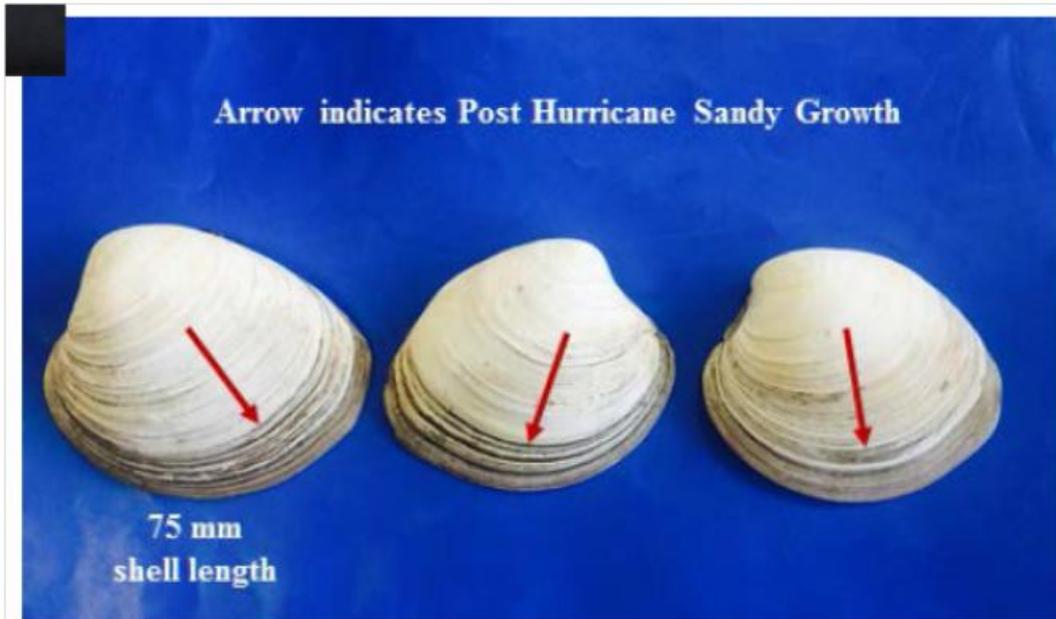
1
2 **Figure 60.** Hard clams collected in Bellport Bay after Hurricane Sandy (from Starke and LoBue 2016).

4 Improved measures of clam success in Bellport Bay after the breach have also been noted by Starke
 5 and LoBue (2016). Clams collected before and after the breach in Bellport Bay show marked
 6 differences in growth rates (Greene 1978; Starke and LoBue 2016). Whereas prior to Hurricane
 7 Sandy, clams in this location had slow growth rates and chalky white shells due to the acidic
 8 sediment in which they lived. Clams collected in Bellport Bay after Hurricane Sandy have secreted
 9 large and healthier-appearing growth rings in their shells, indicating improved growth rate and
 10 sediment habitat condition (Figure 60). Starke and LoBue (2016) also noted improvements in CI
 11 values for clams in Bellport Bay. Researchers sampled 20 individuals of naturally occurring clams
 12 from the same locations on the same date. The results show a striking improvement in CI from before
 13 the breach in 2009 compared to after the breach in 2015 at Bellport Bay, whereas CI for central Great

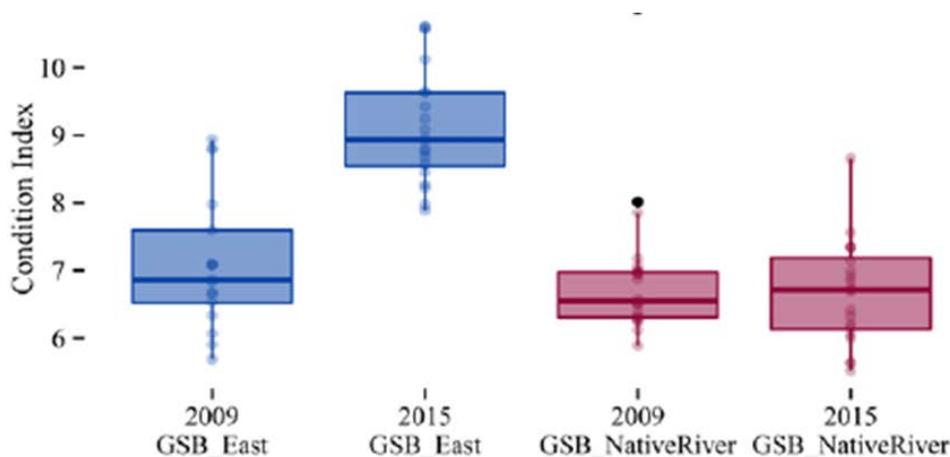
3
4 **Figure 61.** Boxplots displaying mid-November condition index measures at eastern Great South Bay /
5 Great South Bay east and central Great South Bay / Great South Bay native river sites (from Stark and
6 LoBue 2016).

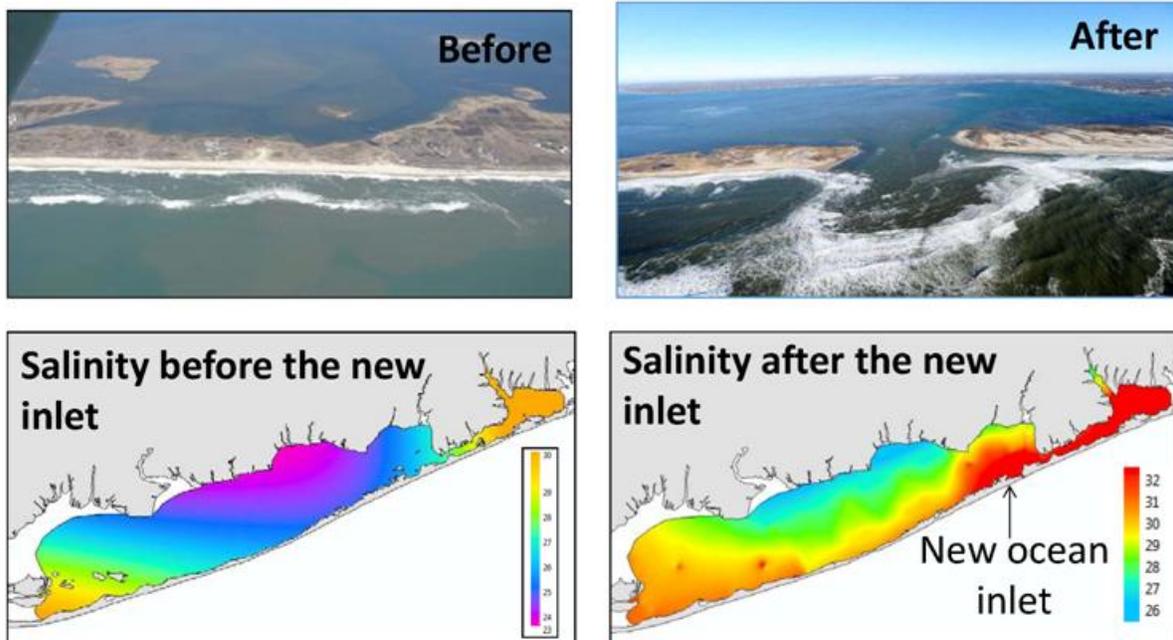
18
19 **Figure 64.** Map of salinity before the breach (left panel) and after the breach (right panel) (from Gobler,
20 Collier, and Lonsdale 2014).

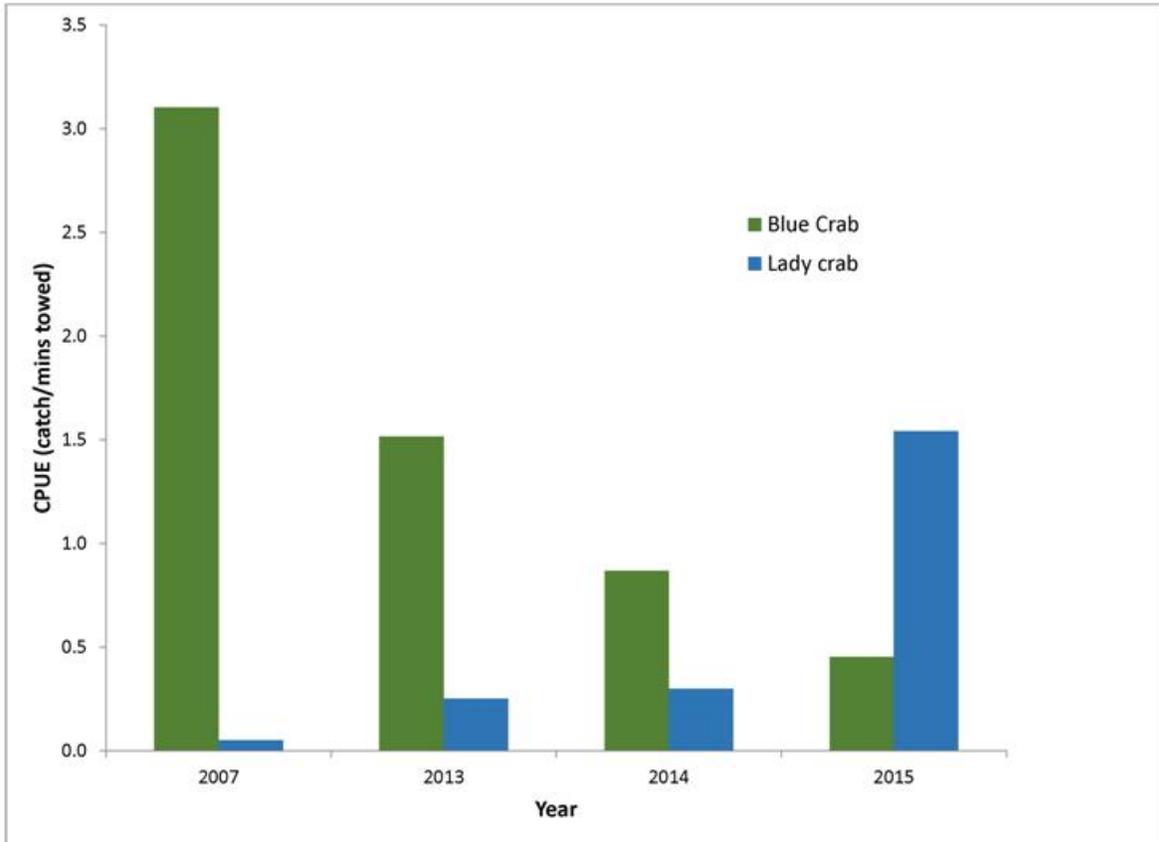
1
 2 **Figure 67.** Change in catch per unit effort over time for blue crab and lady crab collected in Great South
 3 Bay trawl survey (from Frisk et al. 2015).

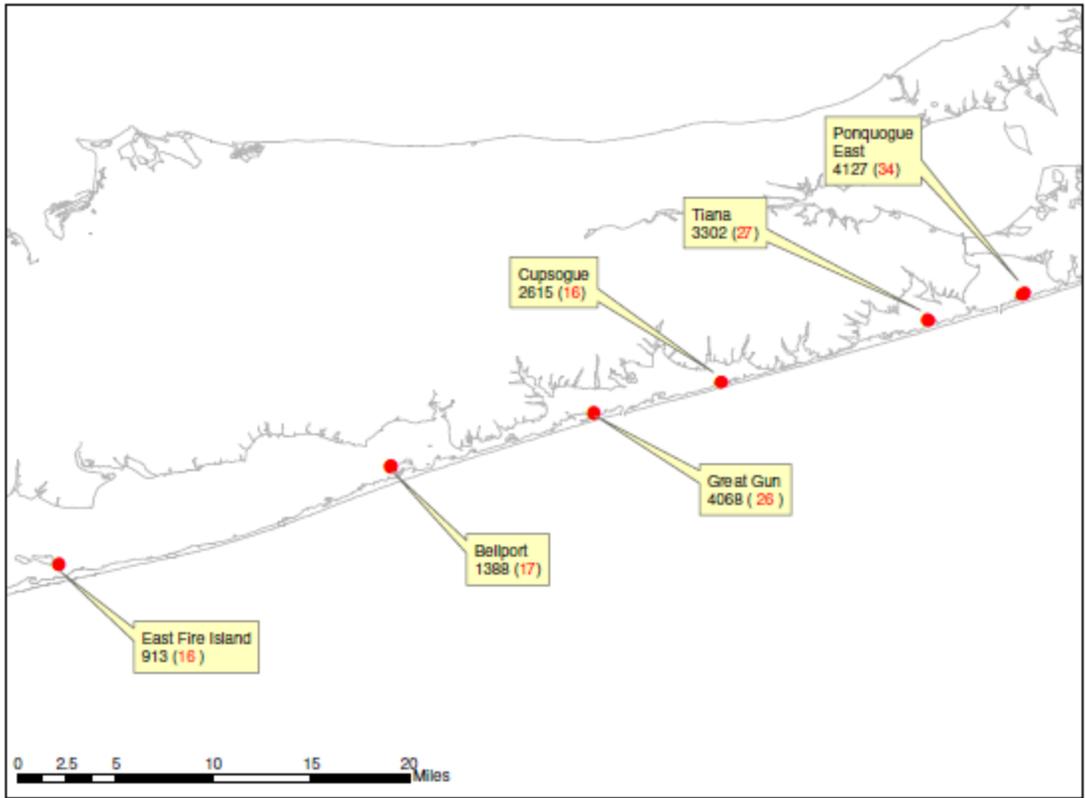
1
 2 **Figure 70.** Finfish abundance (black) and species richness (red) per site in seine samples taken in
 3 submerged aquatic vegetation beds in 2003 (from USACE 2004b).

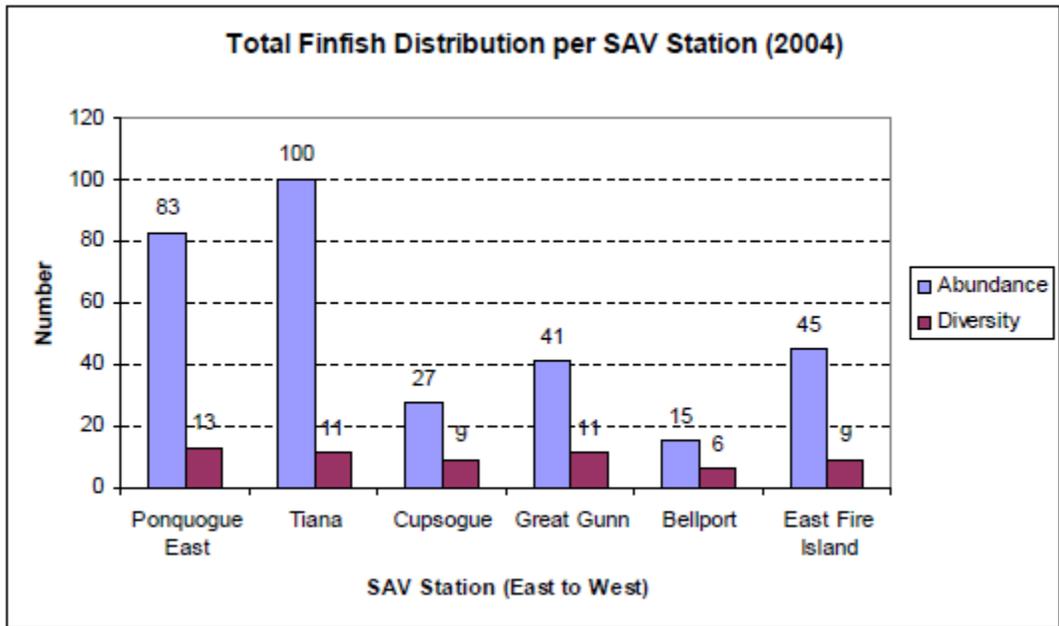
4
 5 **Figure 71.** Finfish abundance and species richness per site in seine samples collected in 2004 (from
 6 USACE 2006b).

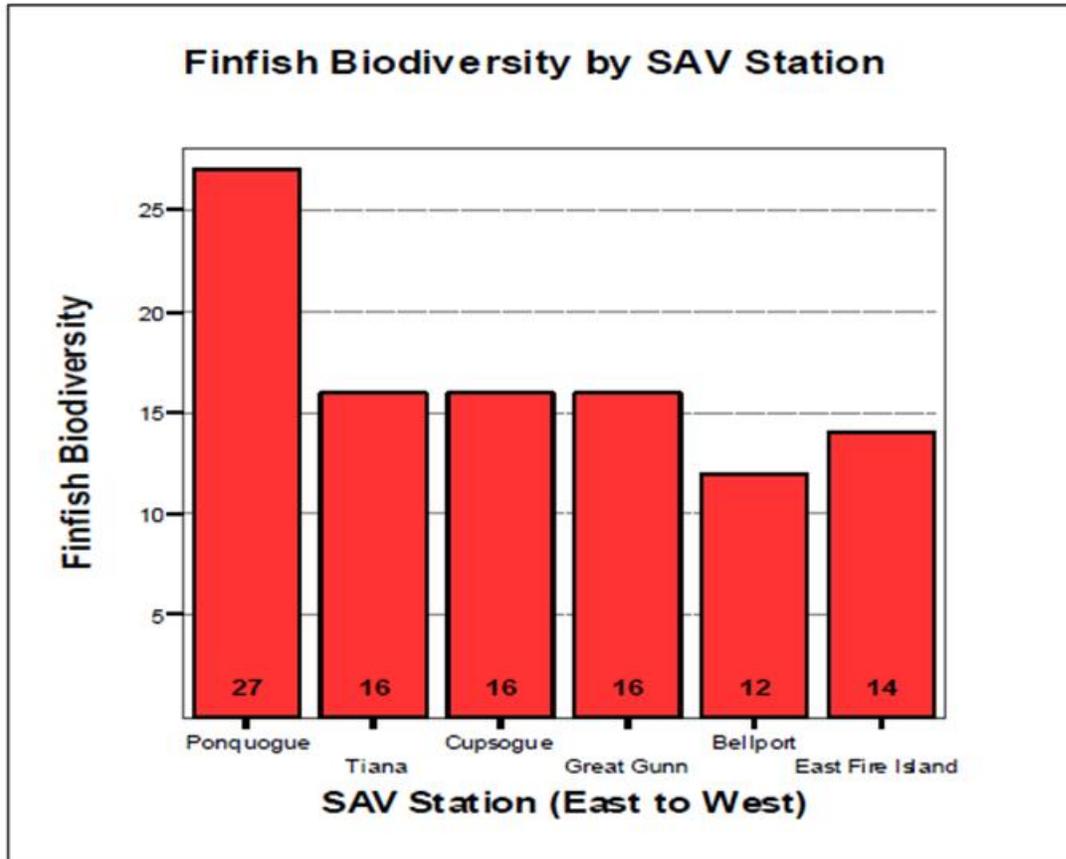
1
 2 **Figure 73.** Finfish diversity per site from the 2005 seine survey in submerged aquatic vegetation beds
 3 (from USACE 2006b).

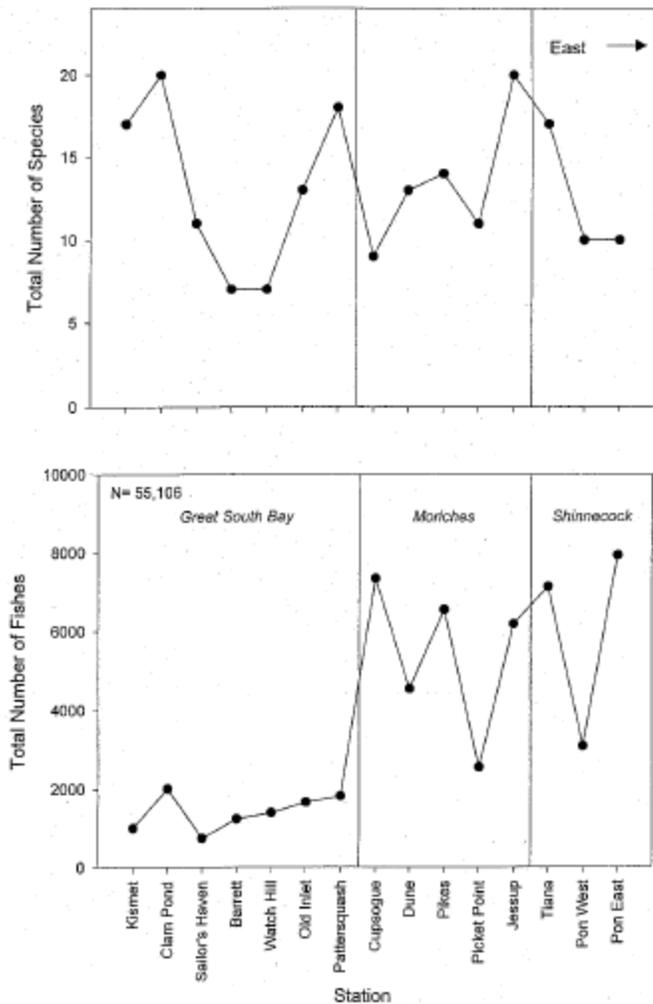
1
 2 **Figure 74.** Finfish species richness (top panel) and finfish abundance (bottom panel) at each site during
 3 seine survey conducted in 2000–2001 (from EEA Inc. 2002).

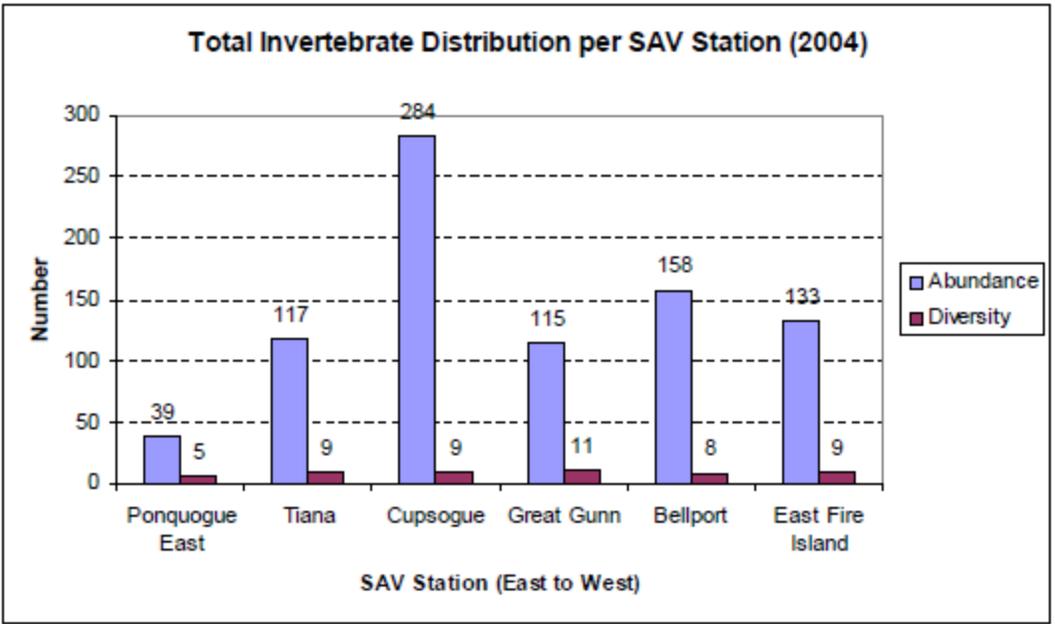
1
 2 **Figure 76.** Invertebrate abundance and diversity in seine samples collected in submerged aquatic
 3 vegetation beds during 2004 survey (from USACE 2006b).

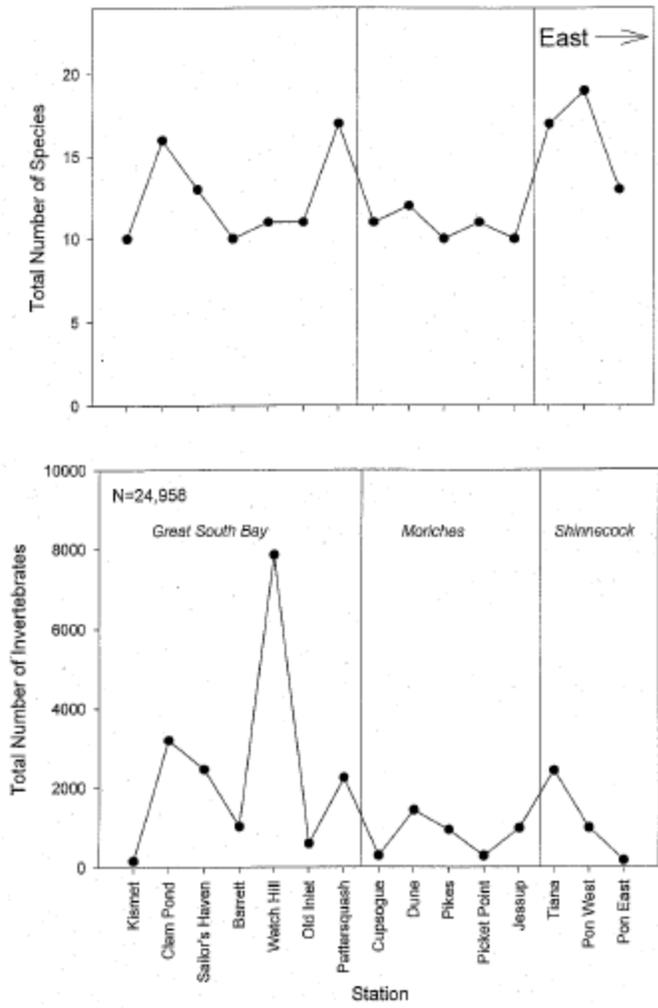
1
 2 **Figure 77.** Invertebrate species richness (top panel) and abundance (bottom panel) from seine survey
 3 conducted in 2000–2001 (from EEA Inc. 2002).
