1 **Technical Synthesis Report for Physical and**
2 **Ecological Resources at Fire Island National Seashore**

3 Natural Resource Report **NPS/XXXX/NRR—2016/XXX**

Technical Synthesis Report for Physical and Ecological Resources at Fire Island National Seashore

August 2016

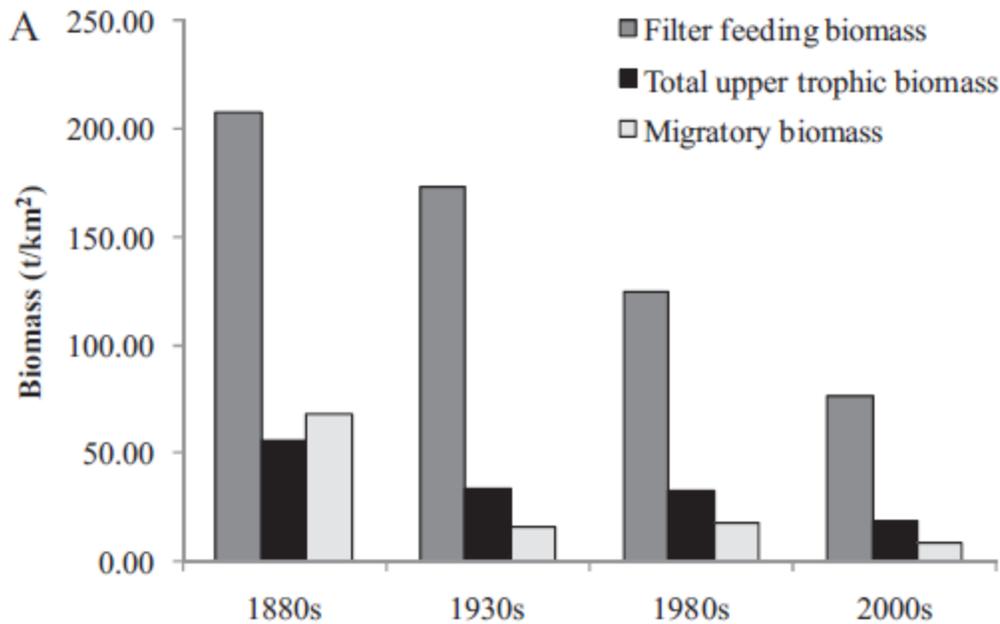
1
 2 **Figure 79.** Biomass of filter feeders (i.e., suspension feeders), upper trophic levels, and migratory species
 3 has declined since the 1880s. Filter feeders included hard clams, oysters, other suspension feeders, sand
 4 shrimp, other shrimp, menhaden, and zooplankton. Migratory species included black sea bass, bluefish,
 5 gadids, menhaden, scup, sharks, skates, squid, striped bass, summer flounder, weakfish, winter flounder,
 6 and tropical fish (from Nuttall et al. 2011).

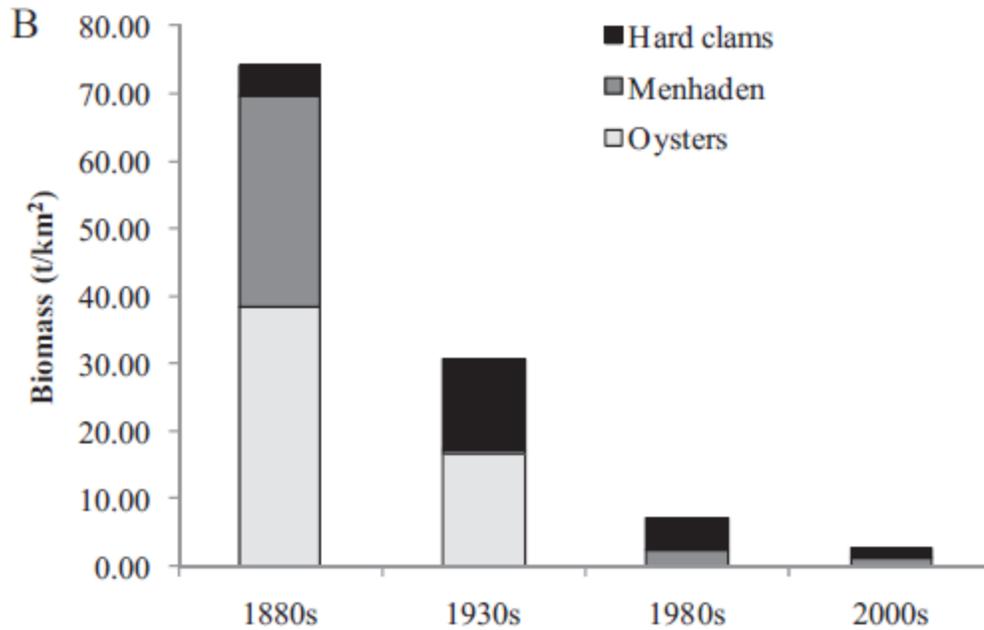
1
 2 **Figure 80.** Biomass of three major suspension feeding groups has declined since the 1880s (from Nuttall
 3 et al. 2011).
