National Park Service
U.S. Department of the Interior

Buffalo National River
Arkansas

Erbie Road Improvements Environmental Assessment

ENVIRONMENTAL ASSESSMENT for the REHABILITATION OF COMPTON ERBIE ROAD, and the COVE CREEK CROSSINGS on COUNTY ROAD 57 and COUNTY ROAD 79 at BUFFALO NATIONAL RIVER

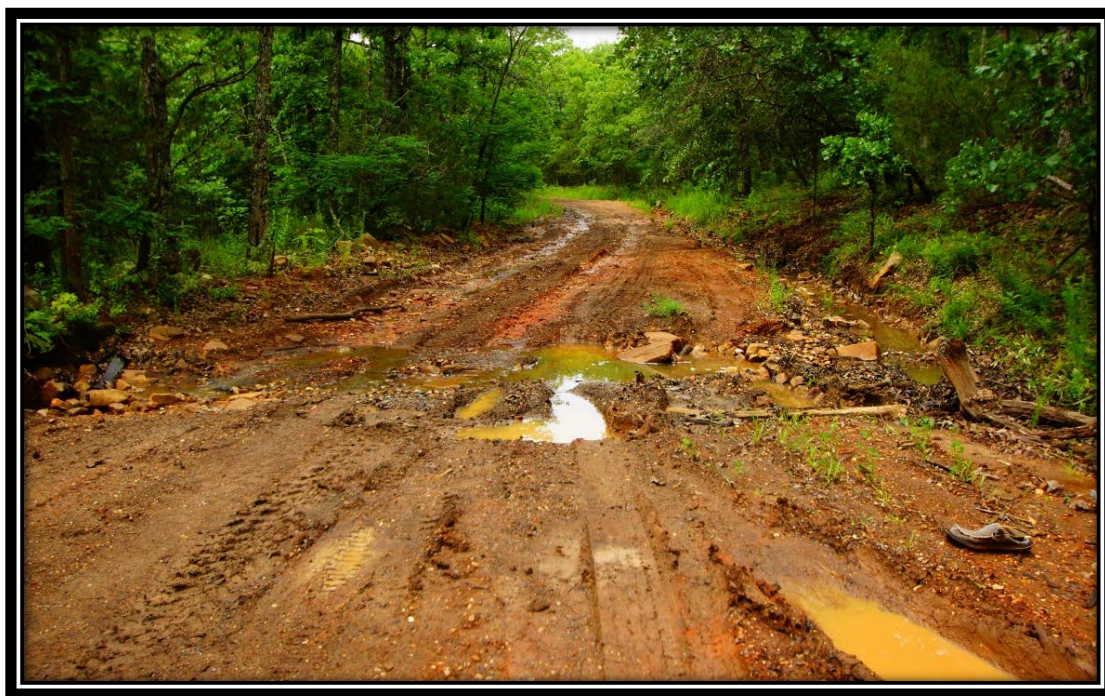
At Compton-Erbie Road, the intense rainfall from the storm overwhelmed the gravel road and its drainage system. The portion of this road that is proposed for repairs is approximately 2.58 miles long, starting at the intersection with County Road 57 and traveling to the west. Several sections of the road were washed out, and multiple culverts were clogged with debris or washed out (Figure 3). The damage was exacerbated by the substandard roadway condition and poor soils. Over time the road has lost its shape; lacking adequate drainage design features, like a crown and a cross slope or rolling dips, that would direct runoff to the adjacent ditches. Without proper drainage for road runoff, water runs down the road and erodes the road surface. The adjacent ditches eventually exceed their capacity and undergo rapid bank erosion in addition to becoming filled with road material and depositing sediment in local waterways. The soil composition also hinders road use due to its high clay content. Clay is difficult to compact, tends to lose stability when wet, and often results in rutting from vehicular use. The combination of these events and conditions has caused the roadway to become entrenched in relation to the surrounding landscape and makes it difficult for rainfall to run off of the roadway. Since the storm damage occurred, the road is now extremely difficult to drive. Visitors are recommended against using this road, as it is only traversable under dry conditions by a four-wheel drive vehicle.

Figure 3. Storm Damage to Compton-Erbie Road (County Road 19)

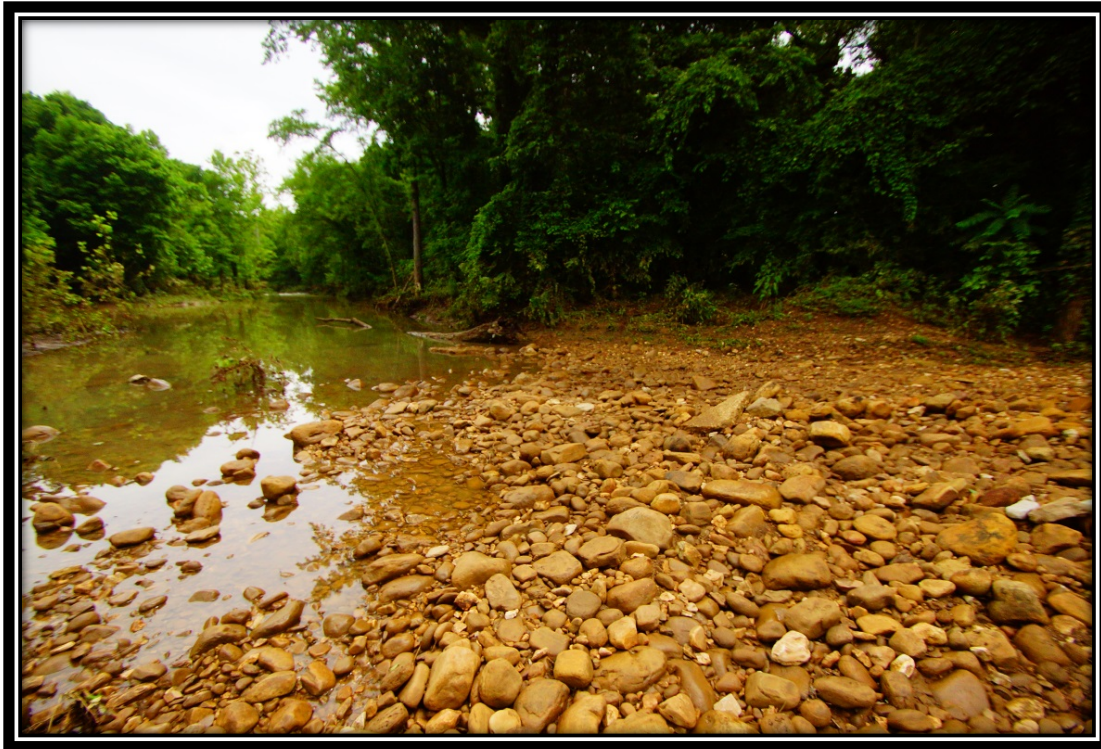
County Road 79, from its intersection with County Road 57 to the Buffalo River (including the low-water crossing at Cove Creek), was severely damaged by the May 2015 storm. Maintenance of this primitive road with a grader throughout the years has resulted in the road becoming lower and wider. Due to the pre-storm configuration of the road being lower than the stream bank, the flood-stage water levels diverted, creating an eroded channel along the roadway. The flood waters also carry a large amount of material downstream which is deposited on the road and into the Buffalo River (Figure 4). With each subsequent flood event, the damage reoccurs and requires repair in order to restore access to the area. The storm damage has changed the hydrology of the confluence of Cove Creek with the Buffalo River.

Figure 4. Deposit of bed materials downstream from crossing at County Road 79

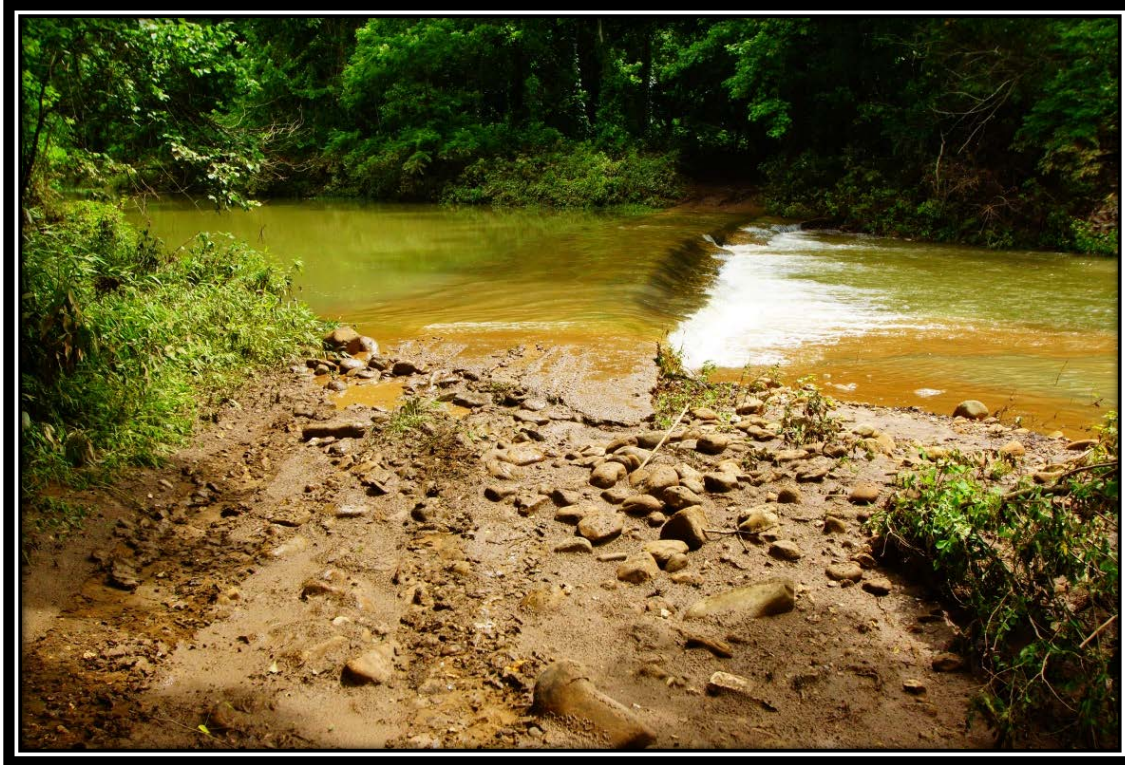
The low-water crossing at County Road 79 acts as a spillway, damming up water upstream before releasing over the top at a higher velocity (Figure 5). The higher velocity increases the scour on the downstream side of the low-water crossing, and so there is now a two-foot drop in the stream channel profile and increased bank erosion. Material has also eroded from underneath the structure on the downstream side, which has weakened the stability of the low-water crossing.

Figure 5. County Road 57 Low-water Crossing

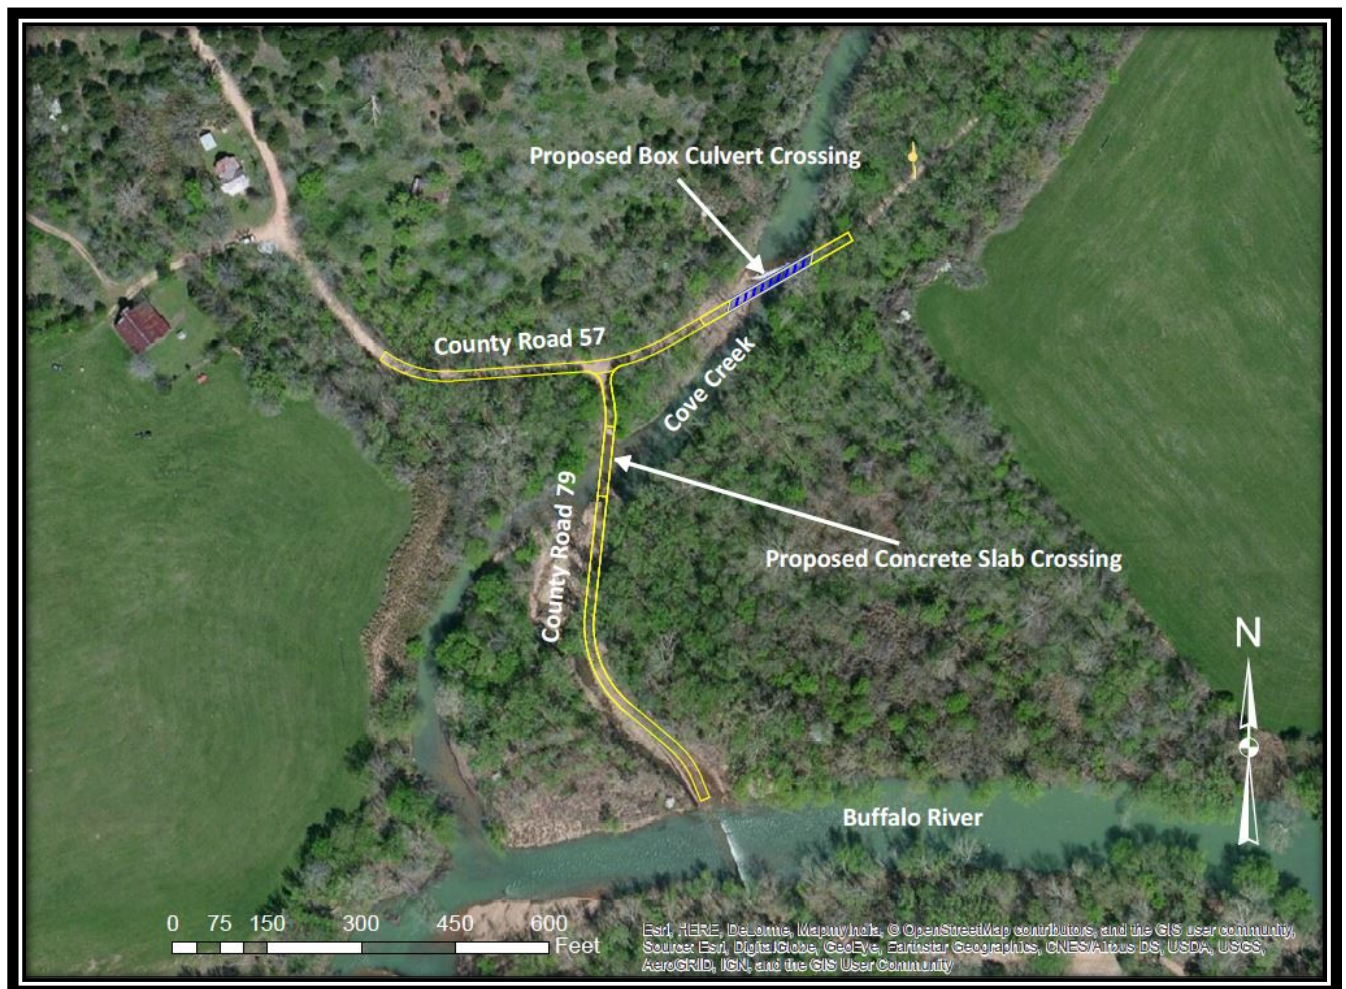
Two low-water crossings traversing Cove Creek would be replaced, one on County Road 57 and one on County Road 79 (Figure 7). This area lies in the floodplain of Cove Creek and the Buffalo River and has seen significant damage due to frequent flooding. In order to repair the damage and provide more sustainable access through this area, low-water crossings on County Road 57 and County Road 79 would be replaced, articulated concrete block mats would be installed on the approaches, and the roads and ditches on County Road 57 and County Road 79 would be reconditioned. The crossing on County Road 57 would be replaced with eight (8-foot span by 4-foot rise) box culverts and the crossing on County Road 79 would be replaced with a concrete slab.

Figure 7. Two Proposed Low-water Crossings

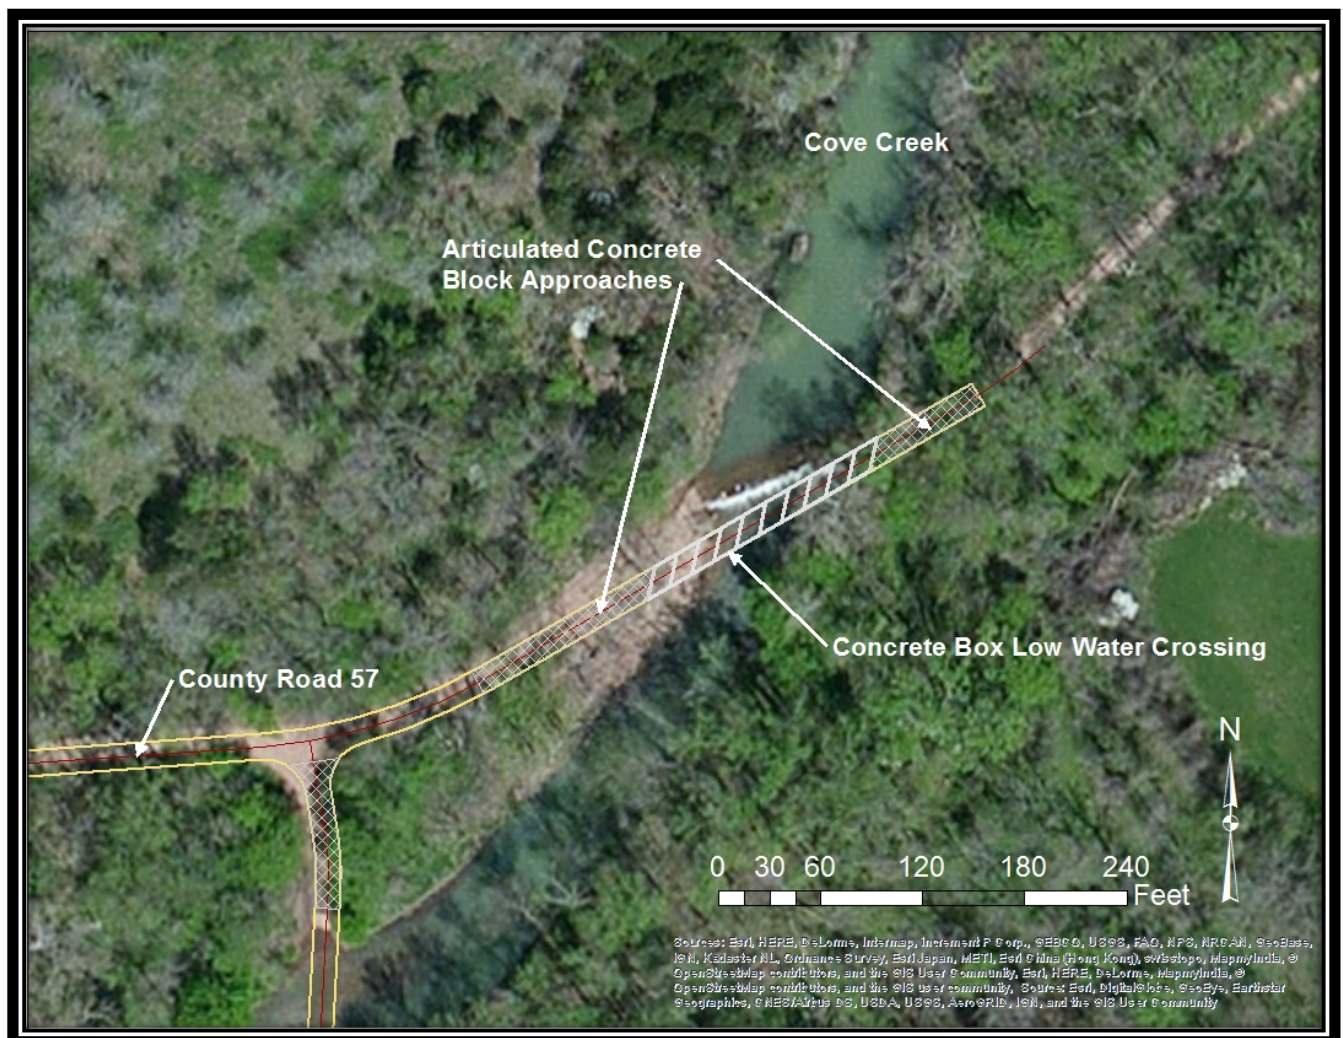
The first low-water crossing is located along County Road 57 at Cove Creek north of the Buffalo River, pictured in Figure 8. Temporary stream diversions would be installed, and the water behind the diversion would be pumped out through a filter bag to dewater the work area. The

work would be completed in two phases to allow stream flow to pass through the open half of the channel. The existing concrete slab would be broken up, removed, and disposed of off-site. A crane would lift and install eight pre-cast concrete box culverts side-by-side to function as a vented ford. The top elevation would be 847.07 feet, whereas the current crossing elevation is approximately 845 feet. This means that the new low-water crossing would be overtopped during flood events. However, during normal flow and minor storms, water would flow through the box culverts. The box culverts would each be eight-foot span by four-foot rise, and would be embedded approximately one foot into the streambed. This crossing would have a six-inch curb on both sides so that the edges of the crossing are known when the water level rises above the road elevation. It should be noted that both crossings are not intended for use during high water, as signs present at the approaches indicate.

Figure 8. Crossing of Cove Creek on County Road 57

During conceptual design, both concrete slab and concrete box culvert (vented ford) low-water crossings were analyzed for County Road 57 and County Road 79 in order to determine which crossing type best fit the conditions at each site. At the Country Road 57 low-water crossing, the existing concrete slab acts as a dam for low flow conditions, and the higher velocity water passing over the slab has eroded material on the downstream side. Installation of a new concrete slab low-water crossing would also require the installation of scour protection (riprap) on the downstream side to keep this condition from getting worse over time. The interdisciplinary team, comprised of members from FHWA and NPS, determined that the replacement of the

existing slab with a new concrete slab should be dismissed from further consideration as a repair option at this location.

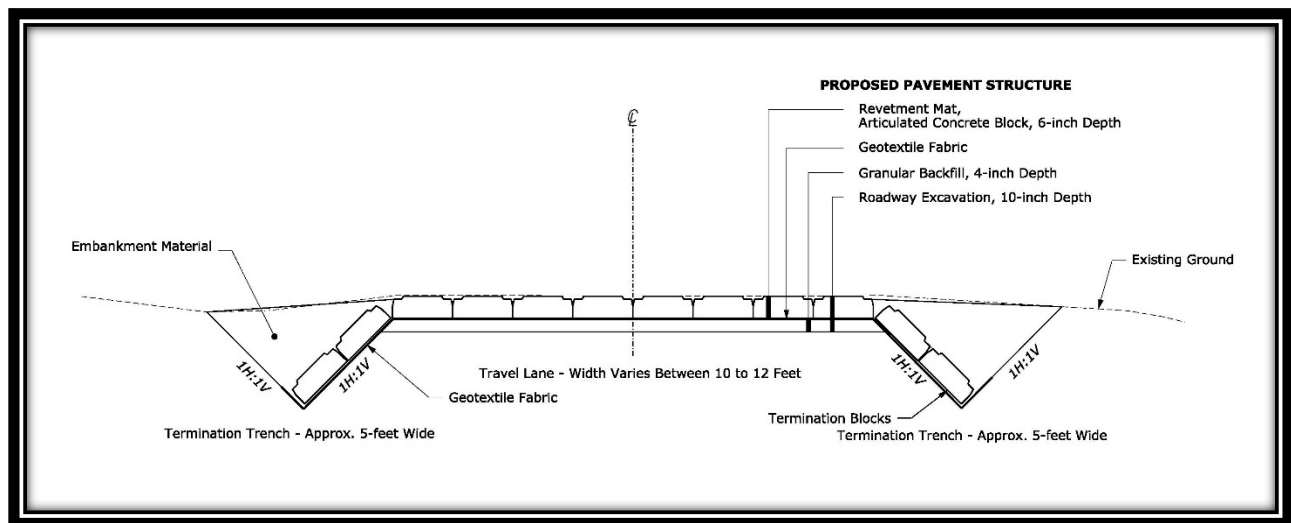
Regrading to raise the roadway approaches is needed to accommodate the raised road elevation resulting from the box culvert installations. Articulated concrete block mats would be installed along the roadway approaches. The mats consist of interlocking concrete bricks, linked by cables, that when placed together form a flexible yet sturdy surface. These mats are intended to prevent erosion on exposed surfaces and provide stability. They are being used solely at the low-

water crossing approaches; since these areas are prone to erosion and instability. The mats would cover the entire 12 feet of the road surface, and would be embedded in the embankment along the road. The cross section is shown in (Figure 9).

Figure 9. Typical Articulated Concrete Blocks Cross Section

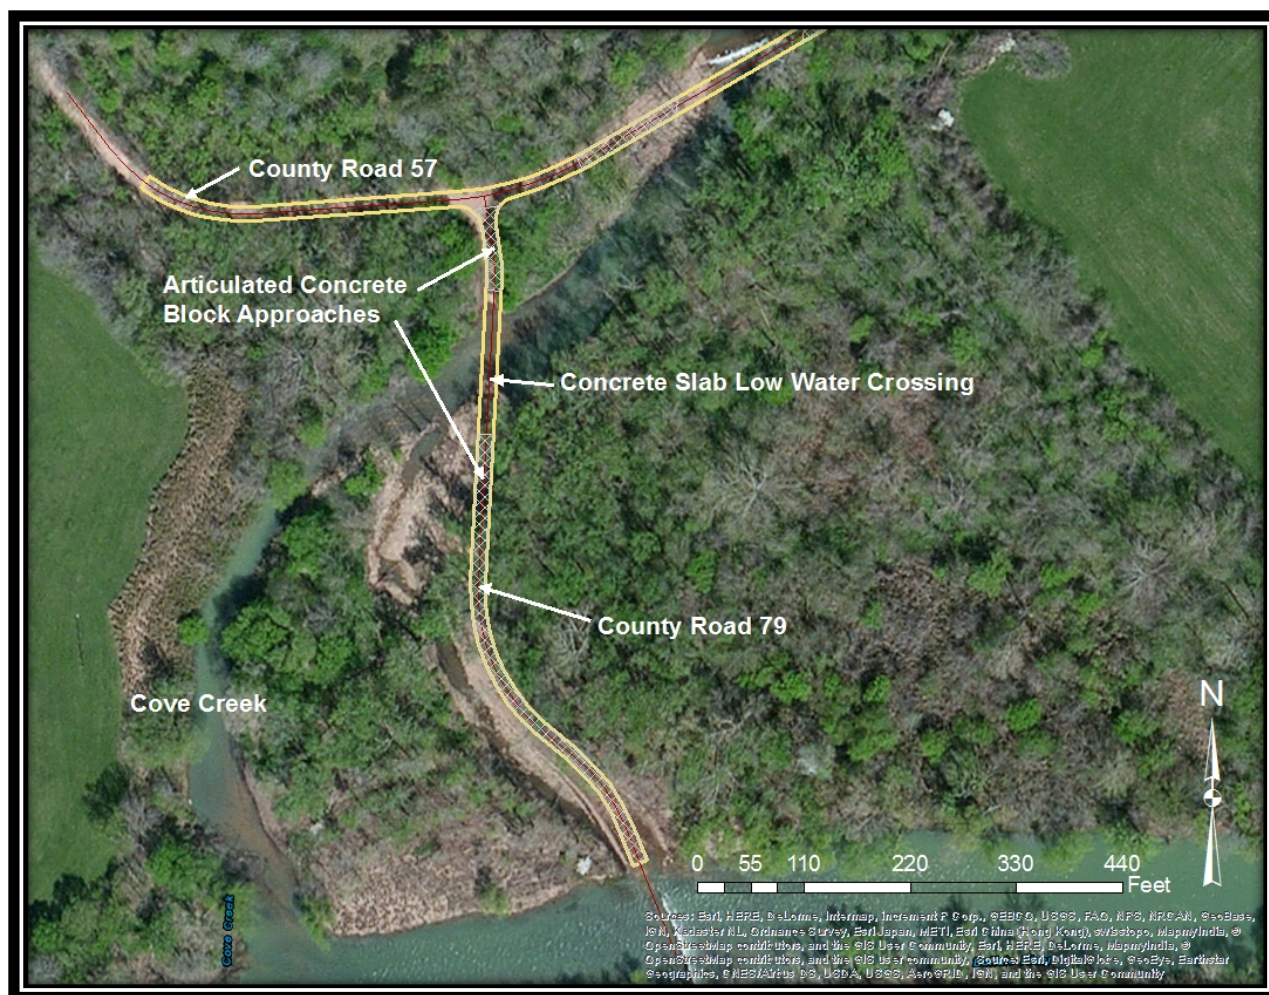
As seen in Figure 10, the second crossing is located along County Road 79 at Cove Creek, immediately south of the first crossing. Temporary stream diversions would be installed, and the water behind the diversion would be pumped out through a filter bag to dewater the work area. The work would be completed in two phases to allow stream flow to pass through the open half of the channel. The existing concrete slab would be broken up, removed, and disposed of off-site. The existing concrete slab low-water crossing would be replaced with a 120-foot long by 12-foot wide concrete slab low-water crossing. The concrete slab would be eight inches thick and would be cast in place. The surface of the concrete slab would be at the same elevation as the streambed. Articulated concrete block mats (six-inches deep) would be added from the intersection with County Road 79 to the end of the project near the Buffalo River. This would be realigned to allow for positive drainage from the roadway and to account for the raised road elevation.

Figure 10. Crossing of Cove Creek on County Road 79

During flood events, the County Road 79 low-water crossing is covered with a large amount of cobbles and debris due to its location in relation to the Buffalo River. Installing a concrete slab low-water crossing in this location would make recovery of this site after a flood event easier, because the site could be cleared of debris down to the slab. Installing box culverts would require additional equipment and effort, since the individual box culverts would need to be cleaned out to make sure they convey normal stream flow. The interdisciplinary team determined that the replacement of the existing concrete slab with a series of box culverts to create a vented ford should be dismissed from further consideration as a repair option at this location.

The concrete slab of the County Road 79 is being replaced in-kind and would be constructed to eliminate the drop off on the downstream side. This would result in improved streamflow conditions.
