Figure 11
 CATO-09
 Catoctin
 NPS/NCR Wetland Restoration Action Plan
 Frederick, Maryland

Figure 12
 CATO-11
 Catocin
 NPS/NCR Wetland Restoration Action Plan
 Frederick, Maryland

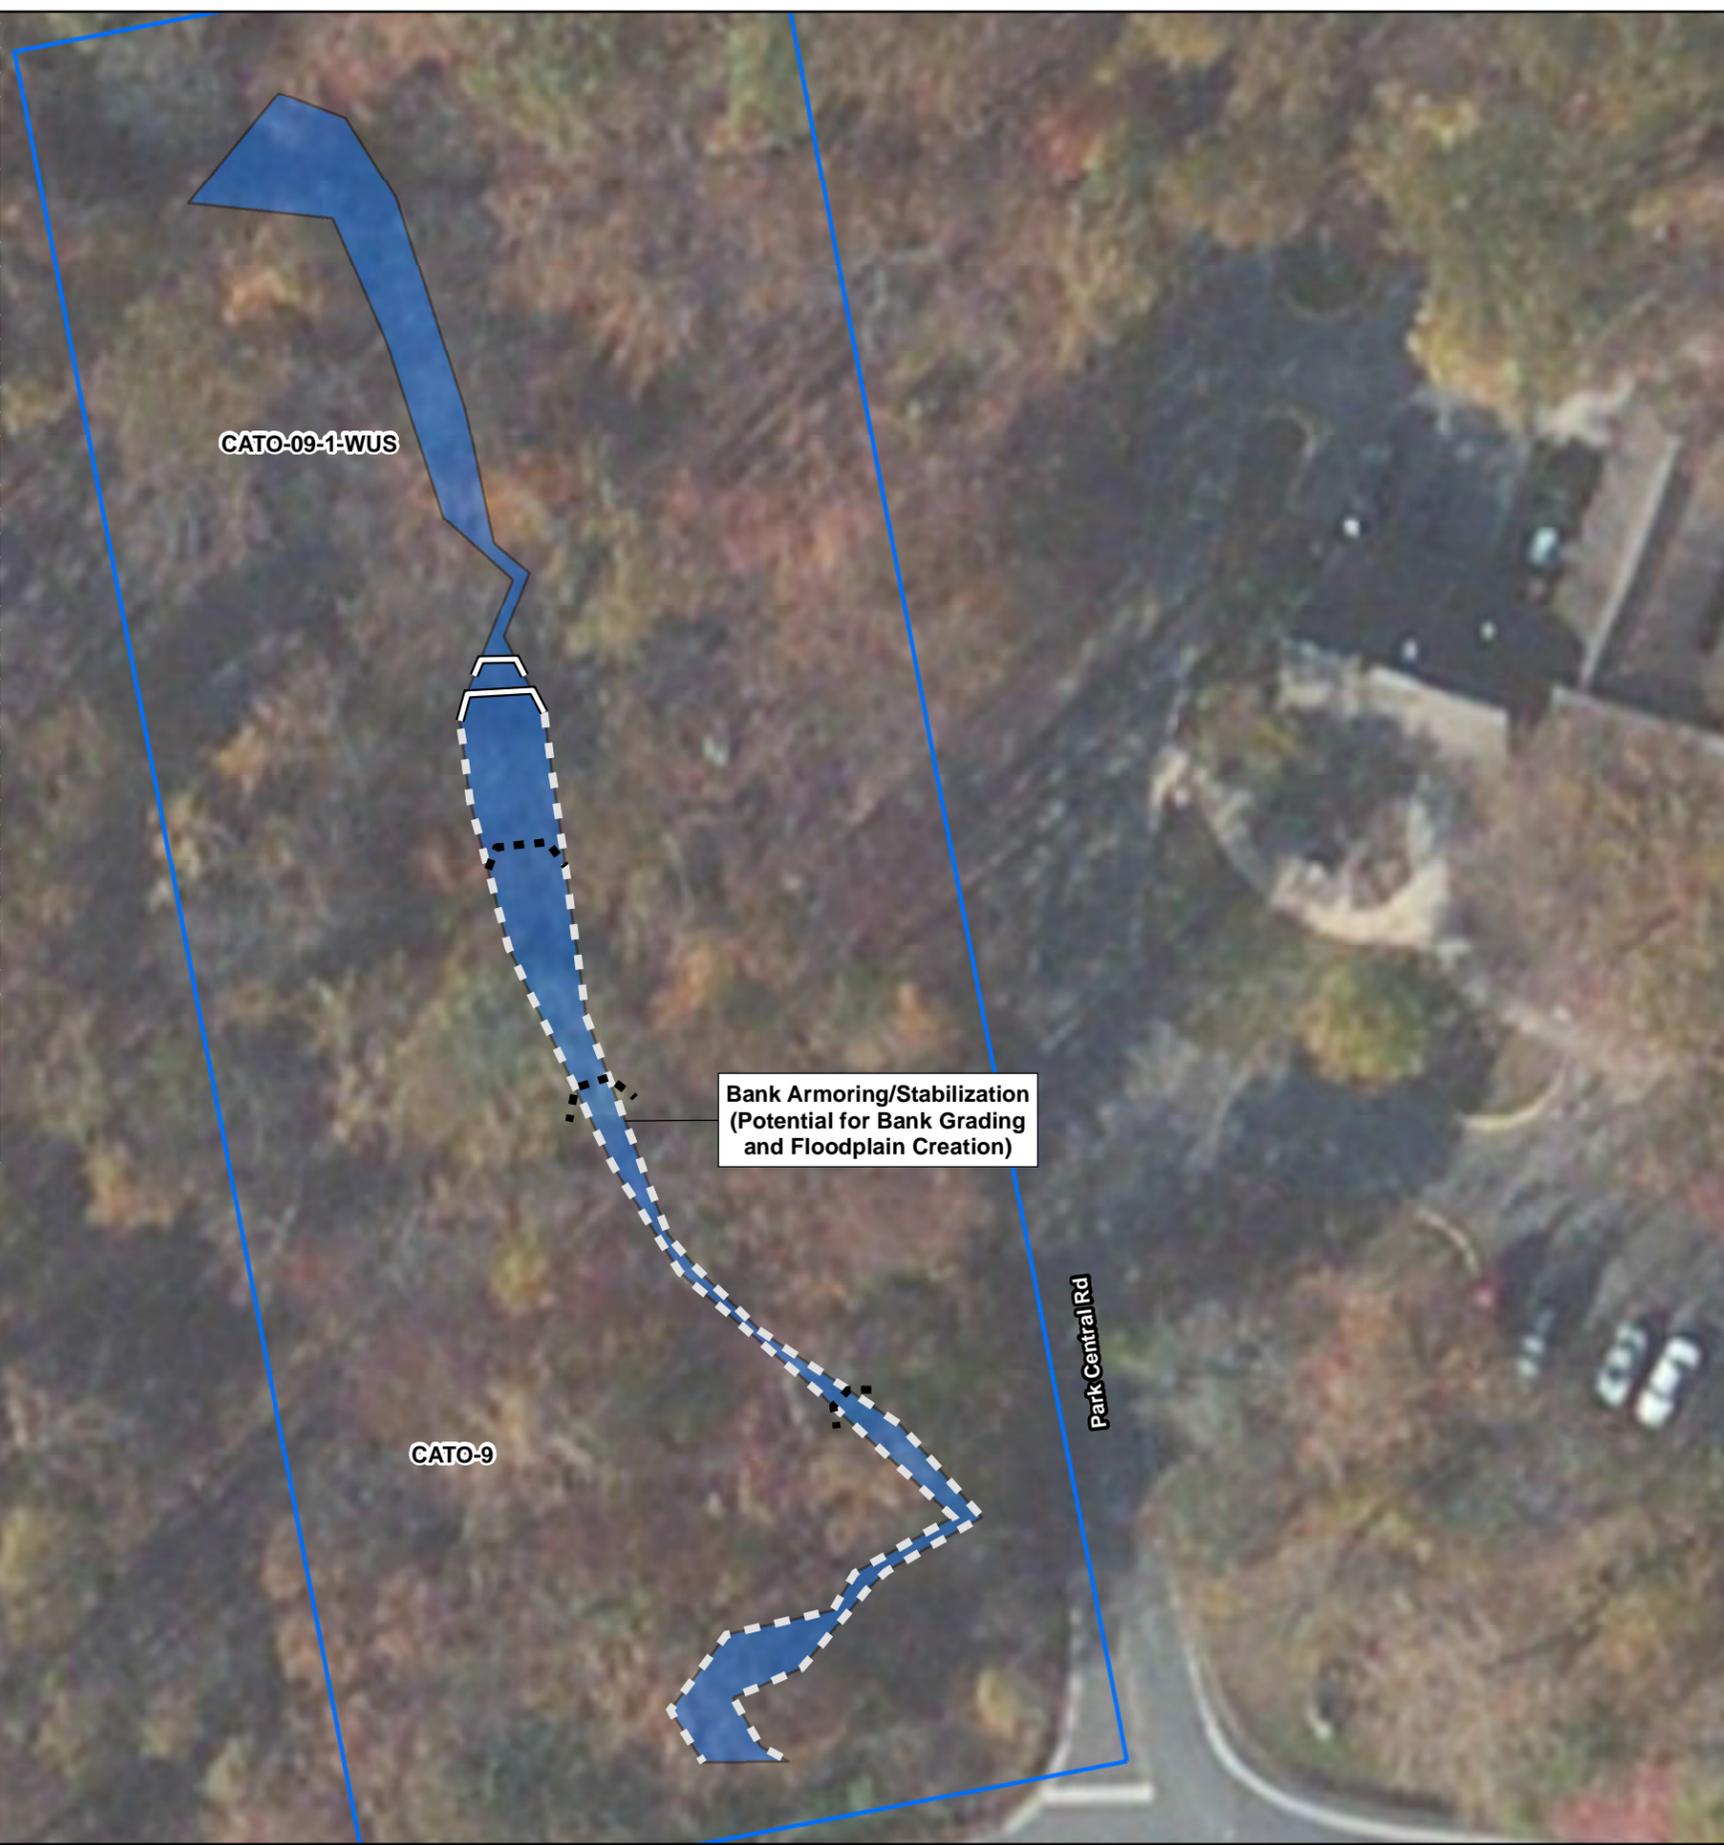
Site ID	CATO-9
Potential Restoration (linear feet)	150
Date	3/24/16
Existing Land Use	Forested with road crossing
Adjacent Land Use	Parking lot
Distance to Nearest Road	O two road crossings
Stream Hydrology	Perennial
RTE Species Present?	No
Known Cultural Concern?	Yes
Wetland Restoration Opportunity?	No
Existing Wetlands Present	No
Evidence of Disturbance	Yes
Can Restoration be Completed in NPS Area?	Yes
Estimated Bank Erosion Score	7
Degree of Channel Incision Score	6
Existing Floodplain Access Score	8
Opportunity for Floodplain Development Score	6
Threat of Impact to Resources Score	4
Surrounding Vegetation Score	5
Land Use Score	4
Opportunity for Ecological Lift Score	5
Ease of Access	9
Surrounding Land Use Score	4
Total Score	58
Invasives Species Control?	No
Riparian Buffer Enhancement?	No
Restore Natural Hydrology?	No
Livestock Agricultural Exclusion	No
Fish Passage?	Yes
Channel Restoration?	Yes
Increase Aesthetic or Educational Value?	Yes

Other	No
Notes	Historic culvert on upstream portion with three to four foot high banks. Mostly forested but road access on upstream and downstream ends. Two to three foot drop at historic culvert and slightly incised eroded banks downstream of culvert, over widened channel as well. grade control structures can be implemented down stream of culvert to reduce fish blockage and also reduce bank erosion.

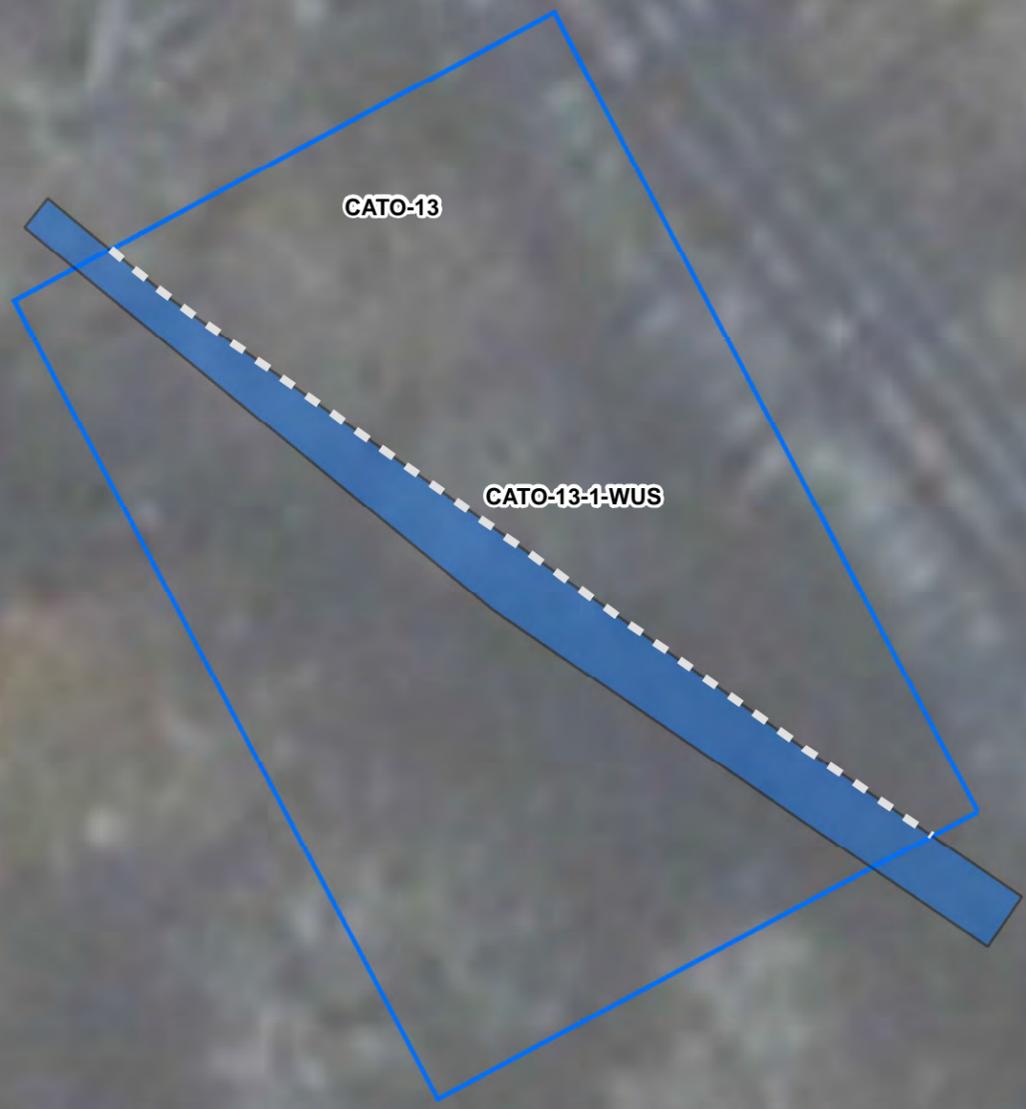
Figure 13
CATO-13
Catoclin
NPS/NCR Wetland Restoration Action Plan
Frederick, Maryland

Site ID	CATO-13
Potential Restoration (linear feet)	50
Date	3/31/16
Existing Land Use	Forested stream
Adjacent Land Use	Railroad tracks
Distance to Nearest Road	200 ft
Stream Hydrology	Perennial
RTE Species Present?	No
Known Cultural Concern?	No
Wetland Restoration Opportunity?	No
Existing Wetlands Present	No
Evidence of Disturbance	Yes
Can Restoration be Completed in NPS Area?	No
Estimated Bank Erosion Score	10
Degree of Channel Incision Score	2
Existing Floodplain Access Score	2
Opportunity for Floodplain Development Score	2
Threat of Impact to Resources Score	8
Surrounding Vegetation Score	4
Land Use Score	5
Opportunity for Ecological Lift Score	2
Ease of Access	1
Surrounding Land Use Score	5
Total Score	41
Invasives Species Control?	No
Riparian Buffer Enhancement?	Yes
Restore Natural Hydrology?	No
Livestock Agricultural Exclusion	No
Fish Passage?	No
Channel Restoration?	Yes
Increase Aesthetic or Educational Value?	Yes

Other	Yes
Notes	Stabilize railroad embankment failure and place rock and vegetation at toe of slope along stream.

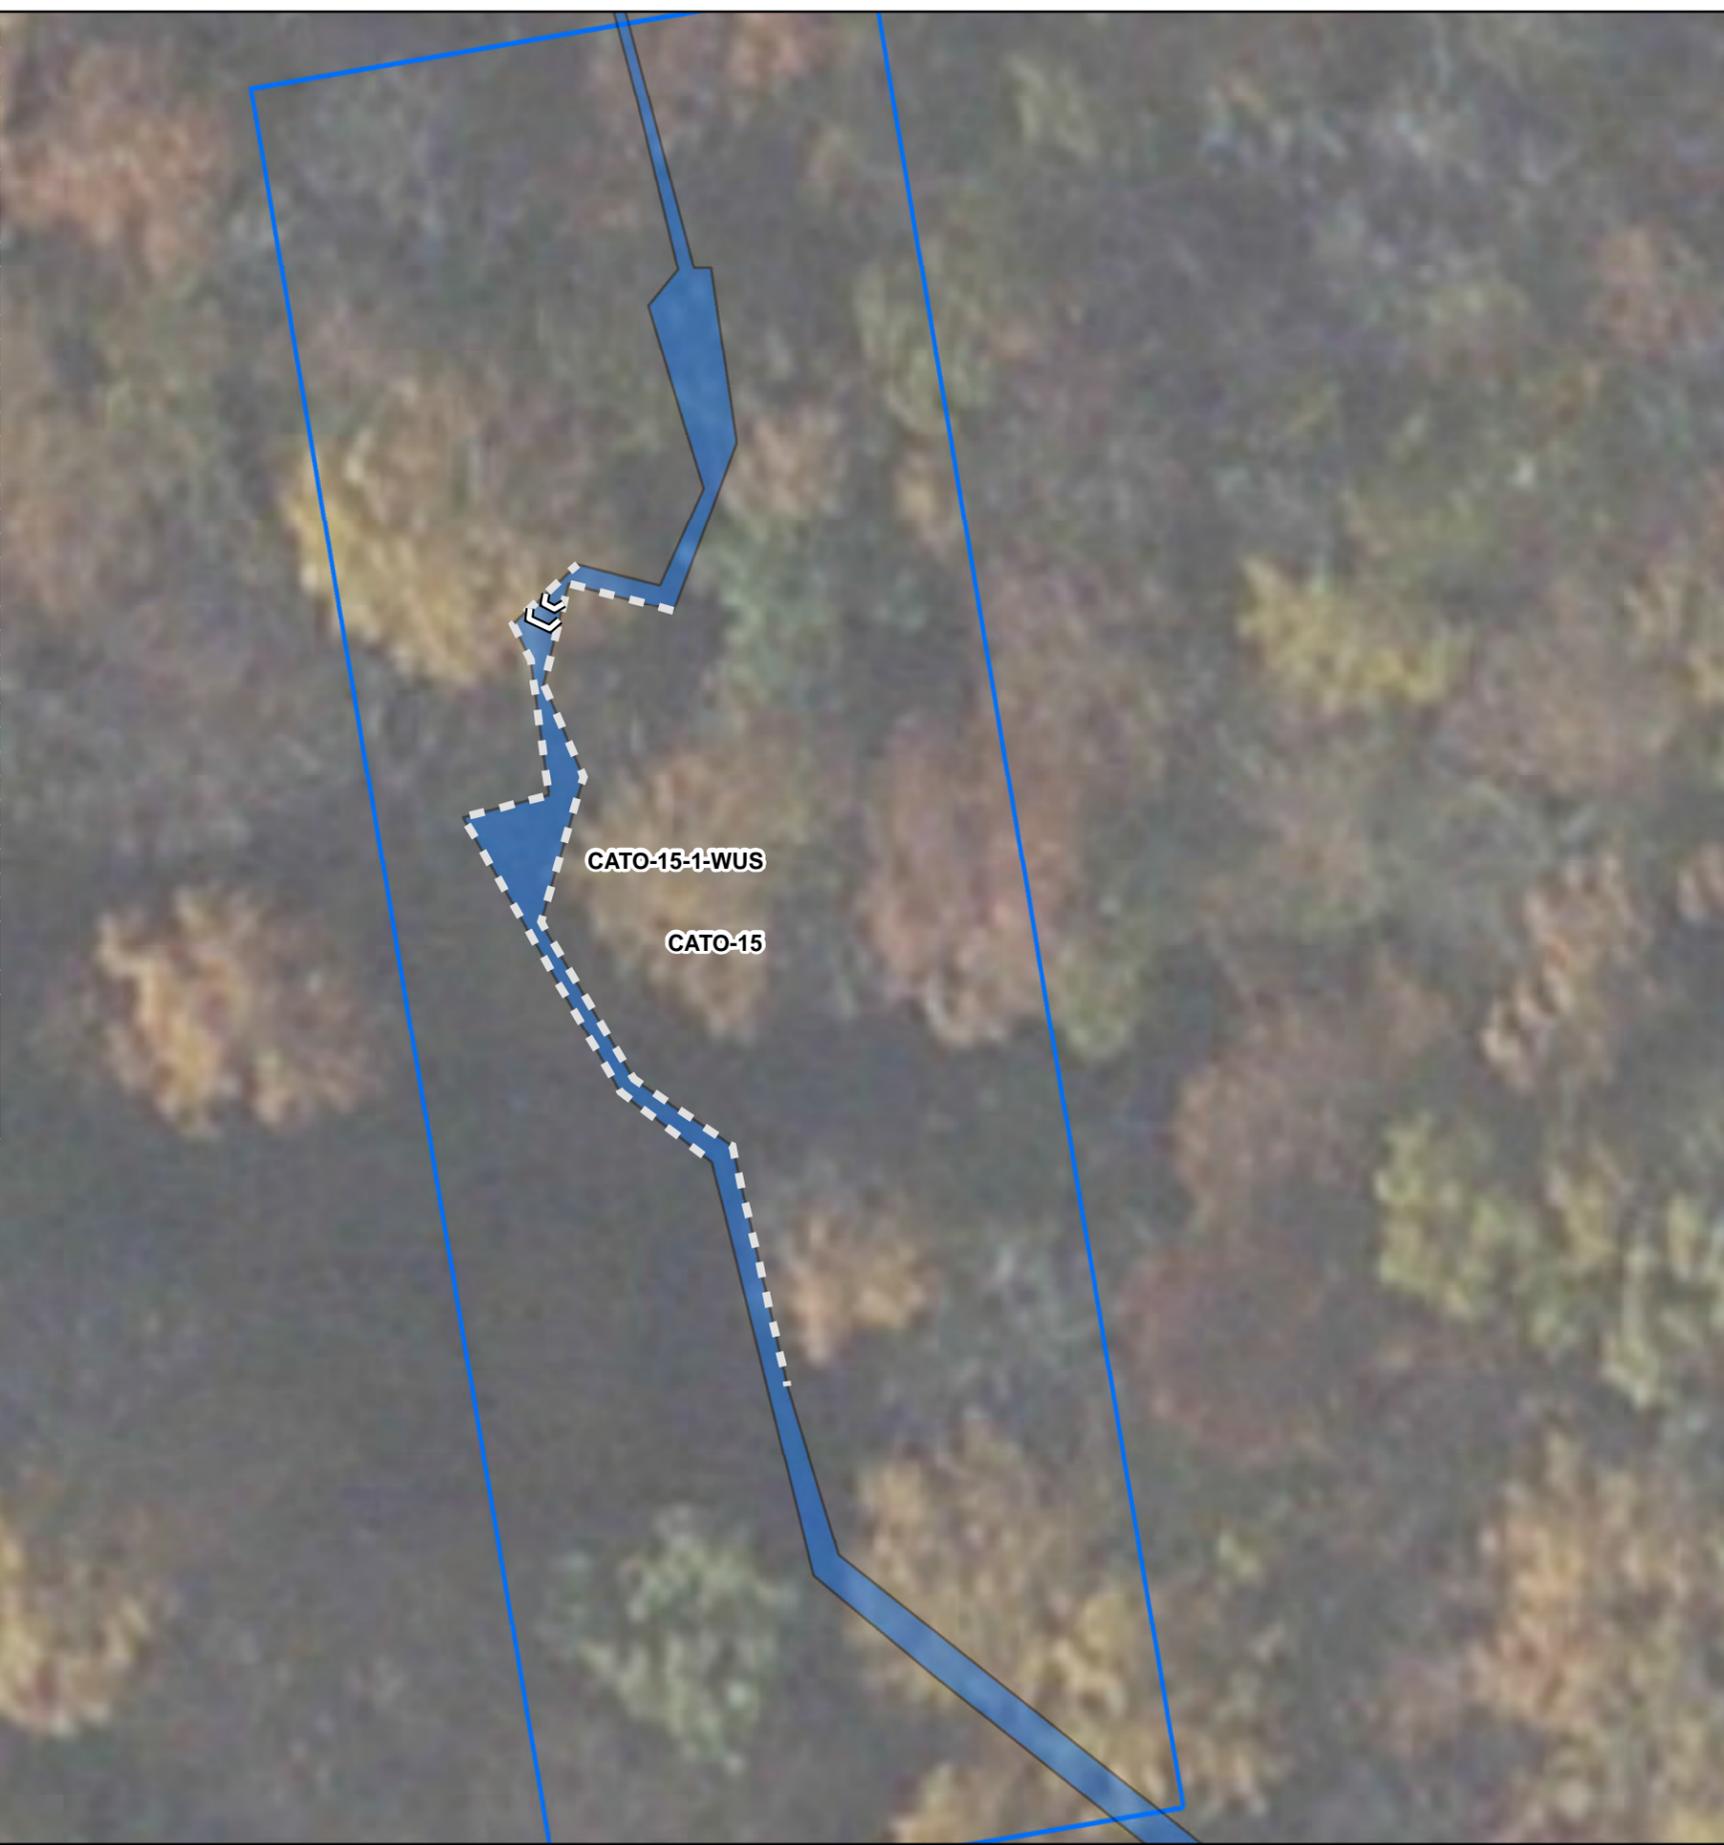
Figure 15
 CATO-15
 Catoclin
 NPS/NCR Wetland Restoration Action Plan
 Frederick, Maryland

Site ID	CATO-15
Potential Restoration (linear feet)	150
Date	3/24/16
Existing Land Use	Forested
Adjacent Land Use	Forested
Distance to Nearest Road	300 ft
Stream Hydrology	Perennial
RTE Species Present?	No
Known Cultural Concern?	No
Wetland Restoration Opportunity?	No
Existing Wetlands Present	No
Evidence of Disturbance	No
Can Restoration be Completed in NPS Area?	Yes
Estimated Bank Erosion Score	10
Degree of Channel Incision Score	7
Existing Floodplain Access Score	7
Opportunity for Floodplain Development Score	4
Threat of Impact to Resources Score	9
Surrounding Vegetation Score	2
Land Use Score	3
Opportunity for Ecological Lift Score	6
Ease of Access	4
Surrounding Land Use Score	9
Total Score	61
Invasives Species Control?	No
Riparian Buffer Enhancement?	No
Restore Natural Hydrology?	No
Livestock Agricultural Exclusion	No
Fish Passage?	Yes
Channel Restoration?	Yes
Increase Aesthetic or Educational Value?	Yes
Other	No
Notes	Highly eroded channel at head cut near hiking trails and maintenance building parking area. Head cut is creating fish blockage and has the potential to migrate upstream impacting stream further and decreasing stream quality. Stream habitat for multiple salamander species. Good grade control upstream and downstream and little invasive and SWM influence.

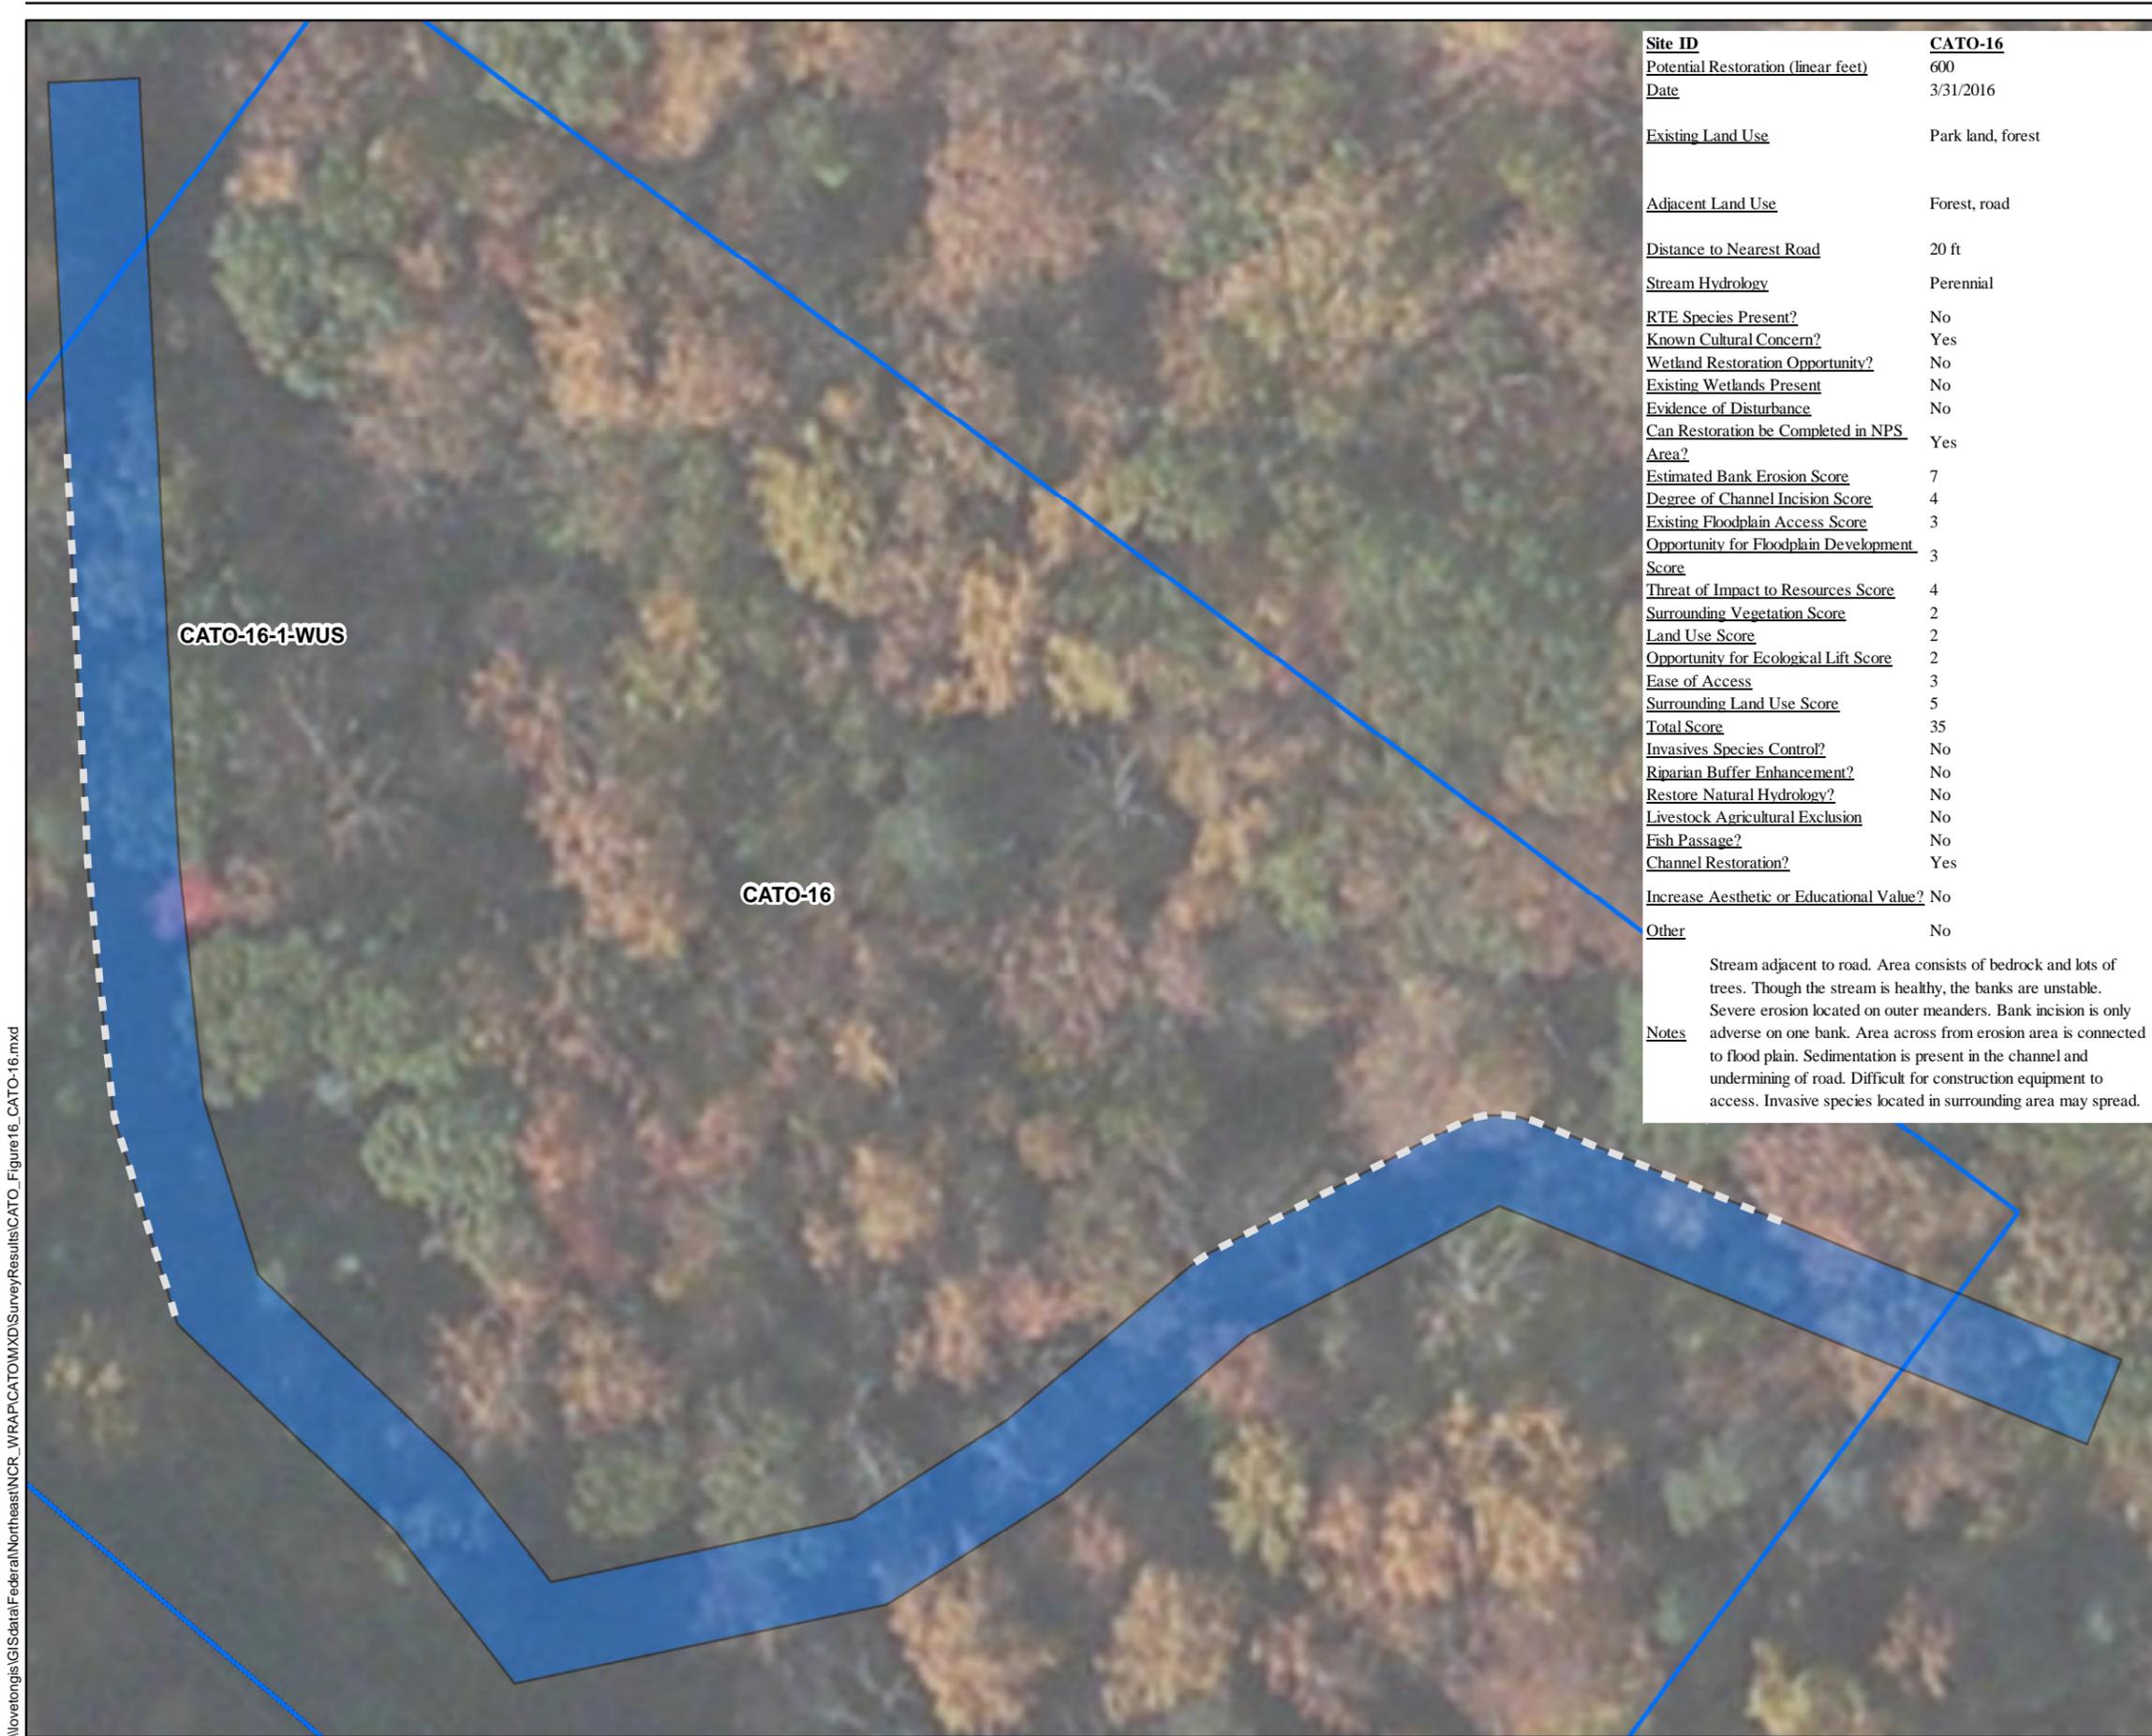
Figure 16
 CATO-16
 Catoctin
 NPS/NCR Wetland Restoration Action Plan
 Frederick, Maryland

Site ID	CATO-16
Potential Restoration (linear feet)	600
Date	3/31/2016
<u>Existing Land Use</u>	Park land, forest
<u>Adjacent Land Use</u>	Forest, road
<u>Distance to Nearest Road</u>	20 ft
<u>Stream Hydrology</u>	Perennial
<u>RTE Species Present?</u>	No
<u>Known Cultural Concern?</u>	Yes
<u>Wetland Restoration Opportunity?</u>	No
<u>Existing Wetlands Present</u>	No
<u>Evidence of Disturbance</u>	No
<u>Can Restoration be Completed in NPS</u>	Yes
<u>Area?</u>	
<u>Estimated Bank Erosion Score</u>	7
<u>Degree of Channel Incision Score</u>	4
<u>Existing Floodplain Access Score</u>	3
<u>Opportunity for Floodplain Development Score</u>	3
<u>Threat of Impact to Resources Score</u>	4
<u>Surrounding Vegetation Score</u>	2
<u>Land Use Score</u>	2
<u>Opportunity for Ecological Lift Score</u>	2
<u>Ease of Access</u>	3
<u>Surrounding Land Use Score</u>	5
<u>Total Score</u>	35
<u>Invasives Species Control?</u>	No
<u>Riparian Buffer Enhancement?</u>	No

<u>Restore Natural Hydrology?</u>	No
<u>Livestock Agricultural Exclusion</u>	No
<u>Fish Passage?</u>	No
<u>Channel Restoration?</u>	Yes
<u>Increase Aesthetic or Educational Value?</u>	No
<u>Other</u>	No

Notes
 Stream adjacent to road. Area consists of bedrock and lots of trees. Though the stream is healthy, the banks are unstable. Severe erosion located on outer meanders. Bank incision is only adverse on one bank. Area across from erosion area is connected to flood plain. Sedimentation is present in the channel and undermining of road. Difficult for construction equipment to access. Invasive species located in surrounding area may spread.

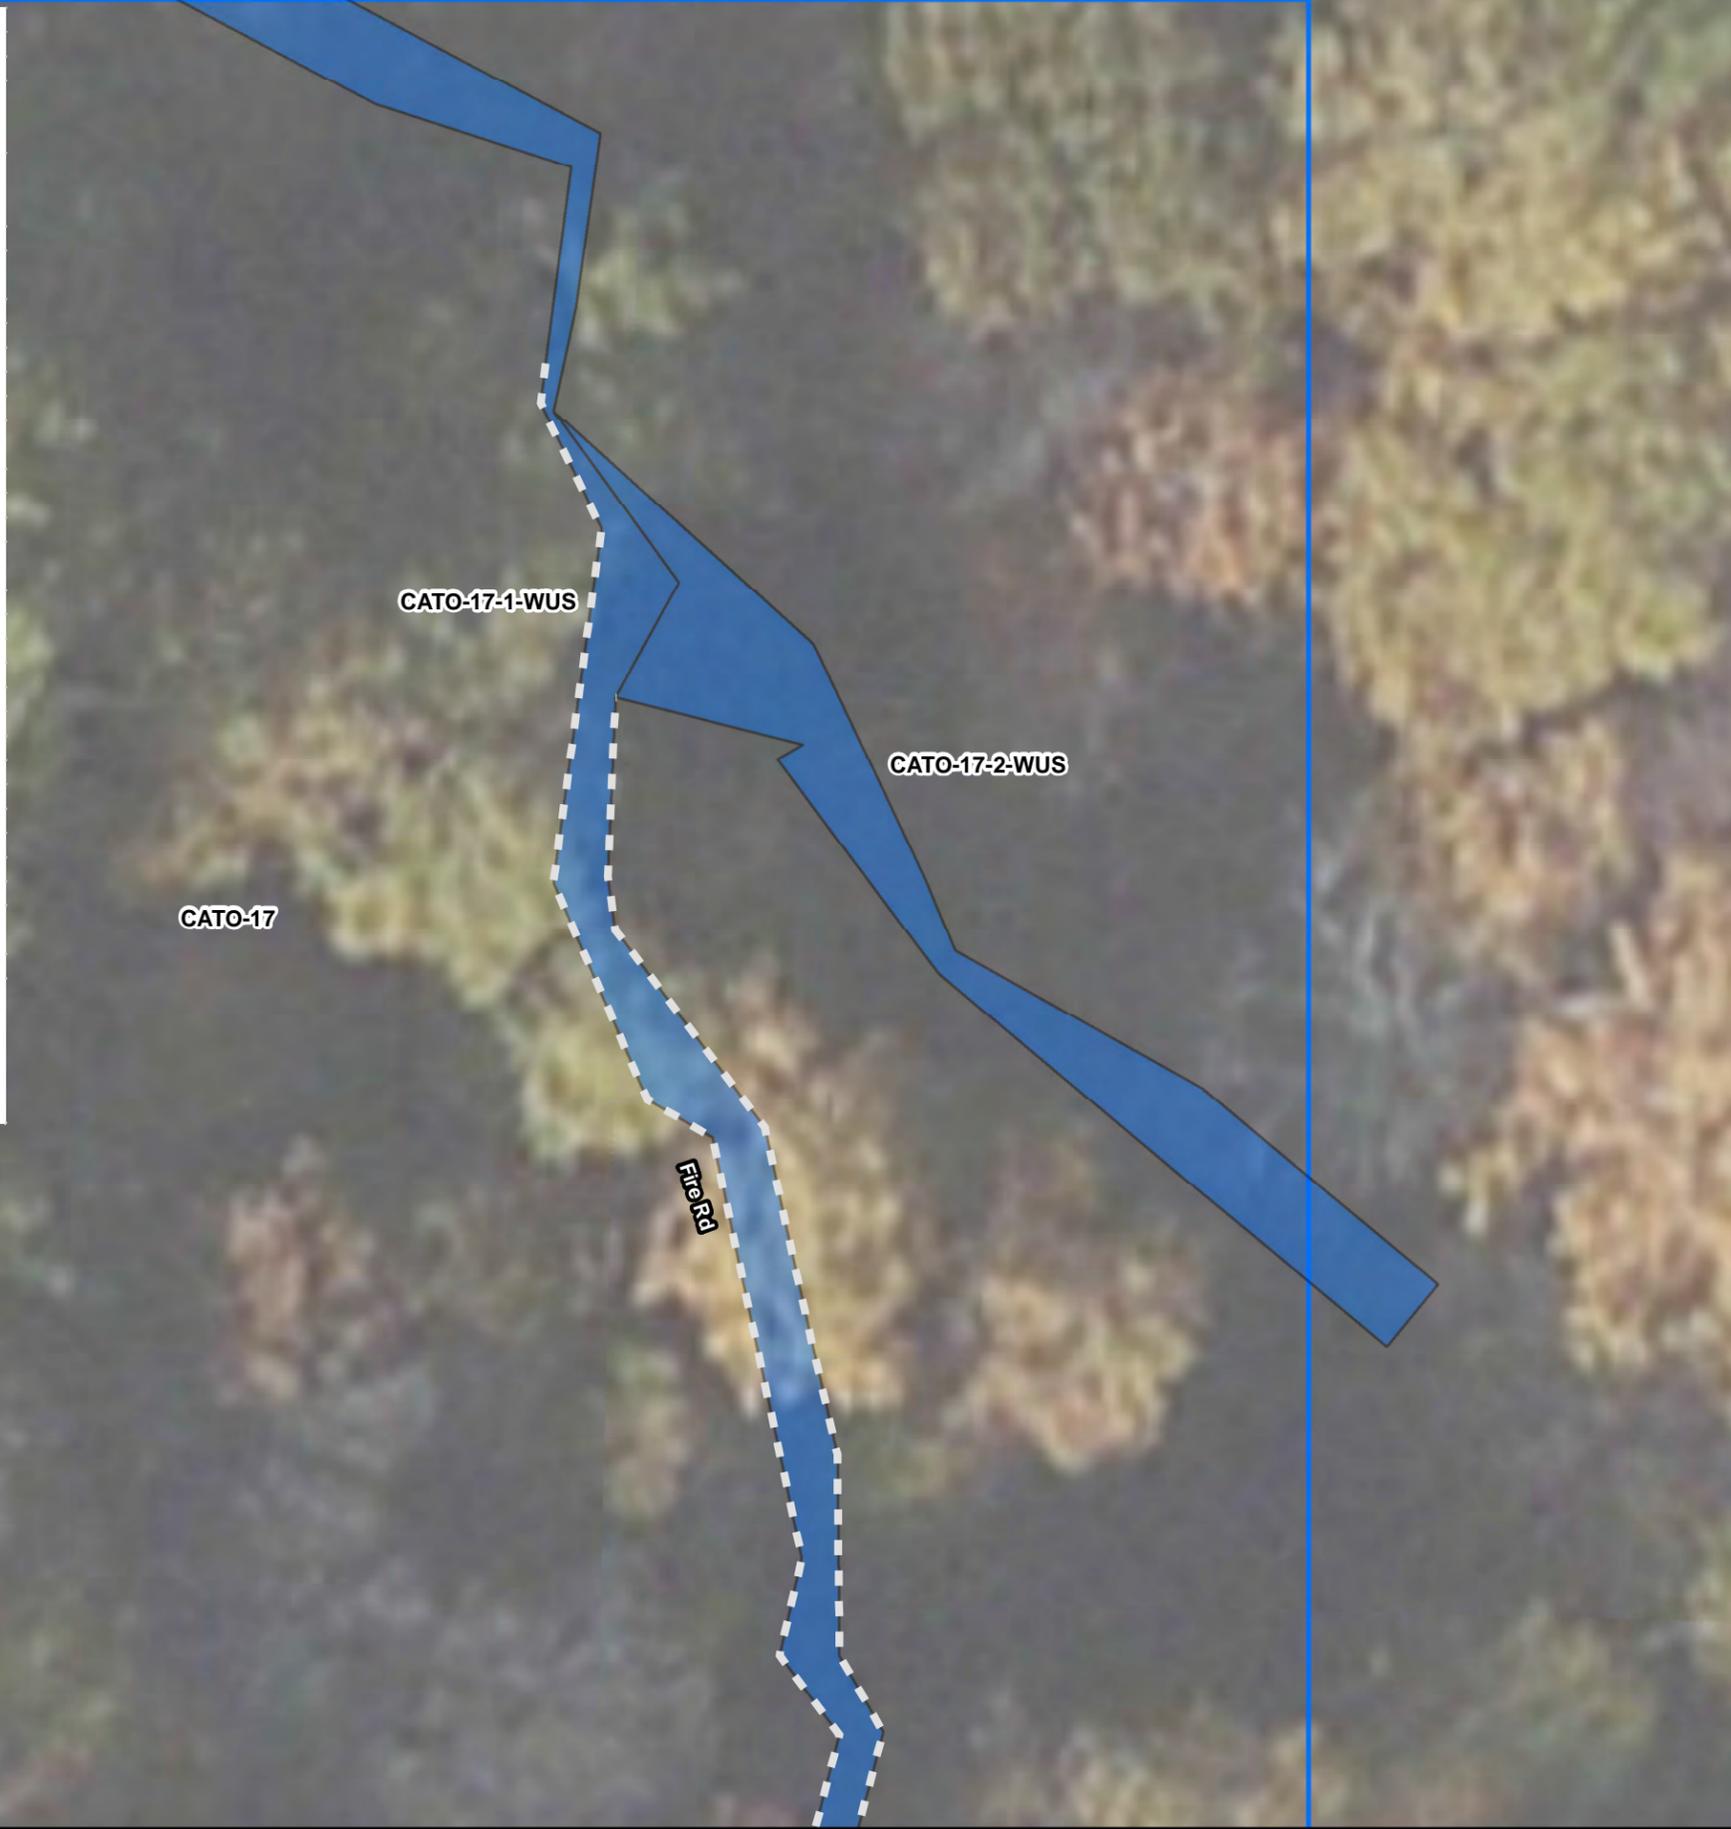
Figure 17a
 CATO-17
 Catoctin
 NPS/NCR Wetland Restoration Action Plan
 Frederick, Maryland

Site ID	CATO-17
Potential Restoration (linear feet)	150
Date	3/24/16
Existing Land Use	Forested
Adjacent Land Use	Forested
Distance to Nearest Road	120 ft
Stream Hydrology	Perennial
RTE Species Present?	No
Known Cultural Concern?	No
Wetland Restoration Opportunity?	No
Existing Wetlands Present	No
Evidence of Disturbance	No
Can Restoration be Completed in NPS Area?	Yes
Estimated Bank Erosion Score	9
Degree of Channel Incision Score	7
Existing Floodplain Access Score	7
Opportunity for Floodplain Development Score	5
Threat of Impact to Resources Score	7
Surrounding Vegetation Score	3
Land Use Score	3
Opportunity for Ecological Lift Score	5
Ease of Access	4
Surrounding Land Use Score	9
Total Score	59
Invasives Species Control?	No
Riparian Buffer Enhancement?	No
Restore Natural Hydrology?	No
Livestock Agricultural Exclusion	No
Fish Passage?	Yes
Channel Restoration?	Yes
Increase Aesthetic or Educational Value?	Yes
Other	No
Notes	Parking area nearby, but mostly forested. Highly eroded channel at head cut near parking area and buildings, has potential to migrate upstream impacting stream further. Good grade control upstream and downstream and little invasive and SWM influence. Large head cut creating fish blockage and highly eroded banks may be stabilized.

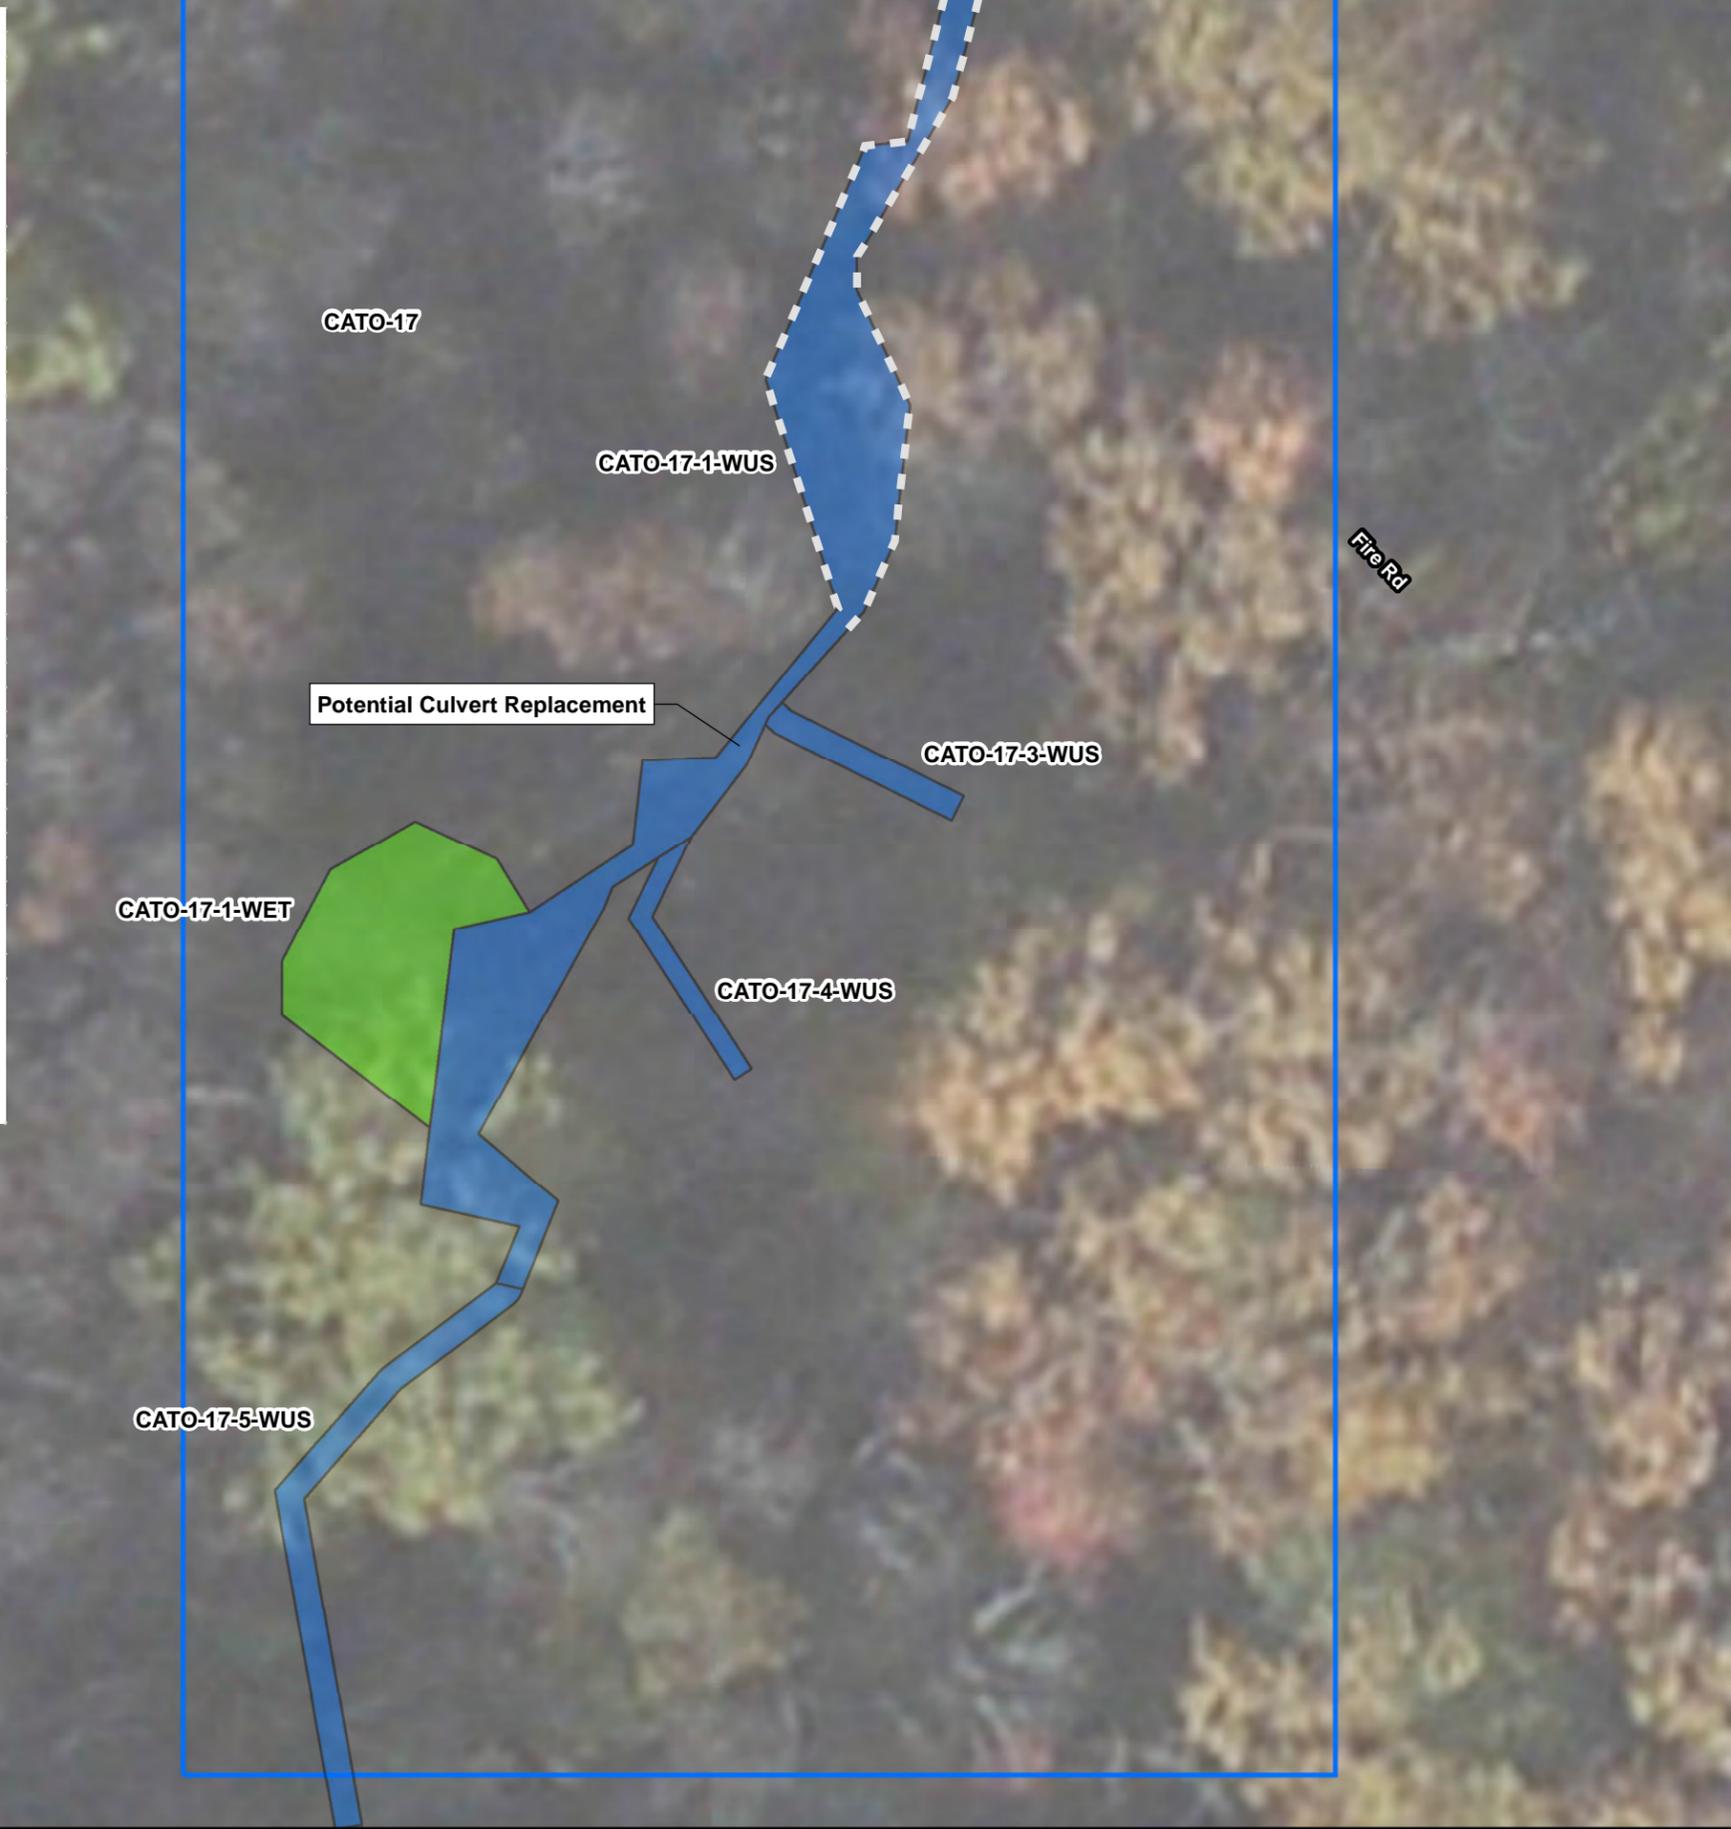
Figure 17b
 CATO-17
 Catoctin
 NPS/NCR Wetland Restoration Action Plan
 Frederick, Maryland

Site ID	CATO-17
Potential Restoration (linear feet)	150
Date	3/24/16
Existing Land Use	Forested
Adjacent Land Use	Forested
Distance to Nearest Road	120 ft
Stream Hydrology	Perennial
RTE Species Present?	No
Known Cultural Concern?	No
Wetland Restoration Opportunity?	No
Existing Wetlands Present	No
Evidence of Disturbance	No
Can Restoration be Completed in NPS Area?	Yes
Estimated Bank Erosion Score	9
Degree of Channel Incision Score	7
Existing Floodplain Access Score	7
Opportunity for Floodplain Development Score	5
Threat of Impact to Resources Score	7
Surrounding Vegetation Score	3
Land Use Score	3
Opportunity for Ecological Lift Score	5
Ease of Access	4
Surrounding Land Use Score	9
Total Score	59
Invasives Species Control?	No
Riparian Buffer Enhancement?	No
Restore Natural Hydrology?	No
Livestock Agricultural Exclusion	No
Fish Passage?	Yes
Channel Restoration?	Yes
Increase Aesthetic or Educational Value?	Yes
Other	No
Notes	Parking area nearby, but mostly forested. Highly eroded channel at head cut near parking area and buildings, has potential to migrate upstream impacting stream further. Good grade control upstream and downstream and little invasive and SWM influence. Large head cut creating fish blockage and highly eroded banks may be stabilized.
