Big Spring Historic District, Ozark National Scenic Riverways Cultural Landscape Report and Environmental Assessment

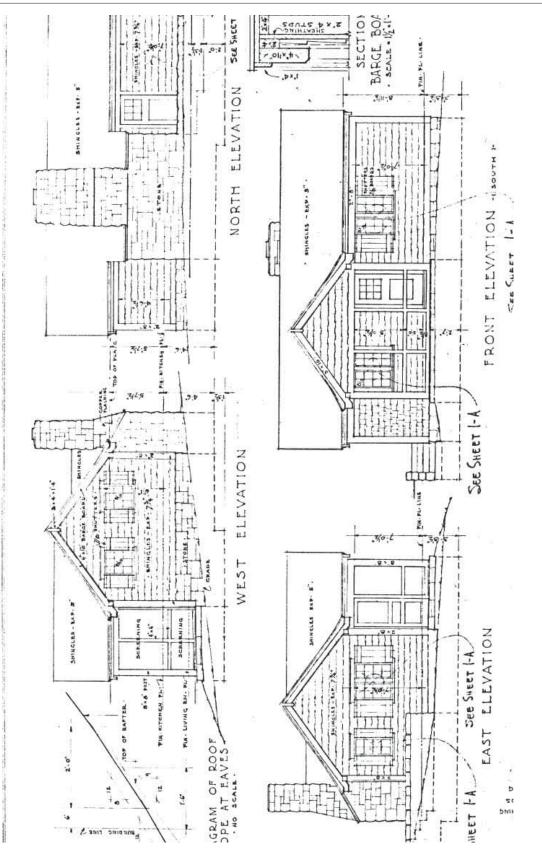
Figure 2-111. Donald A. Blake designed cabin 'type E' as a rustic style, single story gable cabin, 1938. (OZAR Archives)

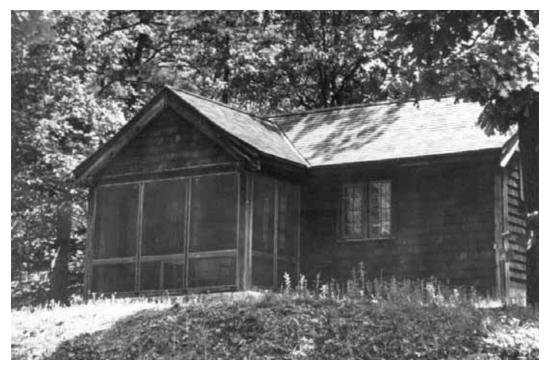
Figure 2-112. The WPA built six 'type E' cabins in 1939, date unknown. (OZAR Archives)

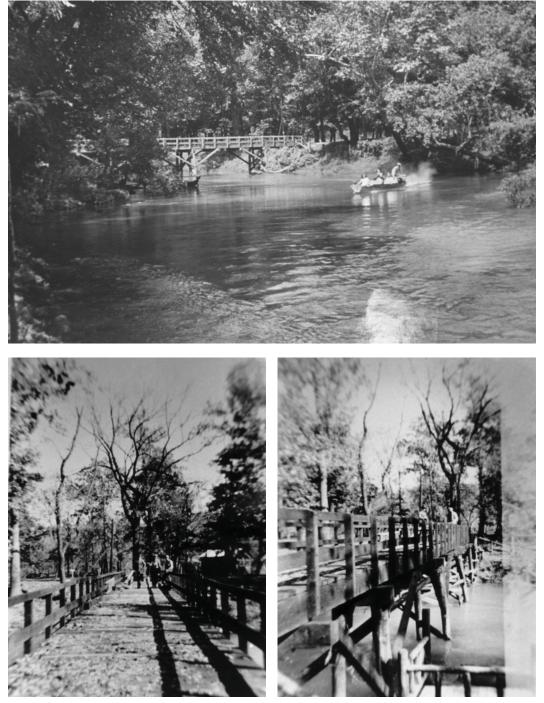
Figure 2-113. The CCC foot bridge that crossed Big Spring branch was replaced with a new single-lane timber bridge, dates unknown (OZAR Archives)

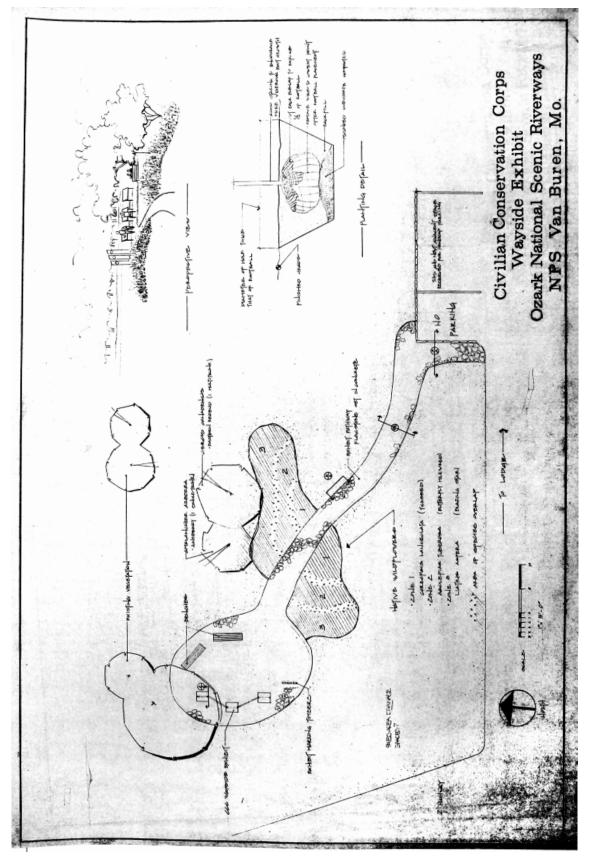
Figure 2-121. NPS prepared plans for two CCC wayside exhibits, date unknown. (OZAR Archives)

- 30
- 31 Pre-1989
- 32 The NPS built two wayside exhibits at the
- 33 Dining Lodge (HS-422). One exhibit at the
- 34 entrance to the parking area included a
- 35 flagstone pathway set on concrete with a
- 36 stone curb on the east side. The exhibit area
- 37 included three exhibit marking timbers,
- 38 three wayside exhibits commemorating CCC
- 39 contributions, and two benches.^{2.125} Another
- 40
- 41 2.121 *2016 CLI, 76-78.*
- 42 2.122 *2016 CLI*, 80.
- ¹² 2.123 *2016 CLI*, 7.
- 43 2.124 *Parking Areas.* U.S. Department of the Interior, National44 Park Service, 1985.
- 45 2.125 Civilian Conservation Corps, Wayside Exhibit, Ozark
- 45 *National Riverways.* U.S. Department of the Interior,
- 46 National Park Service.

- 1 wayside exhibit was built between the turning
- 2 loop and approach to the Dining Lodge. It
- 3 included flagstone paving set on concrete,
- 4 one exhibit timber marking, and one wayside

- 5 exhibit.^{2.126}
- 7 <u>1989</u>
- 8 Construction plans were prepared for a new
- 9 parking area at Big Spring and improvements
- 10 to Peavine Road. The plans resulted in a large

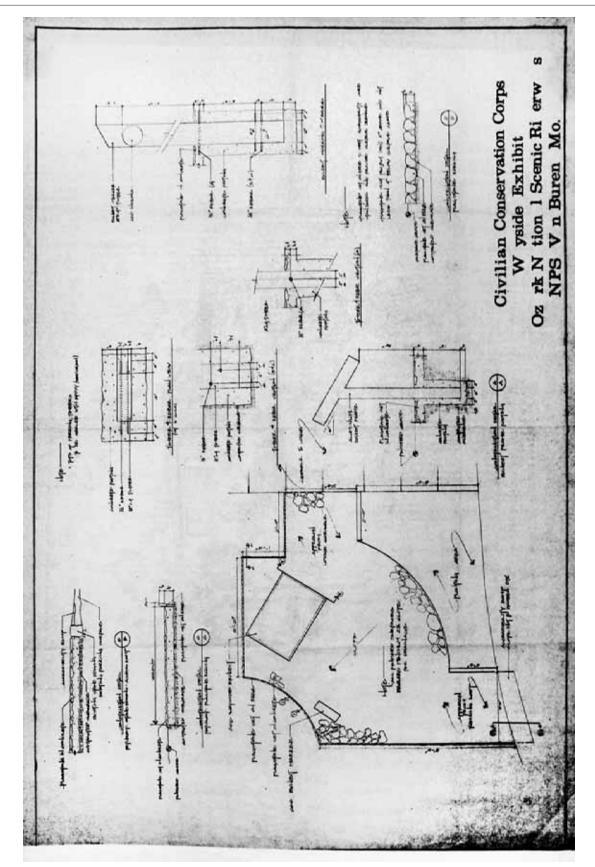
Figure 2-122. NPS prepared plans for two CCC wayside exhibits, date unknown. (OZAR Archives)

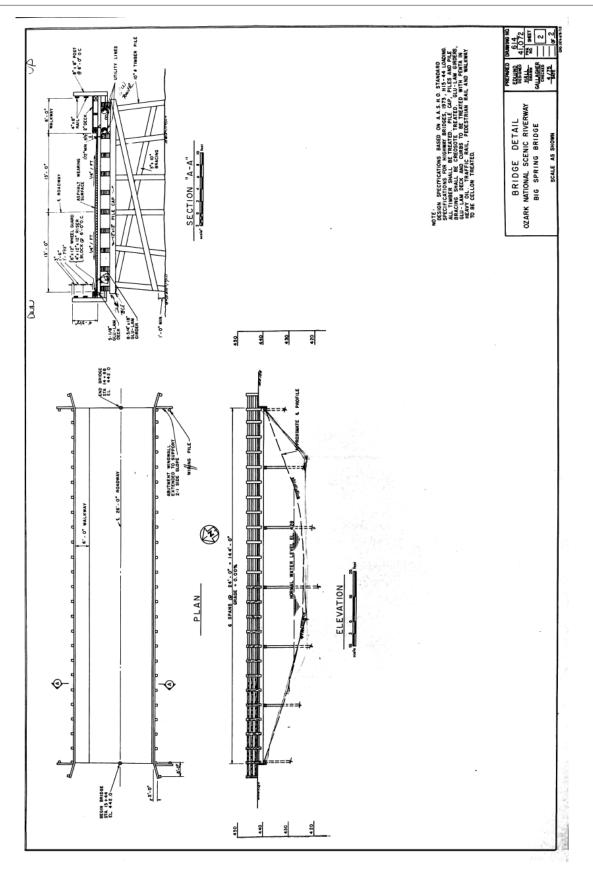
Figure 2-123. NPS prepared plans for the Big Spring Branch Vehicular Bridge which replaced the WPA bridge, 1975. (OZAR Archives)

upgraded bridge over Big Spring Branch. The 7

- 8 WPA bridge needed replacement and the
- 9 approach on the south side was identified as

10 problematic due to a sharp turn and steep

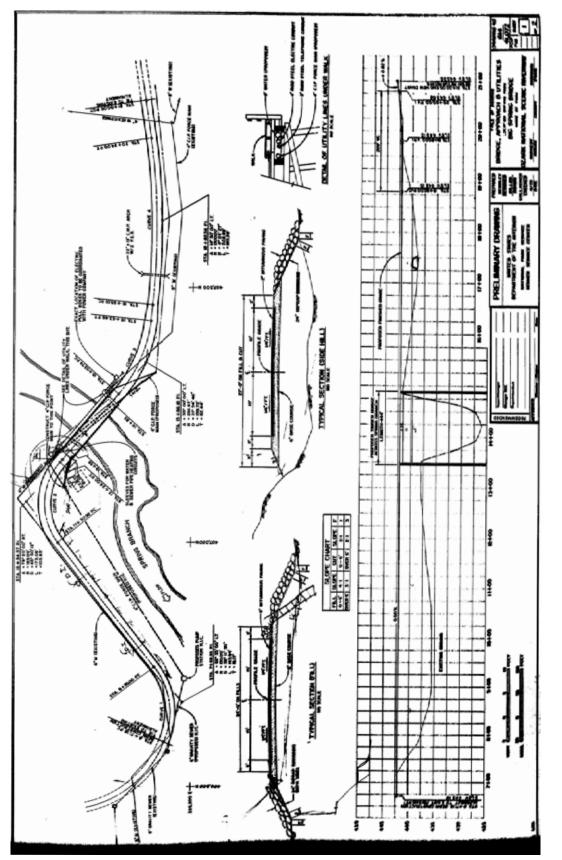
Figure 2-124. NPS prepared plans to replace the Big Spring Branch Vehicular Bridge, 1975. (OZAR Archives)
