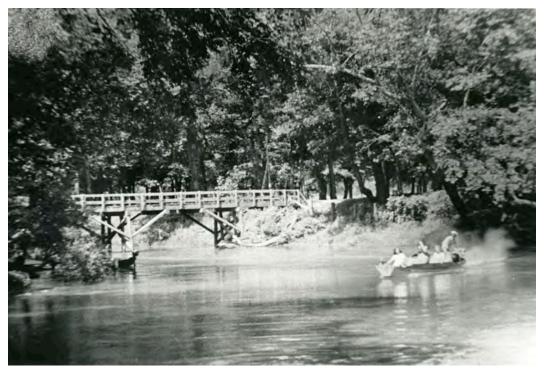
Figure 3-134. Big Spring Branch Vehicular Bridge, note diagonal struts, Circa 1940. (OZAR Archives)

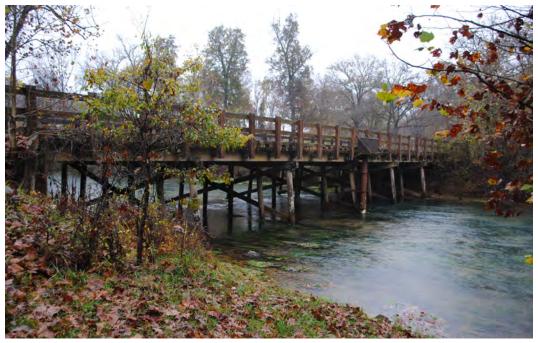
Figure 3-135. Big Spring Branch Vehicular Bridge. (Mundus Bishop 2015)

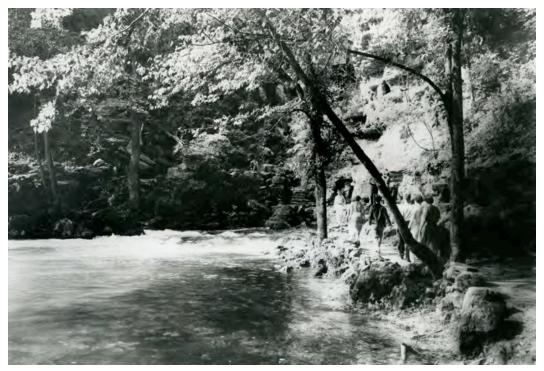
Figure 3-136. The trail to the spring was originally an unimproved dirt path. Stone abutments can be seen at the edge of the water, at right. Date unknown. (OZAR Archives)

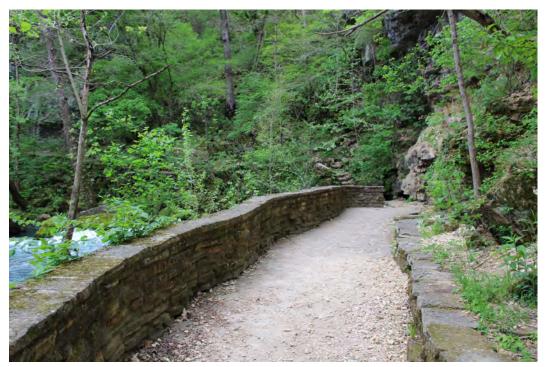
Figure 3-137. The trail to the spring from the parking area has been modified since the period of significance with new stone surfacing and retaining walls. (Mundus Bishop 2016)

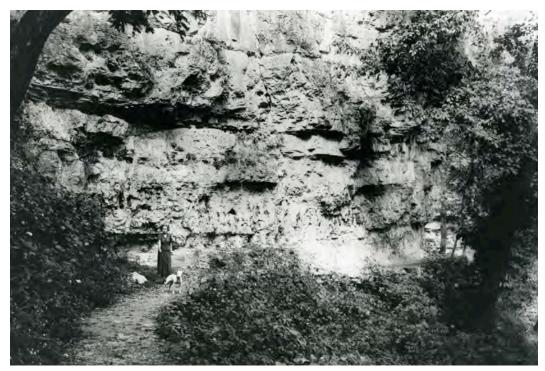
Figure 3-138. The CCC built a trail at the edge of the bluff, stabilized by native cut stone. Date unknown. (OZAR Archives)

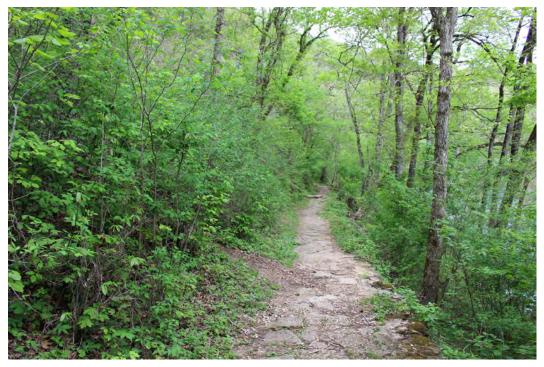
Figure 3-139. The CCC-designed trail remains in its original alignment, however their stone work is difficult to discern. (Mundus Bishop 2016)

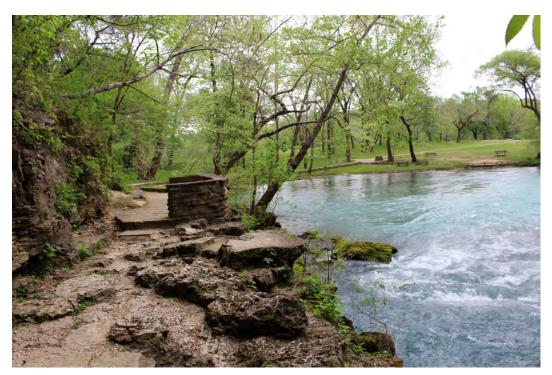
Figure 3-141. The trail at the spring has been washed out in places, and is in fair condition. (Mundus Bishop 2016)
