## Chapter 6. Treatment Plan and Implementation

1 This CLR is the principal treatment document  
 2 for the cultural landscape of Big Spring  
 3 Historic District. This section presents  
 4 treatment recommendations for the repair,  
 5 protection and stewardship of the cultural  
 6 landscape its contributing features. Treatment  
 7 recommendations are intended to guide the  
 8 overall aesthetic and future appearance of the  
 9 cultural landscape, and are founded on review  
 10 of historical documentation, assessment  
 11 of existing condition, and application of  
 12 the Secretary of Interior's standards and  
 13 guidelines as they apply to the treatment  
 14 of historic landscapes.<sup>6.1</sup> At the end of this  
 15 chapter, implementation guidance is provided  
 16 for undertaking these recommendations and  
 17 organizes them into distinct tasks in order to  
 18 identify future projects.

DECEMBER 2016  
 UNITED STATES  
 DEPARTMENT OF THE INTERIOR  
 BIG SPRING  
 HISTORIC DISTRICT  
 DWG # 614 132281

TITLE OF PROJECT  
**CULTURAL LANDSCAPE REPORT  
 AND ENVIRONMENTAL ASSESSMENT**  
 TITLE OF DRAWING  
**TREATMENT - MUSEUM AND DINING LODGE**  
 NAME OF PARK

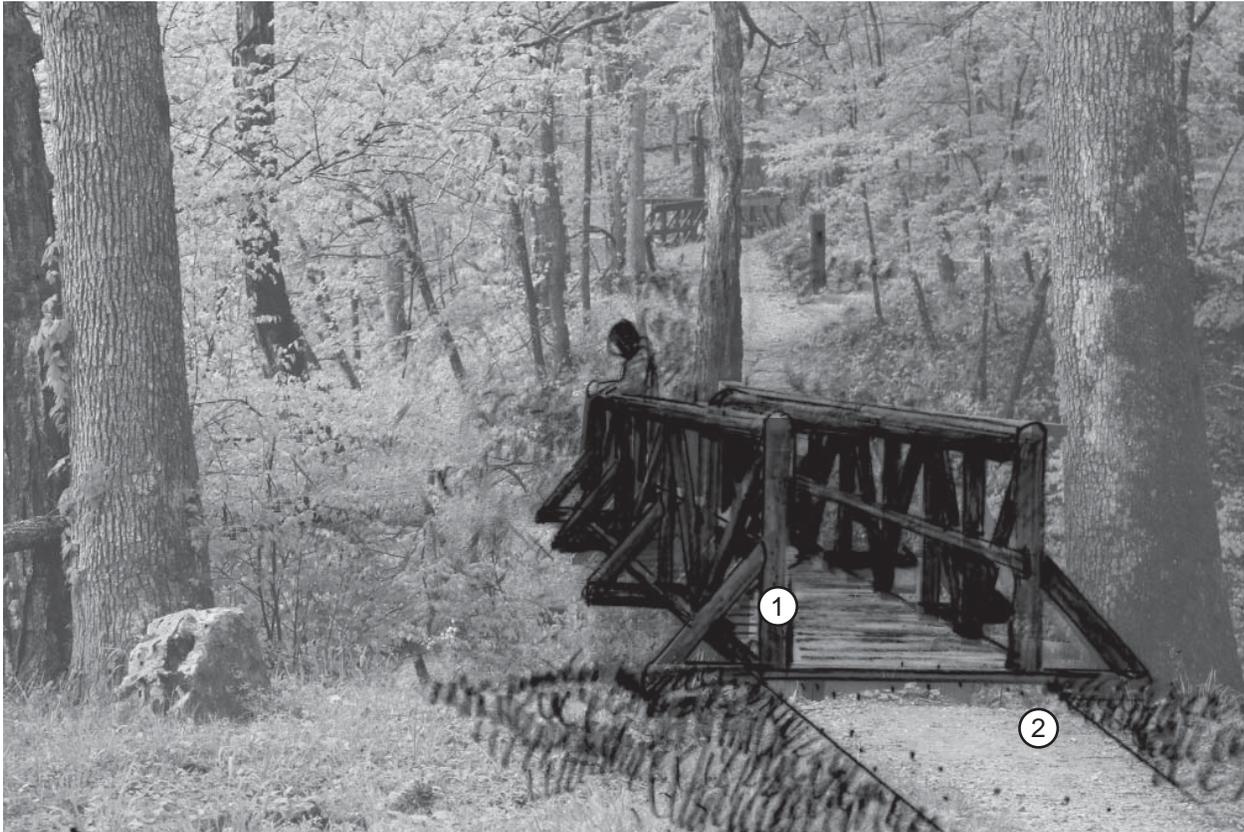
Treatment Notes

- ① Rehabilitate footbridges to blend with the historic character
- ② Repair paths adjacent bridges to mitigate tripping hazards

- 1 5. Maintain existing footbridges throughout  
2 the study area.  
3  
4     ° Rehabilitate the footbridges to reflect  
5 the historic character of the district.  
6 Replace dimensional lumber with  
7 hand-peeled timbers that reflect  
8 the historic aesthetic of hand-  
9 craftsmanship and style that reflects a  
10 Rustic appearance.  
11

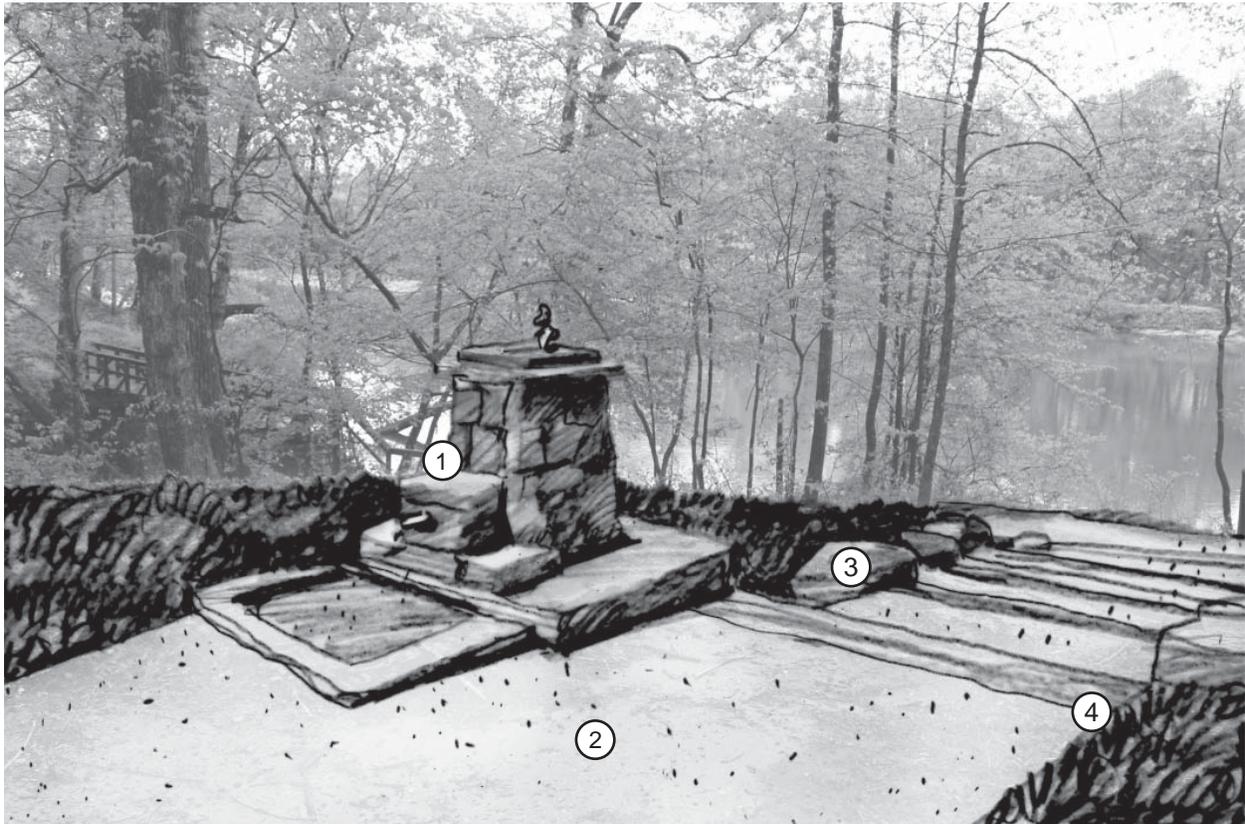
Figure 6-2. Repair contributing Fountains (HS-712) throughout the study area. Trails should be maintained with natural surfacing and native, hand-crafted materials used for water breaks and steps.

- ① Repair Fountains (HS-712) to working order and repair adjacent step and access from trail
- ② Repair trail with locally sourced material that matches native bedrock
- ③ Repair trail edge by clarifying edge, consider boulders where used historically
- ④ Repair steps by removing dimensional lumber and replace with stone or rounded timbers

- 34 1. Repair contributing water Fountains (HS-  
35 712) throughout the study area, replacing  
36 materials as necessary.  
37  
38     ° Repair water connections and restore  
39 the Fountains to working condition.  
40
- 41 2. Allow new, contemporary signs, however  
42 minimize the use of signs in the cultural  
43 landscape as this may detract from the  
44 historic setting.  
45  
46

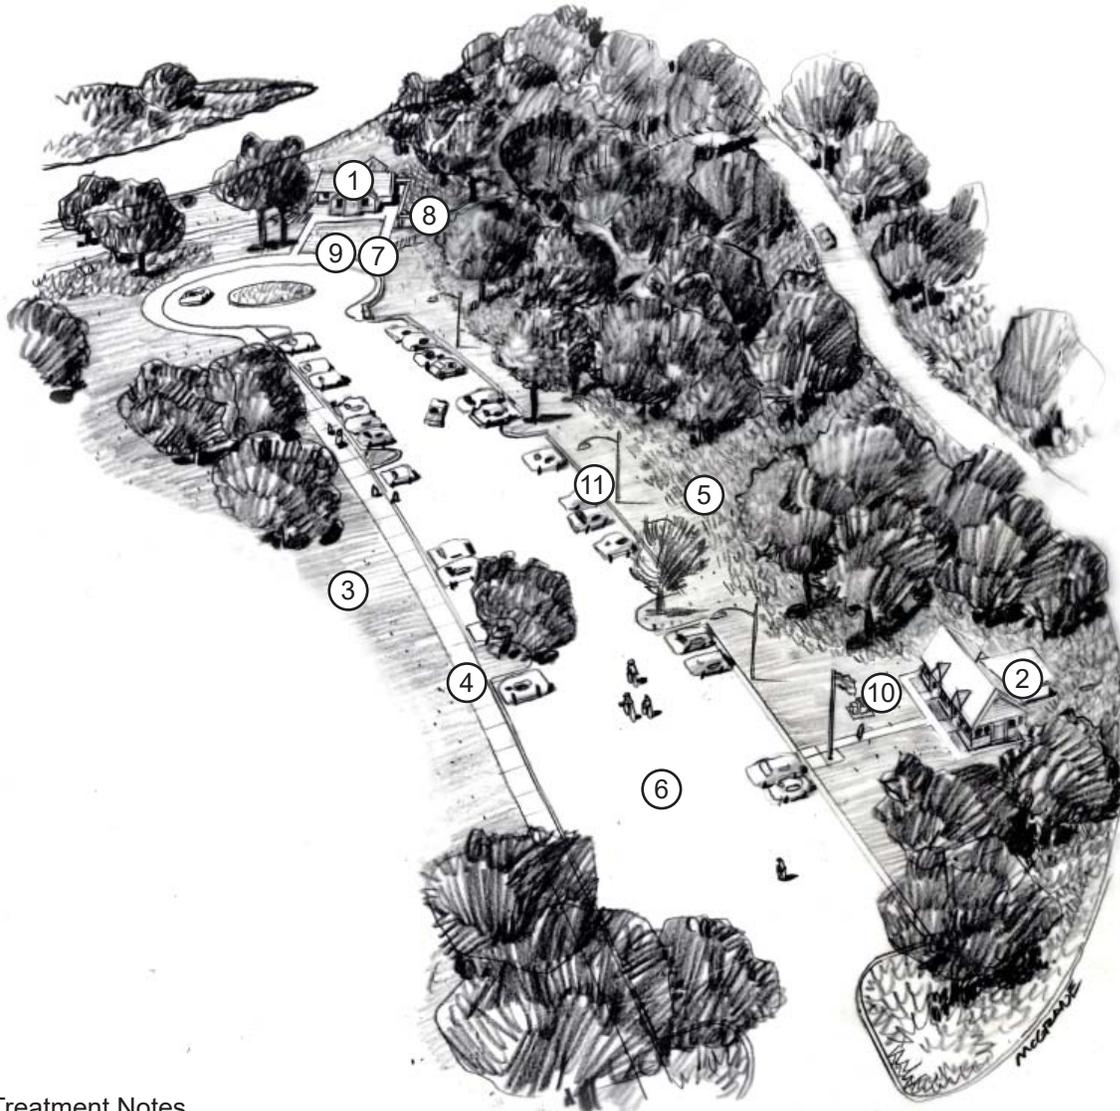
- ① Rehabilitate Dining Lodge (HS-422) and Open for Visitor Use / Concessions
- ② Rehabilitate Museum (HS-420) and Open for Visitor Use – Flexible Use Space (Museum or Concessions)
- ③ Maintain Open Play Field
- ④ Provide Accessible Pedestrian Route at North Edge of Main Parking Area (HS-714) to Connect Dining Hall (HS-422) and Museum (HS-420)
- ⑤ Reestablish Historic Character Plantings and Open Setting with Park-Like Character
- ⑥ Repair Main Parking Area (HS-714), Reveal Concrete Curb, Remove Non-Contributing Features (Waysides)
- ⑦ Establish Accessible Route and Entrance along Historic Patterns at Dining Lodge (HS-422)
- ⑧ Repair Dining Lodge Retaining Wall and Fountain (HS-422A) to Full Extent
- ⑨ Reestablish Historic Character of Plantings (ornamental Vegetation)
- ⑩ Repair Fountain #2 (HS-712)
- ⑪ Lighting Compatible with Setting and Dark Sky Requirements

2  
3 Treatment recommendations for the core  
4 development area reestablish the historic  
5 setting of the Entrance Building (HS-432),  
6 Dining Lodge (HS-422), Museum (HS-420),  
7 cabins, Chubb Hollow, and Maintenance  
8 Area. The recommendations are grouped  
9 by area and offer guidance for preserving  
10 contributing features and qualities, and  
11 methods for rehabilitating the historic  
12 character of the landscape.

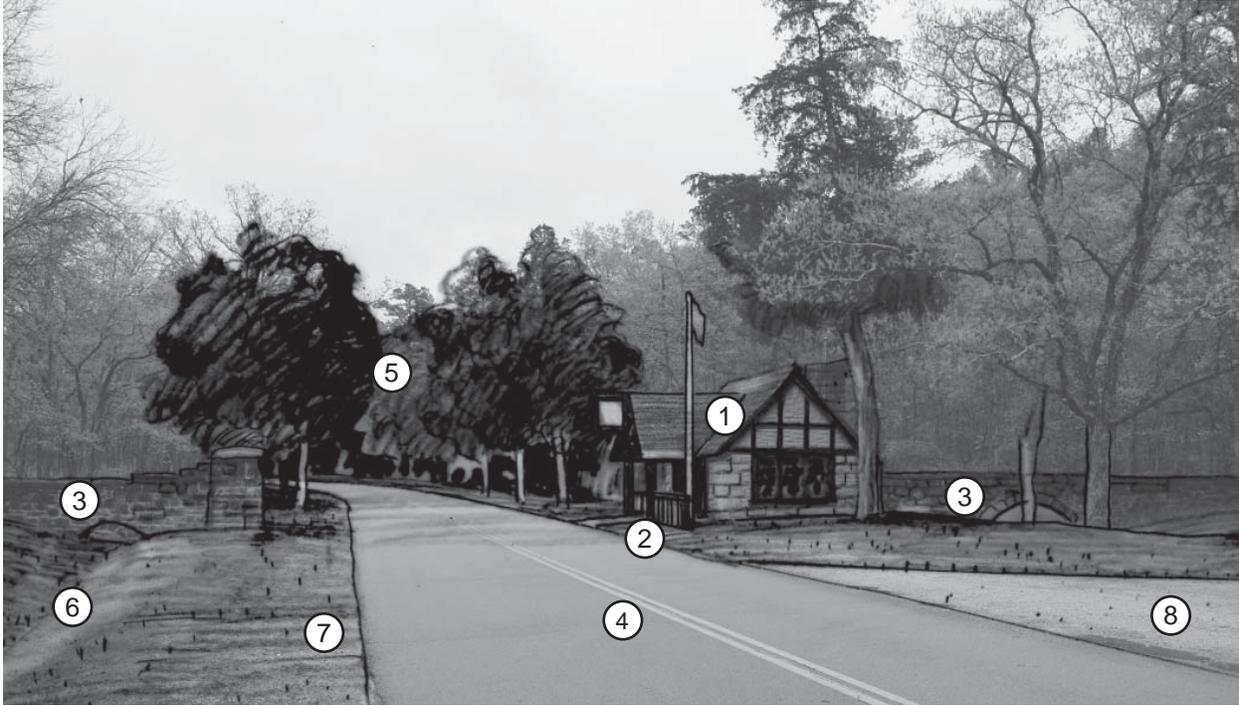
Figure 6-5. Rehabilitate the gateway and entrance experience created by the stone walls and Entrance Building by opening the building to visitors and repairing the woodland setting around the structure.

- ① Repair Entrance Building (HS-432)
- ② Replace missing wood fence
- ③ Repair Entrance Portal Walls (HS-432A)
- ④ Maintain open view to entrance
- ⑤ Repair deciduous tree backdrop
- ⑥ Repair drainage swales, maintain free of woody vegetation
- ⑦ Repair lawn to edge of road
- ⑧ Provide visitor soft surface pull-out

33  
34 5. Restore missing features including the  
35 wooden fence that once occurred adjacent  
36 the building.

37  
38 6. Repair the gate at the north end of the  
39 northern Entrance Portal Wall, and the  
40 secondary path that once lead through the  
41 gate.

42  
43 7. Rehabilitate the vegetation at the  
44 entrance to enhance the feeling of arrival.

45  
46 ° Remove vegetation that encroaches  
47 into the view towards the entrance.

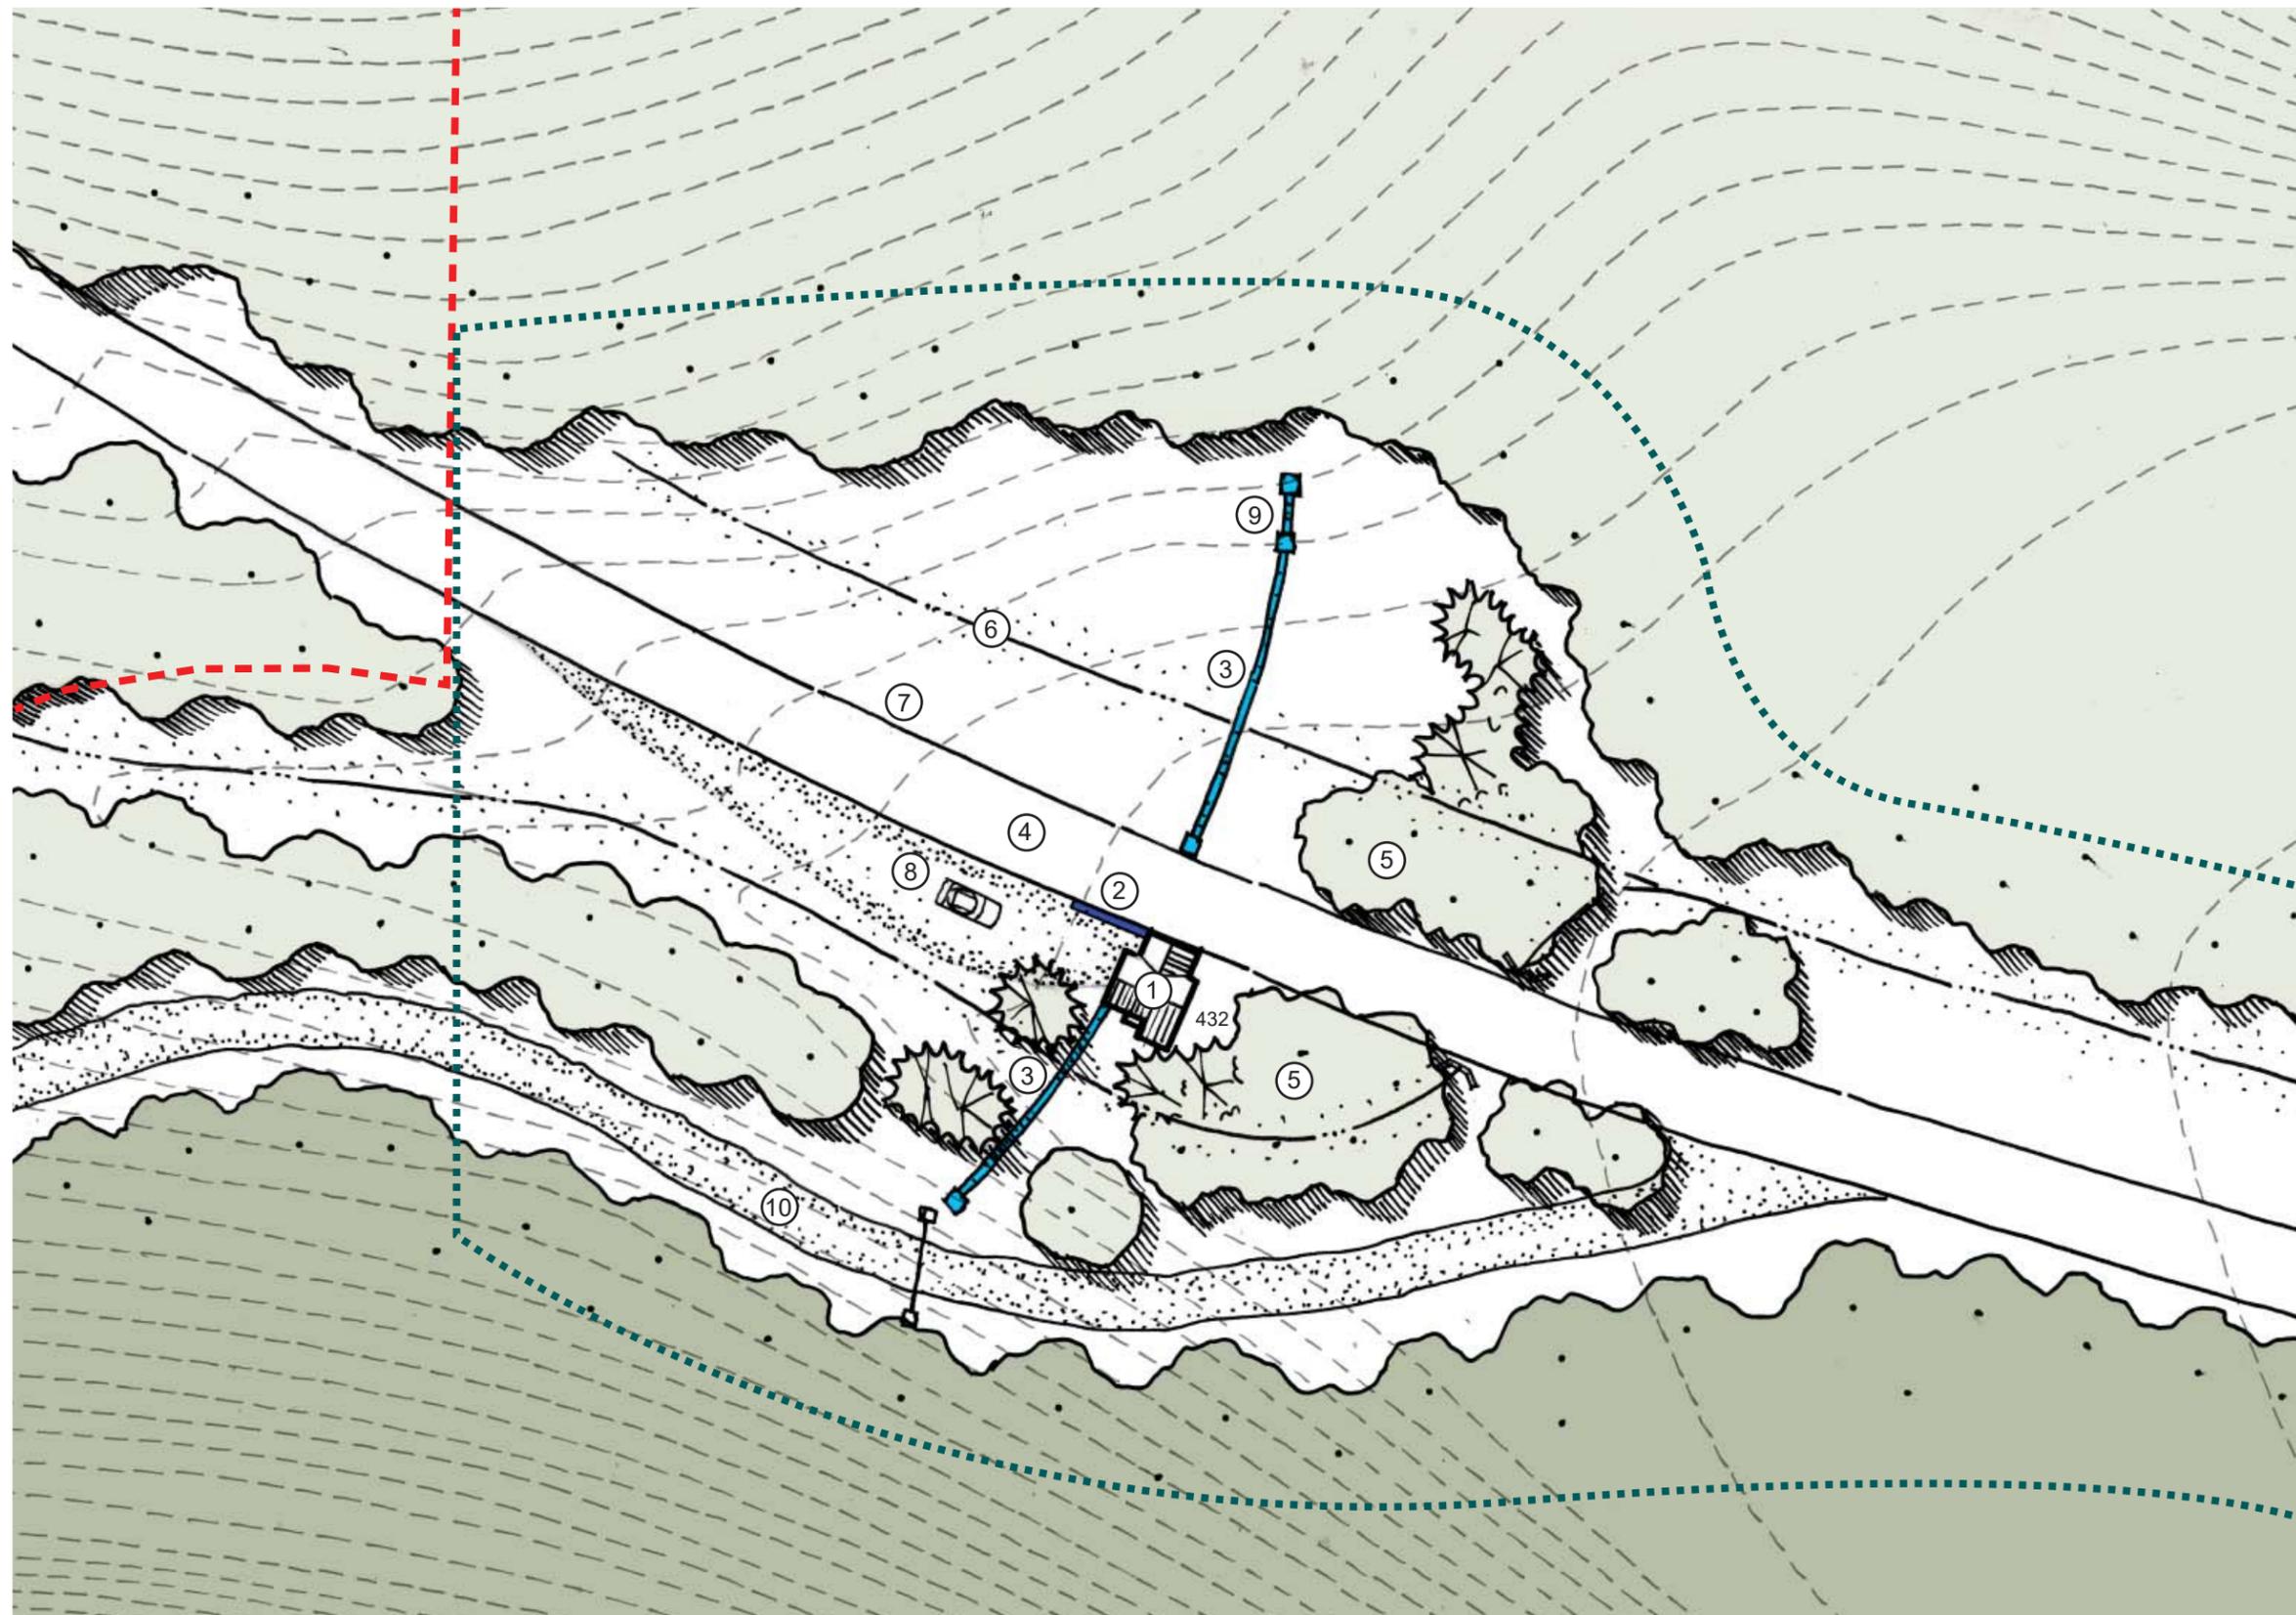
Illustration 6-1.

- Treatment Notes**
- ① Repair Entrance Building (HS-432)
  - ② Replace missing wood fence
  - ③ Repair Entrance Portal Walls (HS-432A)
  - ④ Maintain open view to entrance
  - ⑤ Repair deciduous tree backdrop
  - ⑥ Repair drainage swales, maintain free of woody vegetation
  - ⑦ Repair lawn to edge of road
  - ⑧ Provide visitor soft surface pull-out
  - ⑨ Repair gate and secondary path
  - ⑩ Maintain as secured road

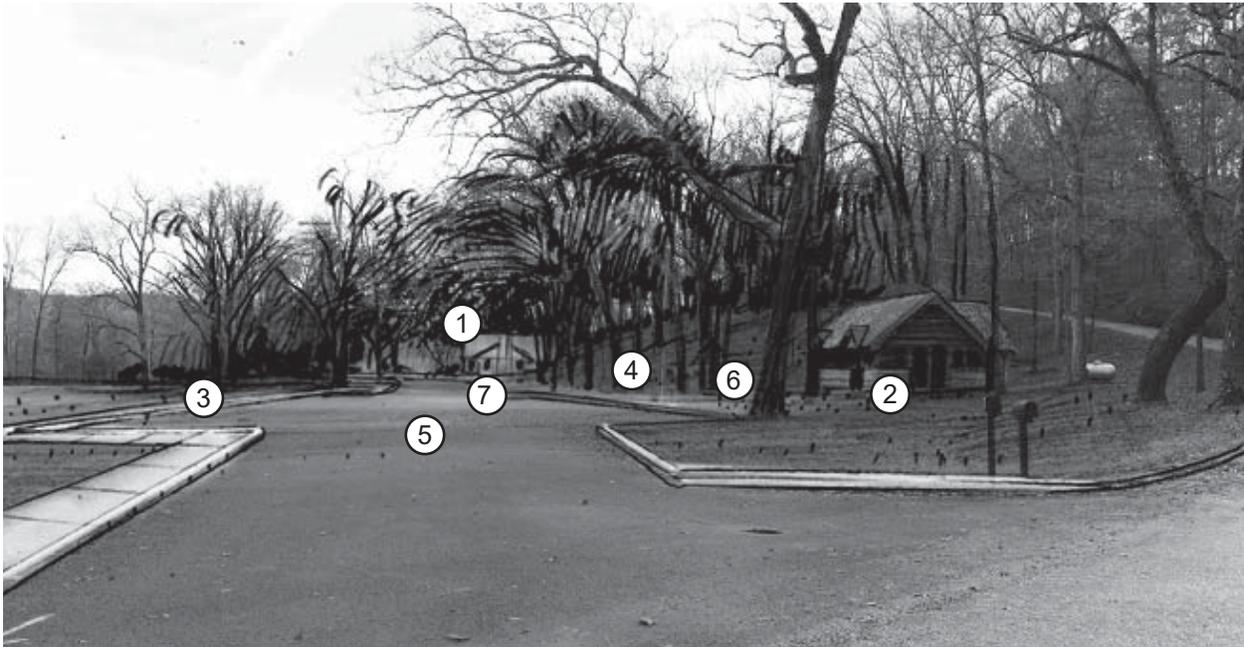
Figure 6-6. Rehabilitate the setting of the Dining Lodge (HS-422) and Museum (HS-420) by repairing the character of vegetation, walks, and removing non-contributing features.

- ① Rehabilitate Dining Lodge (HS-422) and Open for Visitor Use / Concessions
- ② Rehabilitate Museum (HS-420) and Open for Visitor Use – Flexible Use Space (Museum or Concessions)
- ③ Provide Accessible Pedestrian Route at North Edge of Main Parking Area (HS-714) to Connect Dining Hall (HS-422) and Museum (HS-420)
- ④ Reestablish Historic Character Plantings and Open Setting with Park-Like Character
- ⑤ Repair Main Parking Area (HS-714), Reveal Concrete Curb, Remove Non-Contributing Features (Waysides)
- ⑥ Repair Fountain #2 (HS-712)
- ⑦ Maintain View to Dining Lodge

22  
23 At the Dining Lodge (HS-422) and Museum  
24 (HS-420), the buildings will be opened to  
25 the public, the existing Main Parking Area  
26 (HS-714) will be repaired to fully reveal  
27 the historic concrete curb, shade will be  
28 provided along the edge of the parking area  
29 and integrated with new lighting. The open  
30 playfield to the north and the forested edge to  
31 the south will remain and will be maintained  
32 as a clean, park-like space, with views  
33 between the buildings and river.

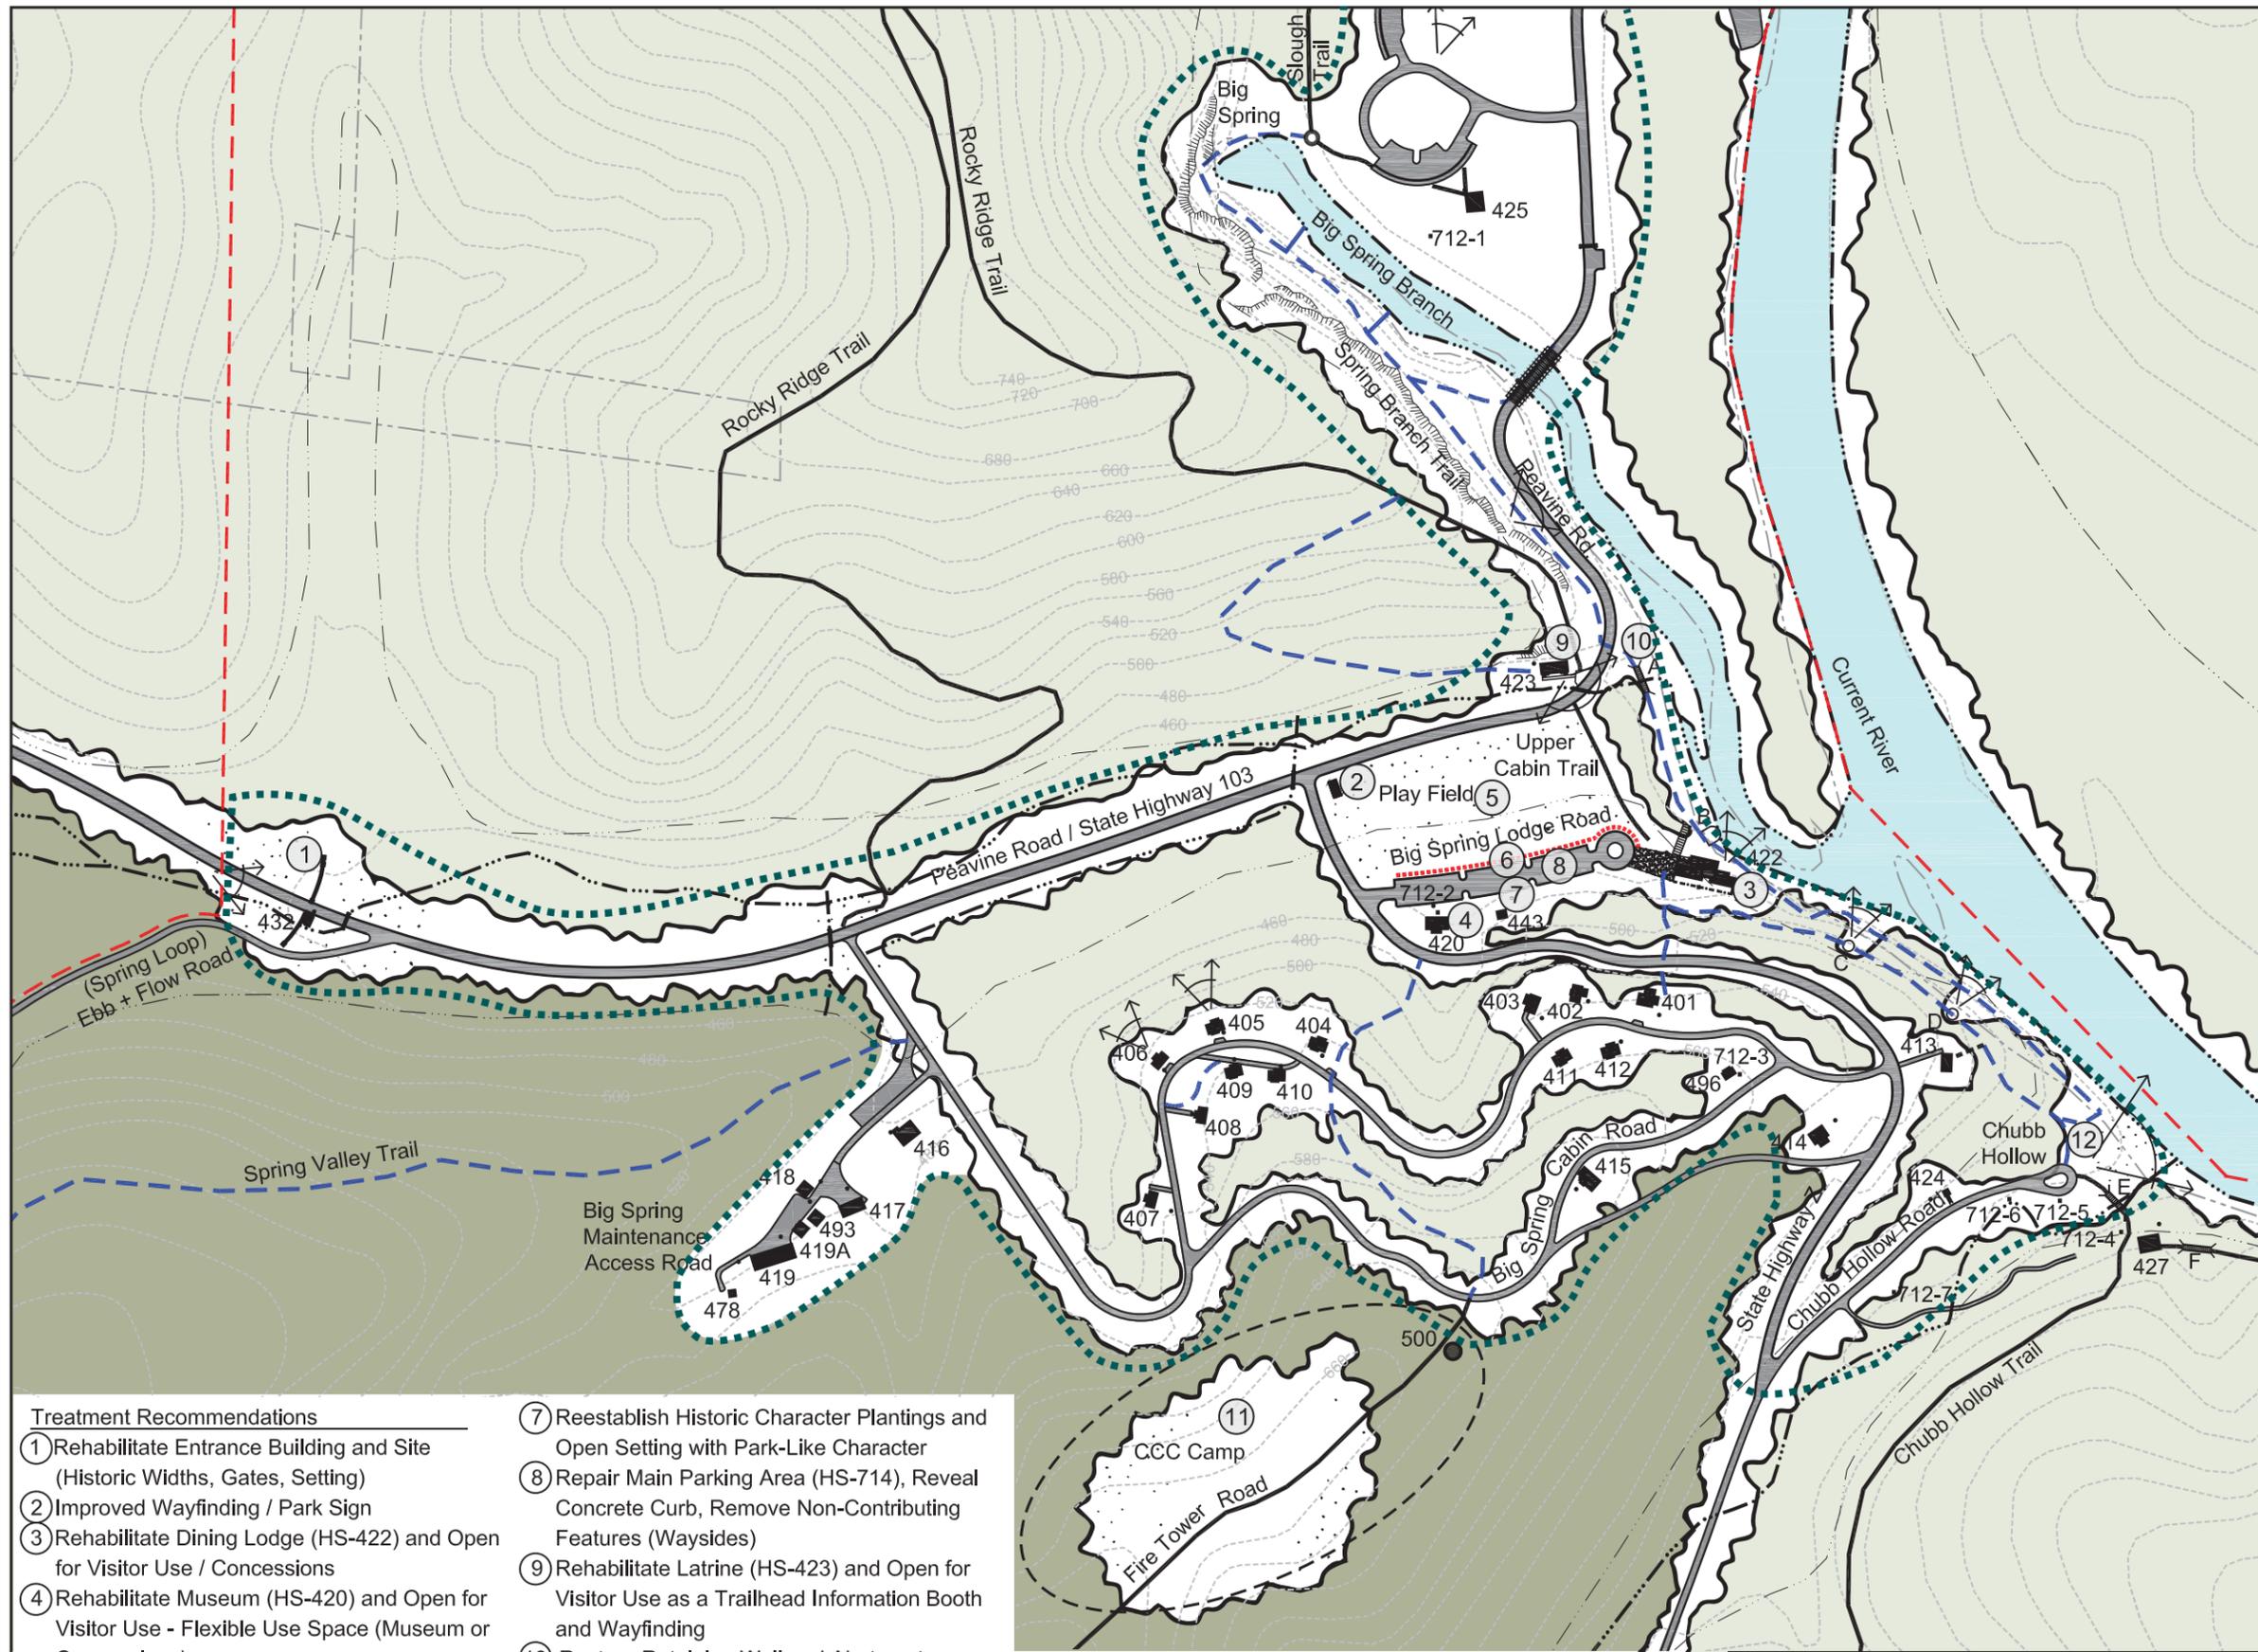
- Treatment Recommendations**
- ① Rehabilitate Entrance Building and Site (Historic Widths, Gates, Setting)
  - ② Improved Wayfinding / Park Sign
  - ③ Rehabilitate Dining Lodge (HS-422) and Open for Visitor Use / Concessions
  - ④ Rehabilitate Museum (HS-420) and Open for Visitor Use - Flexible Use Space (Museum or Concessions)
  - ⑤ Maintain Open Play Field
  - ⑥ Provide Accessible Pedestrian Route at North Edge of Main Parking Area (HS-714) to Connect Dining Hall (HS-422) and Museum (HS-420)

- ⑦ Reestablish Historic Character Plantings and Open Setting with Park-Like Character
- ⑧ Repair Main Parking Area (HS-714), Reveal Concrete Curb, Remove Non-Contributing Features (Waysides)
- ⑨ Rehabilitate Latrine (HS-423) and Open for Visitor Use as a Trailhead Information Booth and Wayfinding
- ⑩ Restore Retaining Wall and Abutments (HS-423A) (Full Extents)
- ⑪ Reestablish Spatial Qualities of CCC Camp and Mark Building Outlines
- ⑫ Thin Vegetation to Provide River Views From Chubb Hollow

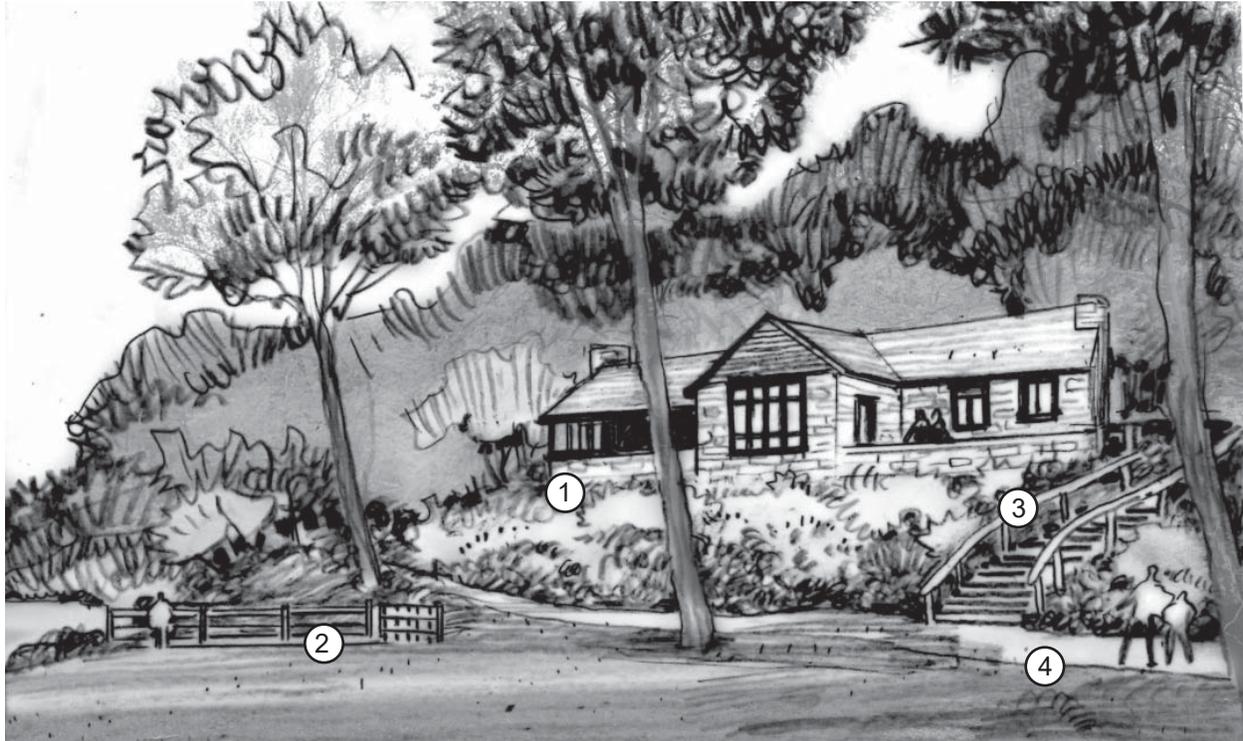
Figure 6-7. Rehabilitate the setting of the Dining Lodge (HS-422) by repairing the relationship between the building and the river. Repair the vegetation to frame views and maintain the slope between the Dining Lodge and the river with low-growing vegetation.

- ① Thin Vegetation to Provide Views to River
- ② Replace Boat Dock and Staircase with Compatible Design / Material
- ③ Maintain Staircase, Replace Handrail with Slim, Secure Railing
- ④ Clarify Trails at Base of Hill and Provide Route from Base of Stair to Boat Ramp

- 
- 1 9. Preserve stone terrace and wall at the  
2 north side of the Dining Lodge.  
3
- 4 10. Repair the non-contributing stone  
5 staircase from the Dining Lodge to the  
6 Boat Dock.  
7

- 8     ° Reset stone steps as necessary to  
9 create uniform rise and tread.  
10
- 11     ° Replace handrail at the stairs with a  
12 new railing that is more sensitive to  
13 the setting.  
14

- 15 11. Repair the Boat Dock to provide safe  
16 access on and off watercraft. Although a  
17 non-contributing feature, the Boat Dock  
18 provides visitor access to the Dining  
19 Lodge.  
20

- 35     ° Maintain the slope between the  
36 Dining Lodge and the river with low-  
37 growing vegetation that allows for  
38 views to the river.  
39
- 40 16. Preserve the open playfield north of the  
41 Dining Lodge and Museum.  
42

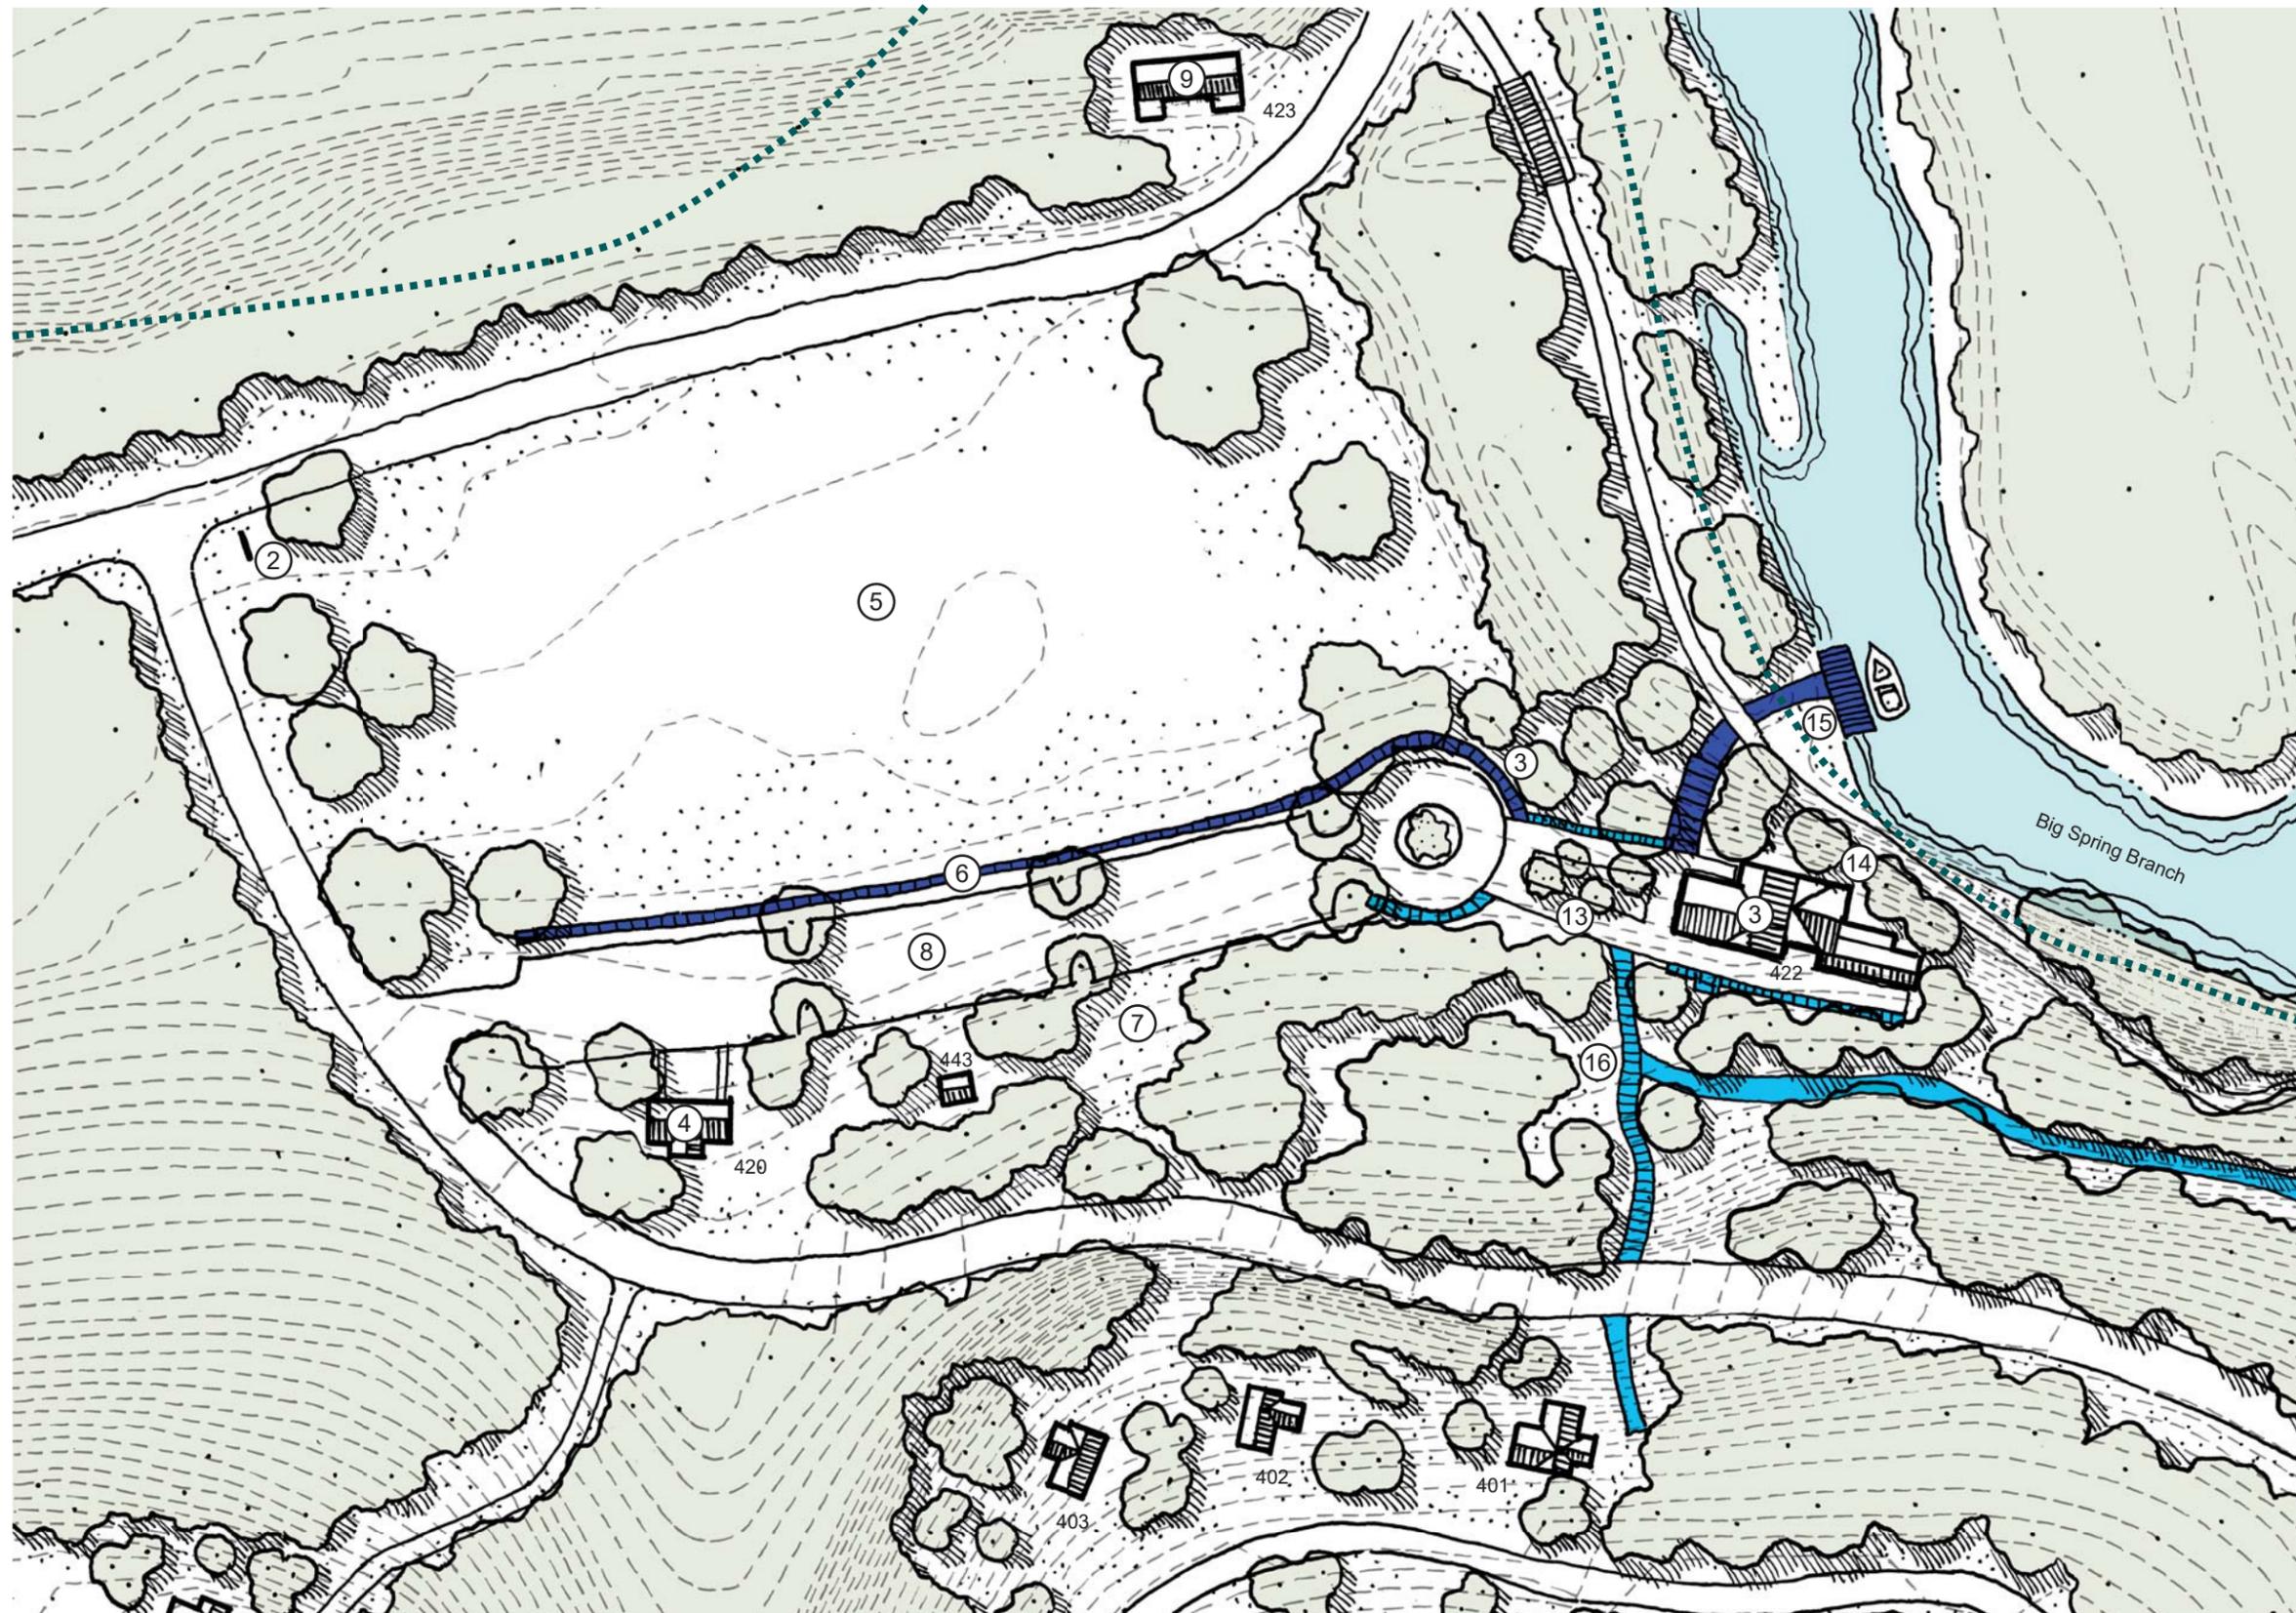
- ⑦ Reestablish Historic Character Plantings and Open Setting with Park-Like Character
  - ⑧ Repair Main Parking Area (HS-714), Reveal Concrete Curb, Remove Non-Contributing Features (Waysides)

- ⑭ Thin Vegetation to Provide Views to River
  - ⑮ Replace Boat Dock and Staircase with Compatible Design / Material
  - ⑯ Repair Path and Stone Steps to Cabins
