## Chapter 6. Treatment Plan and Implementation

1 This CLR is the principal treatment document  
 2 for the cultural landscape of Big Spring  
 3 Historic District. This section presents  
 4 treatment recommendations for the repair,  
 5 protection and stewardship of the cultural  
 6 landscape its contributing features. Treatment  
 7 recommendations are intended to guide the  
 8 overall aesthetic and future appearance of the  
 9 cultural landscape, and are founded on review  
 10 of historical documentation, assessment  
 11 of existing condition, and application of  
 12 the Secretary of Interior's standards and  
 13 guidelines as they apply to the treatment  
 14 of historic landscapes.<sup>6.1</sup> At the end of this  
 15 chapter, implementation guidance is provided  
 16 for undertaking these recommendations and  
 17 organizes them into distinct tasks in order to  
 18 identify future projects.

DECEMBER 2016  
 UNITED STATES  
 DEPARTMENT OF THE INTERIOR  
 BIG SPRING  
 HISTORIC DISTRICT  
 DWG # 614 132281

TITLE OF PROJECT  
**CULTURAL LANDSCAPE REPORT  
 AND ENVIRONMENTAL ASSESSMENT**  
 TITLE OF DRAWING  
**TREATMENT - MUSEUM AND DINING LODGE**  
 NAME OF PARK

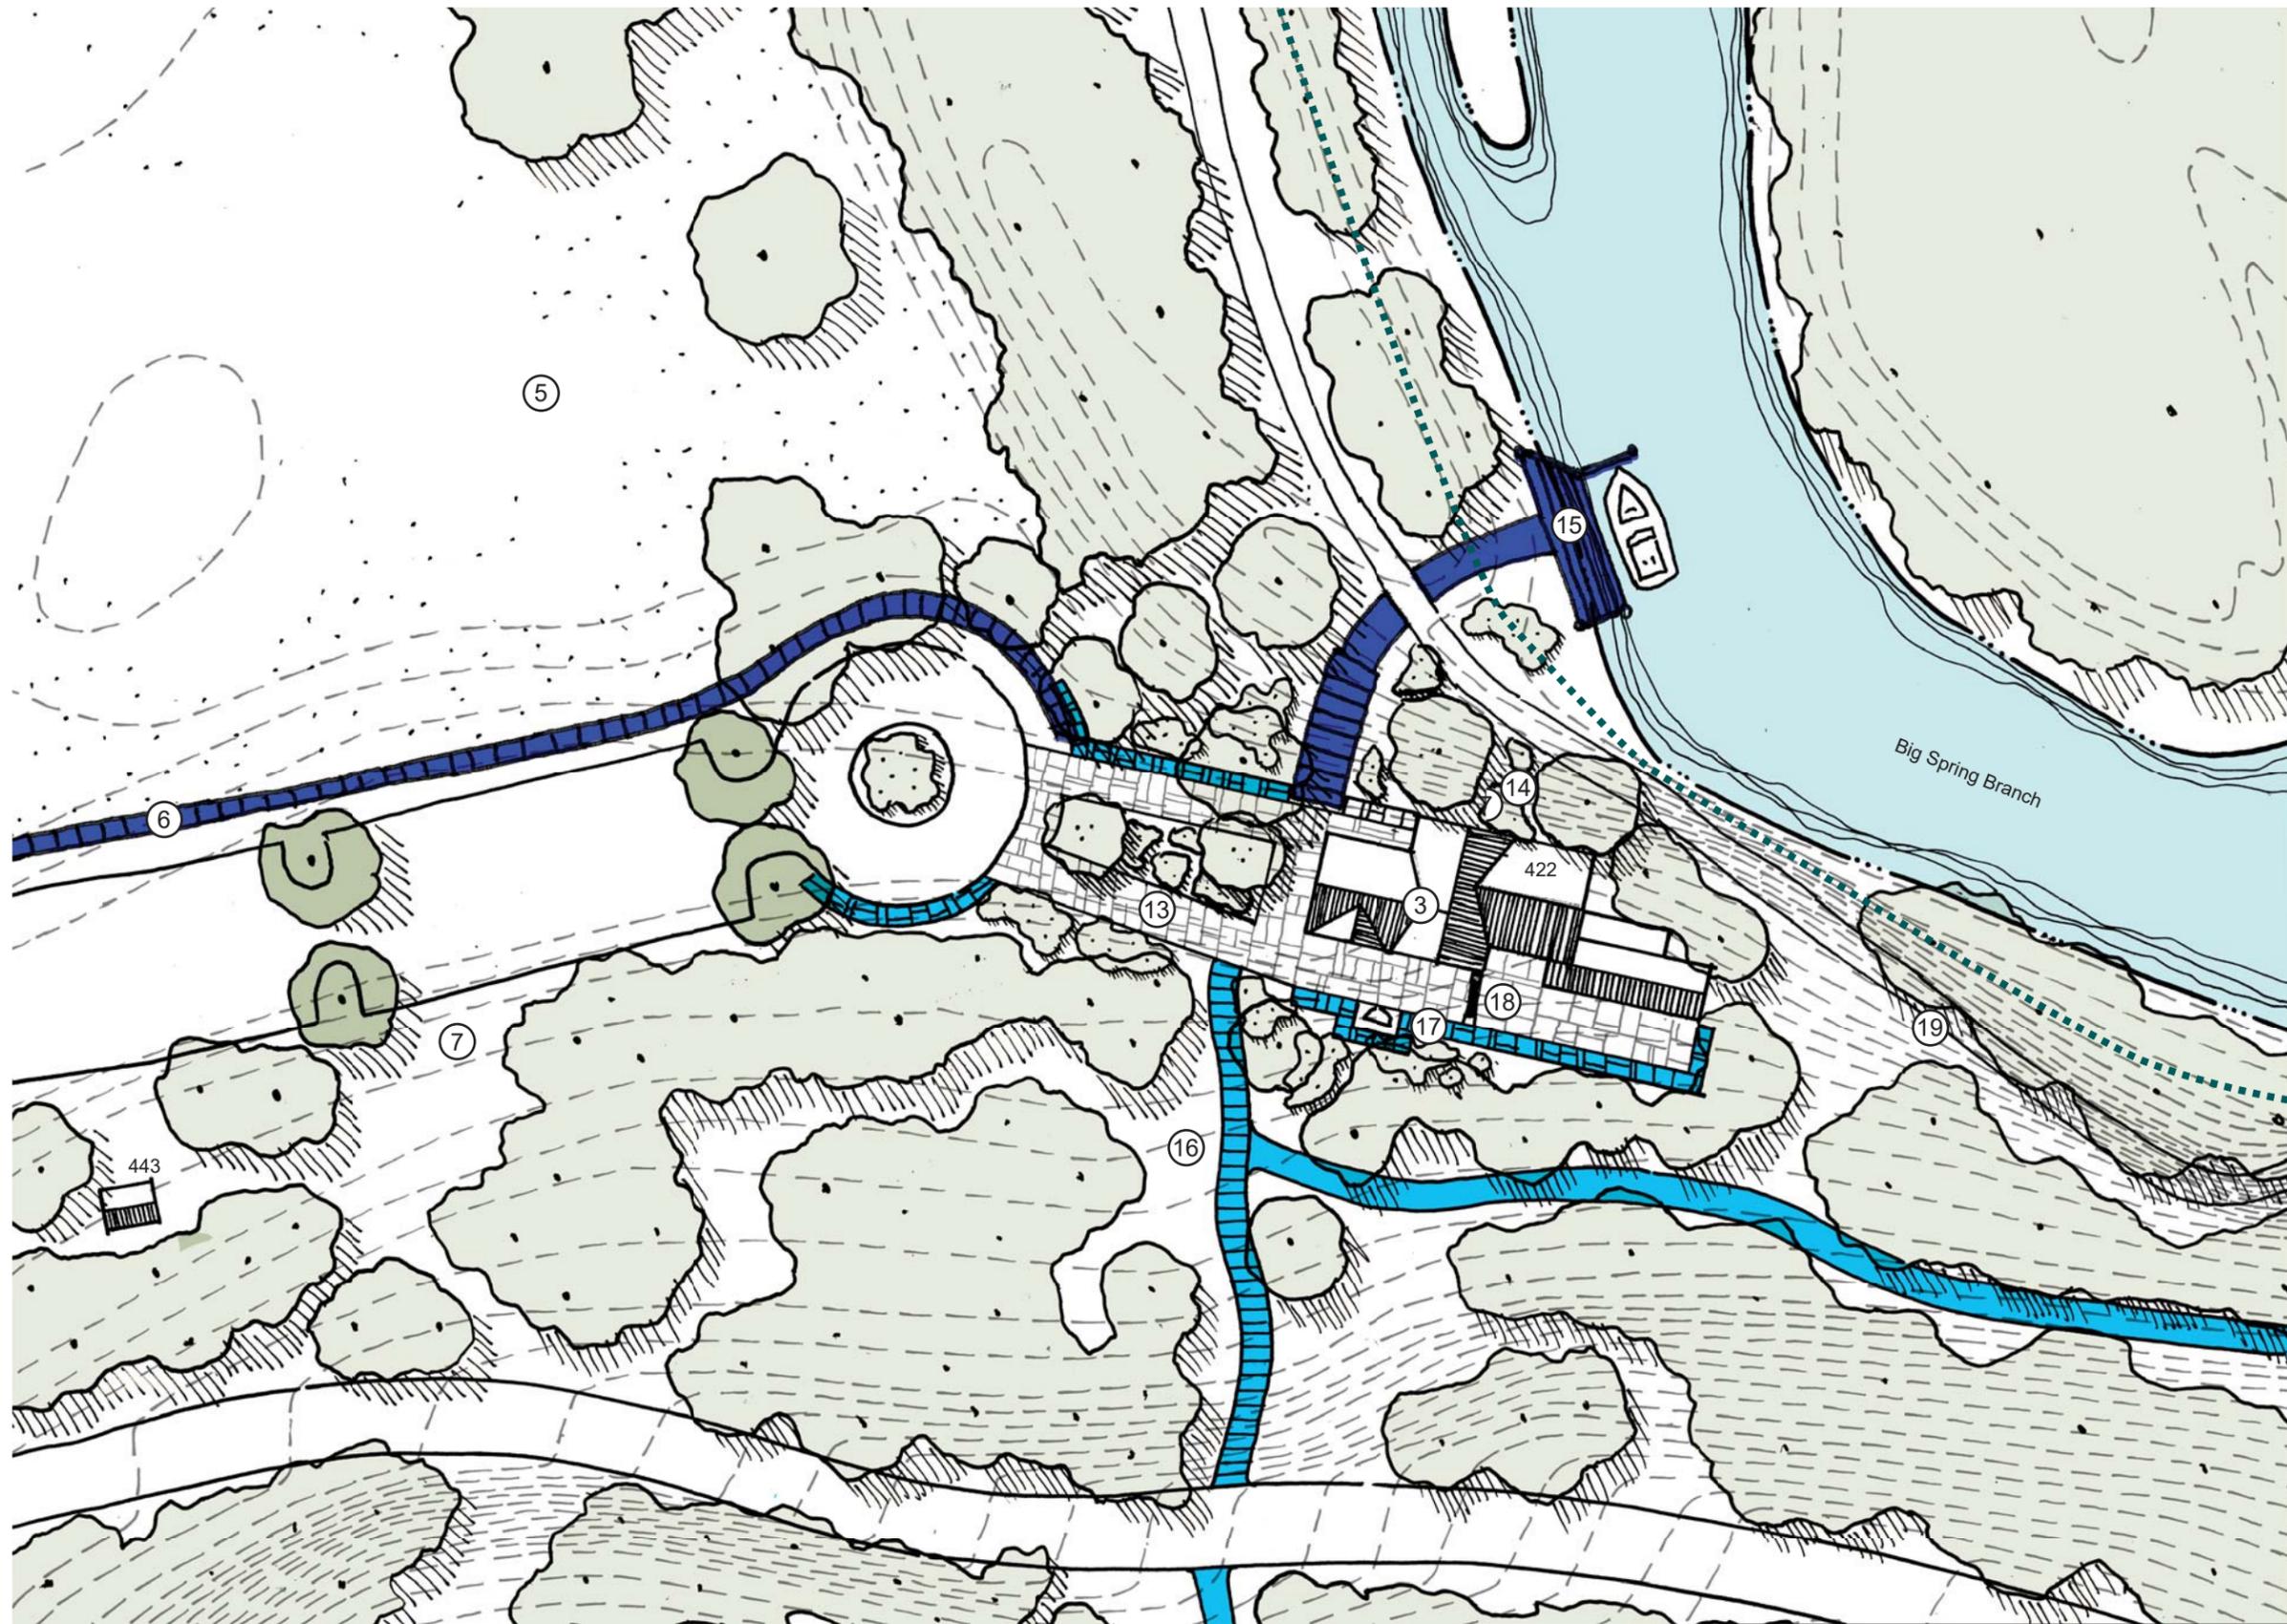
TITLE OF PROJECT  
**CULTURAL LANDSCAPE REPORT  
 AND ENVIRONMENTAL ASSESSMENT**  
 TITLE OF DRAWING  
**TREATMENT - DINING LODGE**  
 NAME OF PARK  
**BIG SPRING HISTORIC DISTRICT**  
 REGION COUNTY STATE  
 MIDWEST CARTER MISSOURI  
 Illustration 6-4. 6-25

- Treatment Notes**
- ① RE: Treatment - Core Development Area
  - ② RE: Treatment - Core Development Area
  - ③ Rehabilitate Dining Lodge (HS-422) and Open for Visitor Use / Concessions

- ⑦ Reestablish Historic Character Plantings and Open Setting with Park-Like Character
  - ⑧ Repair Main Parking Area (HS-714), Reveal Concrete Curb, Remove Non-Contributing Features (Waysides)

- ⑬ Establish Accessible Route and Entrance along Historic Patterns at Dining Lodge (HS-422)
  - ⑭ Thin Vegetation to Provide Views to River
  - ⑮ Replace Boat Dock and Staircase with Compatible Design / Material

- ⑯ Repair Path and Stone Steps to Cabins
  - ⑰ Repair Dining Lodge Retaining Wall and Fountain (HS-422A) to Full Extent
  - ⑱ Gate to Enclose Service Area

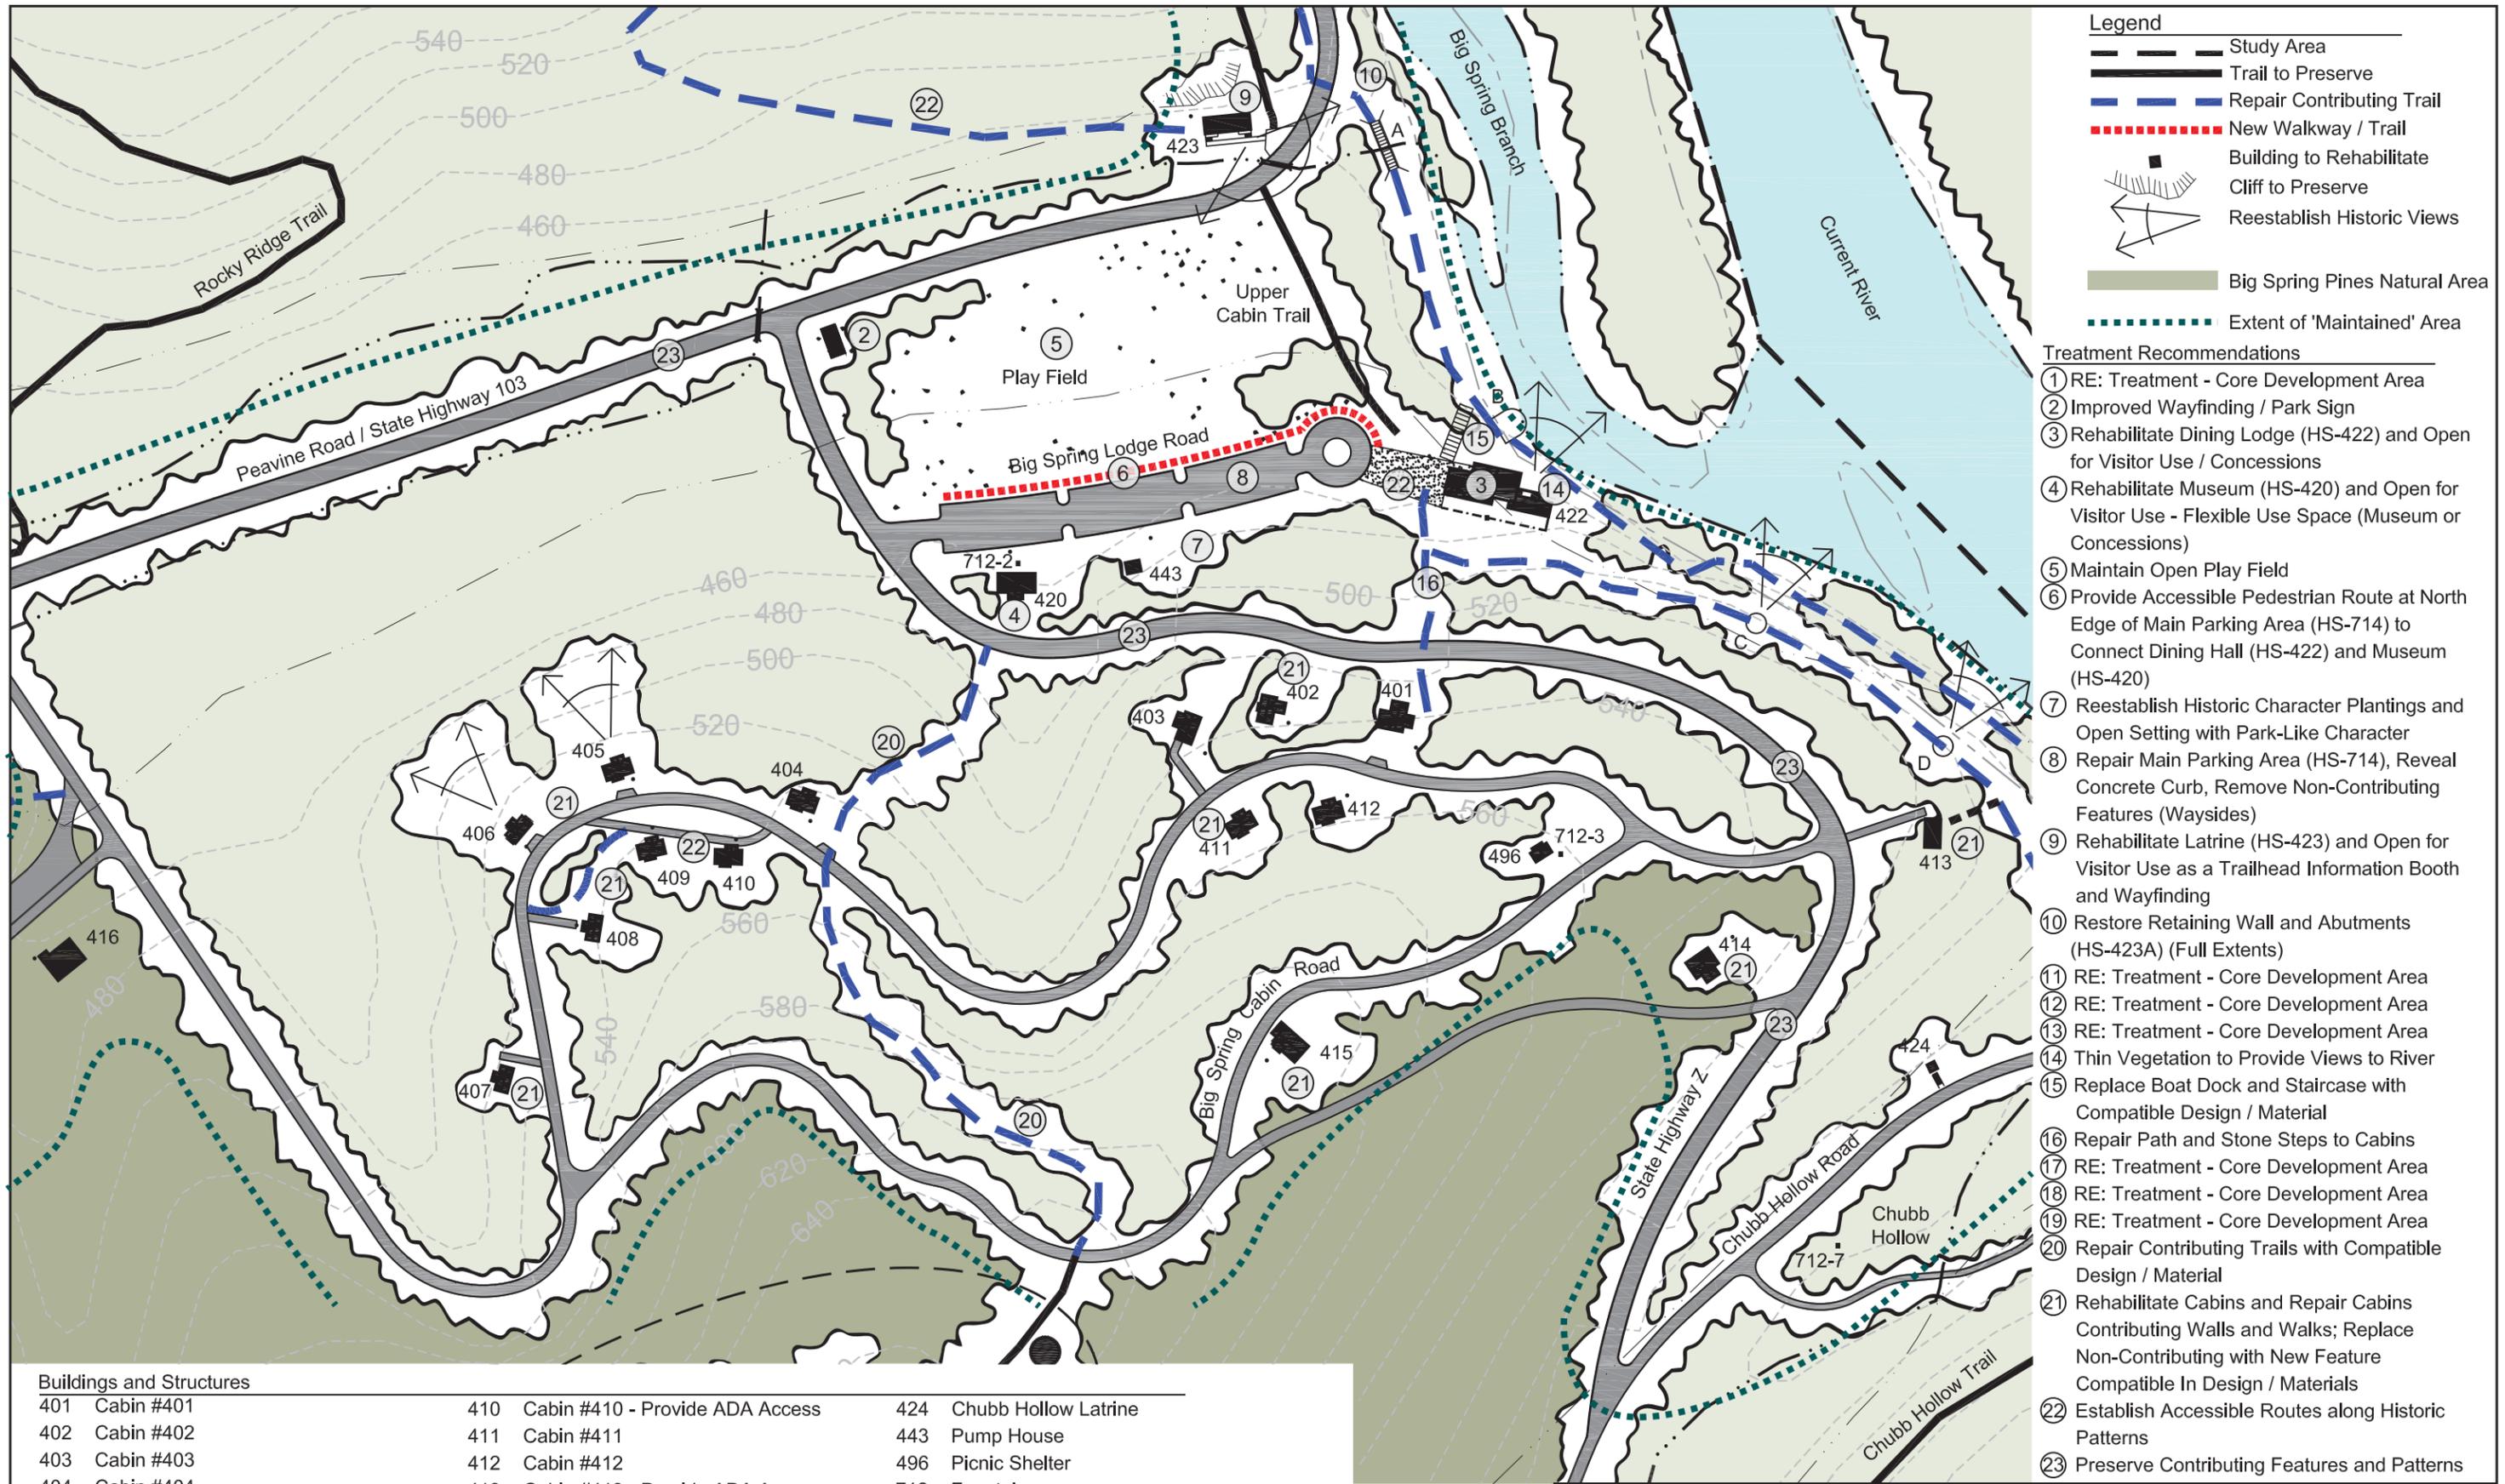
TITLE OF PROJECT  
 CULTURAL LANDSCAPE REPORT  
 AND ENVIRONMENTAL ASSESSMENT  
 TITLE OF DRAWING  
 TREATMENT - MUSEUM, DINING LODGE AND CABIN  
 NAME OF PARK  
 BIG SPRING HISTORIC DISTRICT  
 REGION  
 MIDWEST  
 COUNTY  
 CARTER  
 STATE  
 MISSOURI  
 Illustration 6-5.  
 6-27

- Treatment Recommendations**
- ① RE: Treatment - Core Development Area
  - ② Improved Wayfinding / Park Sign
  - ③ Rehabilitate Dining Lodge (HS-422) and Open for Visitor Use / Concessions

- ⑦ Reestablish Historic Character Plantings and Open Setting with Park-Like Character
  - ⑧ Repair Main Parking Area (HS-714), Reveal Concrete Curb, Remove Non-Contributing Features (Waysides)

- ⑮ Replace Boat Dock and Staircase with Compatible Design / Material
  - ⑯ Repair Path and Stone Steps to Cabins
  - ⑰ RE: Treatment - Core Development Area

- ⑱ RE: Treatment - Core Development Area
  - ⑲ RE: Treatment - Core Development Area
  - ⑳ Repair Contributing Trails with Compatible Design / Material

- ㉑ Rehabilitate Cabins and Repair Cabins Contributing Walls and Walks; Replace Non-Contributing with New Feature Compatible In Design / Materials
  - ㉒ Establish Accessible Routes along Historic Patterns

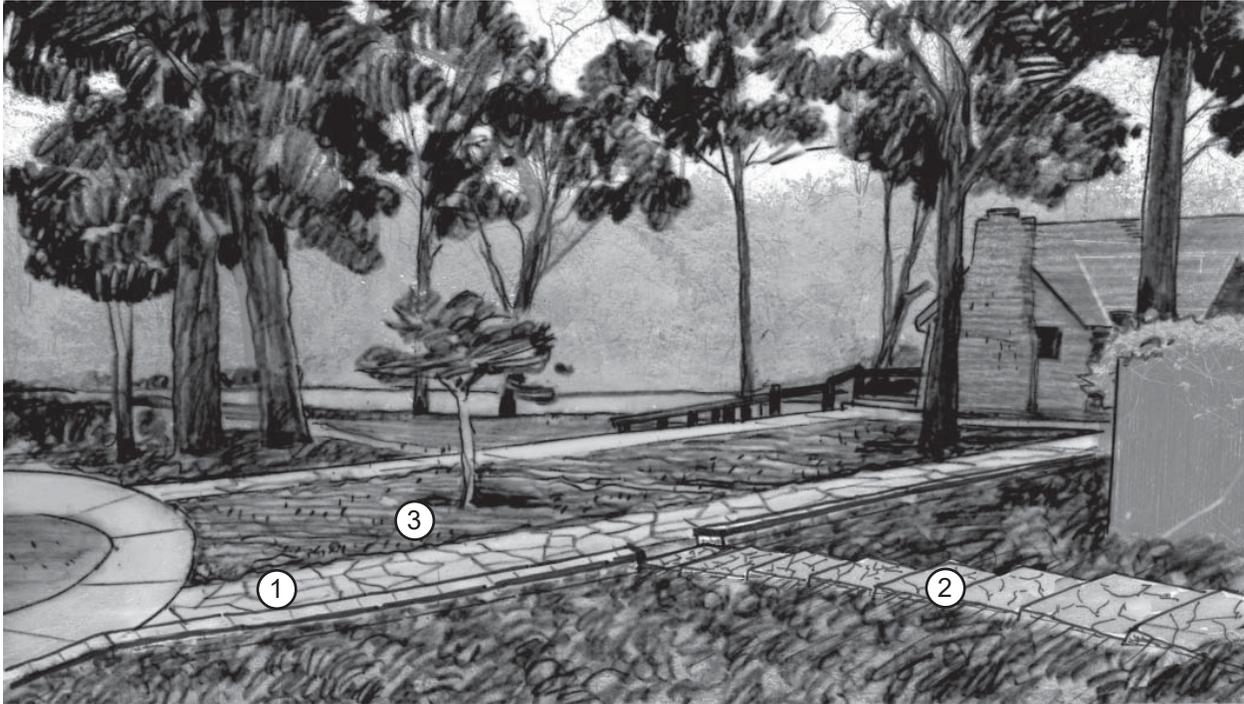
- ① Establish Accessible Route and Entrance along Historic Patterns at Dining Lodge (HS-422). North and South Routes to Match in Appearance, Width, and Texture
- ② Repair Path and Stone Steps to Cabins, Replacing Existing Steps With Compatible (Stone) Material
- ③ Reestablish Historic Character of Plantings (Ornamental Vegetation) Repair Plantings to a More Manicured Appearance to Include Ornamental Trees and Groundcovers in Naturalistic Groupings

- 9 14. Repair the vegetation at the Dining Lodge  
10 to frame views and create a maintained  
11 yet naturalistic appearance.  
12
- 13     ° Repair eroded and damaged plant  
14 material that includes unhealthy  
15 undergrowth and invasive plant  
16 species, specifically on the slope  
17 above and below the Dining Lodge.  
18

- 19     ° Remove downed limbs and fallen  
20 timber from the vicinity. Maintain this  
21 area free of large timber, as possible.  
22
- 23     ° Repair plantings in planting area in  
24 front of the Dining Lodge, to include  
25 ornamental trees and groundcovers in  
26 naturalistic groupings.  
27

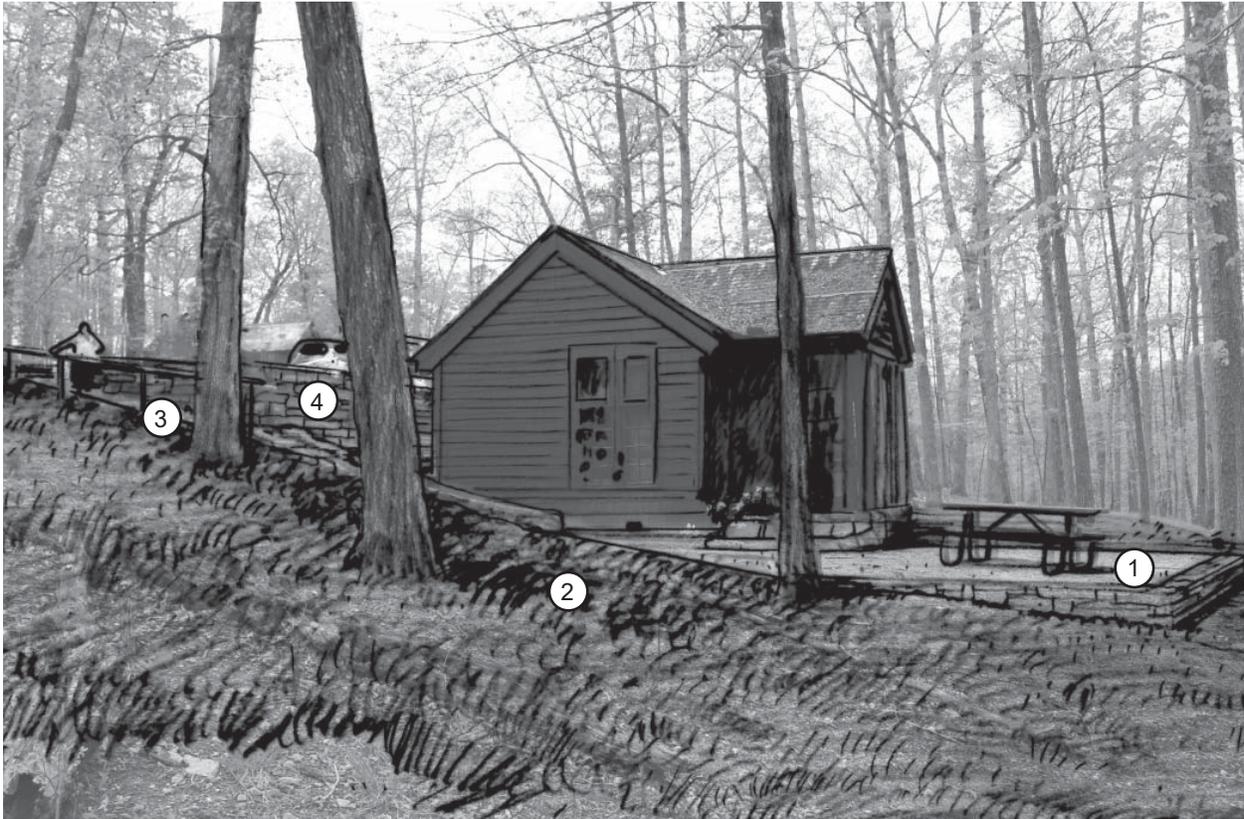
Figure 6-9. Rehabilitate the setting of each cabin by repairing vegetation using additional new native shrubs and groundcovers; replacing non-contributing retaining walls with new materials that match historic; and utilizing small scale features compatible with the historic setting.

- ① Reestablish Outdoor Spaces to be Compatible with Historic Design to Blend with Setting, Defined by a Level, Soft, and Well-Drained Surface with Sheltering Vegetation and Enhanced View
- ② Thin Vegetation to Match Historic Pattern and Provide Views, Rehabilitate Plantings in Naturalistic Groupings, Repair (Thin, Prune, New Plantings) Vegetation to More Park-Like Appearance, And Naturalistic Groupings, Clearings for Views, With Removal Of Fallen Timbers
- ③ Repair Contributing Stone Wall and Steps With In-Kind Materials
- ④ New Retaining Wall to be Compatible with Historic

34  
35 Accessible paths will accommodate visitors  
36 into the Dining Lodge (HS-422), Museum  
37 (HS-420), and cabins. The cabin setting will  
38 be enhanced by repairing retaining walls,  
39 steps, and adjacent vegetation to reflect the  
40 naturalistic setting envisioned by the CCC and  
41 WPA.
