# North Cascades 2015 Fires Post-Fire Response Plan

North Cascades National Park Service Complex

## EXECUTIVE SUMMARY

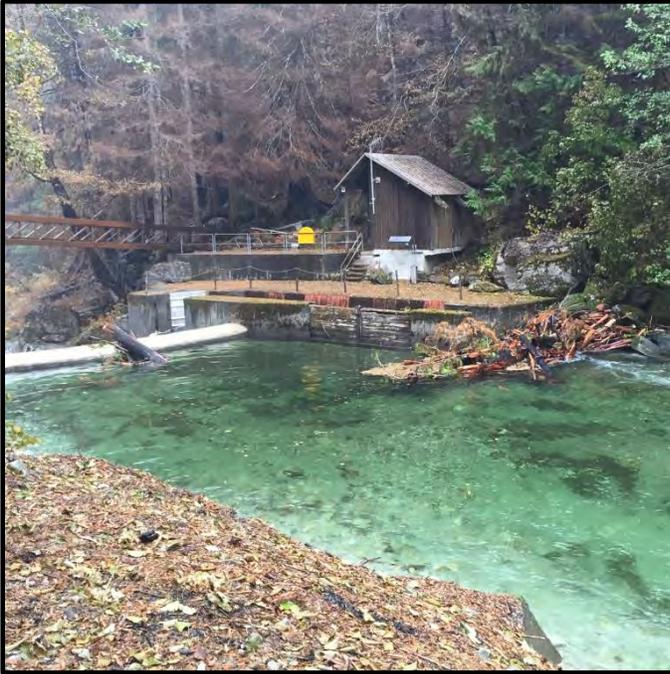
**Photo 1.** Seattle City Light hydroelectric intake station

**Seattle City Light powerhouse and inlet on Newhalem Creek.** Seattle City Light operates a hydroelectric powerhouse in the Newhalem Creek drainage. The intake station is comprised of a small building and diversion dam. At the time of the assessment, burned woody debris was partially blocking the intake for the penstock (Photo 1). Accumulation of this debris could cause damage to the infrastructure at the site.

Seattle City Light should increase patrols and maintenance of the diversion dam and basin for the next three to five years. No treatments are needed to protect from rock fall or debris flows; however, care should be taken to inspect and maintain structures before or after large storm events to protect employees from rock fall and debris flow risks.

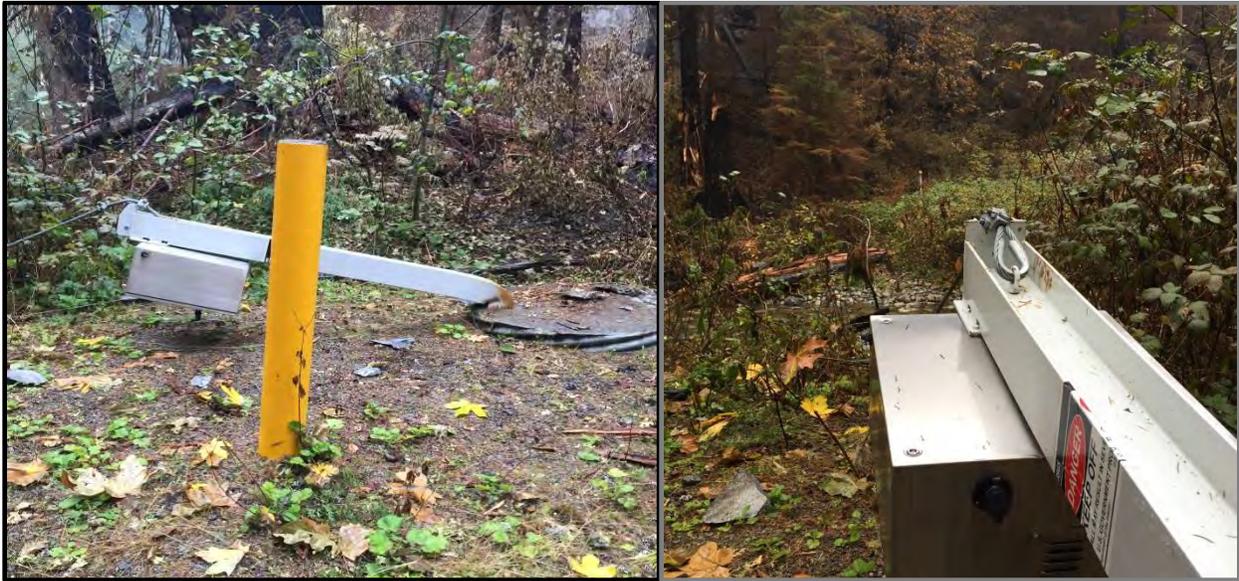
**Photo 2.** Damaged USGS streamgage infrastructure.

**USGS streamgage station on Newhalem Creek.** A USGS streamgage station was damaged during the Goodell fire. The mounting pole is bent parallel to the ground and the cross-stream cable is damaged (Photo 2).

Watershed: A combination of aerial and ground reconnaissance were utilized to assess the threats of post-fire watershed conditions within and downstream of the North Cascades 2015 Fires. In addition, a Burned Area Reflectance Classification (BARC) image, generated September 11, was used to assist classification of soil burn severity within the fire perimeters. In general, the mosaic of fire severity raises few watershed concerns. Watershed response concerns focus on the debris flow fans at Manly Wham Campground and Riddle Creek cabins, although a ground assessment is needed to determine the extent of the threat (*Specification W4*). Additional watershed protection specifications include clearing roads and cleaning culverts (*W1*), hazard warning signs and public information/education materials (*W-2*), limiting the spread of potential hazardous material (*W3*), constructing a berm to protect NPS buildings from rockfall and cleaning the associated ditch (*W5, W6*), providing for law enforcement closure of roads when landslides block the highway (*W7*), and repairing the USGS stream gage in Newhalem Creek (*W8*).

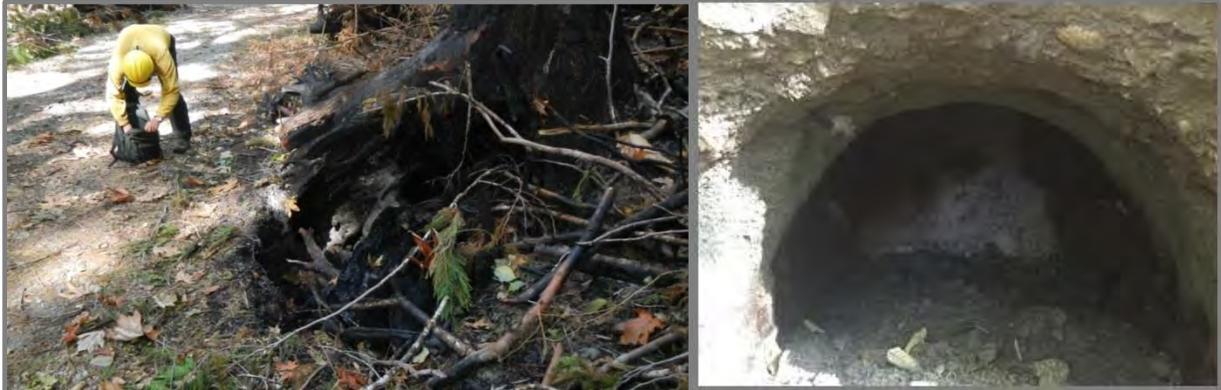
**Photo 4.** Tree with burned roots below roadbed destabilizing Upper Goodell Creek road (top) and burned culvert along Goodell Creek Road (bottom).

**Road to Upper Goodell Creek Group Campground.** This road was generally in good condition, but does have multiple hazard trees. A 25' long x 36" diameter plastic culvert in the road matrix of the Goodell Campground road was completely burned (Photo 4).

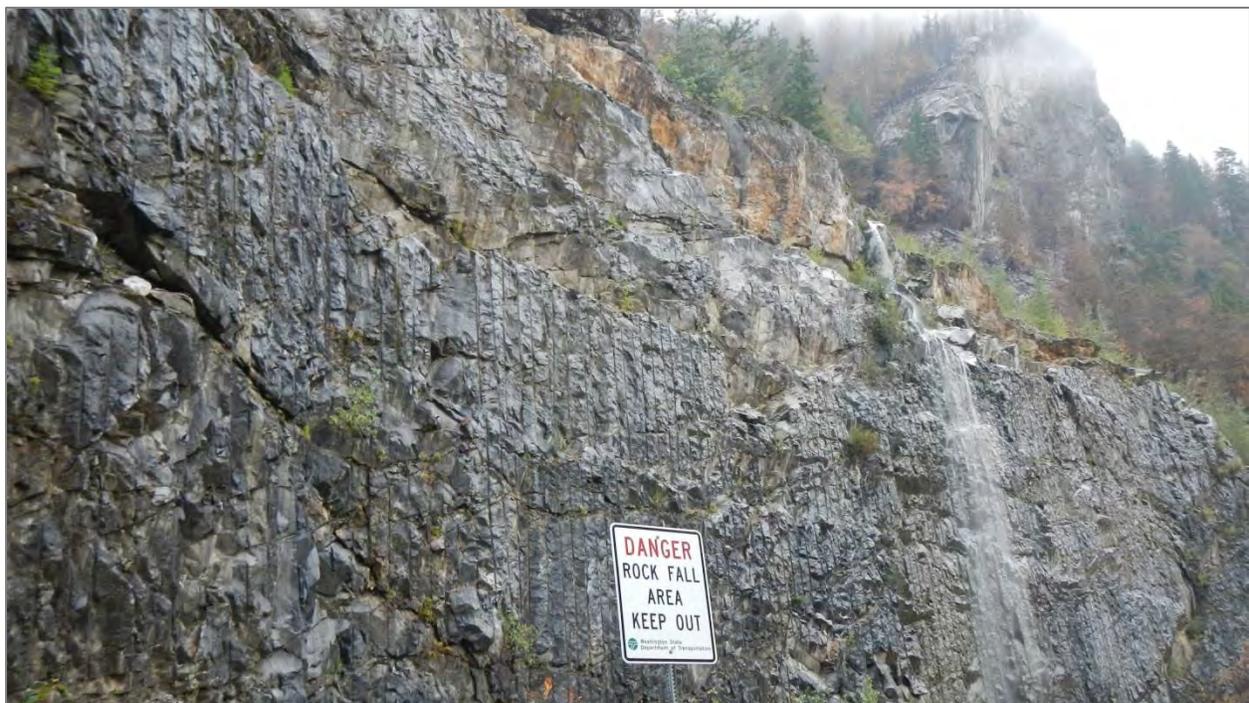
**Photo 5.** Debris slide mitigation area along State Route 20.

**State Route 20.** This highway through NOCA provides a travel corridor through the park and access between communities on the west and east side of the Cascades. This highway regularly experiences rock fall, debris slides, and tree falls (Photo 5). Additionally, culverts along this route are expected to experience increased flows and susceptibility to clogging with debris.

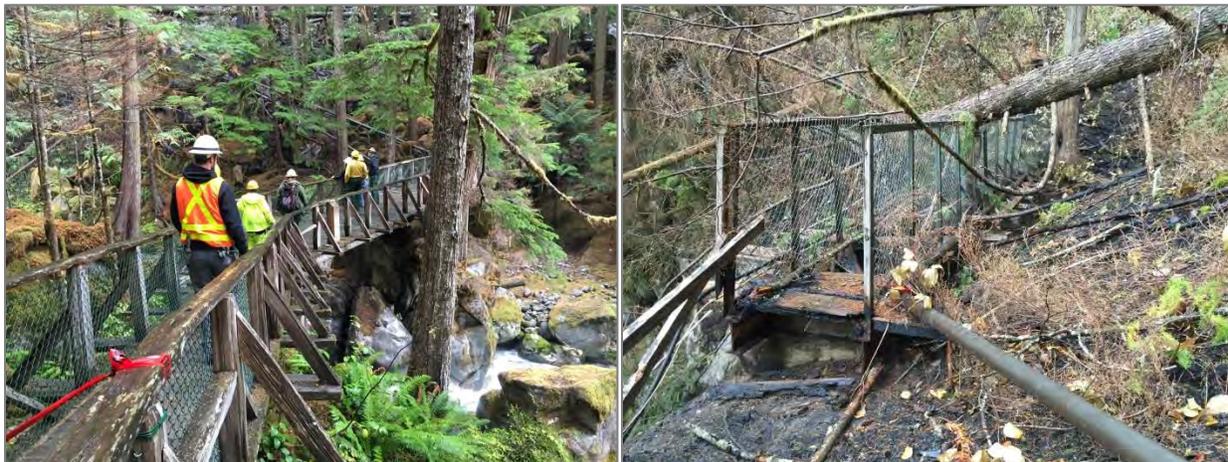
**Photo 6.** Lower footbridge (L) and upper footbridge (R) in Ladder Creek drainage.

**Footbridges over Ladder Creek.** Two historic, wooden footbridges are located over Ladder Creek. Damage from flood-transported log debris is unlikely, given that both bridges survived the 2003 flood event and several other previous large floods. One bridge suffered significant damage from the fire and subsequent treefall (Photo 6).

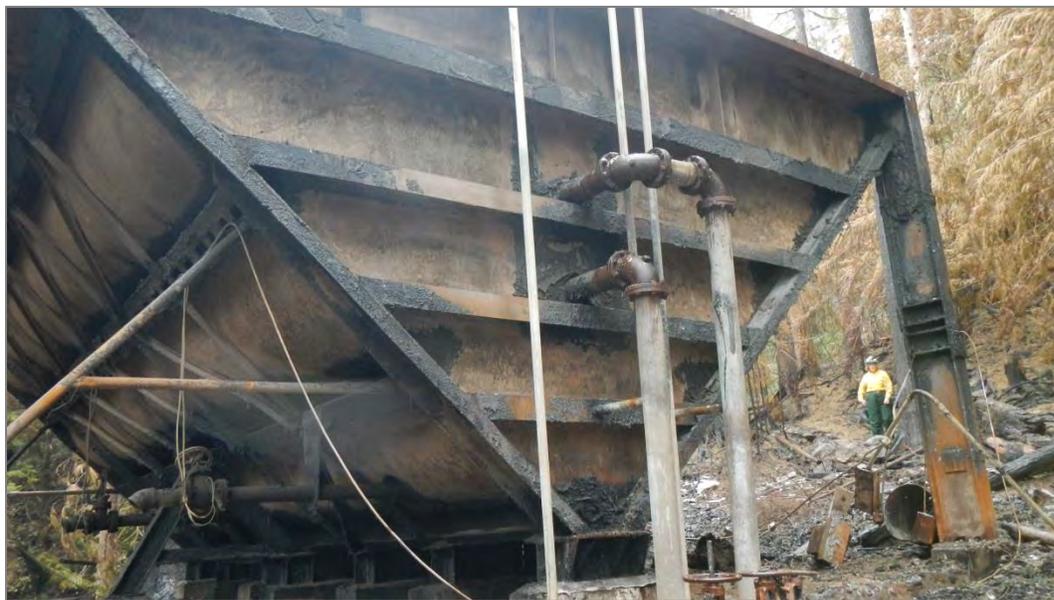
**Photo 7.** Water settling tank exterior).

**Settling Tank near Ladder Creek.** This water settling tank historically provided water to the town of Newhalem and was later repurposed to supply irrigation water in the town. It is not currently used for any purpose (Photo 7). The corrugated aluminum roof burned during the fire.

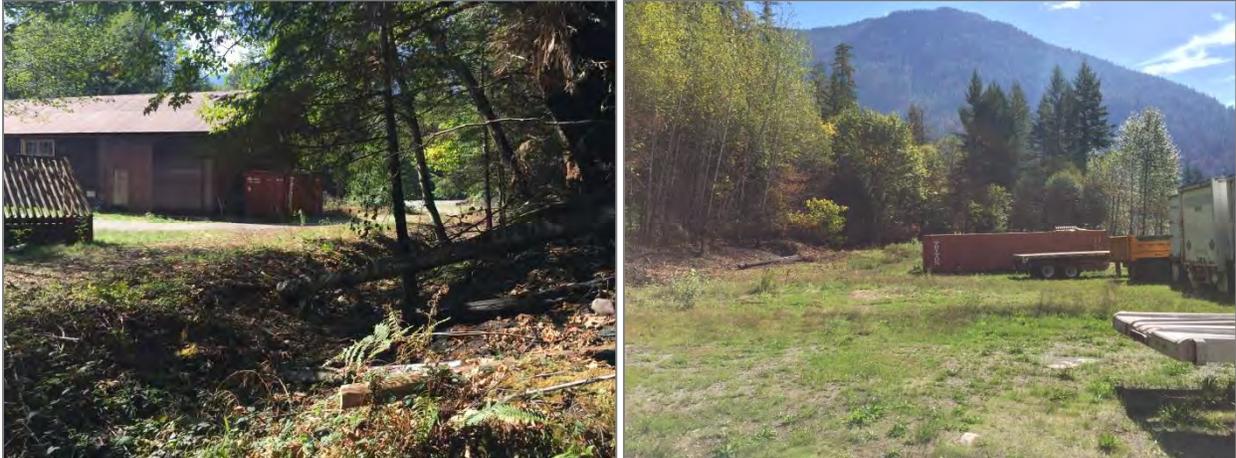
**Photo 8.** Location of recommended berm and channel clearing.

**Structures north of State Route 20 in Newhalem.** Several building and assets belonging to Seattle City Light, Washington Department of Transportation, and the NPS are located north of State Route 20 in Newhalem and below a steep cliff face (Photo 8). There is a discontinuous berm protecting the structures from nuisance flooding located along the northern side of the buildings. A gap in the berm, which appears to have eroded in a flood event, is located adjacent to the NPS building.

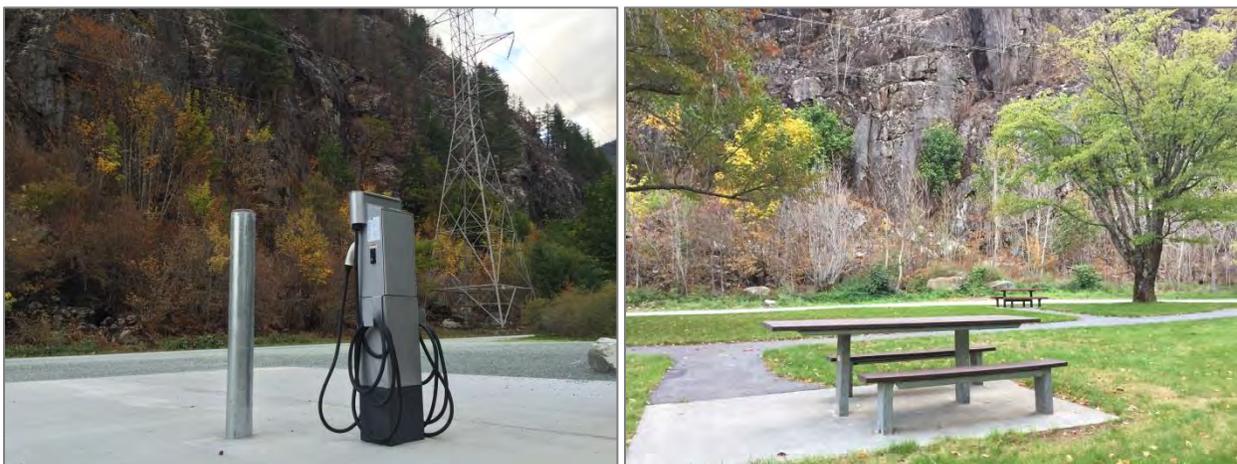
**Photo 9.** Electric vehicle charging station and picnic area near the Goodell Fire.

**Picnic Area, Electric Vehicle Charging Station, and Ross Crypt – Newhalem, WA.** A popular picnic area, electric vehicle charging station, and crypt for J.D. and Alice Ross is located north of State Route 20 and directly below of cliffs and steep hillslopes (Photo 9). Several large rocks are located along the base of the cliff, indicating that the area is prone to rock fall.

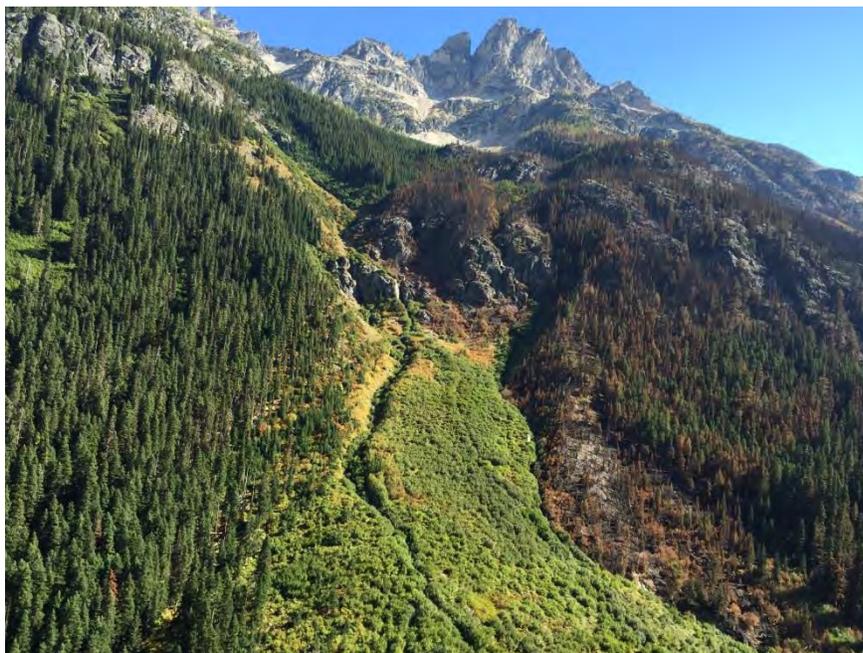
**Photo 10.** Burned area above Five Mile Campground

**Five Mile Campground.** This campground was evaluated during a helicopter survey (Photo 10), through the BARC map, and hydrological modeling. The campground is projected to have relatively low increases in runoff.

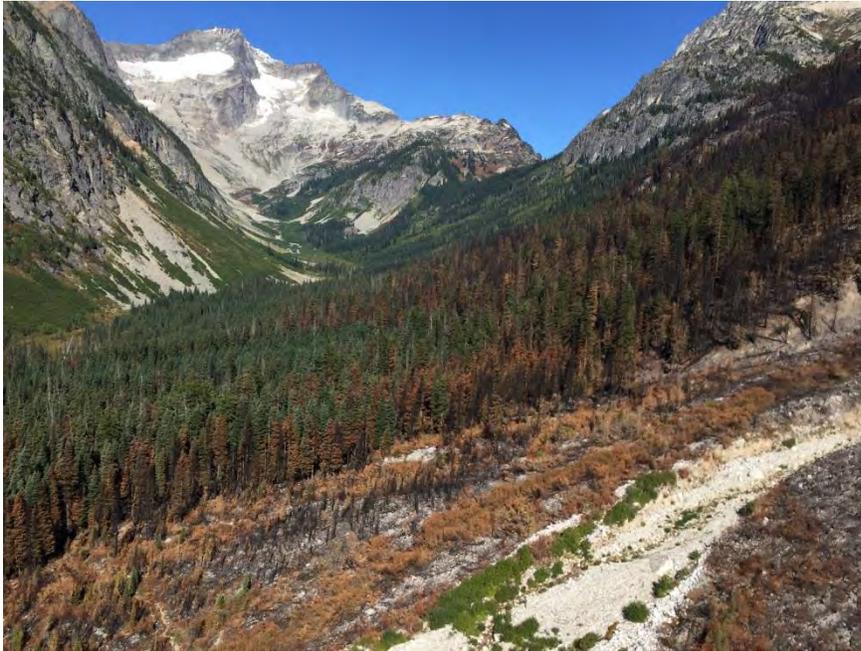
**Photo 11.** Burned slopes above Park Creek Pass Trail.

**Park Creek Pass Trail.** This trail was evaluated during a helicopter survey (Photo 11), through the BARC map, and hydrological modeling. The campground is projected to have moderate to high increases in runoff.

We recommend that this section of the Park Creek Trail remain closed through at least spring 2016. The NPS should post warning signs in appropriate locations on both side sides of the burned area. Signs should be placed close to the burned area (considering the area is designated Wilderness). The warning signs should include a map of the hazard area, warning language to hasten travel through the area, and describe the risks of debris flow, rock fall, flash-flooding, and hazard trees, particularly in windy conditions. The signs should be remain for up to five years after the fire and inspected for integrity each spring after snow melt opens the trail.

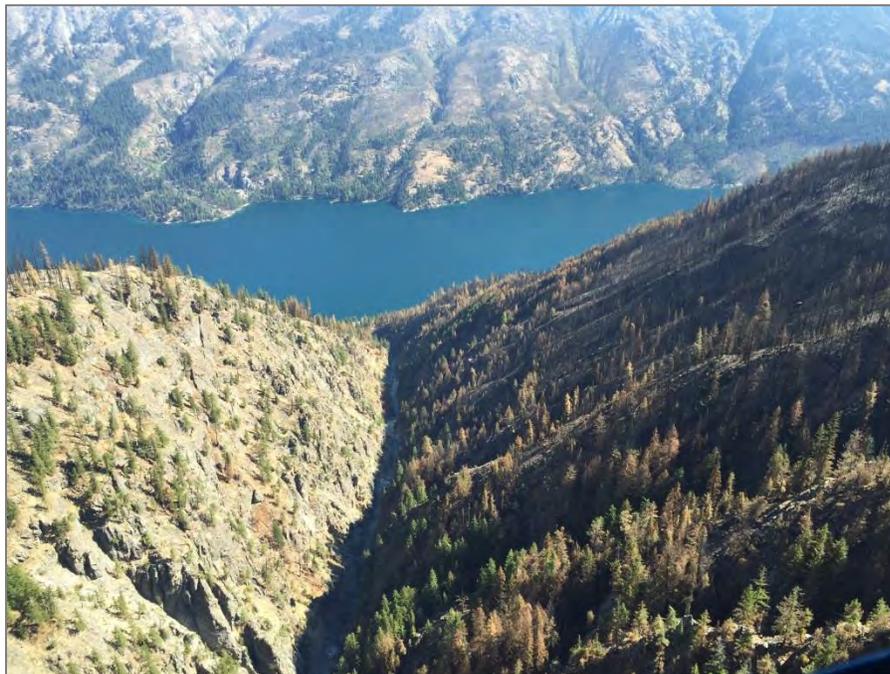
**Photo 12.** Burned area above Manly Wham Campground.

**Manly Wham Campground.** This campground was assessed during a helicopter survey (Photo 12), and determined to need additional assessment for impacts to life and property.

Closure of these areas is recommended until a more detailed ground assessment can be made. *Specification W4* requests the funds to complete this assessment.

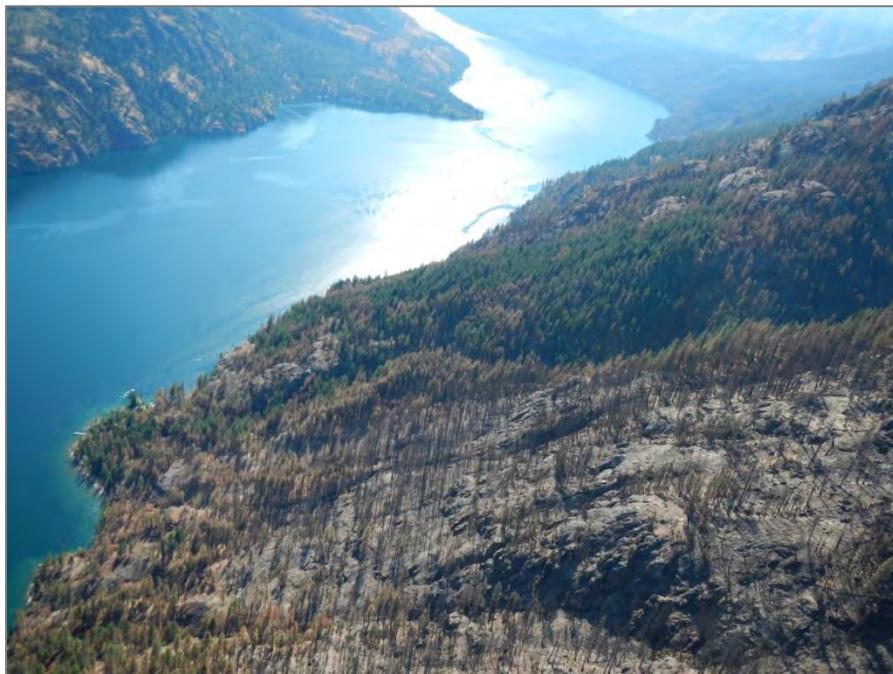
**Photo 13.** Burned slopes above Riddle Creek cabins.

**Riddle Creek Cabins.** These cabins were assessed during a helicopter survey (Photo13) and through hydrologic modeling using the BARC map. Additional assessments from the ground are needed to determine potential impacts.

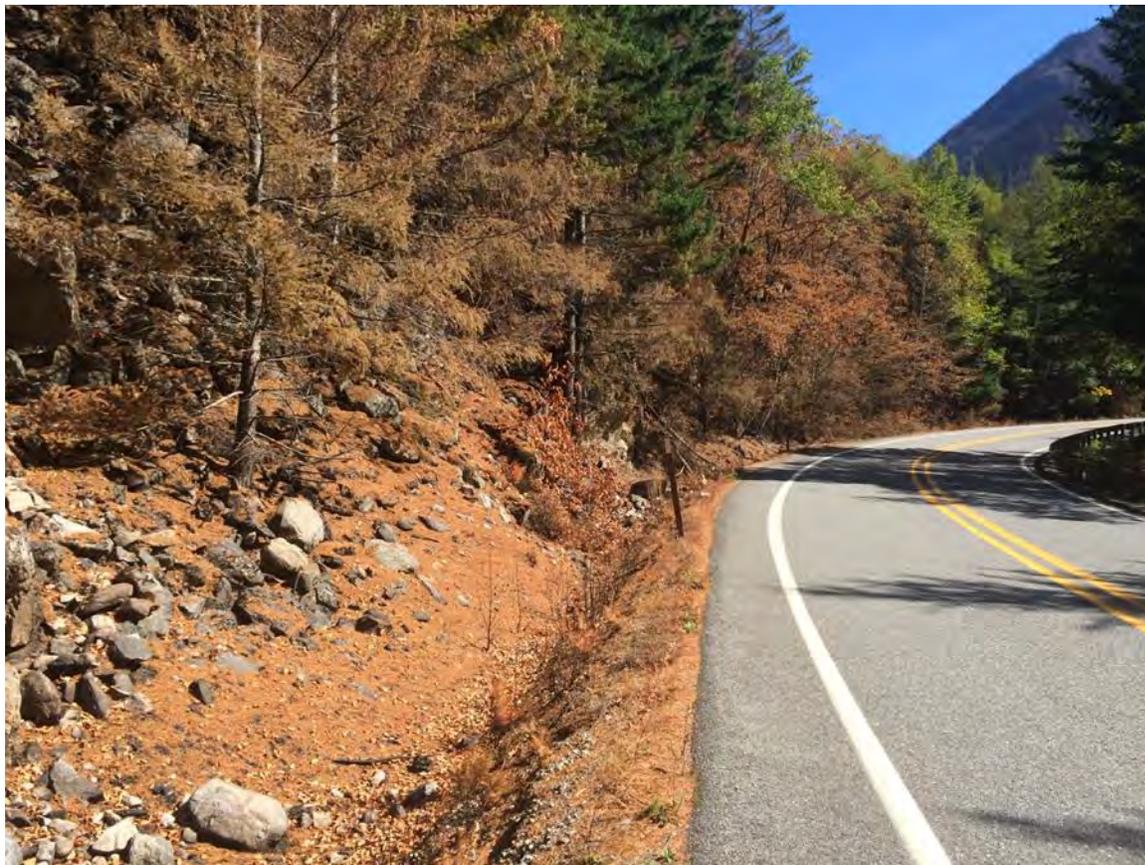
Photo 14. The Goodell Fire intermittently burned approximately five miles of roadside along State Route 20.

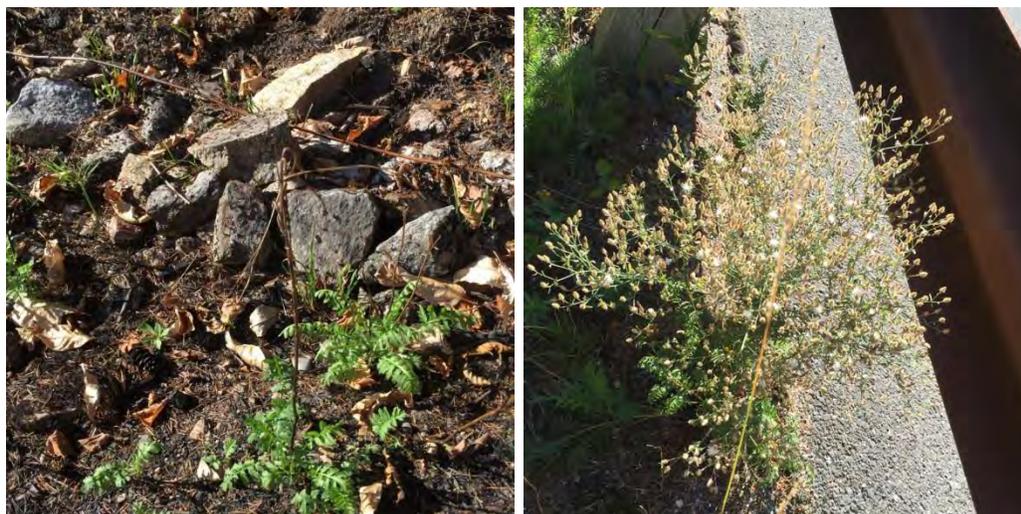
At least 43 invasive plant species are known to occur within or immediately adjacent to the Goodell Fire area. The Goodell Fire burned through several developments along the Skagit River, including the Seattle City Light company-town of Newhalem, a power transmission line, NPS campgrounds, several interpretive trails and a state highway. Due to high levels of human activity in these front country sites, a large number of non-native species occur in the area and are at high risk of moving into adjacent burned areas.

Photo 18. Common Tansy sprouting after the fire along Highway 20 and knapweed within fire perimeter.

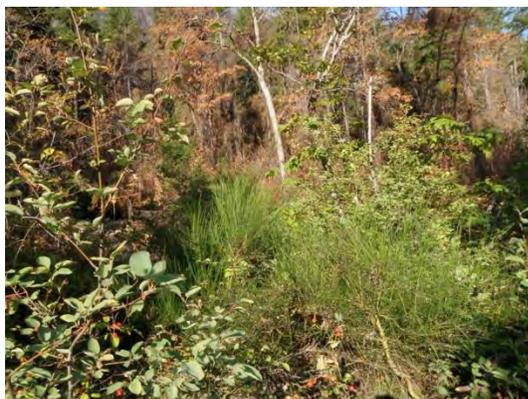
Three non-native invasive species are known to occur within the fire boundary at the Riddle Creek cabin site in the Wolverine Fire: Scotch broom (*Cytisus scoparius*) (Photo 17), sweet pea (*Lathyrus latifolius*) and periwinkle (*Vinca minor*). Scotch broom and periwinkle are listed as “Medium-High” priorities for treatment under the NOCA Invasive Non-Native Management Plan (2012). Scotch broom is a Class B noxious weed. Although sweet pea and periwinkle are not state-listed, they are known to be highly invasive within the Stehekin Valley.

Photo 17. Scotch broom at Riddle Creek site.

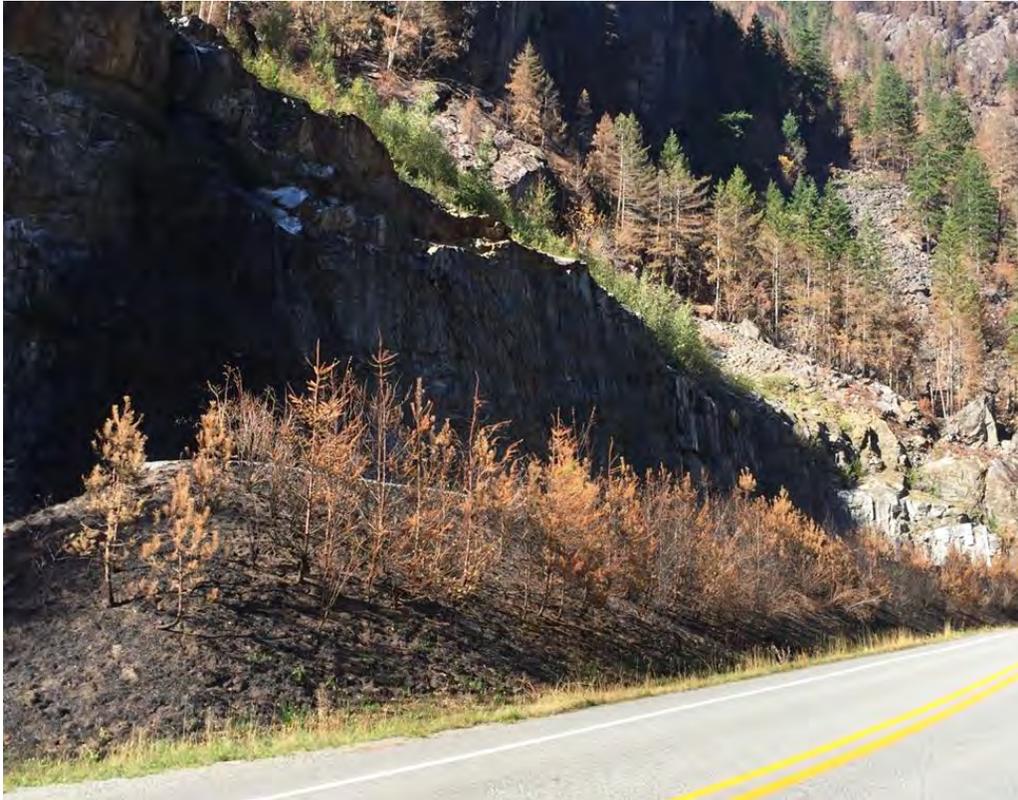
Falls Creek Berm. In 2003, a landslide occurred in the Skagit Gorge area, damaging State Highway 20. In order to prevent damage from future slides in this area, Washington State Department of Transportation constructed a catchment basin with a 6,000 square foot berm to protect the road way from potential rock fall (Photo 15). The berm was faced with top soil and NOCA grew and installed native plants on the berm. This functioned both to enhance the aesthetics of the site and to prevent the berm from being infested with weed species. The site was monitored intermittently in the years following planting. These surveys documented decreasing weed cover with increasing native plant cover. 100% of the berm burned in the Goodell fire and is at high risk of exotic invasion due to disturbance and proximity to the road corridor.

Photo 15. The Falls Creek highway berm after the Goodell Fire.

Revegetation with native species is another way to combat noxious weed invasion. A large (6000 ft<sup>2</sup>) stone and earthen berm constructed by WA DOT to stop rockfall from impacting State Highway 20 in the Skagit River Gorge was originally planted by NOCA to native trees and grasses. These plantings burned in the fire. *Specification V2* allows NOCA to propagate and re-plant the berm with local native species, as well as control any invasive plants that appear.

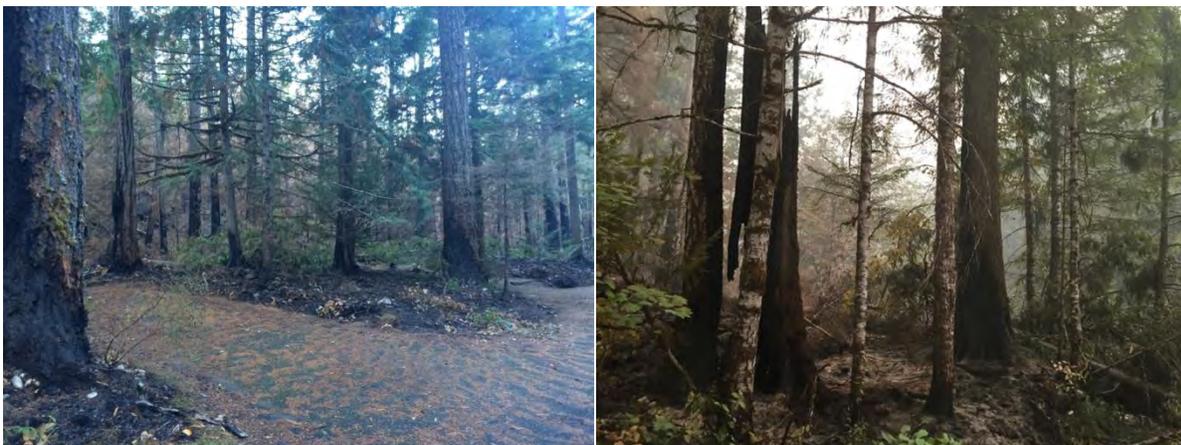
Hazard Trees. The Goodell Fire burned part or all of the Newhalem Creek campground (Photo 18), the Upper Goodell Group campground, the Newhalem Creek penstock intake, and most of the trails in the Newhalem area. Numerous trees in these developed areas were killed by the fire or weakened enough that they pose threats to park staff, hikers, and campers. NOCA park management has closed Newhalem campgrounds and trails to prevent visitors from entering burned areas.

Photo 18. Newhalem Campground Loop C, part of which burned in the Goodell Fire.

Equally important were concerns raised by the large number of potential hazard trees associated with facilities and infrastructure in burned areas. A BAR treatment specification (*Specification V3*) was developed to address immediate mitigation of hazard trees directly threatening life and property and to re-assess burned tree hazards within the park's developed areas in the spring of 2016. The closure of public facilities (campgrounds, trails) within the burn areas through at least one winter for safety is recommended.

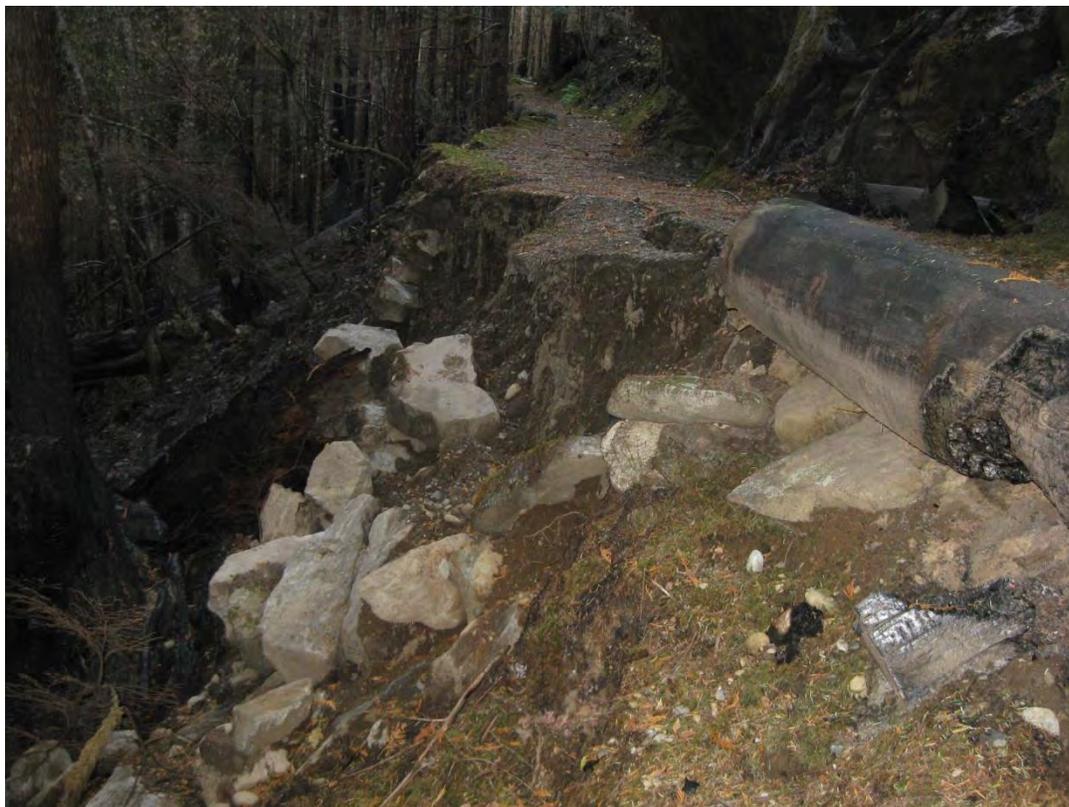
The Newhalem Creek access trail burned over completely, suffering tread damage and complete loss of trail through some heavily forested sections due to the high burn severity. The upper ¼ mile of this trail has many standing snags and is very dangerous to traverse.

Photo 19: Section of Newhalem Rock Shelter access trail; loss of crib logs led to failure of dry stack rock wall.

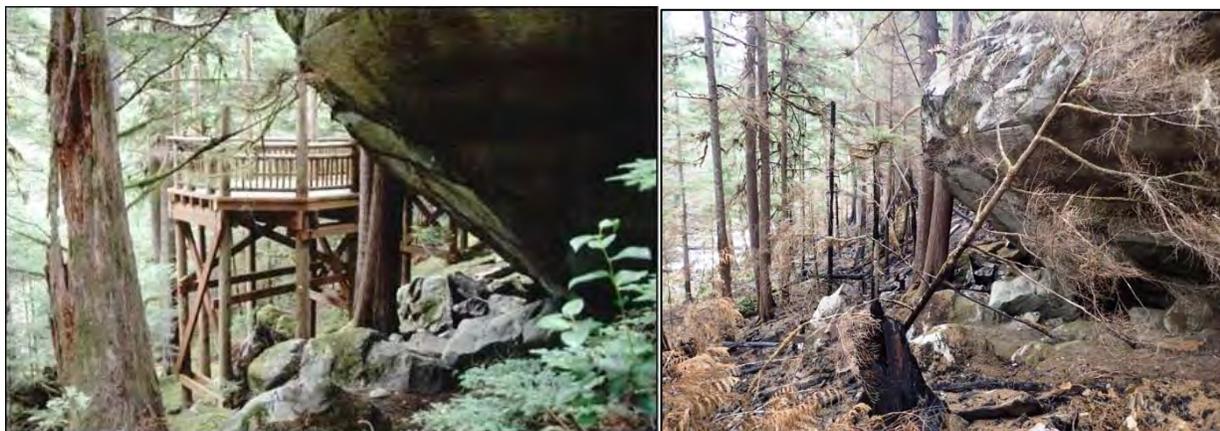
The interpretive exhibit for the viewing platform was intended to be both protective and interpretive for the rock shelter and archaeological resources in general with input given from the local tribes. Interpretive panels were placed on the rock shelter viewing platform to encourage visitors to consider archeological, historic, and Native American perspectives about the locality and the surrounding mountains. The carefully considered design of the boardwalk and viewing platform with interpretive displays was incorporated into features to physically protect the archaeological values of the Newhalem Rock Shelter and through visitor education in such a way to mitigate potential adverse effects to the site and to manage the site in a manner that results in no adverse effect to its significant qualities.

Photo 21. The Newhalem Rock Shelter and boardwalk before fire (left) and after fire (right).

along roads and trails. Field reconnaissance by trail crew employees and the BAER Team documented damage to many of these facilities. Burned Area Emergency Response funding is requested to address repairs to roads and culverts (*Specifications F1, F5*). Funding is requested through the Burned Area Rehabilitation program to repair or replace the traffic counter (*F2*), trail tread (*F3*) campground infrastructure (*F4*), and the Rock Shelter boardwalk (*F6*).

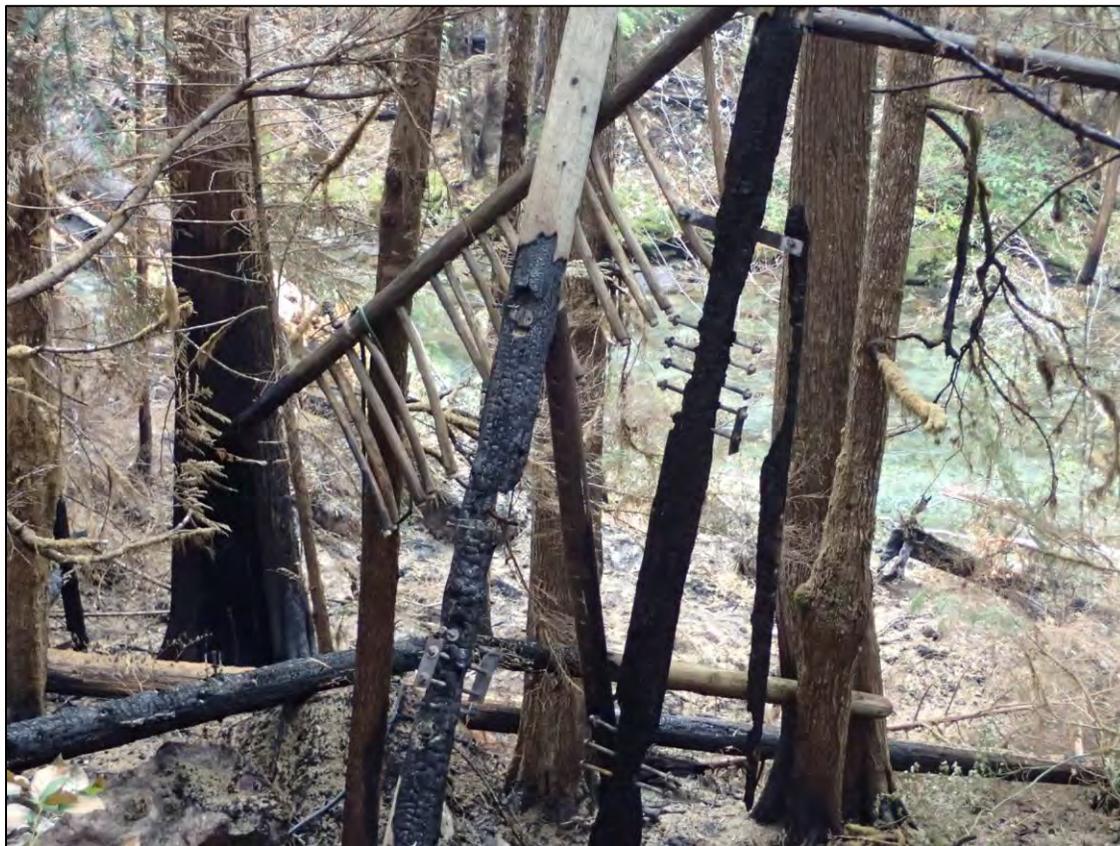
However, the fires burned in a mosaic pattern with small pockets of high burn severity, some of which were found within or near archaeological sites. In particular burn severity was high at the Newhalem Rock Shelter when the wooden boardwalk immediately in front of the rock shelter burned. The boardwalk was the most significant loss, both in terms of resource protection and facilities. Very high burn severity was also noted at the newly discovered rock shelter that is part of site 45WH698 where heavy rock spalling was noted on the interior rock face of the rock shelter.

Photo 22. Close up of burned hand rails and support posts of boardwalk with a sprinkler and hose still attached.
