Appendix C: Trail Types

Appendix D: Indicators and Thresholds

CHATTAHOOCHEE RIVER NATIONAL RECREATION AREA

COMPREHENSIVE TRAILS MANAGEMENT PLAN / ENVIRONMENTAL ASSESSMENT • 2022

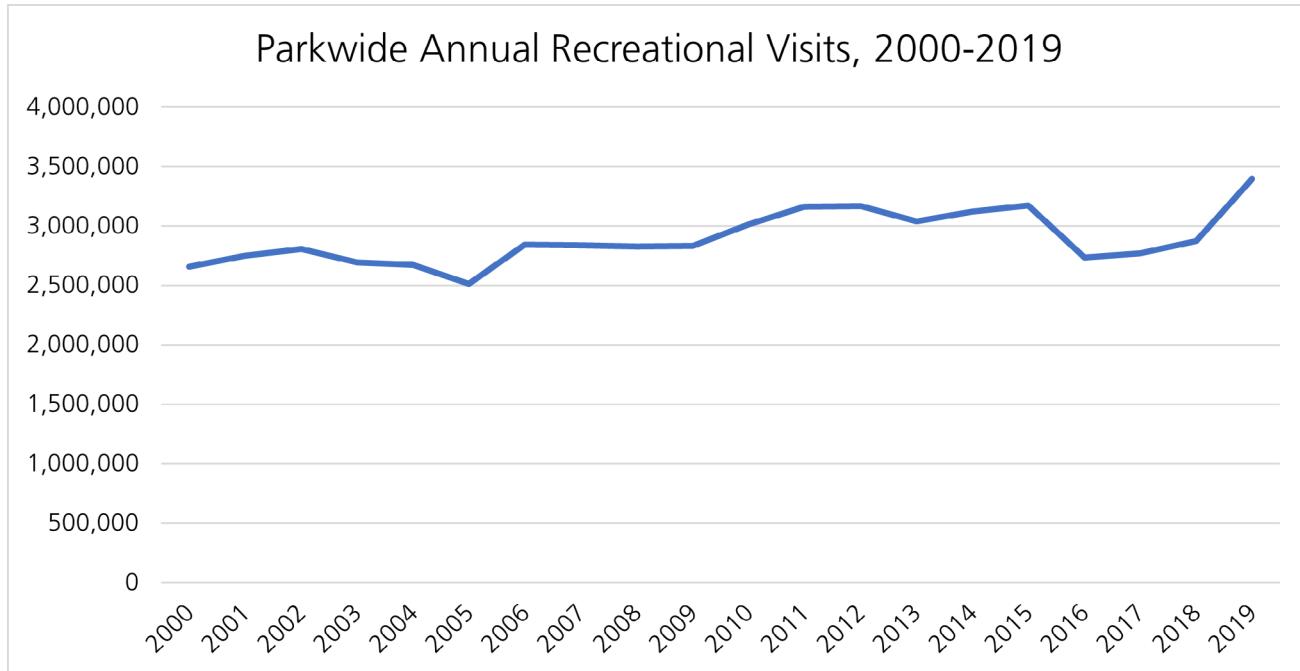
Figure E-1. Parkwide Annual Recreational Visits, 2000–2019

Overall, annual recreational visits to the park have increased 28% over the 20 years leading up to the COVID-19 pandemic (figure E-1). Figures from 2020 are omitted from this graph due to widespread shifts in visitor use patterns seen nationwide during the pandemic (Rice et al. 2021).

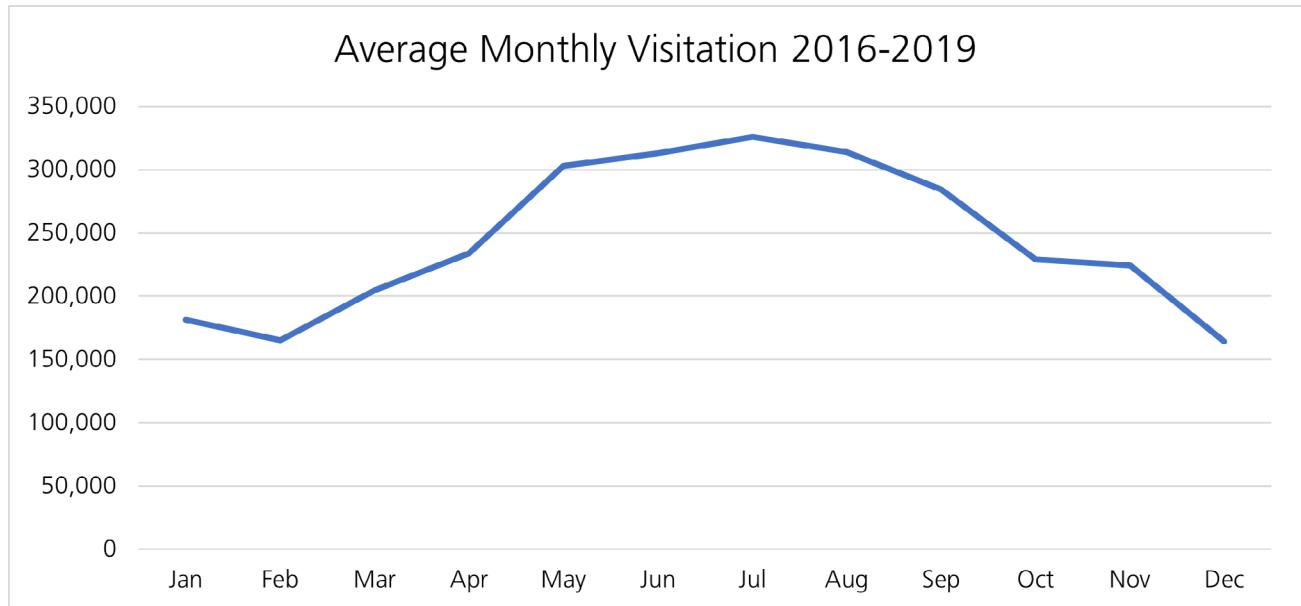
Figure E-2. Parkwide Average Monthly Visitation, 2016–2019

Visitation to the park is concentrated in the summer months of May through September, when overall visitation is nearly double what occurs in the winter months of December through March (figure E-2).

This parkwide data is generated primarily through inductive loop traffic counters located at entrances to parking areas throughout the park (NPS 2021). These raw traffic counts are adjusted for nonreportable visits (e.g., administrative or residential traffic), multiplied by a person-per-vehicle factor of 2.0, and added to estimates of nonvehicular arrivals to generate a count of parkwide visitation. While this parkwide data is useful for a comprehensive and long-term understanding of visitor use at the park, it may not accurately reflect visitor use on the trail system, as it does not distinguish between trail users and other visitor types who may be using the parking lots (e.g., river users). The data also does not track actual pedestrian arrivals and does not provide information about distribution across the trail system.

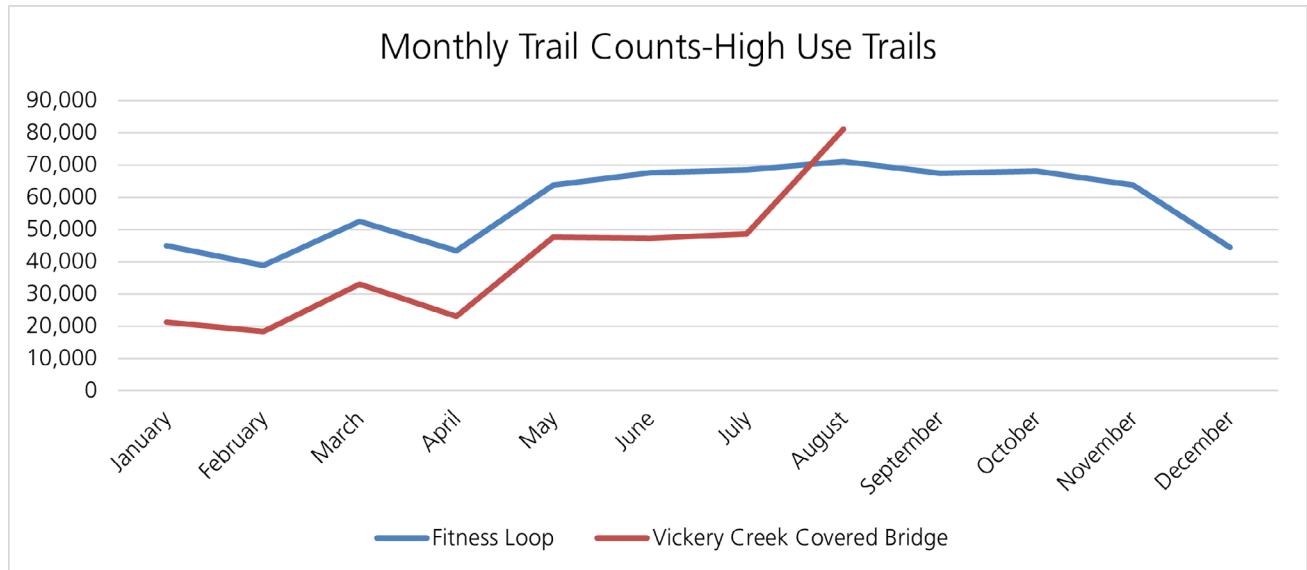
Figure E-3. Monthly Trail Counts on High-Use Trails

To develop a more refined understanding of trail use in the park, six infrared trail counters were deployed in November 2019 along trails at Bowmans Island West (1), on the Cochran Shoals Fitness Loop (1), at Island Ford (2), and at Vickery Creek (2). Data collected by these trail counters mimic the parkwide visitation data in that summer use of the trail system is higher than in the winter months, though the difference is not as dramatic as with the parkwide visitation, perhaps due to the relative attractiveness of winter month trail use as compared to winter month river use. For example, the Fitness Loop counter recorded around 40,000 to 50,000 users in the December through April period and around 60,000 to 70,000 users in the May through November period. While summer use was not quite double winter use as with parkwide visitation, trail use in the summer is still busier than winter use (figure E-3).

Breaks in lines represent months for which no data was recorded due to vandalism, theft, or a technical issue. January through July represent averages of 2020 and 2021 data. August through November represent 2020 data. December represents an average of 2019 and 2020 data.

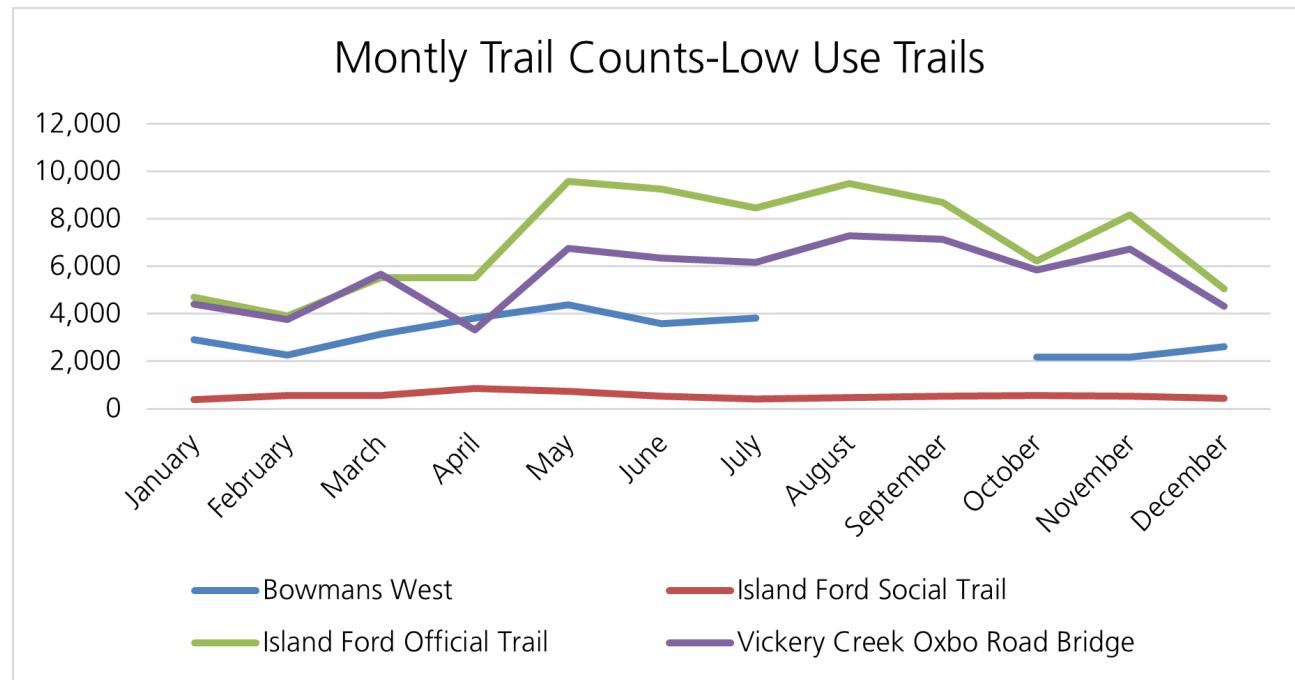
Figure E-4. Monthly Trail Counts on Low-Use Trails

However, the difference between summer and winter use is more dramatic on some of the lower-use trails, such as Bowmans Island – West (roughly 2,200 in February, October, and November; over 4,300 in May), the official riverside trail in Island Ford (fewer than 4,700 in January and February; more than 9,200 in May,

June, and August), and the Covered Bridge Trail in Vickery Creek (around 20,000 in January and February; over 45,000 in May, June, July, and August). Generally, these lower-use trails tended to see a peak around May, with use tapering a bit in the hottest summer months before rebounding slightly in August and September (figure E-4).

Breaks in lines represent months for which no data was recorded due to vandalism, theft, or a technical issue. January through July represent averages of 2020 and 2021 data. August through November represent 2020 data. December represents an average of 2019 and 2020 data.

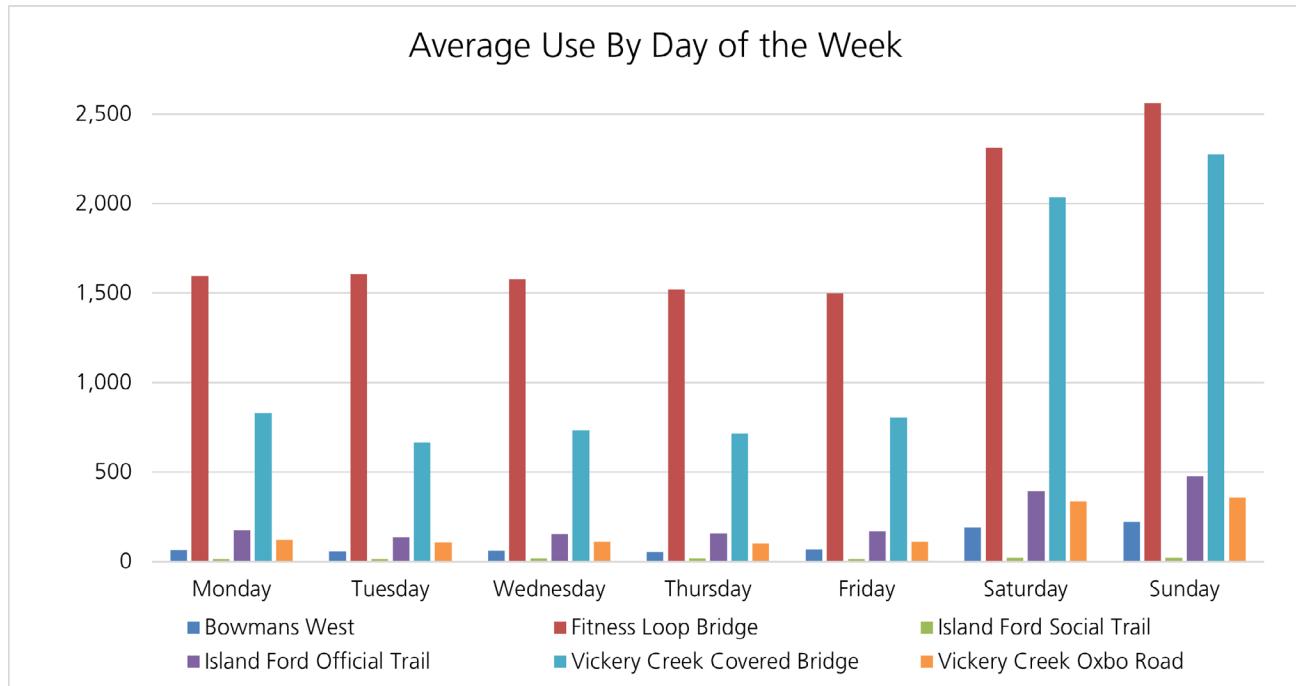
Figure E-5. Average Trail Use by Day of the Week

This trail counter data provides additional insight into the timing of visitor use. Across all six sites, weekends had more use than weekdays. However, that difference was much more pronounced at Bowmans Island and Vickery Creek, where use is over three times higher on weekends than weekdays than at the Cochran Shoals Fitness Loop, where visitation was only 50% busier on weekends. On average, weekends were twice as busy as weekdays (figure E-5).

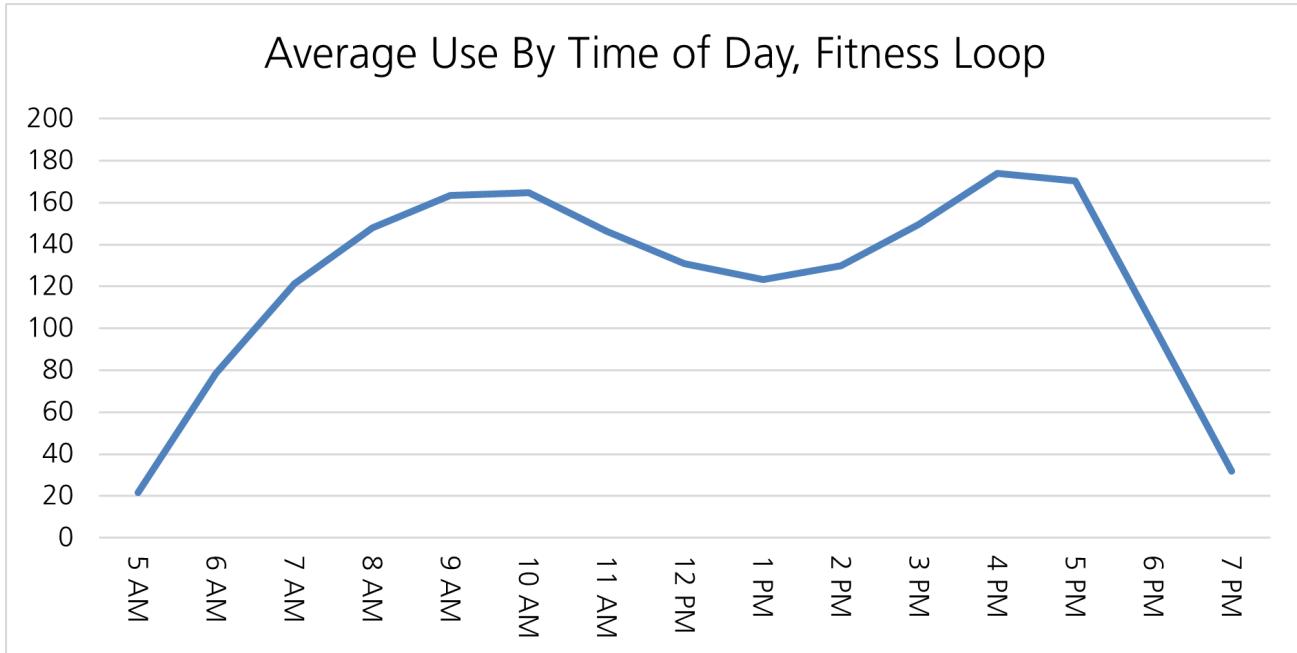
Figure E-6. Average Use of the Fitness Loop by Time of Day

In terms of time of use, the trail counters indicate different patterns depending on the trail. At the Cochran Shoals Fitness Loop, there was a pronounced two-peak visitation pattern, with visitation peaking from 9:00 a.m. to 10:00 a.m., dipping during the middle of the day, and peaking again from 4:00 p.m. to 5:00 p.m. (figure E-6).

This trend could be a result of visitors avoiding the heat in the middle of the day and using the trail system before and after work or school. Interestingly, the two-peak visitation pattern is not as pronounced, and in most cases, not present at all at the other trails (figure E-7).

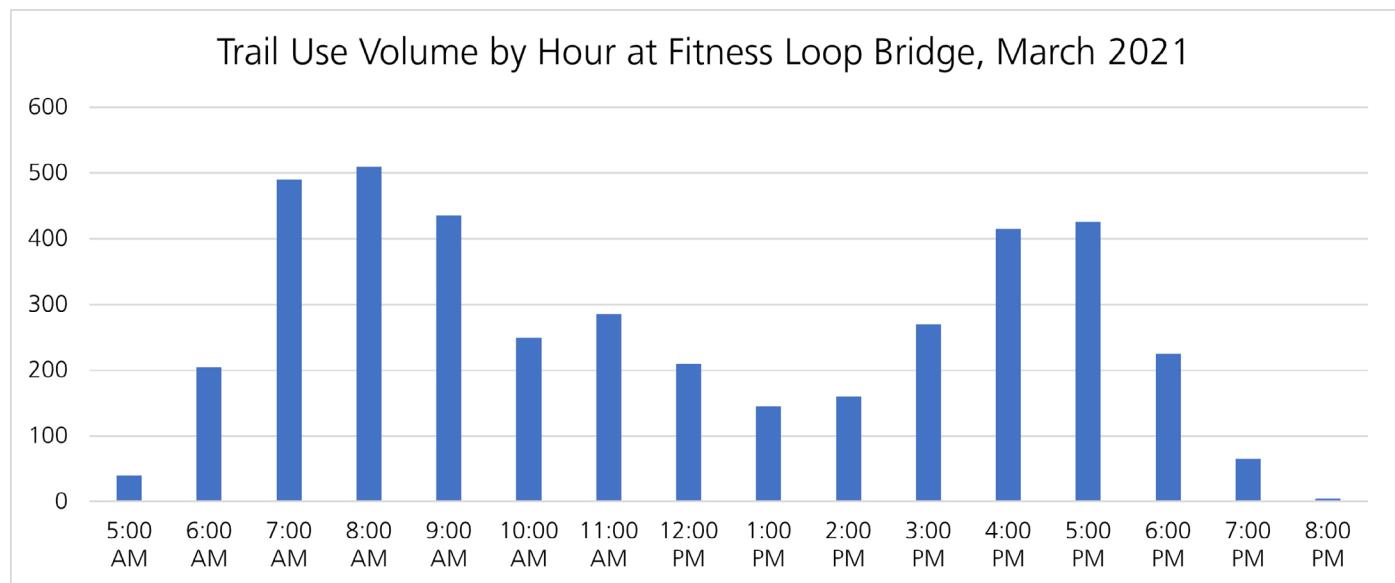
Figure E-8. Trail Use Volumes by Hour on the Fitness Loop Bridge, March 2021
Data Source: Strava Metro Dashboard

Many of the same patterns and trends observed in the infrared trail counter data were apparent in the Strava data. For example, the two-peak visitation pattern seen at the Fitness Loop bridge was also noticeable in the Strava data for the corresponding stretch of trail (for comparison, see figures E-6 and E-8). The Strava data also mimicked the trail counter data in that weekends were much busier than weekdays.

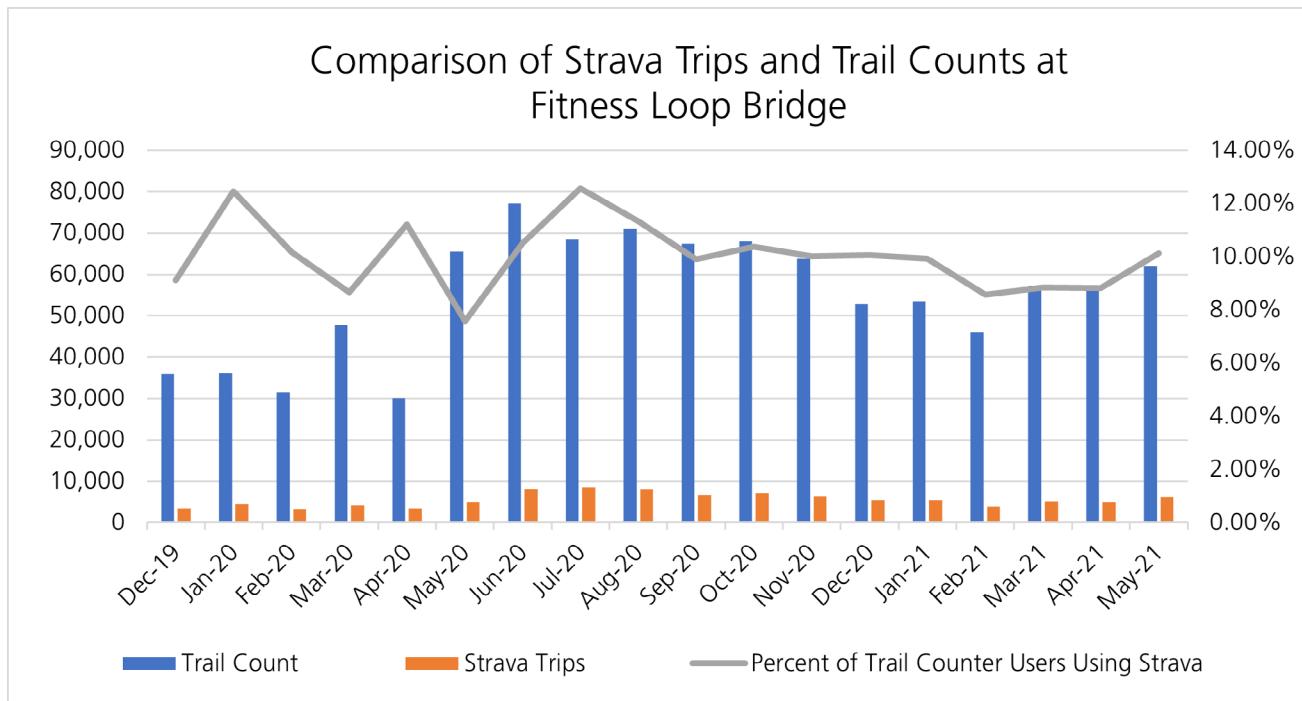
Figure E-9. Comparison of Strava Trips and Trail Counts at Fitness Loop Bridge

Knowing that the Strava data seems to be correlated with the trail counter data, it is possible to calibrate the former using the latter. Calibration is the process of adjusting estimates of total trail use to account for how much actual use is represented by the Strava use (Headwaters Economics 2021). At the Fitness Loop bridge, a comparison of Strava use levels with trail counter use levels shows that between 8% and 12% of users tracked their activity using Strava (figure E-9). The average over these 18 months was 10.0%, and the standard deviation was relatively low at 0.0128.

However, the proportion of trail users tracking their activity on Strava varies from unit to unit. During the same period at the Bowmans Island West counter, the proportion was a little over 5%, while it was just over 1% at the Vickery Creek Oxbo Road counter and around 0.5% at the Island Ford Bridge counter. This variability is not uncommon. A similar study comparing trail counts with Strava counts at four trailheads near Whitefish, Montana, found that Strava users made up between 1% and 5% of total trail users (Headwaters Economics 2018). The variability at Chattahoochee River NRA can likely be attributed to the varying levels of fitness orientation the different units attract.

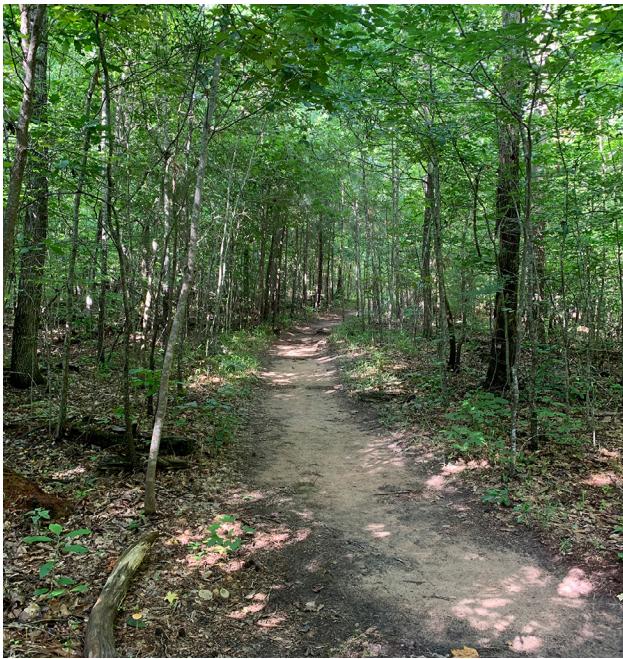
Figure F-1. Typical Section of Natural Surface Pedestrian Trail (Island Ford)

Trail Features	Description
Trail Width—Natural Zone, Rustic Zone, Historic Resource Zone, Rustic Zone	1–2 feet*
Trail Width—Natural Area Recreation Zone, and Developed Zone	2–4 feet*
Trail User	Pedestrian only
Tread Surface/Material	Natural native soils, surfaced as needed for hardening with natural native materials such as stone, rock, or wood
Horizontal Clearance	3–4 feet
Vertical Clearance	8 feet
Longitudinal Slope	Varies, not to exceed 30%
Cross-sectional Slope	2% typical, but not to exceed 5.5%
Special Structures*	Structures where protection of resources are needed, including boardwalks, stairs, foot bridges
Signage*	Kiosks; loops and trails marked at intersections and with difficulty. Limited interpretive signage.
Trailheads	Visible trail markings/signage
Accessibility	Substantial barriers present. Challenges to accessibility may exist.
Trail Maintenance	Routine annual maintenance. Maintenance in response to reports of unusual resource problems requiring repair/resource protection/trail safety, such as storm damage creating heaving large numbers of downed trees.

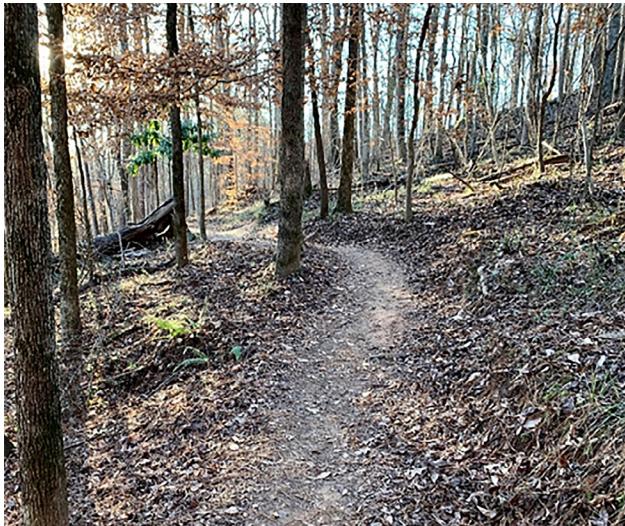
Figure F-2. Typical Section of Natural Surface Multiuse Trail (Cochran Shoals)

Trail Features	Description
Trail Width	4–8 feet typical and 10 feet when necessary for passing
Trail User	Pedestrian and bicyclists
Tread Surface/ Material	Natural native soils, surfaced as needed for hardening with natural native materials such as stone, rock, or wood
Horizontal Clearance	3–4 feet
Vertical Clearance	8 feet
Longitudinal Slope	Varies, not to exceed 30%
Cross-sectional Slope	2% typical, but not to exceed 5.5%
Special Structures	Trail structures may be common. Trail bridges as needed for resource protection and appropriate access Boardwalks; drainage; bridges, puncheons, and armoring
Signage	Kiosks; loops and trails marked at intersections. Limited interpretive signage.
Trailheads	Visible trail markings/signage; caution signs at trail crossings or technical sections
Accessibility	Substantial barriers present. Challenges to accessibility may exist; however, per the park compendium (2021), electric bikes and other power-driven mobility devices are allowed on all multiuse trails, which may reduce some athletic barriers.

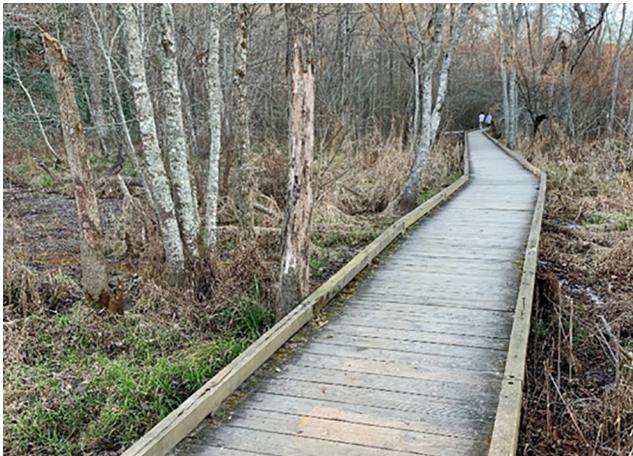
Figure F-3. Typical Section of Universal Access Trail (Cochran Shoals)

Trail Features	Description
Trail Width	3–8 feet
Trail User	Pedestrian only
Tread Surface/ Material	Crushed aggregate; boardwalk; brick/masonry/porous pavers
Horizontal Clearance	1–2 feet
Vertical Clearance	8 feet
Longitudinal Slope	Up to 5% (standard), 5% to 8.33% maximum; requires resting intervals every 200 feet, 8.33% to 10% every 30 feet, and 10% to 12% maximum every 10 feet.
Cross-sectional Slope	5% maximum
Special Structures	Structures present and substantial. Trail infrastructure meets ABA requirements. Substantial trail bridges are used at water crossings. Drainage structures are present. Curbing could be used to retain aggregate and control braiding.
Signage	Where provided, informational and directional signage along the trail will meet Harpers Ferry Center's Programmatic Accessibility Guidelines for park signage. Loops and trails are marked with distances.
Trailheads	Trailhead signage should include length of the trail or trail segment; type of trail surface; typical and minimum trail tread width; and typical and maximum trail grade; typical and maximum trail cross-slope. Temporary conditions and hazards will also be communicated when necessary.

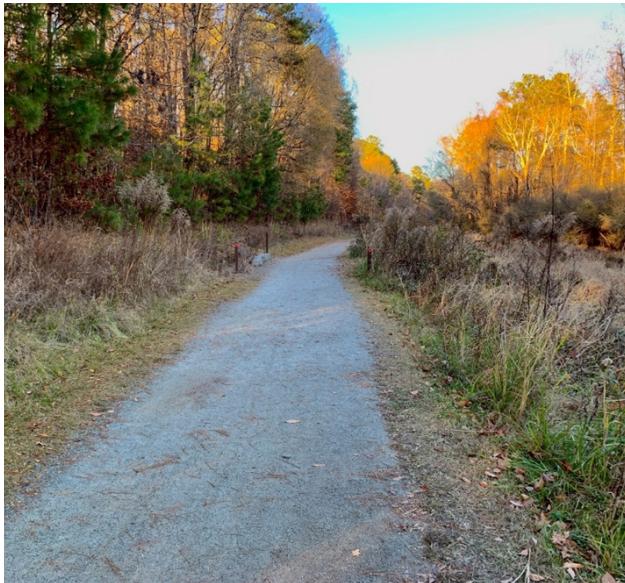
Figure F-4. Typical Section of Aggregate Multiuse Trail (Cochran Shoals)
