Winter Road Plowing in Denali National Park and Preserve

Monitoring Results 2017

Natural Resource Report NPS/DENA/NRR—2018/1579

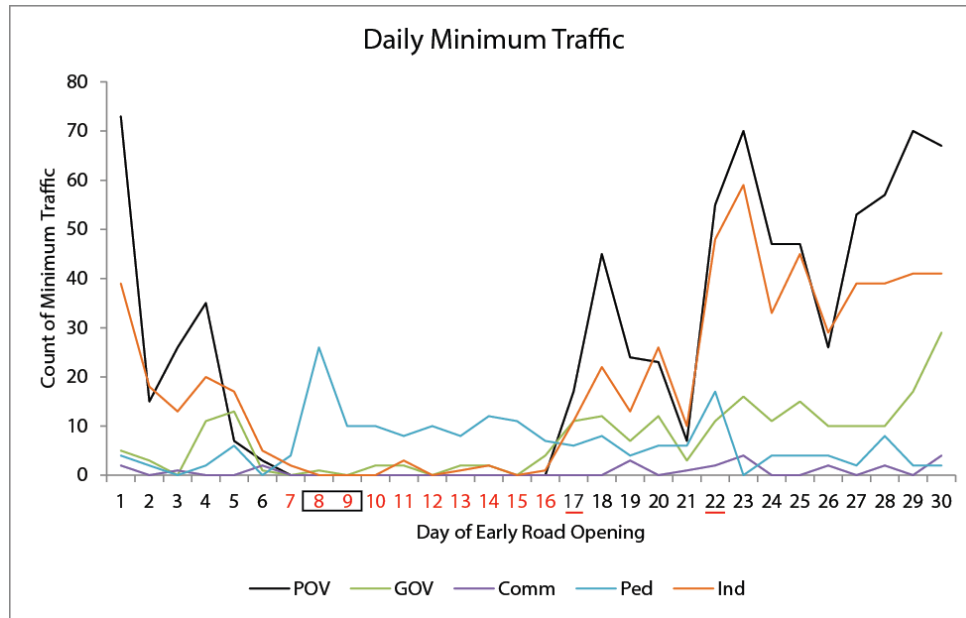
Figure 3. Road use by day during Early Road Opening as captured by a traffic camera on the Denali Park Road, Denali National Park and Preserve, Denali Park, Alaska, USA. The number of indeterminate (Ind) counts was greater in 2017 compared to past years. Red days indicate the road was closed all day due to driving conditions (snow and ice); underlined days indicated partial-day closures, days in the box indicate Denali Winterfest.

Camera data show that 2017 ERO traffic patterns broadly resembled those of 2014-2016. POV use of the road peaked at 73 vehicles on Saturday, February 18, the first day of ERO. Peak time of day for POVs was between 1300 and 1400 hours (Figure 4). Generally, weekends were busier than weekdays (Figure 5). Generally, as POV use of the road increased, pedestrian use of the road decreased. Maximum pedestrian occurred on February 24 (ERO day 8), which coincided with a road closure due to snowfall.

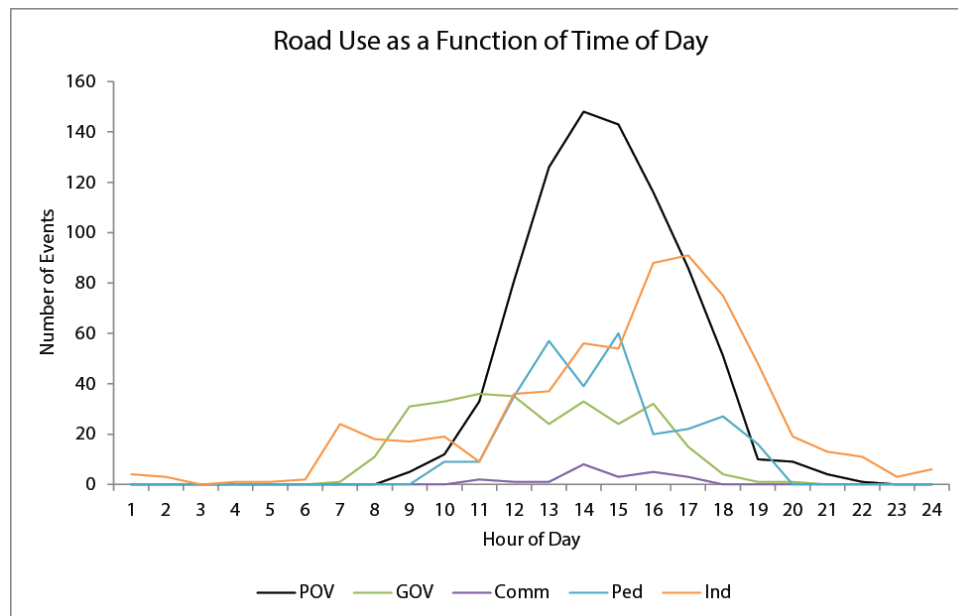
Figure 4. Road use by hour of day during Early Road Opening captured by a traffic camera on the Denali Park Road, Denali National Park and Preserve, Denali Park, Alaska, USA. Private vehicles accessed the road during the peak of daylight hours, indeterminate (Ind) captures were skewed toward twilight hours, and government road use occurred earlier in the day compared to most other user groups.
