Wolf Trap National Park for the Performing Arts
Vienna, Virginia

CULTURAL LANDSCAPE REPORT
WOLF TRAP NATIONAL PARK FOR THE PERFORMING ARTS

May 2021

Quinn Evans Architects
Washington, DC
Madison, WI

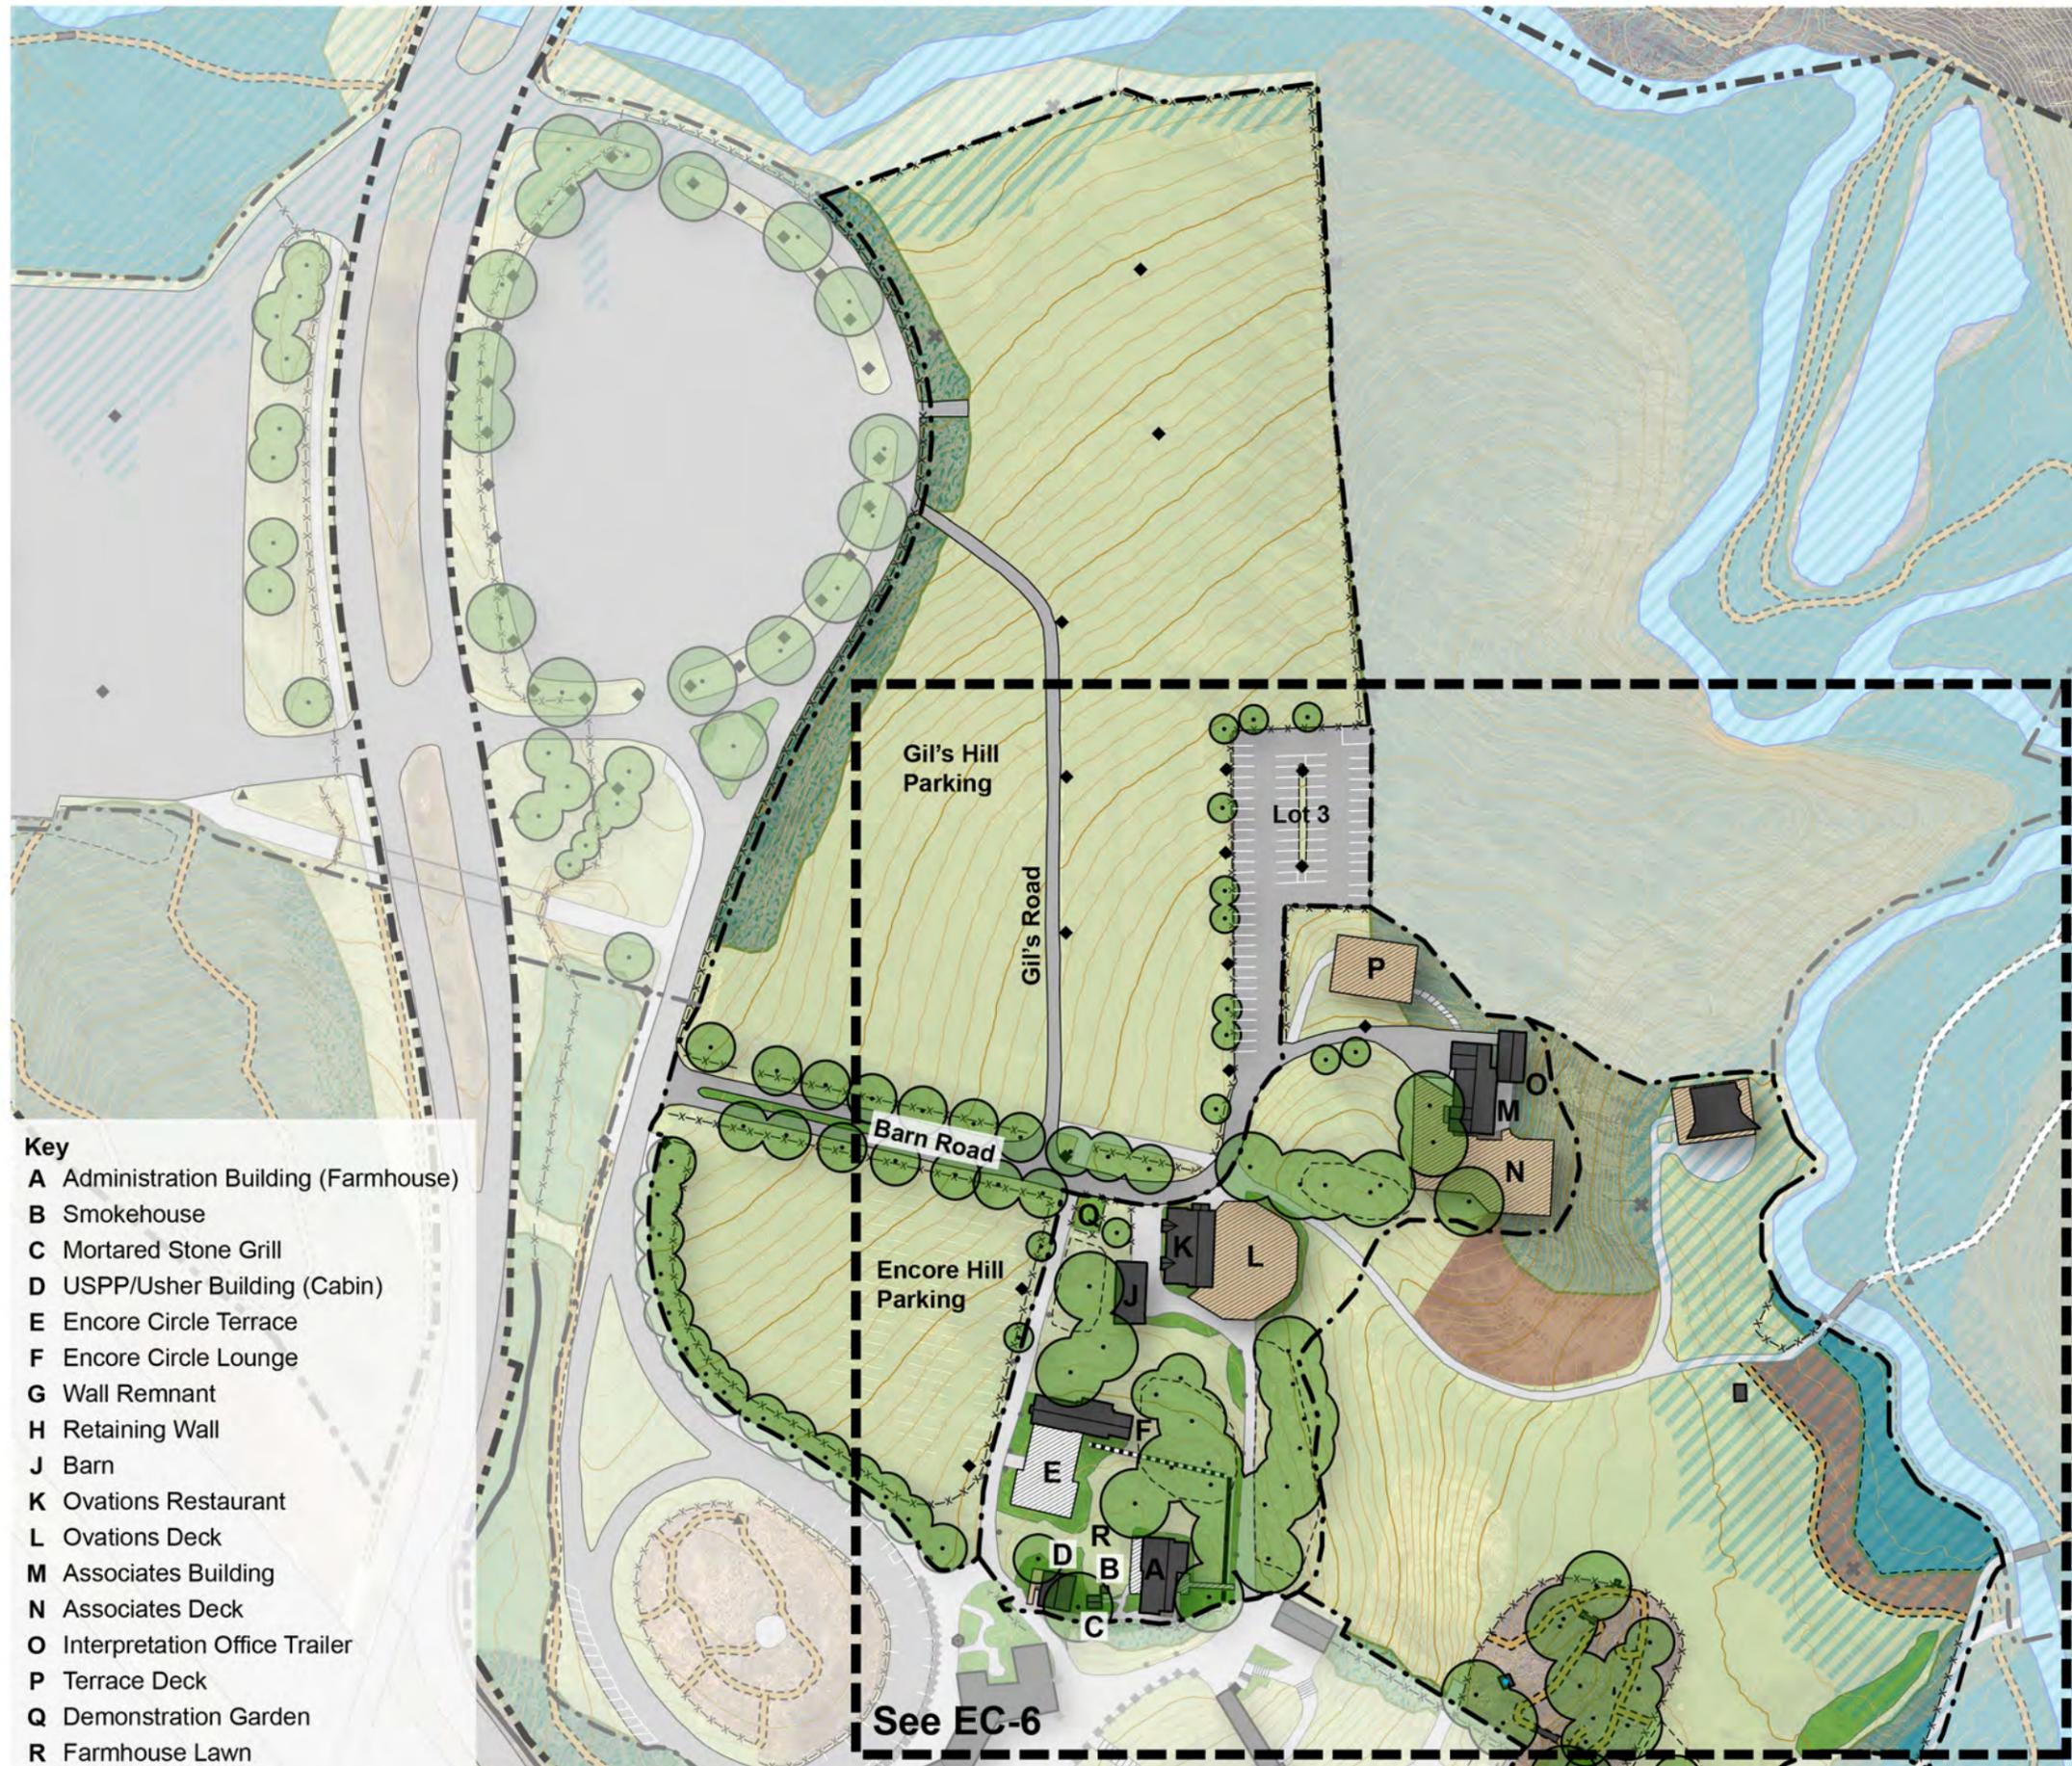
- Key**
- A Administration Building (Farmhouse)
 - B Smokehouse
 - C Mortared Stone Grill
 - D USPP/Usher Building (Cabin)
 - E Encore Circle Terrace
 - F Encore Circle Lounge
 - G Wall Remnant
 - H Retaining Wall
 - J Barn
 - K Ovarions Restaurant
 - L Ovarions Deck
 - M Associates Building
 - N Associates Deck
 - O Interpretation Office Trailer
 - P Terrace Deck
 - Q Demonstration Garden
 - R Farmhouse Lawn

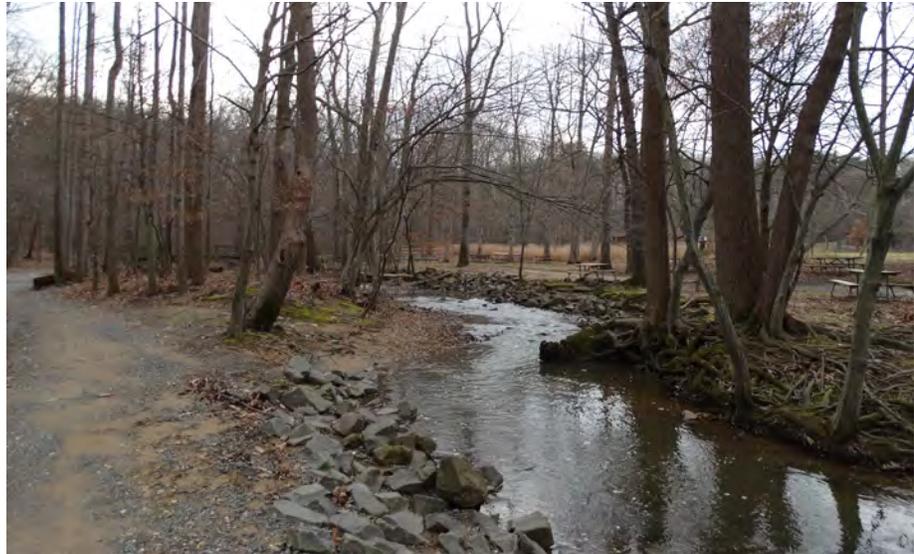
Figure 3-2. Armored portion of Wolftrap Creek (QE, 2020).

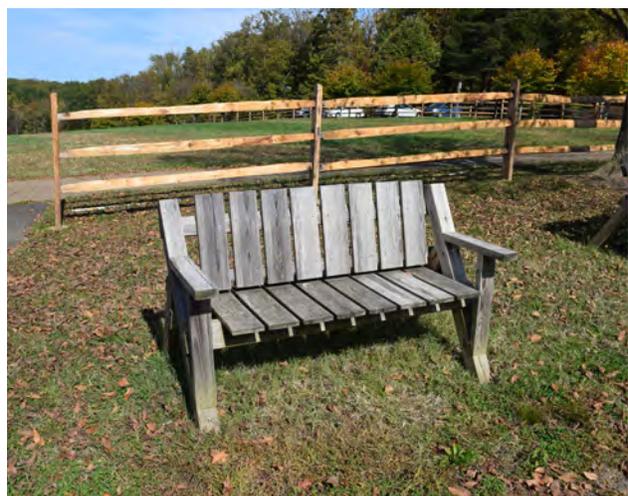
Figure 3-55. Rustic wood bench (QE, 2020).

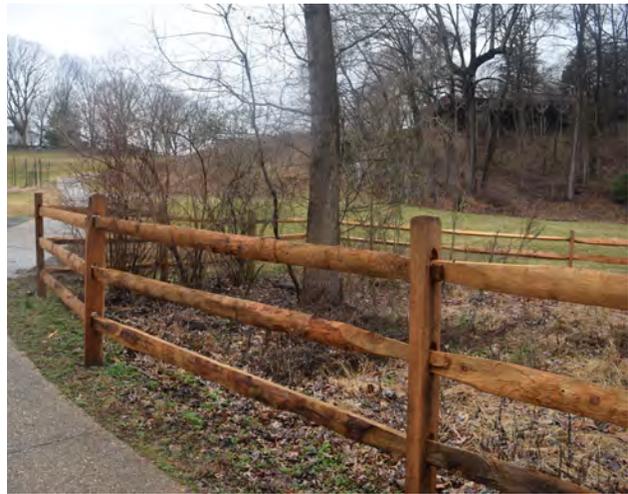
Figure 3-65. Split rail fence (recently replaced) (QE, 2020).

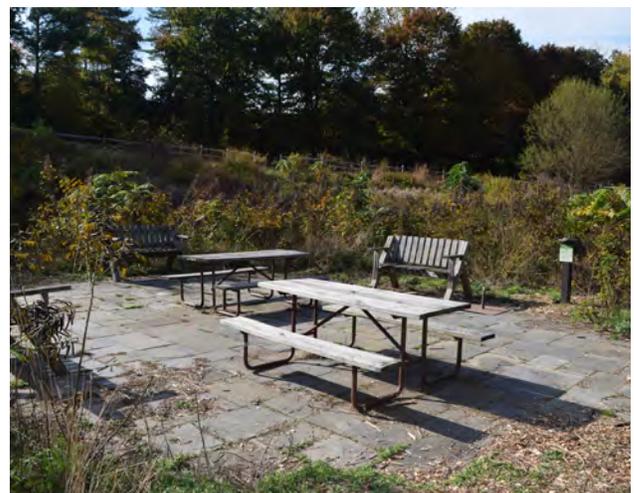
Figure 3-82. Flagstone seating area within the meadow restoration area (QE, 2020).

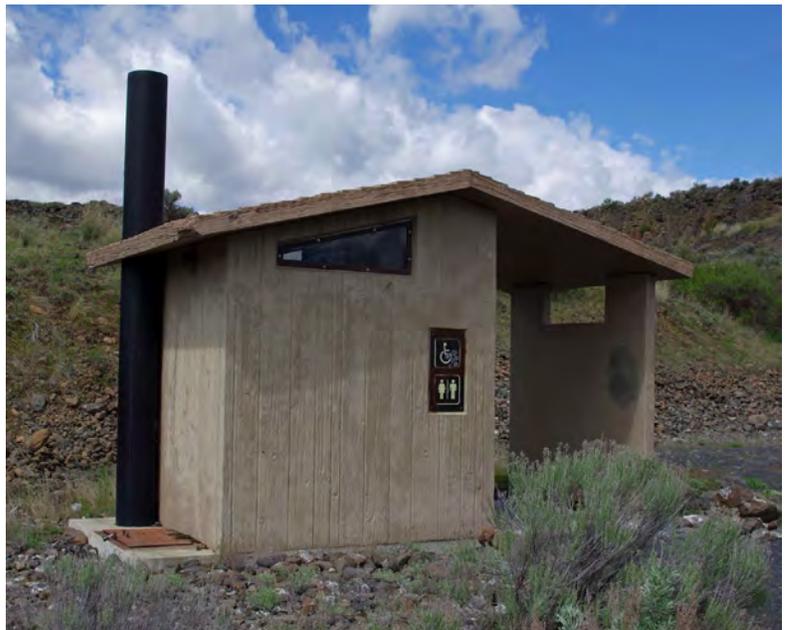
Figure 6-39. Proposed vault toilet precedent images showing compatible styles and materials. (RomTec, Dwell, and US Backroads).
