Replace Plumbing Components to the Shower in the Master Bedroom of the Superintendent's House (Quarters #2)
Photos

Superintendent's House (Quarters #2)

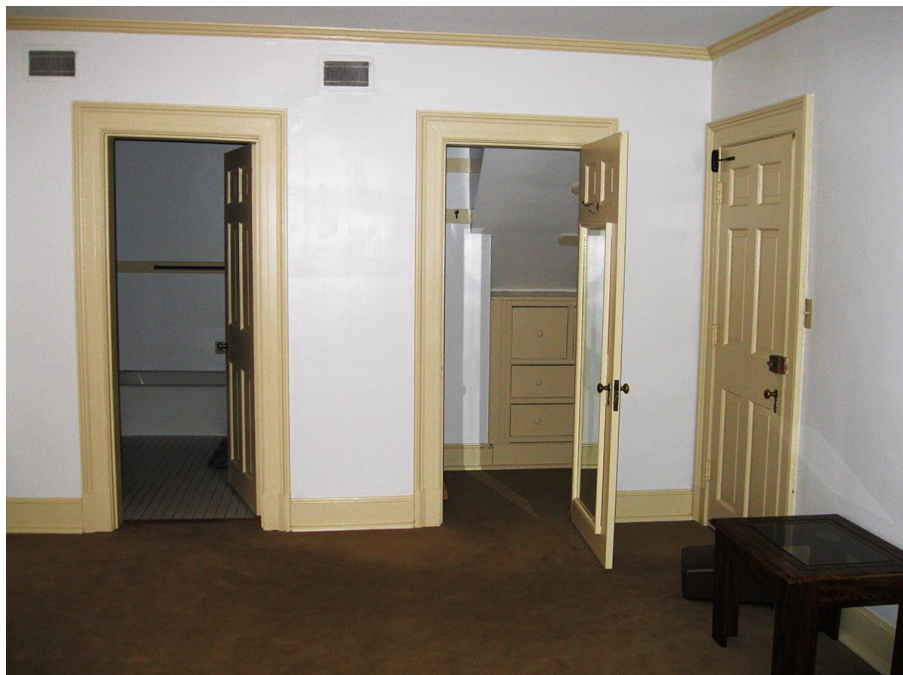
Inside the Master Bedroom of the Superintendent's House, looking east. The bathroom is through the door to the left. The center door opens to the closet. The door to the right opens into the second floor hallway.

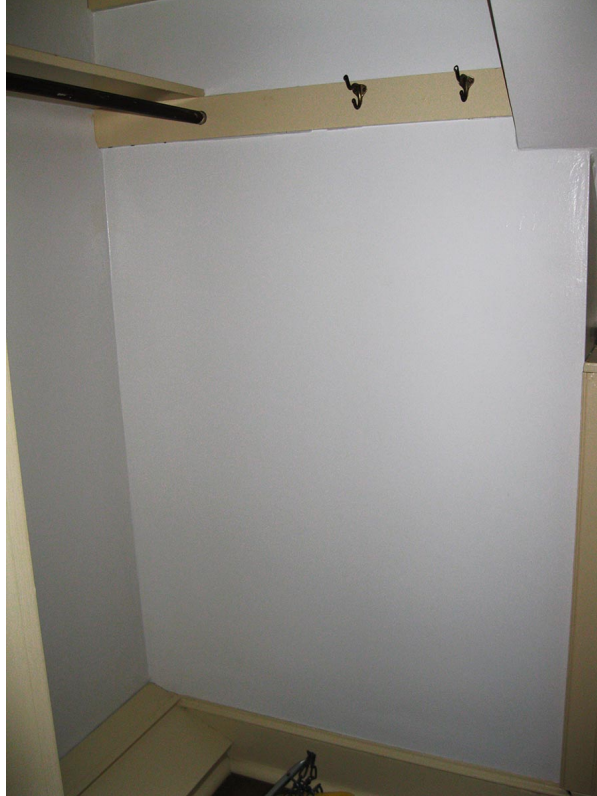
Inside the closet in the Master Bedroom. The wall to the front is shared with the back of the shower on the other side. The plumbing for the shower is inside the wall. The park is proposing to cut an access hole into the gypsum wall in the closet. This will provide the needed access to the pipes. The necessary repairs and replacement of the plumbing will occur. A simple access panel will be framed out and left in the closet wall for future plumbing access needs.

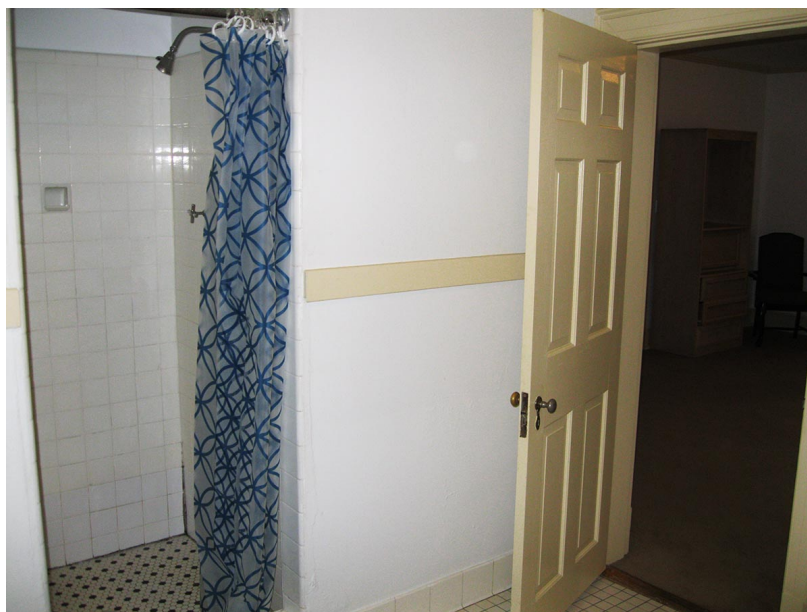
Inside the bathroom in the Master Bedroom. The door to right opens into the bedroom. To the left is the shower.

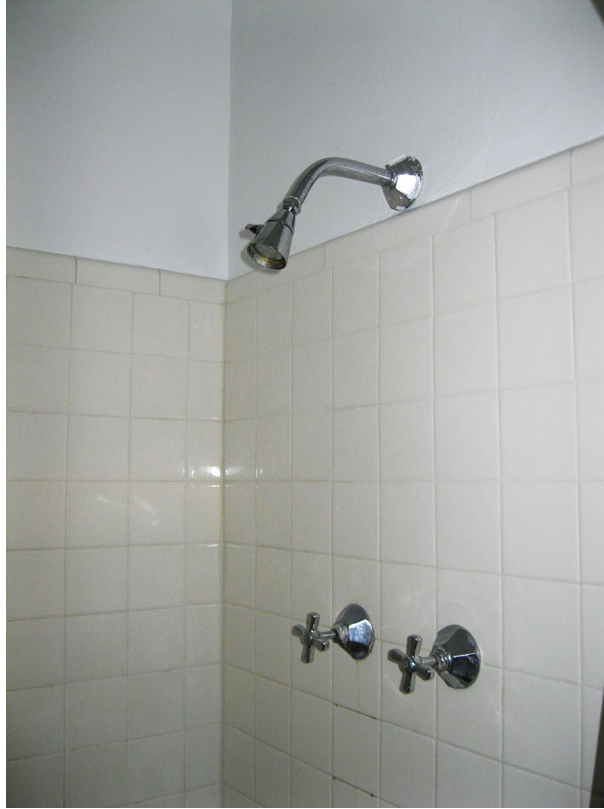
Inside the shower in the bathroom of the Master Bedroom. The fixtures are stripped, leaking and failing to operate correctly. This project will require the removal of some tile around the fixtures in order to access the valve(s) for the dual handle shower fixtures. Repair/replacement will occur.

The park will work to retain the handles. Replacement of the tiles will occur once the repair/replacement of the valve(s) has occurred.
