Rehabilitation of the First Bank of the United States

Independence National Historical Park
(East Elevation of the First Bank)

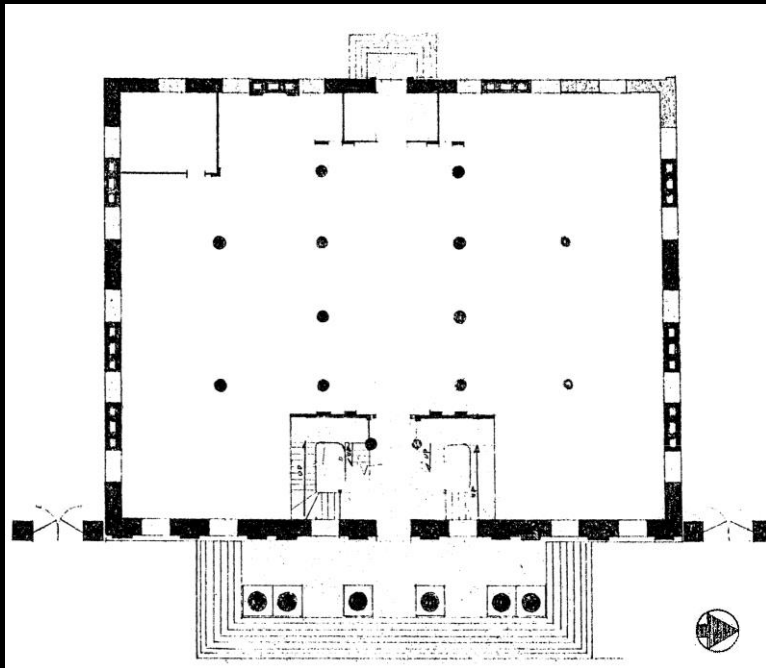
1797
First Floor Plan

The bank featured an entrance flanked by winder staircases
and a grand barrel-vaulted banking hall

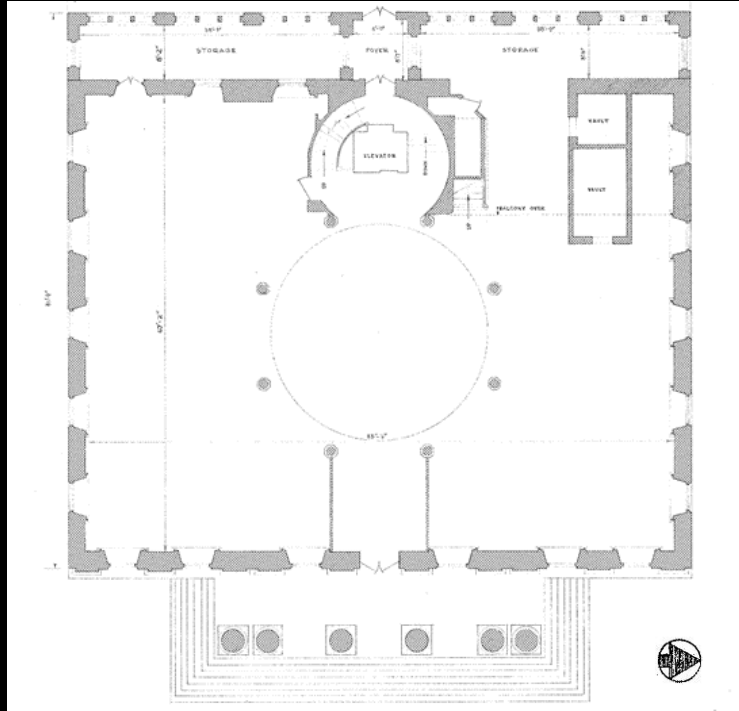
1902 & 1911 West Addition
First Floor Plan

A major interior renovation was completed in 1902. Designed by James H. Windrim the renovation included a new rotunda, grand staircase, and addition on the west elevation (1911).

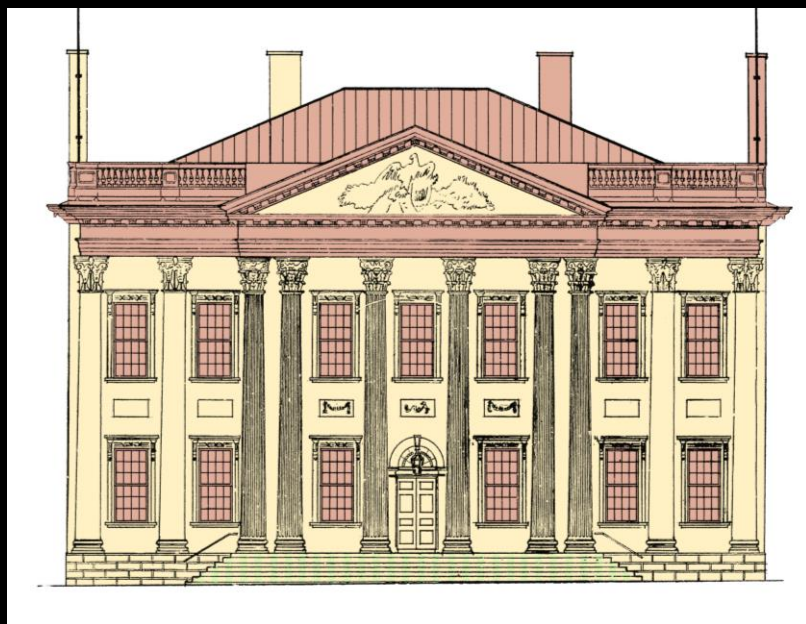
East Elevation

- Priority #1 : Original 1797 Fabric
- Priority #2 : Character Defining 1902 Construction
- Priority #3 : Reconstructed 18th c. Fabric
- Priority #4 : Non-original Fabric

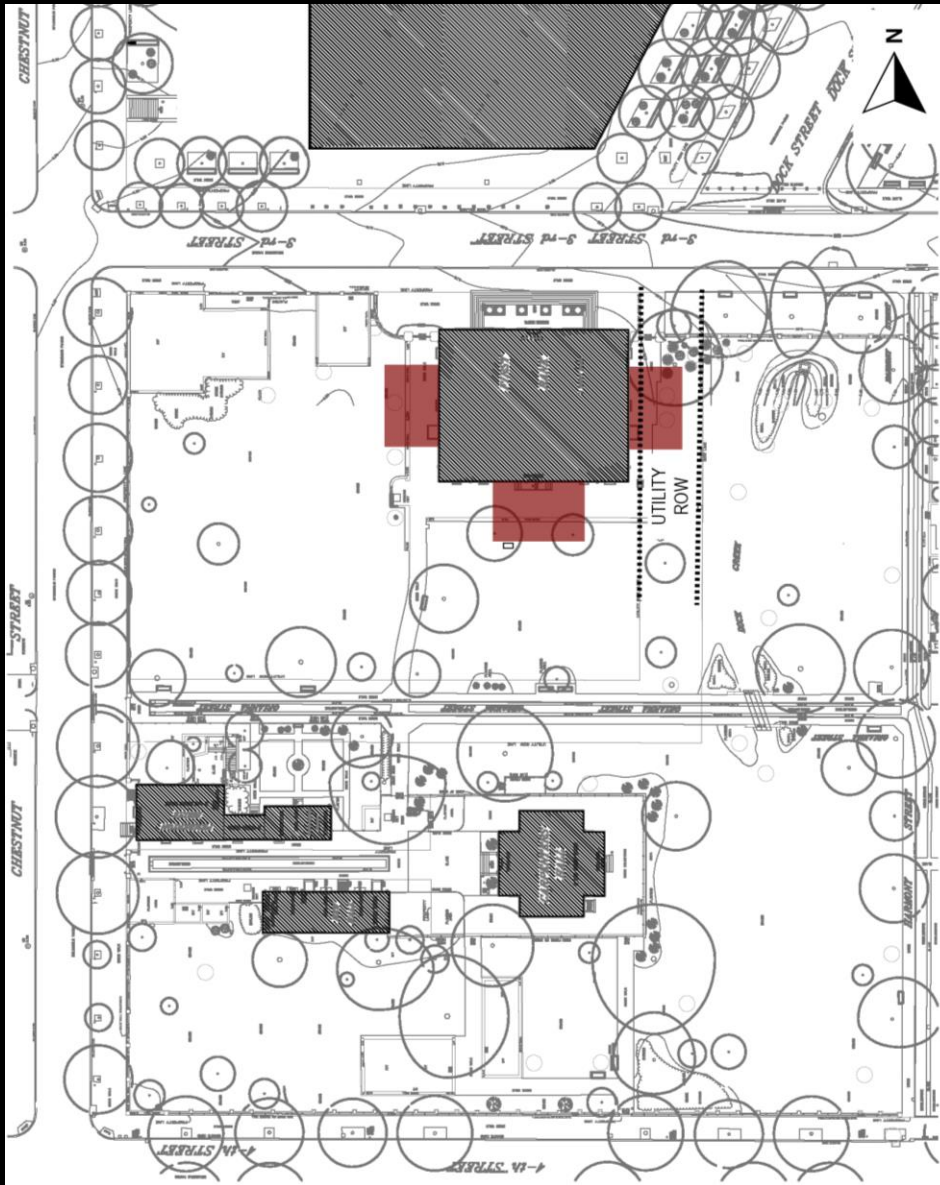
Alternative locations for an addition considered

1. No addition
2. Limited west addition
 - 2A. Expanded west addition
3. Limited north addition
 - 3A. Expanded north addition

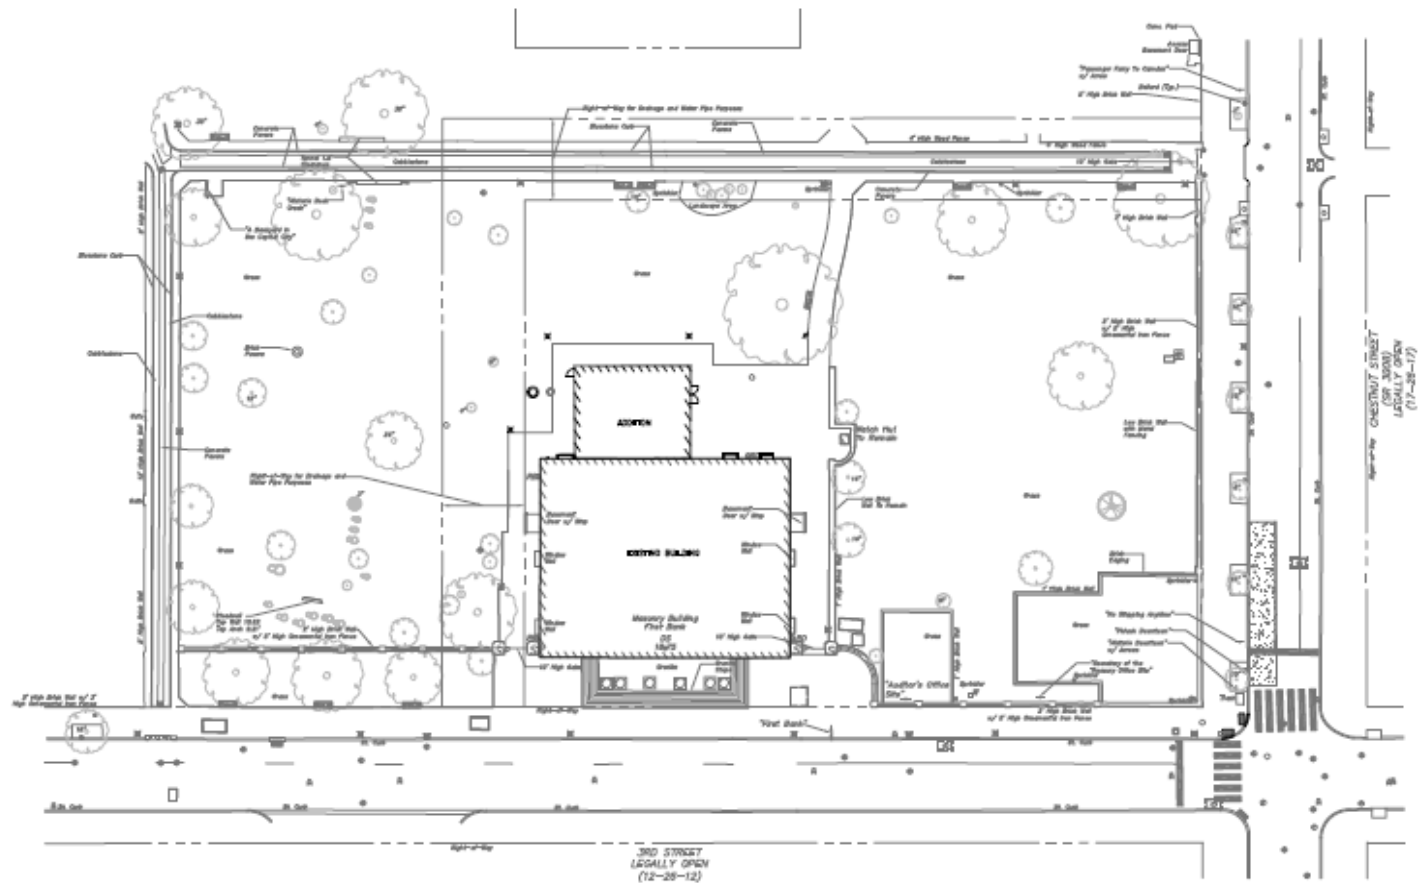
1 SITE PLAN - OVERVIEW
SCALE A

Proposed site plan showing the proposed new addition on the west elevation of the First Bank.

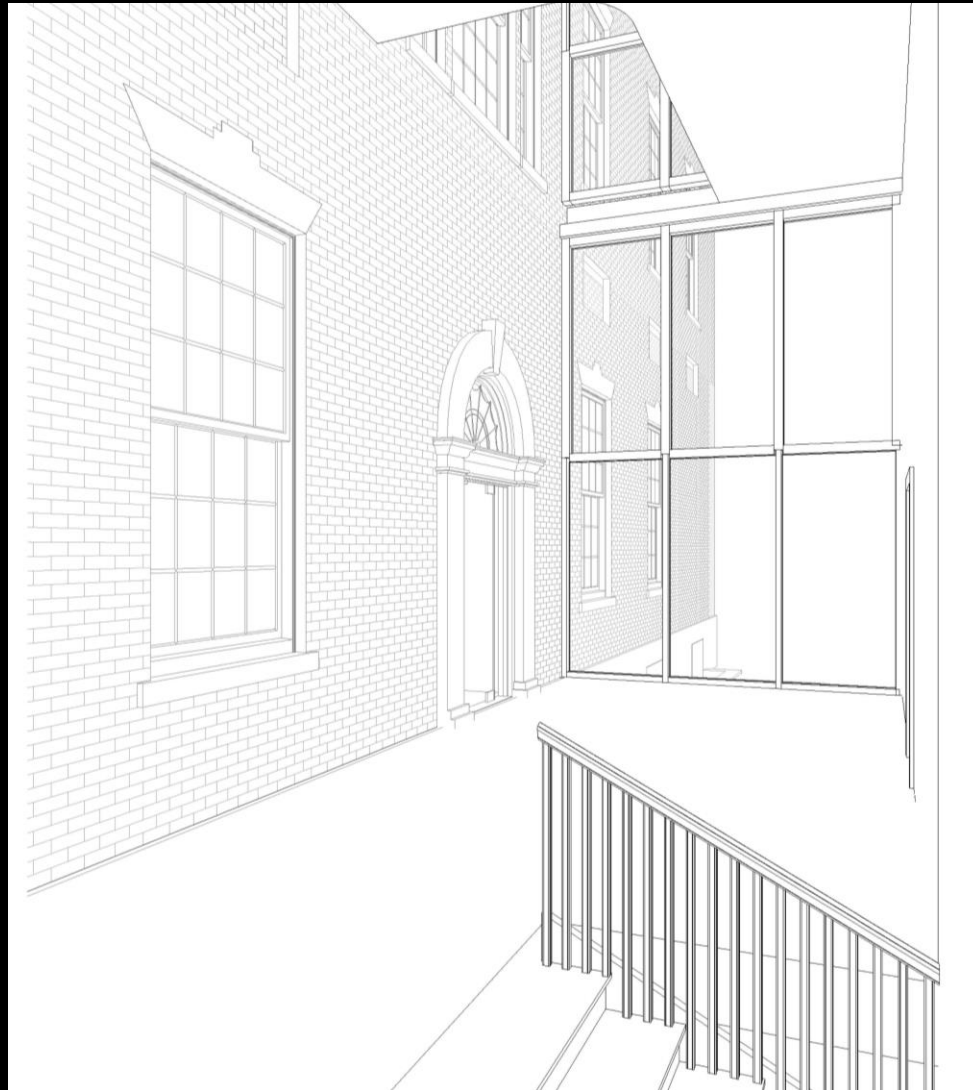
Interior View @ Entry, west elevation of the First Bank retained. Addition set away from the building separated from the First Bank by glass.
