Theodore Roosevelt National Park  
North Dakota

**South Unit Loop Road Reconstruction Project  
Wetlands and Floodplains Statement of Findings**

Theodore Roosevelt National Park  
Billings County, North Dakota

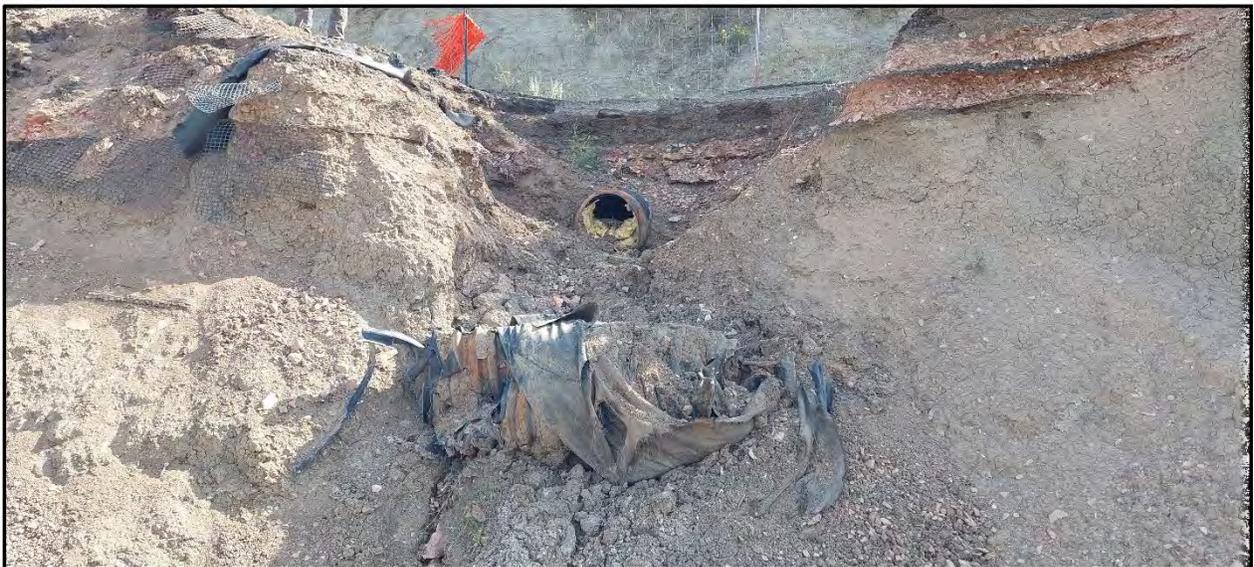
**FIGURE 1. A FAILED SECTION OF SCENIC LOOP DRIVE FROM A LANDSLIDE**

Historically, sections of Scenic Loop Drive have failed because of subsurface water conditions and existing culverts partially or fully filled with sediment. Several active seeps (i.e., wetlands where groundwater reaches the surface through an aquifer) have been observed, and it is assumed that most of the areas displaying embankment failure are experiencing a loss of strength because of high moisture content under the road surface.

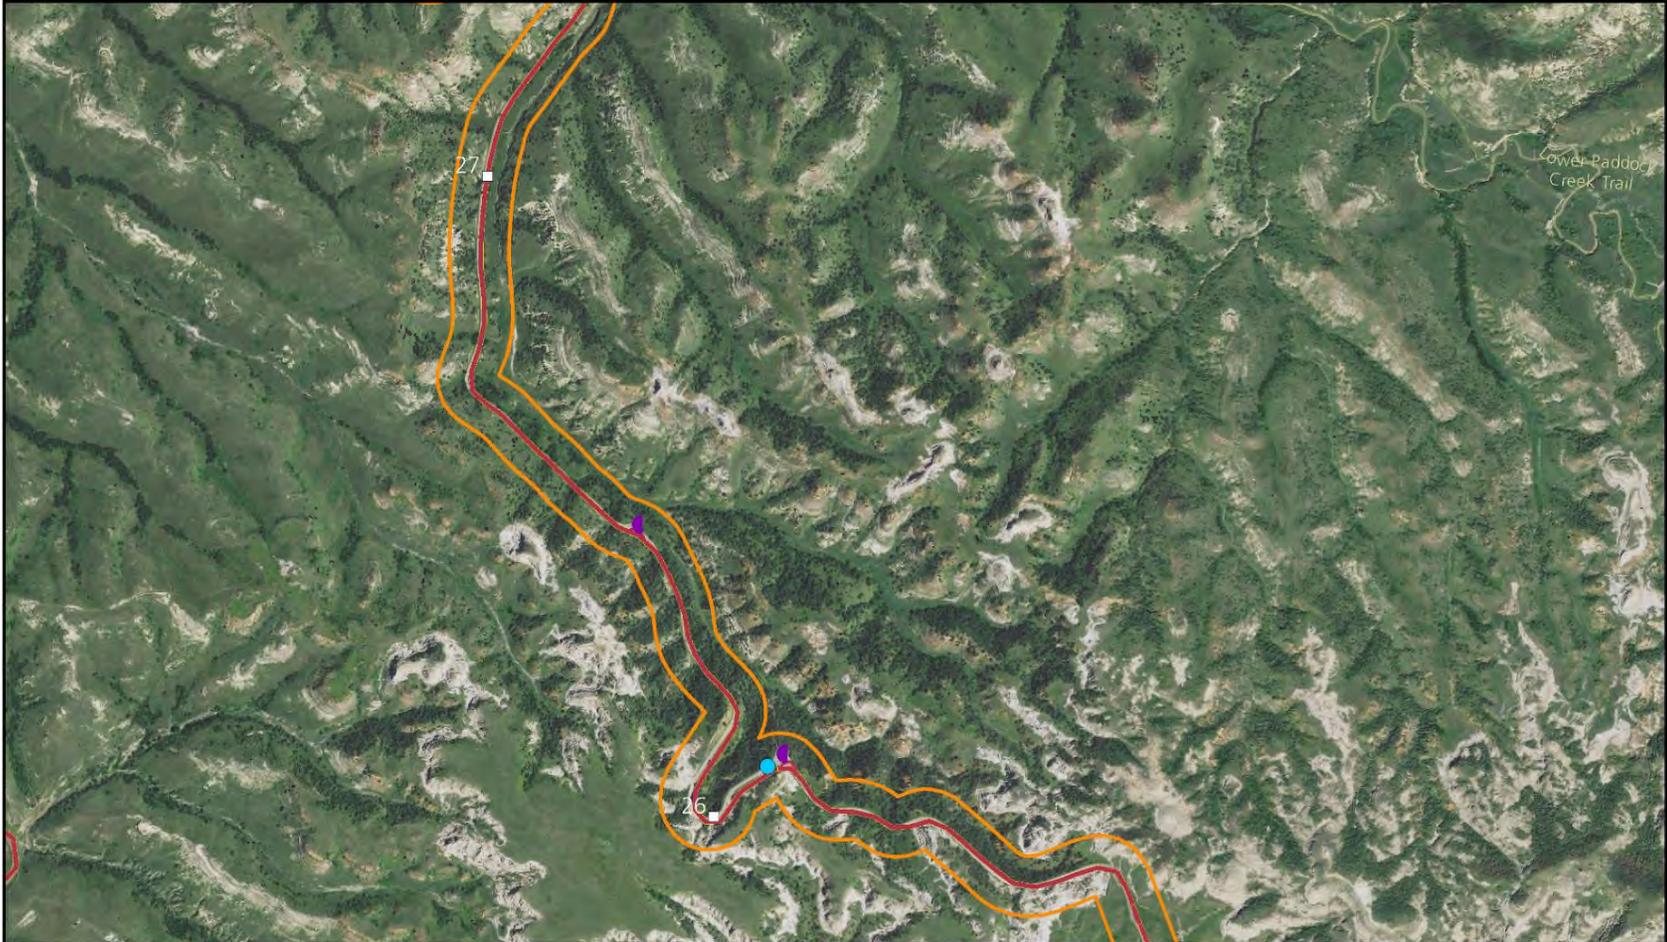
FIGURE 3. ROAD PROBLEM AREAS: WEST-CENTRAL

- Mile Markers
  - Pull-Out
  - NPS Road
  - Road Closure Zone
- Road Problem Areas (20191025)**
- Major Issue - Needs Detailed Examination

The project is needed because the existing drainage system cannot convey stormwater runoff from the road surface effectively, resulting in unstable slopes that have damaged pavement along Scenic Loop Drive causing partial or total closures. These road closures have adversely impacted visitor enjoyment of the area and the park's ability to provide visitor services because portions of the road are currently unstable, inaccessible, and unsafe (figures 2 through 5).

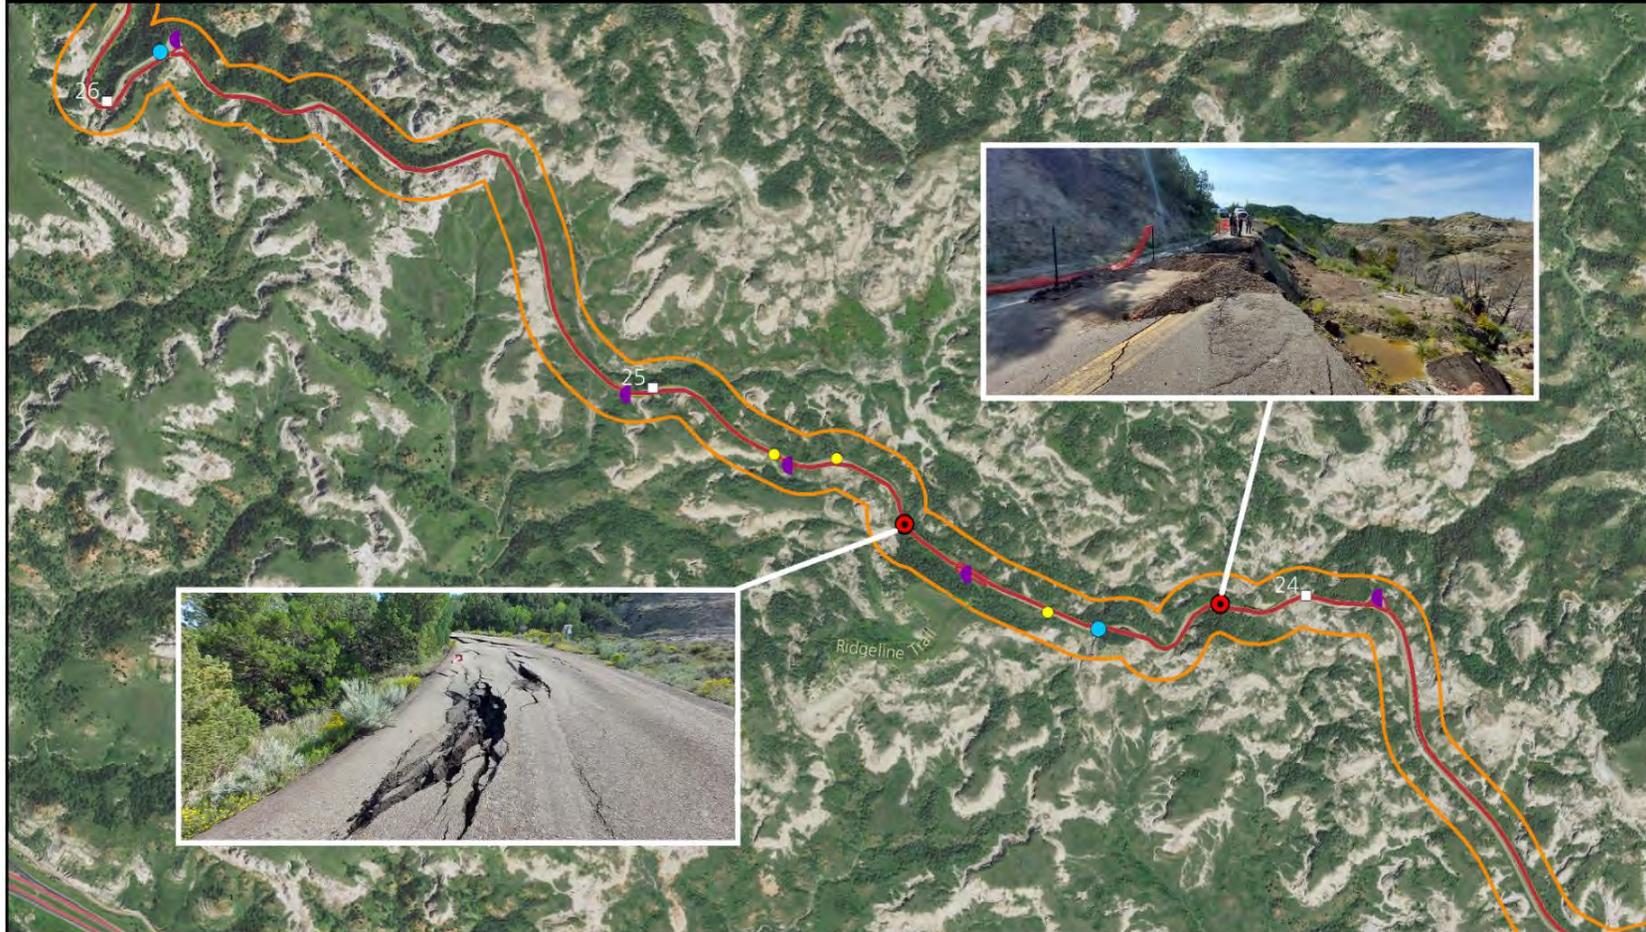
FIGURE 4. ROAD PROBLEM AREAS CENTRAL-EAST

- Mile Markers
  - Pull-Out
  - NPS Road
  - Road Closure Zone
- Road Problem Areas (20191025)**
- Major Issue - Road Failure
  - Major Issue - Needs Detailed Examination
  - Continued Monitoring of Area

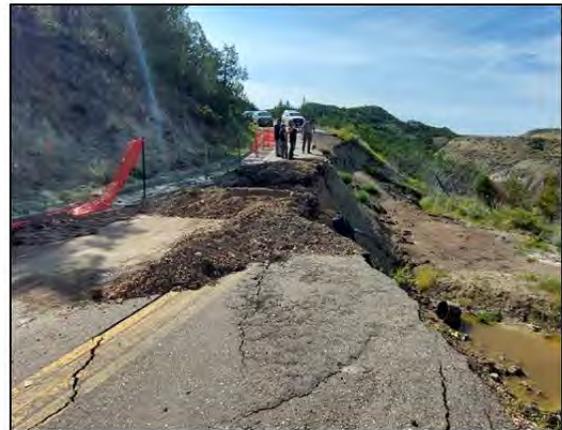
**FIGURE 9. PROJECT AREA CONDITION UNDER THE NO-ACTION ALTERNATIVE**

Alternative 1, the no-action alternative, describes current management and the existing condition of Scenic Loop Drive in the South Unit of the park (figure 9).

Under alternative 1, the 6.15-mile section of Scenic Loop Drive would remain closed to visitors, erosion would continue to worsen the condition of the roadway, and structural and accessibility issues would remain. Current management (i.e., road closure) would continue under this alternative; however, it would not relieve the risk of future roadway failures.
