Theodore Roosevelt National Park
North Dakota

**South Unit Loop Road Reconstruction Project
Wetlands and Floodplains Statement of Findings**

Theodore Roosevelt National Park
Billings County, North Dakota

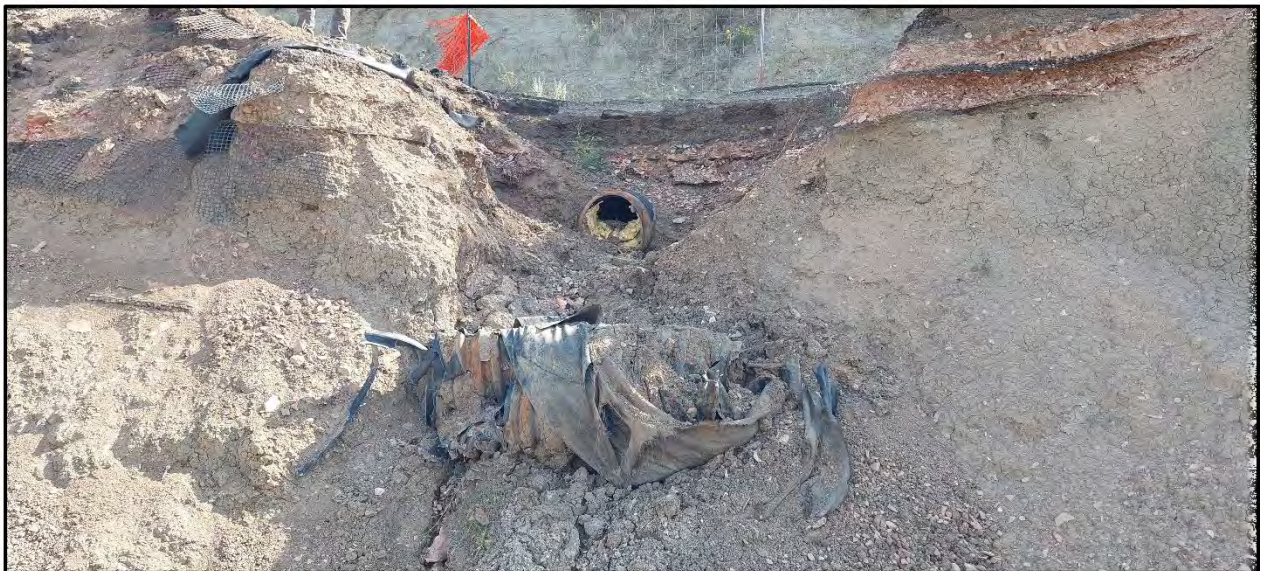
FIGURE 1. A FAILED SECTION OF SCENIC LOOP DRIVE FROM A LANDSLIDE

Historically, sections of Scenic Loop Drive have failed because of subsurface water conditions and existing culverts partially or fully filled with sediment. Several active seeps (i.e., wetlands where groundwater reaches the surface through an aquifer) have been observed, and it is assumed that most of the areas displaying embankment failure are experiencing a loss of strength because of high moisture content under the road surface.

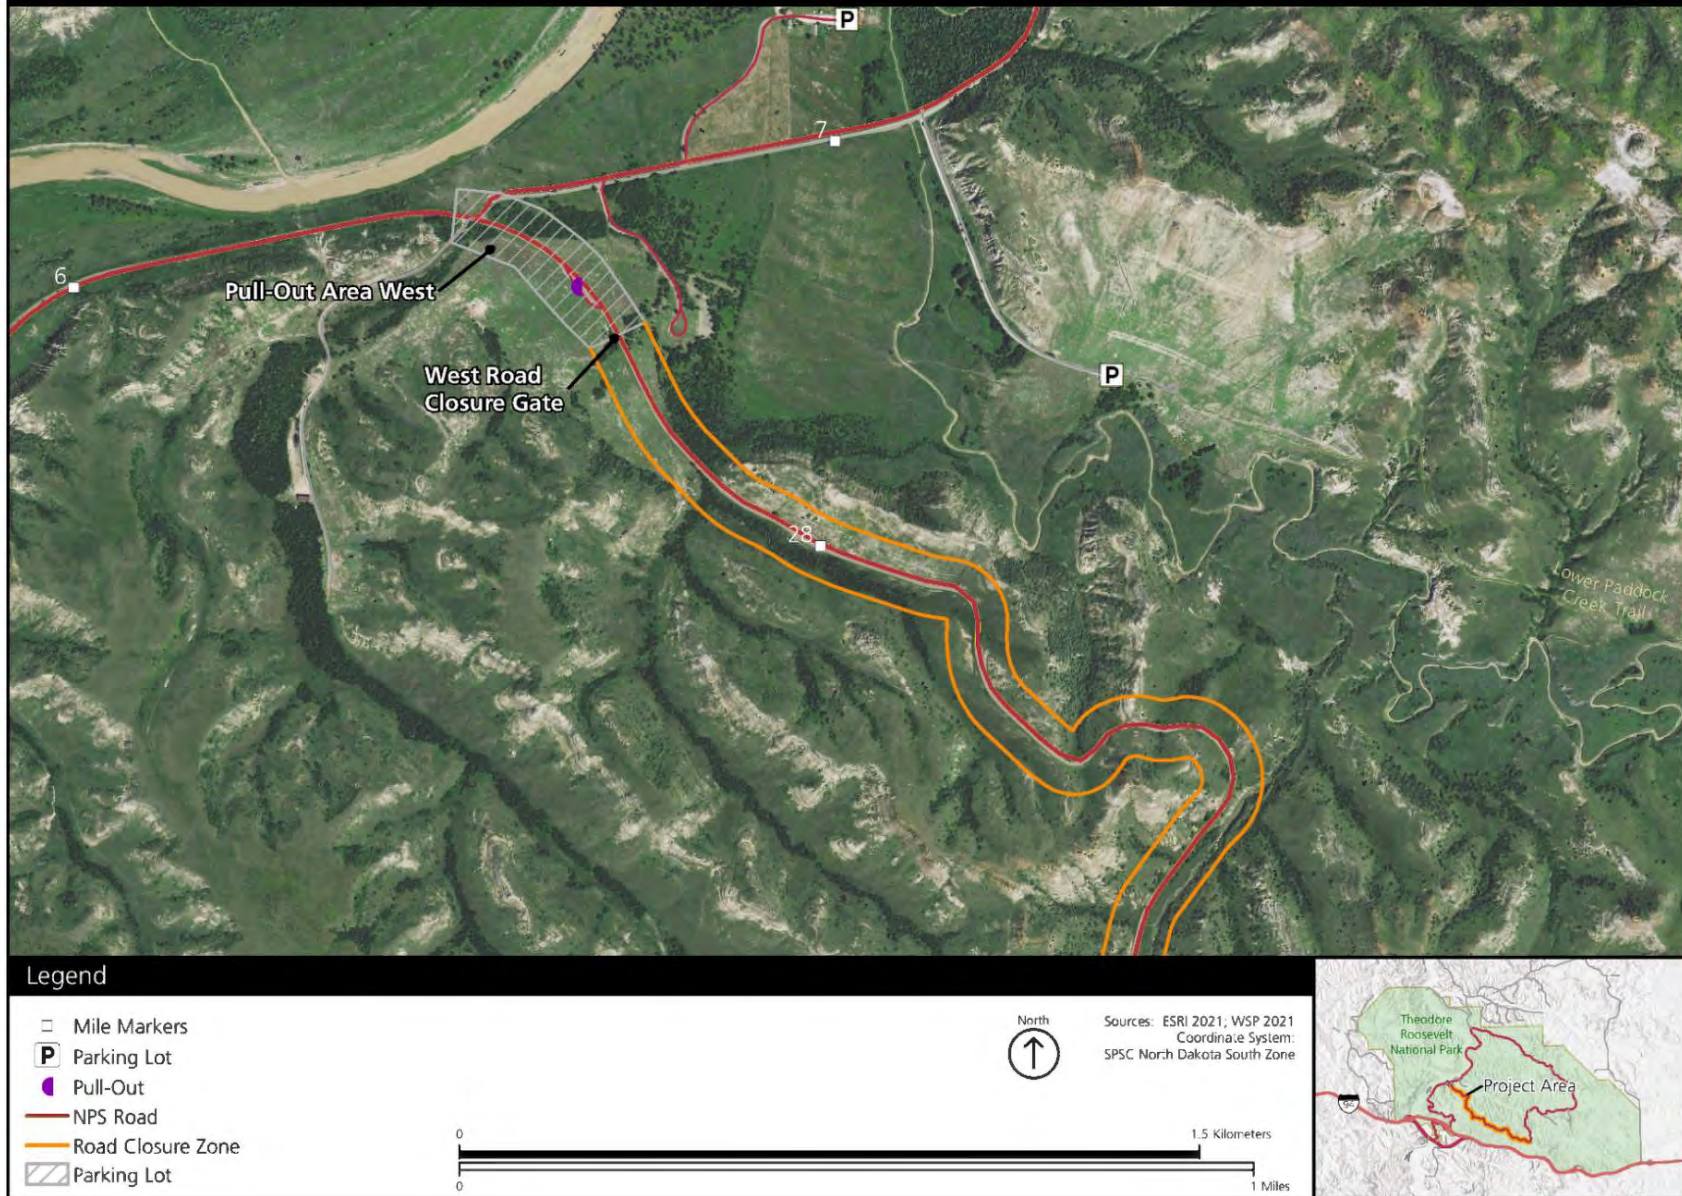
FIGURE 2. ROAD PROBLEM AREAS: WEST

The project is needed because the existing drainage system cannot convey stormwater runoff from the road surface effectively, resulting in unstable slopes that have damaged pavement along Scenic Loop Drive causing partial or total closures. These road closures have adversely impacted visitor enjoyment of the area and the park's ability to provide visitor services because portions of the road are currently unstable, inaccessible, and unsafe (figures 2 through 5).

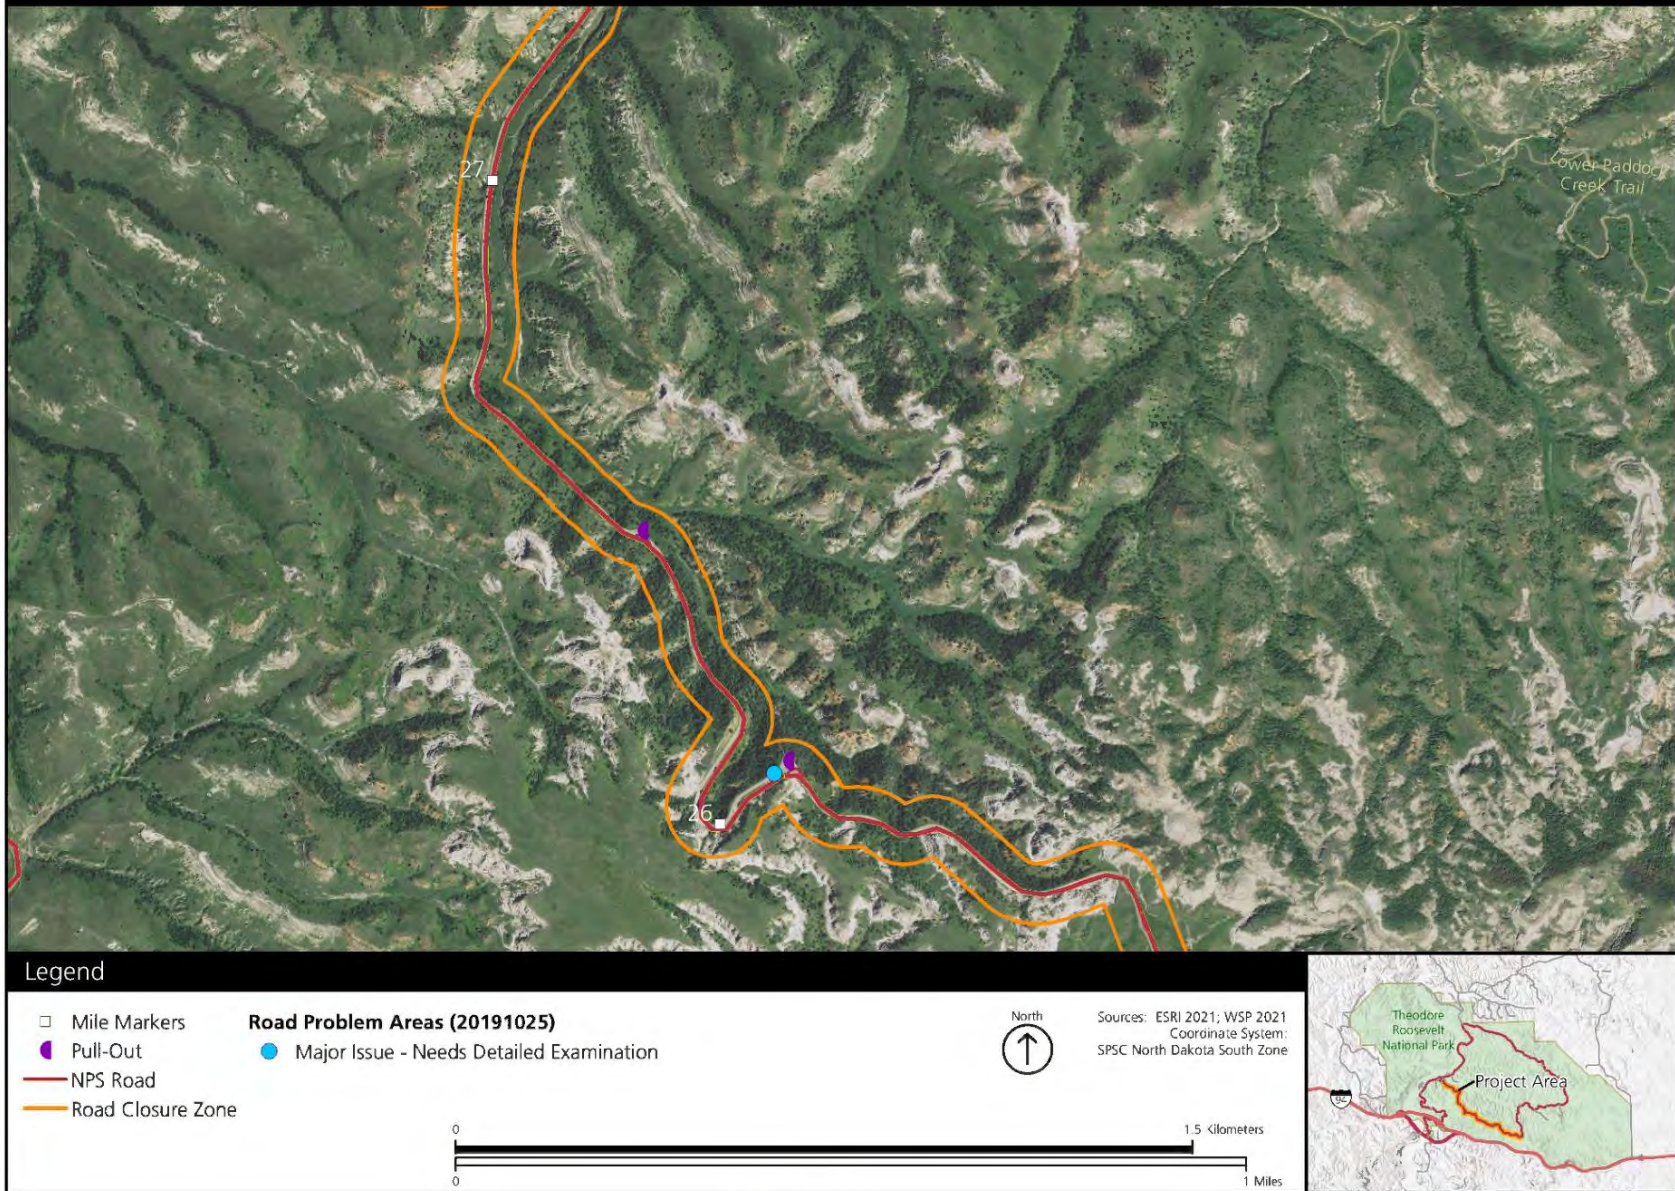
FIGURE 3. ROAD PROBLEM AREAS: WEST-CENTRAL

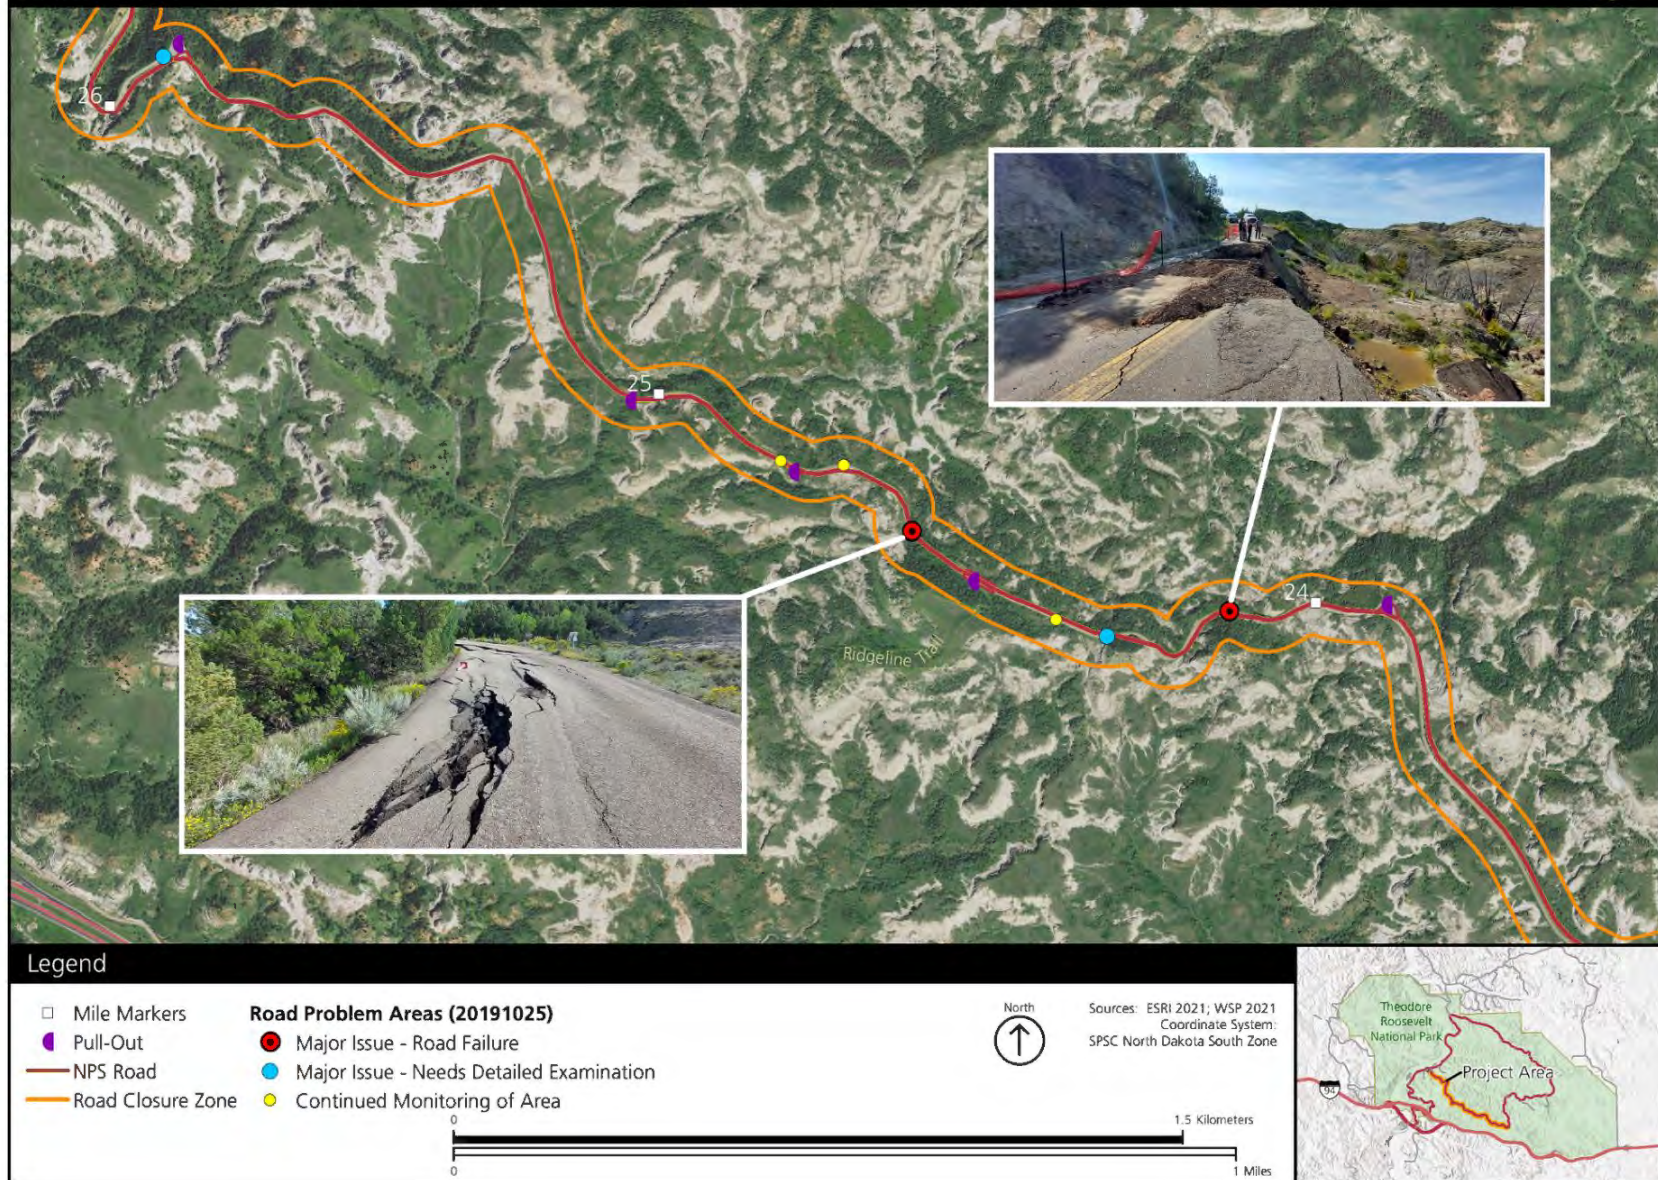
FIGURE 4. ROAD PROBLEM AREAS CENTRAL-EAST

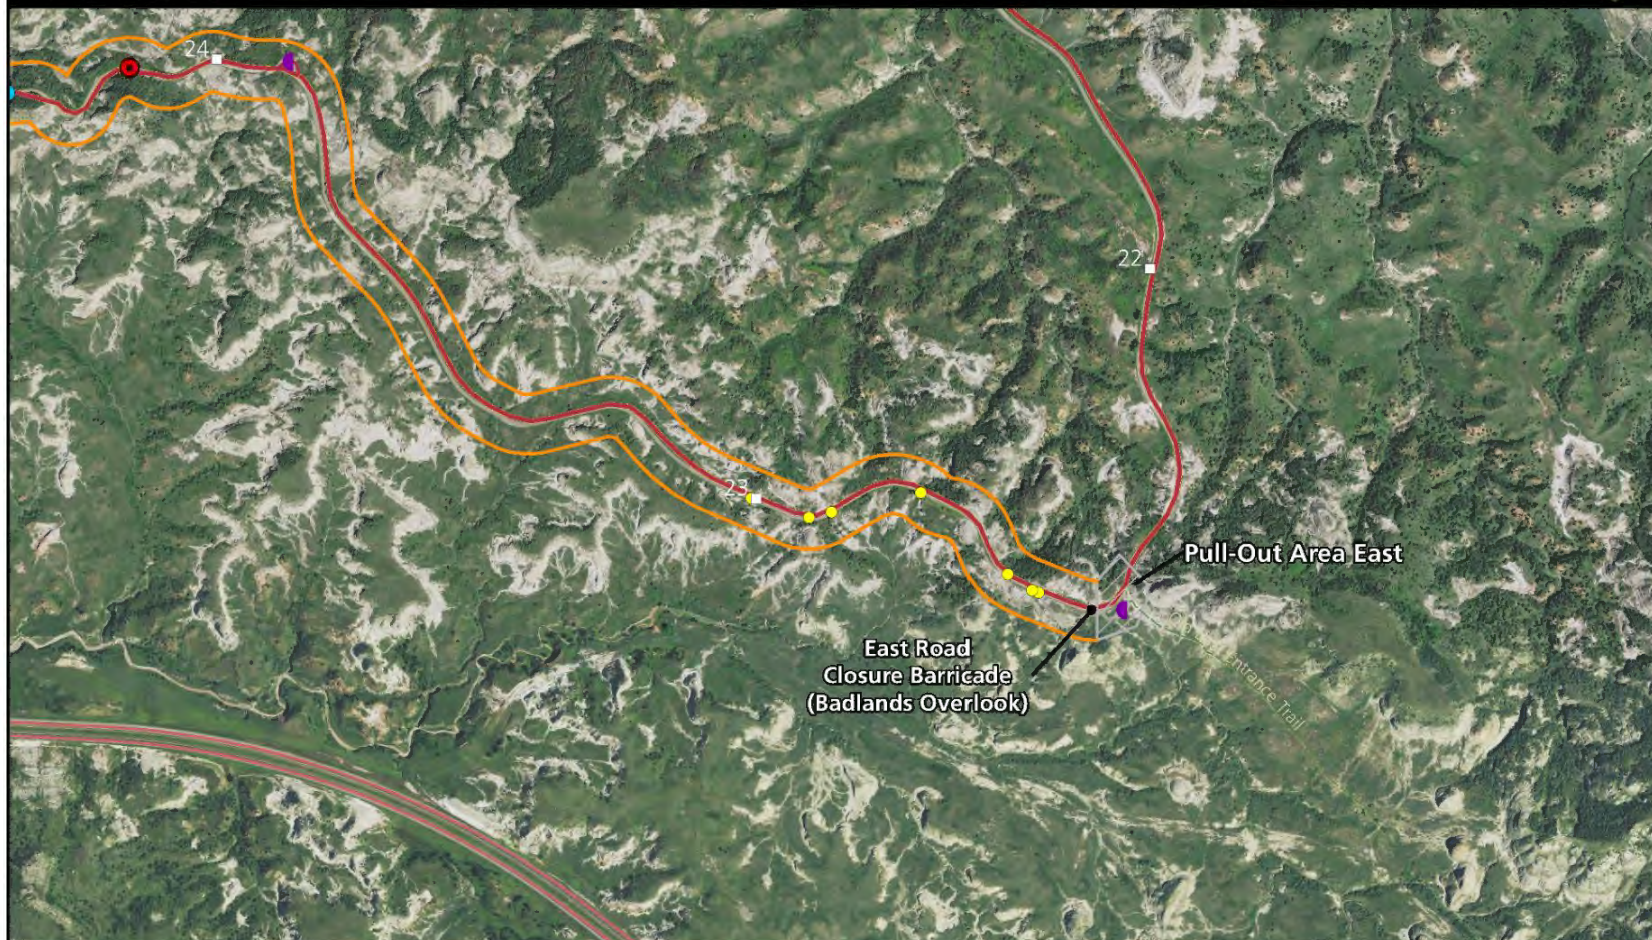
FIGURE 5. ROAD PROBLEM AREAS: EAST

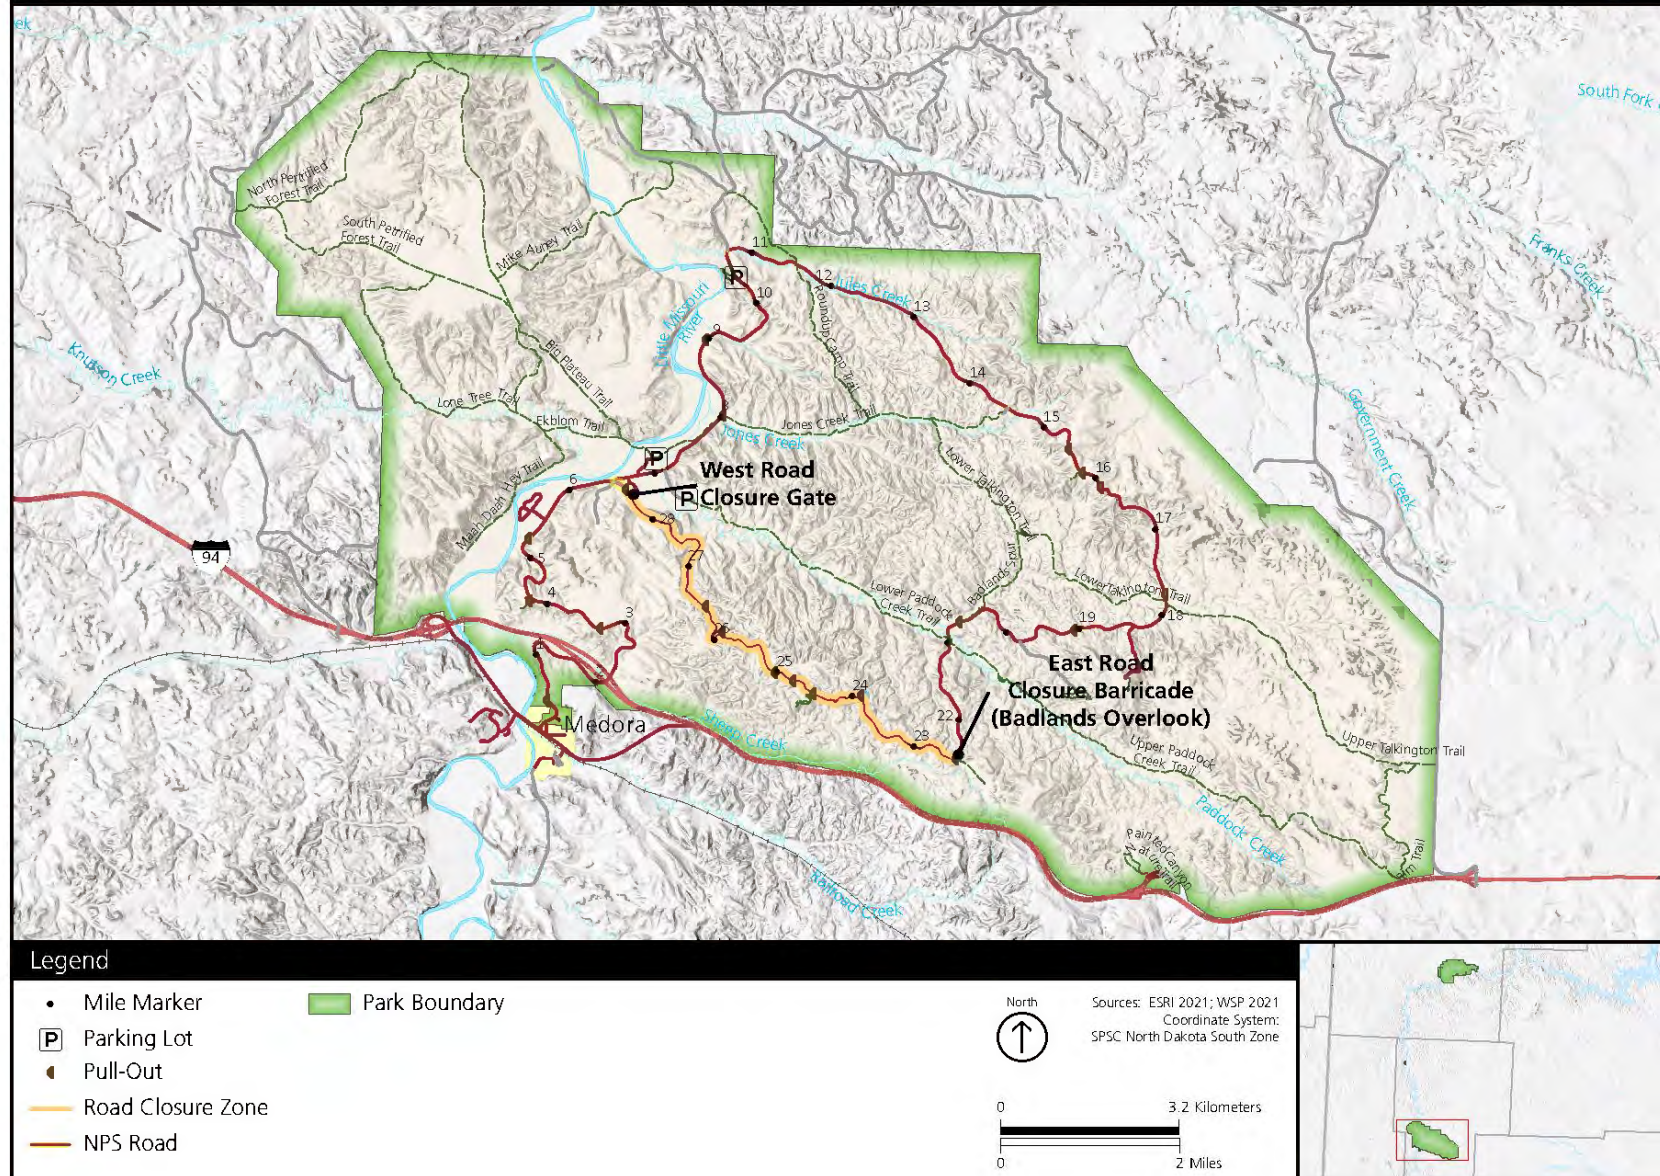
FIGURE 6. PROJECT AREA IN THE SOUTH UNIT

The project area is 6.15 miles of Scenic Loop Drive located southeast of East River Road and approximately 6.5 miles from Medora, North Dakota (figure 6). The project area consists of a 400-foot-wide corridor (i.e., approximately 200 feet from the centerline on each side of the road). The project area also includes several locations beyond the 400-foot-wide corridor to allow for adequate stormwater drainage.

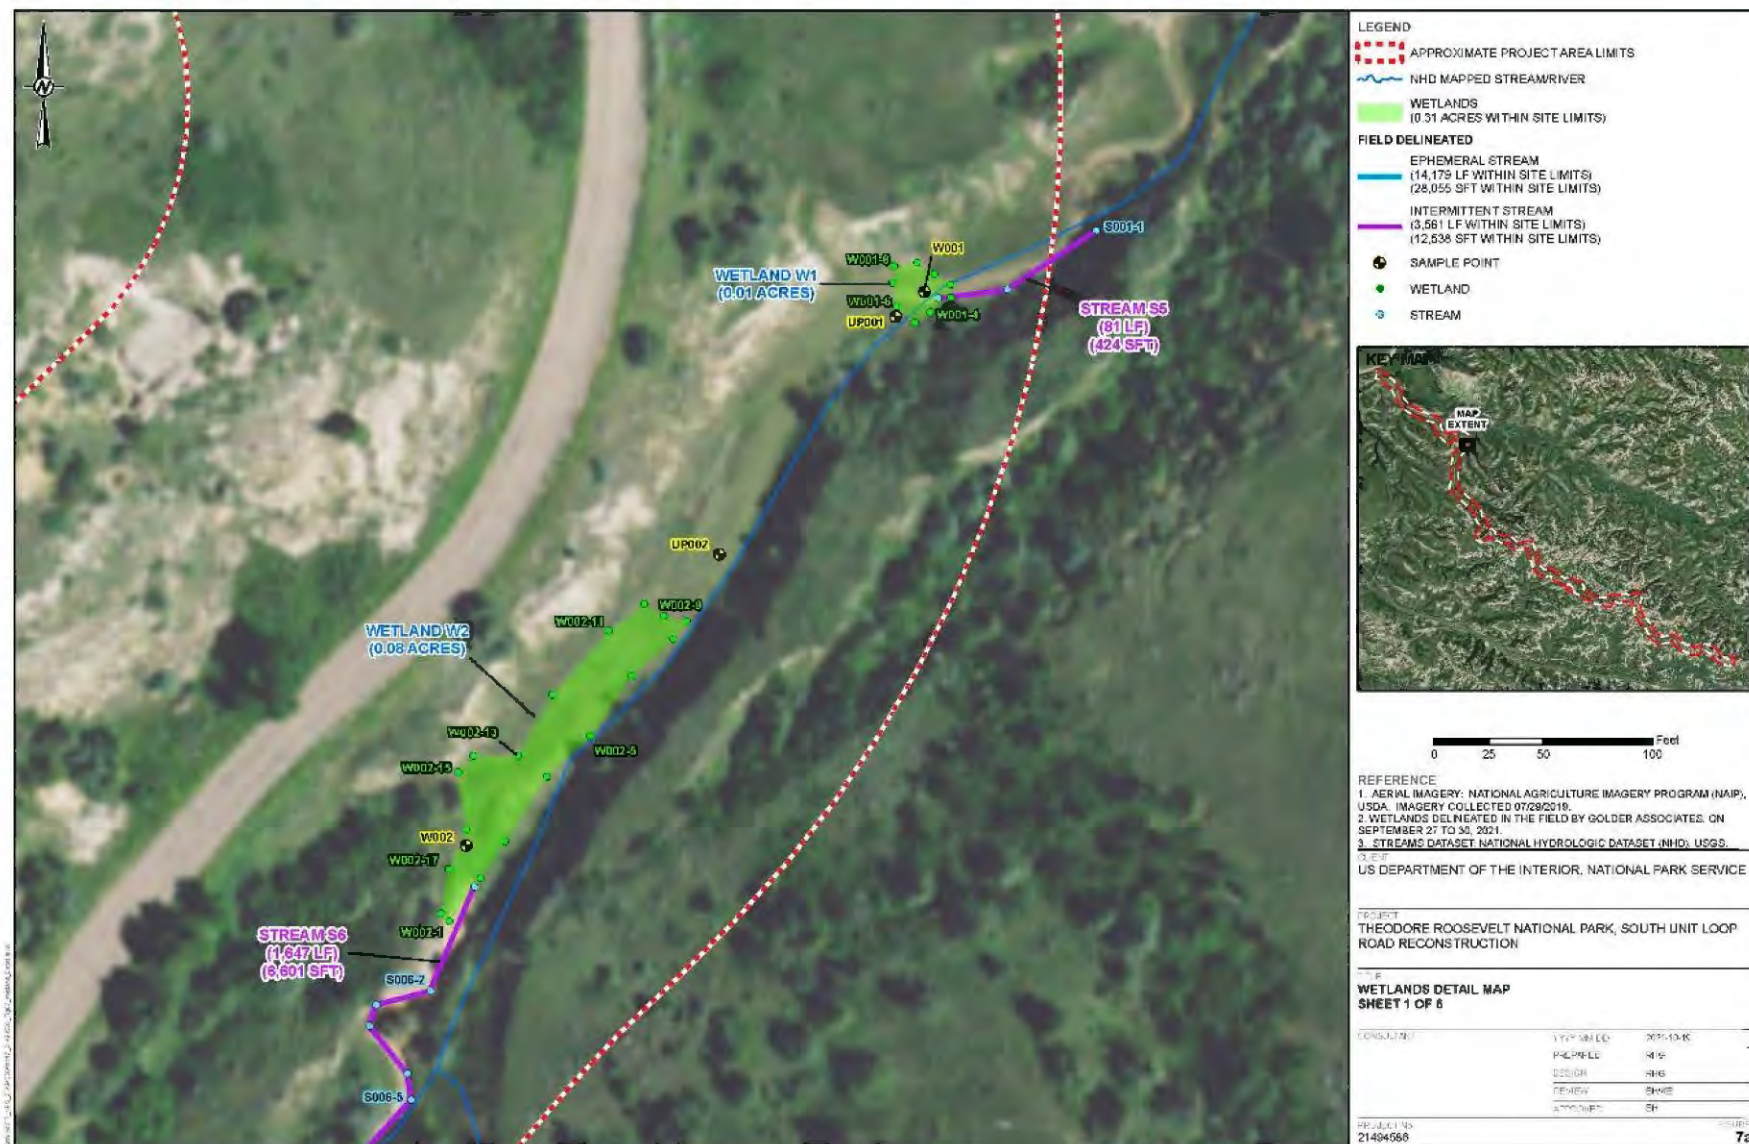
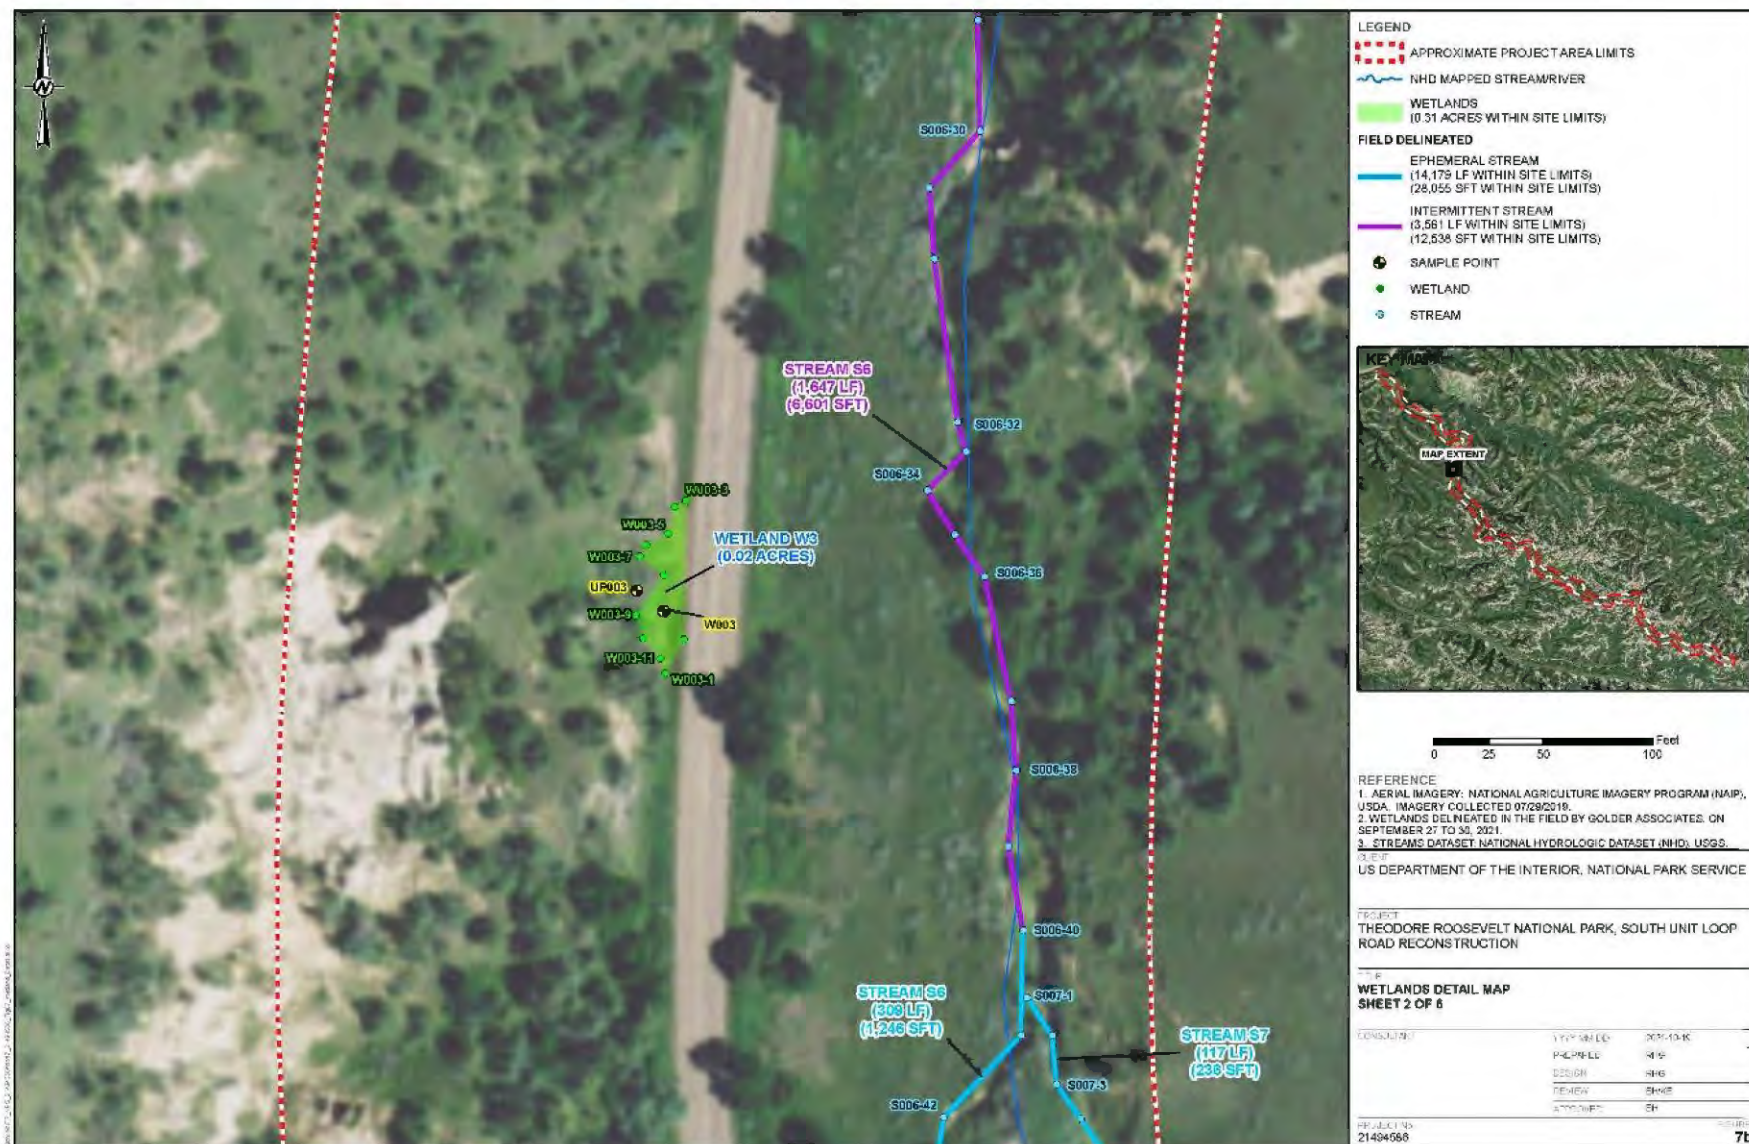
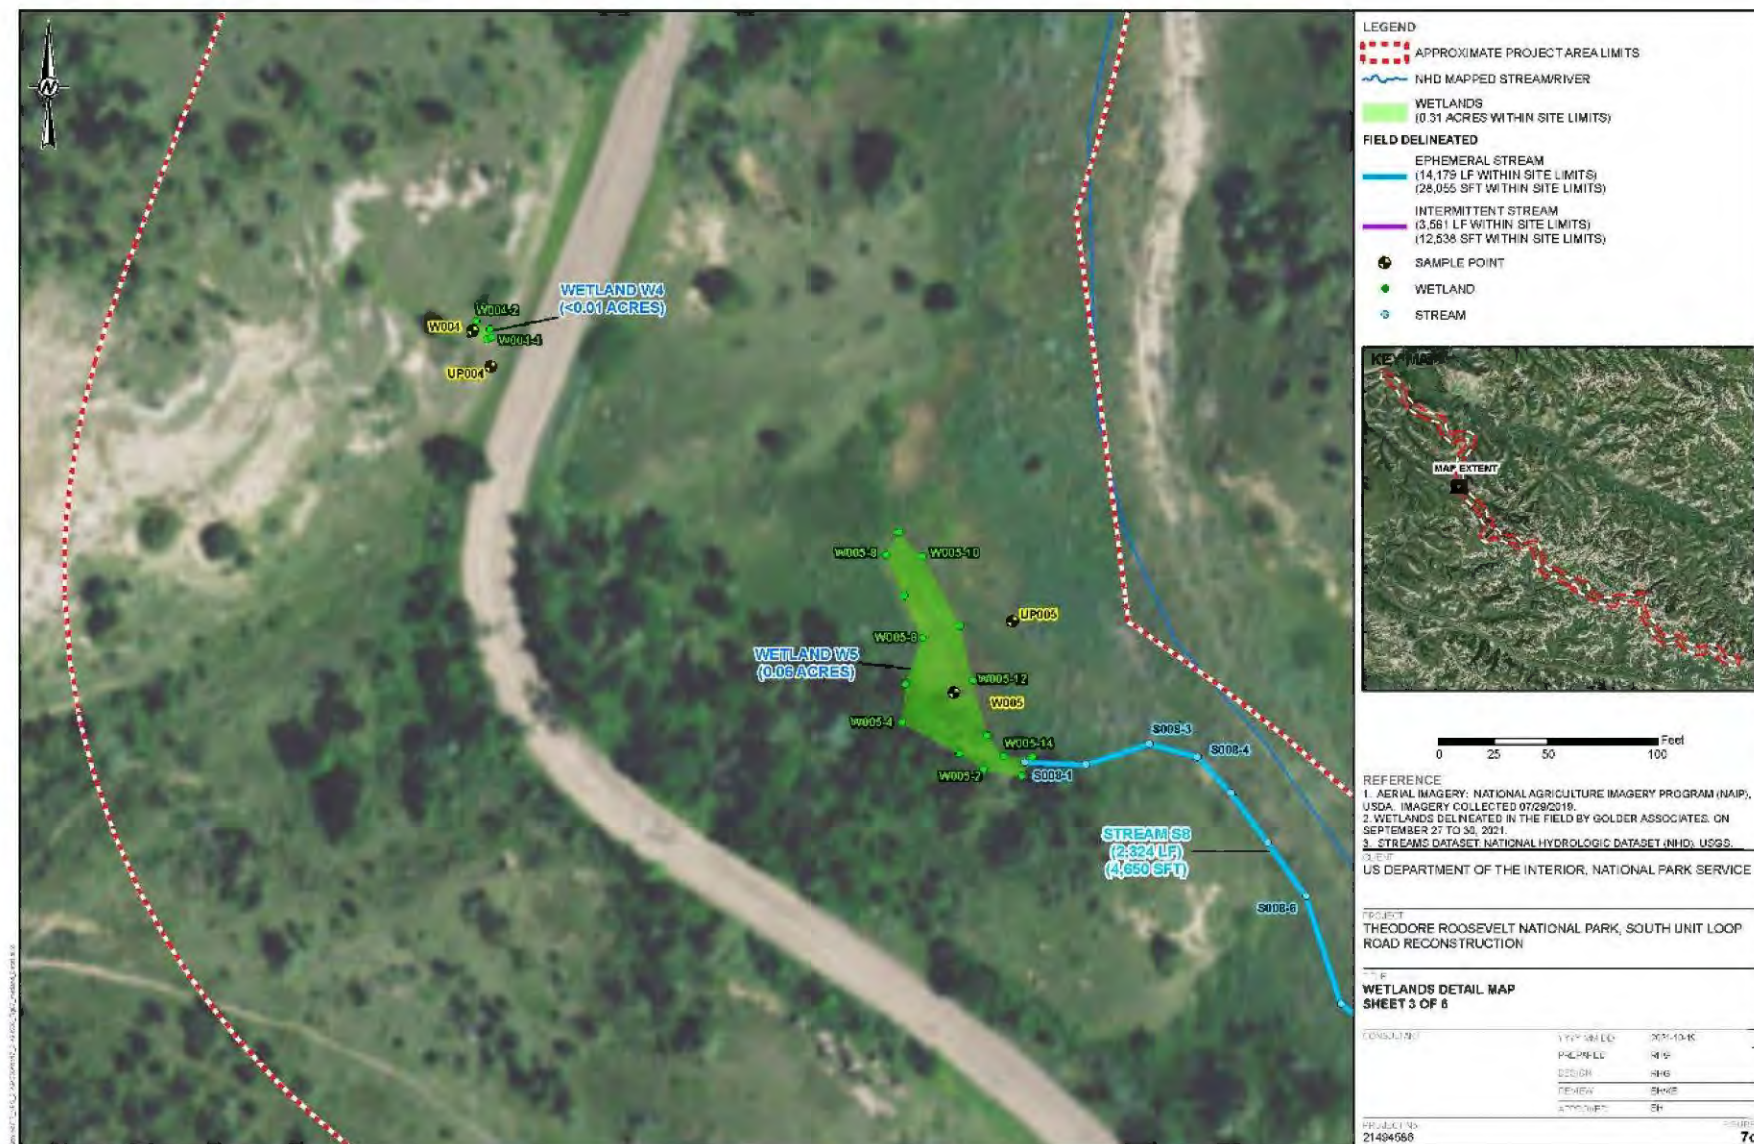
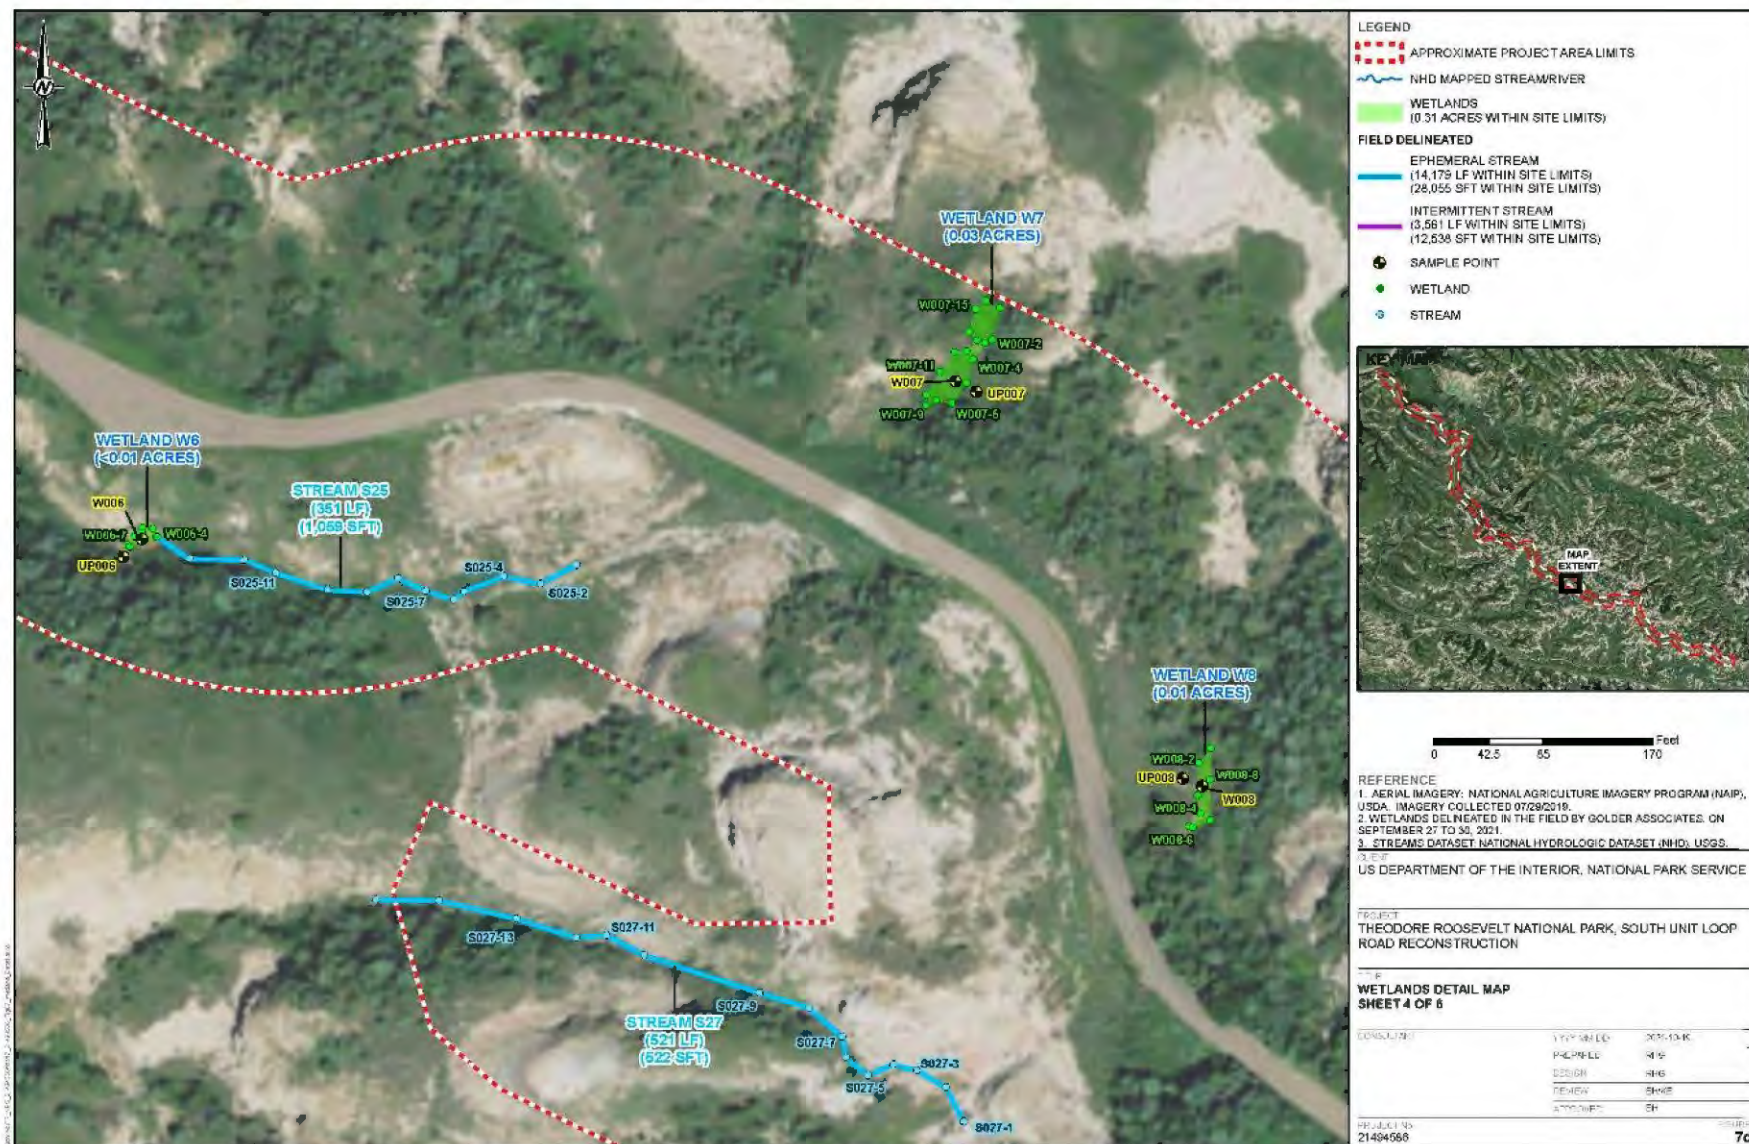
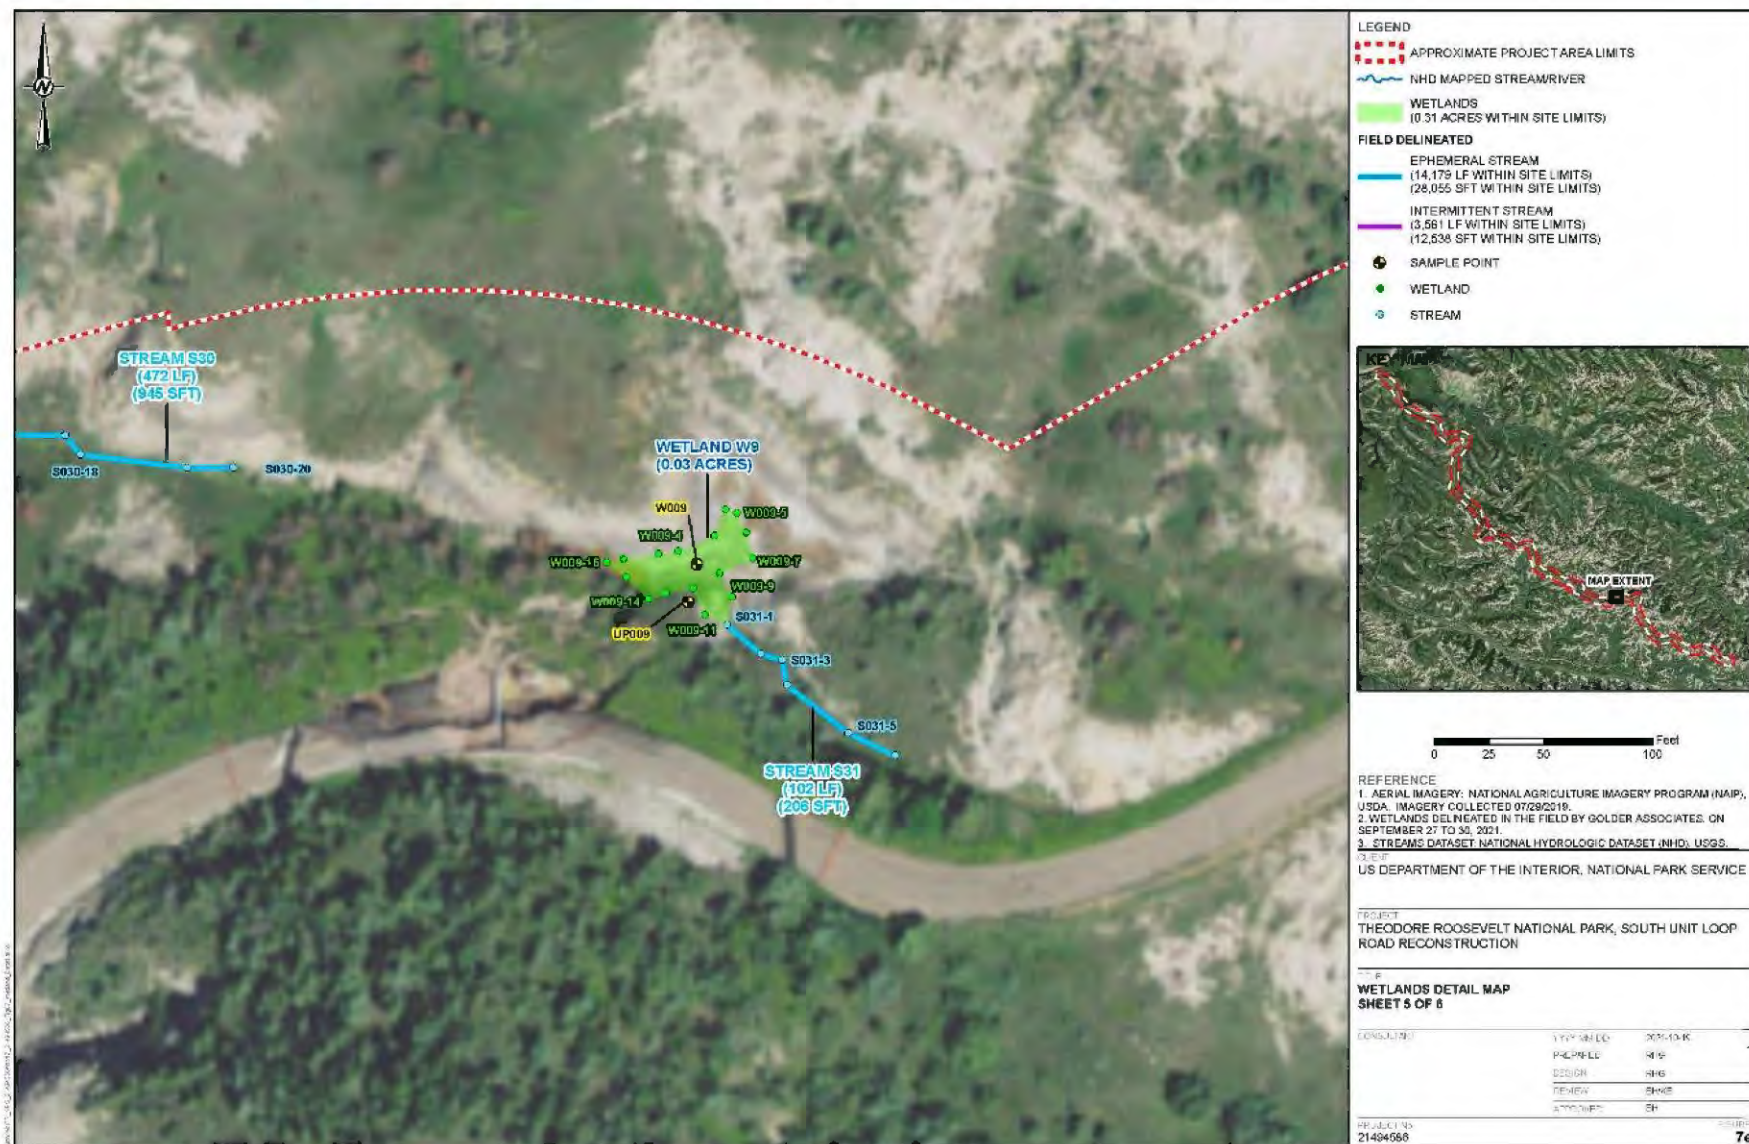
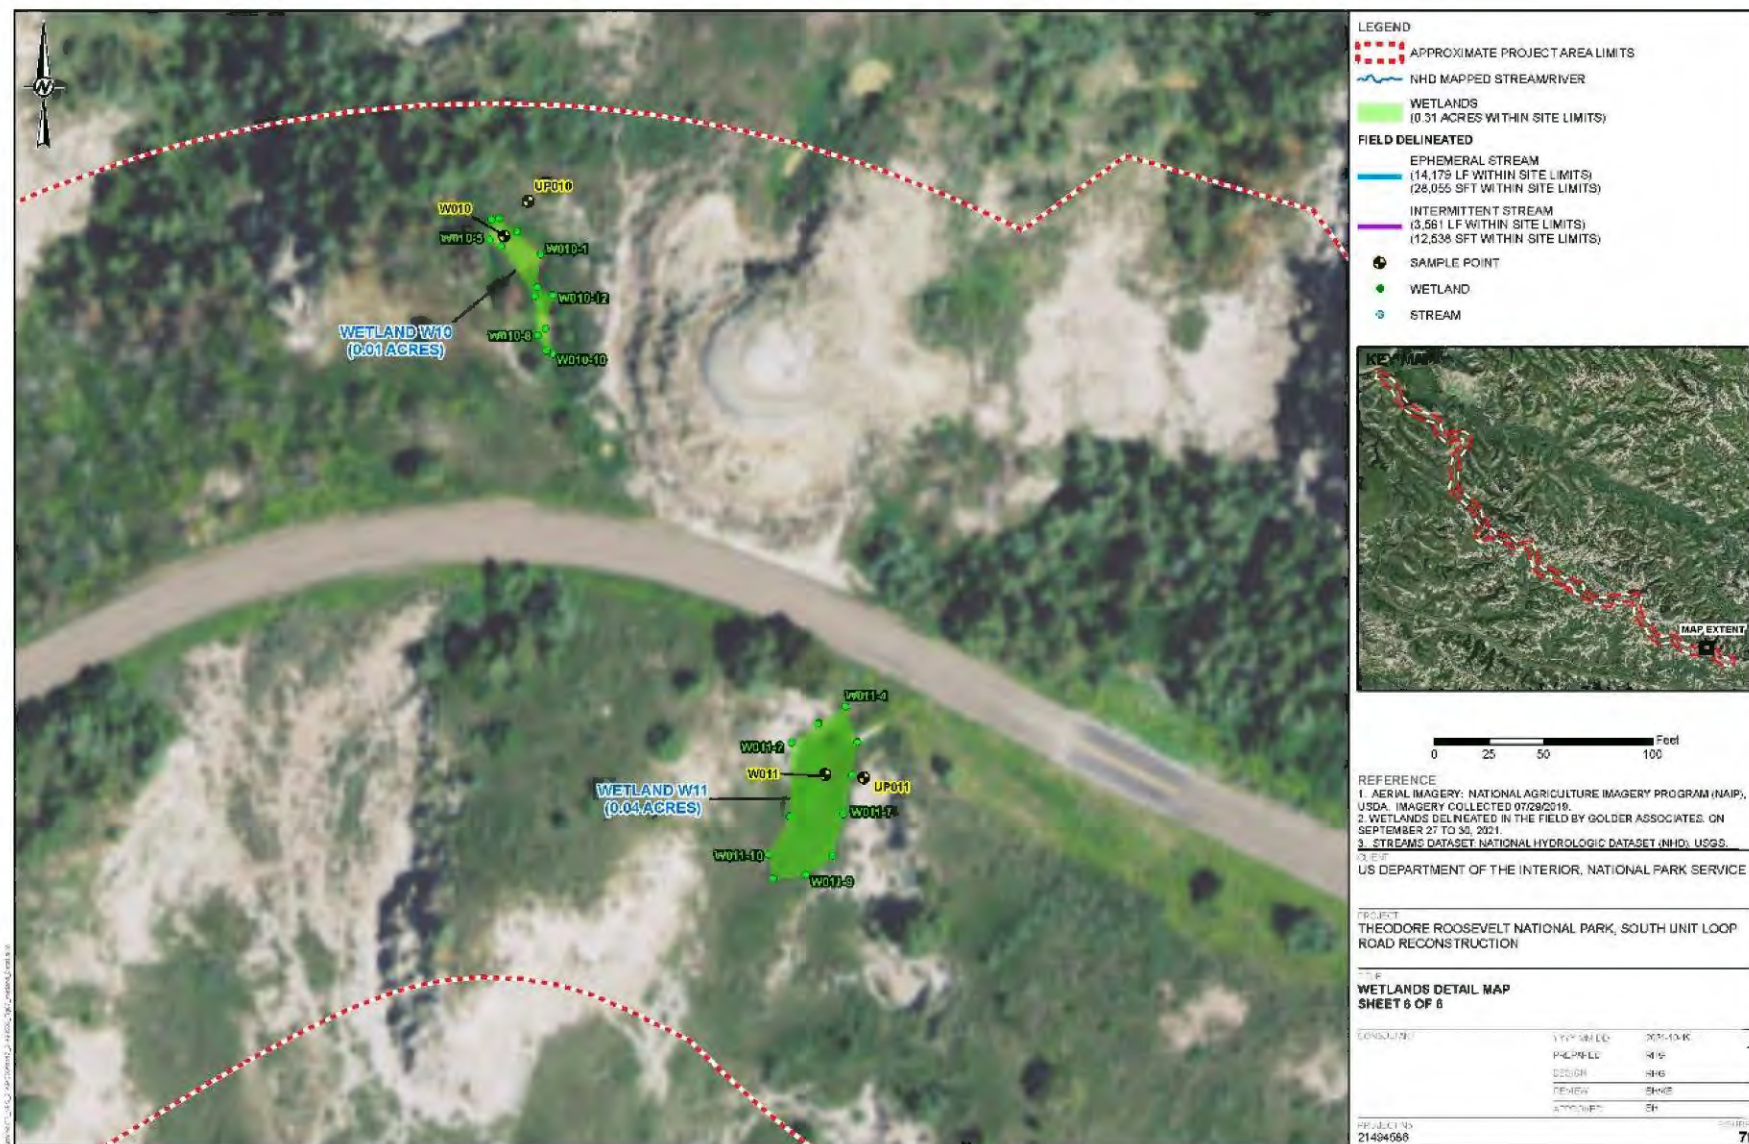
FIGURE 7A. WETLANDS DETAIL MAP

FIGURE 7B. WETLANDS DETAIL MAP

FIGURE 7C. WETLANDS DETAIL MAP

FIGURE 7D. WETLANDS DETAIL MAP

FIGURE 7E. WETLANDS DETAIL MAP

FIGURE 7F. WETLANDS DETAIL MAP

The wetland delineation identified 11 palustrine emergent (PEM) wetlands within the project area, totaling approximately 0.31 acres. These wetlands are listed in table 1 along with supplemental information collected during the delineation. Figures 7a through 7f show the locations and classifications of the wetlands throughout the project area.
