Theodore Roosevelt National Park
North Dakota

**South Unit Loop Road Reconstruction Project
Wetlands and Floodplains Statement of Findings**

Theodore Roosevelt National Park
Billings County, North Dakota

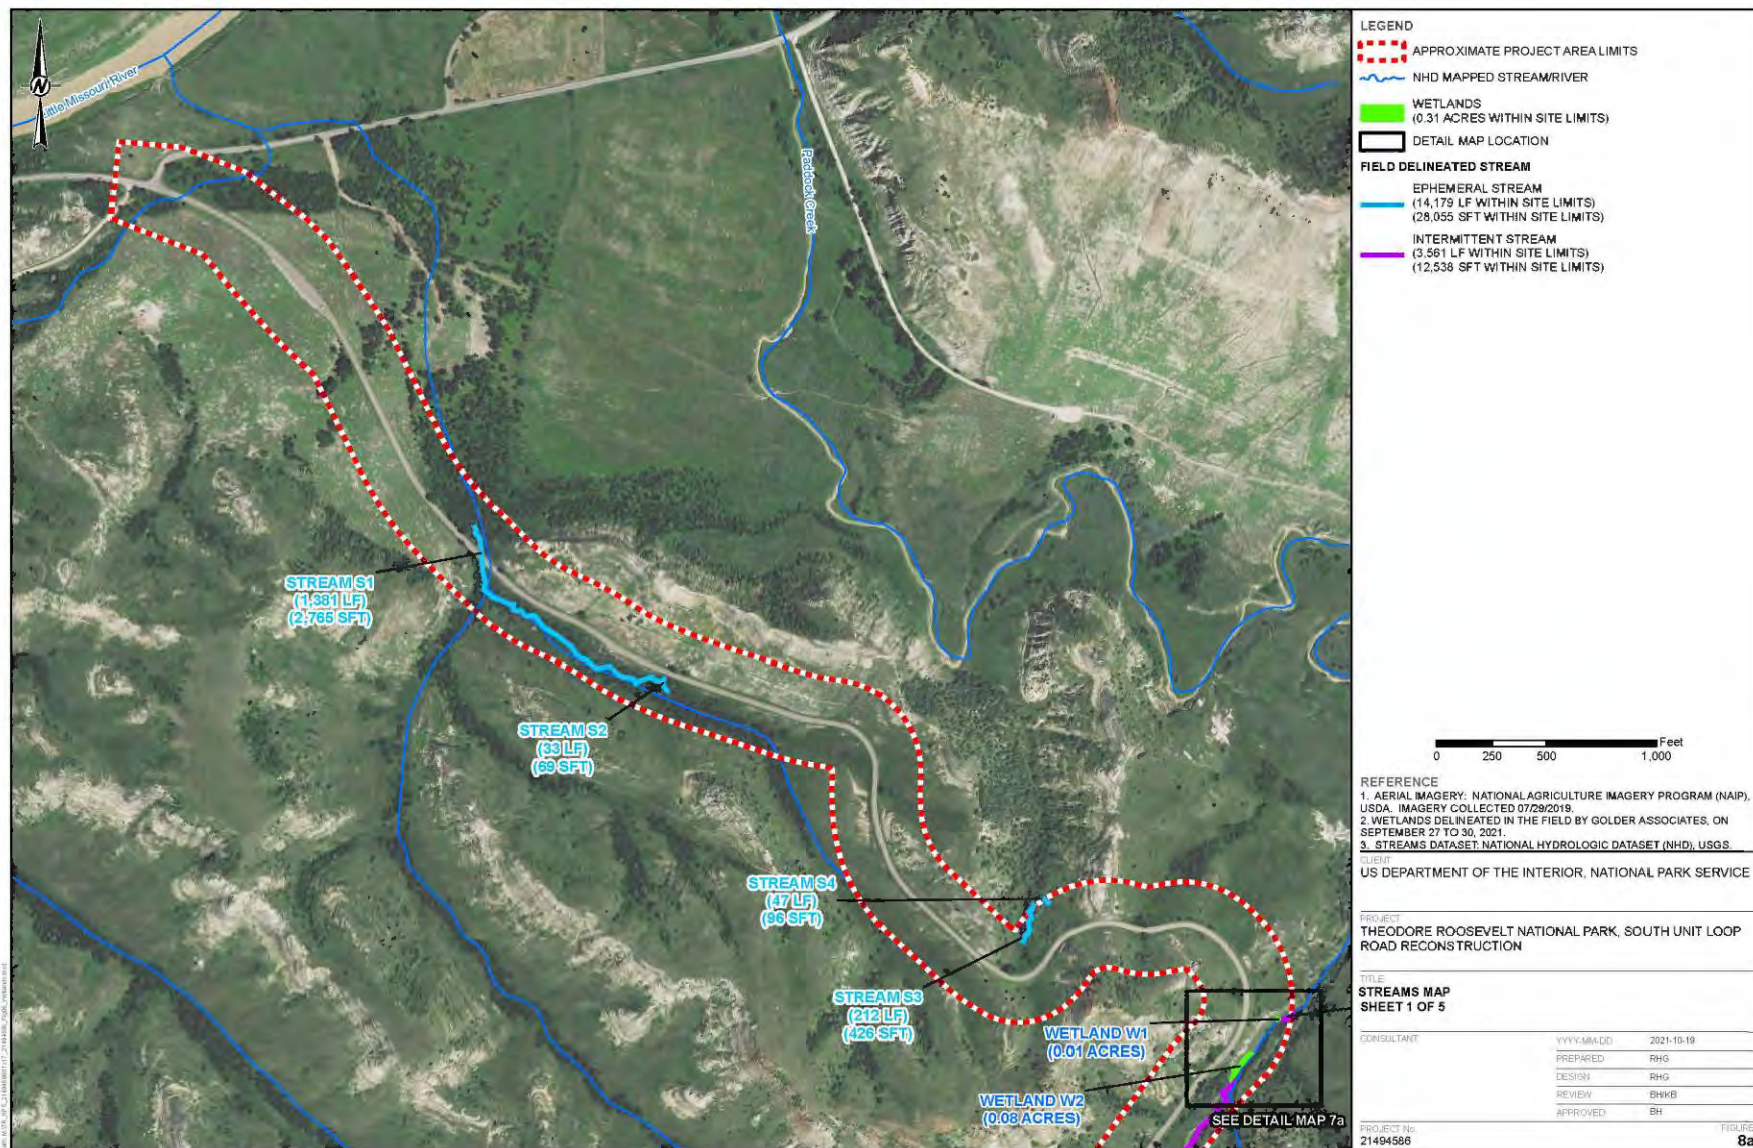
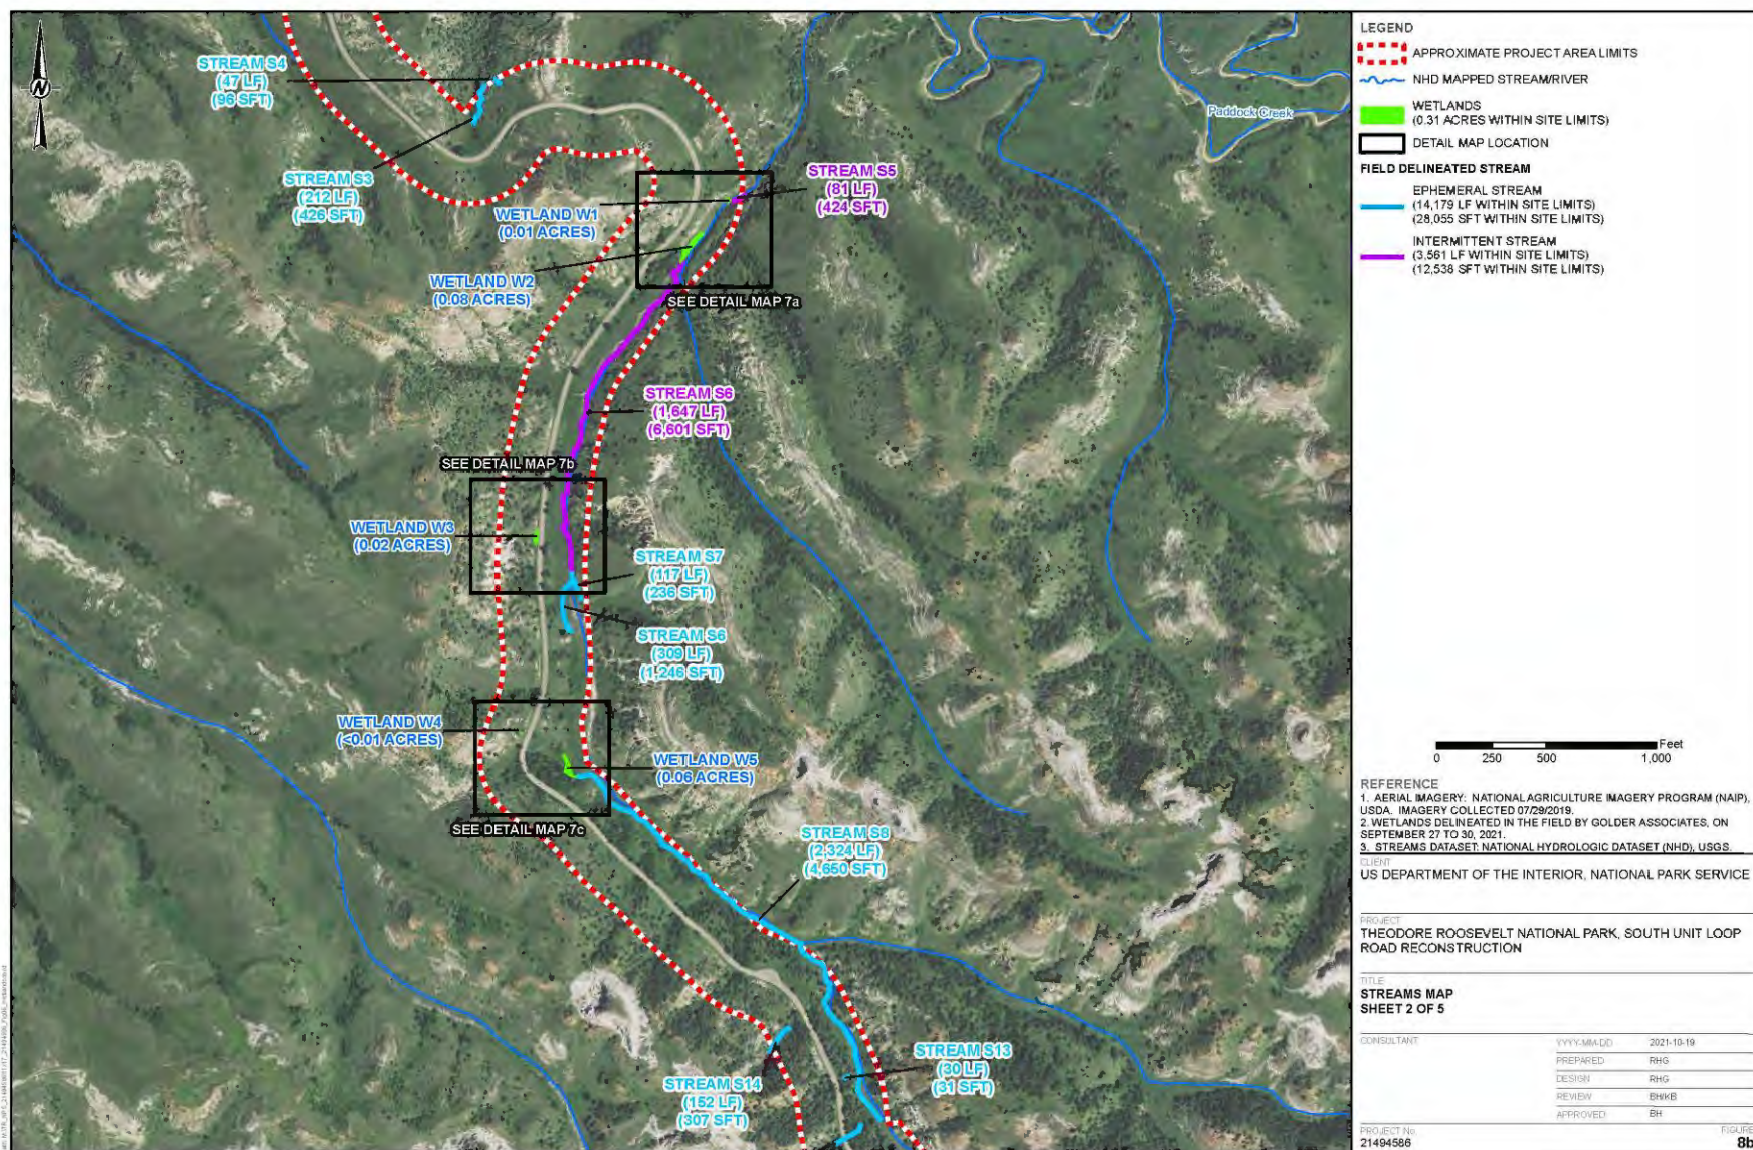
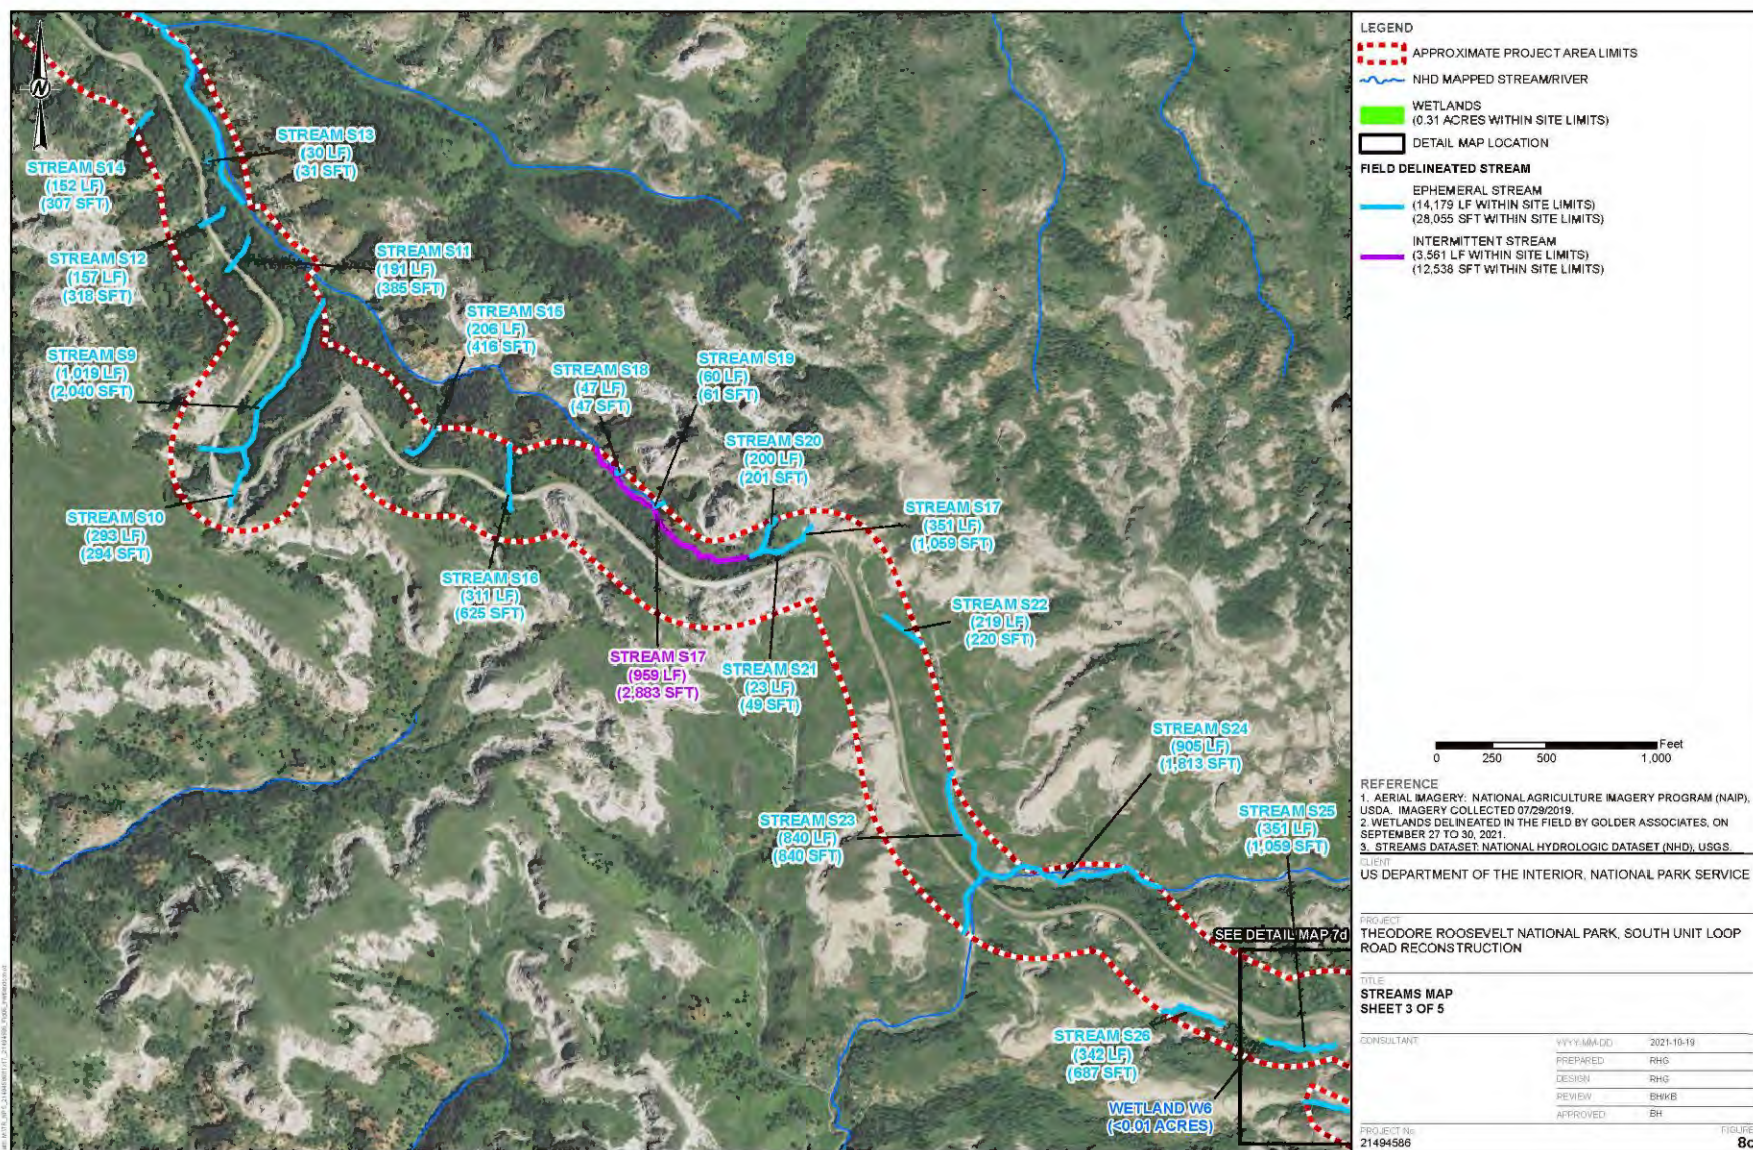
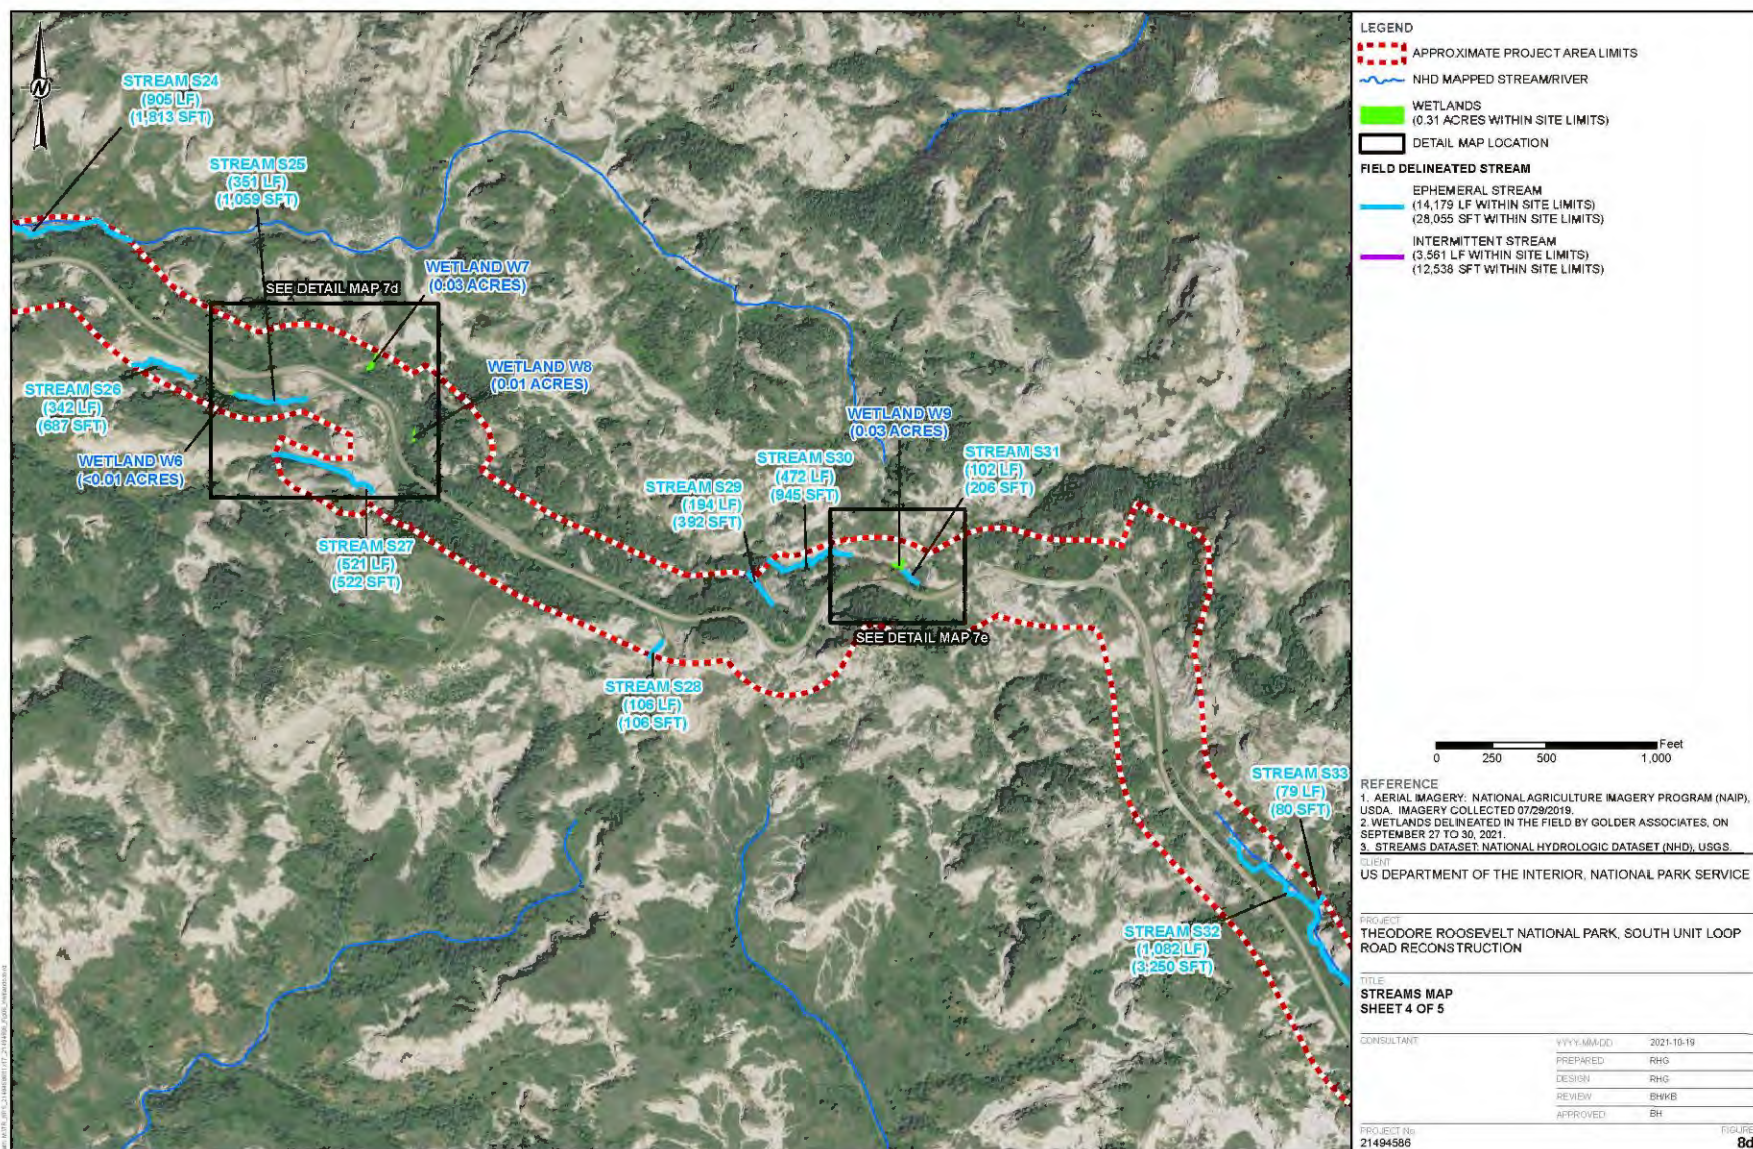
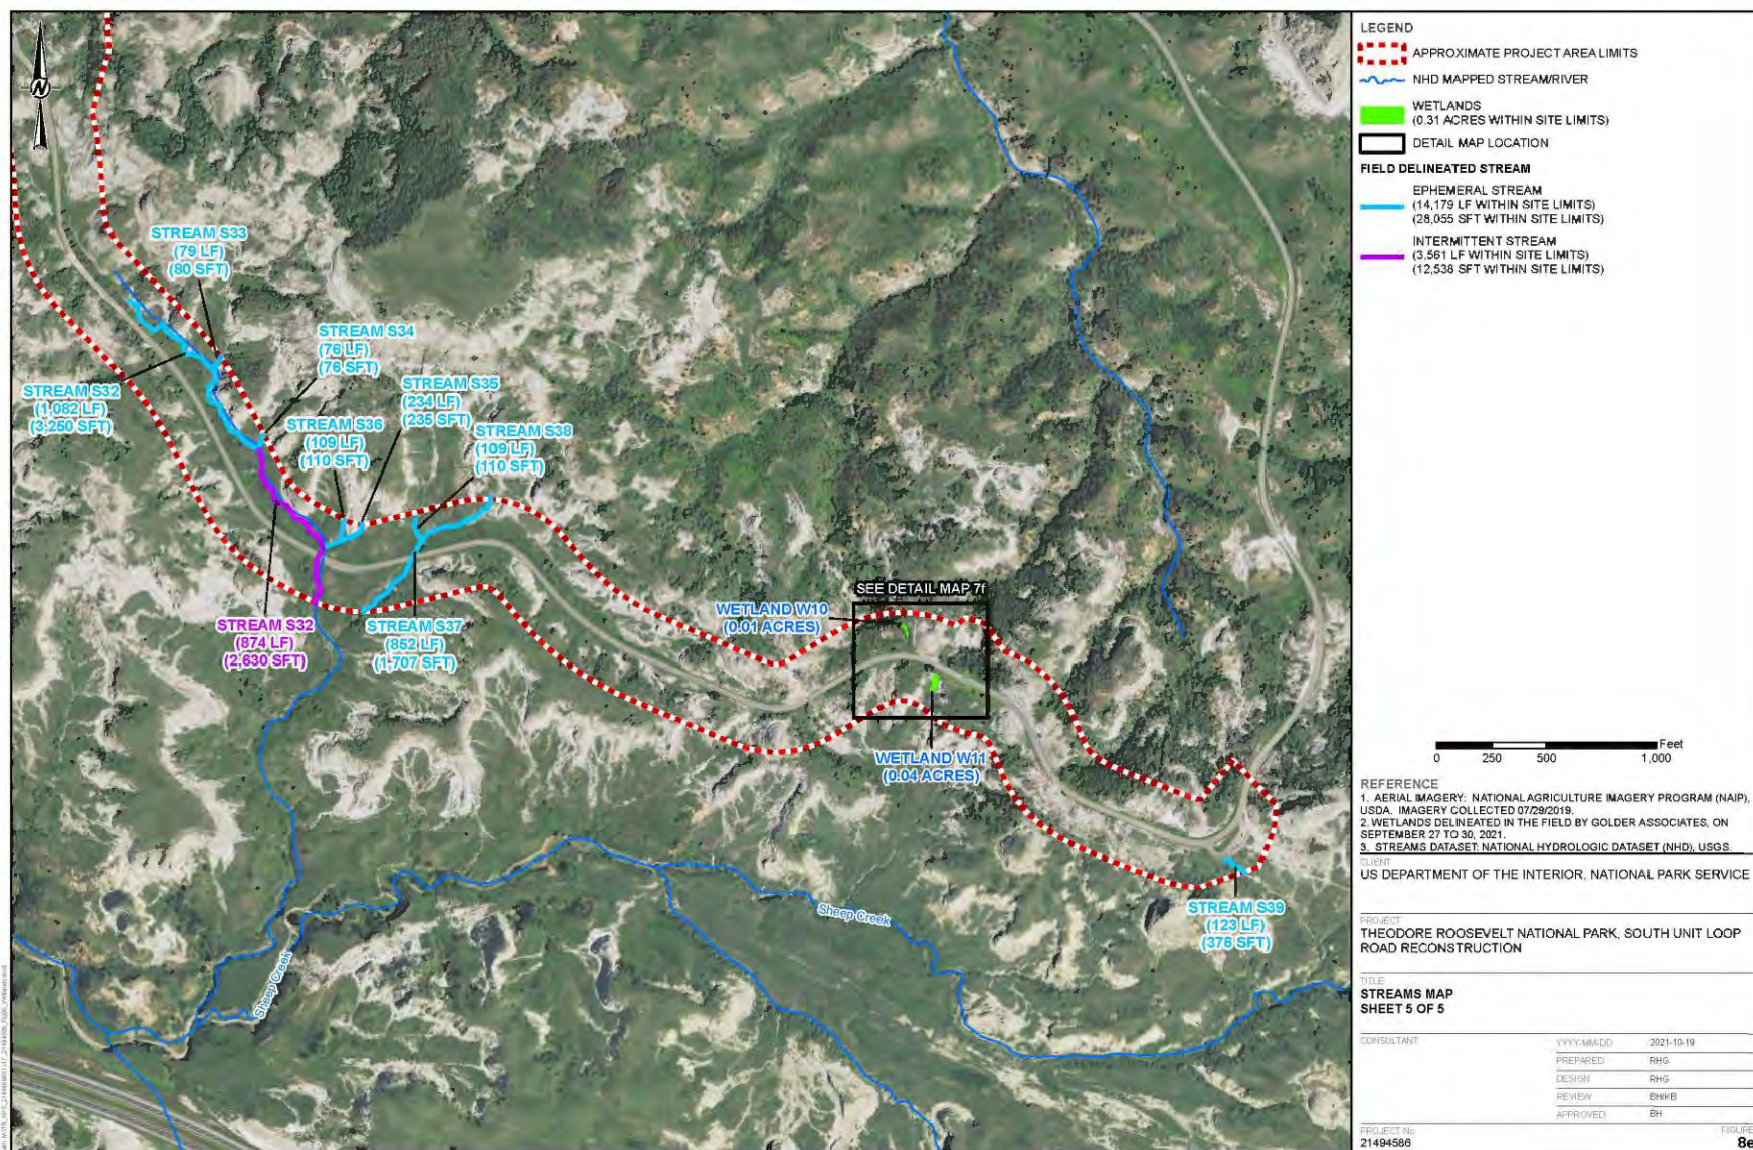
FIGURE 8A. STREAM MAP

FIGURE 8B. STREAMS MAP

FIGURE 8C. STREAMS MAP

FIGURE 8D. STREAMS MAP

FIGURE 8E. STREAMS MAP

The certified wetland delineator identified 39 streams in the project area, of which, 35 were classified as ephemeral, 3 streams contained ephemeral and intermittent reaches, and 1 was classified solely as intermittent. The length of streams totaled approximately 17,740 linear feet. These streams are listed in table 2 along with supplemental information collected during the delineation. Figures 8a–8e show the locations and classifications of the streams throughout the project area.

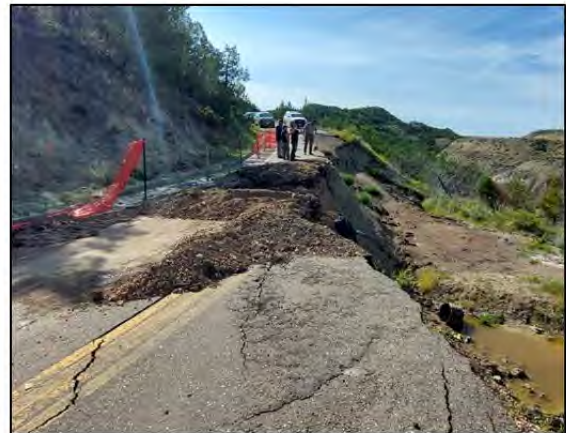
FIGURE 9. PROJECT AREA CONDITION UNDER THE NO-ACTION ALTERNATIVE

Alternative 1, the no-action alternative, describes current management and the existing condition of Scenic Loop Drive in the South Unit of the park (figure 9).

Under alternative 1, the 6.15-mile section of Scenic Loop Drive would remain closed to visitors, erosion would continue to worsen the condition of the roadway, and structural and accessibility issues would remain. Current management (i.e., road closure) would continue under this alternative; however, it would not relieve the risk of future roadway failures.
